Foul and Surface Water Drainage Report

2 Reservoir Place, Ashurst

Reference **C3547**

Project Name: 2 Reservoir Place
Project Description: CCTV survey, trace and plot
Project Status: Complete
Project Date: 14/02/2025
Inspection Standard: MSCC5 Sewers & Drainage GB (SRM5 Scoring)

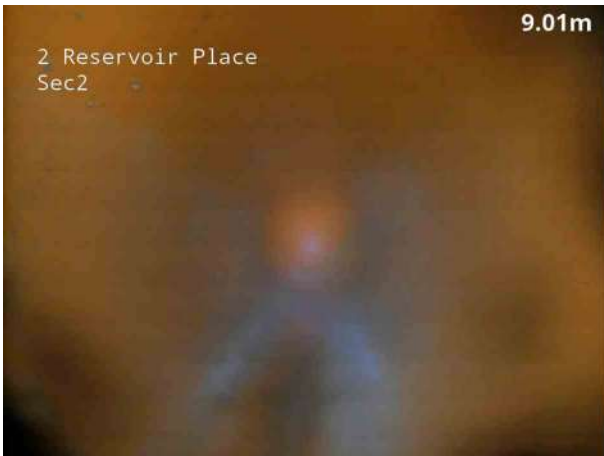
3, 00:01:16, 9.00 m
Settled deposits, fine, 5% cross-sectional area loss, finish

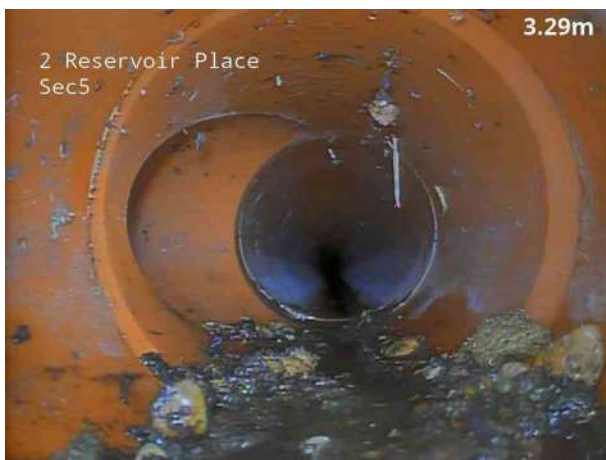
3, 00:00:23, 3.40 m
Junction at 9 o'clock, 100mm dia

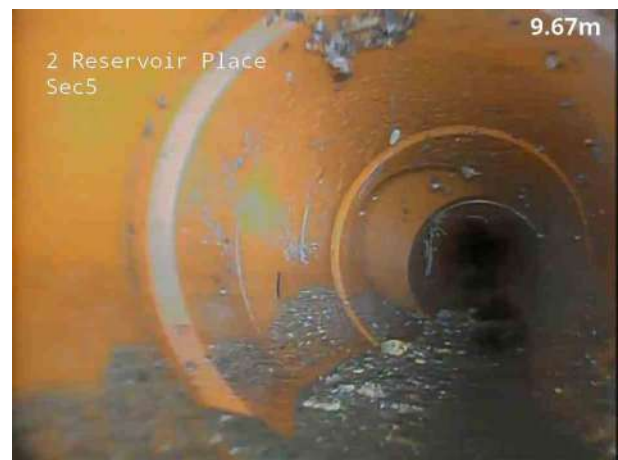
4, 00:00:37, 9.70 m
Line deviates right

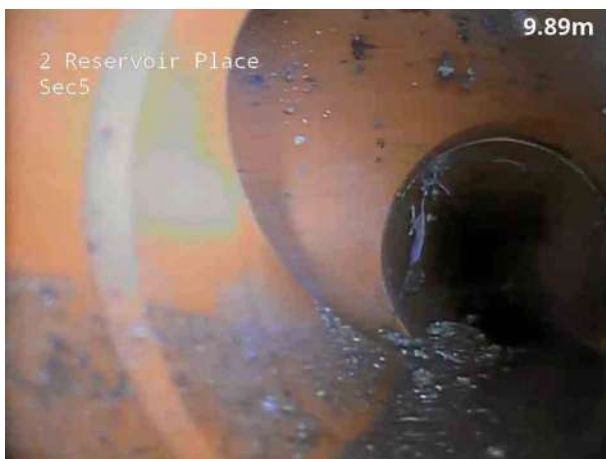
5, 00:00:48, 9.90 m
Junction at 9 o'clock, 100mm dia

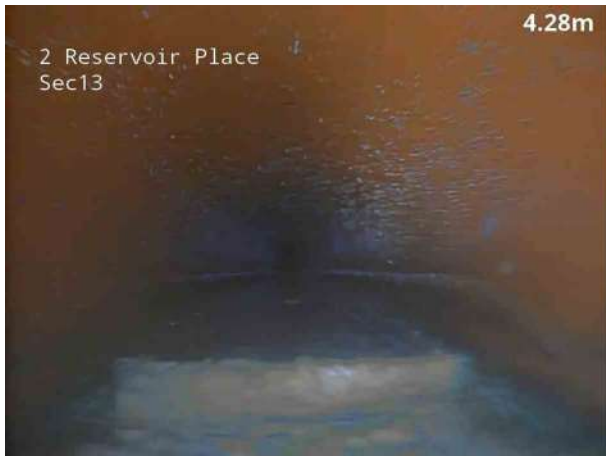
3, 00:00:21, 4.30 m
Attached deposits, fouling from 5 o'clock to 7 o'clock, 10% cross-sectional area loss, change, Scale

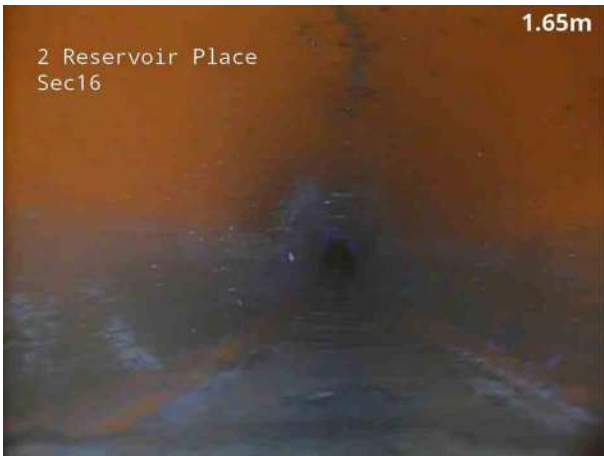
3, 00:00:20, 1.70 m
Settled deposits, other, 5% cross-sectional area loss, finish

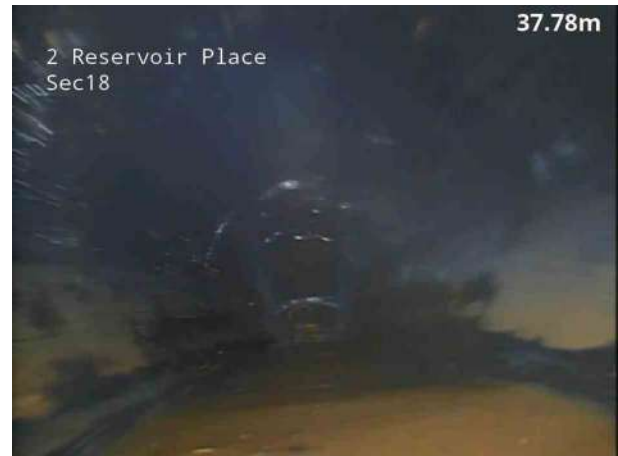
10, 00:03:06, 37.40 m
Attached deposits, fouling from 3 o'clock to 9 o'clock, 20% cross-sectional area loss, finish
