*Project ref: TV241020*

SITE: 45 The Broadway  
Haywards Heath  
West Sussex  
RH16 3AS

# ***CCTV Survey Report***

*Sewer Inspection, Cleaning and Repair*

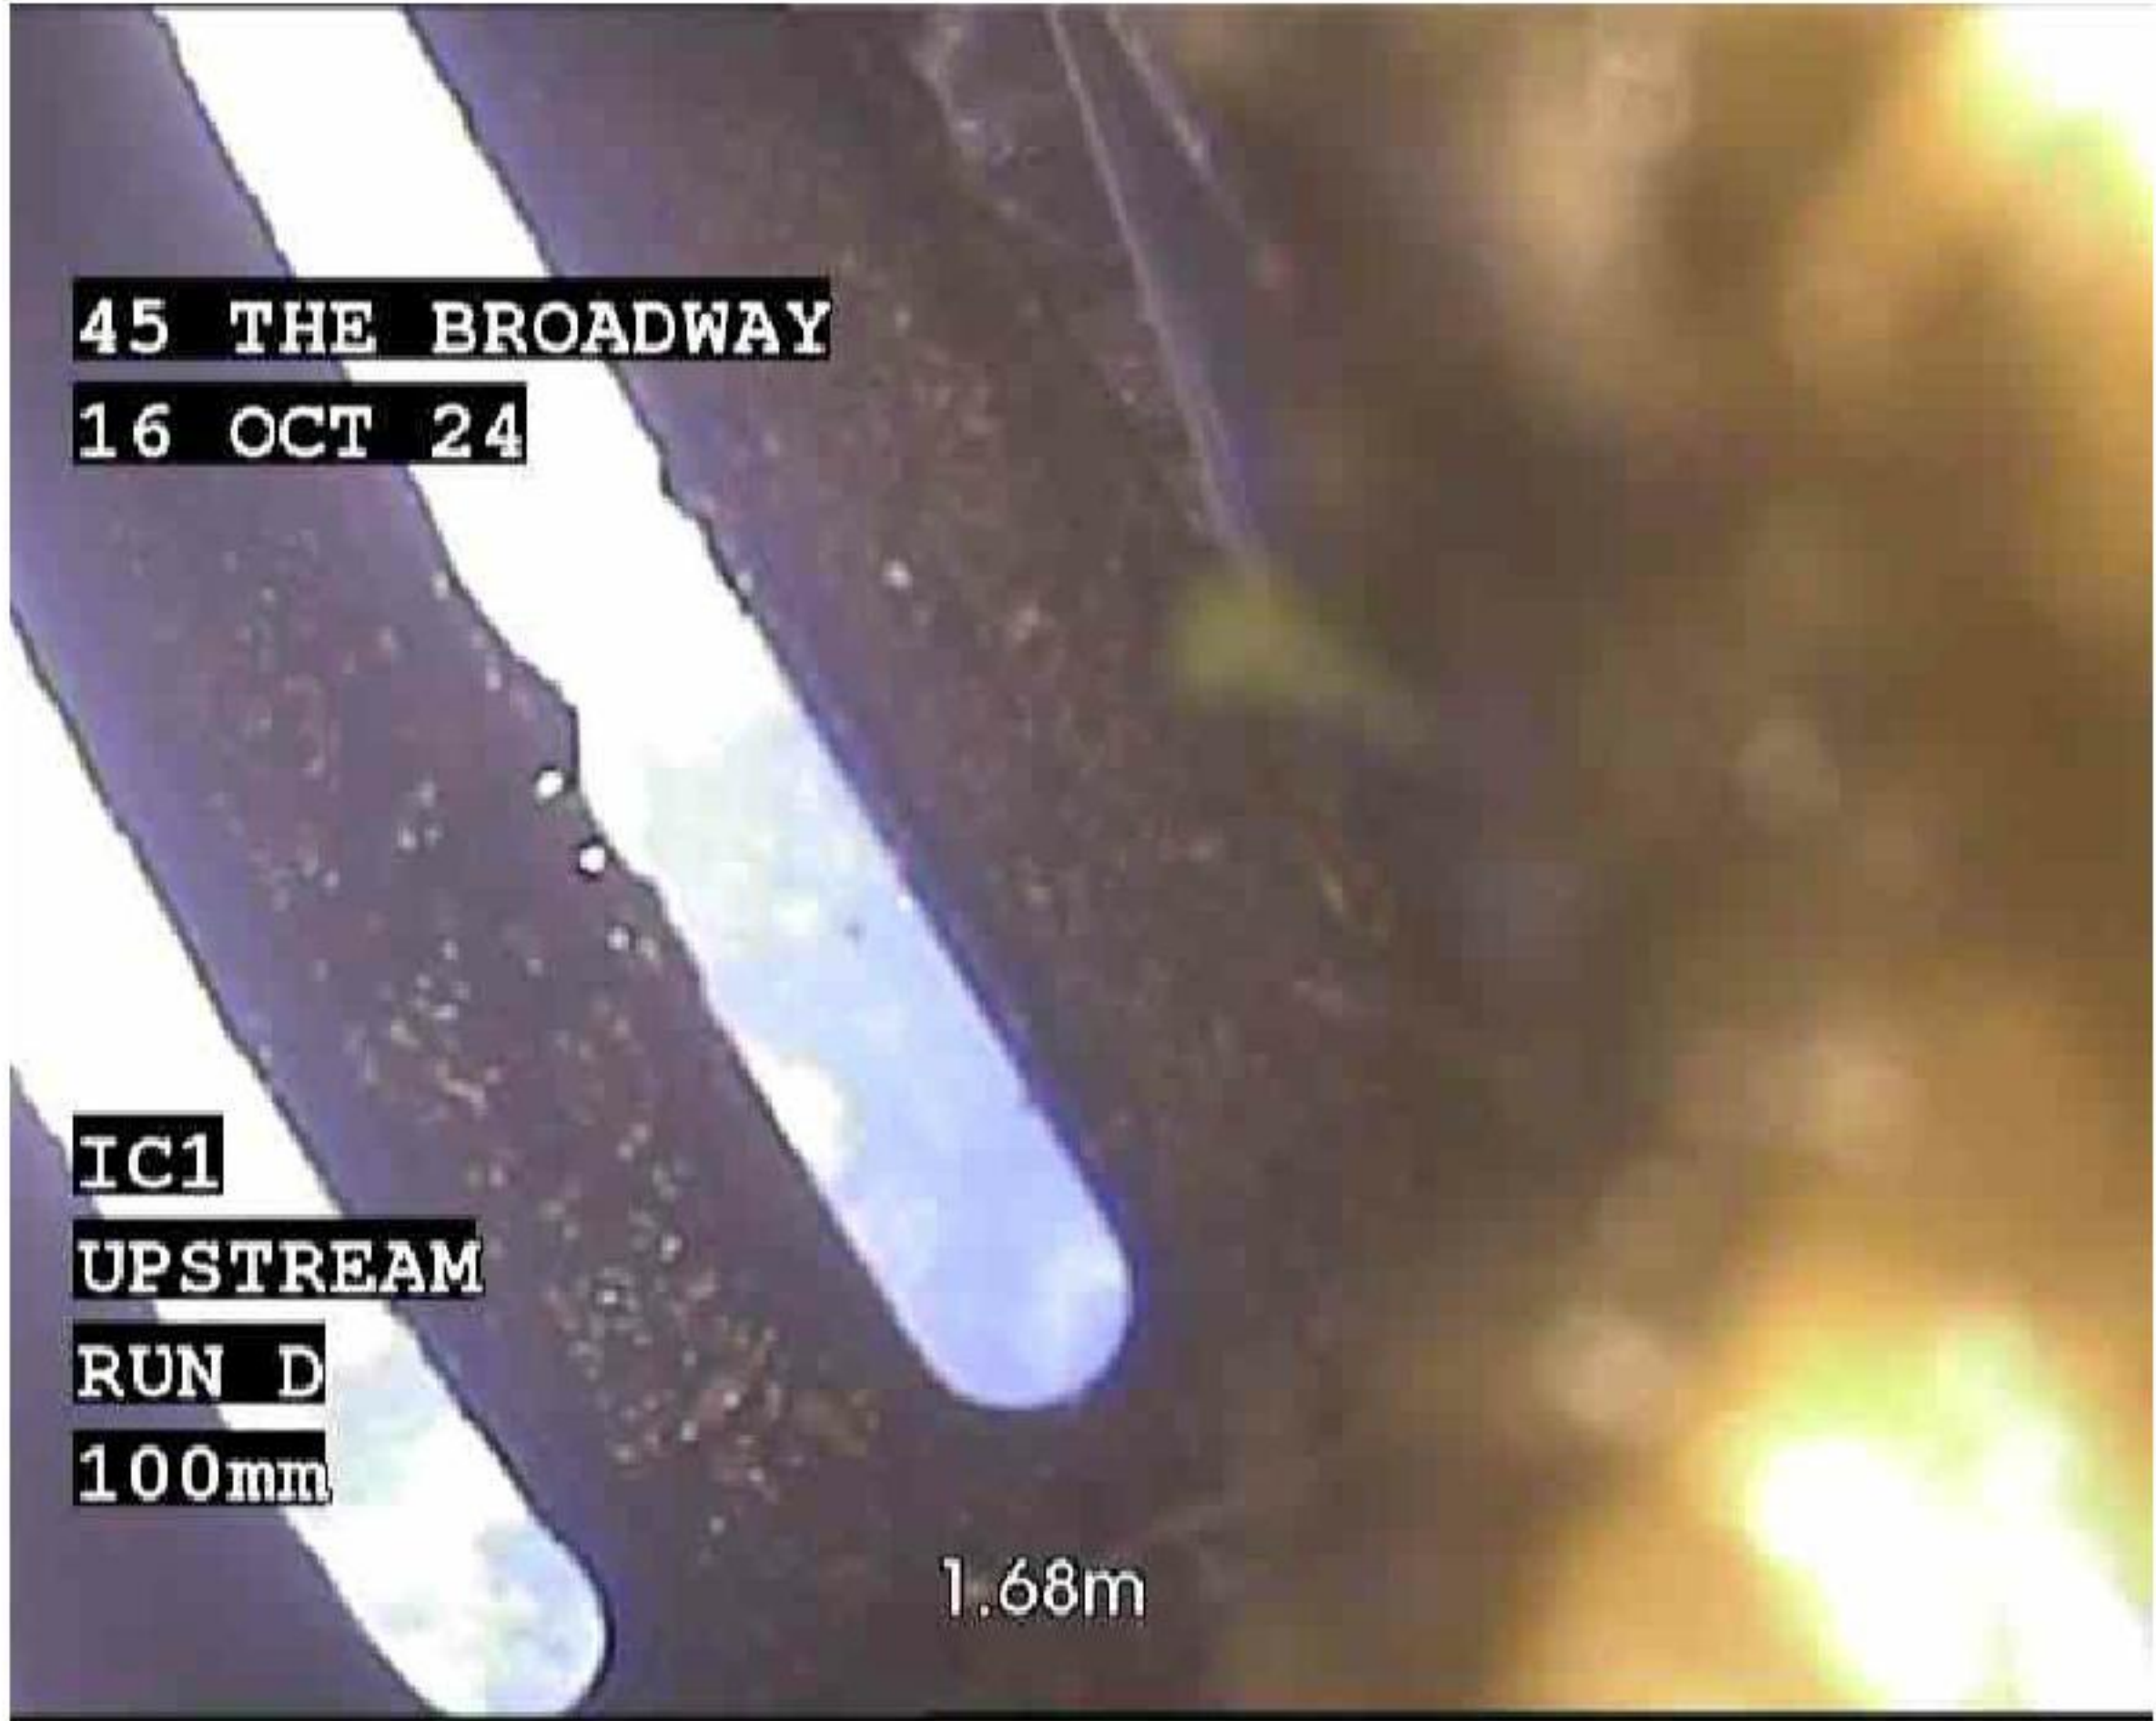
1, 00:00:18, 1.68 m  
Finish node, manhole, reference: RUN D, At aco drain

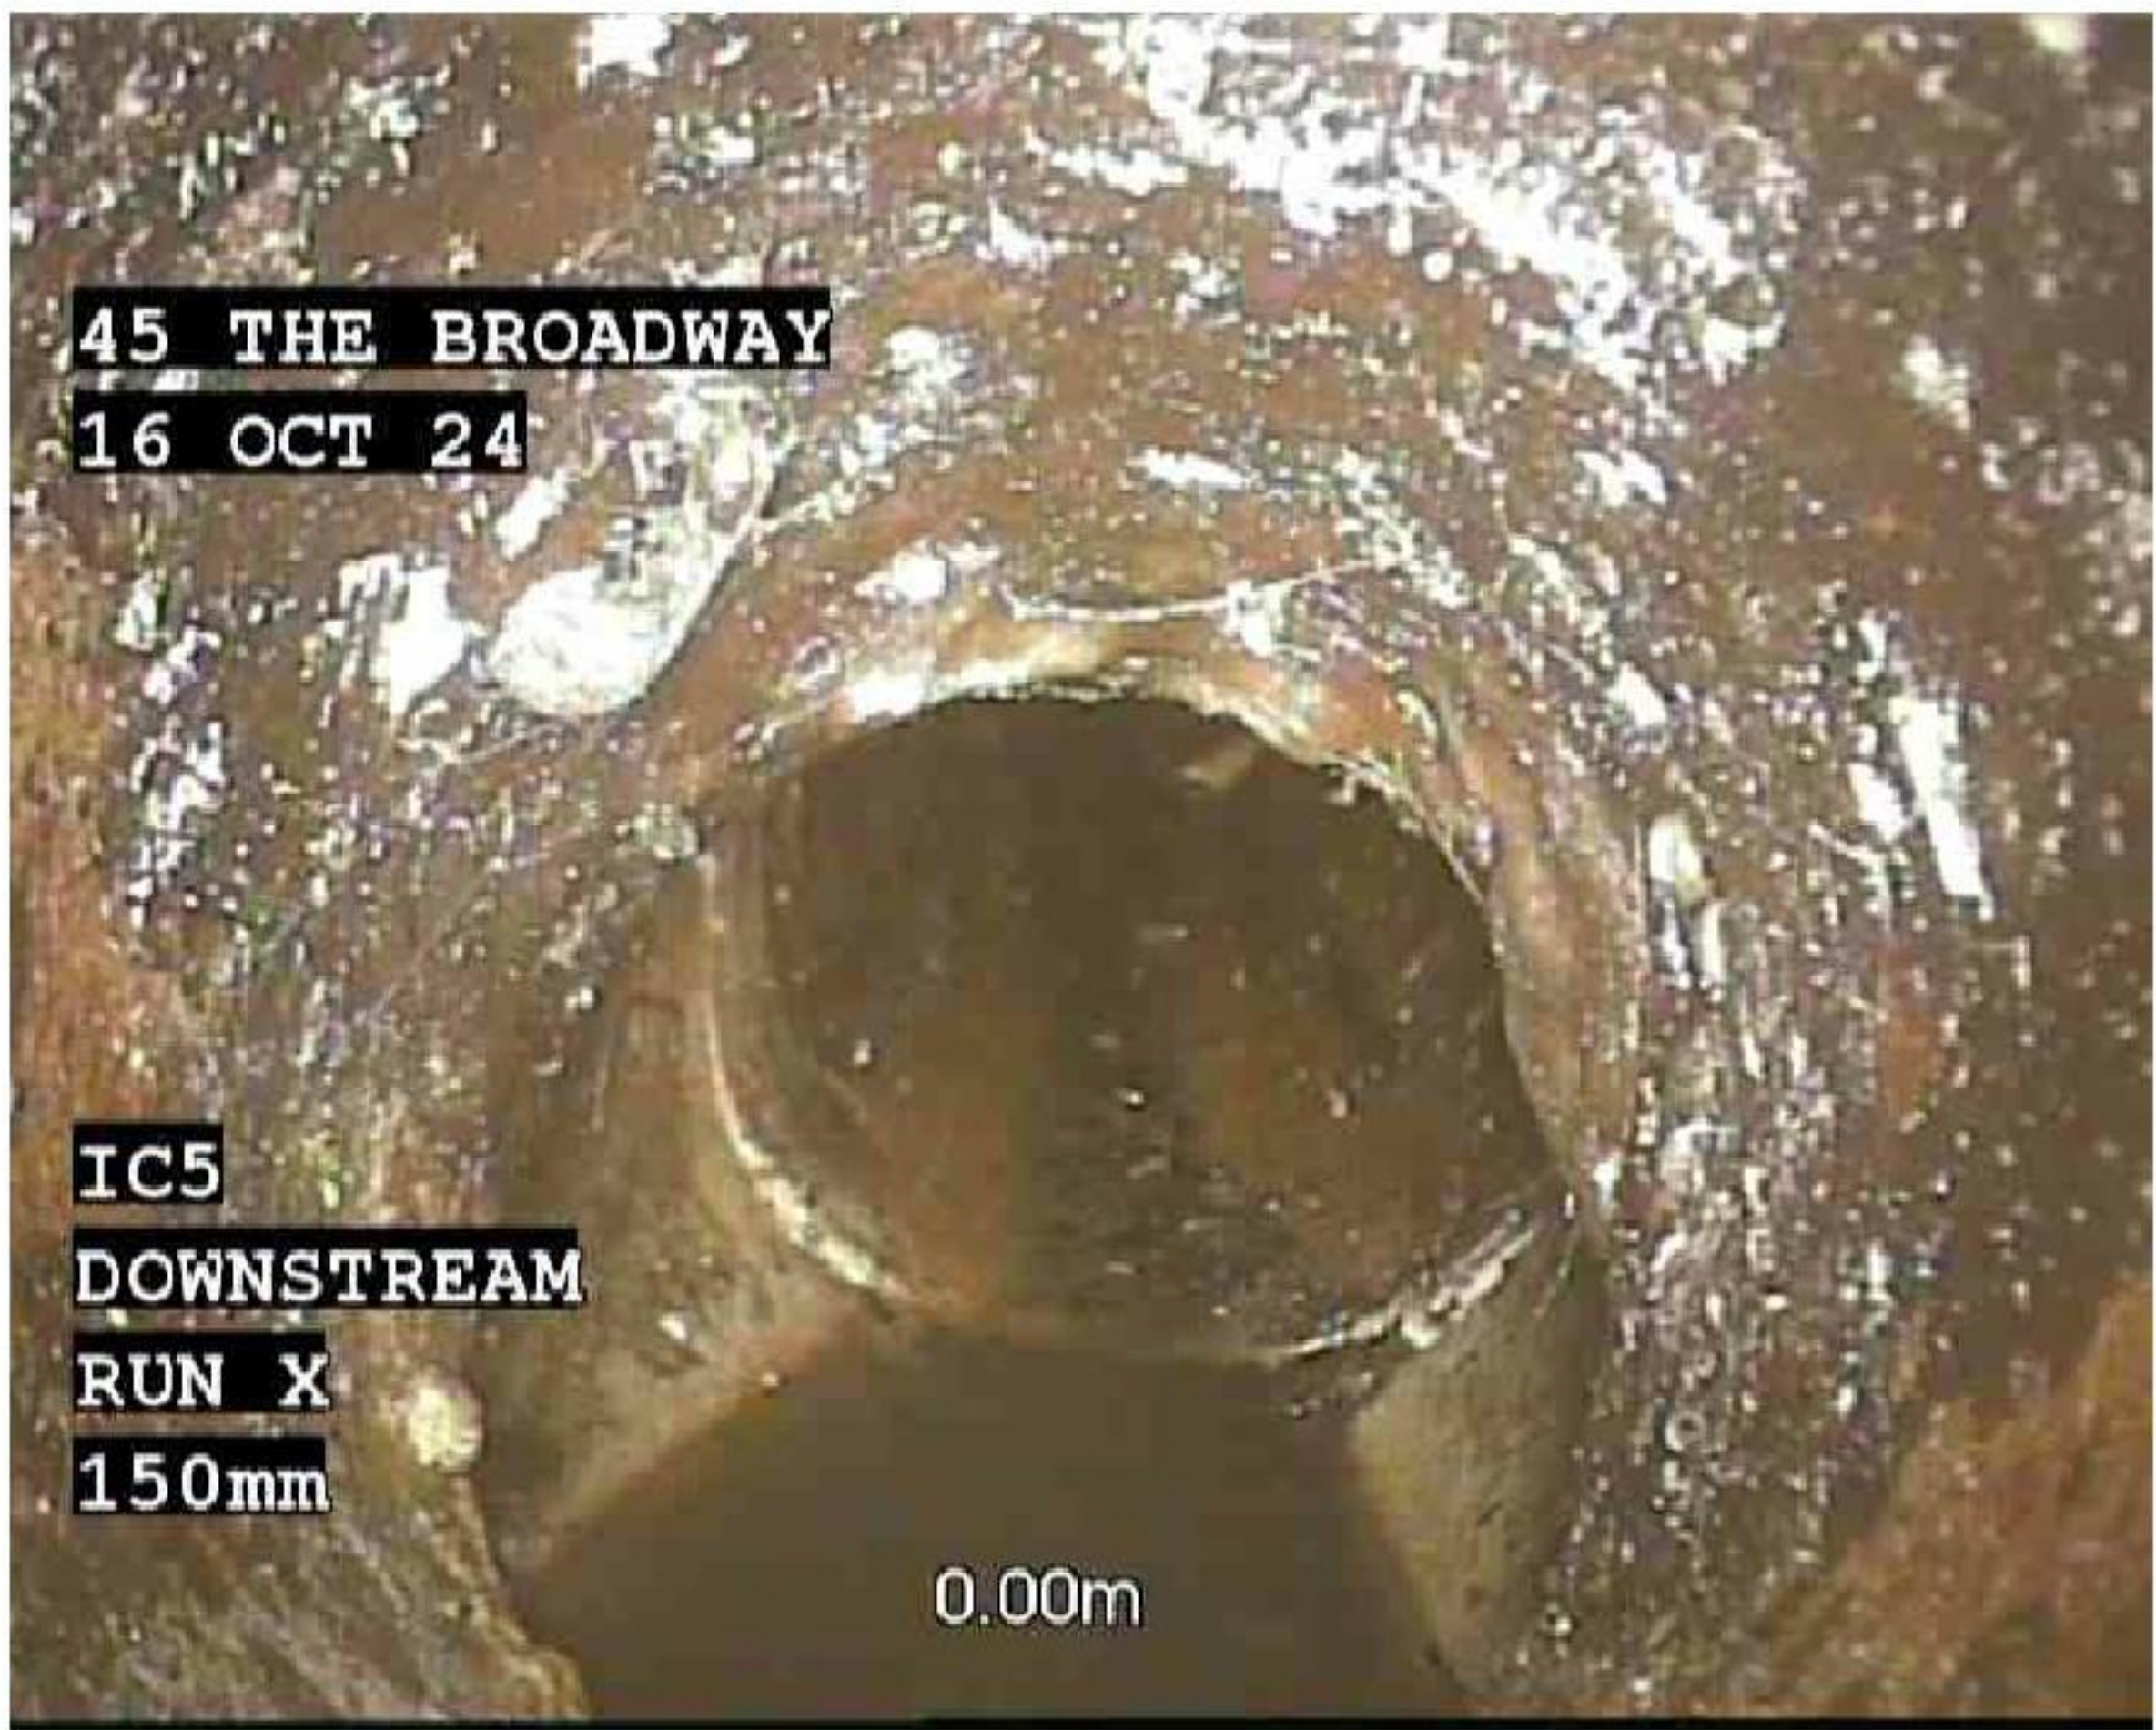
1, 00:00:00, 0.00 m  
Junction at 6 o'clock, 150mm dia, Interceptor trap

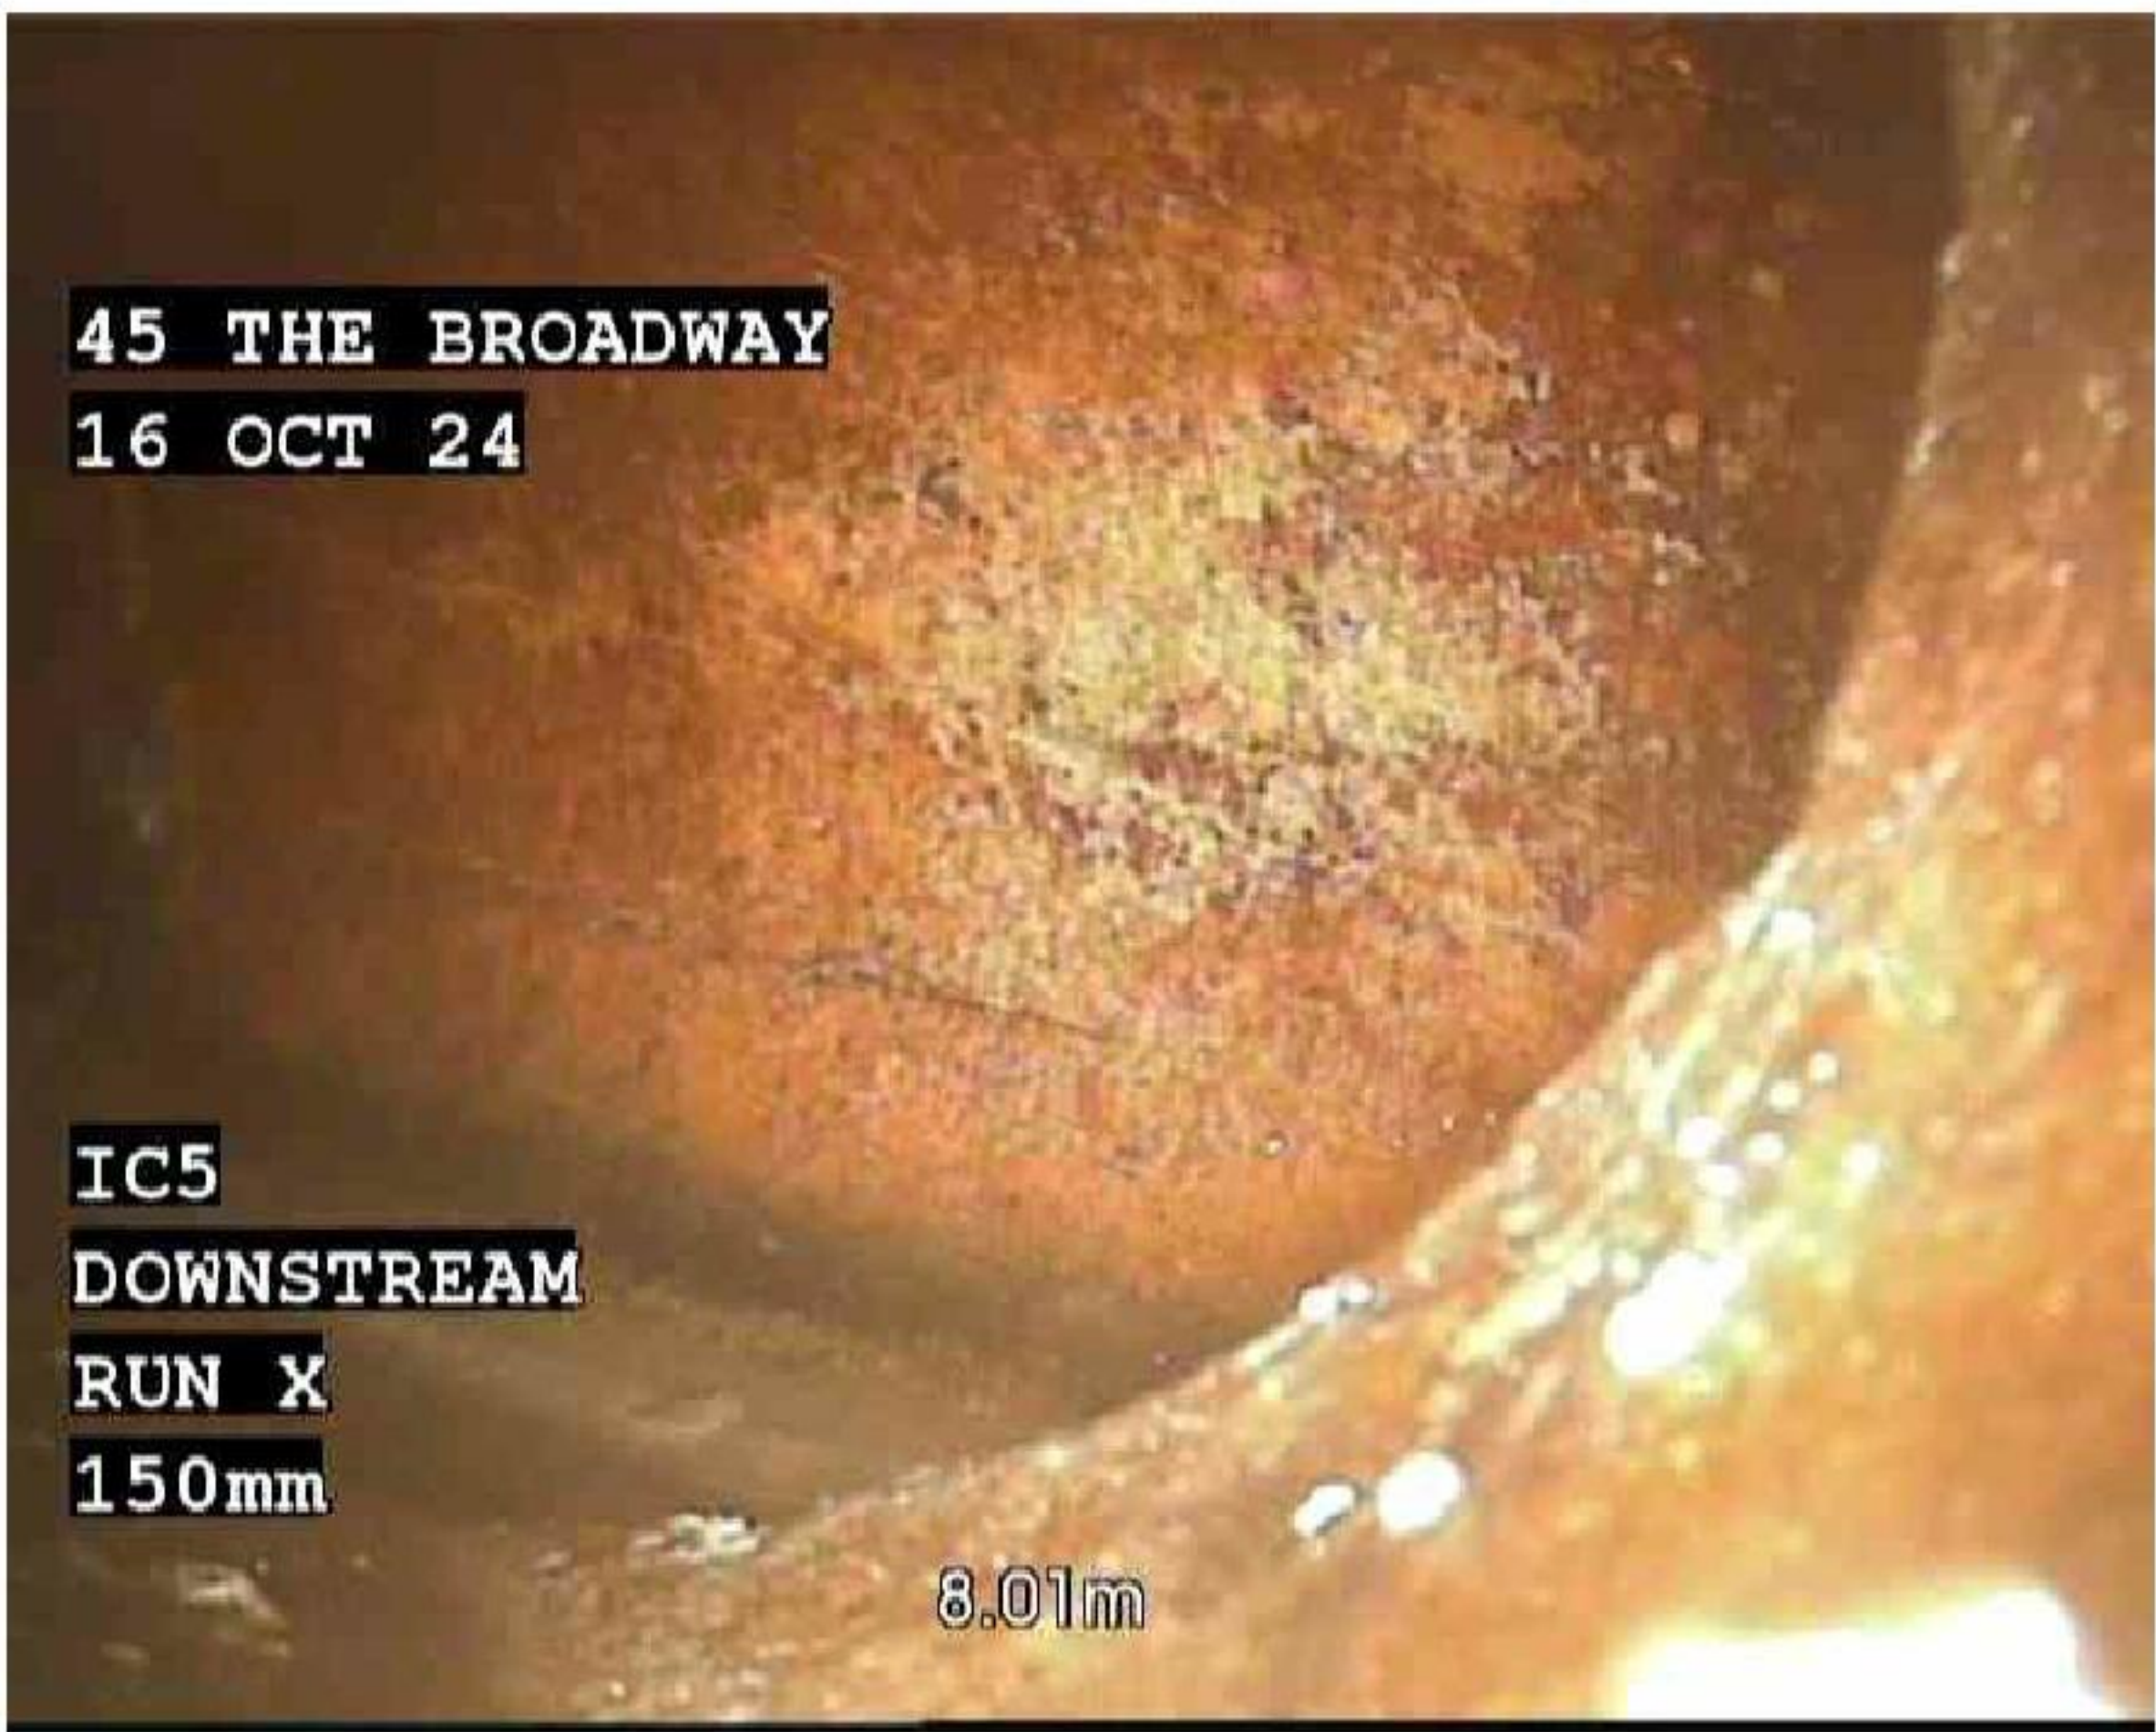
2, 00:00:44, 8.01 m  
Finish node, major connection without manhole, reference:  
RUN X, At saddle connection

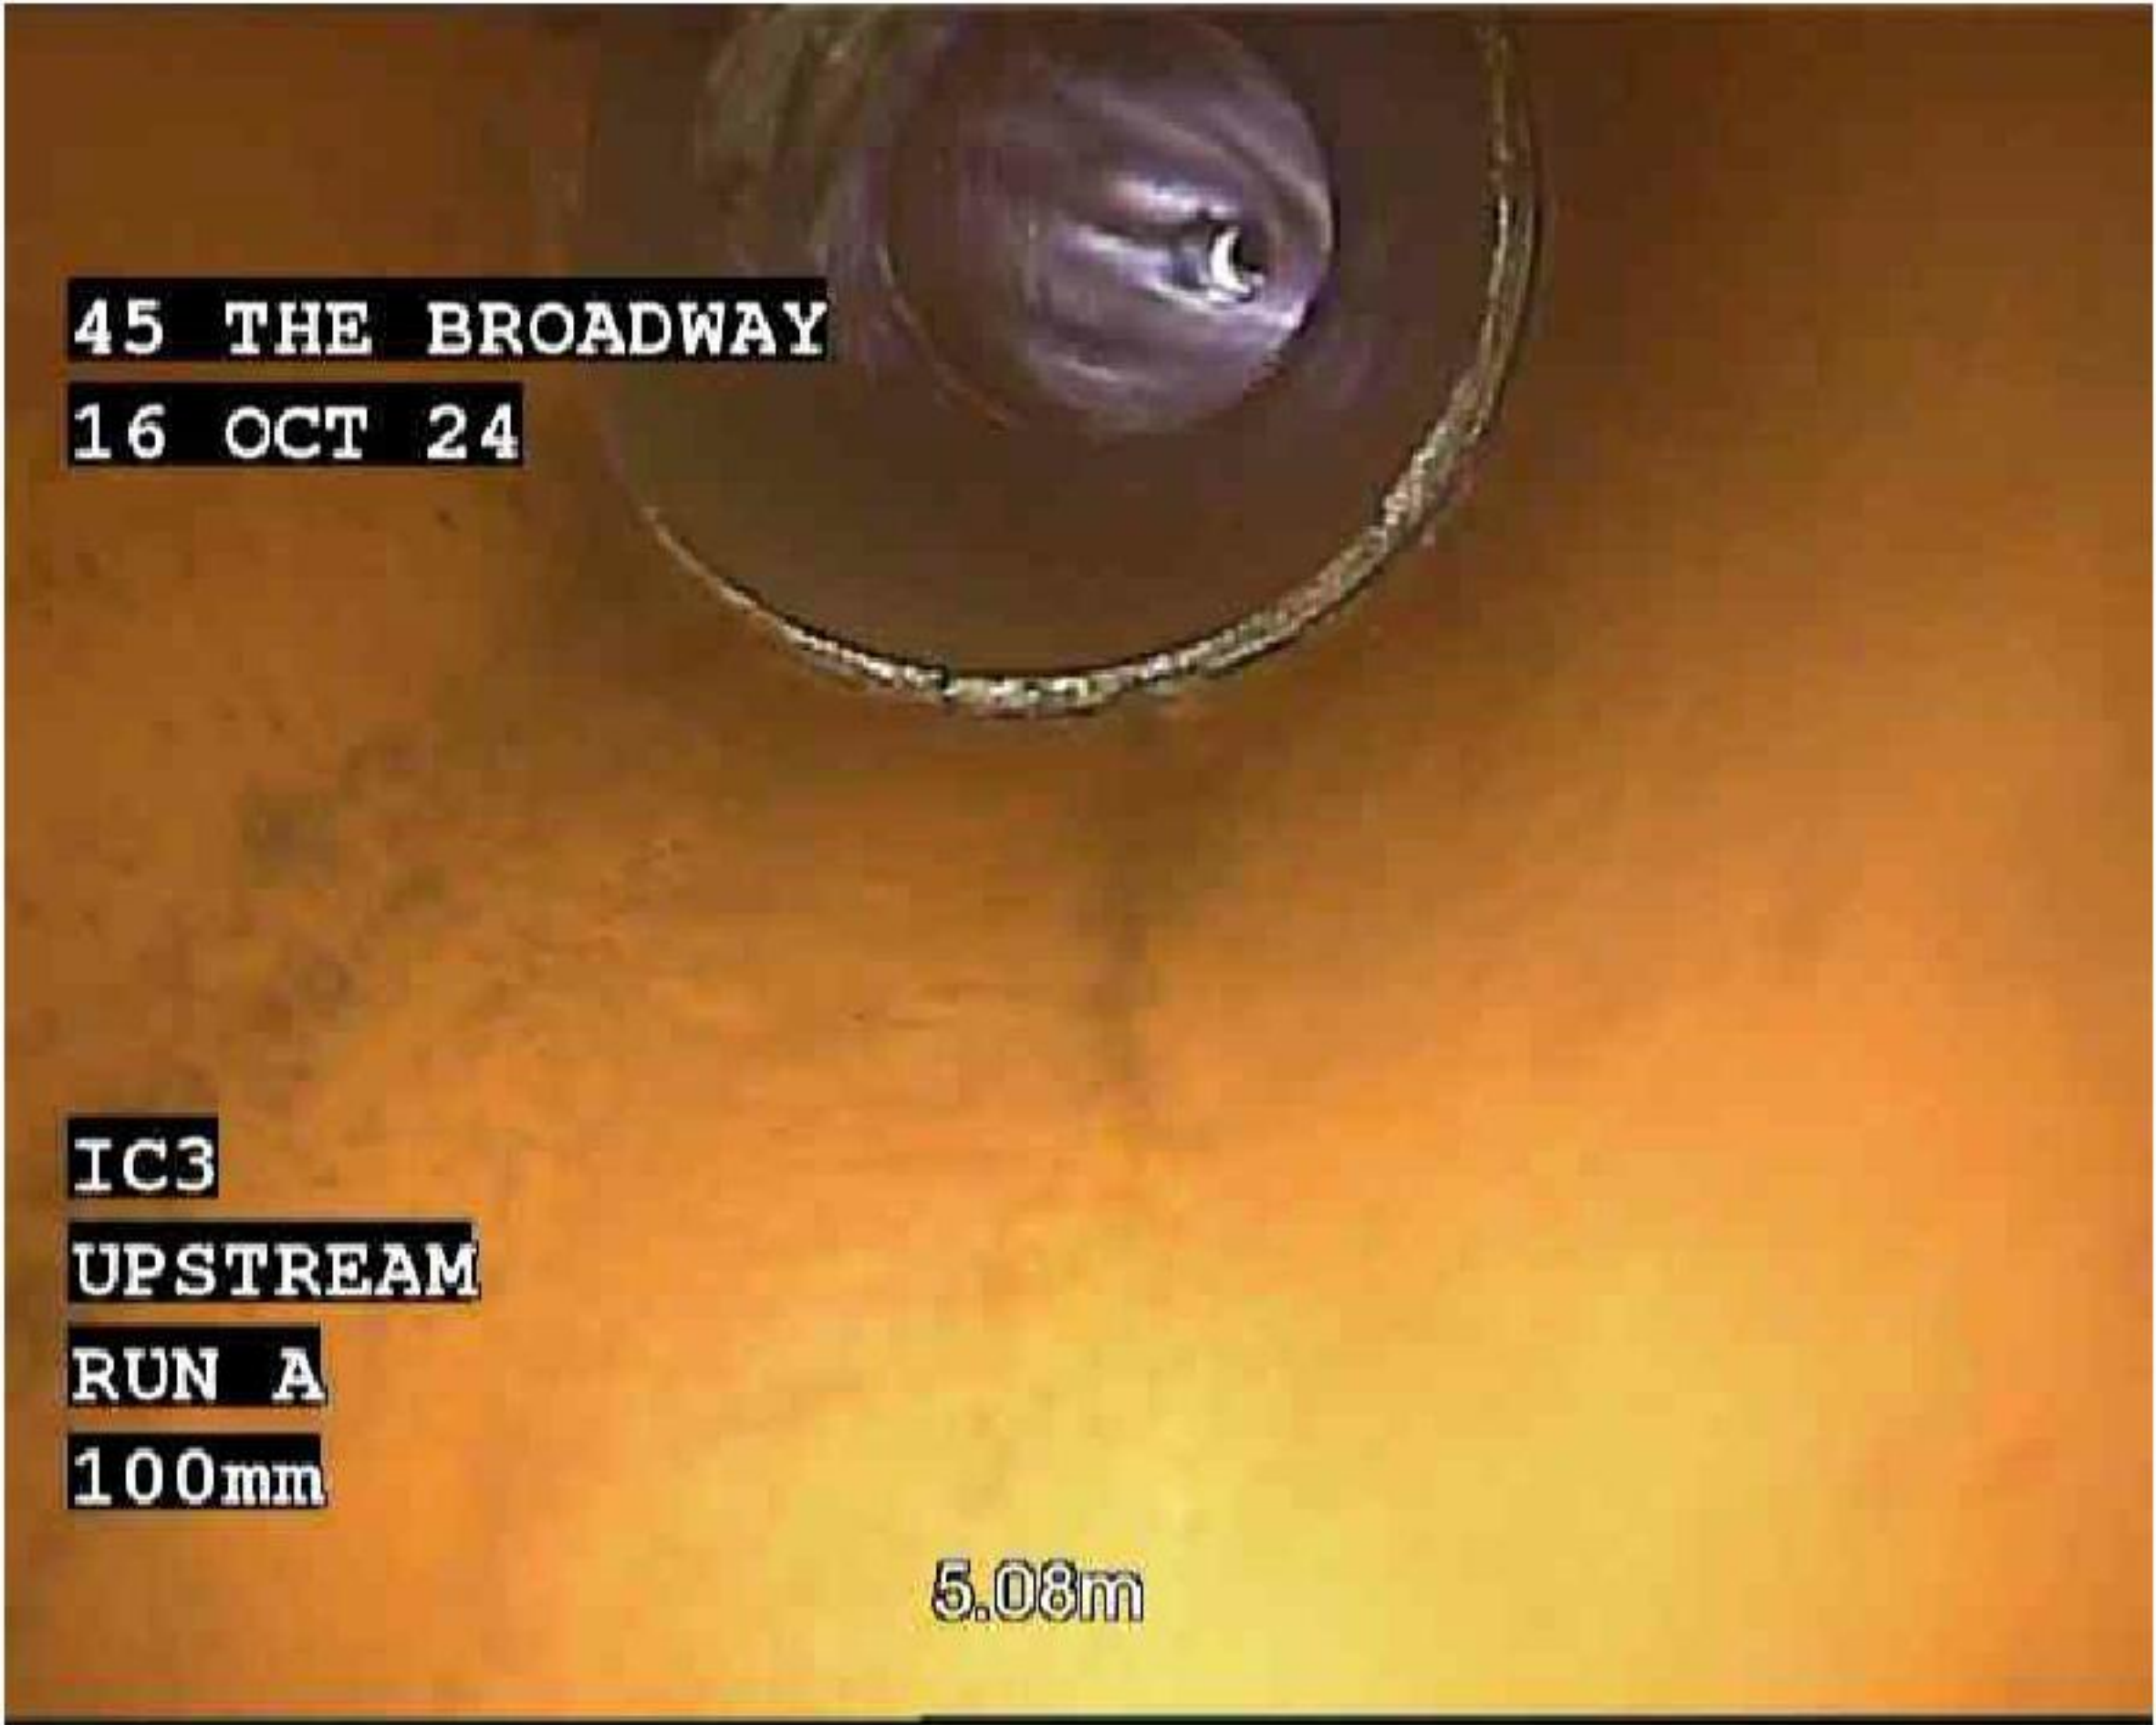
1, 00:00:42, 5.08 m  
Finish node, manhole, reference: IC3-A, At svp

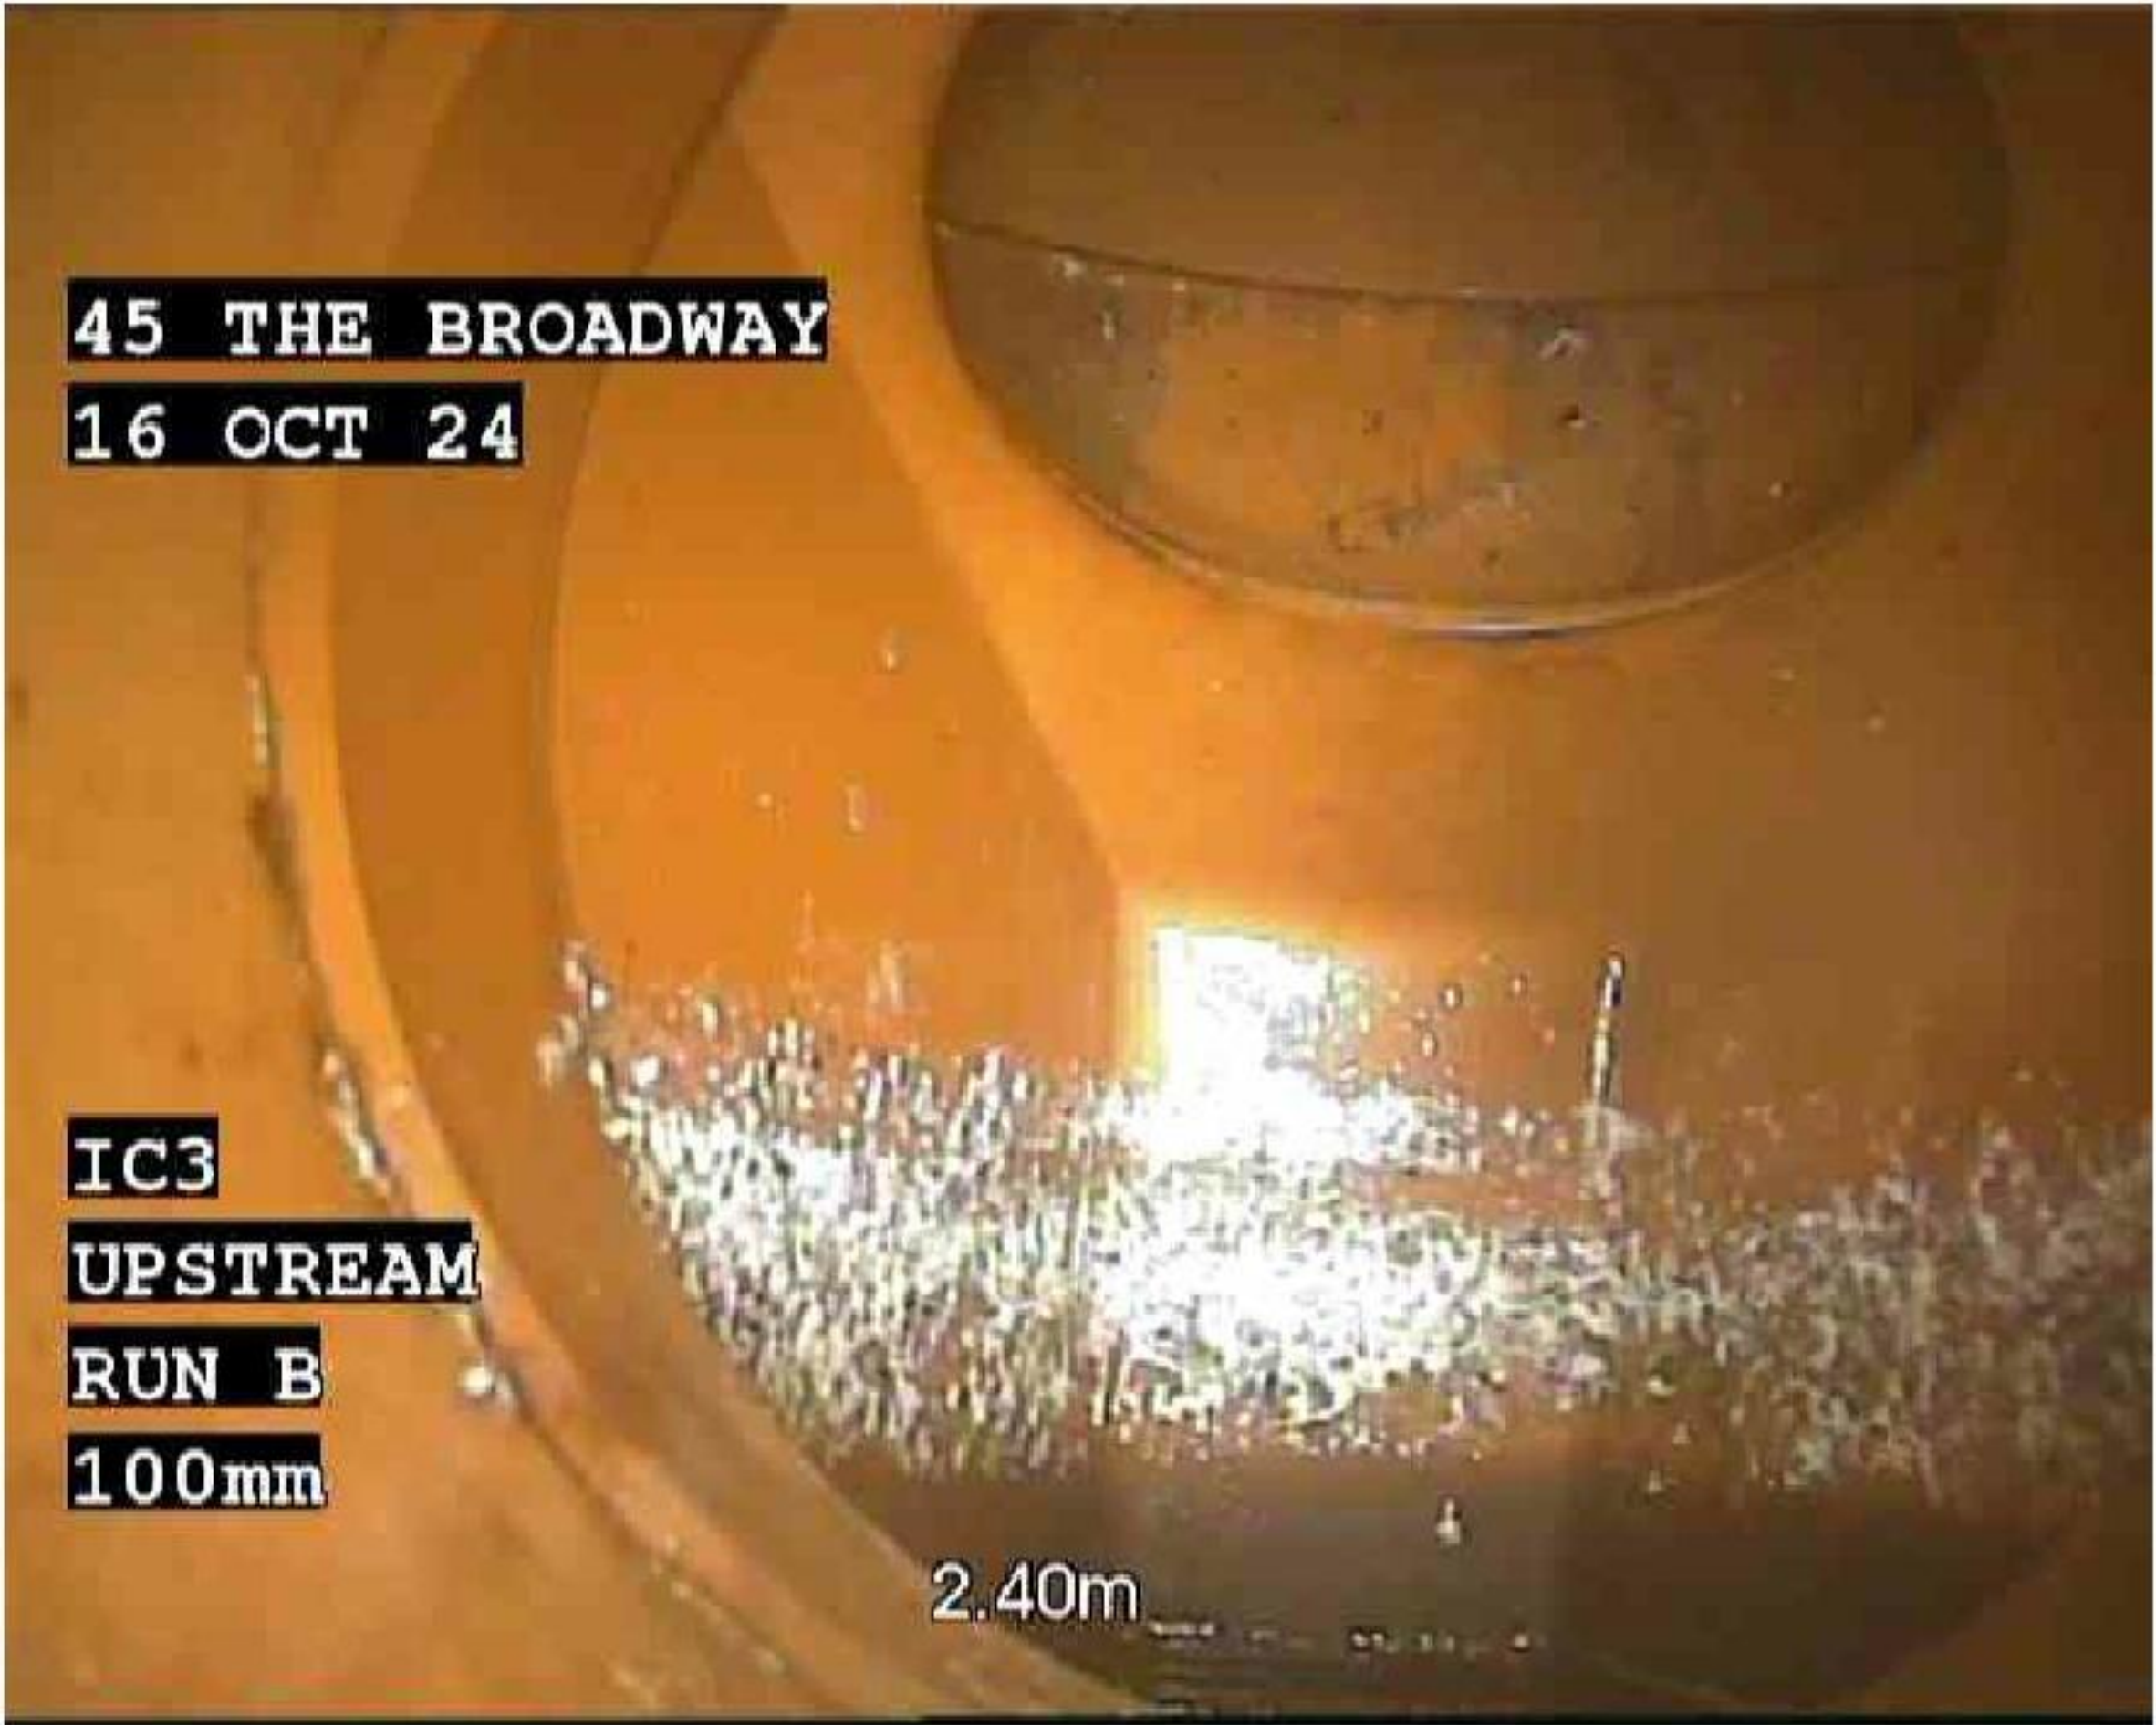
1, 00:00:19, 2.36 m  
Finish node, manhole, reference: IC3-B, At foul gully (sinks)

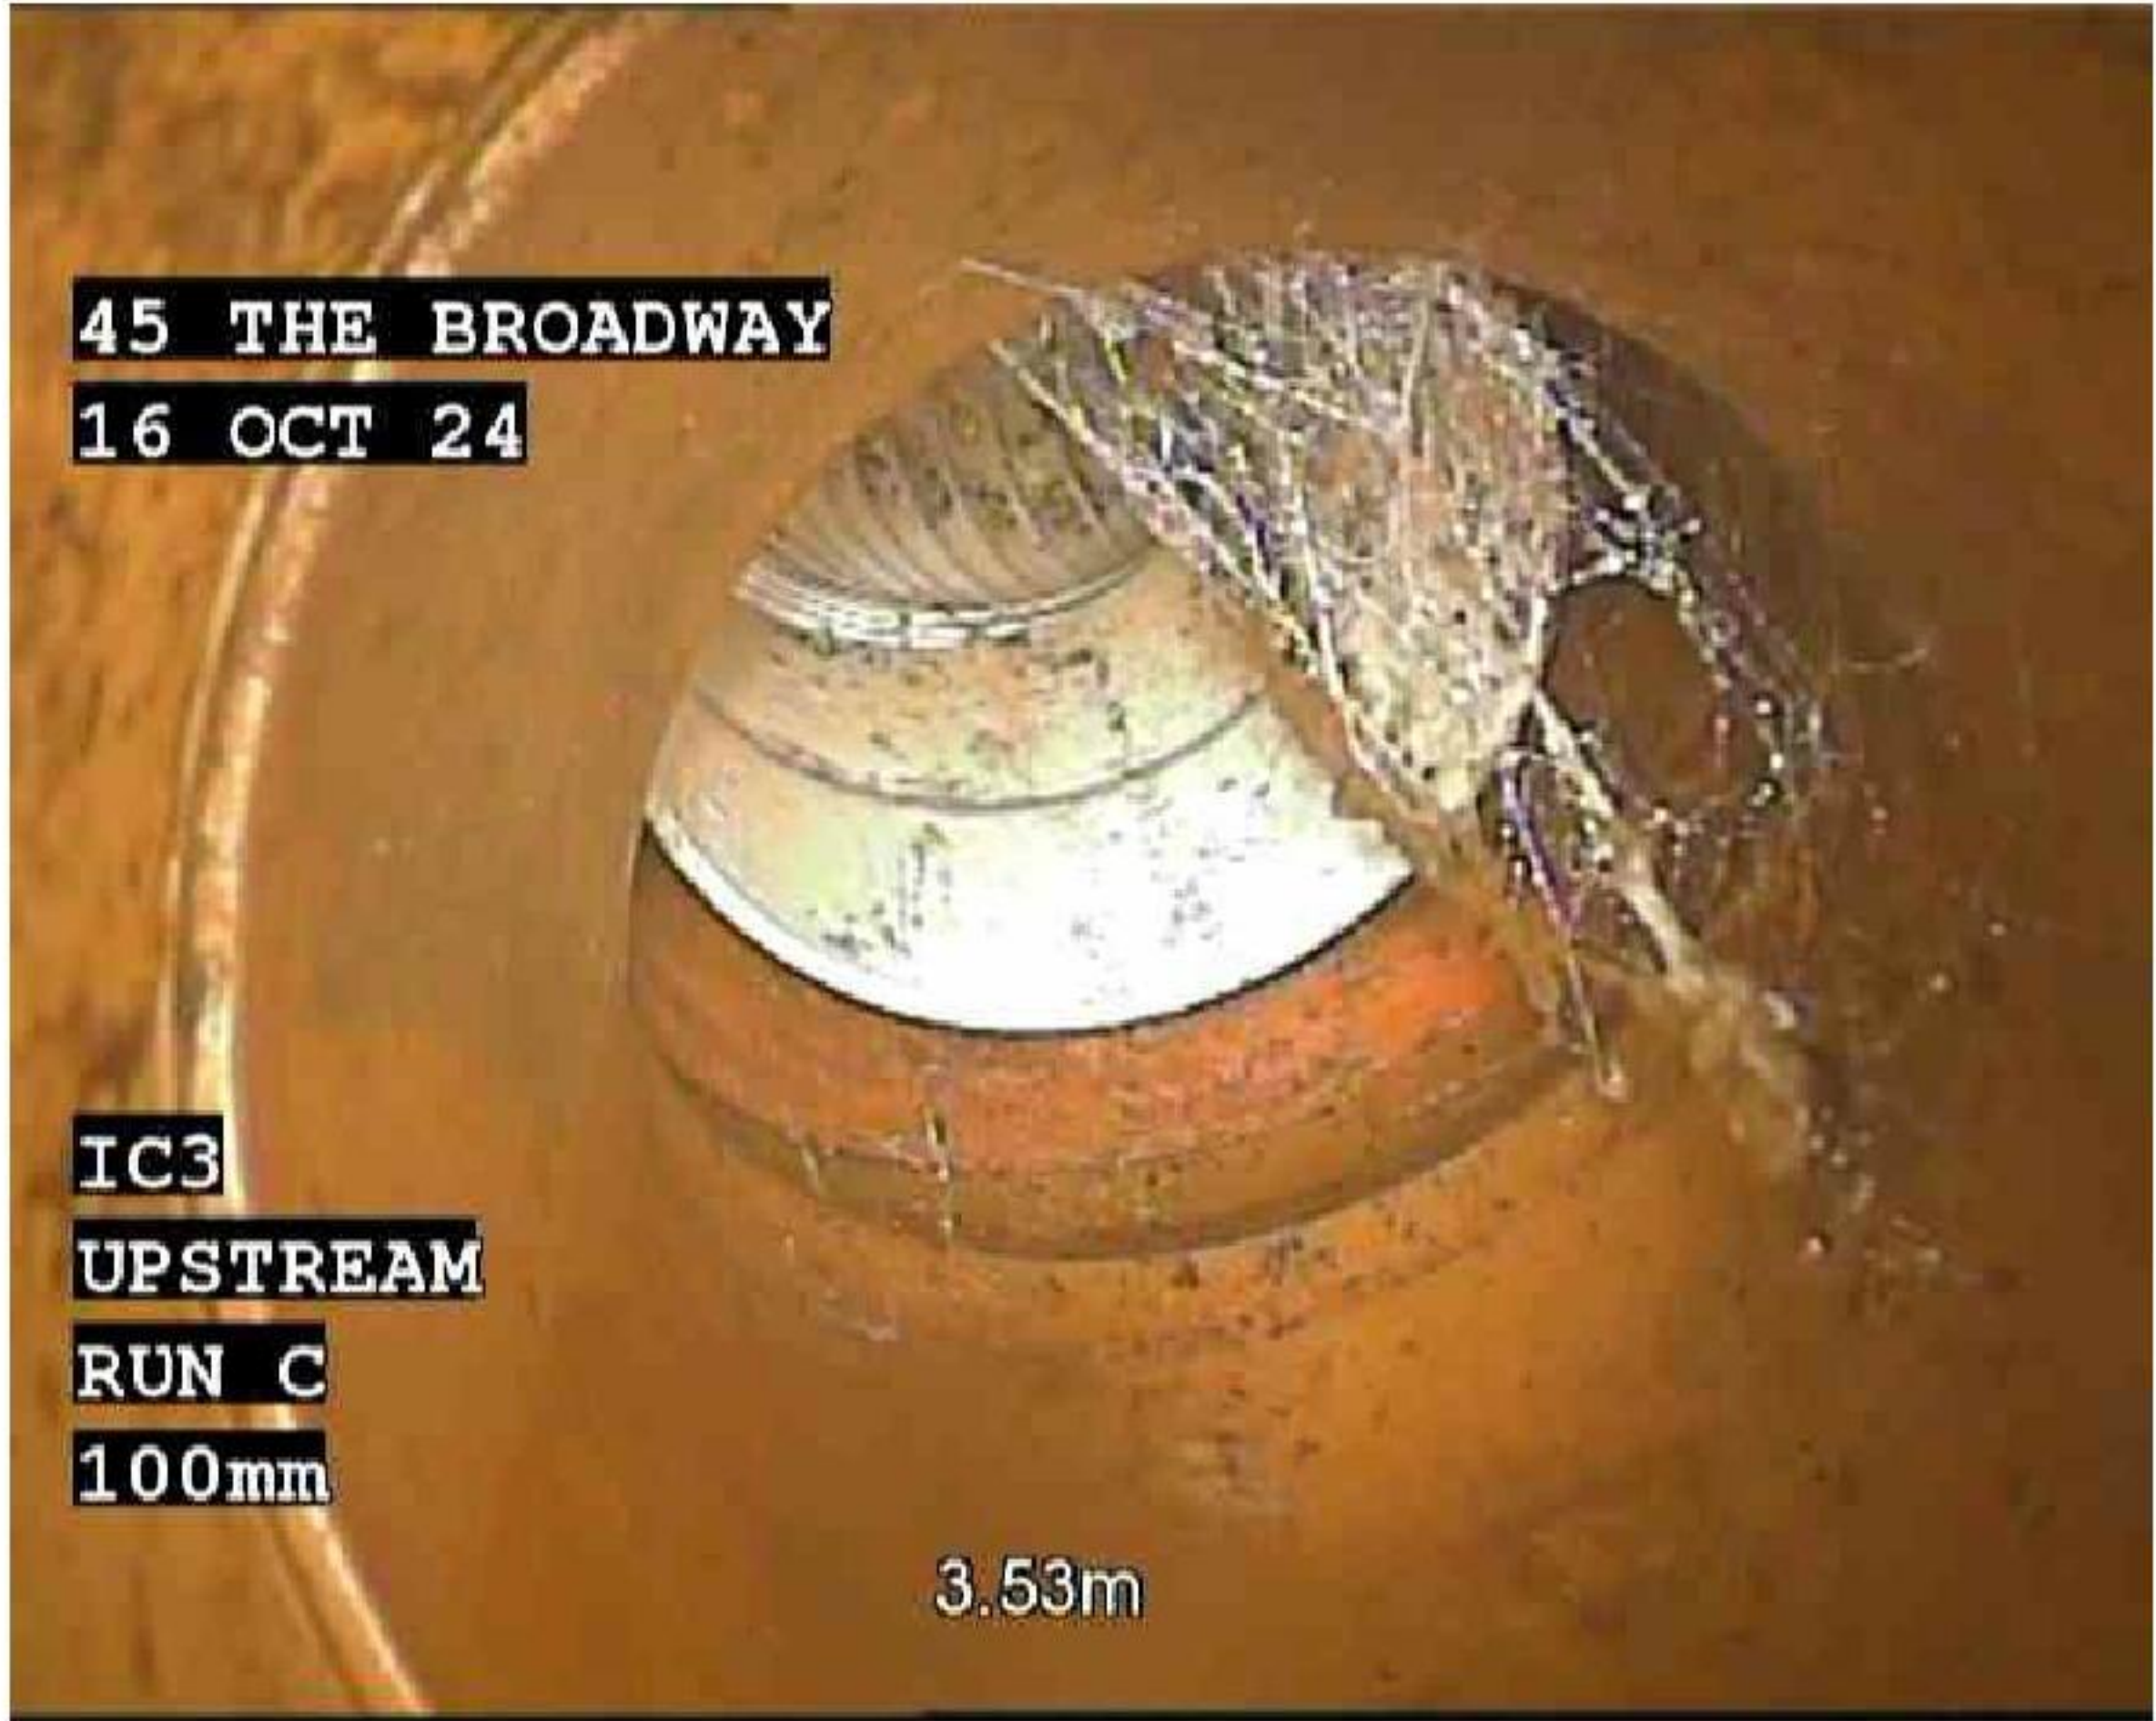
1, 00:00:16, 3.53 m  
Finish node, manhole, reference: IC3-C, At wc
