*Project ref: TV241020*

SITE: 45 The Broadway  
Haywards Heath  
West Sussex  
RH16 3AS

# ***CCTV Survey Report***

*Sewer Inspection, Cleaning and Repair*

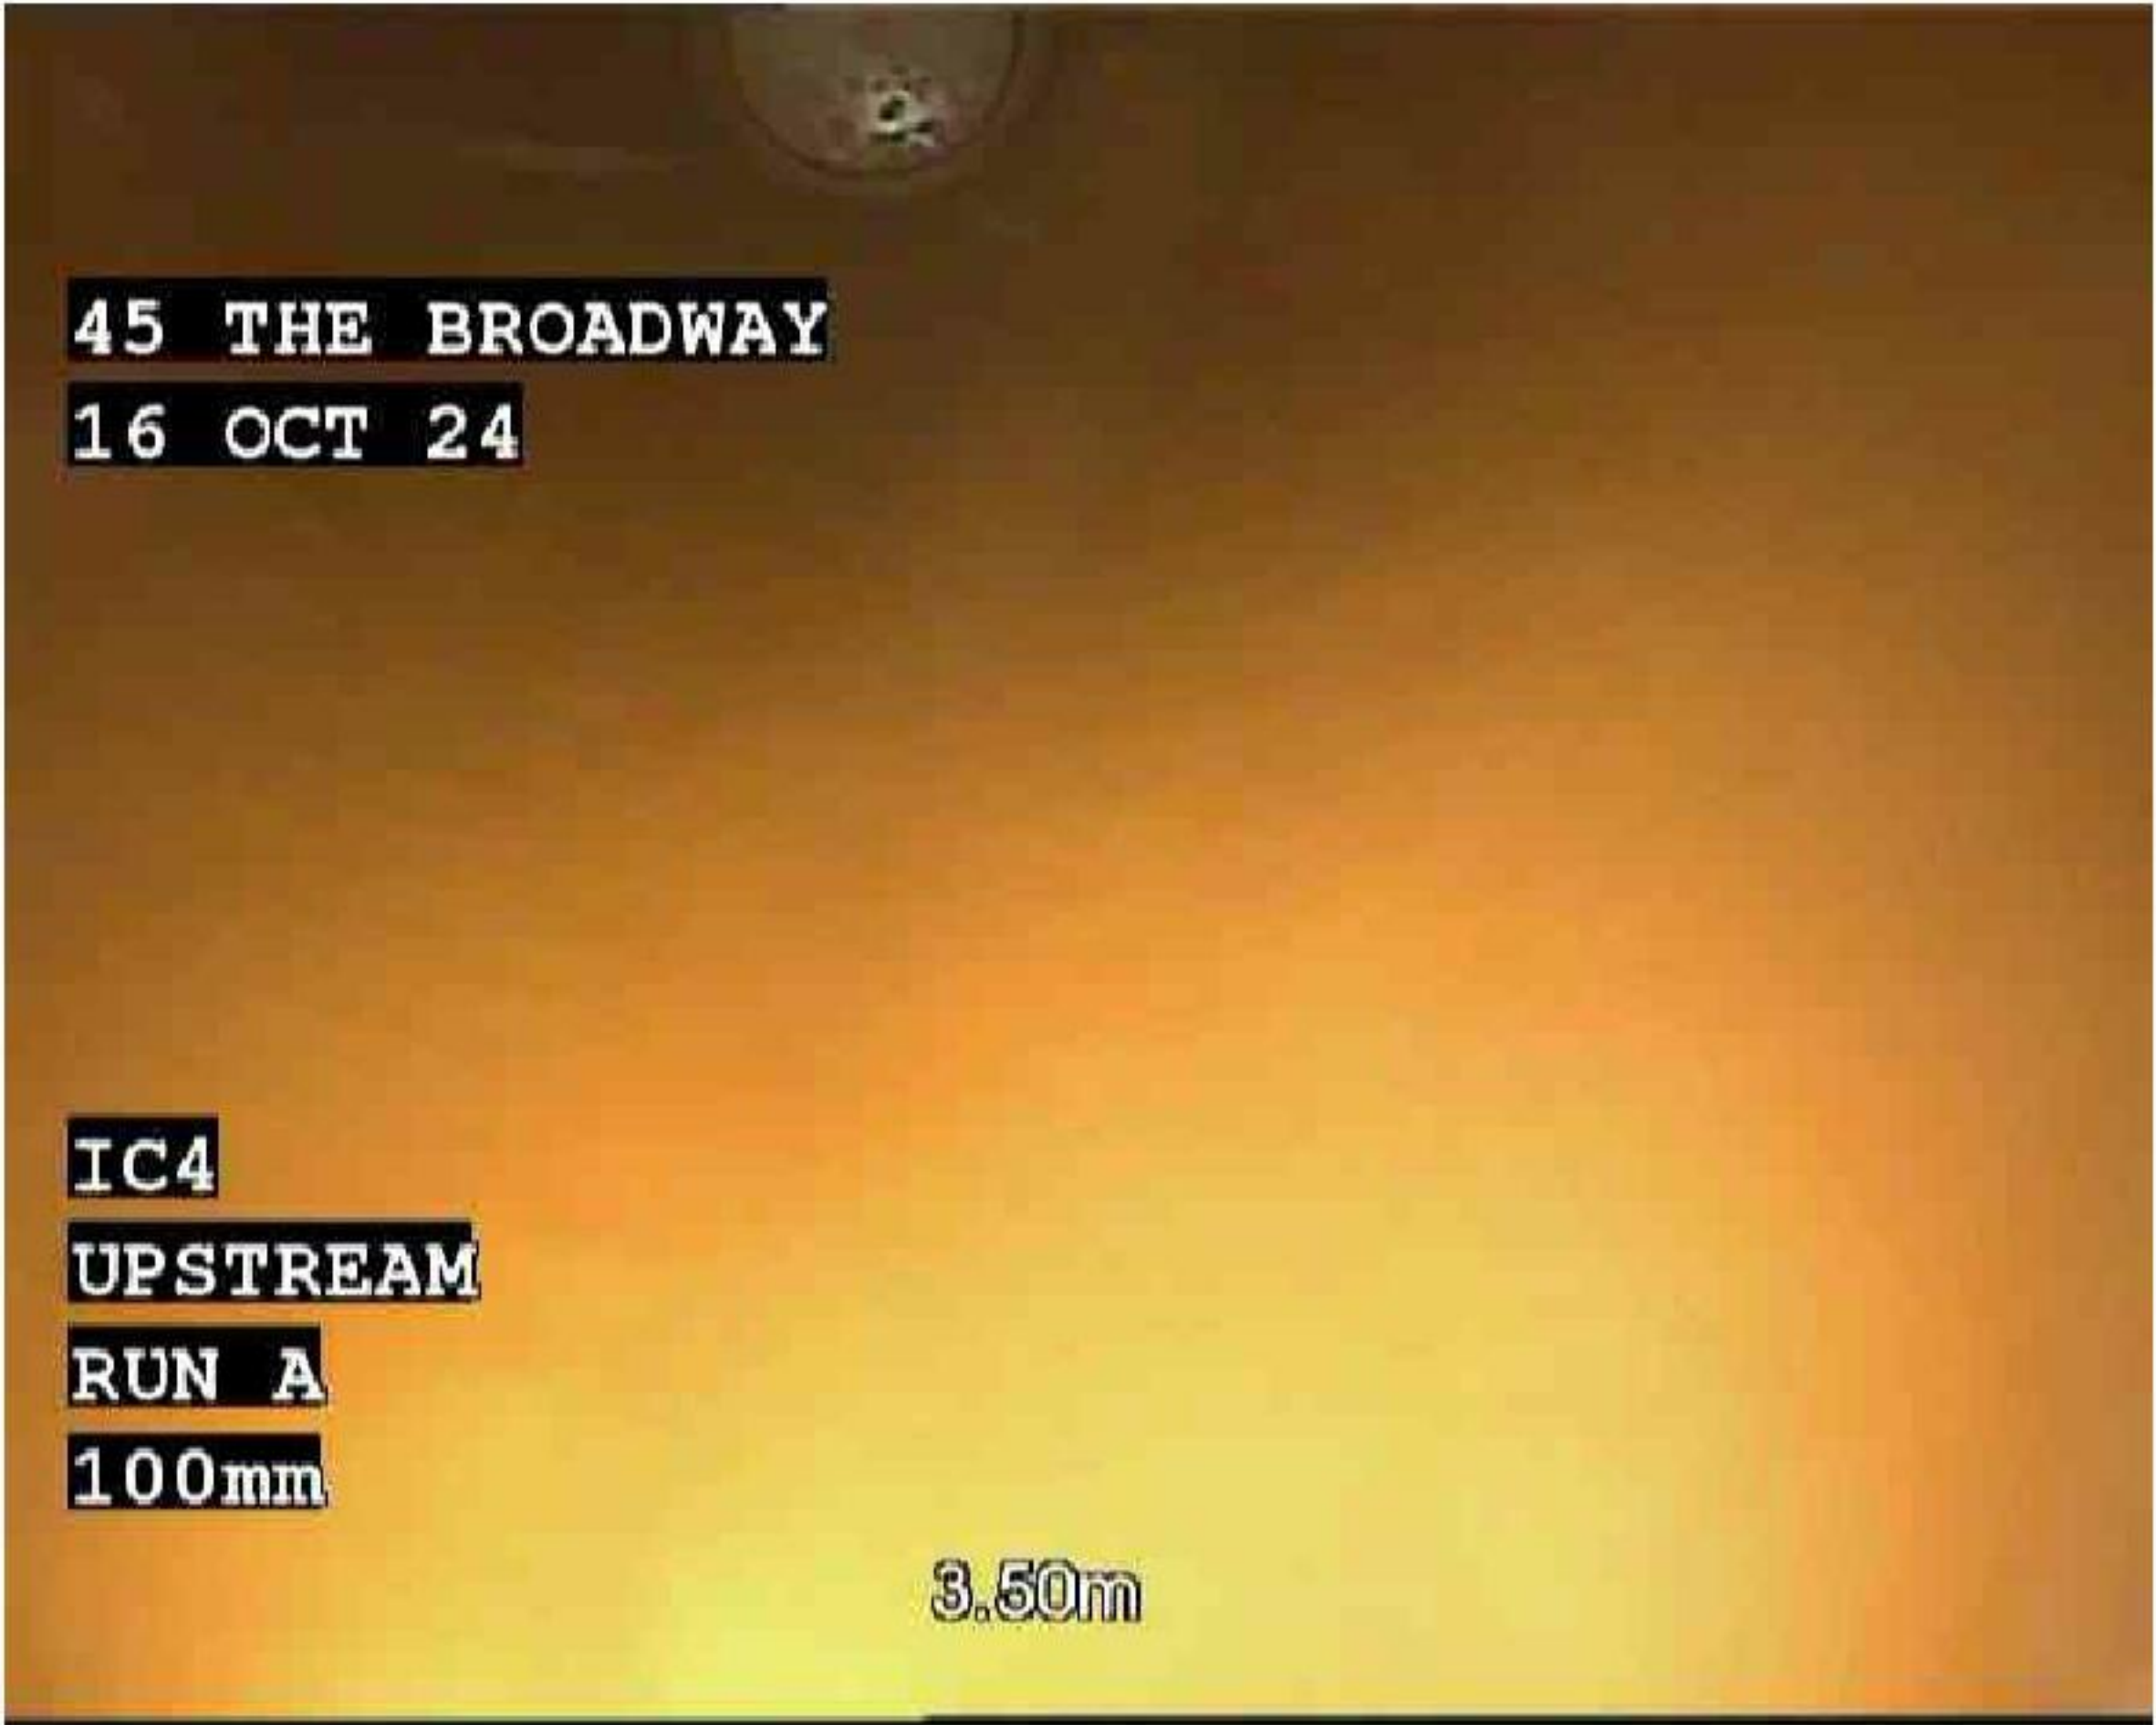
1, 00:00:25, 3.50 m  
Finish node, manhole, reference: IC4-A, At svp

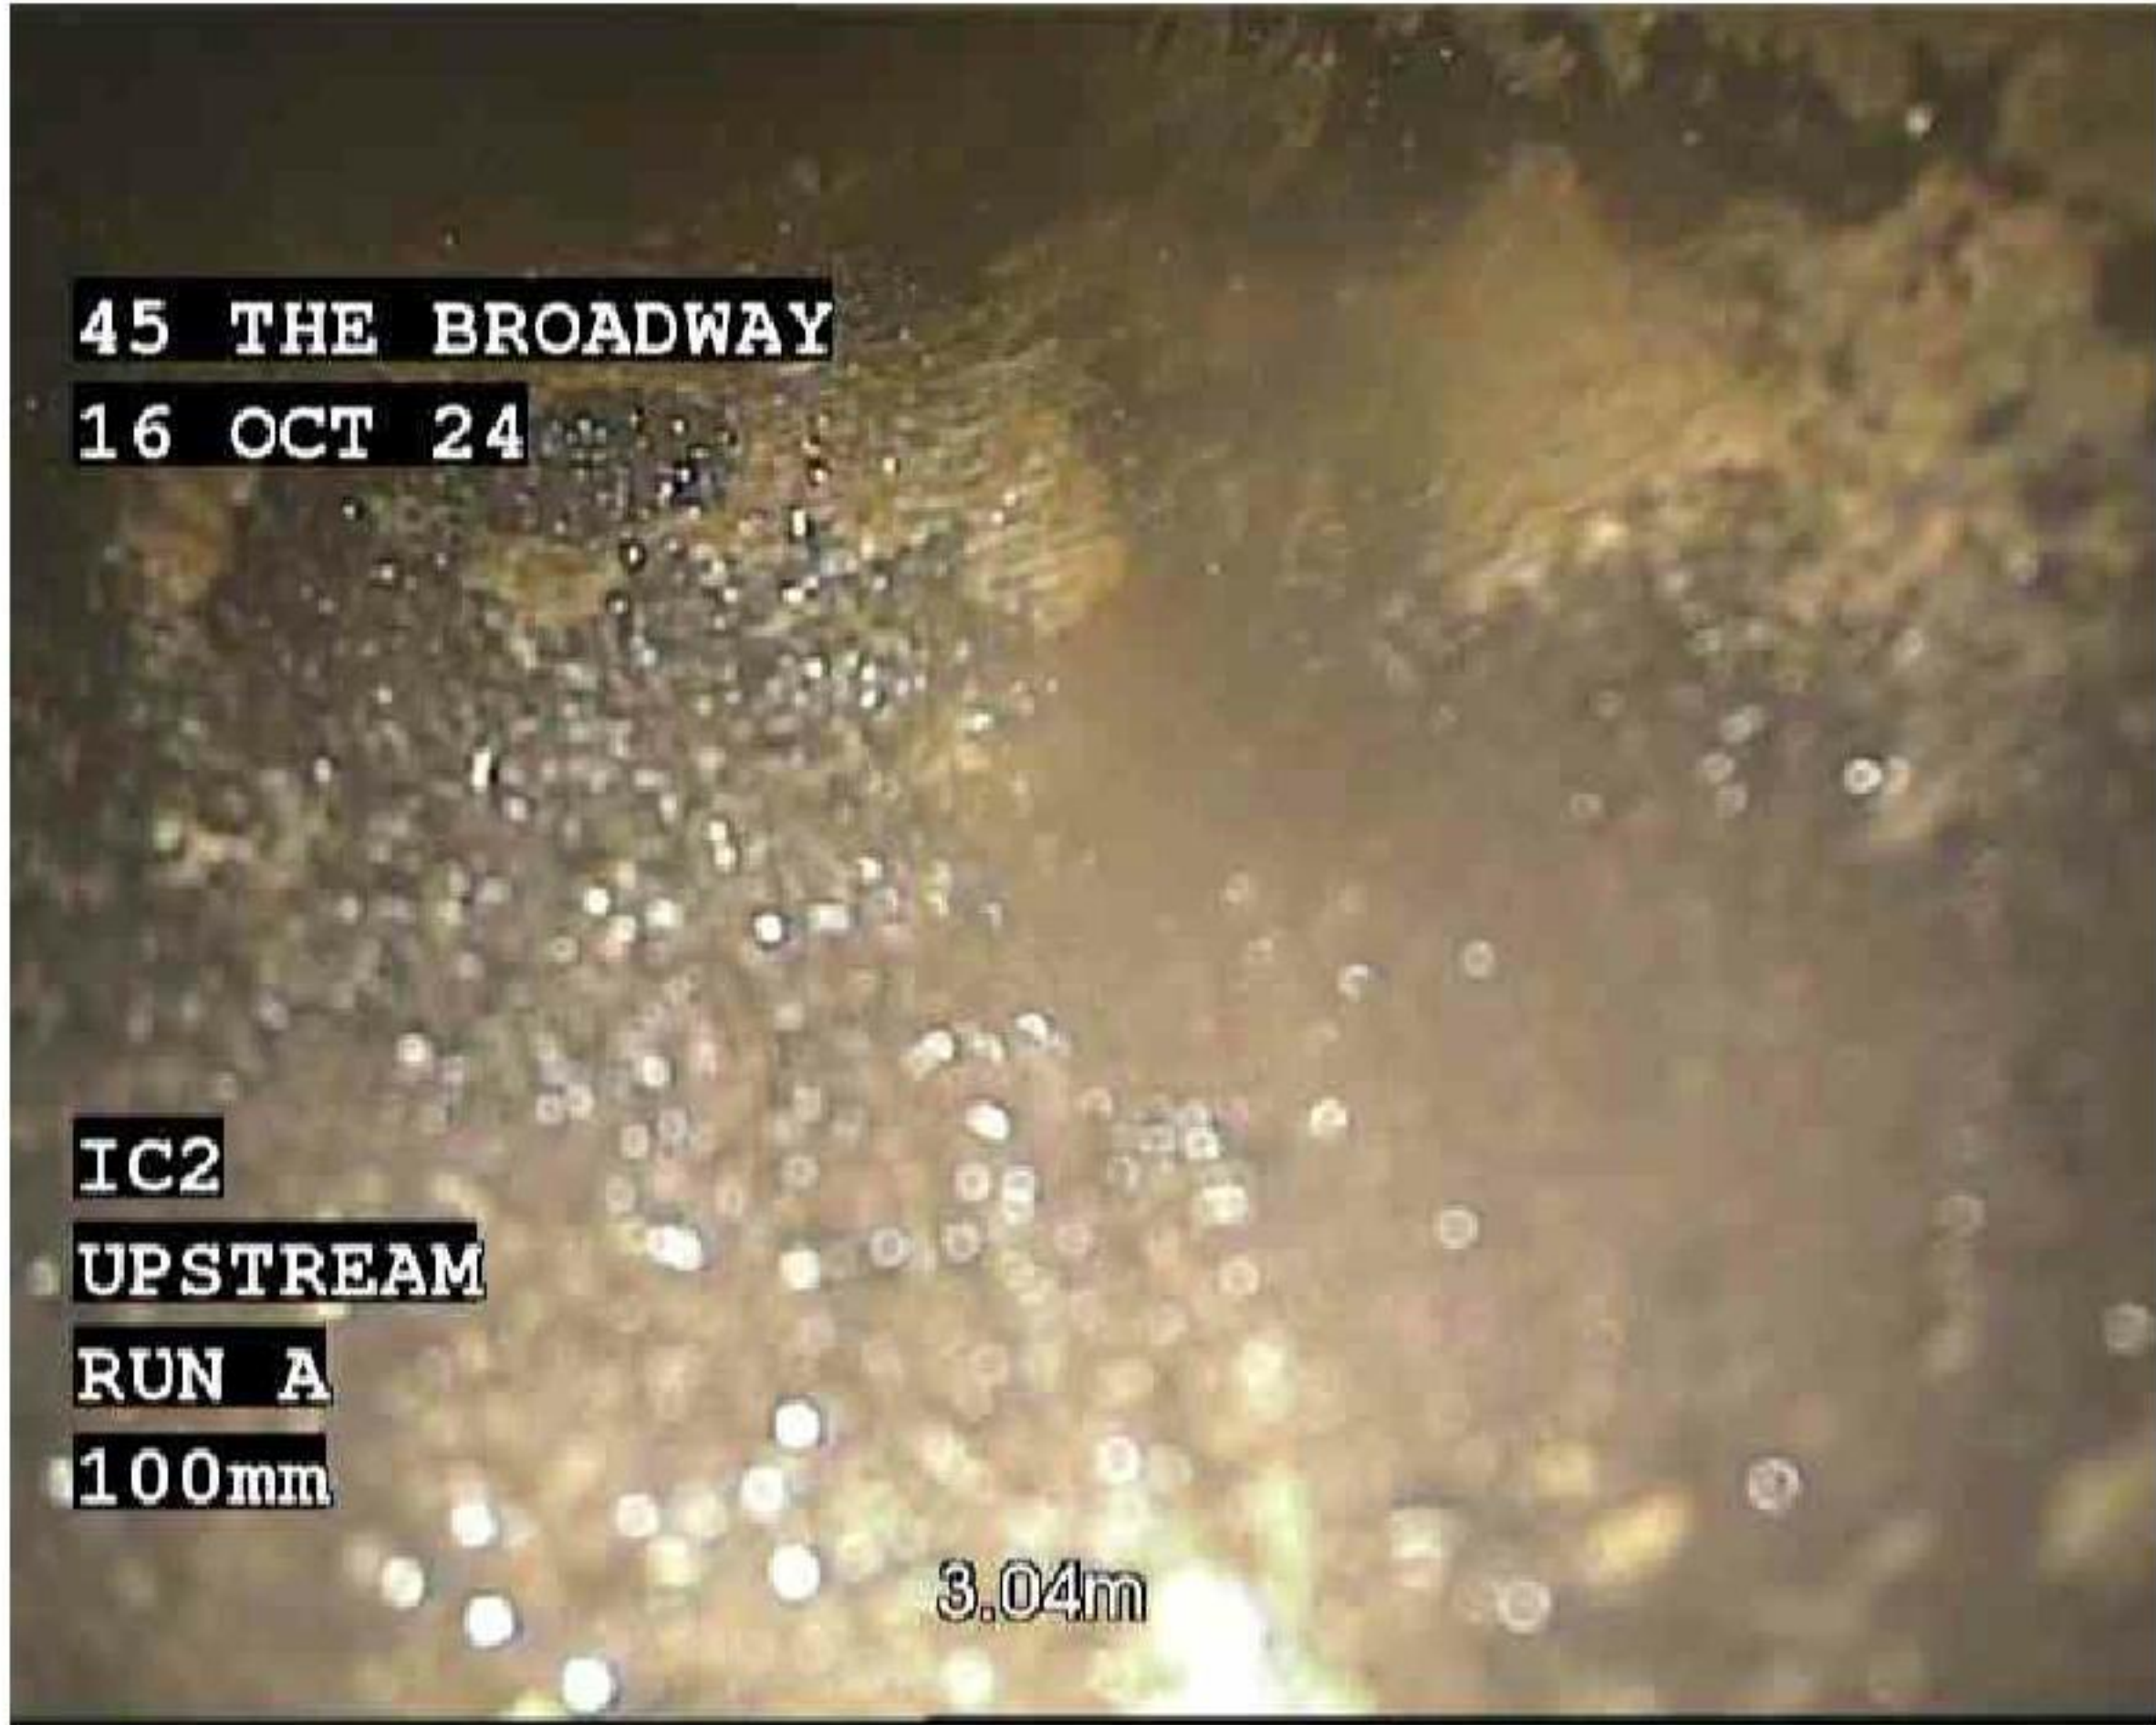
1, 00:00:17, 3.04 m  
Finish node, manhole, reference: IC2-A, At soil pipe
