**Report on a Structural Appraisal
14th September 2025**

**Three barns at the rear of
Pilgrims Farm, Stairbridge Lane,
Bolney, Haywards Heath. RH17 5PA**

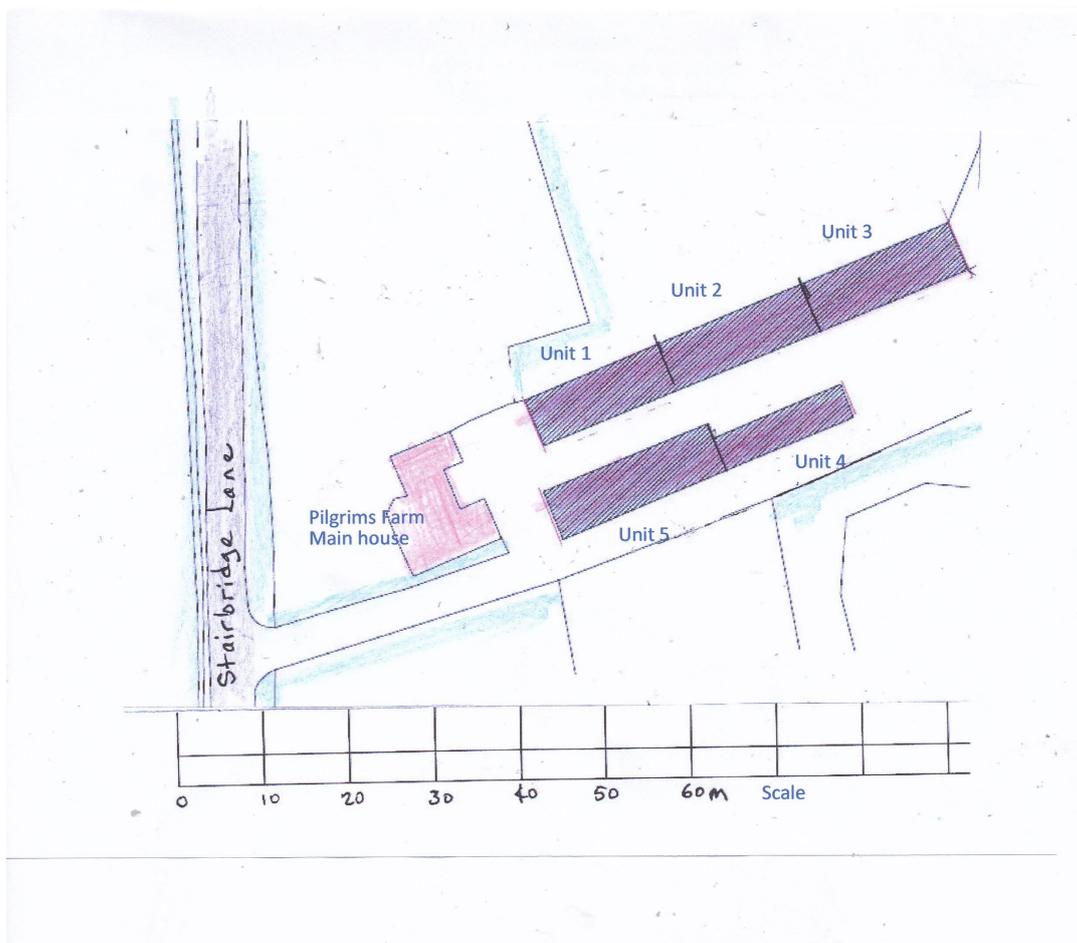
There are three barns which split into five units as shown below.

Units 1, 2 & 3 - 6m wide x 54m long overall x 4.2m high (Long Barn)

Unit 4 is 4.5m wide x 16.2m long x 4.0m high

Unit 5 is 6m wide x 20.2m long x 5.0m high
