## **Damp and Timber Survey Report**

### **Marshalls Manor**

High Street  
Cuckfield  
Haywards Heath  
West Sussex  
RH17 5EL

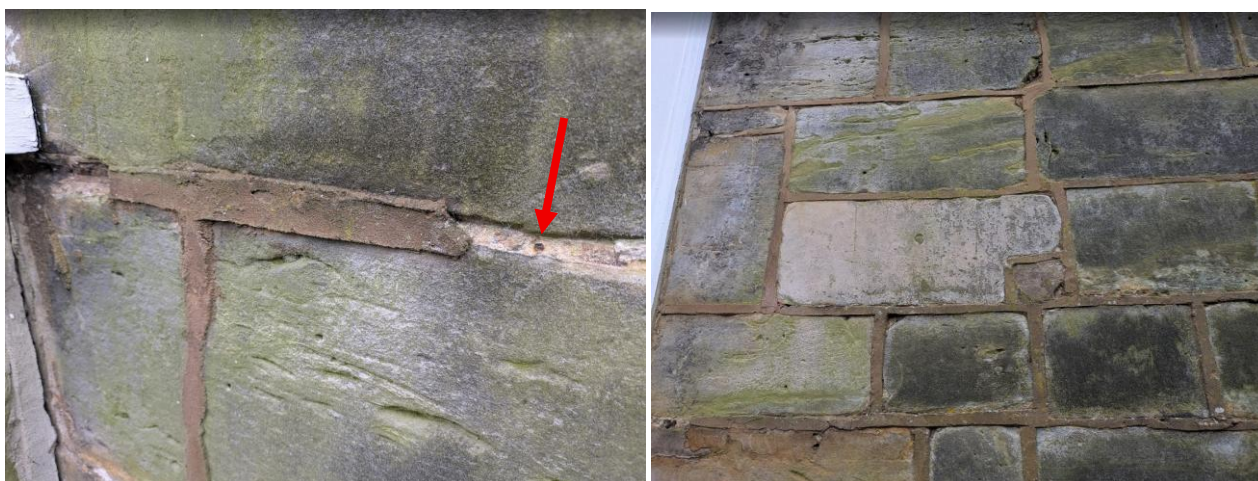
The Ardingly sandstone used on the main elevation is naturally porous. It contains tiny voids and capillaries that allow it to absorb water during rainfall and then release it again as conditions dry. This cycle of wetting and drying is normal and helps the stone remain durable over time.

That balance changes when cement pointing is introduced. Cement is harder and far less breathable than traditional lime mortar. Instead of helping the wall dry through the joints, it slows evaporation and forces more of the drying process to occur through the stone's face. As a result, the masonry remains wet for longer after rainfall. Water is not escaping as efficiently as it was designed to, and the stone stays saturated for extended periods.

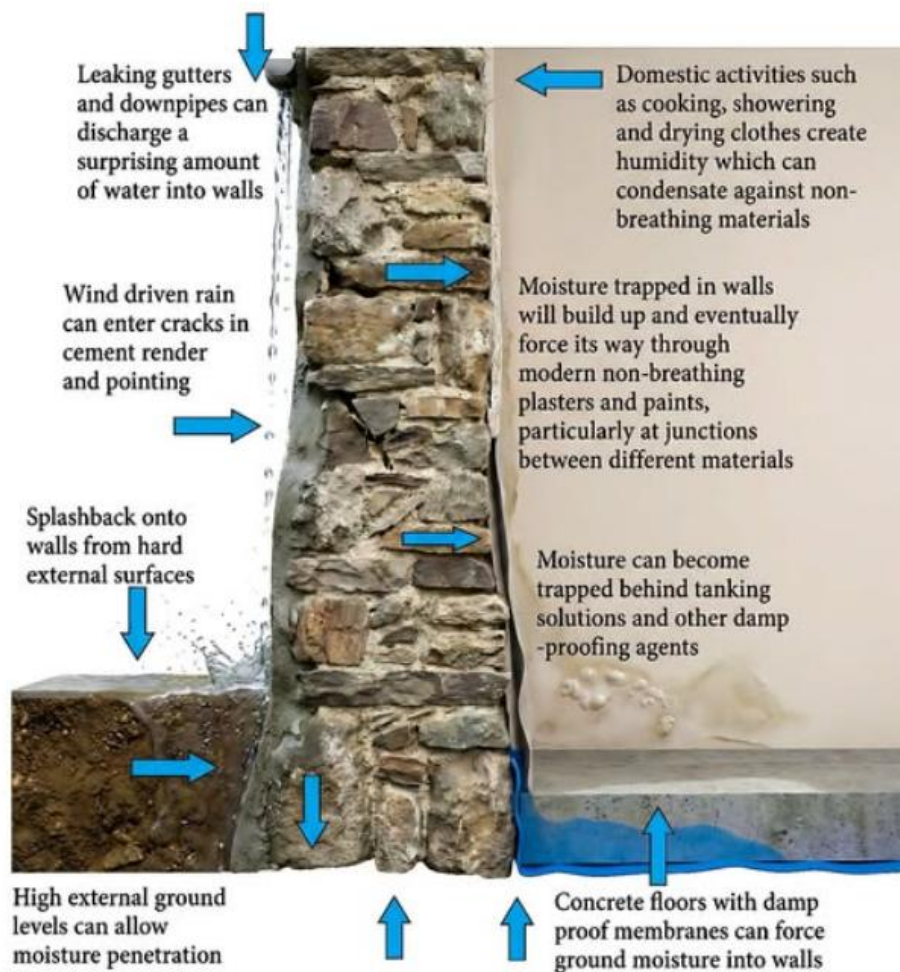
This is a critical point. Moisture within masonry does not simply create a damp appearance. It directly alters the wall's thermal behaviour.

Once the surface temperature decreases, the difference between the air temperature and the dew point becomes smaller. When this margin narrows sufficiently, condensation forms.

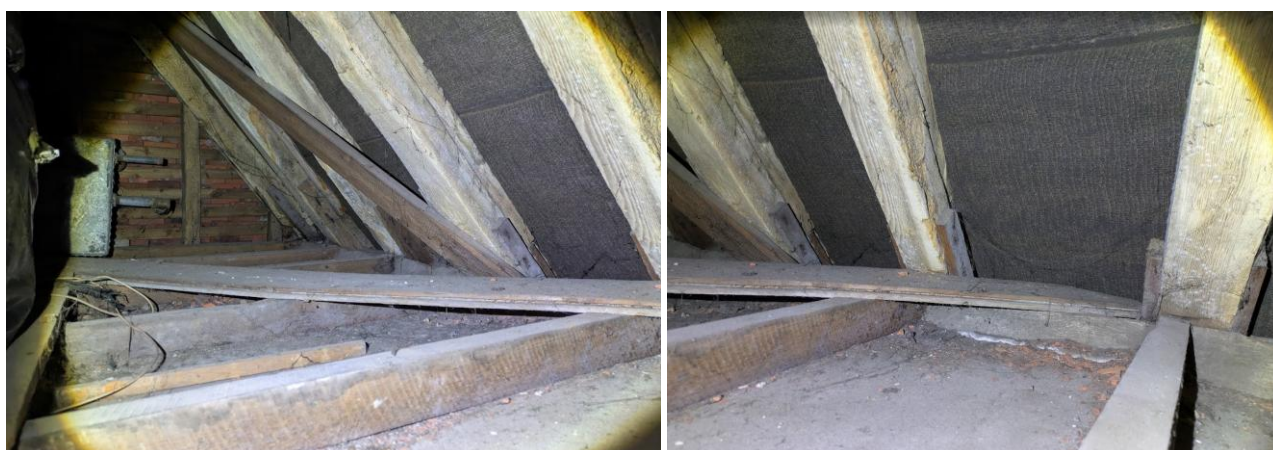
The annexe is thermally weak due to the absence of effective loft insulation within the roof void. Heat loss through the ceiling reduces internal air temperature and increases mouldy conditions.

- Relative humidity increases for the same moisture content.
- The dew point moves closer to the internal air temperature.
- The probability of condensation increases.

This means that even without additional moisture being introduced, reduced temperature alone can trigger condensation. Where cold masonry surfaces coincide with high internal humidity, surface water deposition becomes unavoidable.

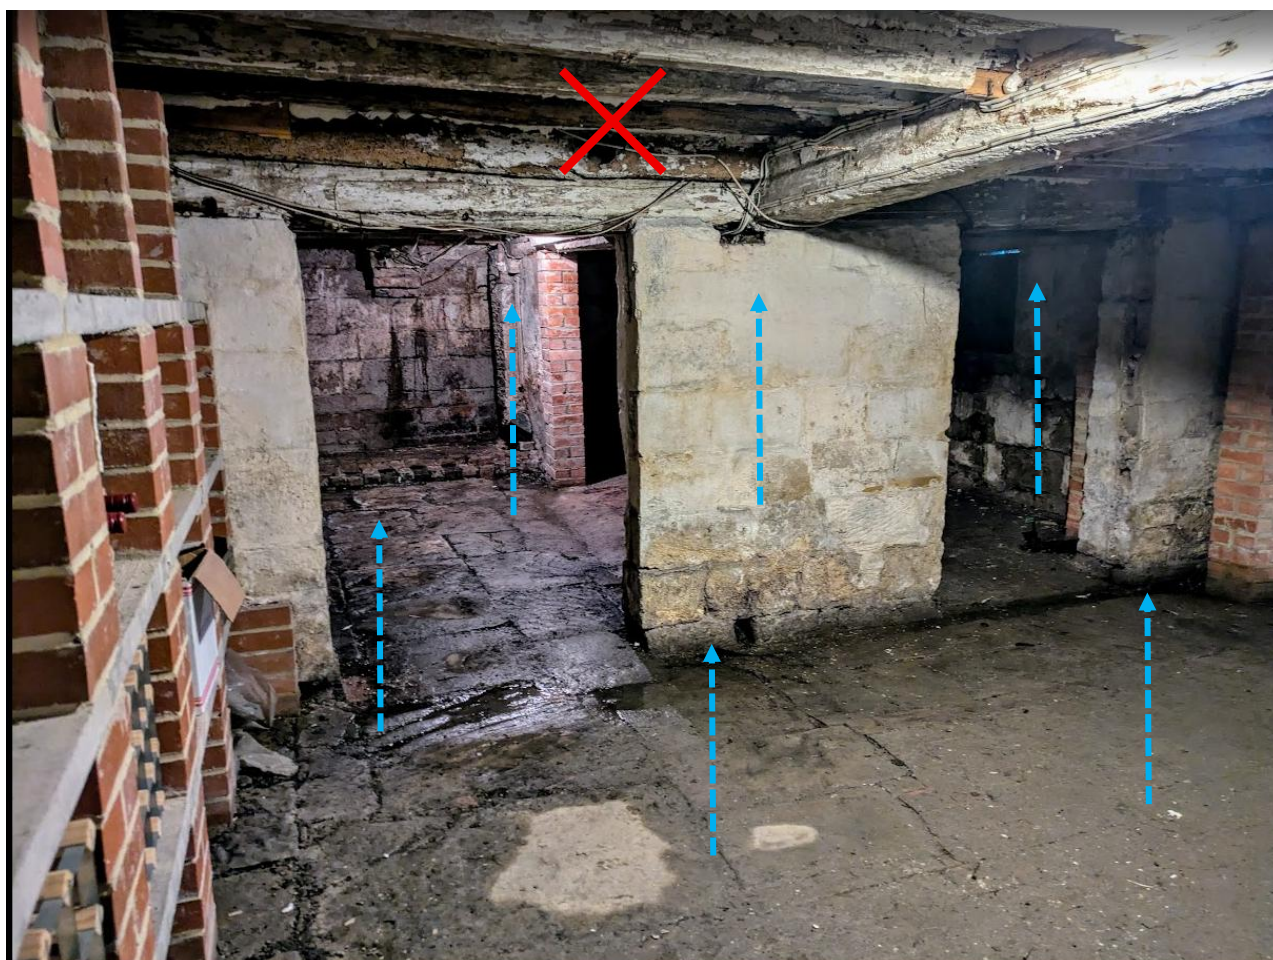
As internal vapour load increases, the dew point temperature rises. When the dew point rises, surfaces that were previously above the condensation threshold may fall below it.

This means that the basement condition influences condensation risk in upper floors, even if those rooms have no direct water ingress.
