## Climbed Inspection Report

**Client:** Burgess Hill Girls School

**Site:** Burgess Hill Girls School, Keymer Road, Burgess Hill, RH15 0EG

**Scope:** Carry out climbed inspection to T296 Oak

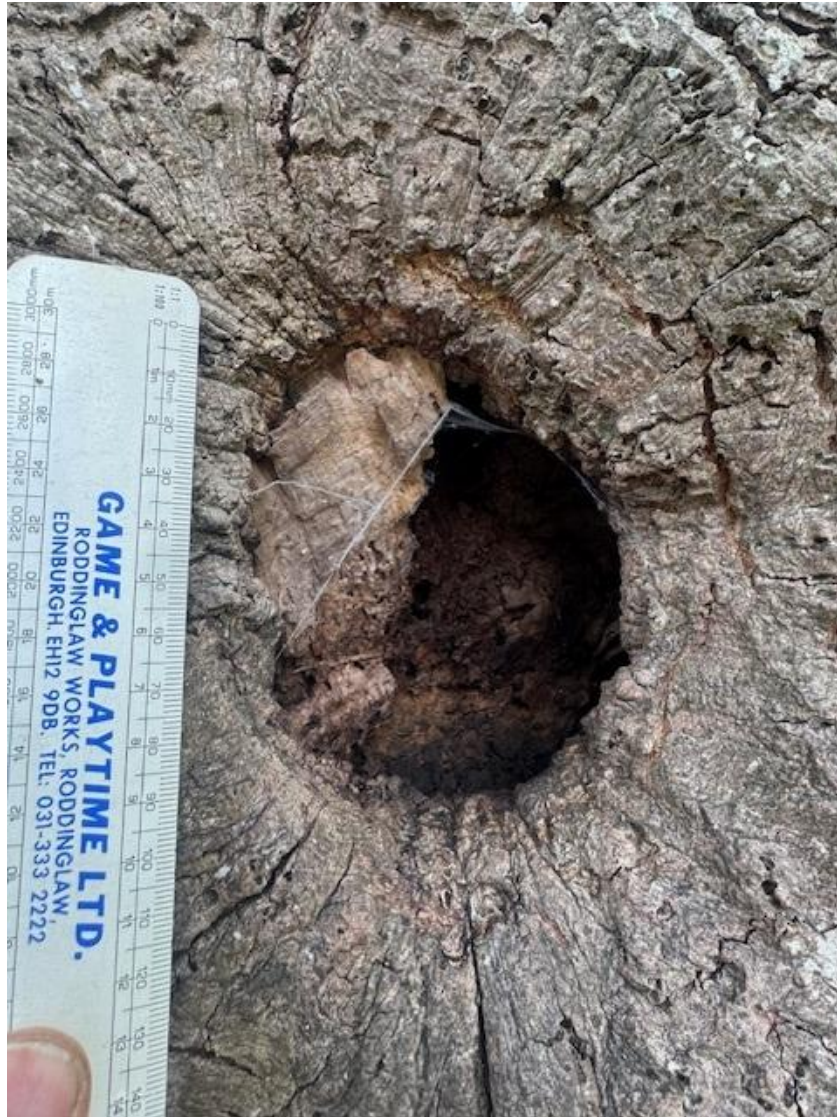
2. Historical tear out scar (900mm long x 600mm wide) on south side of crown at 7m AGL. Scar from entire stem failure. Advantageous regrowth at top of old failure point, with the largest stem being 240mm in diameter and forming significant portion of the lower south side of crown. Branch etiolated in nature and extends beyond crown. Significant heartwood decay as expected from such a large wound, but good wound-wood formation. As expected differences in tone heard when tapped with an acoustic hammer. Branch recently reduced back from phone cables.

Reduce long advantageous branch growing from top of large historical tear-out wound, by up to 2m from current tip, leaving a finish branch length of 9m. Reduce back to suitable side branches to leave as natural a shape as possible. Similarly reduce back branch beneath as above to match and leave a more balanced crown. Re-assess at next inspection Summer 2028.
