## FORMAL INSPECTION OF 1 X COMMON BEECH (T284)

**AT:** Keymer Road,  
Burgess Hill,  
West Sussex,  
RH15 0EG

**CLIENT:** Burgess Hill Girls School

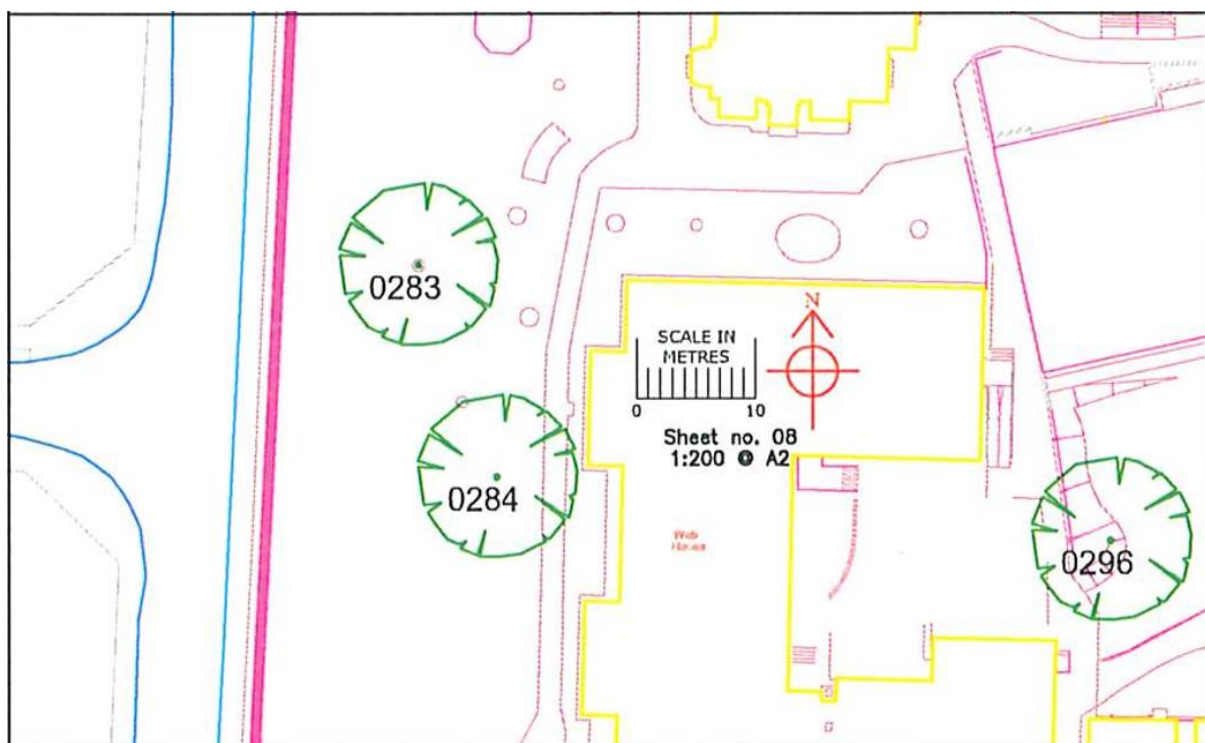
Figure 1 – Showing the location of the beech tree (T284).

5.1 Burgess Hill Girls School has been at its current location since 1928 and has expanded with demand on various occasions. It comprises of older (circa late 1800's and more moderns school buildings throughout the site. The site is within the Silverdale and Birchwood Grove Road Conservation Area. There are residential boarding properties within large Victorian dwellings on the south side of Silverdale Road and on either side of Glendale Road, abutting the school. Other large private dwellings are found on all other compass cardinal points around the school grounds. The beech tree is in a prominent position, being on the front lawn, adjacent on the west boundary of the school and visible from the public highway.

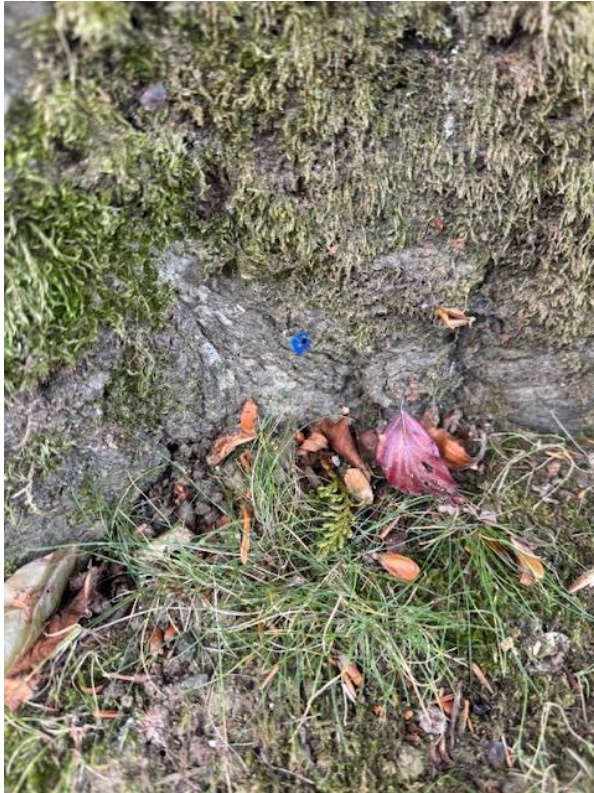
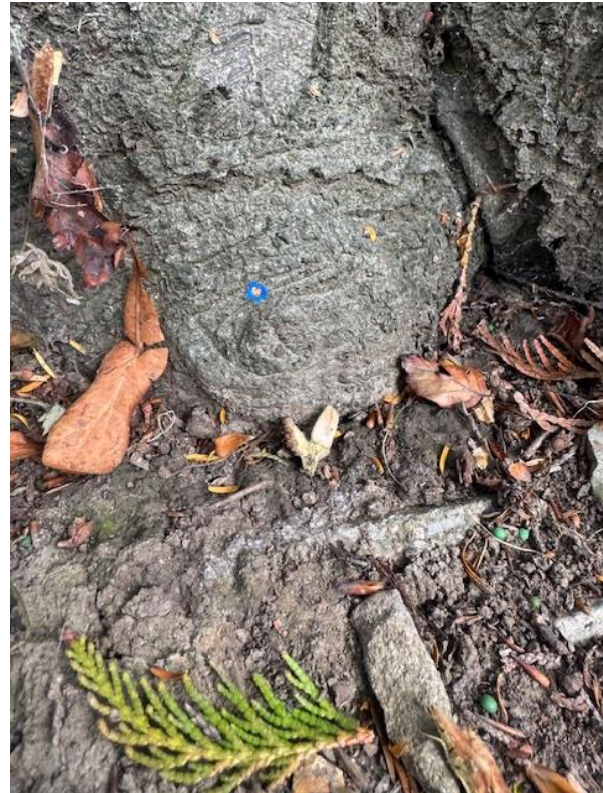
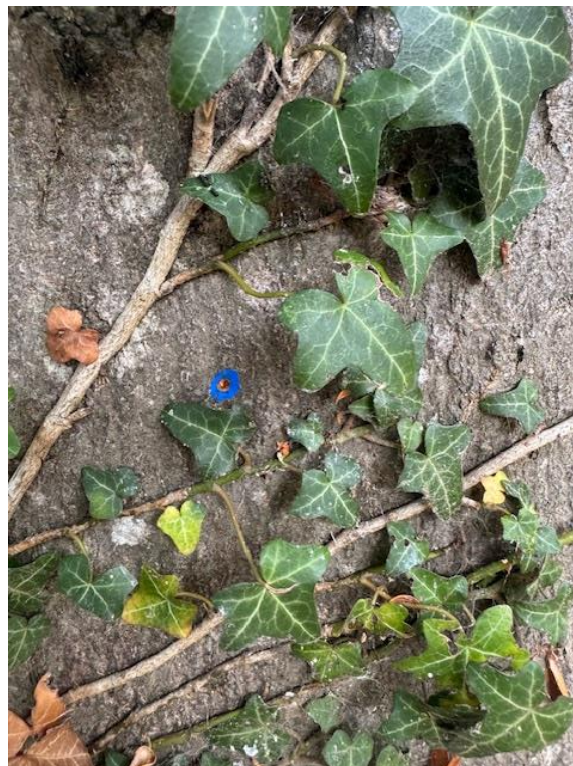
## APPENDIX 2: SITE PHOTOGRAPHS

9.1 Pathogenic decay fungus *Kretzschmaria deusta* was visually identified at various locations at the base of the tree. This particular fungus is known to be a particularly dangerous decay fungus, due to the type of decay it causes. The decay starts as a soft rot of wood progressing in later-stages to a white rot, which reduces the strength of the tree. The decay can extend up the stem, as well as into the roots. Eventually the tree can succumb to windthrow.

9.3 In most of the microdrill investigations (see tables 3, 6, 7 & 8, in the results above) there were areas where the wood integrity appeared evidently compromised, this is demonstrated by a clear reduction in both the microdrill's feed and drill resistance throughout each investigation. These samples were taken from various locations at the trees base, suggesting that most of the tree's base is affected by internal decay.

9.4 Most significantly, investigations carried out at the base on south-east side and another at 1.5 metres from ground level on the south side of the trunk clearly shows an internal decay cavity (see tables 5 & 9, in the results above). Note that the microdrill automatically retracted, as a safety precaution to prevent damage to the equipment.

9.8 Usual management options for trees in this condition are entire removal. Below is the discussion for removal rather than repeated pruning:
