## Foul and Surface Water Drainage Report

**C- Store, Prince Albert, Copthorne**

**Westcoast Developments Ltd**

**Project Name:** Prince Albert Pub RH10 3QX  
**Project Description:** General CCTV - Condition Check  
**Project Number:** JSD7518  
**Project Status:** Complete  
**Project Date:** 25/07/2024  
**Inspection Standard:** MSCC4 Sewers & Drainage GB (SRM4 Scoring)

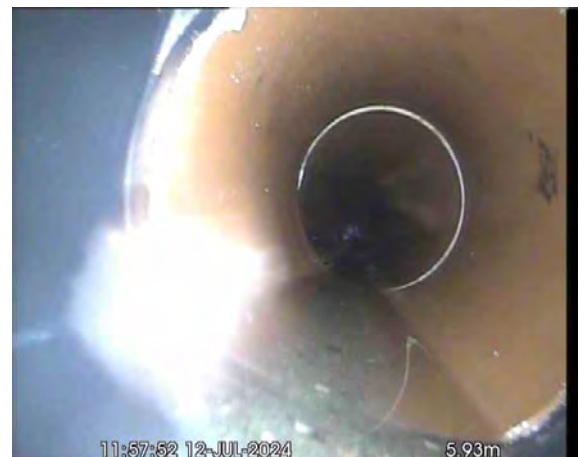
MH2X\_2c7dd602-37a2-429a-a2ab-0279f14f5071\_20240725\_093210\_012.jpg, 00:01:46, 5.93 m  
Water level, 5% of the vertical dimension

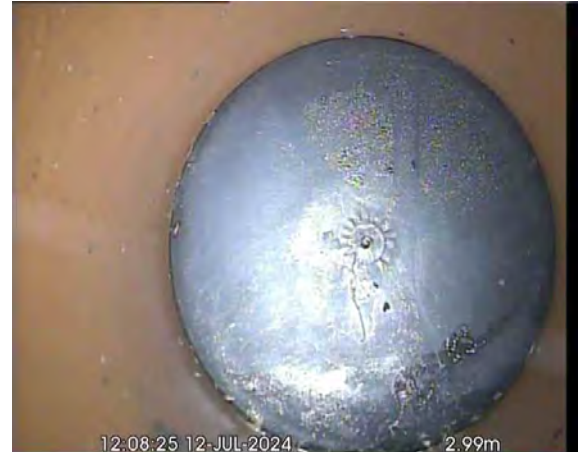
CAPPED  
OFFX\_dc97001a-2078-4b93-b9a2-163b14f502db\_20240725\_  
093522\_395.jpg, 00:01:03, 2.99 m  
Survey abandoned, S/A - CAPPED OFF

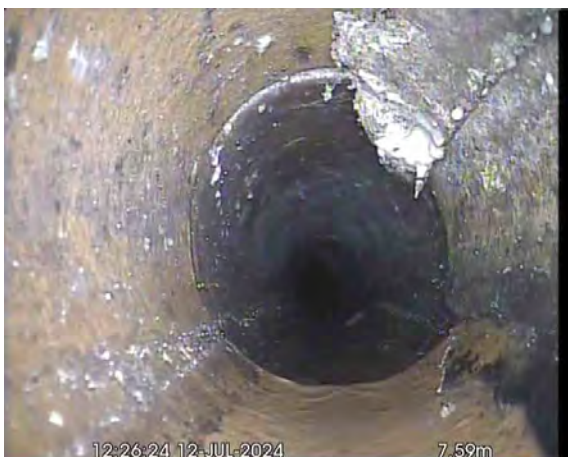
MH5X\_a25c901e-431c-4751-af44-e6286baac714\_20240725\_094843\_842.jpg, 00:01:51, 7.59 m  
Attached deposits, grease from 12 o'clock to 5 o'clock, 5% cross-sectional area loss

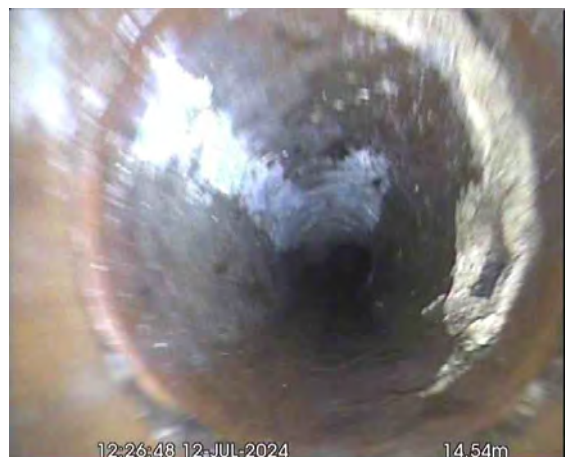
MH5X\_b9529b71-08d6-4df3-a0ef-83327201d51f\_20240725\_094926\_931.jpg, 00:02:15, 14.54 m  
Hole in drain or sewer at 4 o'clock

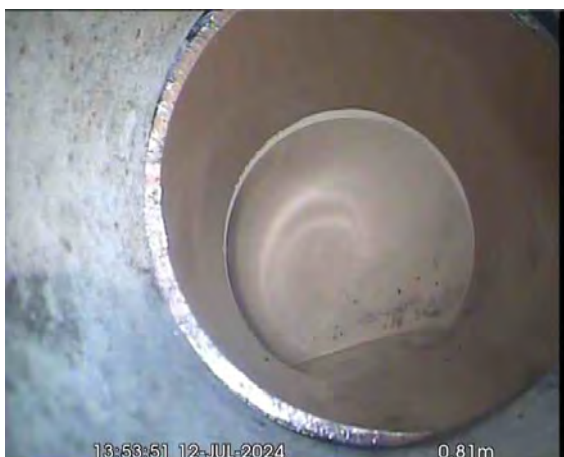
SVPX\_6126ff3a-8feb-42cf-b4a8-289a35627abd\_20240725\_095243\_344.jpg, 00:00:43, 0.81 m  
Joint displaced, medium

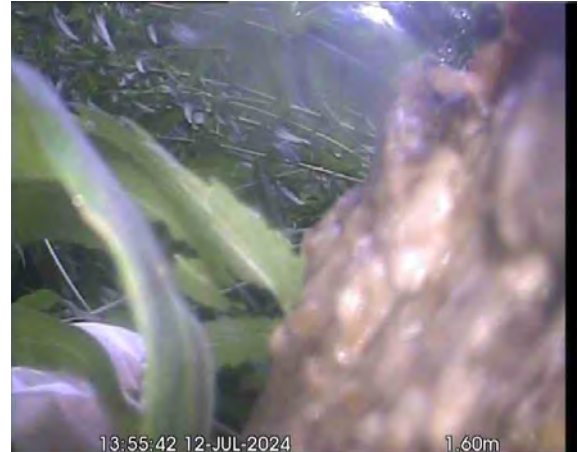
SVPX\_9d8768b1-86dd-4d7b-b136-613c52434c58\_20240725\_095530\_137.jpg, 00:01:28, 1.60 m  
Survey abandoned, S/A - OPEN PIPE - SOIL VENT PIPE NOT CONNECTED UP
