## 2.9 GEORGIAN STYLE HOUSE - AS CURRENTLY

## 2.10 BUILDING CONDITION

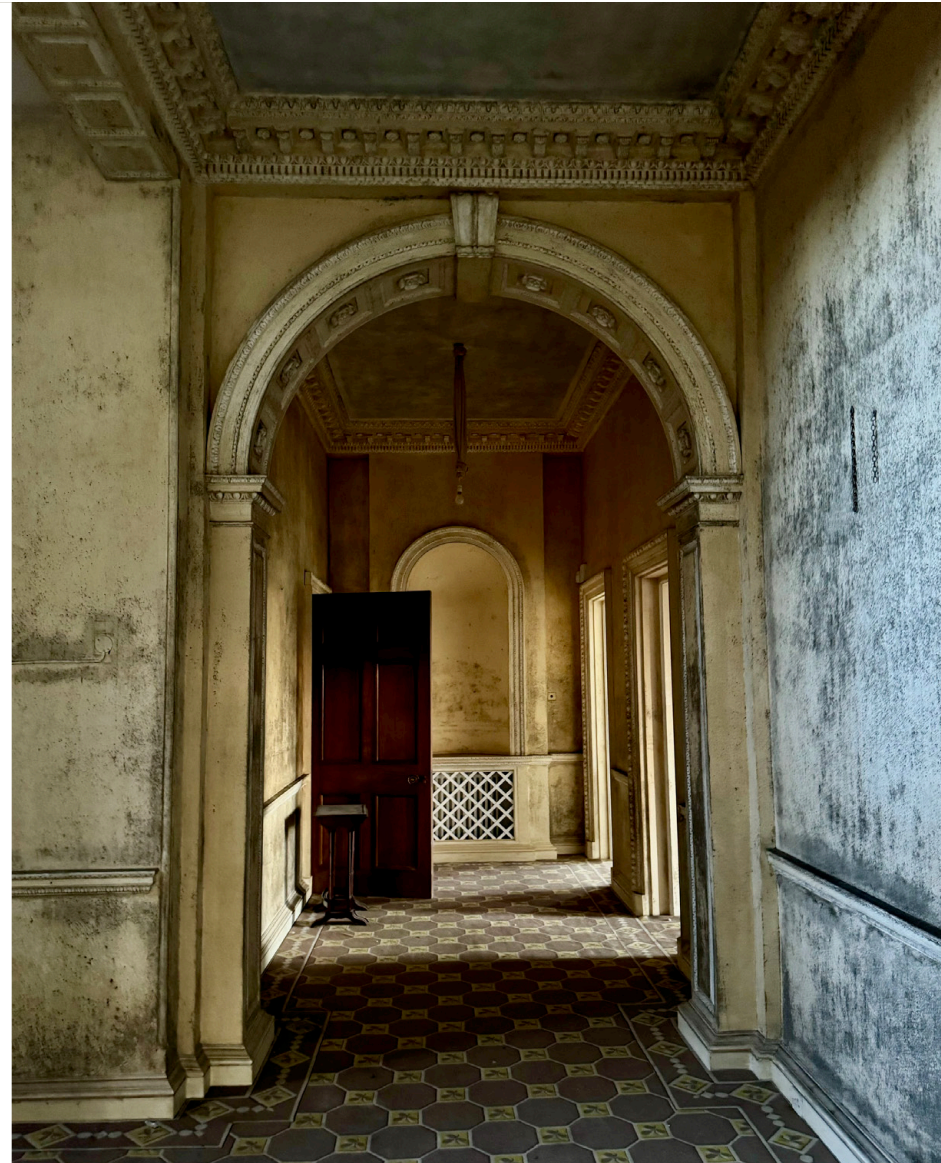
The existing dwelling has been unoccupied for many years and is now dilapidated. In this time significant degradation of the property has occurred as can be seen in some of the photographs included here. The primary issue is the significant damage caused by damp.

As a vacant dwelling with no heating, the moisture that has likely risen from the basement, has penetrated the fabric of the building. The rectification of this damage would need to be undertaken alongside major renovation works. To rectify this issue and prevent further ingress the works would need to undertake (but not be limited to) the following:

Top Left: Significant moisture degradation is evident to all surface

- Complete tanking and installation of ventilation within the basement
- Insulate basement walls and floor to avoid cold zone within dwelling.
- Removal and replacement of all internal finishes.
- Remove any parts of the timber structure that are defective with rot.
- Removal and replacement of all single glazed windows and replacement with double or preferably triple glazed windows.
- Installation of energy efficient heating system
- Assessment of heat loss through walls and provision of 'breathable' woodfibre internal insulation.
- Provide insulation at ground floor level
- Provide insulation at roof level
- Install whole house ventilation system to ensure constant adequate ventilation

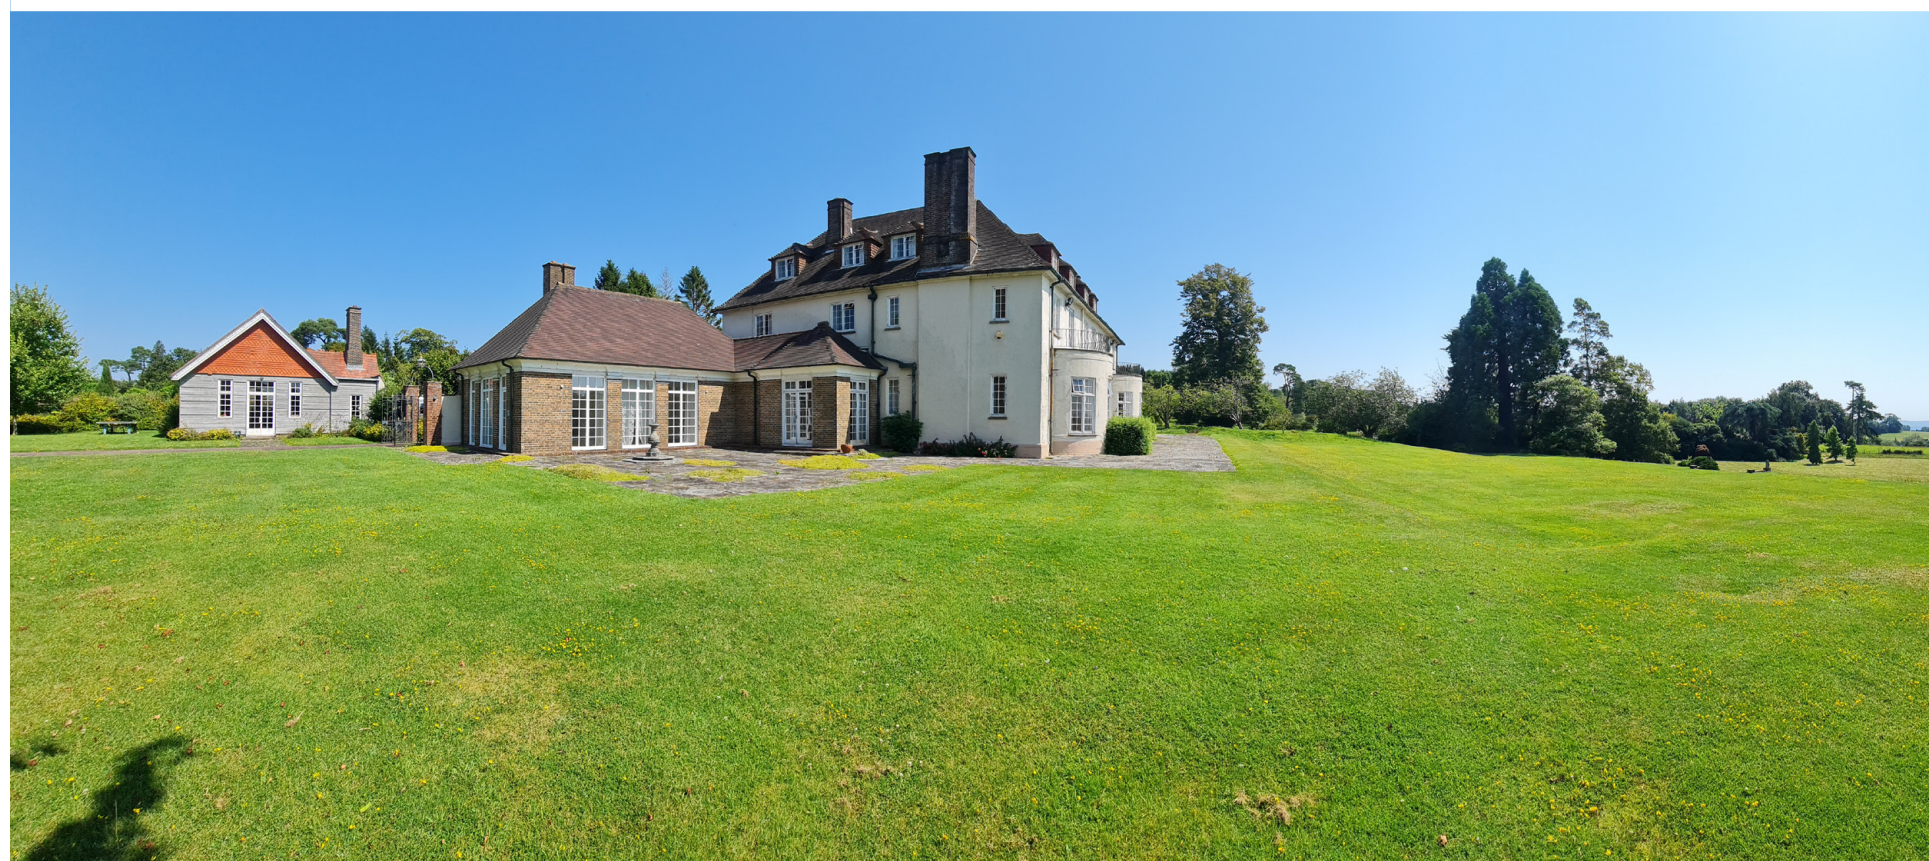
View of the house from the west showing the elevated position of the house within the grounds. To the left of the photo is the detached 'Games Room' building which is the only wholly remaining part of the original Gothic Revival house. This is to be retained as part of the proposals.
