- 1.01 In accordance with your instructions, subsequently confirmed by our letter of the 4<sup>th</sup> November 2025 we attended the above property on 12<sup>th</sup> November 2025 in order to carry out a detailed inspection of the property, identify any defects, causes of such defects, and advise in relation to possible remedies.
- 1.02 We have listed our findings with respect to the Garage/Annexe in Appendix 4, Leisure Complex in Appendix 5 and The Cottage in Appendix 6.
- 1.03 We have not been instructed to provide or arrange for any other associated services.

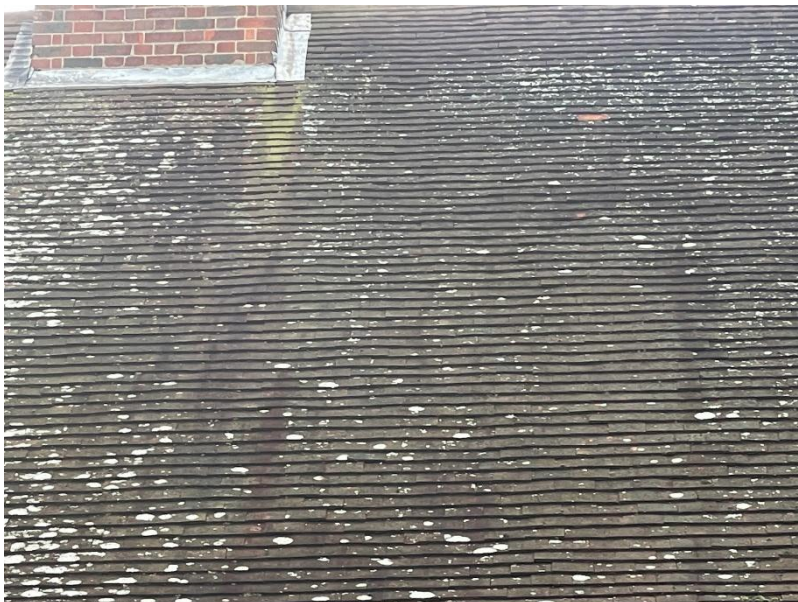
1. The roof profiles remain generally true and even with no signs externally to indicate any deterioration of the underlying supporting timber framework.

2. Moreover, there was no evidence of surcharging of the external walls by the rafter feet at eaves level.
3. The clay tiles are of reasonable quality and remain generally free from excessive surface spalling.

4. The alignment and gauge of the tiles, although slightly uneven in places, is considered satisfactory.
5. As is to be expected given the age of the roof covering, a number of tiles are chipped, cracked, spalled or have slipped and will need to be replaced as part of ongoing maintenance.
6. The ridge and hip lines undulate slightly but significantly so.
7. The majority of the ridge and hip tiles remain well pointed and bedded.
8. Isolated tiles however have open and weathered bedding joints and will need to be repointed/rebedded when access is next available.
9. The swept tiled valley gutters are generally well detailed and remain in reasonable condition.

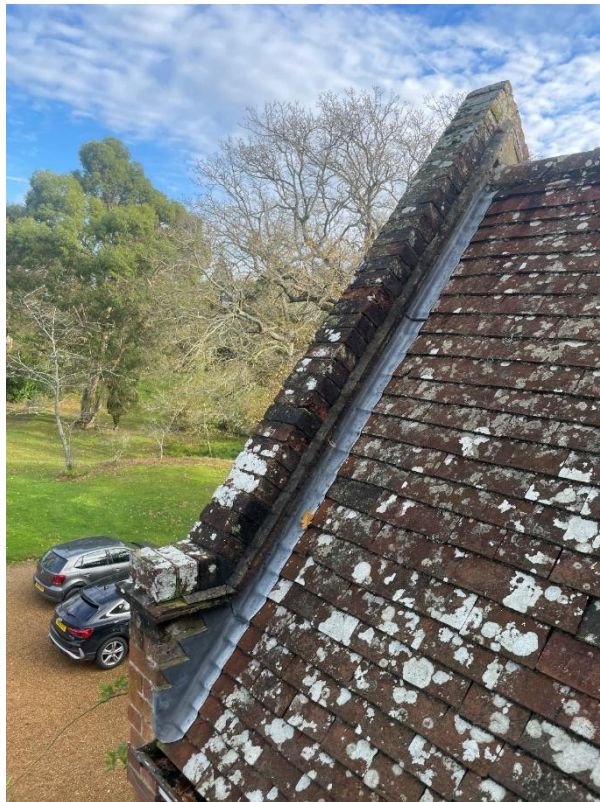
19. Sections of the cracked cement fillets will need to be repointed, and some isolated spalled bricks replaced as part of ongoing maintenance.
20. The upper brickwork is damp stained which has led to the early stages of the surface spalling.

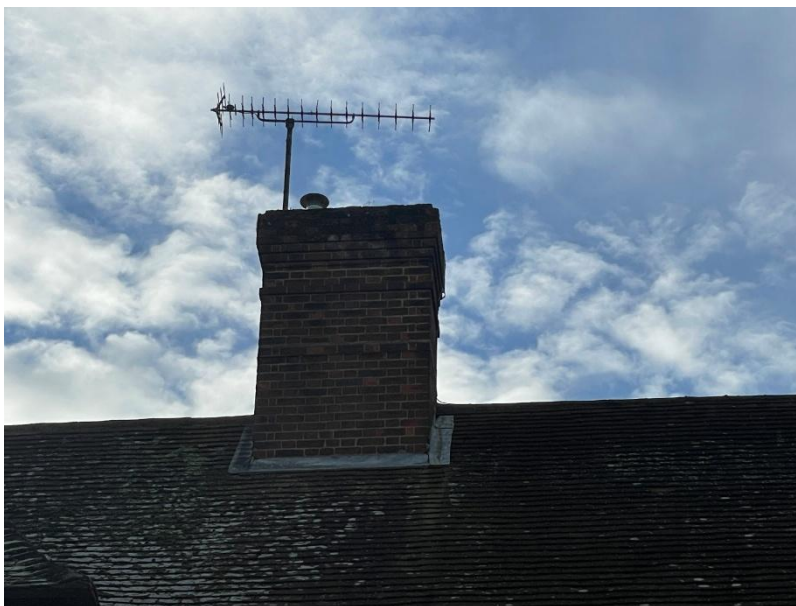
3. The bricks are of reasonable quality and are well preserved, free from significant surface spalling.
4. The cement-based mortar joints are generally well preserved and intact.

5. The cement flaunching into which the chimney pots are seated is cracked in places and will need to be repaired/reformed when access is next available.

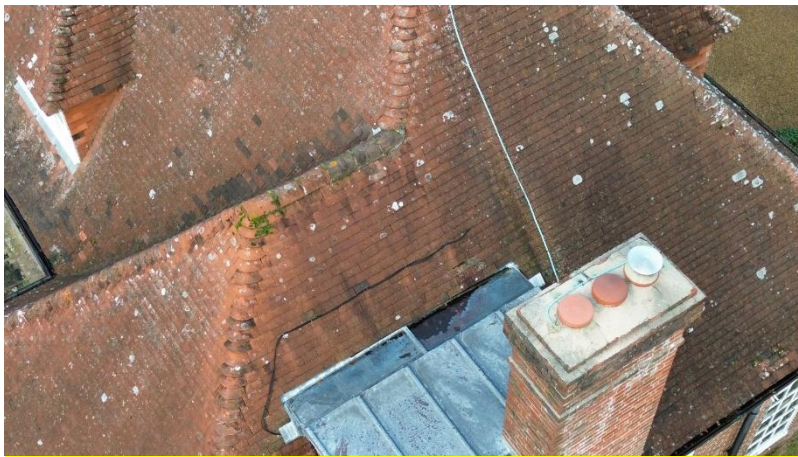
2. For the most part the bricks are in reasonable condition.
  3. An isolated number of bricks are however showing signs of early stages of surface spalling. This process is unfortunately irreversible and over a period of time will require the affected bricks to be cut out and replaced or refaced with a tinted mortar.

4. Some moss and lichen growth was noted to the upper oversailing courses and ideally should be removed.
  5. Two layers of slate have been incorporated within the brickwork to act as a horizontal damp proof course to discourage vertical penetrating internal dampness.

7. Isolated tiles are cracked or missing from the lower shoulders and should be replaced.
8. The junctions with the projecting dormer window and roof slopes are formed with stepped lead flashings and back lead apron gutters.
9. The leadwork is generally well detailed and is considered serviceable
10. The flaunching is cracked in places and will need reforming.

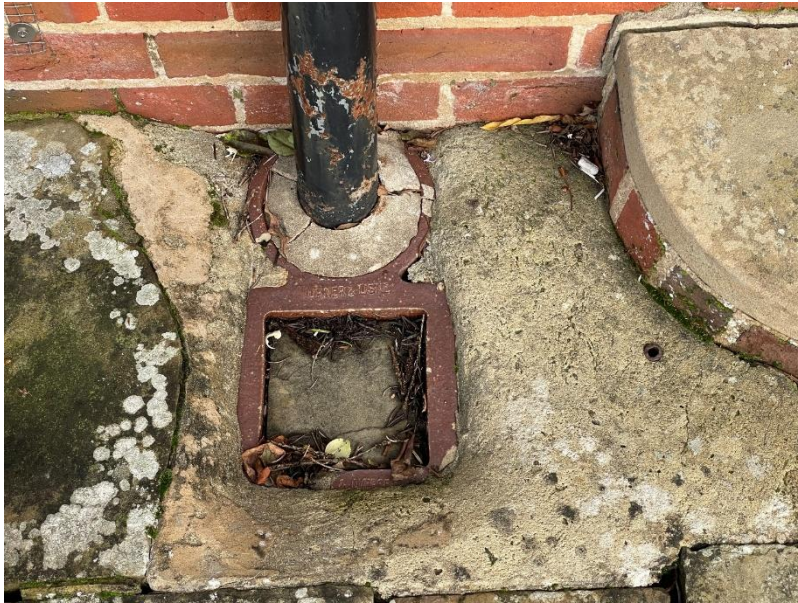
7. Gutters also require clearing of leaves/debris on a regular basis to prevent overflowing and damp staining of the external brickwork.
8. Waste pipes serving sanitary fittings at second floor level have been crudely fixed into larger downpipes to the south elevation wall. This detailing in our opinion is poor, and the general fixing of the pipework is inadequate. Consideration should be given to the re-running of the waste pipes internally. Some additional soil and vent pipes may need to be added.

9. We would recommend that all external gutters and open gullies be regularly cleared of leaves. The kerbed gullies appear to be in fair condition with only minor repairs anticipated as part of routine maintenance work. Some repointing to cracked and loose sections of cement fillets and clearance of the build up of leaves and debris are required.

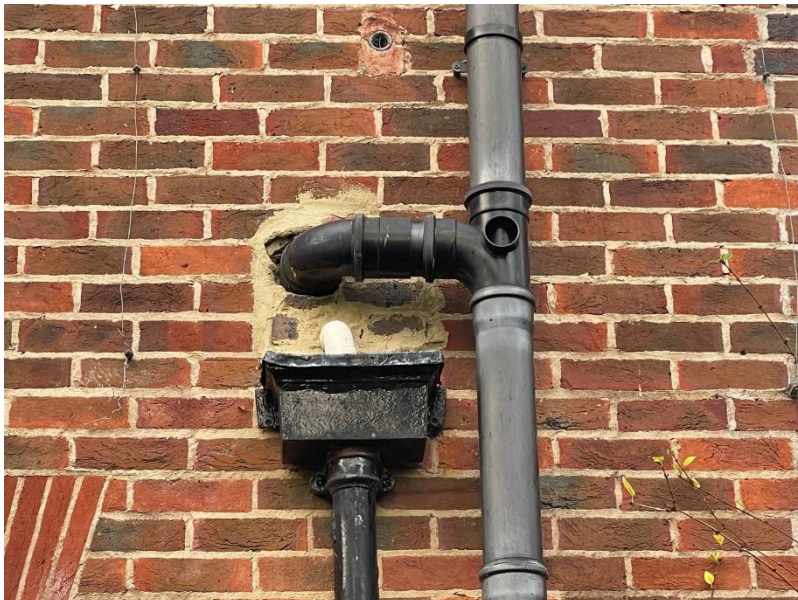
4. The mortar joints remain generally well preserved and intact.
5. It was noted on the north elevation wall that some holes remain where redundant pipework has been removed over the years. We would advise that they should be filled in with a lime gauged mortar.
6. Crude repairs to sections of brickwork (east elevation wall) have been carried out in recent years.

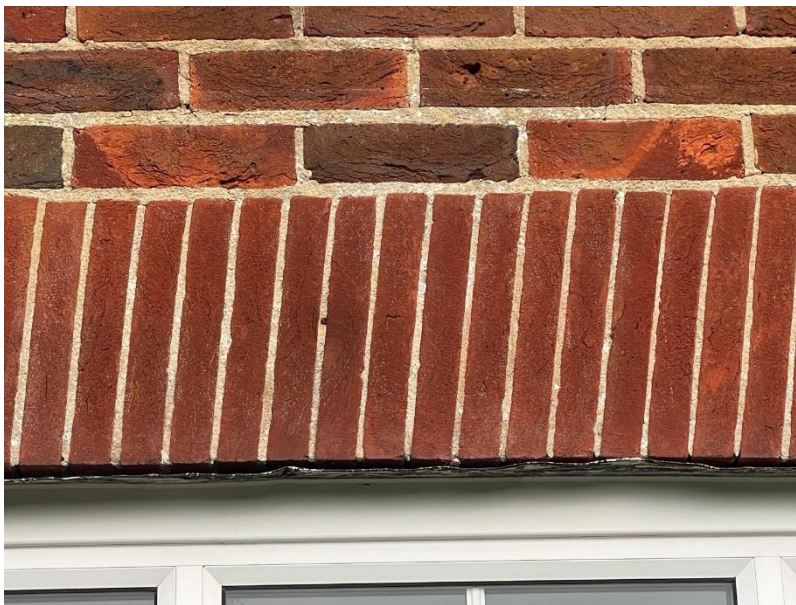
7. The rubbed brick arches are well formed and generally free from rotational cracking around their bearing ends.
8. The lead trays which protrude over the arches facilitate drainage of the brick cavities.

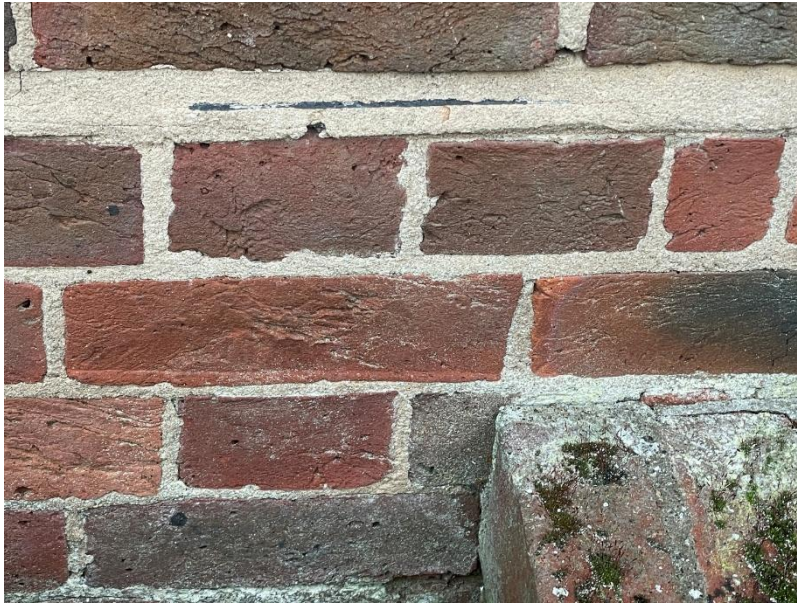
- 8.59 The external walls incorporate two layers of natural Welsh slate embedded within a mortar joint to form an effective damp proof course.

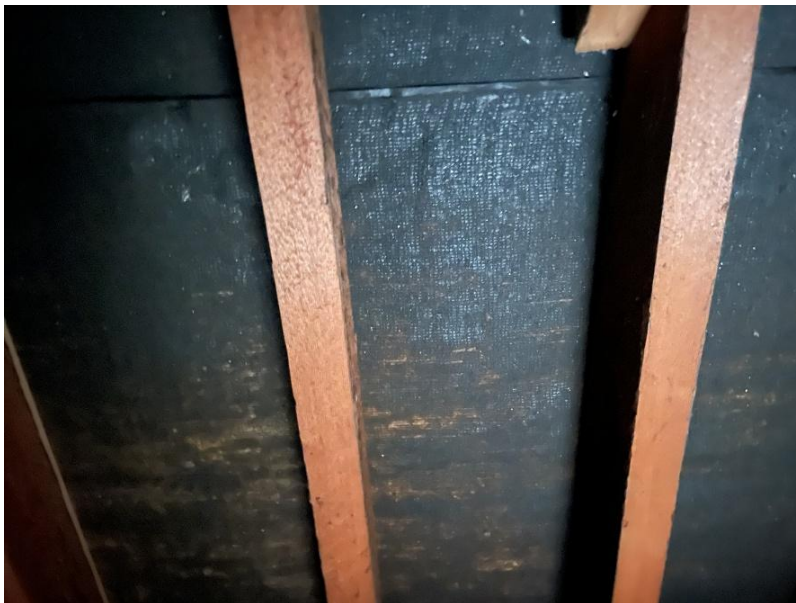
7. The main roof slopes have been lined with roofing felt which provides a secondary line of defence against internal water penetration. The felt would appear to be original and is now somewhat old and fragile.

8. The presence of the felt prevented a full assessment of the condition of the projecting nibs and nails which secure the tiles to timber battens.
9. In isolated areas where the felt is torn or split, or has been removed, the projecting nibs appear to be well preserved.

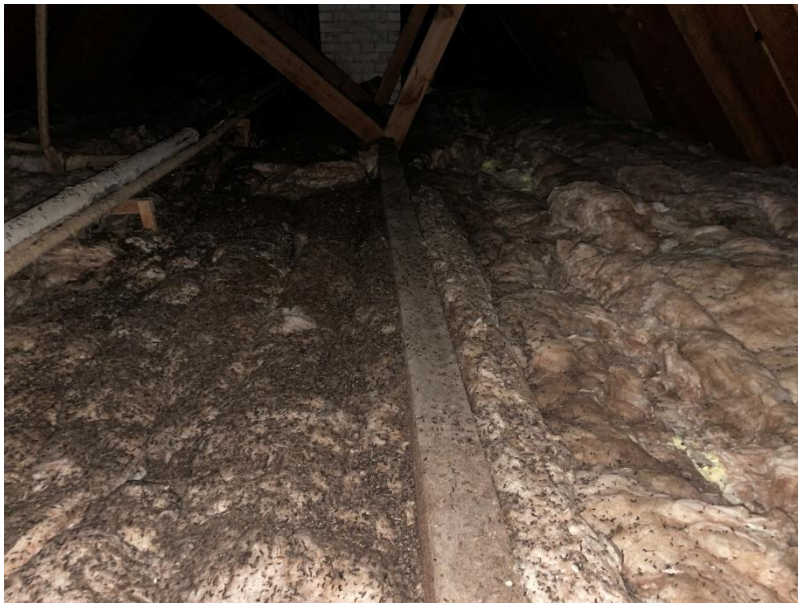
17. Ancillary pipework feeding the tanks has been well lagged with hessian wrap foam insulation and fibre lagging.
18. Whilst inspecting the roof void it was noted that there was considerable evidence of bats and rodent infestation.
19. Bats are protected by The Wildlife and Countryside Act 1981. It is illegal not only to kill, injure or handle bats, but also to damage, destroy or obstruct access to any place that a bat uses for shelter or protection, or disturb a bat while it is occupying such place.

20. If any action is proposed which would affect bats or their roosts, then the Nature Conservancy Council must be informed and allowed time to advise on any special precautions that may be necessary.

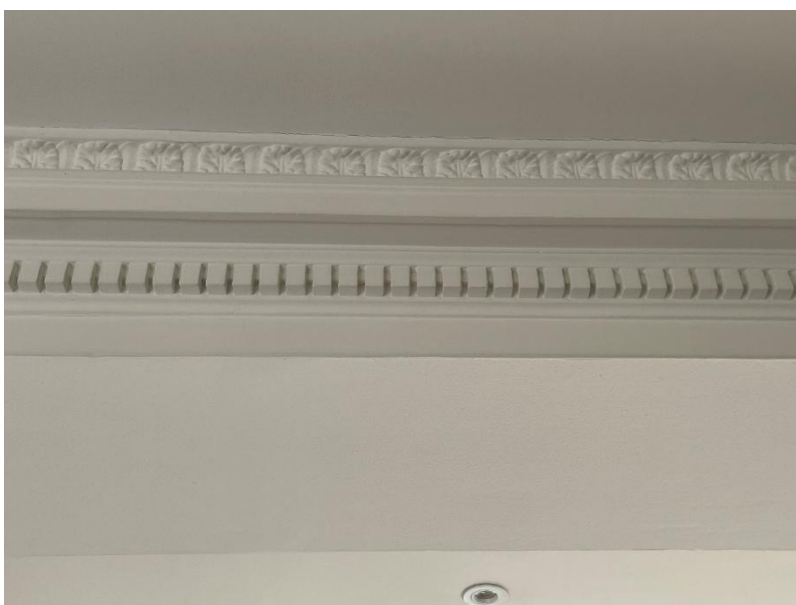
3. The life of lath and plaster ceilings depends upon the quality of the original construction, and the degree of exposure to leaks and flexing. Where tested, the ceilings and skellings appeared to be in reasonable condition.
4. Hairline cracking was noted in isolated places at junctions with the timber cornices, or internal partition walls. Such cracking in our opinion relates to thermal shrinkage and is not considered to be of structural significance. The hairline cracks can easily be cut out prior to the next phase of internal redecoration works.
5. We would add that some reopening of cracks should be anticipated.
6. The embellished cornices throughout are of high quality and remain in good condition.

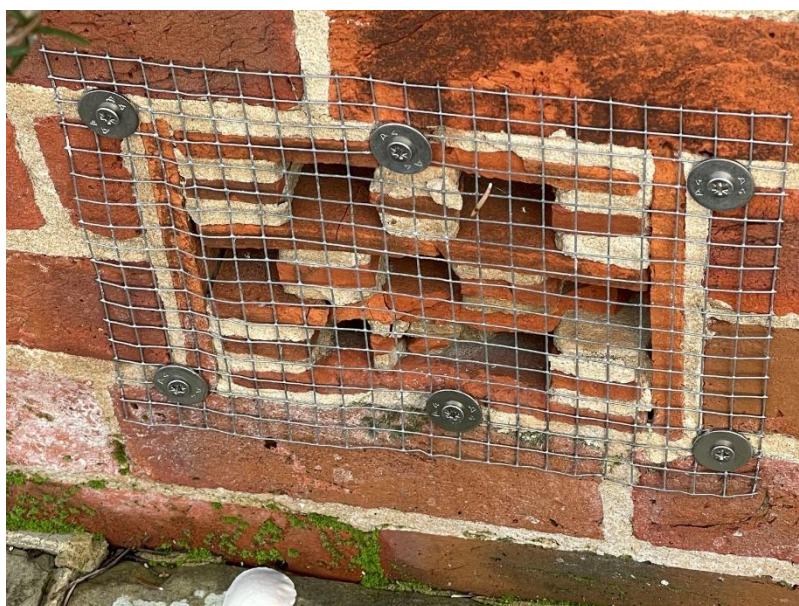
- 9.33 A number of slip tile air bricks have been provided within the perimeter walls to allow air to penetrate below the ground floor joists. It is essential that these slip tile air bricks are not blocked as they perform a preventative measure against both wet and more importantly dry rot.

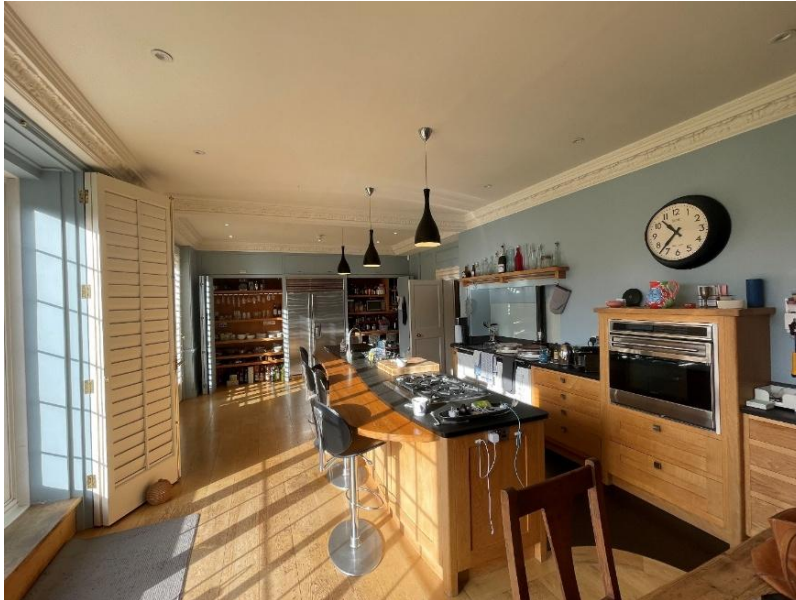
5. The kitchen fittings comprise of low Shaker style oak cupboards with inset sink unit and square edged oak and polished granite work surfaces.
6. The units are of modern design, and we understand were installed by the current vendor.

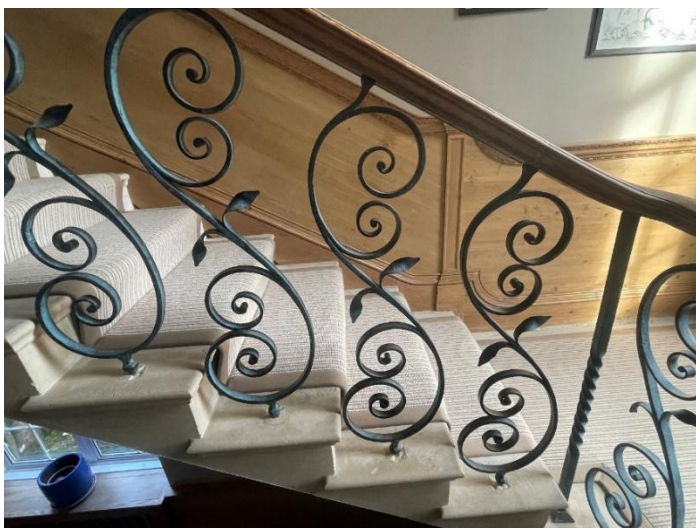
7. The property is provided with timber framed and cantilevered stone staircases.
8. The main staircase which is approached from the reception hall, incorporates wrought iron decorative balustrading and oak handrails with capped newel posts.
9. The staircase is formed with treads of 350mm, and risers of 175mm.
10. The wrought iron balustrading remains well fixed.
11. In our opinion the staircase is a particular feature of the property and of high quality and remains in good order.

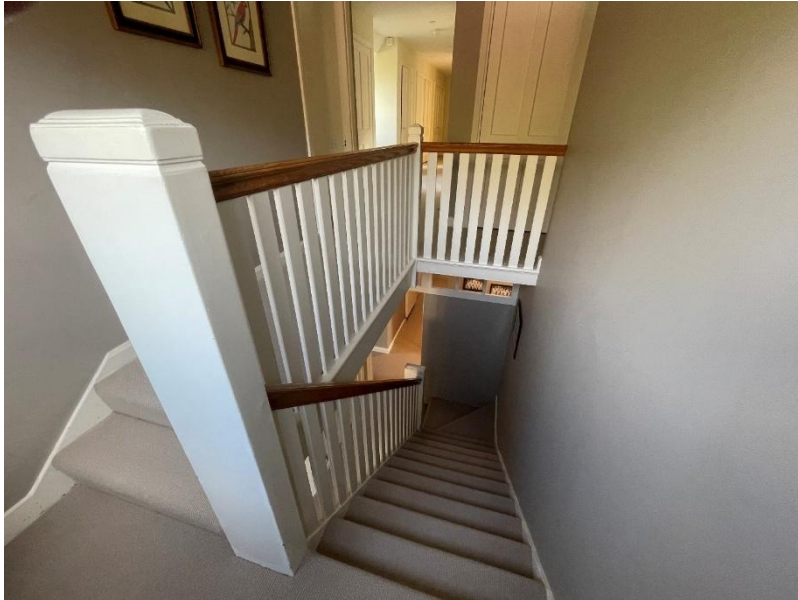
12. The secondary staircase, which serves the western end of the property, has been enclosed with softwood painted square edged timber balusters.

13. We are of the opinion that the staircase has also been adequately constructed and is considered easy and safe to negotiate.
14. The pine panelling is of good quality and remains in good order. Similar comments can be made with respect to the pine dado rails.

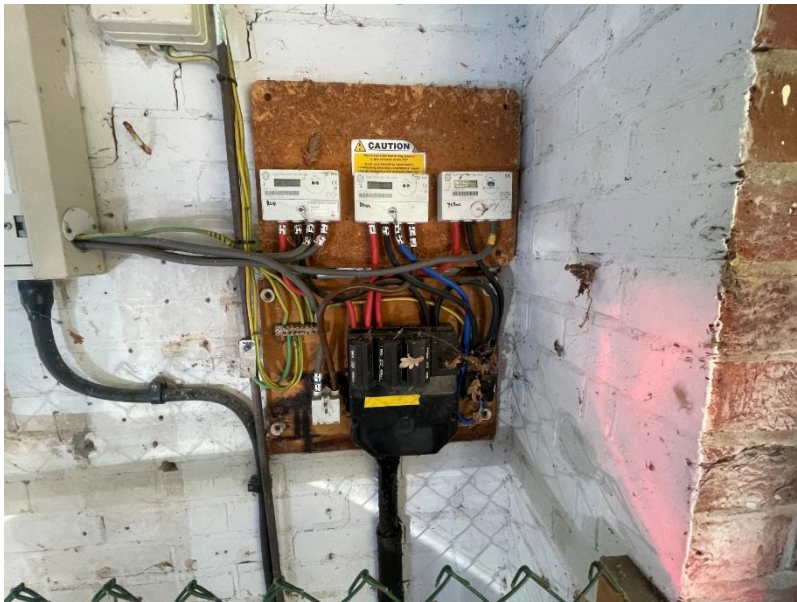
- 10.02 The house is provided with mains electricity.
- 10.03 The incoming main, meter and consumer unit are located on the inner south elevation wall of the garage.

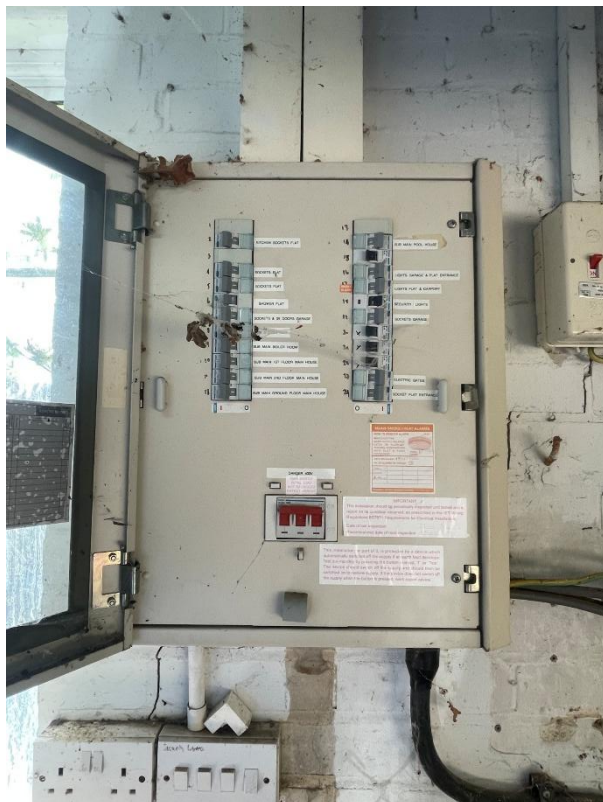
- 10.04 An underground electrical supply feeds 3 phase 100amp intake with digital electrical meters.
- 10.05 Sited adjacent to the main intake is a large metal-based consumer unit with miniature circuit breakers and residual current detection.

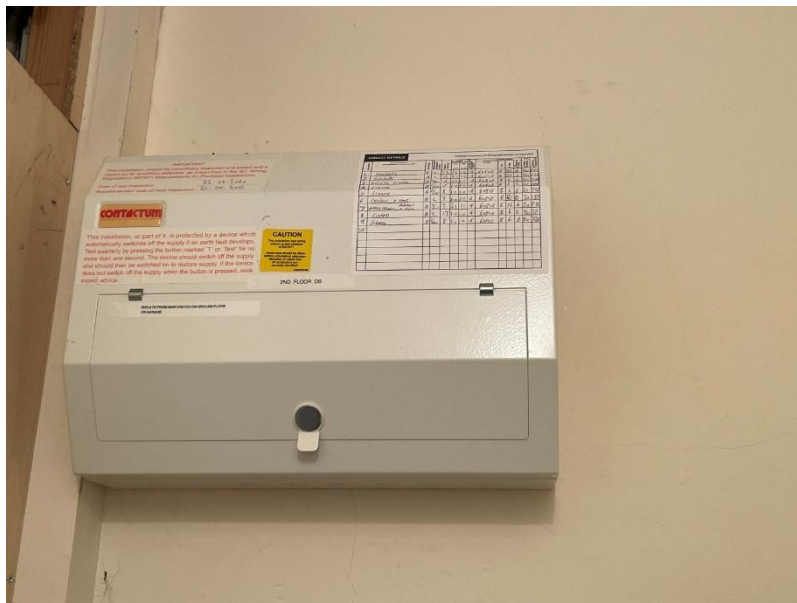
2. There are metal-based consumer units located on each floor, sited within individual cupboards. Each unit incorporates miniature circuit and residual circuit protection. The individual circuits have been well labelled.

3. The consumer units are of modern design and would appear to comply with the current 18<sup>th</sup> Edition of the IET Regulations. We understand from the vendor that the consumer units have been installed in the last few years.
4. Sanitary fittings have generally been provided with secondary earth bonding.
5. From our visual inspection it would appear that the electrical installation has been installed to a satisfactory standard. Nevertheless, it would be prudent to arrange for a suitably qualified electrical contractor to carry out a polarity and resistance test on the installation. Pending receipt of their report, it is likely that only minor upgrading works will be required to ensure compliance with the current Edition of the IET Regulations.

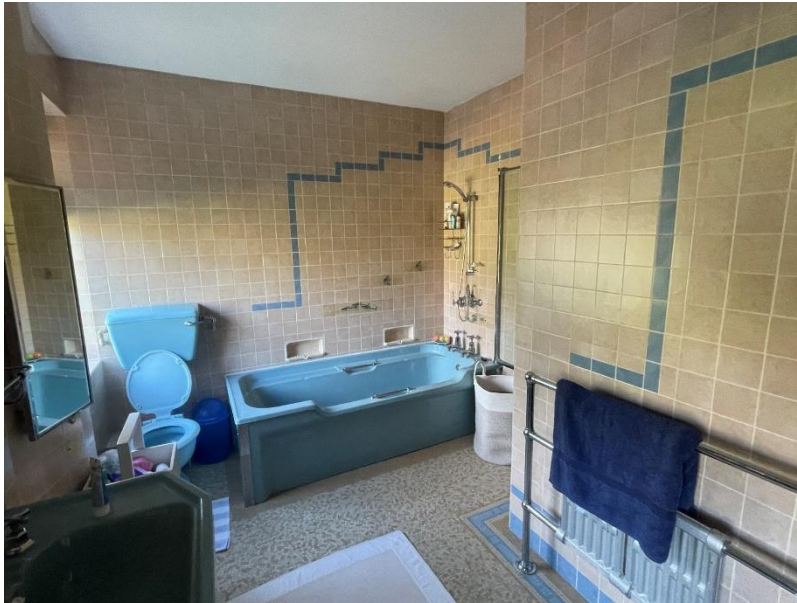
- 10.15 The bathrooms, cloakrooms and shower rooms are provided with wash hand basins, WCs, baths and shower cubicles, some of which appear to be original.

1. Any original pipework remaining, on the grounds of age and health, would be considered vulnerable to rusting and furring, and the renewal of such pipework is likely to be required in the near future.
2. Visible copper distribution pipework was generally free from any weeping or leaking joints.
3. The water pressure to the pipework to the sanitary and kitchen fittings at first floor level where tested appeared to be adequate. The pressure at second floor level to sanitary fittings was not as good.
4. We understand that ISO Energy completed the installation of one CTC air source and two CTC ground source air pumps, in 2012. It would appear that the heat pumps connect up to a buffer CTC tank and Bolly 500 litre hot water cylinder located in the plant room.

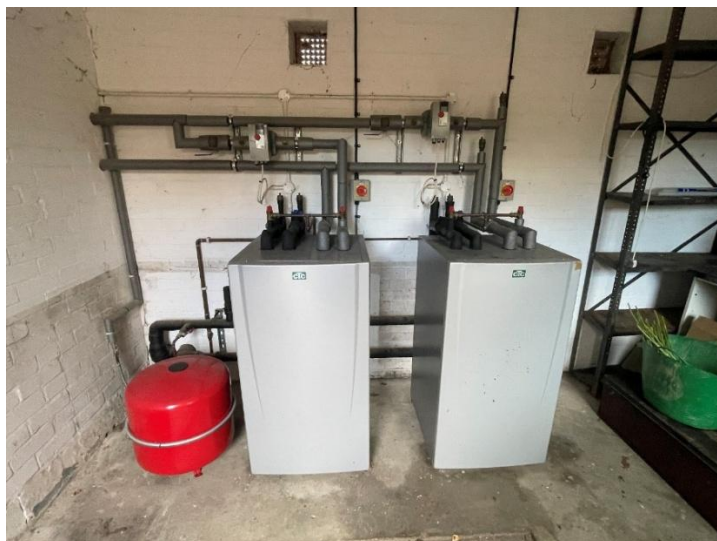
5. The heat pumps serve copper pipework, steel panelled, wall mounted radiators.
6. The pumps and buffer tank/hot water cylinders are of modern design and appeared to be operating satisfactorily at the time of our inspection.
7. The sanitary fittings throughout generally appear to be serviceable where tested.

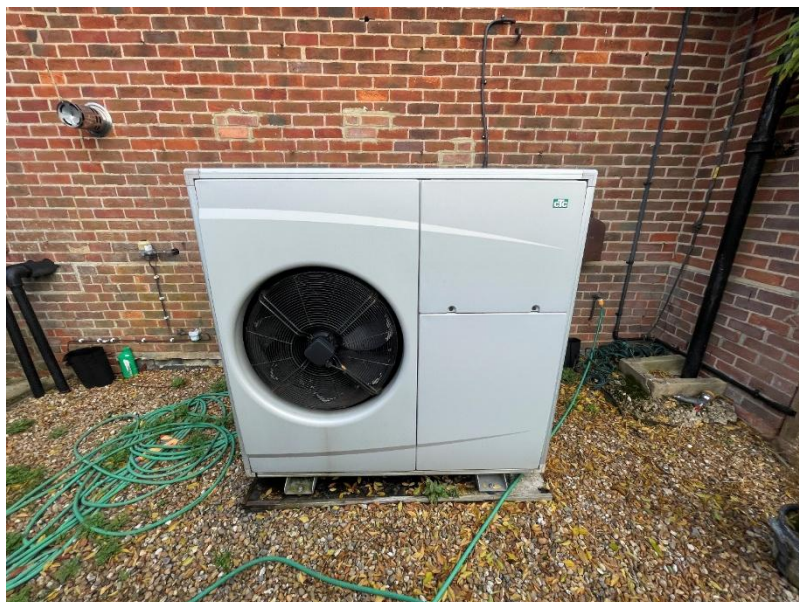
- 10.18 The property is served by one air source and two ground source heat pumps, supplemented with an oil fired Thermicon boiler located in the boiler room.

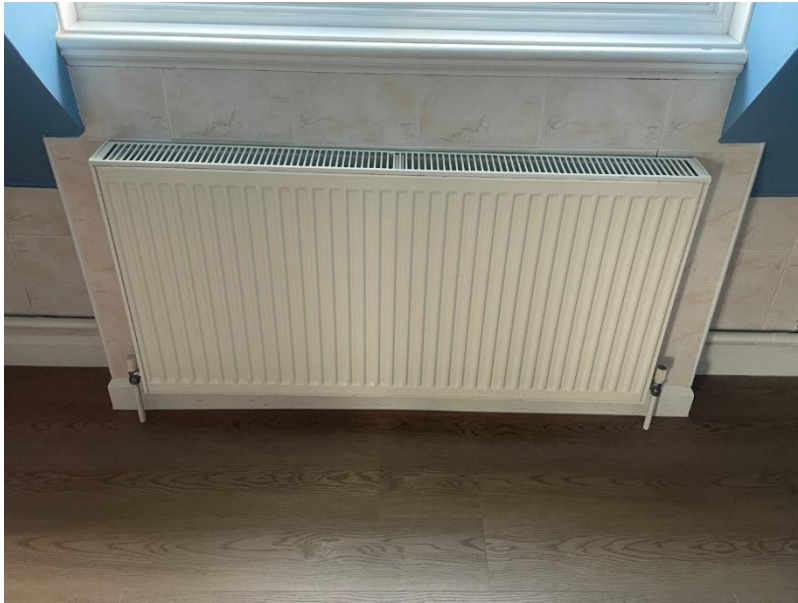
- 10.19 The heat pumps and oil fired boiler supply the source of heat for the central heating and hot water installations.
- 10.20 Steel panelled radiators have been fitted throughout. The radiators are fitted with thermostatic control valves.
- 10.21 We would make the following observations:
1. The heat pumps were installed by ISO Energy in 2012. They appeared to be working satisfactorily at the time of our inspection.
  2. The pipework feeding the tanks and radiators appeared to be in reasonable condition.

3. The pipework has been carefully fixed to walls and insulated in hessian wrap/foam insulation.
4. The oil fired boiler has a balanced flue outlet which projects through the south elevation wall of the boiler room.
5. Notwithstanding the above, we recommend arranging for testing/inspection of the boiler by a OFTEC registered heating engineer prior to use.
6. Whilst from our visual inspection it would appear that the mechanical and electrical installations are of modern design and in reasonable condition it would be prudent to engage the services of a Mechanical /Electrical engineer to make a more detailed inspection and advise you in relation to your future requirements and expenditure.

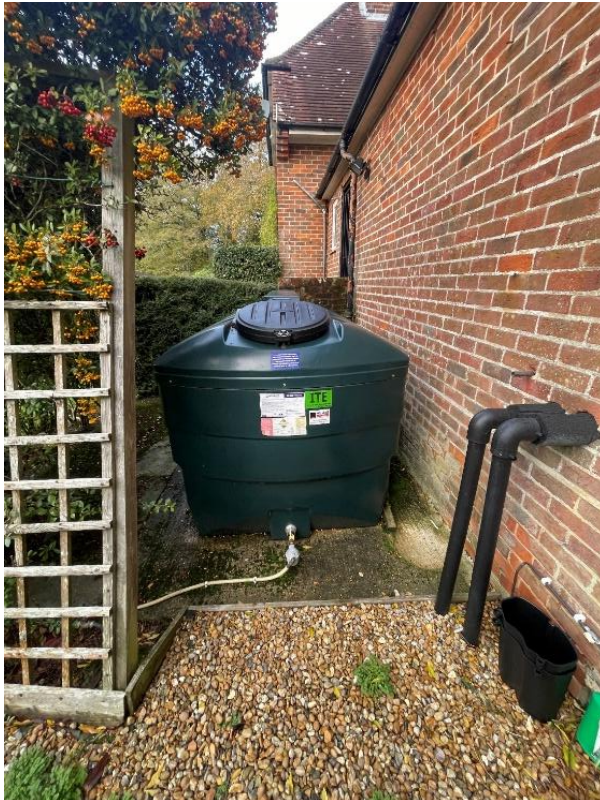
- 10.23 The property has a modern double bunded plastic oil tank located in front of the garden wall (north elevation).

10.24 The tank is in good order.

10.25 The testing of oil installations does not form part of a normal Survey procedure, and we are therefore unable to verify that it is satisfactory. We would recommend that an 'OFTEC' registered heating engineer be asked to inspect the premises and give advice as to the suitability of the installation for your future requirements.

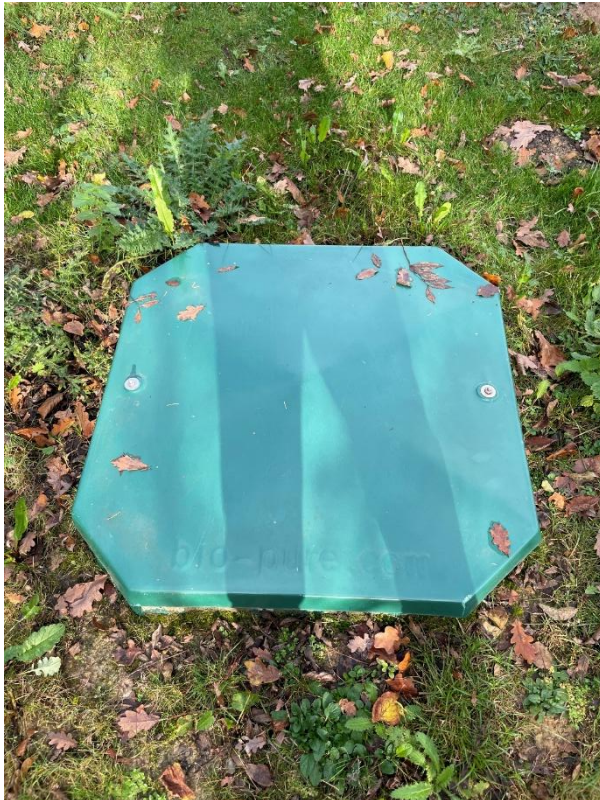
10.27 We understand that a new Bio Pure 3 below ground sewerage treatment plant was installed by the current vendor.

- 10.28 The treatment plant replaced the old septic tank.
- 10.29 In addition to the treatment plant being installed, pea shingle filled trenches and 110mm uPVC pipework were installed and laid to outfall to a ditch.

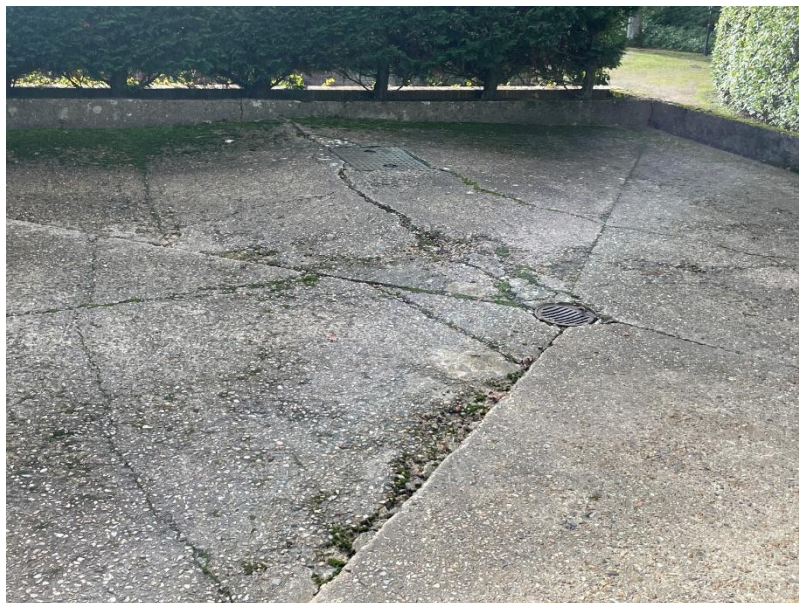
11.03 The concrete hardstanding in front of the three bay garage is showing signs of deterioration. Sections of concrete were uneven and cracked in places.

11.04 Repairs/upgrading of both the driveway and concrete hardstanding should be anticipated.

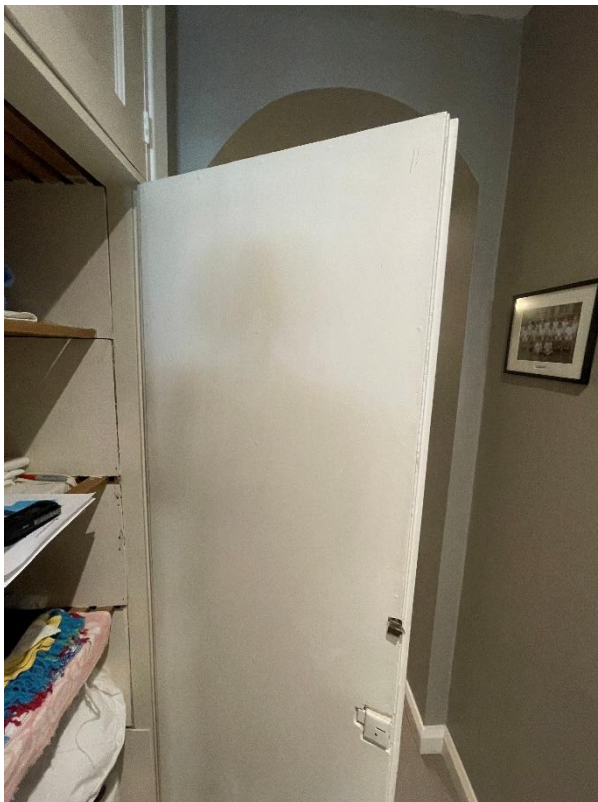
- 12.08 We did not carry out a full survey for asbestos at the time of our inspection as this would be beyond the terms of our engagement.
- 12.09 Given the age of the property, it is likely that asbestos based products would have been used in its original construction. Such products will include asbestos lagging to original pipework serving the central heating installation and fire retardant boarding around radiators, and linings of ceilings in the plant room and to internal doors that we noted. Where visible, the boarding remains in reasonable condition.

- 12.16 We would recommend that you take specialist advice before undertaking any such work to asbestos based products. We would refer you to the Health and Safety Executive web link <http://www.hse.gov.uk/asbestos/essentials> HSE - Asbestos: Asbestos essentials for guidance when maintaining or removing asbestos products.

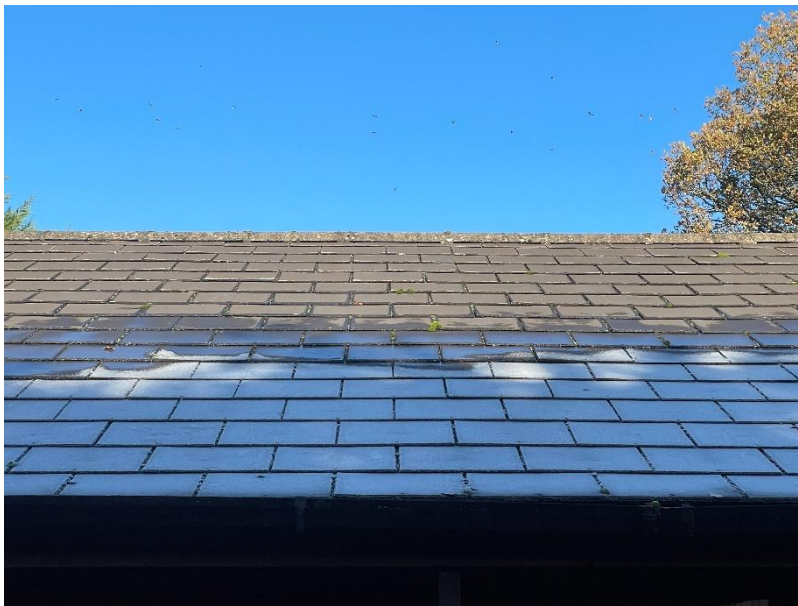
1. The roof profiles are true and even with no signs of any significant undulations or major distortions.

2. The fibre slates are well fixed with proprietary fixings and considered to be in good condition.
3. Similar comments can be made with respect to the ridge line which is formed with half round concrete tiles.
4. It was noted that the Velux roof lights were leaking at the time of our inspection with water penetration noted to the ceiling below.
5. The north facing roof slopes are covered with moss and lichen growth which should be removed.
6. Once repairs have been carried out to the flashings at the junction with the roof lights, the roof covering should continue to perform satisfactorily.

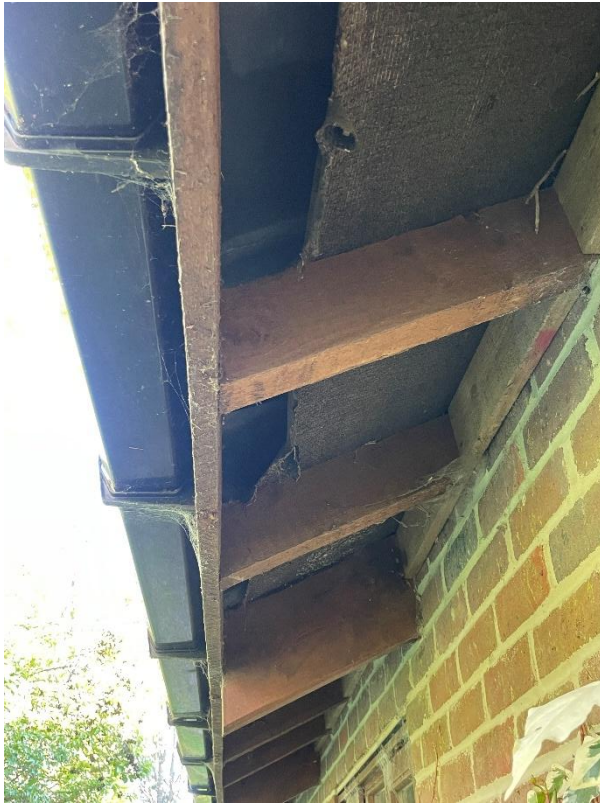
2.09 The rafter feet remain in good condition as are the projecting fascia boards.

2.11 It was noted that the number of the collar joints to the guttering are leaking, which has led to damp staining to the underlying brickwork.

2.13 In our opinion, the gutters are in need of an overhaul, and all leakages should be attended to.

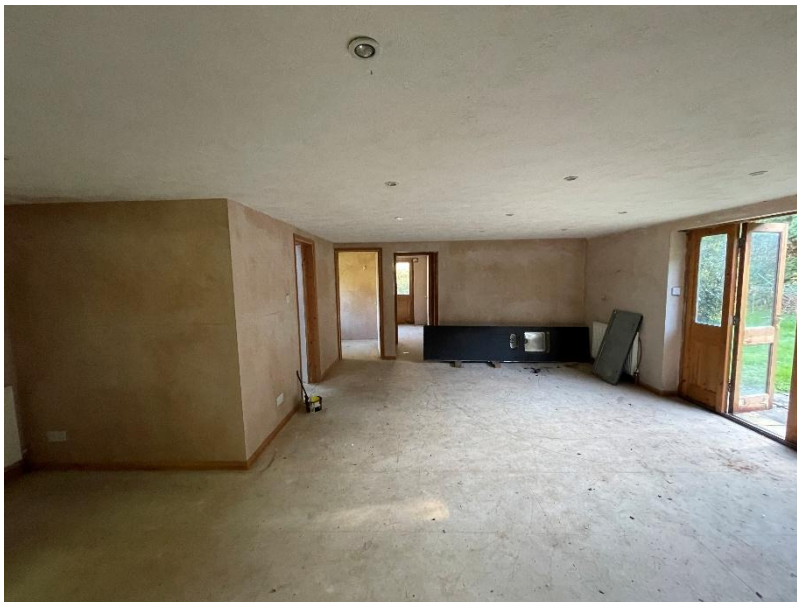
- 3.10 The internal walls and partitions primarily comprise of timber stud partitioning covered with plasterboard and a plaster skim finish.

- 3.11 No paint has been applied to the plaster skim coat.
- 3.12 The walls generally remain upright and plumb with no evidence of any major structural cracking.
- 3.13 Summary Condition Rating **1**

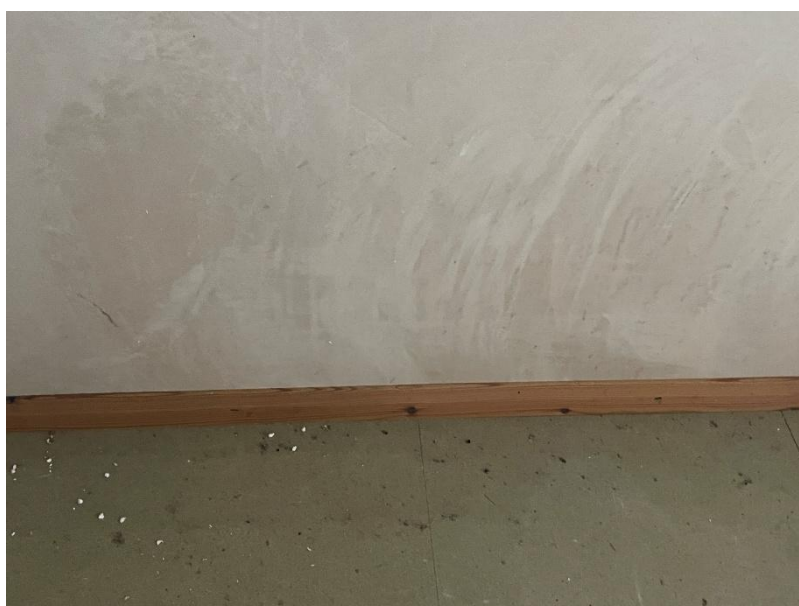
- 3.14 The floors throughout would appear to be of solid concrete construction overlaid, we suspect, with an insulated floating chipboard floor. This could not be confirmed without taking up some of the chipboard.
- 3.15 We suspect that a polythene or similar damp proof membrane has been incorporated within the solid concrete floor.
- 3.16 No significant defects were observed.
- 3.17 No significant gaps were noted between the floor and timber skirtings.
