**APPENDIX 6**  
**BUILDING SURVEY REPORT**  
**On**  
**THE COTTAGE**

**Client**

**Patricia Estridge**

**GH1080**

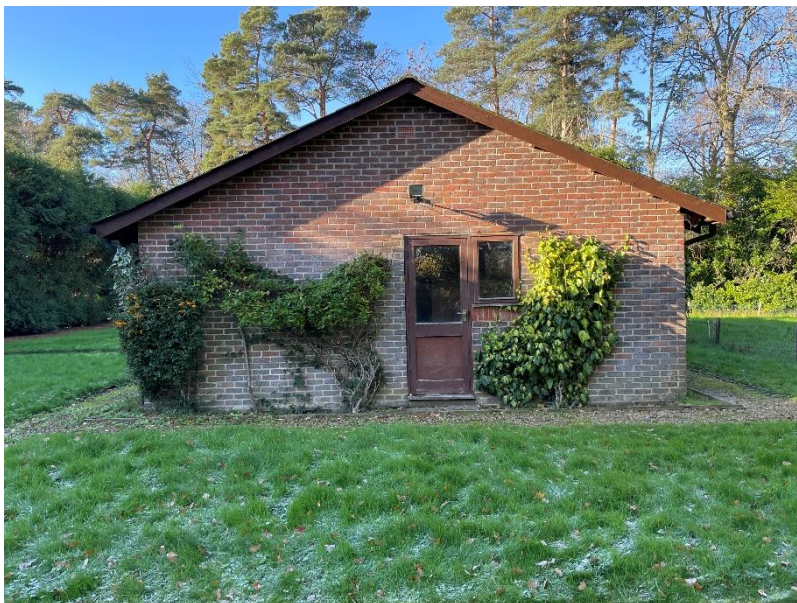
- 1.03 The main external walls are of cavity brick construction surmounted with a timber framed, pitched gabled roof, covered with proprietary fibre cement slates.
- 1.04 Internally the walls are of timber stud construction covered with a plaster skim finish.
- 1.05 The ground throughout is of solid concrete construction.
- 1.06 Double glazed side hung timber casement windows are provided to all elevations.
