## Foul and Surface Water Drainage Report

**Prince Albert, Copthorne**

**Westcoast Developments Ltd**

Reference **C3261**

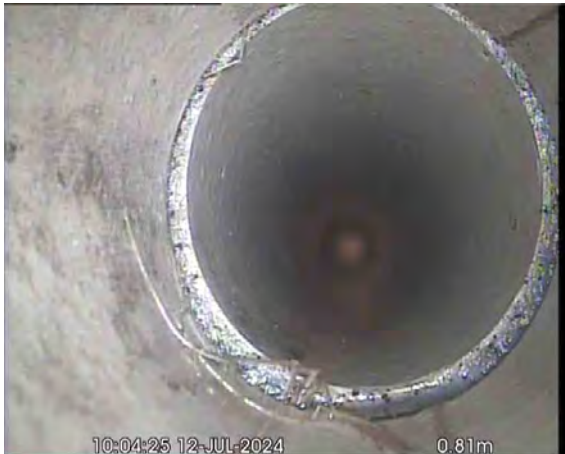
GULLYX\_be408751-b267-4dcb-87b2-47920da53df0\_20240725\_090226\_317.jpg, 00:01:01, 0.81 m  
Joint displaced, medium

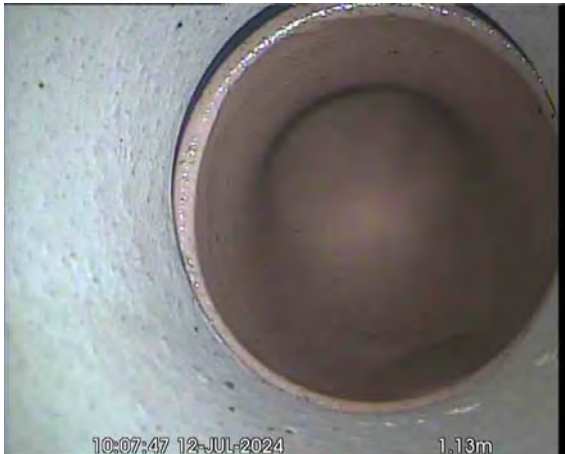
W\_CX\_1865770f-a7a0-438a-95c3-9da68d53db4d\_20240725\_090701\_492.jpg, 00:00:39, 1.13 m  
Joint displaced, medium

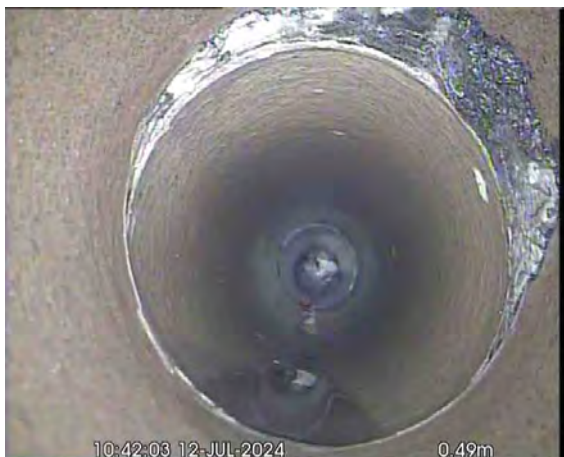
| Section | PLR | Grade | Description |
|---|---|---|---|
| 5 | REDUNDANTX | 4 | Broken pipe from 10 o'clock to 3 o'clock |

REDUNDANTX\_0df9520d-4cc8-45ca-b8b9-6ea8c8cc1138\_20  
 240725\_091130\_965.jpg, 00:00:34, 0.49 m  
 Joint displaced, large

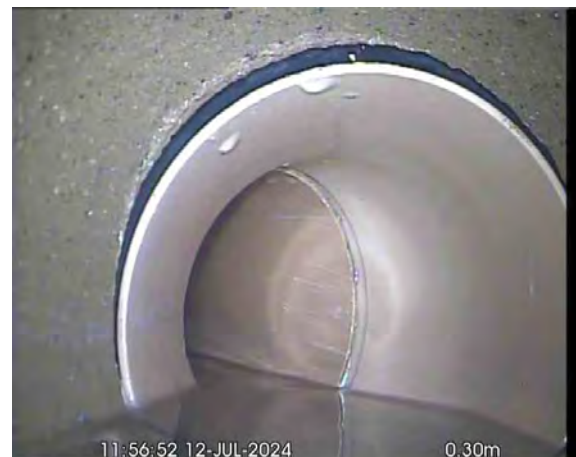
MH2X\_9e3848a9-2aef-4403-9dc0-06a55e9cccf0\_20240725\_092609\_653.jpg, 00:00:56, 0.30 m  
 Joint displaced, medium

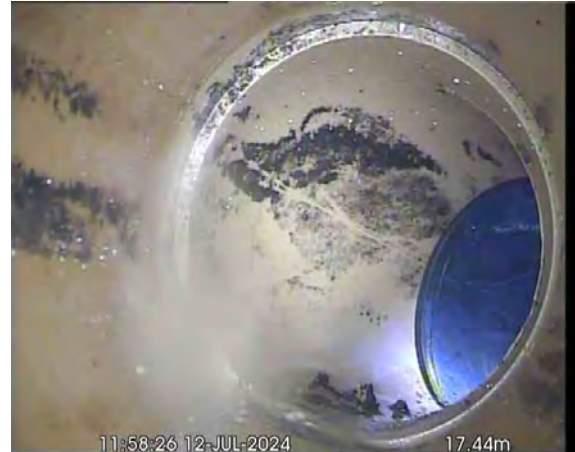
MH2X\_ecbc01d4-5401-430c-a4cc-4e8128ef4209\_20240725\_093238\_853.jpg, 00:02:20, 17.44 m  
Line deviates right

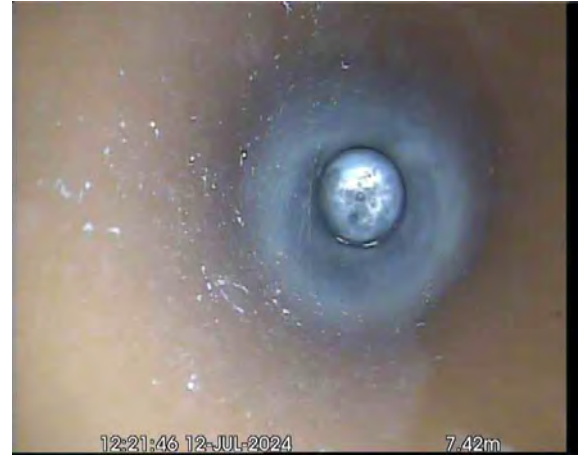
CAPPED  
OFFX\_b9c4dbb3-d9c6-4d09-9f4f-e40713d124b7\_20240725\_0  
94300\_939.jpg, 00:02:19, 7.42 m  
Survey abandoned, S/A - CAPPED OFF

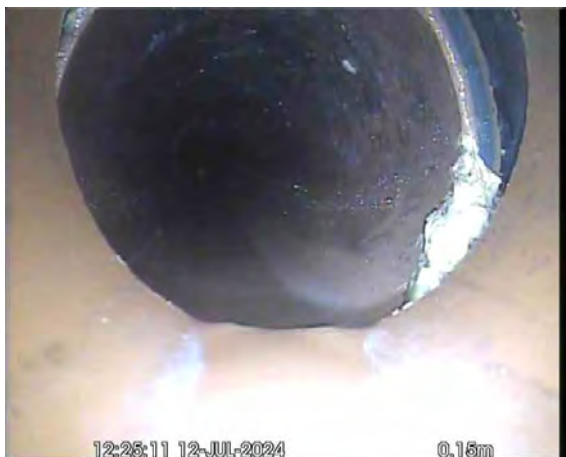
MH5X\_a67b5490-9c73-459b-9229-8a05c12ea946\_20240725\_094558\_658.jpg, 00:00:41, 0.15 m  
 Joint displaced, large

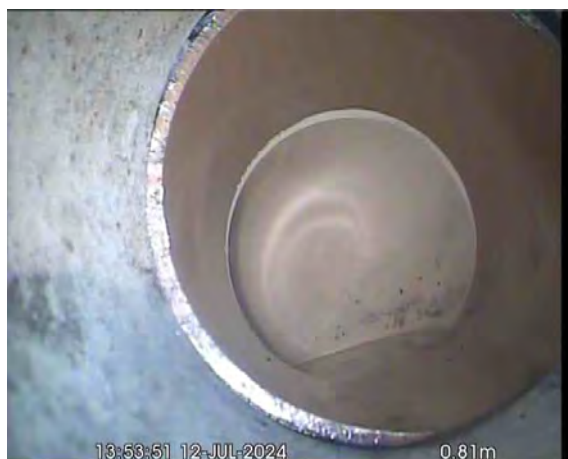
SVPX\_6126ff3a-8feb-42cf-b4a8-289a35627abd\_20240725\_095243\_344.jpg, 00:00:43, 0.81 m  
Joint displaced, medium

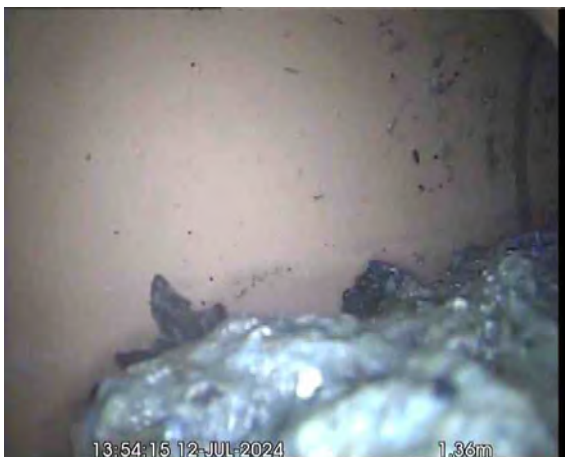
SVPX\_b8b7fa38-33f3-45aa-a30b-8dfd9bcbd768\_20240725\_095417\_154.jpg, 00:01:07, 1.36 m  
Settled deposits, hard or compacted, 15% cross-sectional area loss
