## Foul and Surface Water Drainage Report

**Prince Albert, Copthorne**

**Westcoast Developments Ltd**

Reference **C3261**

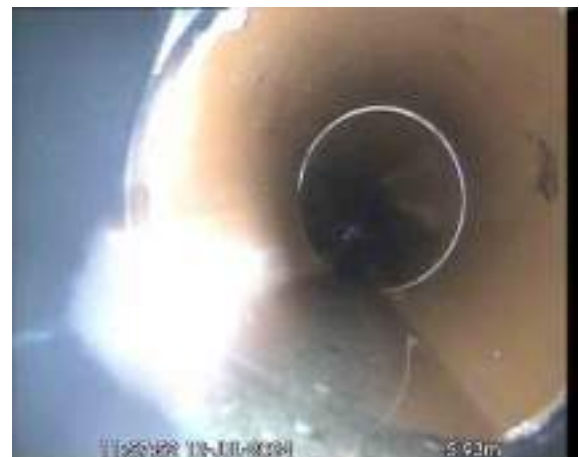
MH2X\_2c7dd602-37a2-429a-a2ab-0279f14f5071\_20240725\_093210\_012.jpg, 00:01:46, 5.93 m  
Water level, 5% of the vertical dimension

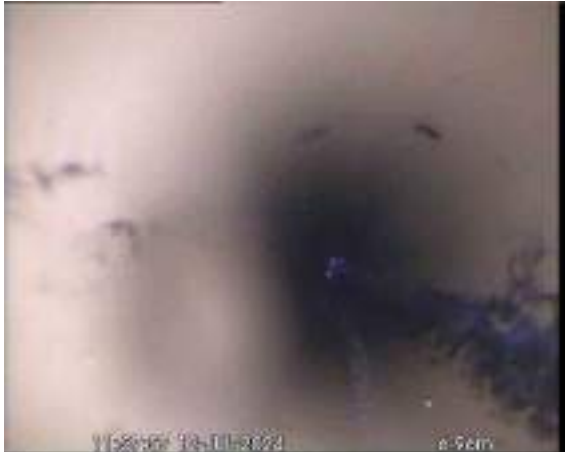
MH2X\_88b39d42-4c30-4654-8841-754422e4dc7a\_20240725\_093224\_970.jpg, 00:01:50, 6.96 m  
Water level, 0% of the vertical dimension

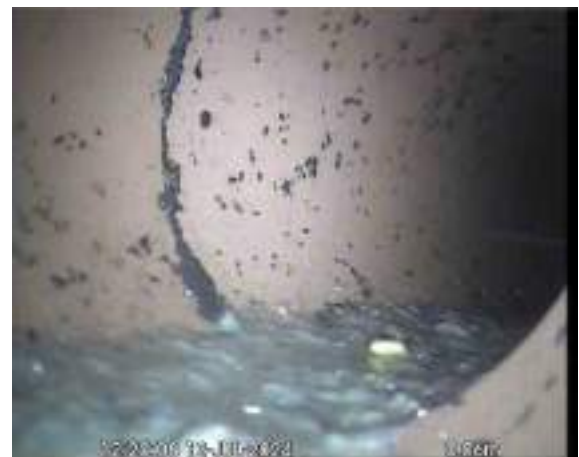
CAPPED  
OFFX\_962b07f7-60c1-43c4-ba8a-1193030da8e6\_20240725\_094225\_233.jpg, 00:00:42, 0.06 m  
Settled deposits, fine, 5% cross-sectional area loss

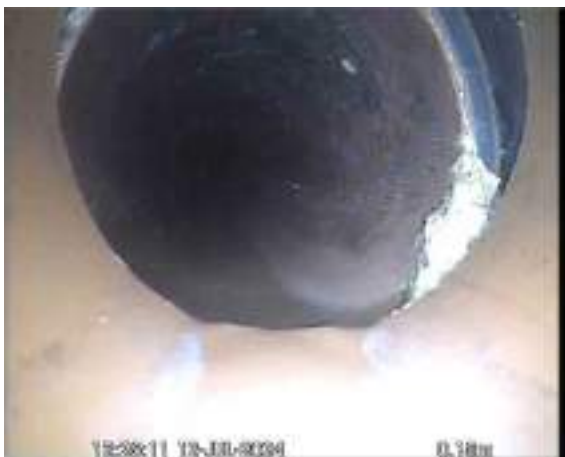
MH5X\_a67b5490-9c73-459b-9229-8a05c12ea946\_20240725\_094558\_658.jpg, 00:00:41, 0.15 m  
Joint displaced, large

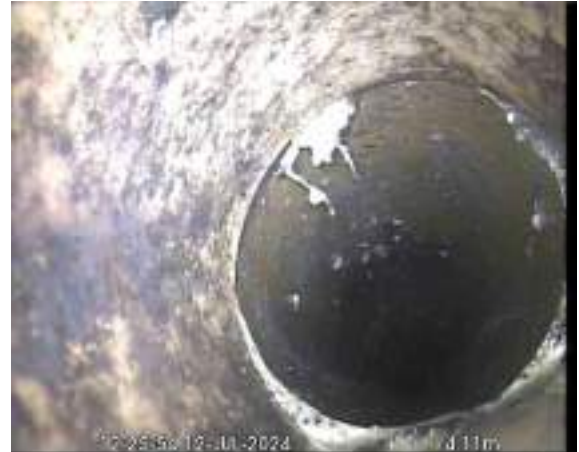
MH5X\_059f6707-2778-4d9f-998a-3e91e87c5d40\_20240725\_094727\_709.jpg, 00:01:24, 4.11 m  
Joint displaced, medium

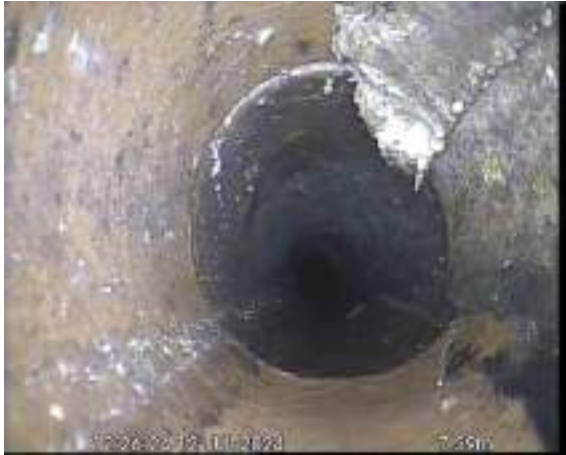
MH5X\_a25c901e-431c-4751-af44-e6286baac714\_20240725\_094843\_842.jpg, 00:01:51, 7.59 m  
Attached deposits, grease from 12 o'clock to 5 o'clock, 5% cross-sectional area loss

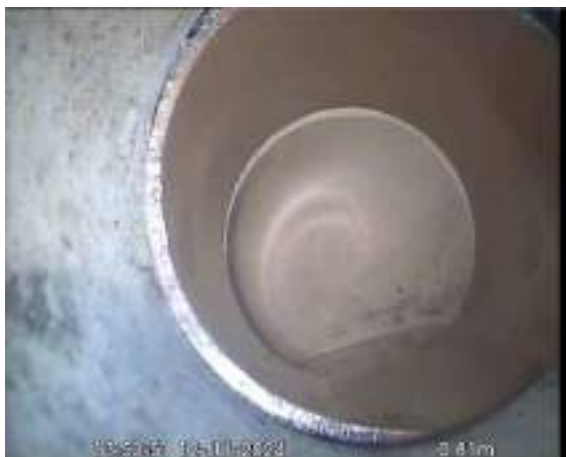
SVPX\_6126ff3a-8feb-42cf-b4a8-289a35627abd\_20240725\_095243\_344.jpg, 00:00:43, 0.81 m  
Joint displaced, medium

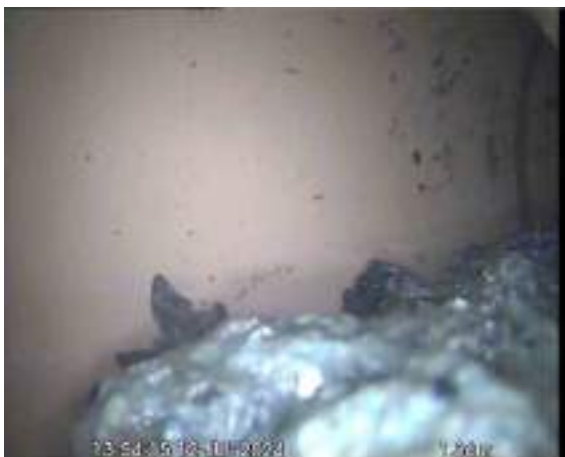
SVPX\_b8b7fa38-33f3-45aa-a30b-8dfd9bcbd768\_20240725\_095417\_154.jpg, 00:01:07, 1.36 m  
Settled deposits, hard or compacted, 15% cross-sectional area loss
