## DRAINAGE STATEMENT

Ote Hall Farm  
Jane's Lane  
Burgess Hill RH15 0SR

**Ref:** 2021-103  
**Issue:** 3  
**Date:** 09 April 2025

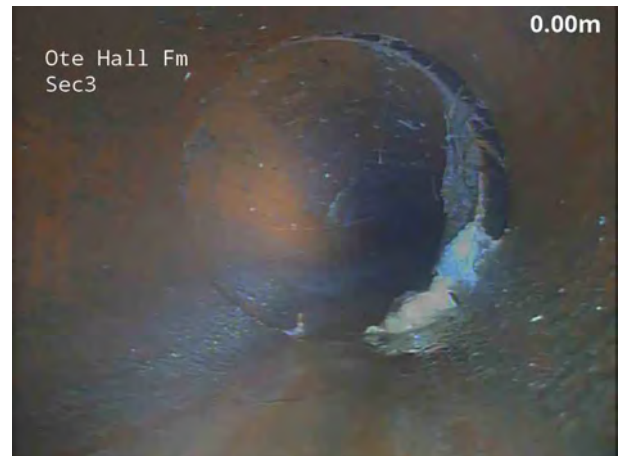
2, 00:00:11, 0.30 m  
Roots, fine at joint
