Stonehurst  
Selsfield Road, Ardingly,  
Haywards Heath RH17 6TN

Structural Inspection Report

| Date | Version | Notes/Amendments/Issue Purpose |
|---|---|---|
| 27 <sup>th</sup> May 2025 | 1 | For Information |

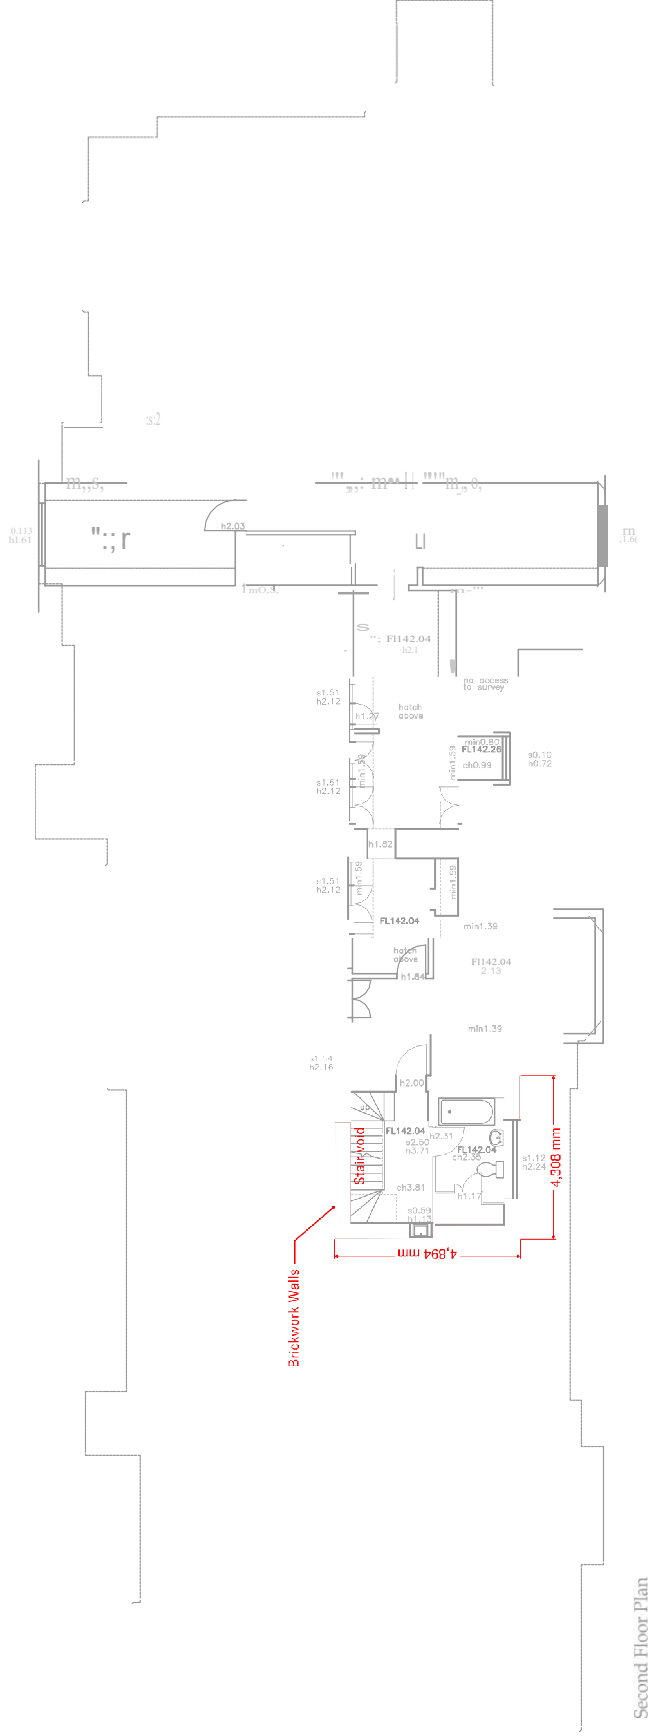
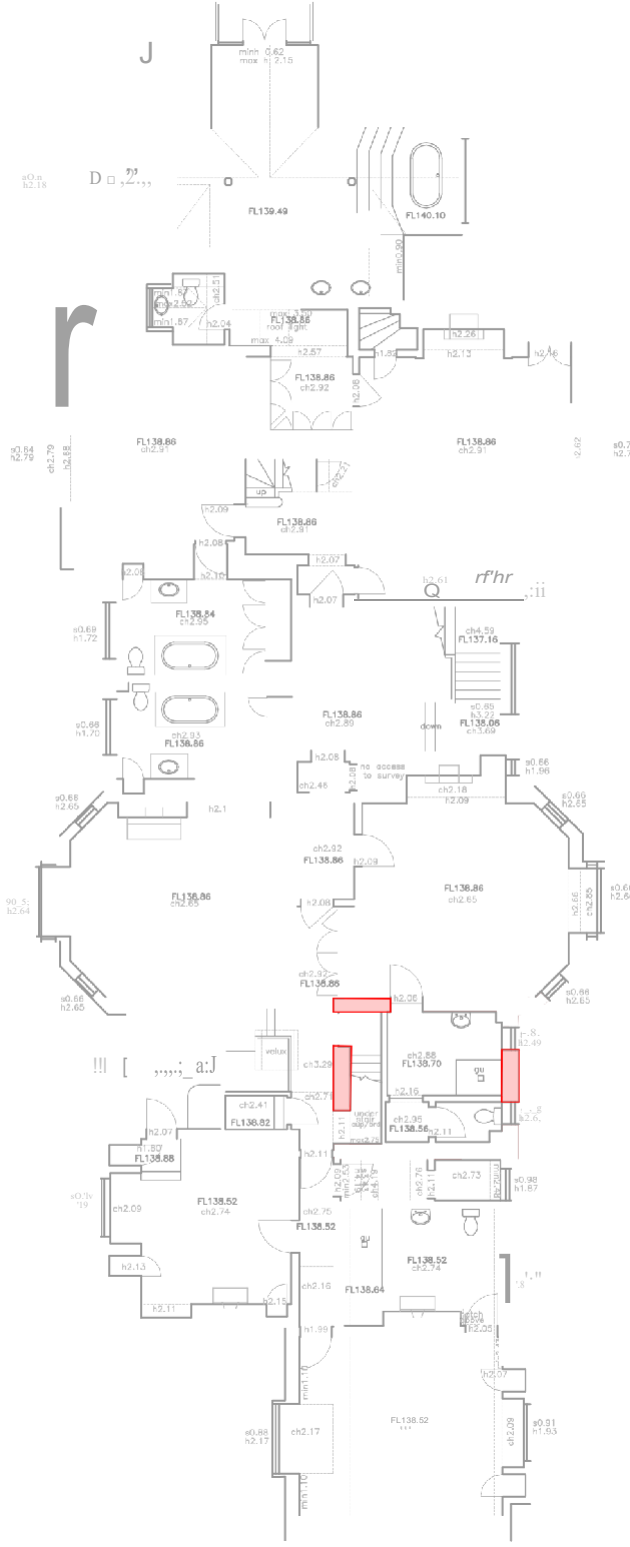
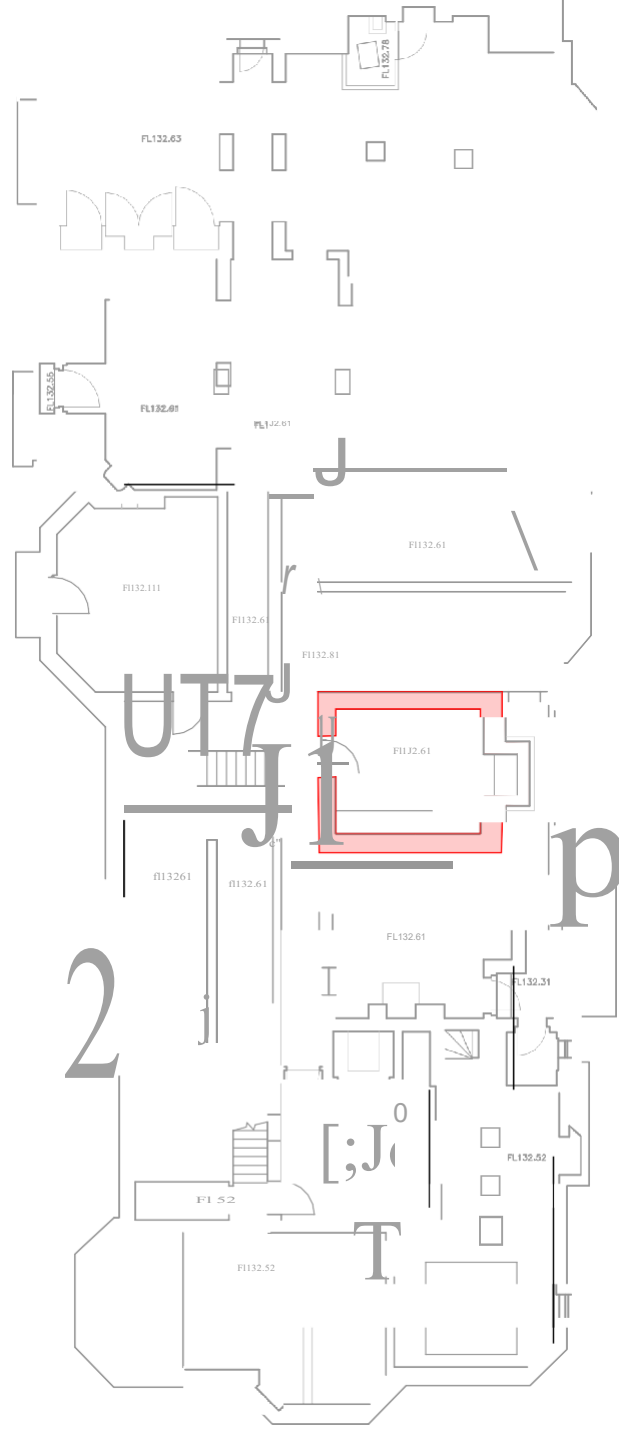
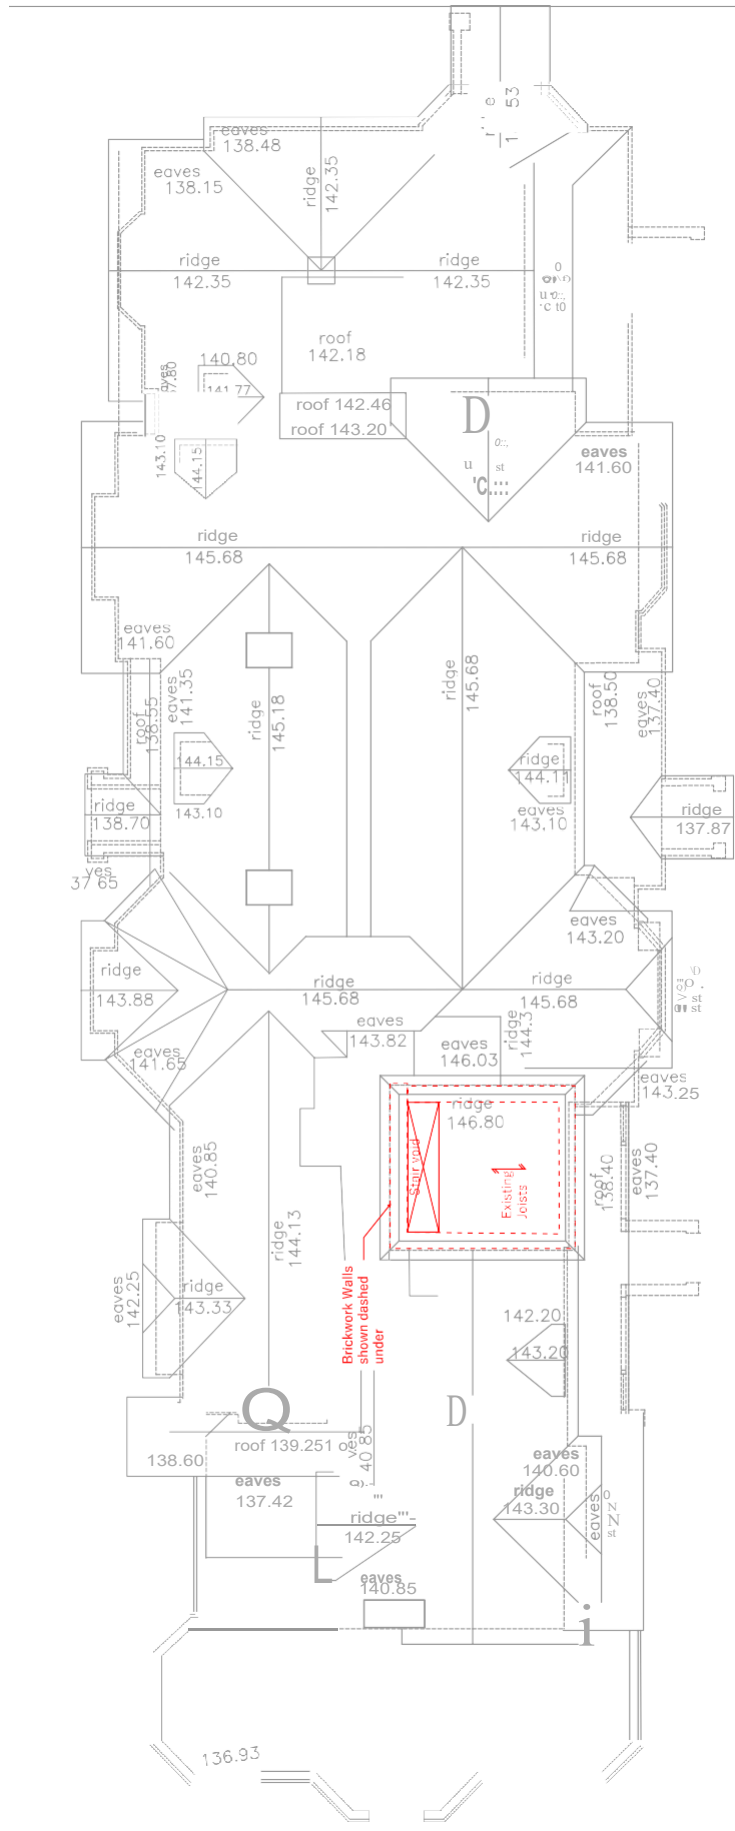
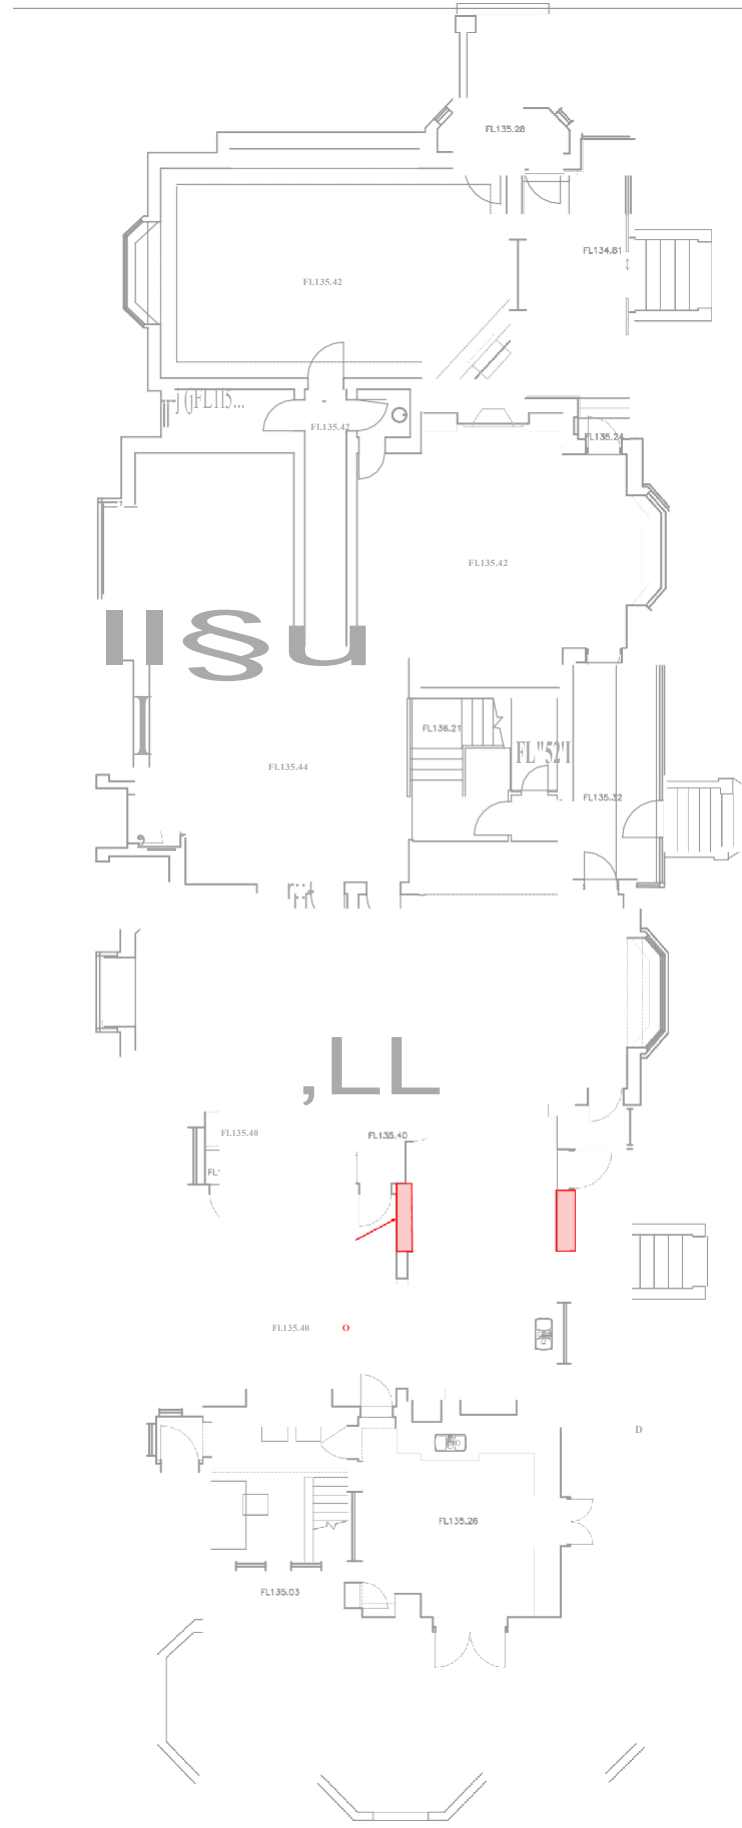
# Existing Structural Layouts

The walls of the tower are 330thk brickwork, which the survey information indicates an increase in thickness below ground level which is typical. Minor openings are present in the walls at each level and the southern wall at ground floor level is not present. It is not clear whether this is the original construction or a later alteration. Refer to Appendix A for the existing survey drawings marked up with structural notes outlining the initial findings.
