# Visual Tree Assessment - VTA (Tree Survey)

Beacon Woods (Burgess Hill)  
Burgess Hill  
West Sussex  
RH15 0ZL

Report ref: 00831-2-2025

**Survey Inspection date:** 7<sup>th</sup> February 2025

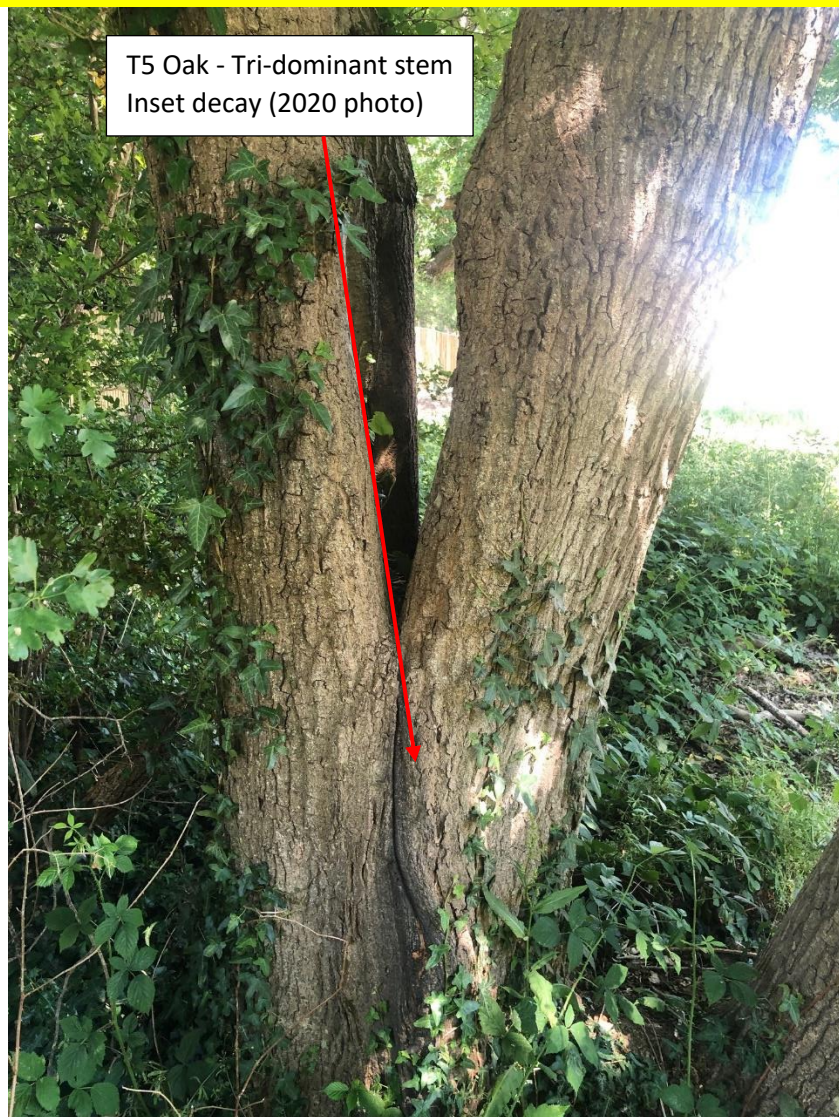
T5 Oak - Tri-dominant stem  
With associated bark inclusion  
(2025 photo)
