TIMBER FRAME REPAIR TO MAIN PARLOUR

107 HIGH STREET, LINDFIELD, HAYWARDS HEATH, RH16 2HR

AS IMPLEMENTED PHOTOGRAPHIC DOCUMENTATION

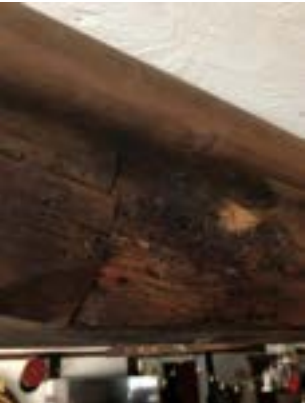
The Timber frame was carefully cleaned and left untreated. There could have been some damage done by the previous owners as the Heritage Statement by Desbruslais confirms that the frame was cleaned on a regular basis. Additionally, many of the oak joists and bressummers have been oiled, as illustrated on the adjacent photograph.

Photographs of oiled oak joist prior to restoration

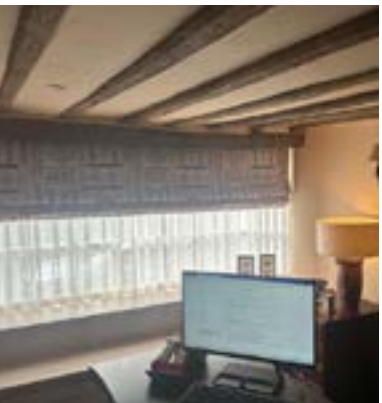
Photographs of ground floor study - previously not visible timber frame on ceiling exposed

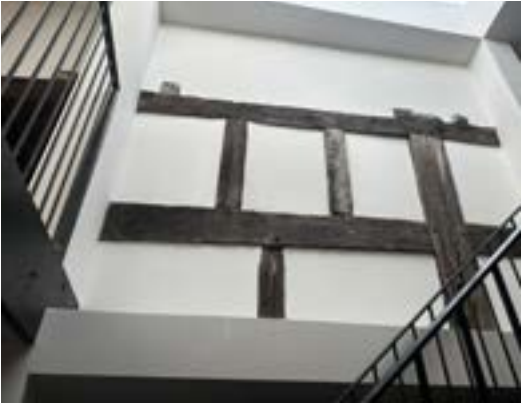
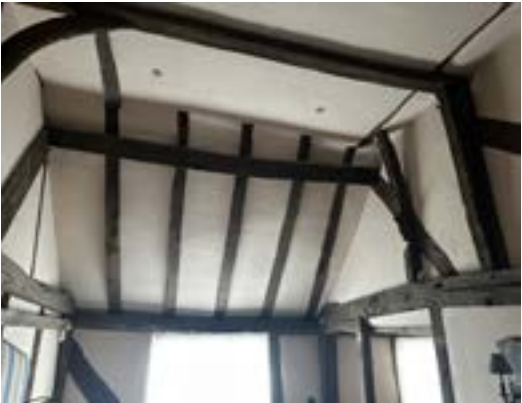
Photographs of restored historic oak frame

- 1. Comprehensive survey of the historic timber elements to assess the condition of the oak. Timbers checked for decay, insect damage, splits, warping, or structural weakness.
- 2. Timber renovated using historically appropriate techniques - gentle clean using soft bristle brush. Timber left are without any coatings. The timber’s patina, age marks, and tool finishes retained.

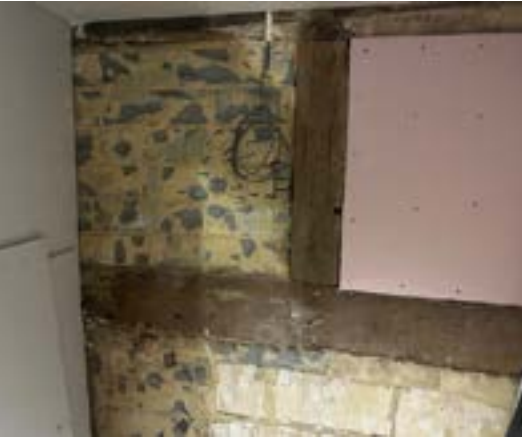
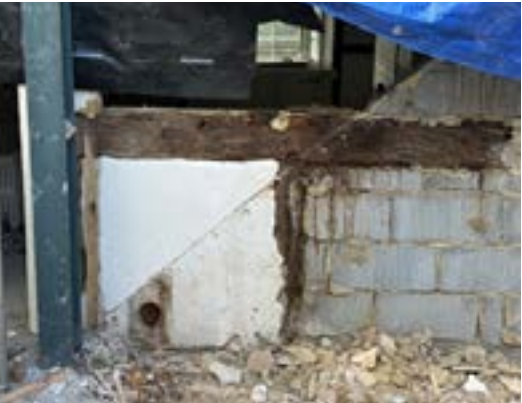
Photographs of historic oak frame prior to restoration

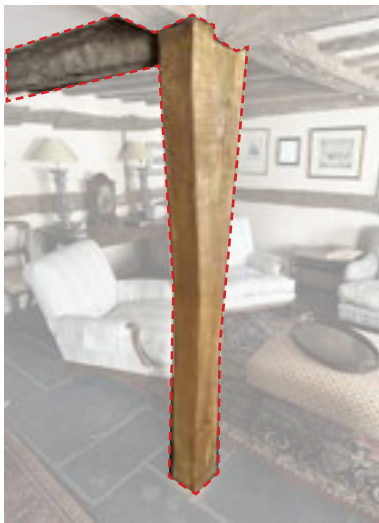
- Key
- Figure 1. East wall
  - Figure 2. Gunstock post
  - Figure 3. South wall
  - Figure 4. West and North wall
  - Figure 5. North and West wall

As part of the implemented works, the timber gunstock post has been reinstated using materials and detailing appropriate to the historic fabric. This approach ensures that the structural expression of the frame remains consistent with traditional construction, limiting the use of steel only where strictly necessary for structural stability and long-term preservation. In addition, modern plasterboard finishes have been removed and replaced with lime plaster applied in a more considered and sympathetic manner. The reinstated lime plaster allows the timber framework to be clearly expressed as the primary structural and visual element of the wall, while maintaining a breathable and compatible finish. The improved quality and finish of the plasterwork, alongside the careful cleaning and treatment of the exposed timber, enhances both the clarity and presentation of the historic fabric. The lounge now reveals a comprehensive extent of the timber framing, allowing the structure to be fully appreciated within the space. These works collectively represent a sensitive enhancement of the room, improving its relationship with the building’s historic character and resulting in a clear heritage benefit when compared to the previous condition.

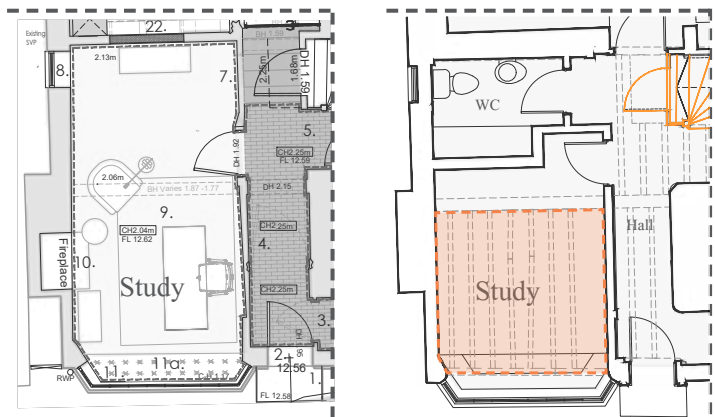
Ceiling Areas Adjusted to Expose the Timber Framing

Approved Study                      As Implemented Study

The exposure of this timber framing provides a significant heritage benefit. Revealing the original structural elements helps to preserve the historic timber by allowing it to breathe, while also celebrating the craftsmanship and construction techniques of the period. In addition, the exposed framing enhances the architectural character of the space and improves the ability to understand and visually interpret the historic structure of the building. The following images therefore illustrate the as-built condition of the study space, where the historic timber framing has been revealed and now forms a key architectural feature within the room. This intervention represents a clear enhancement to the originally approved proposal, both in terms of heritage conservation and spatial character, reinforcing the historic significance of the building while improving the overall quality of the internal environment.

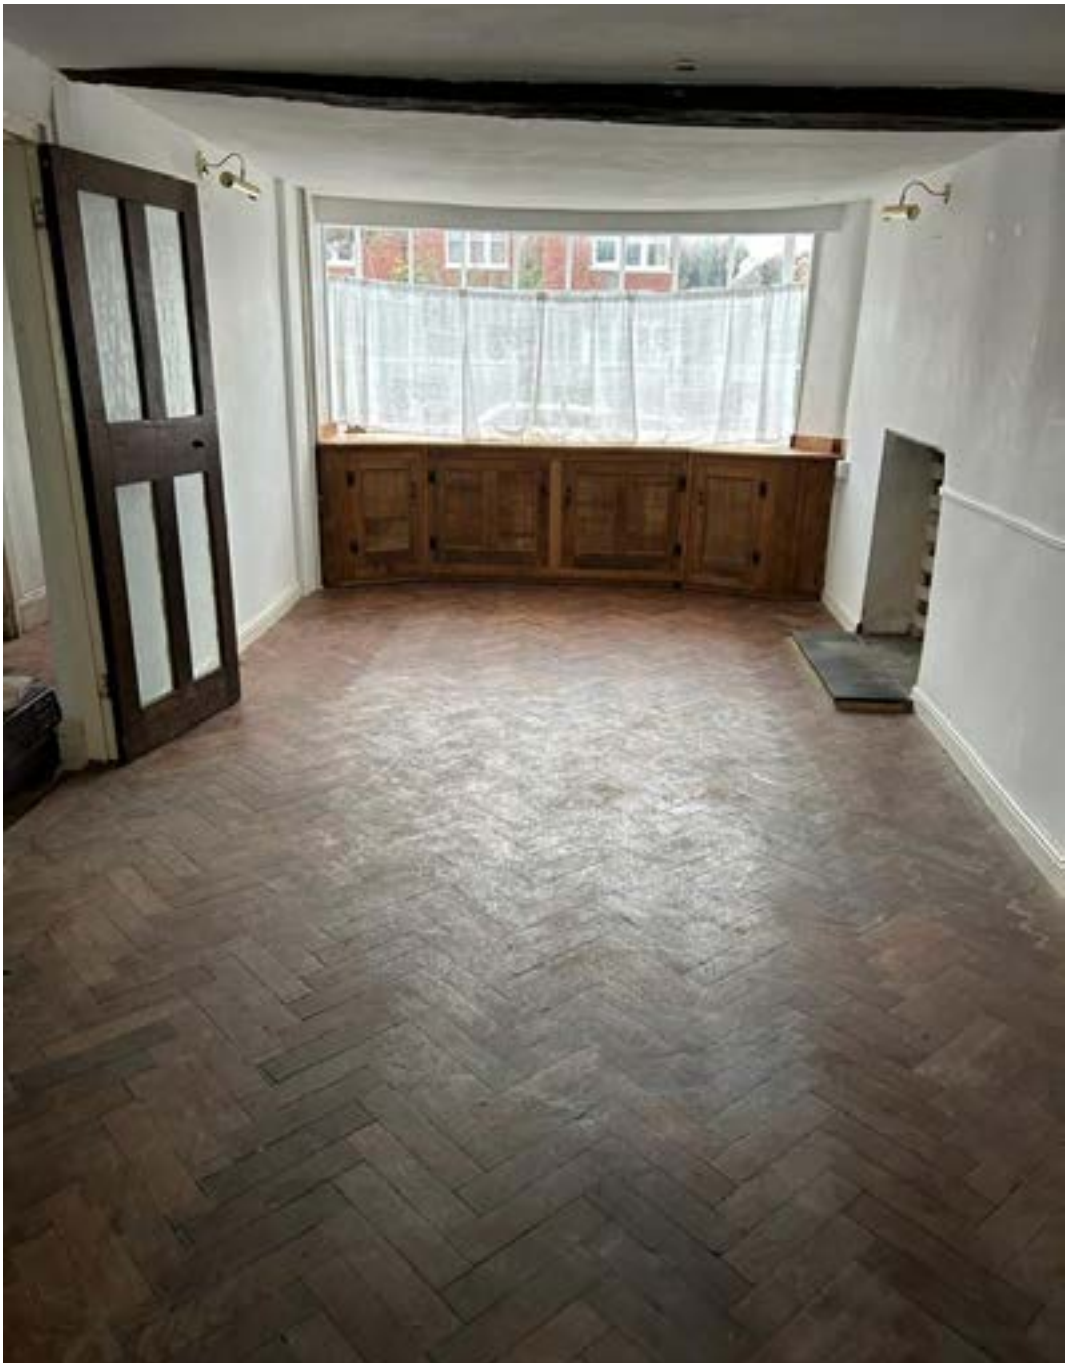
PRE CONSTRUCTION - PHOTOGRAPHIC DOCUMENTATION

1.  
Key  
Figure 1. Pre-construction study space.  
Figure 2. Proposed / as-built study space.  
Figure 3. Exposed timber beam and ceiling detail.  
Figure 4. Exposed timber joists within the study ceiling.

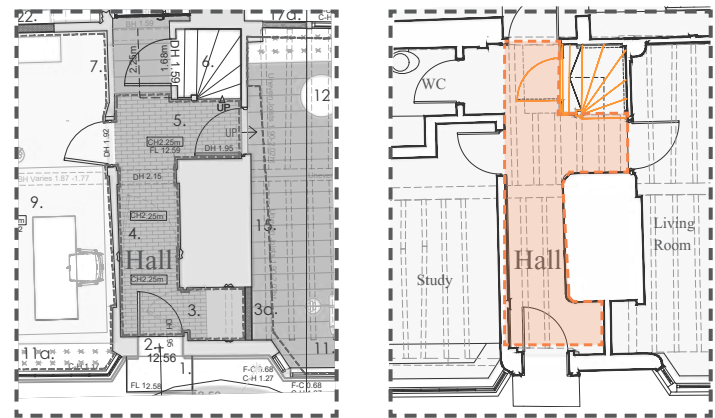
Ceiling Areas Adjusted to Expose the Timber Framing

Approved Hallway                      As Implemented Hallway

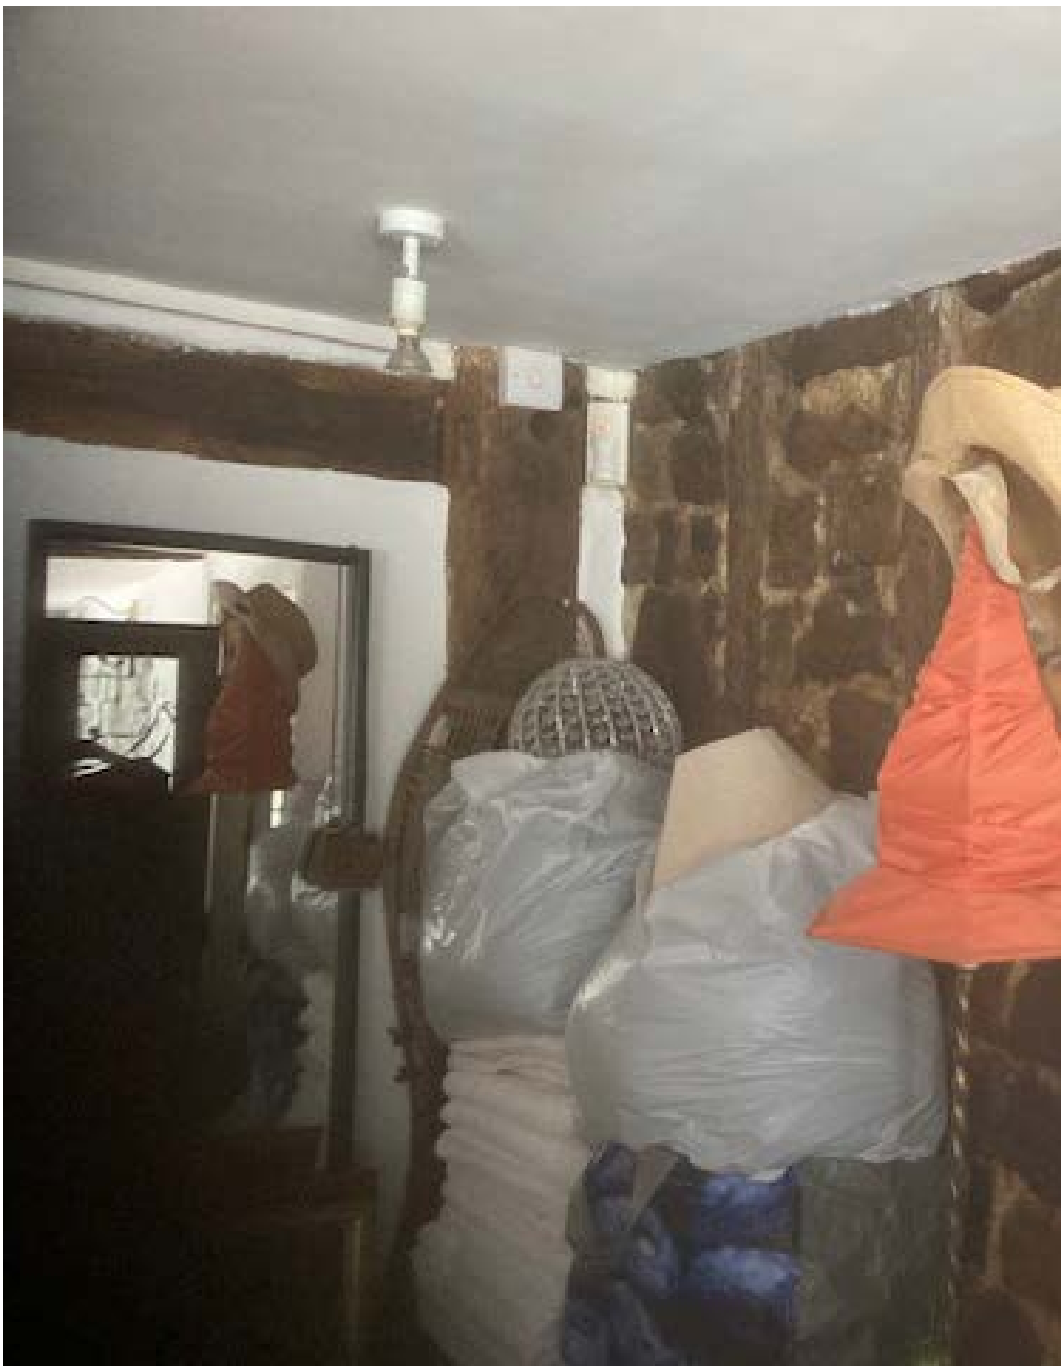
- Figure 1. Pre-construction hallway.
- Figure 2. Proposed / as-built entrance hall.
- Figure 3. Exposed timber beam and joists framework.
- Figure 4. Exposed timber beam and ceiling detail.
