## STATEMENT OF HERITAGE SIGNIFICANCE

**Property Address:** The Barn House, Cuckfield Road, Ansty, Haywards Heath  
RH17 5AG

**Prepared by** Richard Pocock MSc MRICS

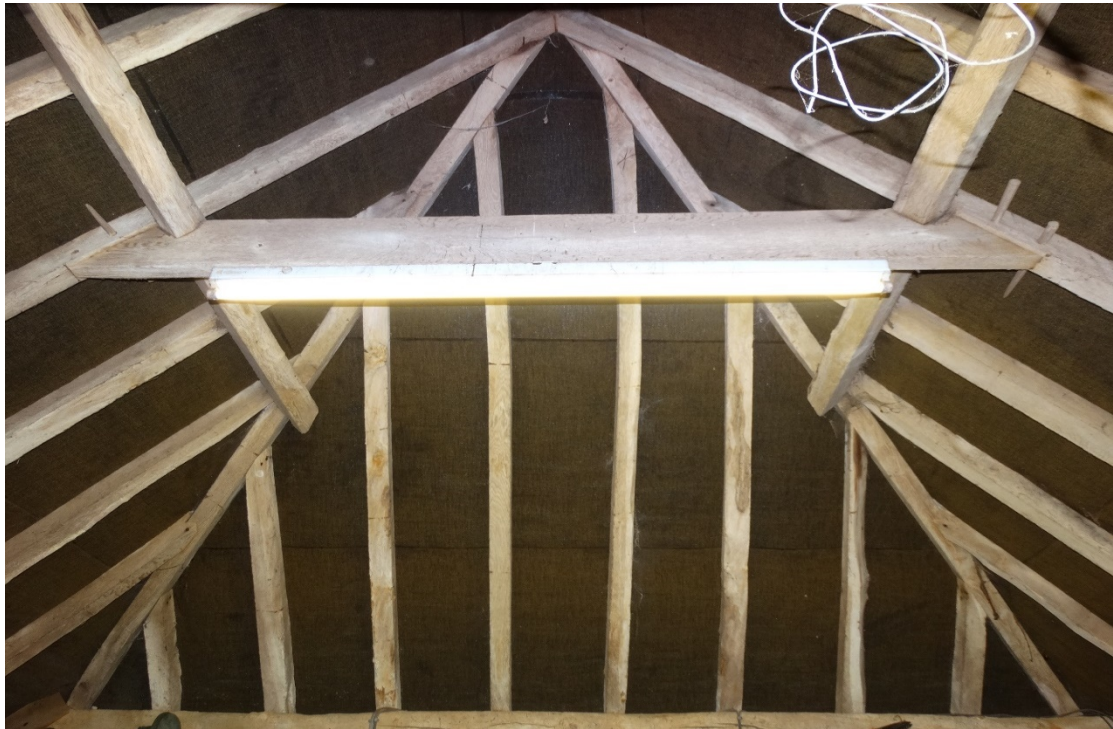
Rafters are also hardwood and are jointed with a pegged side halved joint at the apex. Hipped ends are original, with the purlins cantilevering beyond two end lateral braces, again clasping the purlins.

There are no notable iron fixings, and the frame is wholly pegged.
