Tree Survey Schedule  
Site: 17 Lewes Road, Haywards Heath, Rh17 7:  
Ref: 2335  
Date: October 2025

17 Lewes Road

Tree Constraints plan

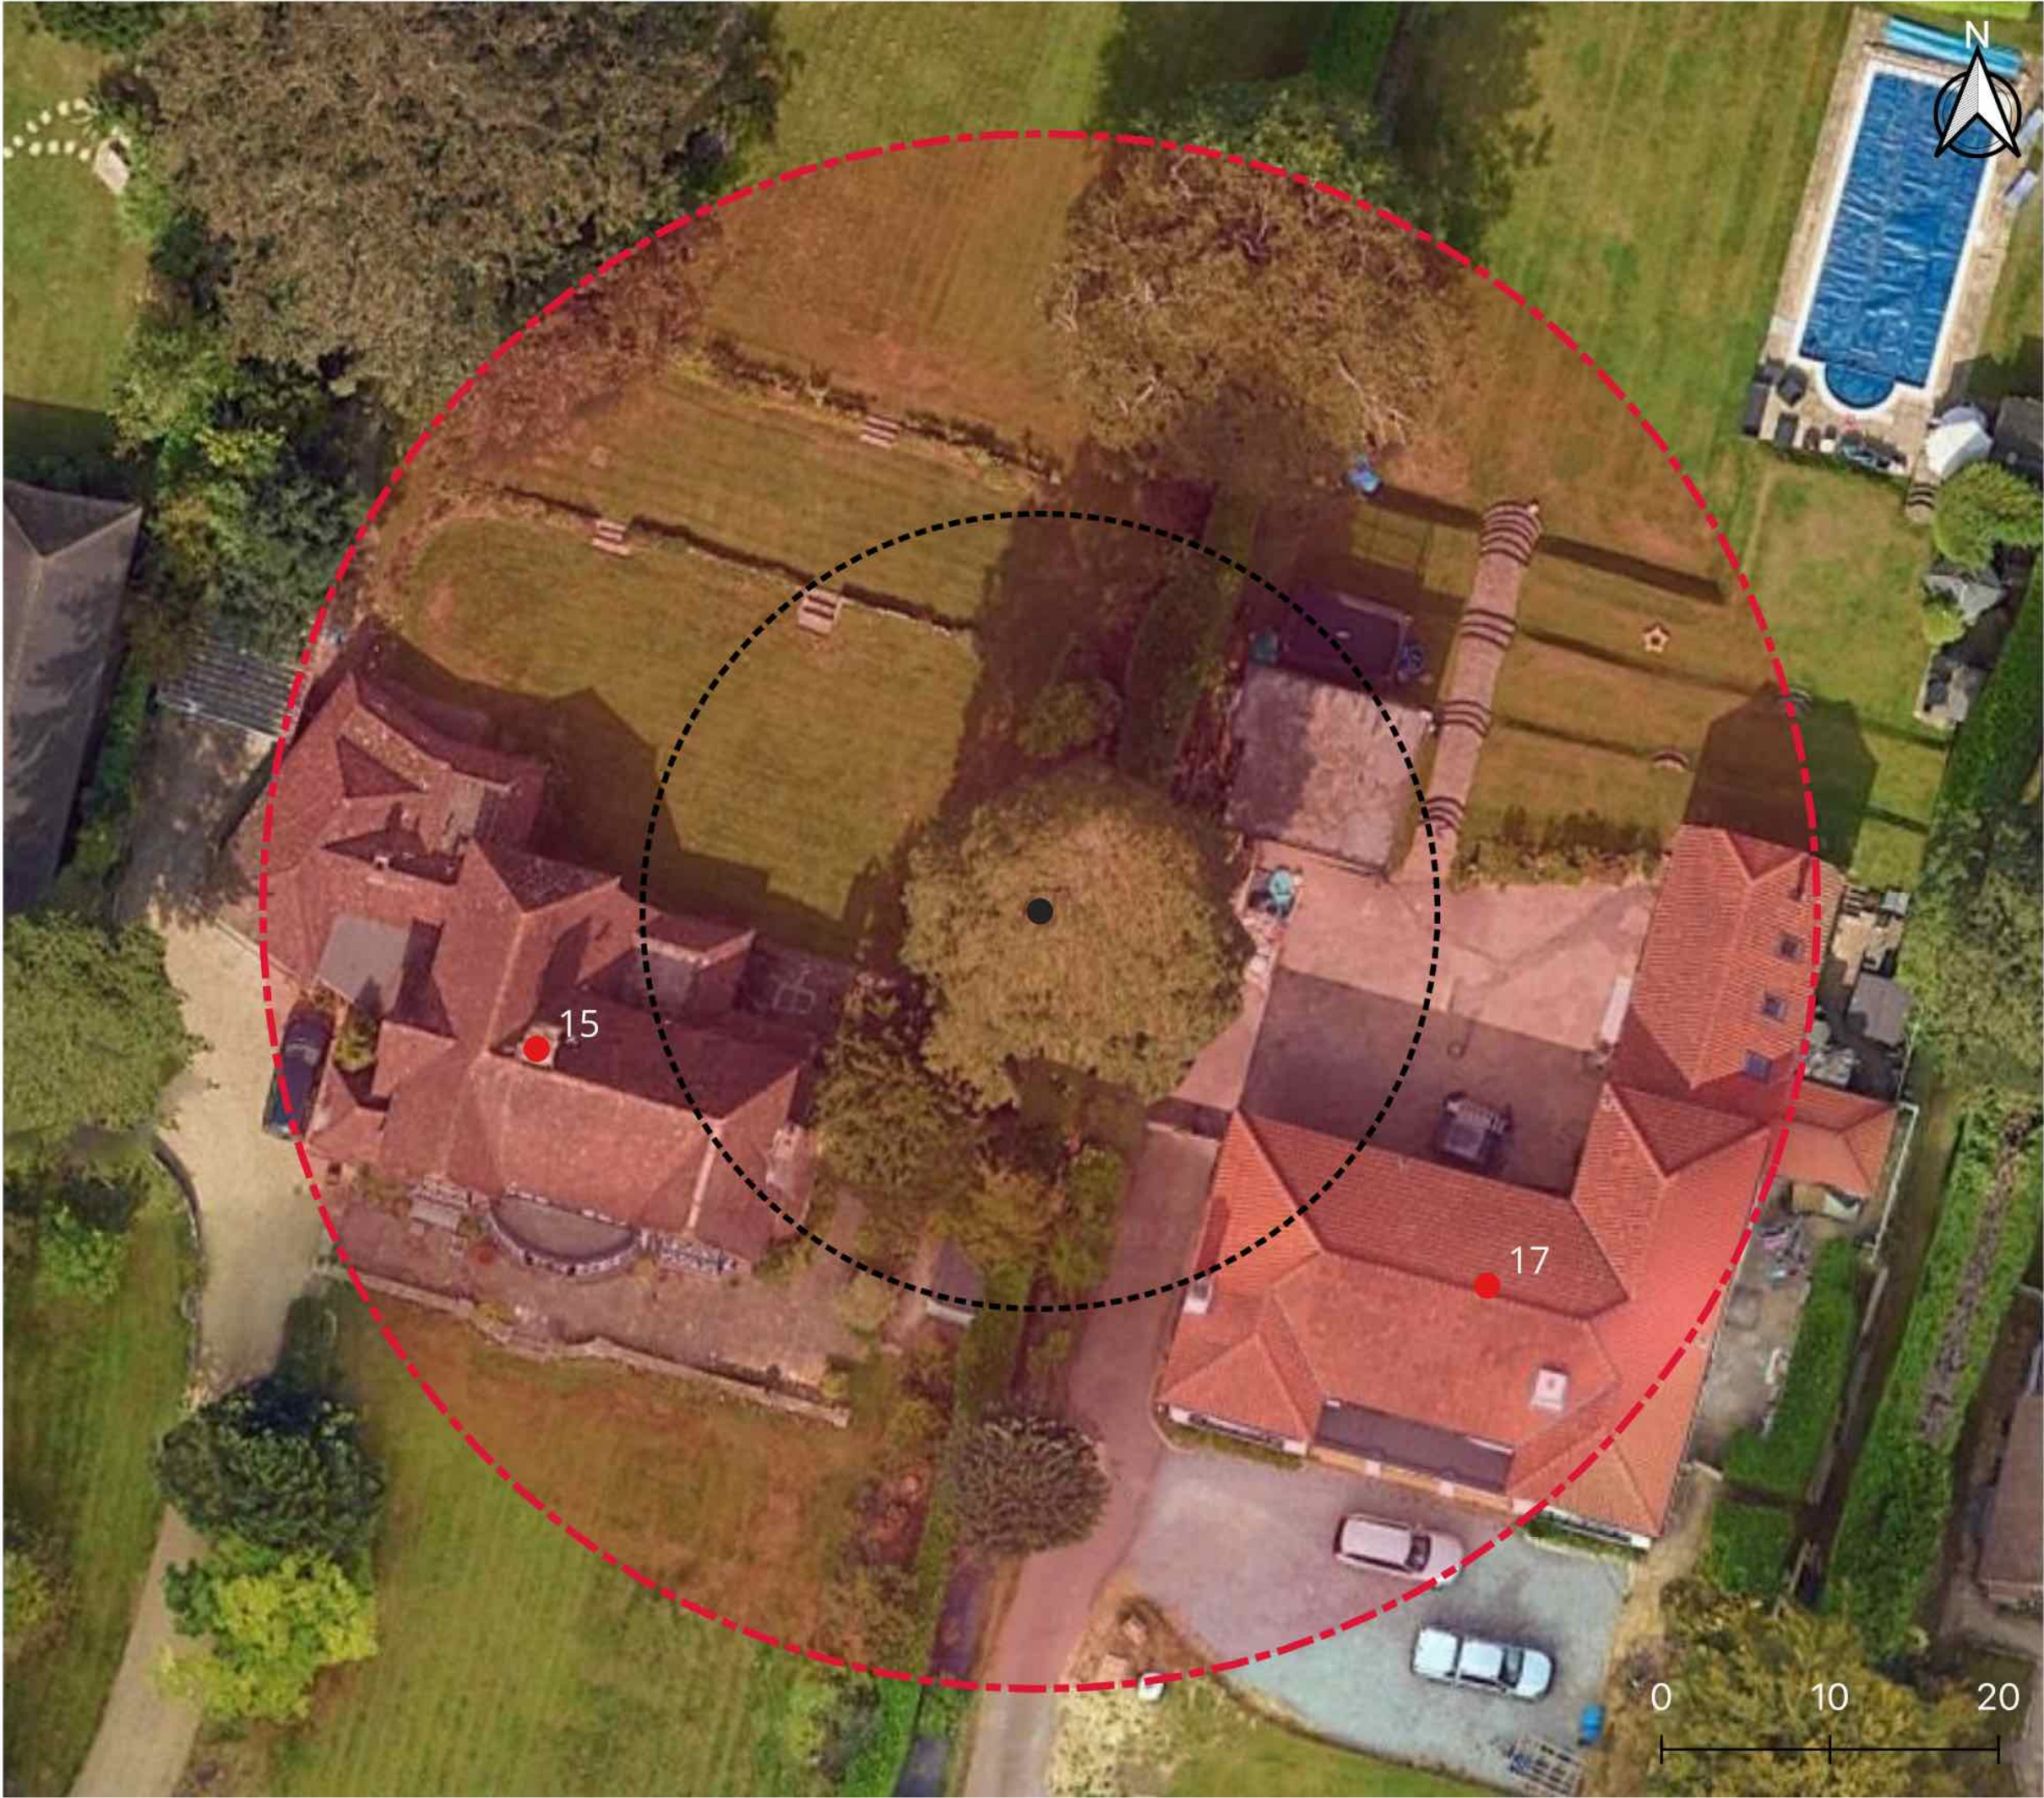
| Ref. | Species | Description | Measurements | Survey Notes | Condition | Structural | Inspect Period | Risk Rating | Timescale | Discussion / Recommendations |
|---|---|---|---|---|---|---|---|---|---|---|
| T001 | Giant Sequoia<br>(Sequoiadendron giganteum) | Large tree located in the grounds of 15 Lewes Road. 2m from the boundary of 17 Lewes road with a lean to the north east towards the property at 17 Lewes Road. | Height (m): 30<br>Crown Radius (m): 8<br>DBH (mm): 1830<br>Trees: 1<br>Life Stage: Mature | Very large tree located on ground which is >1m higher than the patio and drive within 17 Lewes Road. The topography of the ground may have impacted the structural integrity of the root plate.<br>Tree has a lean towards the property at 17 Lewes road with sparse canopy cover on the northwest aspect.<br>At ground level a void on the northeast aspect was observed with a depth of 300mm and dead wood present.<br>Badgers are known to be in the area with signs of digging activity around the base. | Fair | Fair | 1 Year | High | 1 year | <p><b>Location</b></p> <p>The Giant Sequoia located between 15 and 17 Lewes Road exhibits a pronounced lean towards the property at 17 Lewes Road. The tree stands on elevated ground relative to the property, with voiding noted around the root plate and evidence of mammal activity (likely badger disturbance) contributing to possible root instability.</p> <p><b>Canopy</b></p> <p>While the tree retains some canopy vitality, the combination of structural lean, elevated ground position, and observed voiding presents a foreseeable risk of partial or total failure towards the dwelling at 17 Lewes Road. Given the tree's size and proximity to residential areas, any such failure could result in significant harm to persons or property.</p> <p><b>Root-plate instability indicators</b></p> <p>The combination of slope loading, lean and mammal excavation constitutes evidence of differential root-plate movement. According to BS 5837 Annex A and AFAG 401, trees on raised ground adjacent to excavation or erosion should be regarded as higher risk for rotational failure.</p> <p><b>Soil moisture and seasonal heave</b></p> <p>Given the elevated position and the property's lower ground level, soil moisture variation could accelerate downslope movement during prolonged wet periods.<br/>This connects the lean and voiding to foreseeable seasonal triggers.</p> <p><b>Mass and target severity</b></p> <p>At an estimated mass exceeding 25 t, even partial failure of the main stem or root-plate could cause structural damage to the dwelling or present life-threatening injury to occupants, placing this tree within the 'high consequence' category under the HSE's tree-safety zoning principles (SIM 01/2007/05).</p> <p><b>Further surveys</b></p> <p>Further investigation by sonic tomography or static load testing may assist in quantifying the extent of any internal decay or root-plate compromise.</p> <p><b>Recommendations</b></p> <p>In accordance with the duty of care placed upon landowners and occupiers under the Occupiers' Liability Acts 1957 and 1984, the tree owner should take reasonable steps to identify and manage risks associated with trees on their land. In this instance, appropriate and proportionate risk management would include:</p> <p>Carry out a crown reduction (up to 20% or 1.6m from each aspect) to reduce sail area and loading on the root plate. The crown reduction will leave a crown radius of 6.4m</p> <p>Reinspection following significant meteorological events (e.g. wind speeds exceeding Beaufort Scale 6) and at least annually, or sooner if further ground movement or canopy change is observed.", and after any remedial works, to monitor for further ground movement or canopy decline.</p> <p>All operations should comply with BS 3998:2010 – Tree Work – Recommendations</p> |
