# Arboricultural Consultancy for Royal & Sun Alliance

| Insured | Mrs Susan Keymer | Address | 1 Calbourne , Haywards Heath , RH16 4AQ | | |
| Client | Subsidence Management Services | Contact | Richard Bryant | Claim No. | IFS-RSA-SUB-25-0116647 |

## 2. Property and Damage Description

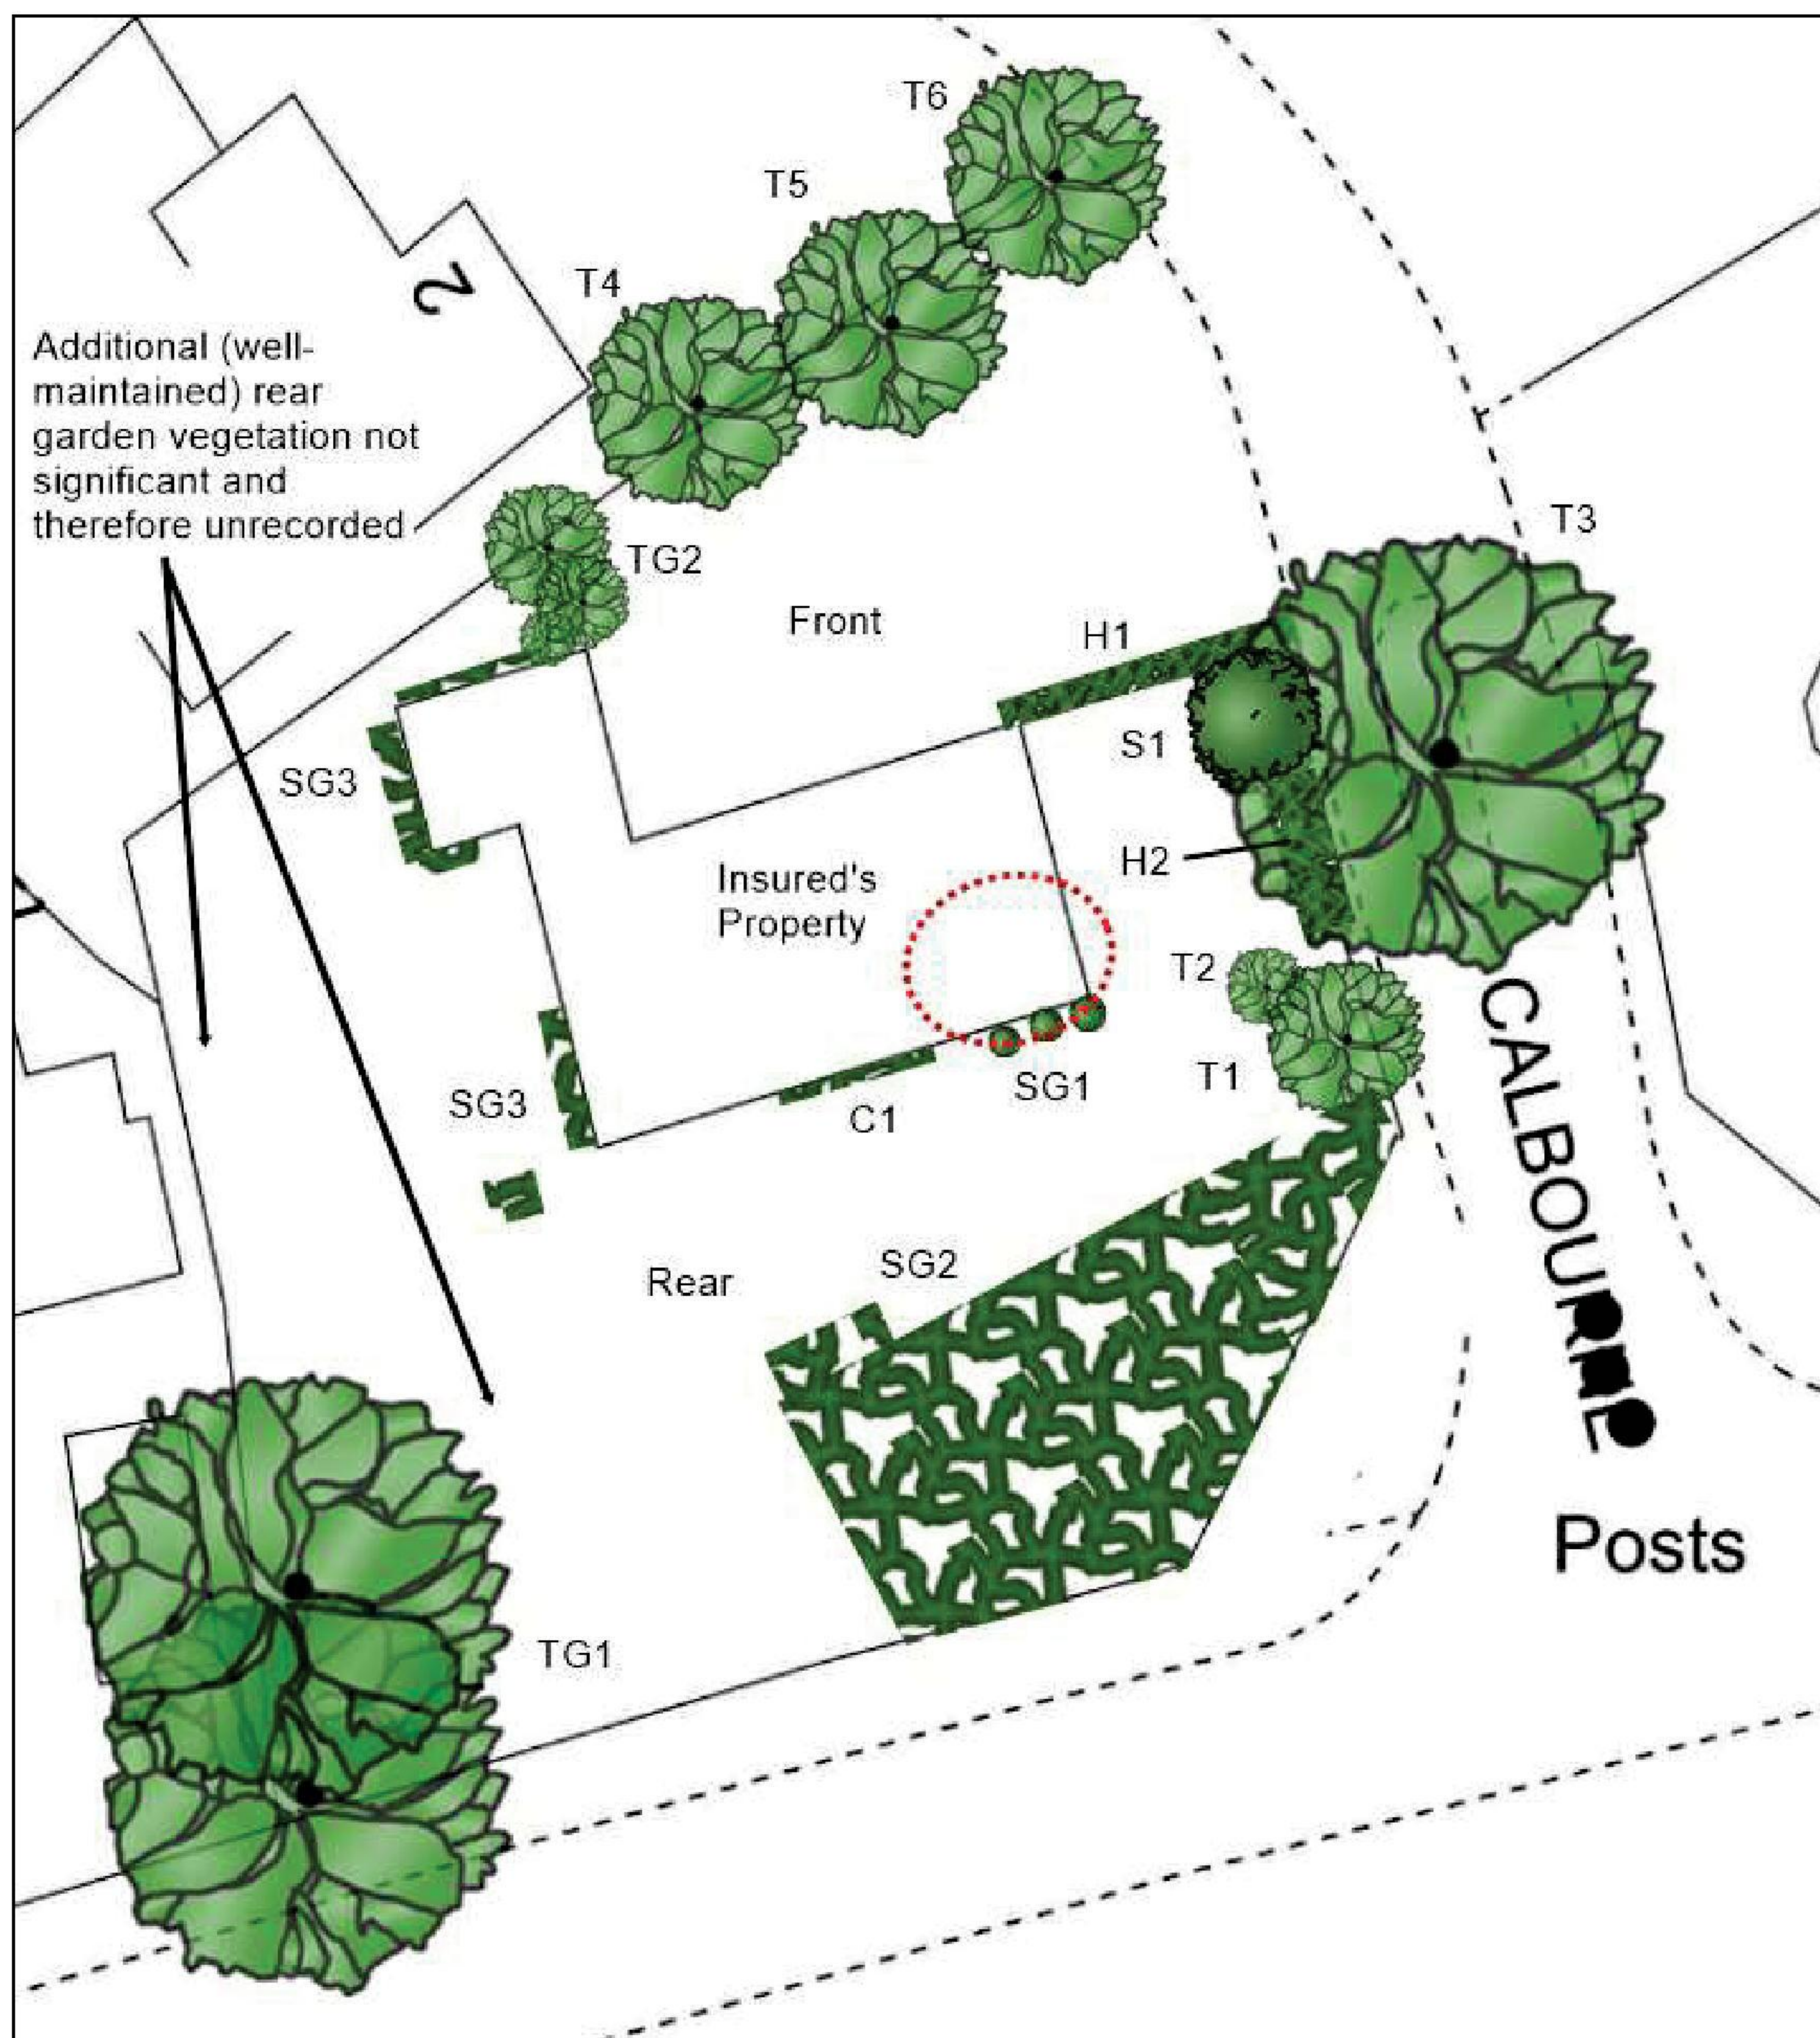
## 7. Site Plan

The primary causal vegetation has been noted to be under the ownership / control of the Local Authority, who should be notified of the current building damage and requested to effectively mitigate soil drying (from T3) below the subject property.

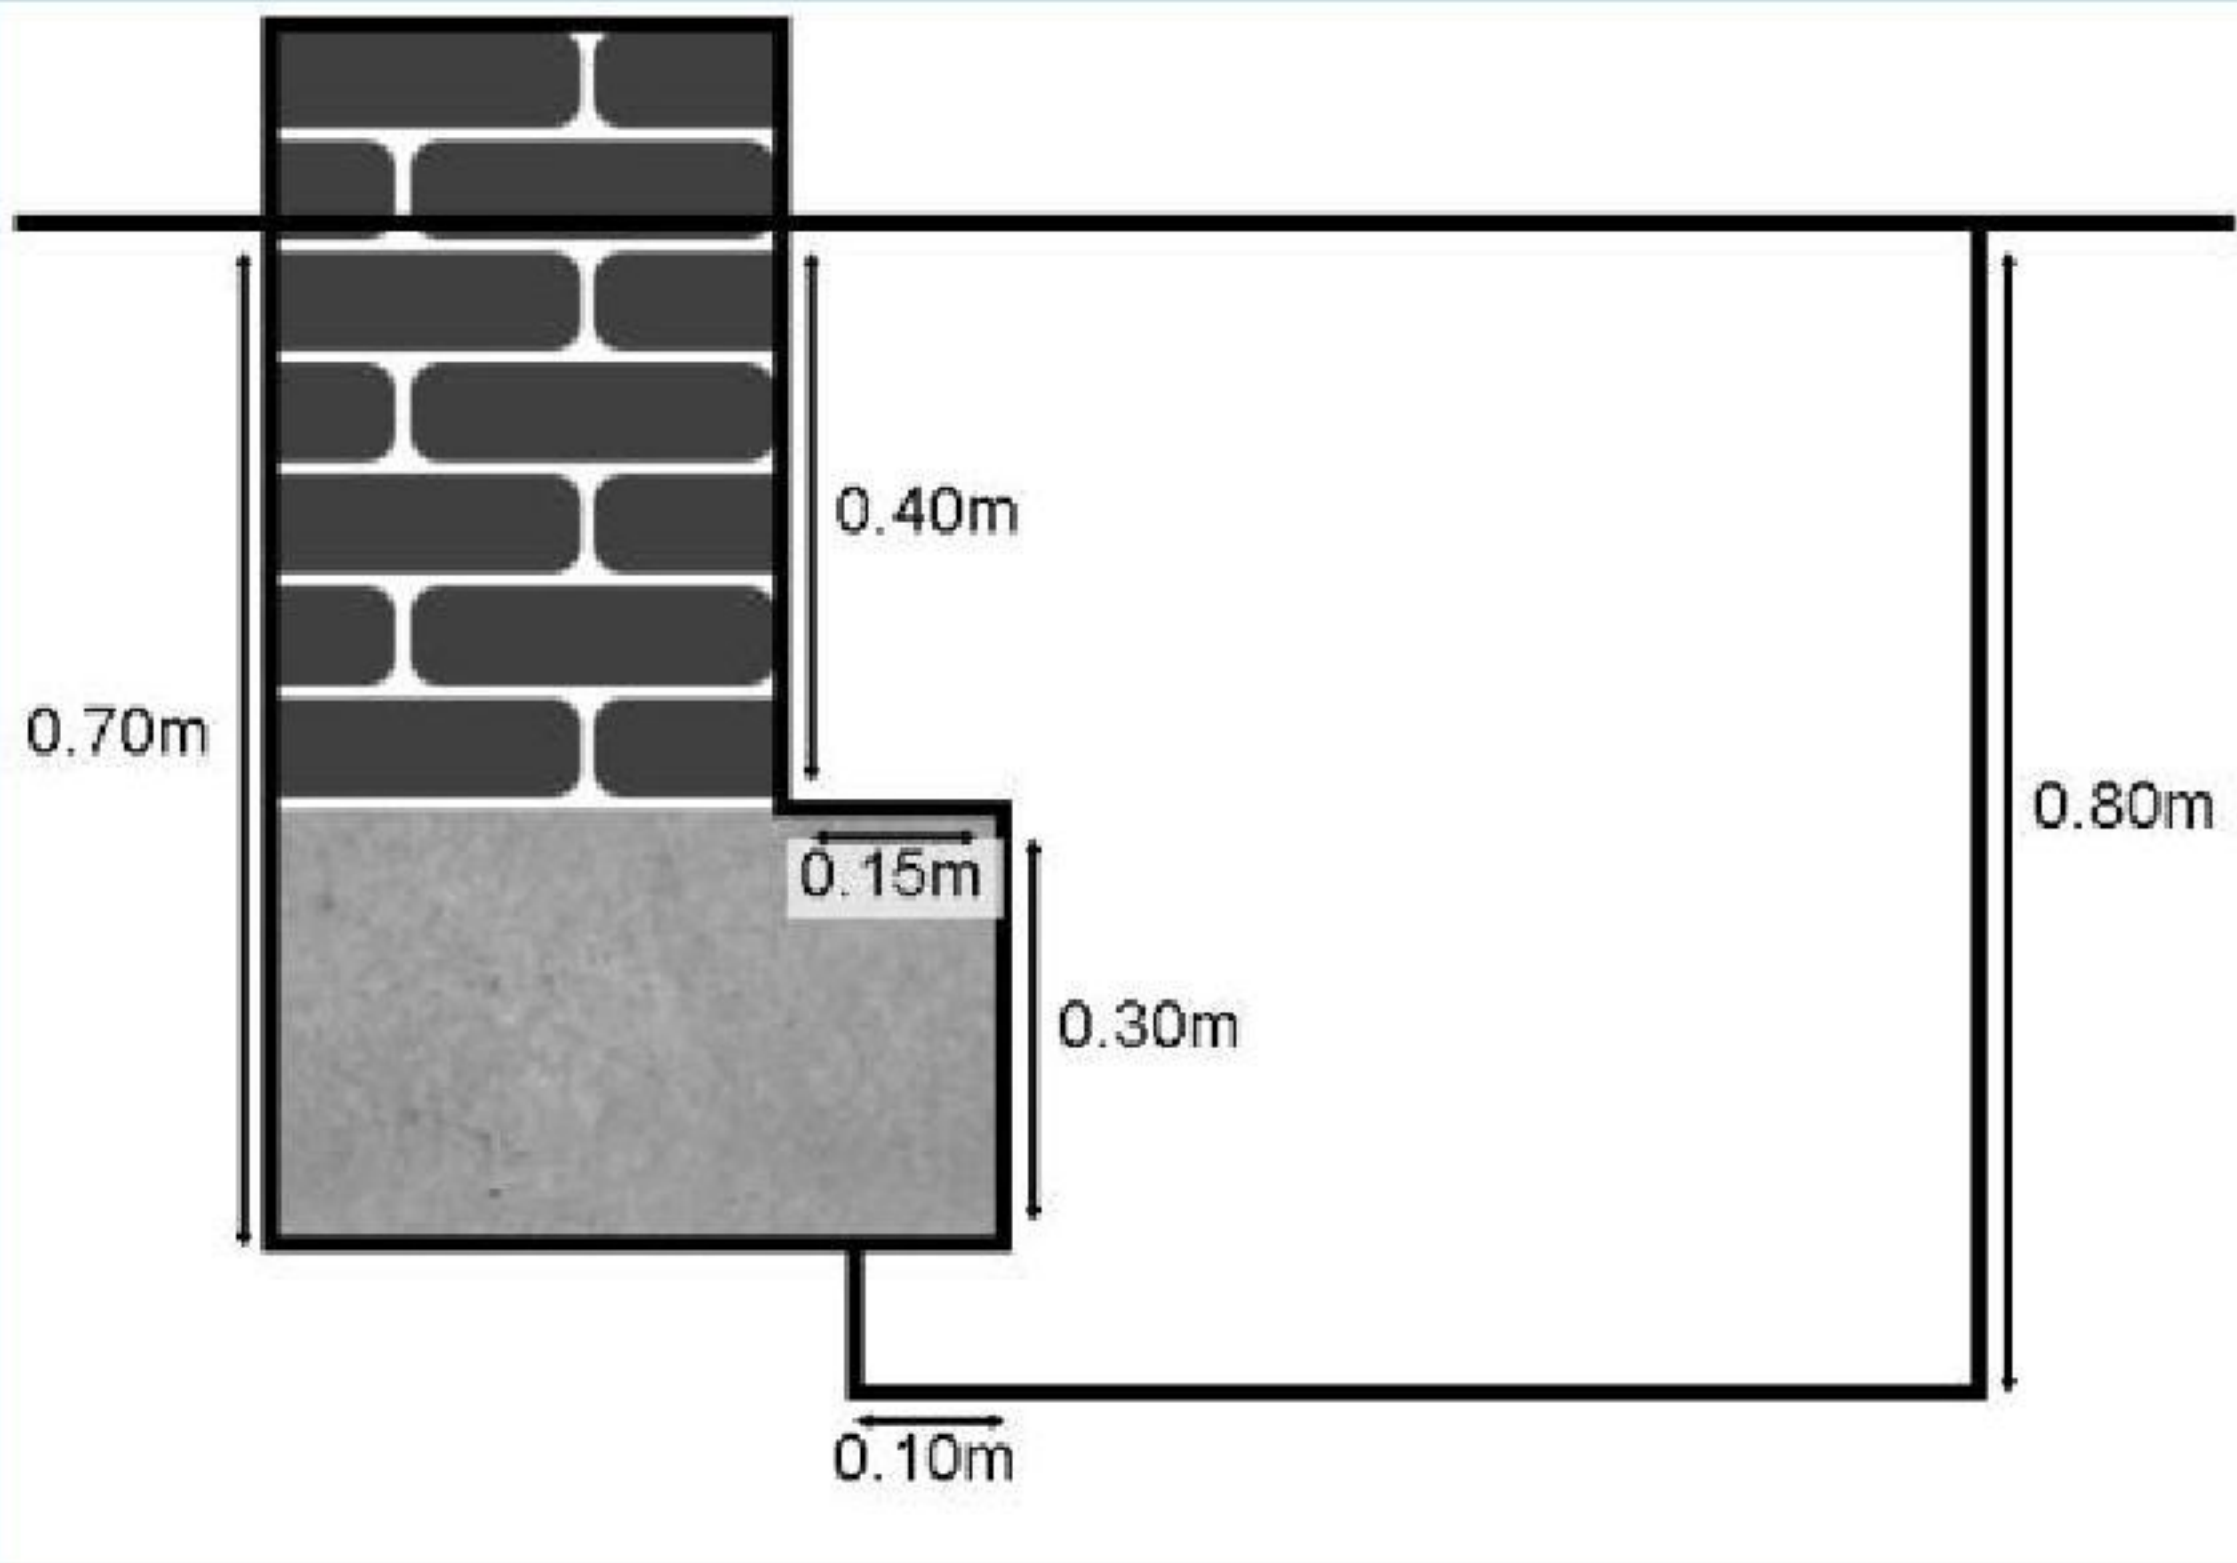
TP/BH1 Foundation Detail and Borehole Log

House foundation comprised of brick wall to 400mm bgl, bearing on concrete to 700mm bgl, with a total projection of 150mm from the elevation. Underside of foundation (USF) was exposed to 100mm back from the face of the foundation and probed 500mm back from the face of the foundation.

House foundation was exposed and the underside of foundation (USF) recorded to be 0.7m bgl (TP/BH 1).
