## PART VIII | JUSTIFICATION

## JUSTIFICATION

107 HIGH STREET, LINDFIELD, HAYWARDS HEATH, RH16 2HR

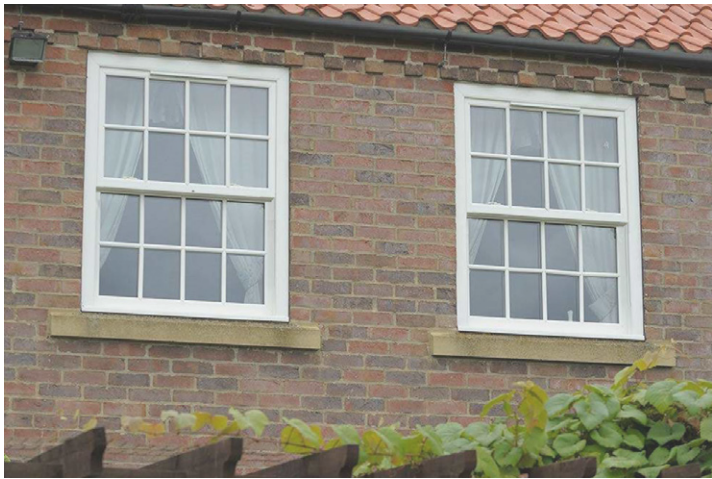
Proposed internal window replacement (example image) to better reflect the building’s historic character, providing a Georgian sash window that aligns with the original architectural intent. The existing window was non-original.

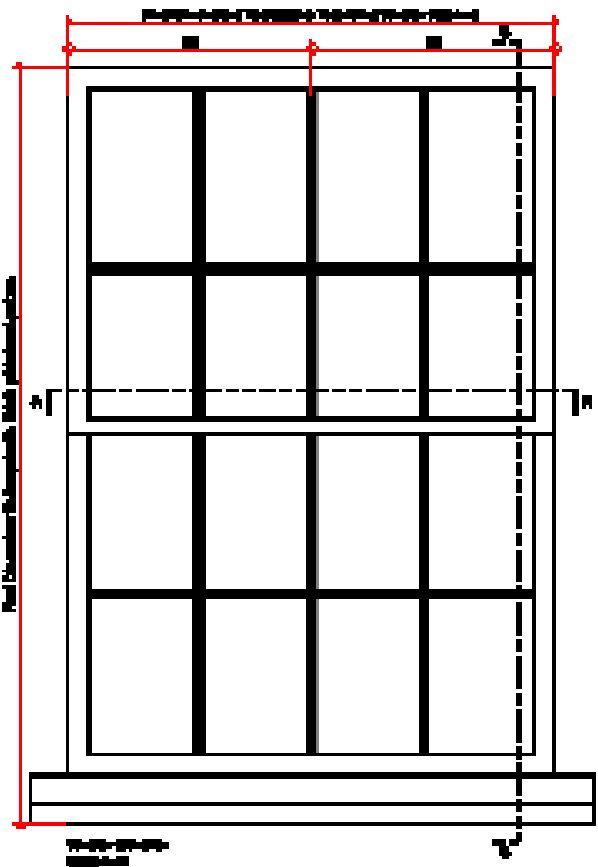
Proposed internal window replacement (example image) to better reflect the building’s historic character, providing a sash window that aligns with the original architectural intent. The existing window was non-original.

As illustrated within the accompanying formal drawings, the proposal involves the replacement of the existing Victorian window within the original c.1830 window aperture. The historic aperture will be fully retained. The existing window will be carefully removed and replaced with a bespoke hardwood sash window designed to respect and complement the historic character and fabric of the building, resulting in a modest uplift in heritage value. The new window will be installed within the retained opening and positioned in the same location as the existing window. Glazing will comprise 12mm frosted glass. All dimensions will be confirmed on site prior to fabrication to ensure an accurate fit within the existing aperture.

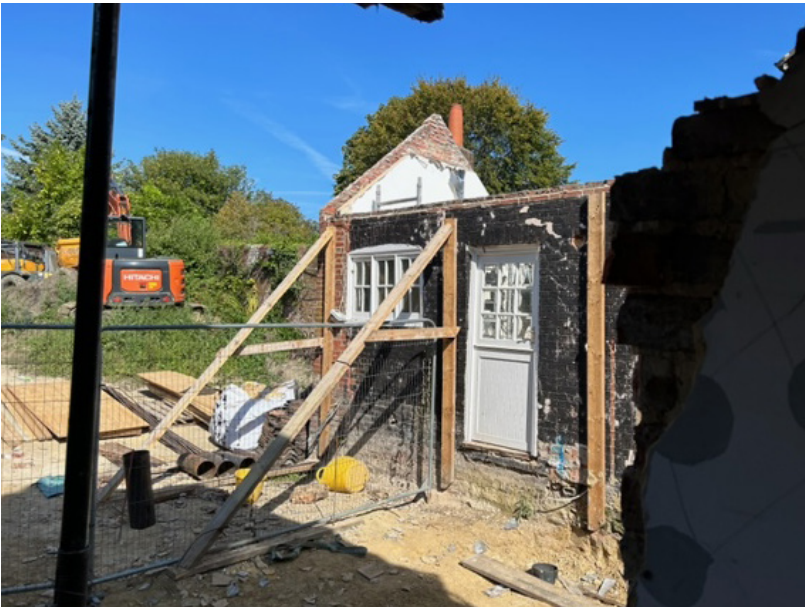
Bake house falling down during strip-out.  
Photograph provided by the Applicant.

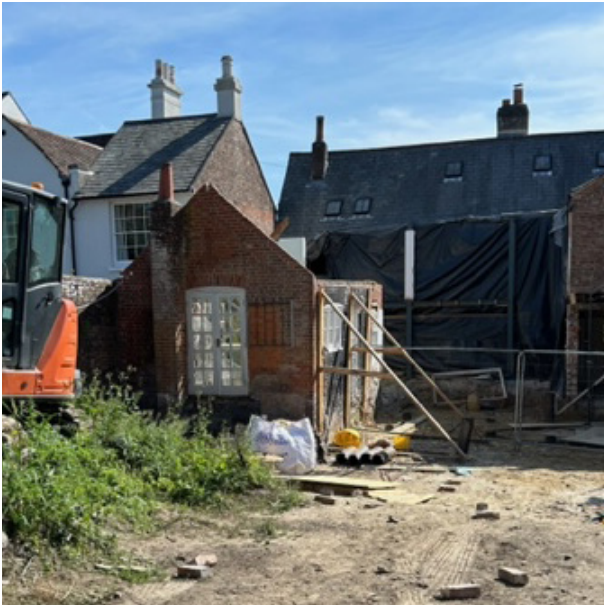
Bake house falling down during strip-out.  
Photograph provided by the Applicant.

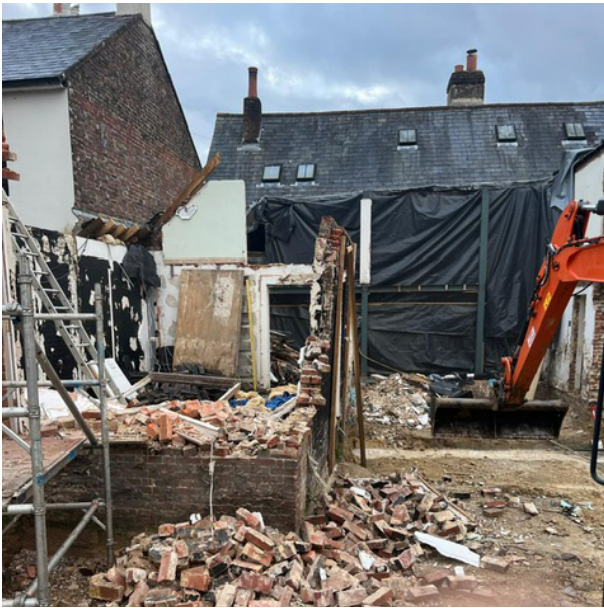
Bake house after its collapse during strip-out.  
Photograph provided by the Applicant.

The bake house was reconstructed with reclaimed brickwork from the collapsed building. Where new brickwork was required, the Hamsey Mixed Stock was used, visually blending with the existing.

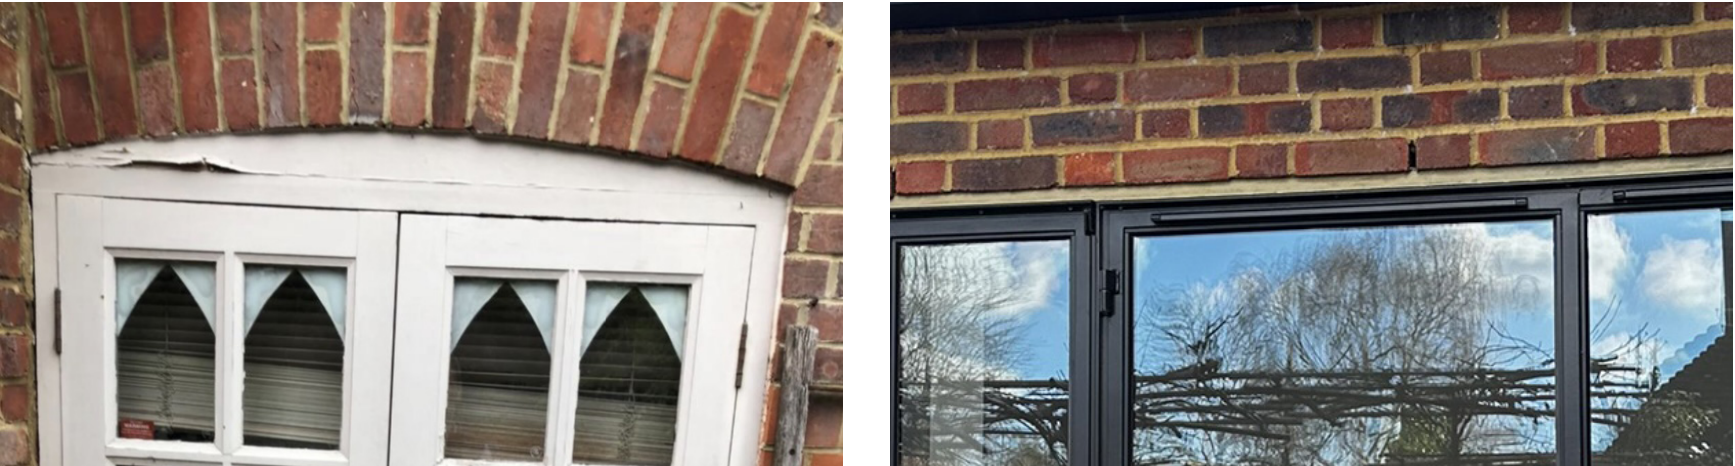
Just like the brickwork of the original bake house, the Hamsey Mixed Stock brickwork used for re-construction of the bake house is mixed-colour. The adjacent images serve as a comparison of brickwork.

Comparison of brickwork used on the original (left) and re-constructed (right) bake house.

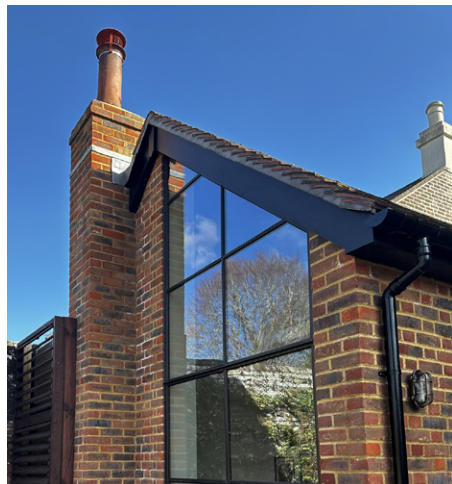
‘As-built’ bake house chimney with lead waterproofing dressing

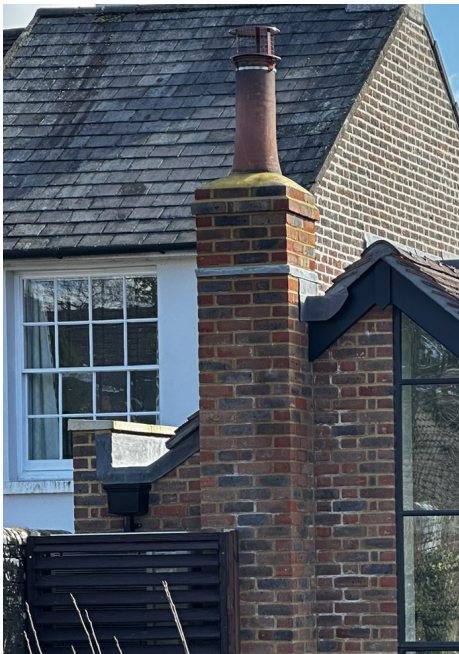
Recent photograph of parapet wall detail

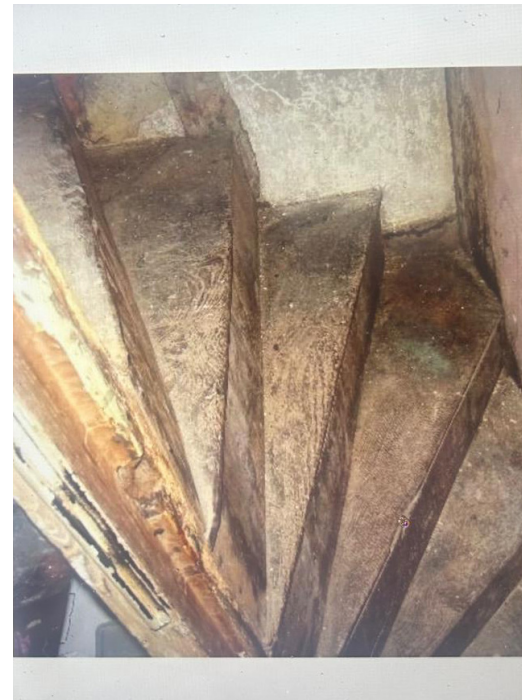
Staircase during demolition works

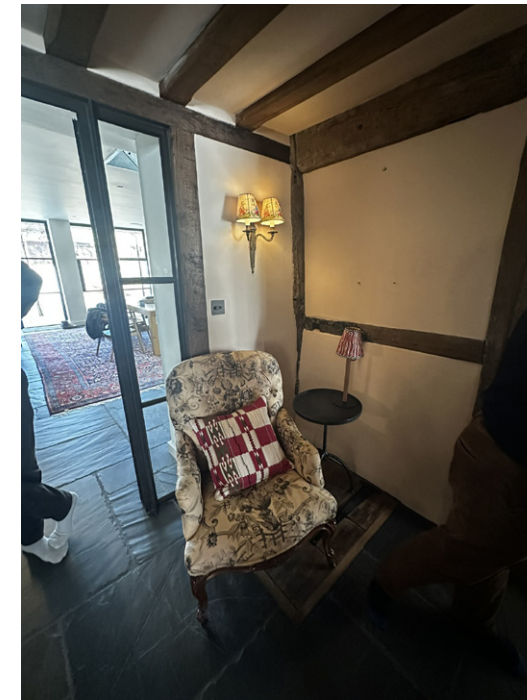
Current photograph- staircase removed, trap door to basement access made out of historic floorboards and installed

The proposed reinstated staircase is to be reconstructed as close to the original as possible, given the limited information of the historic condition. As the staircase is to take form of the original one, it will not be suitable for regular use due to its steepness and limited step depth. Instead, it will most likely serve as a decorative feature that acknowledges the historic fabric of the building, while a new staircase in the living room, compliant with current building regulations, will provide the functional connection between levels.

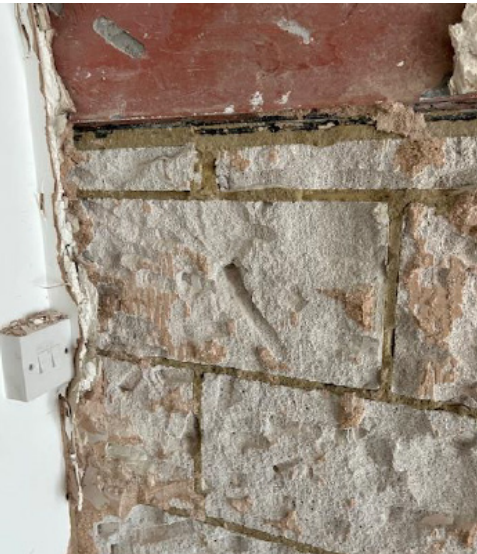
Blockwork construction underlying the exposed timber stud wall with stonework nogging

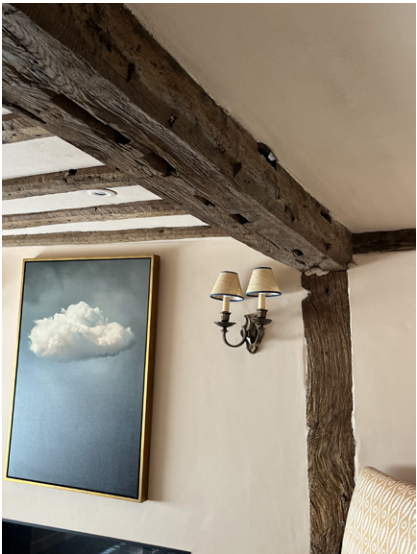
Evidence in the oak frame overhead that there used to be a lateral partition in the current study room

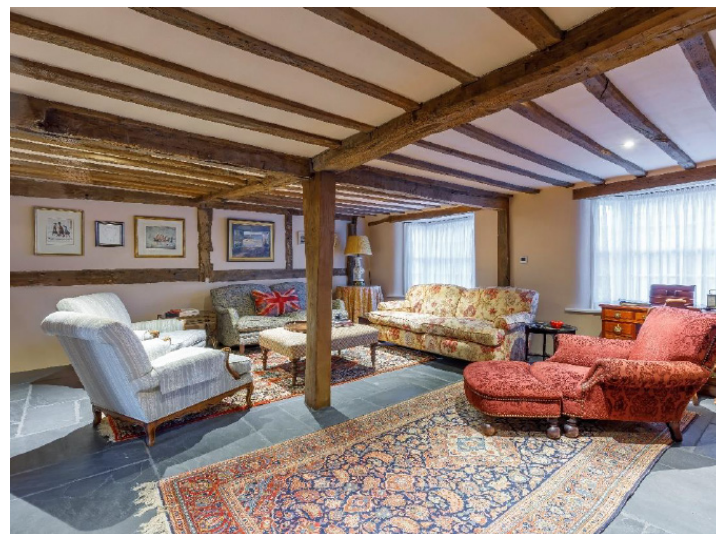
New oak gun stock post and improved internal space

Steel post replaced with traditional gunstock post in seasoned oak

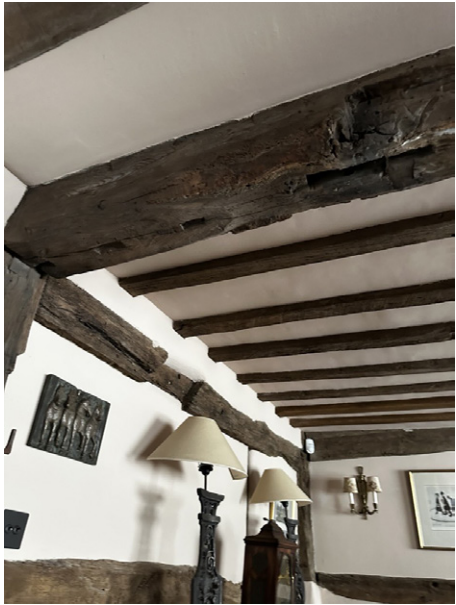
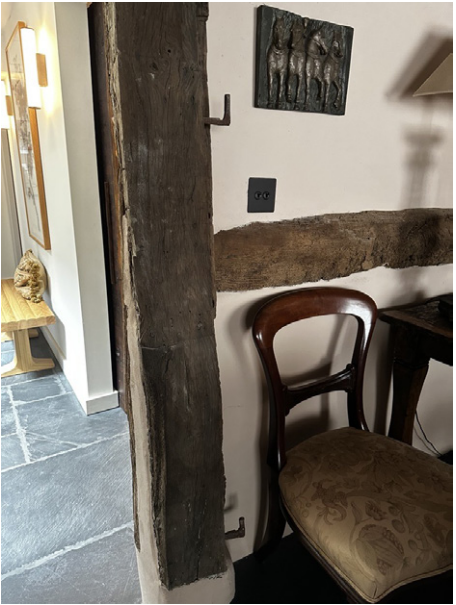
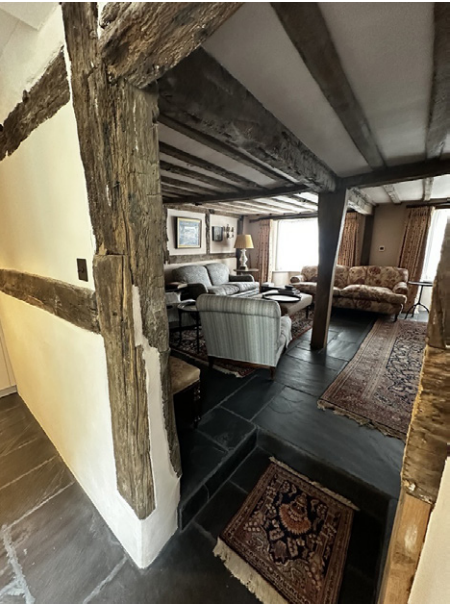
A small section of wall, found to have modern infill, but with references to a historic door opening was removed from the lounge. Whilst the removal of the modern materials is a helpful step in retaining the character of the property, the owner is willing to install a new high quality hand carved oak post, to be dowelled into the original oak frame in the position of the doorway in question, and associated horizontal timber member. Please refer to the following page for detailed justification.

Photographs July 2025: historic evidence of a partition being installed in this location along with a door - the door hooks are still in place.

The undertaken study demonstrates that only a small amount of the remaining historic fabric was removed. Furthermore, the removal of the partition does facilitate a plan form that is more conducive to modern living. Its removal is also justified to facilitate a traditional conservation repair of the central post in seasoned oak, which is a substantive heritage benefit. The impact of wall removal is neutral given the heritage benefit of the timber post repair and improved quality of the living space. Despite of the neutral impact of its removal, it is proposed that the removed horizontal timber frame element and door jamb will be reinstated. This measure should help to retain the legibility of historic door and the dividing screen and to further create a secularised plan that will relate to the historic plan form of the 15th century building. It should therefore be received positively as a mitigating factor.

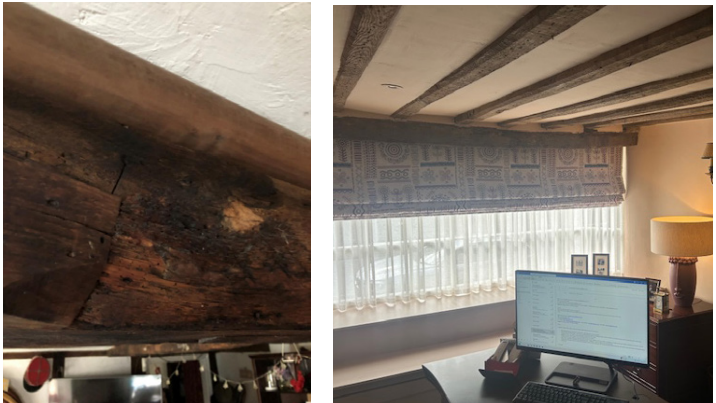
The Timber frame was carefully cleaned and left untreated. There could have been some damage done by the previous owners as the Heritage Statement by Desbruslais confirms that the frame was cleaned on a regular basis. Additionally, many of the oak joists and bressummers have been oiled, as illustrated on the adjacent photograph.

Photographs of oiled oak joist prior to restoration

- 1. Comprehensive survey of the historic timber elements to assess the condition of the oak. Timbers checked for decay, insect damage, splits, warping, or structural weakness.
- 2. Timber renovated using historically appropriate techniques - gentle clean using soft bristle brush. Timber left are without any coatings. The timber’s patina, age marks, and tool finishes retained.

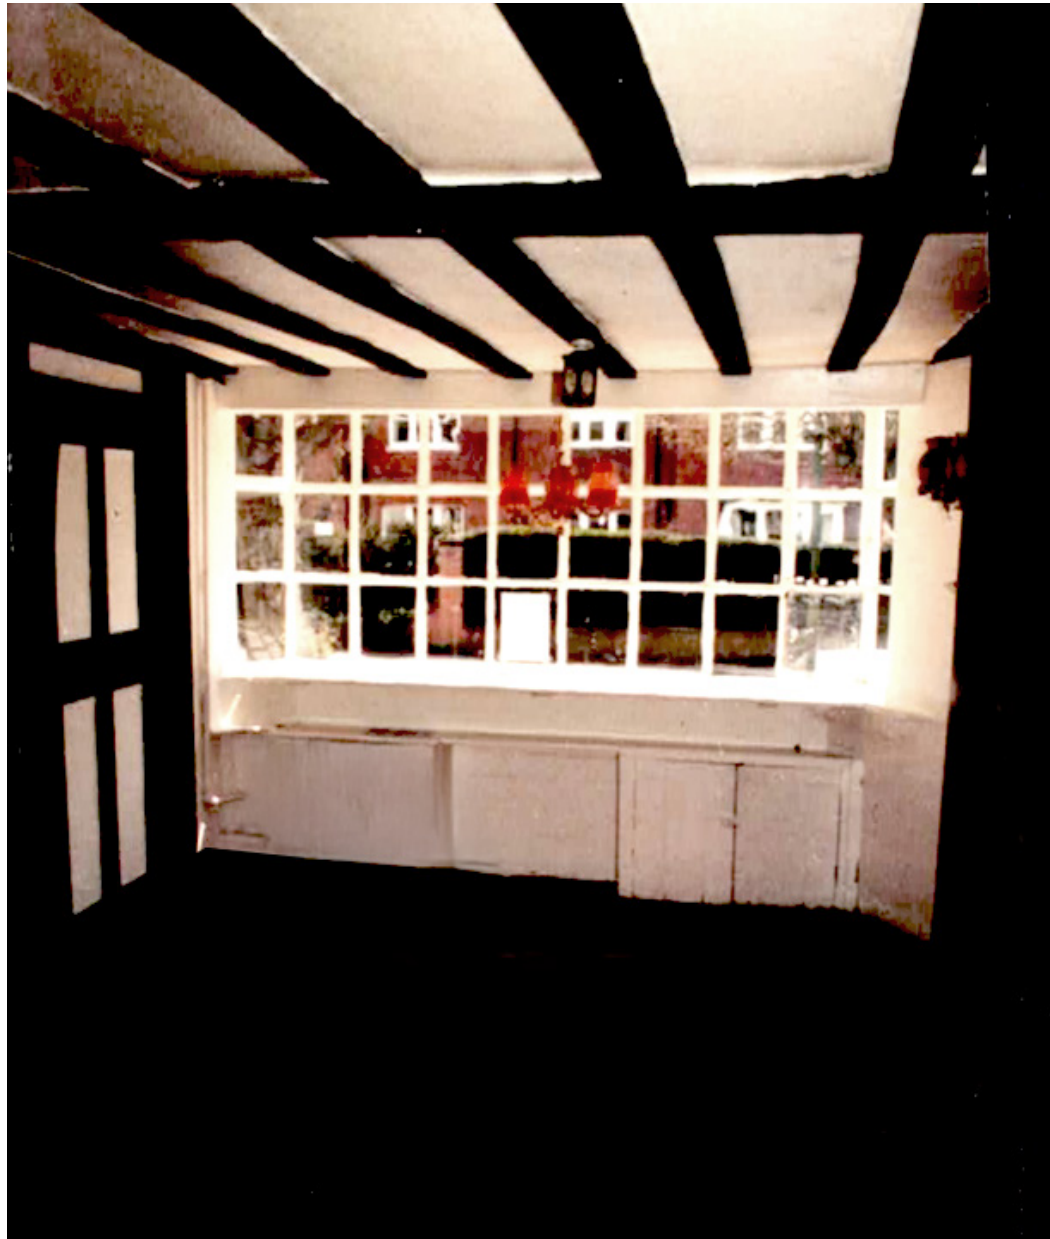
Historic Photo of the Study Space

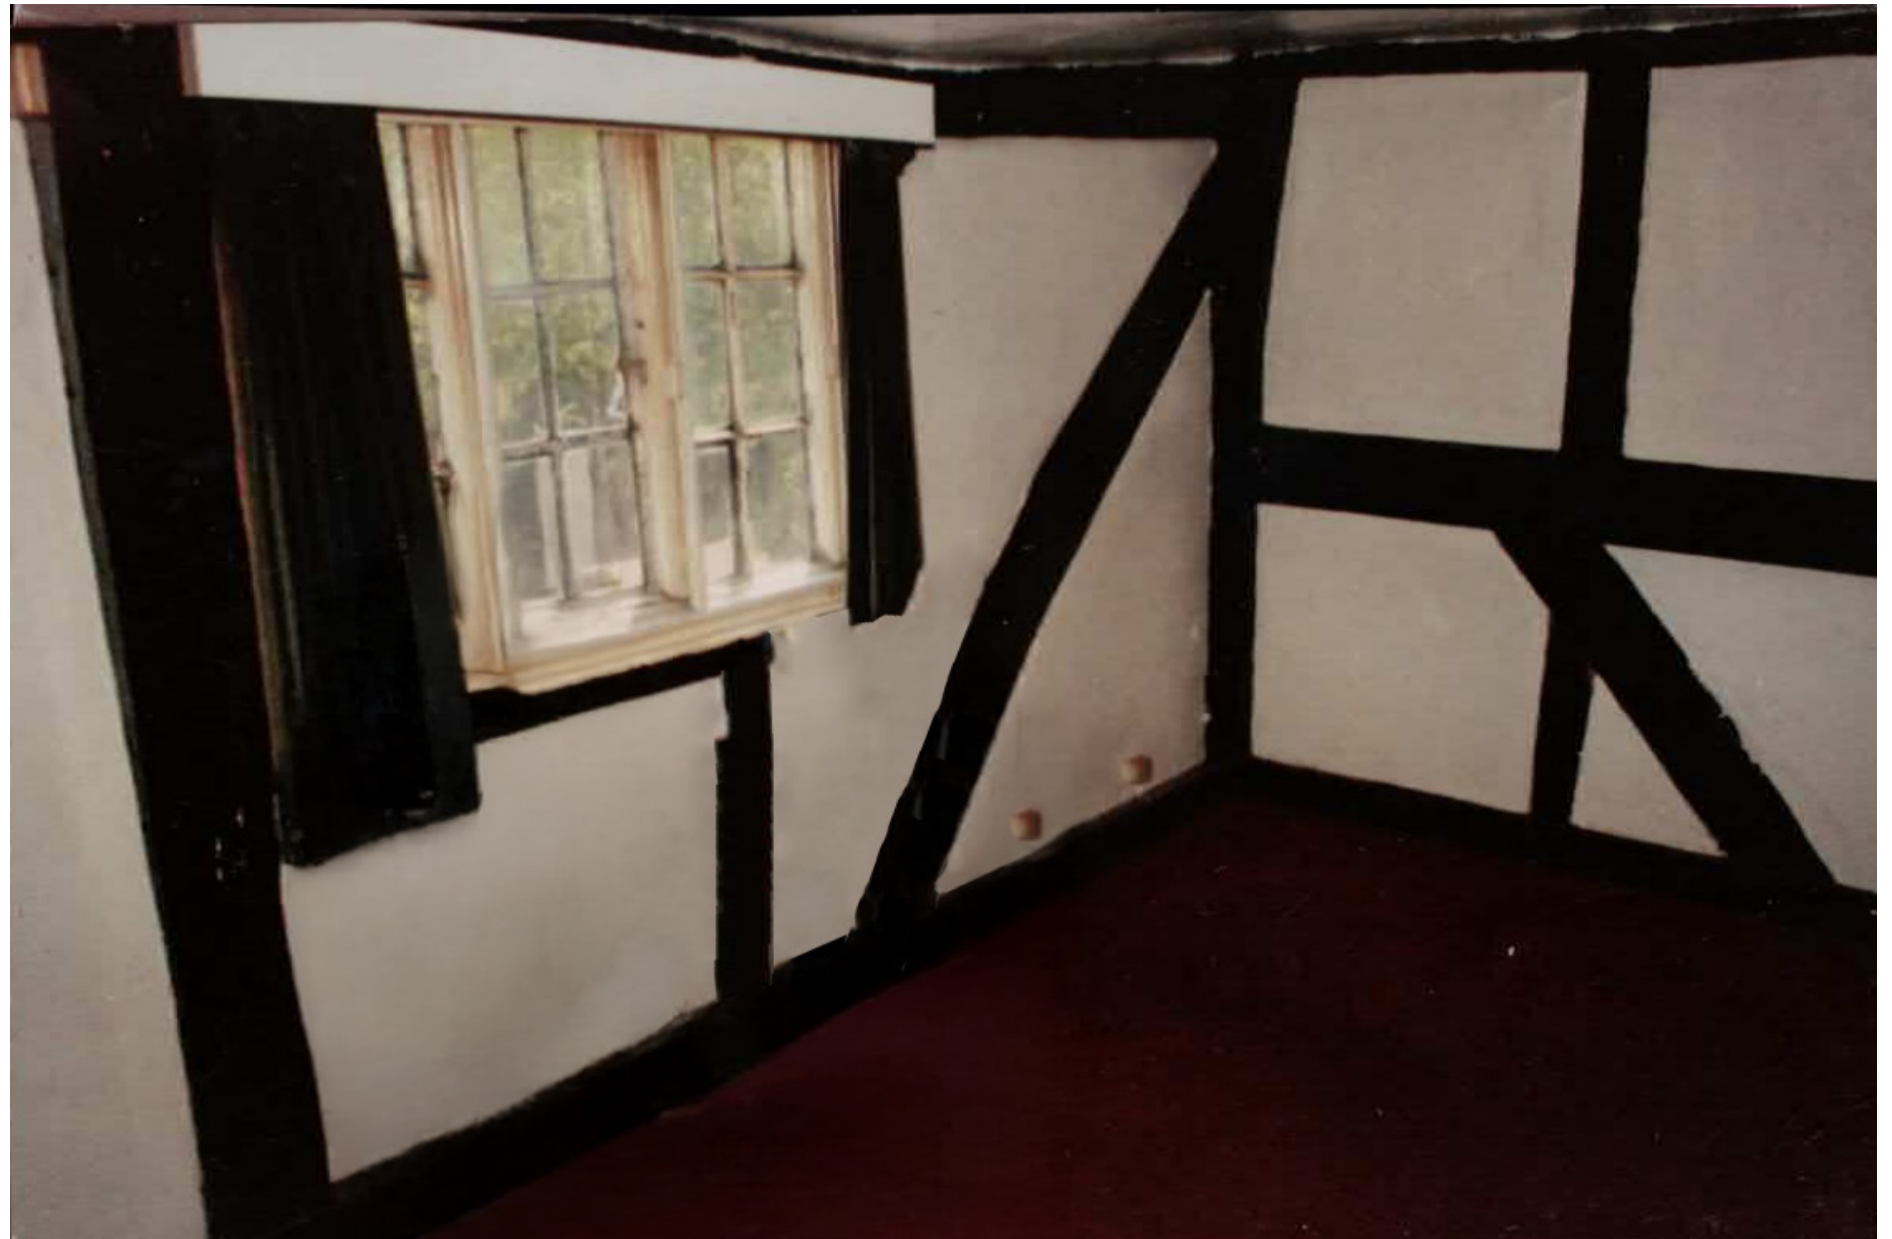
Historic Photo of the South East Bedroom

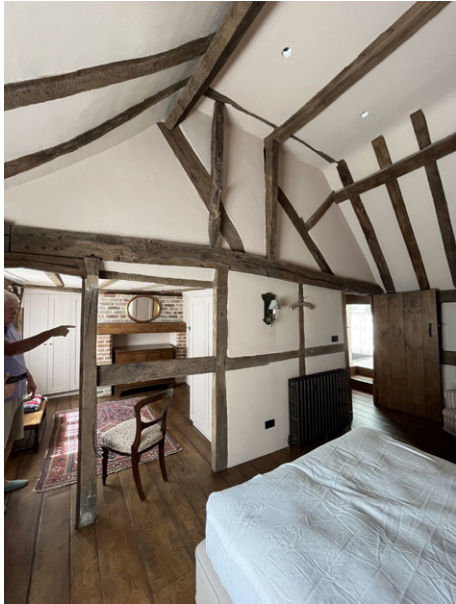
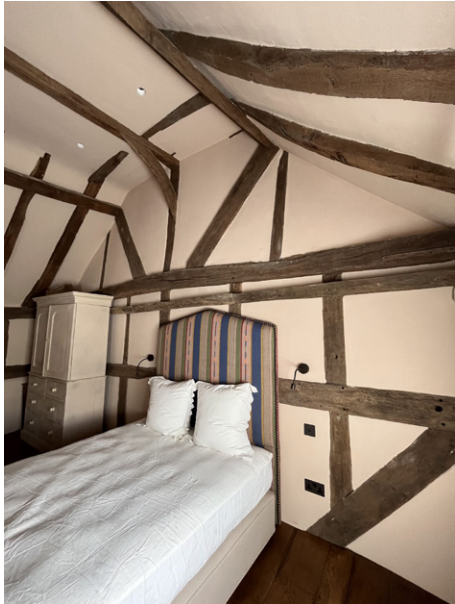
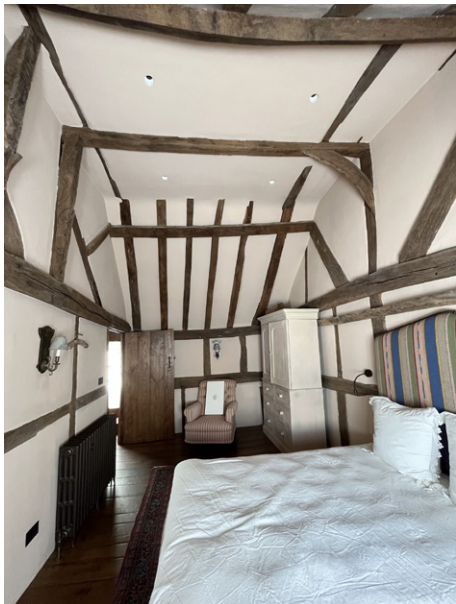
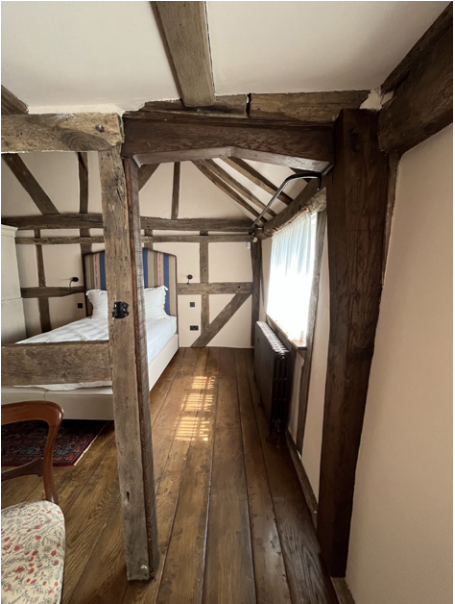
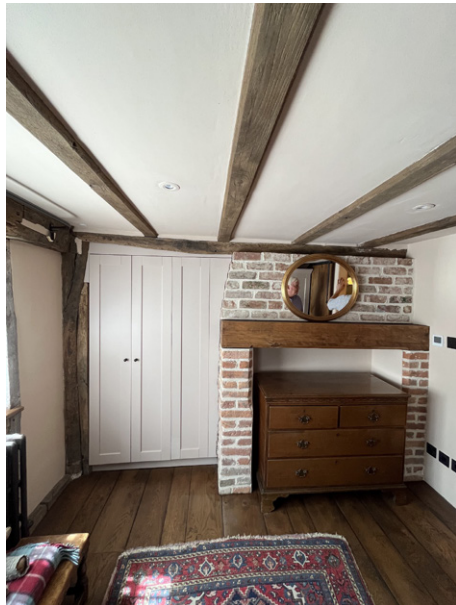
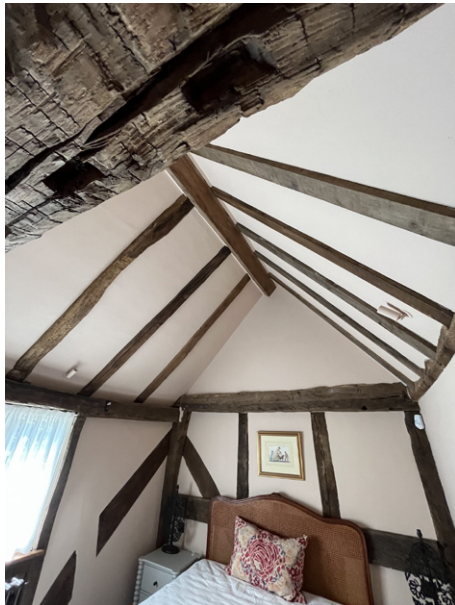
The adjacent photographs taken in July 2025 illustrate the successful treatment and exposure of the timber frame throughout the building. Approximately 60% of the historic timber framing is now visible throughout the building.

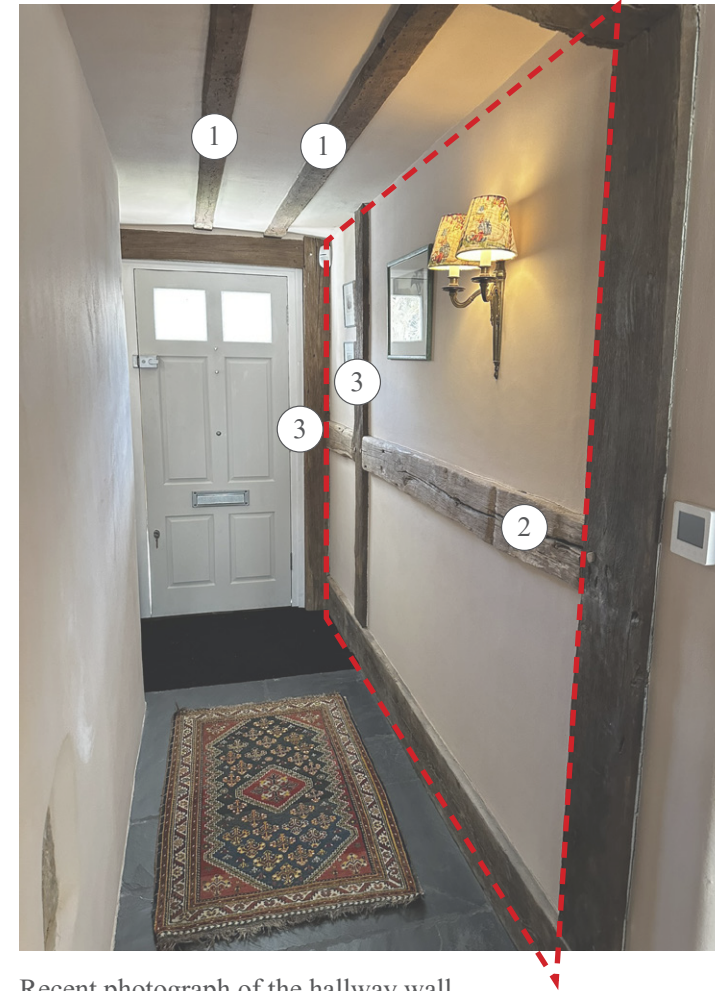
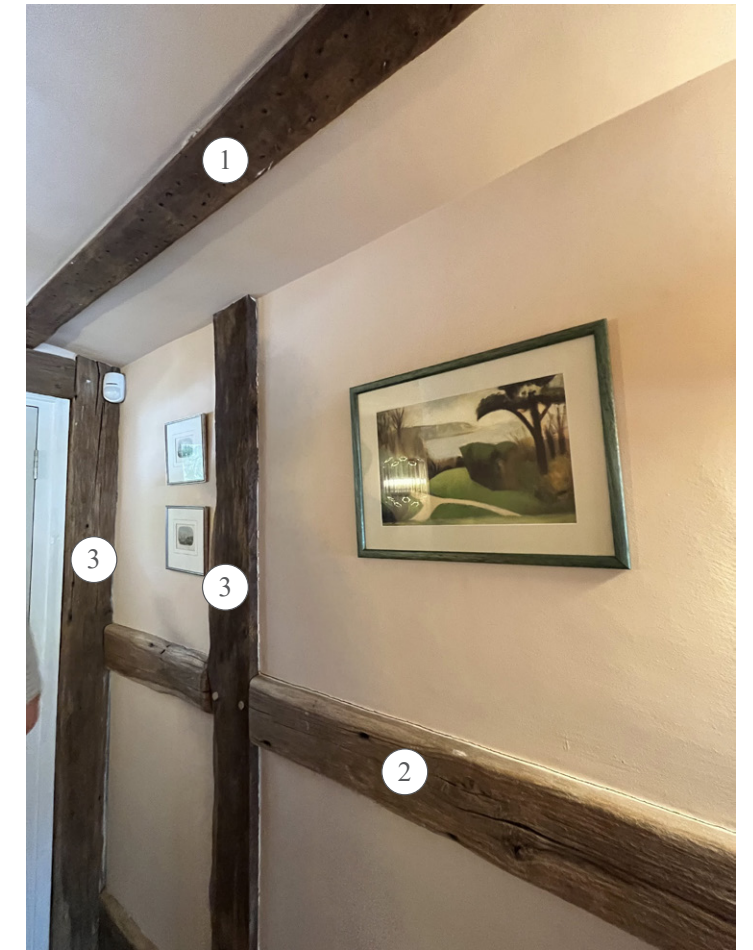
Recent photograph of the hallway wall

1. Comprehensive survey of the historic timber elements to assess the condition of the oak. Timbers checked for decay, insect damage, splits, warping, or structural weakness.
2. Timber renovated using historically appropriate techniques - gentle clean using soft bristle brush. Timber left are without any coatings. The timber's patina, age marks, and tool finishes retained.

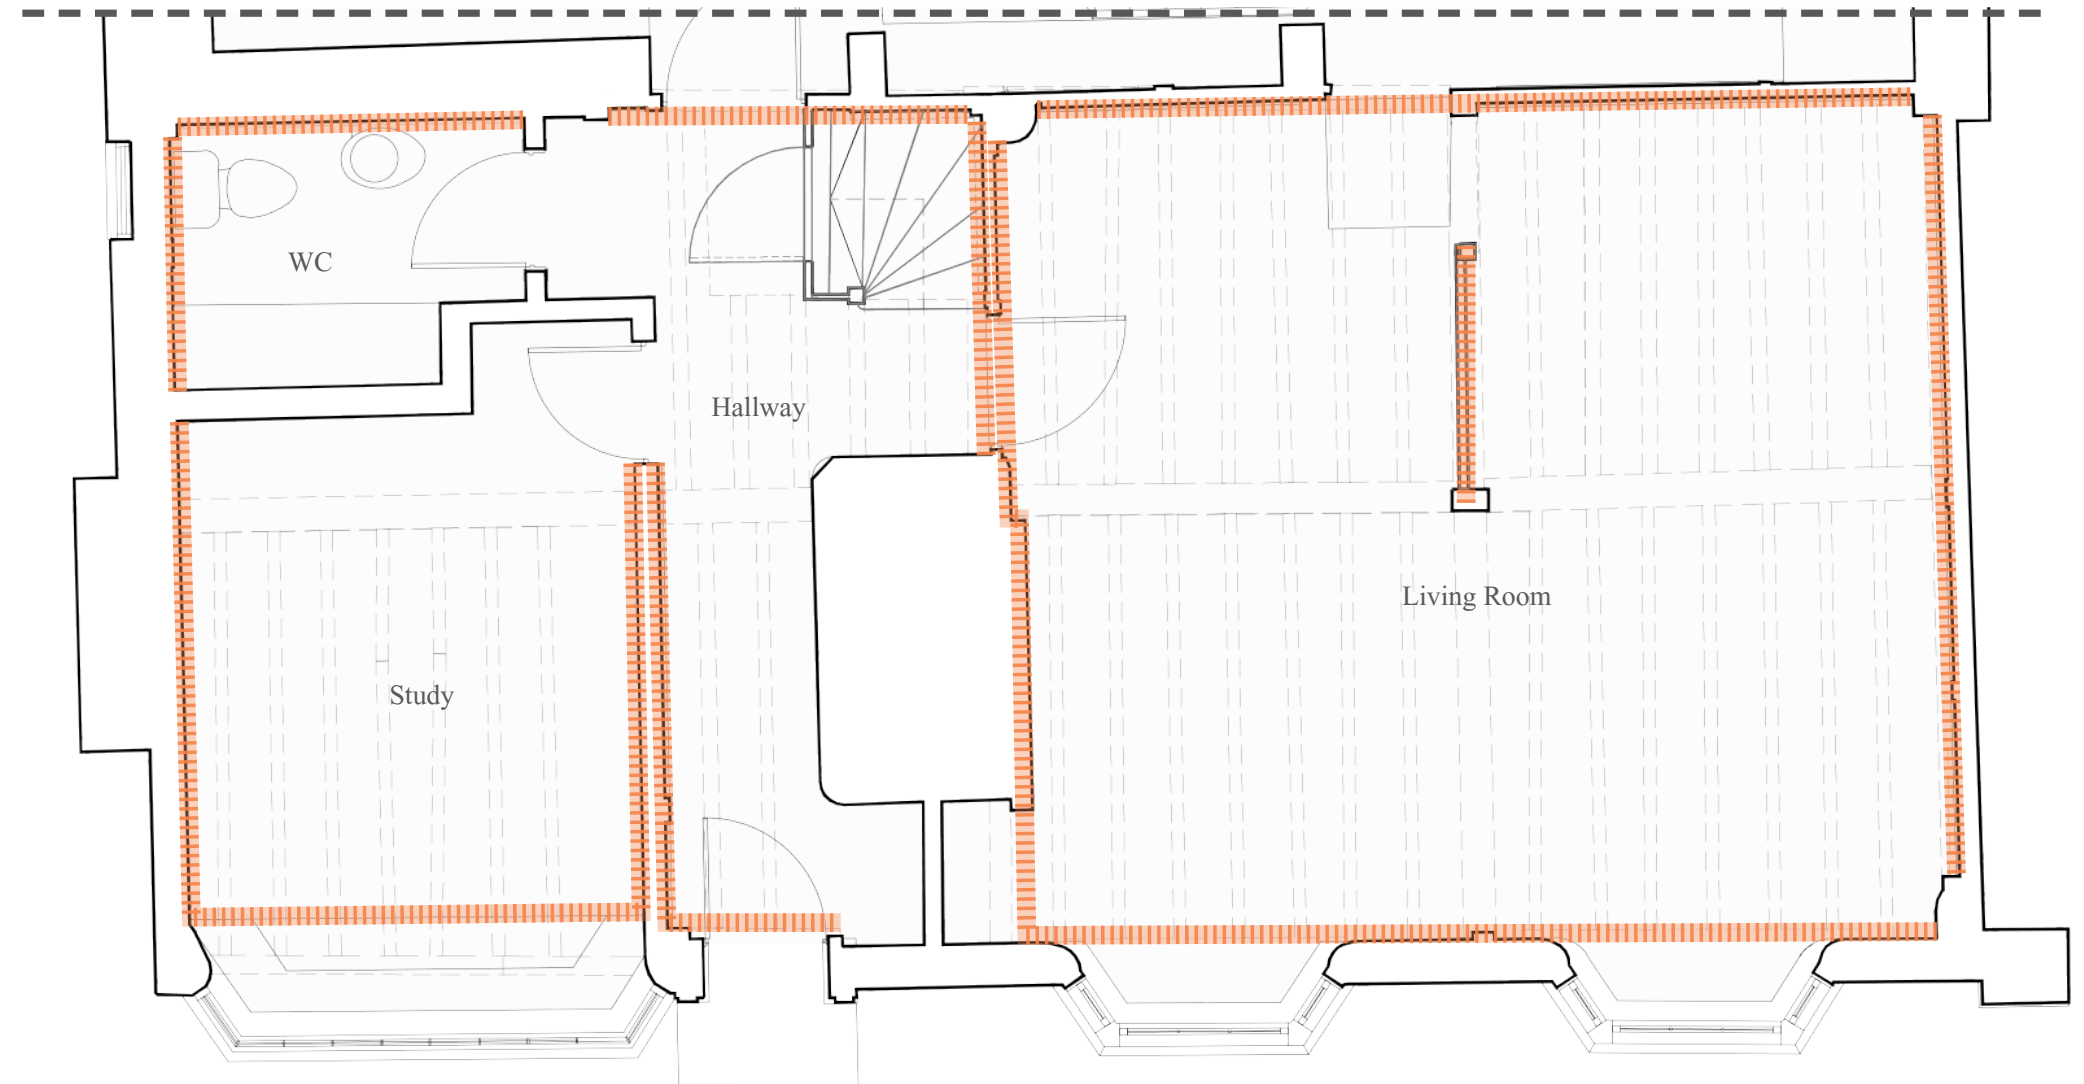
As Implemented ground floor plan showing areas within the ground floor where the walls have been exposed to showcase the historic timber framing.

The reinstatement works have prioritised the use of traditional materials, with inappropriate modern finishes replaced by breathable lime plaster. This ensures compatibility with the historic fabric while allowing the timber frame to remain visible and properly conserved. Previously concealed elements - covered by unsympathetic alterations - have been uncovered, repaired, and integrated into the internal spaces in a manner that better reflects the building's historic character.

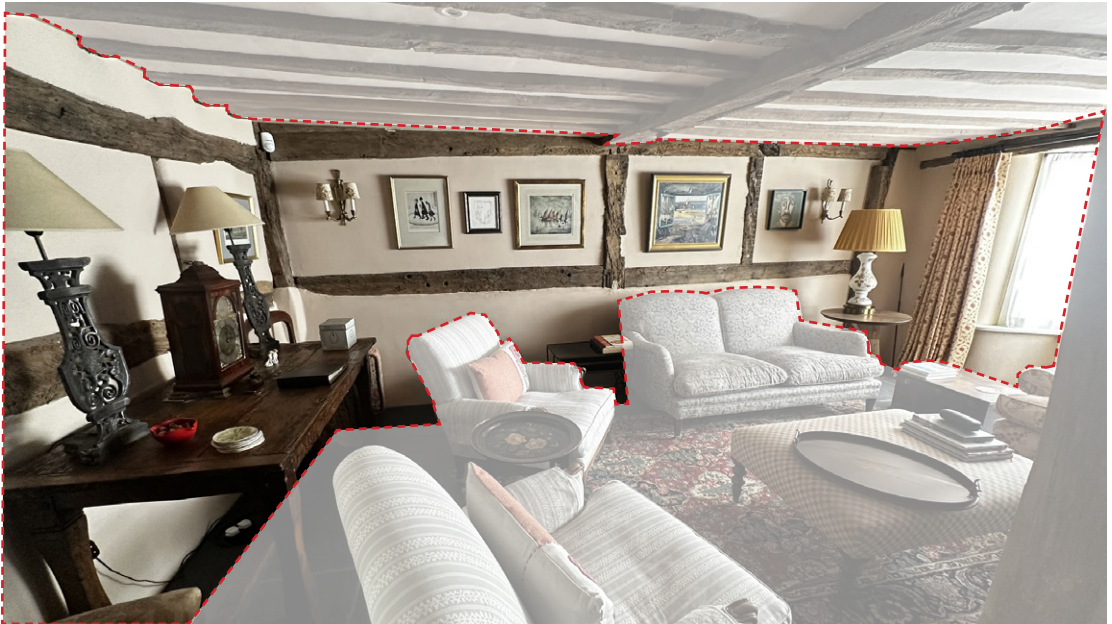
5.

- Key
- Figure 1. East wall
- Figure 2. Gunstock post
- Figure 3. South wall
- Figure 4. West and North wall
- Figure,5 North and West wall

As part of the implemented works, the timber gunstock post has been reinstated using materials and detailing appropriate to the historic fabric. This approach ensures that the structural expression of the frame remains consistent with traditional construction, limiting the use of steel only where strictly necessary for structural stability and long-term preservation. In addition, modern plasterboard finishes have been removed and replaced with lime plaster applied in a more considered and sympathetic manner. The reinstated lime plaster allows the timber framework to be clearly expressed as the primary structural and visual element of the wall, while maintaining a breathable and compatible finish. The improved quality and finish of the plasterwork, alongside the careful cleaning and treatment of the exposed timber, enhances both the clarity and presentation of the historic fabric. The lounge now reveals a comprehensive extent of the timber framing, allowing the structure to be fully appreciated within the space. These works collectively represent a sensitive enhancement of the room, improving its relationship with the building’s historic character and resulting in a clear heritage benefit when compared to the previous condition.

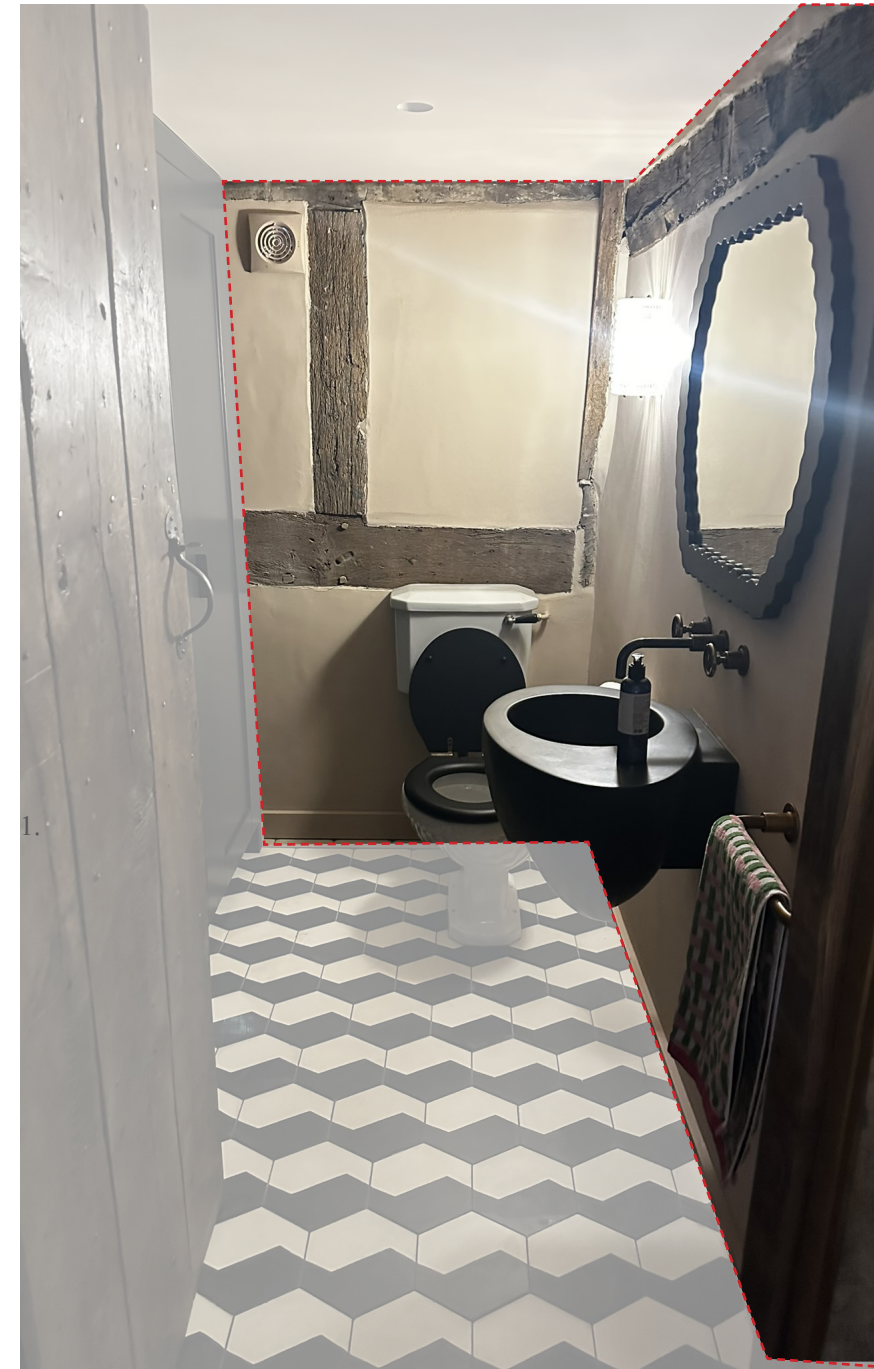
Figure 1. West and South wall

The combination of exposed timber framing and lime plaster finishes creates a simple yet historically responsive space. Overall, the approach preserves and highlights the historic fabric while accommodating modern use, resulting in a considered intervention that contributes positively to the building's heritage significance.

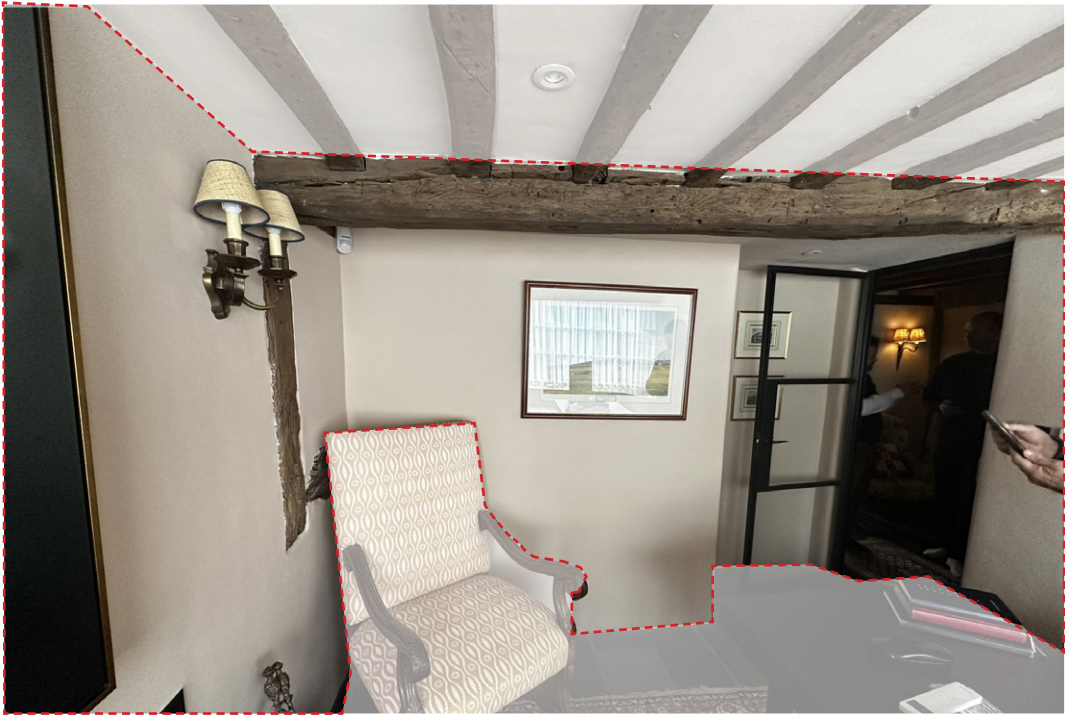
1.  
Key  
Figure 1. South and West wall  
Figure 2. East wall  
Figure 3. South

In addition, the formation and refinement of the chimney breast contributes positively to the space, providing a focal point that is consistent with the building’s historic arrangement. This intervention enhances both the legibility and usability of the room. Overall, the study achieves a balanced integration of historic character and modern use. The works represent a clear enhancement over the previous condition, resulting in a space that better reflects and supports the building’s heritage significance.

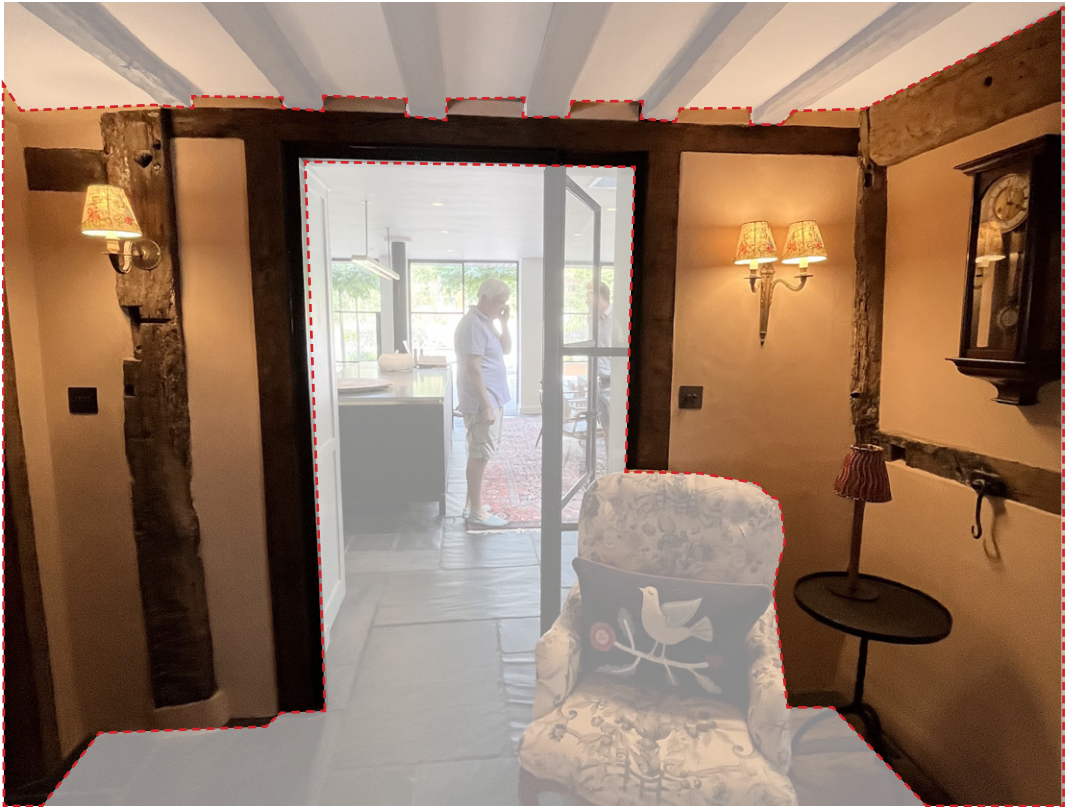
1.  
Key  
Figure 1. West wall  
Figure 2. East wall  
Figure 3. South

As illustrated in the adjacent photographs, the implemented works have resulted in a notable improvement in the preservation and visibility of the historic timber framing when compared to the previous condition. Historic records indicate that prior to the works, the space was characterised by poor-quality finishes and inconsistent material applications, which detracted from the legibility of the original structure—particularly along the south wall. The current scheme has carefully addressed these issues, reinstating appropriate materials and finishes that better preserve the original structural composition and historic fabric of the building. The exposed timber framing is now clearly visible upon entry, allowing the construction and character of the building to be immediately understood and appreciated.
