## PART VIII | JUSTIFICATION

## JUSTIFICATION

107 HIGH STREET, LINDFIELD, HAYWARDS HEATH, RH16 2HR

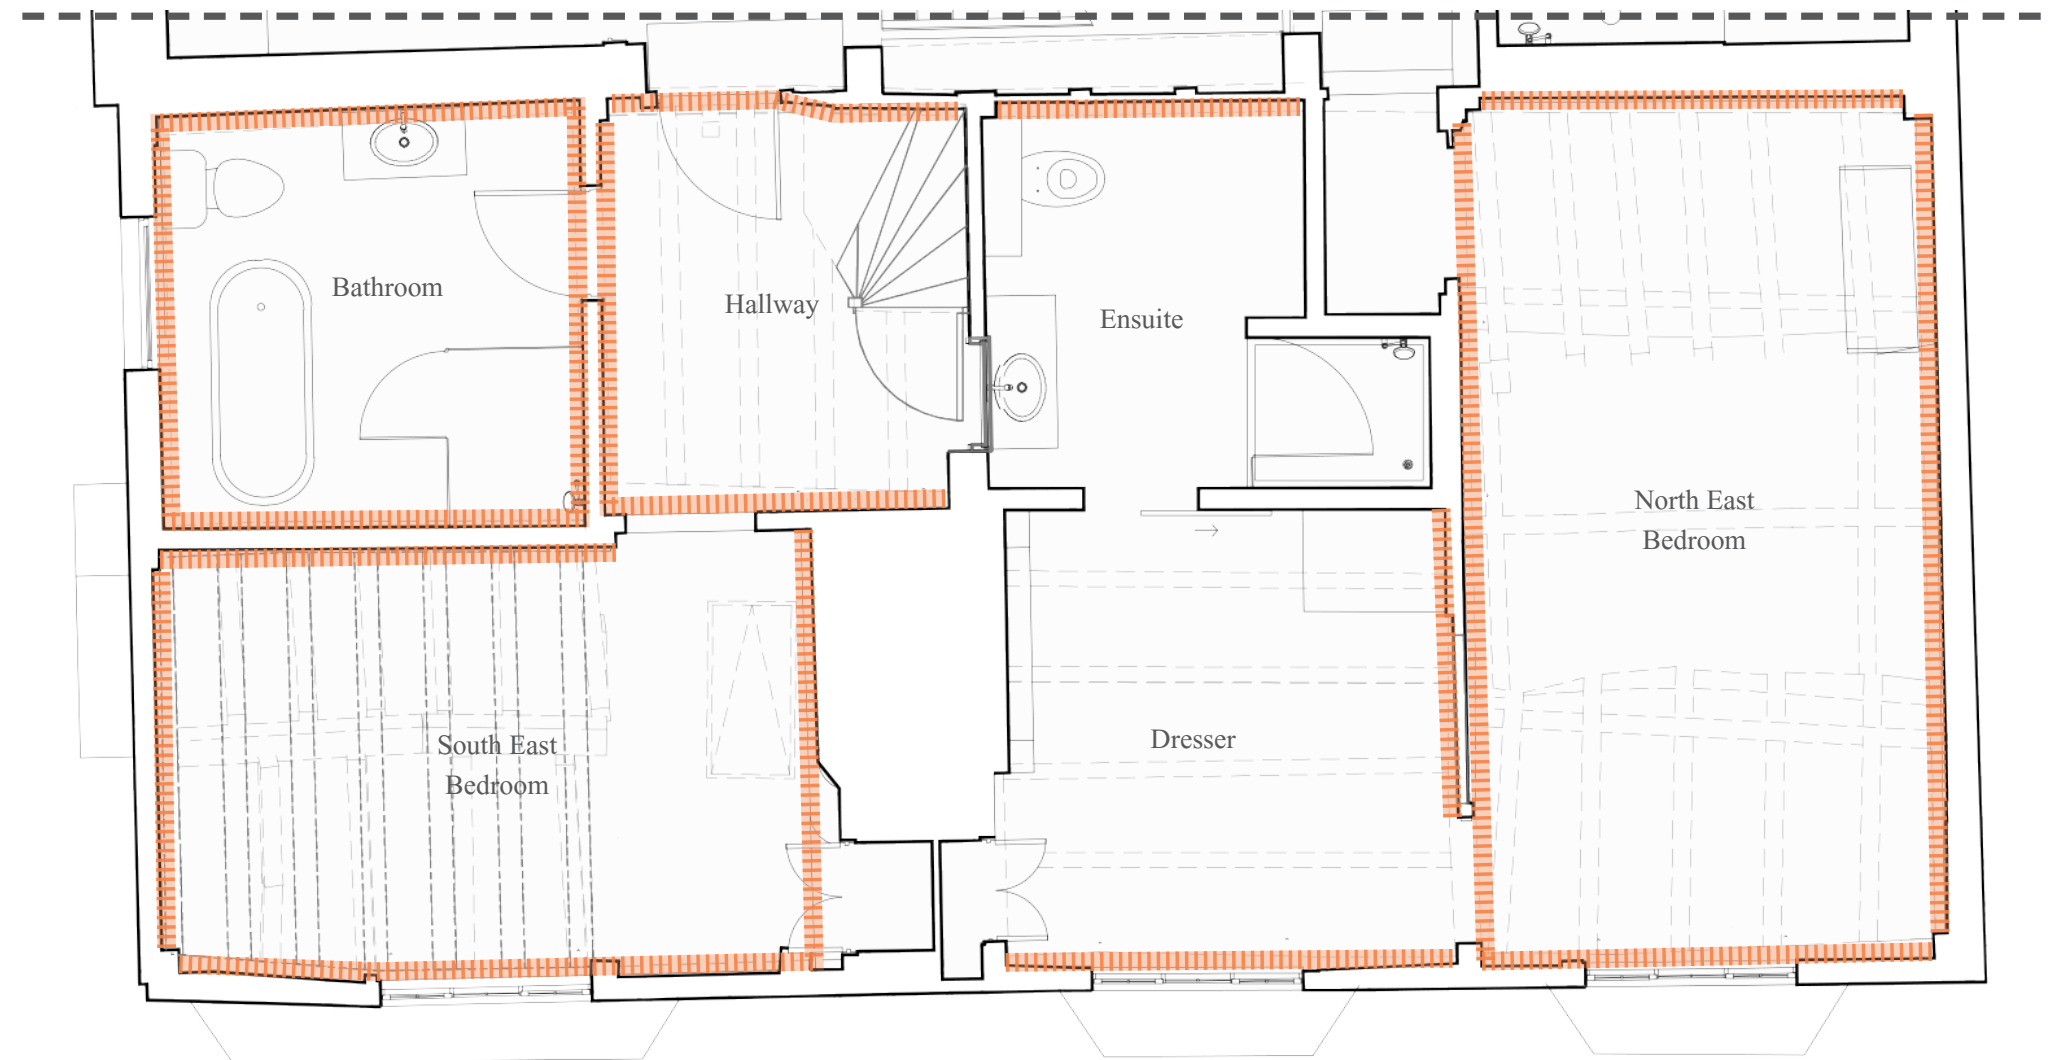
As Implemented ground floor plan showing areas within the first floor where the walls have been exposed to showcase the historic timber framing.

The implemented works have carefully addressed these issues, reinstating a more appropriate and coherent treatment that reveals and preserves the historic timber framework. As a result, the first floor now provides a significantly improved understanding of the building's construction and spatial character.

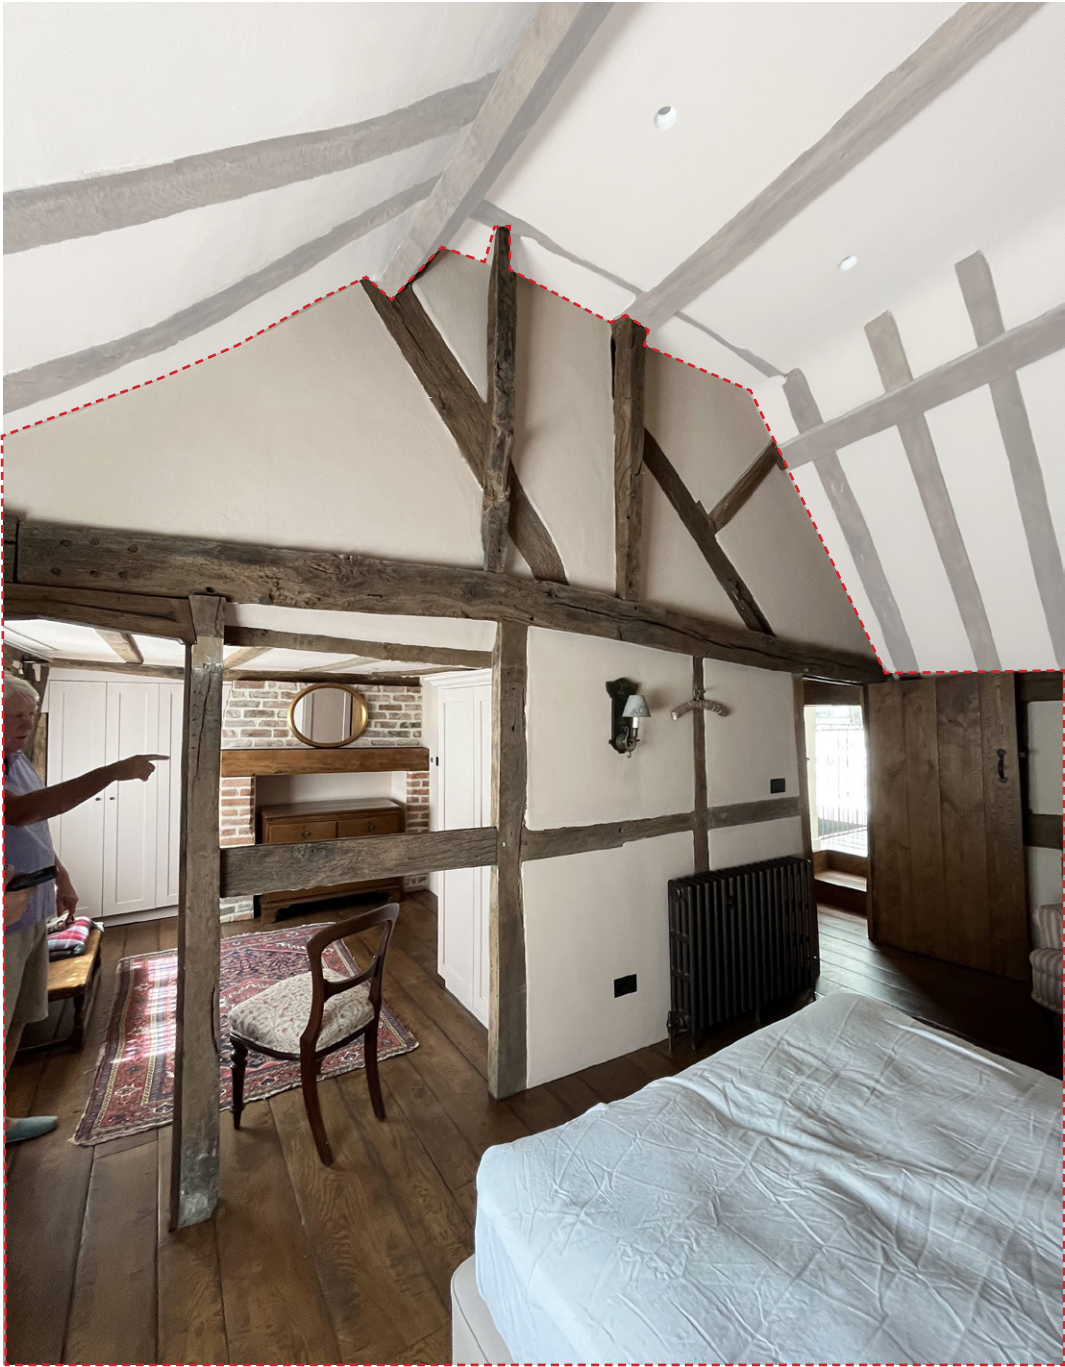
- Key
- Figure 1. South wall
  - Figure 2. North wall
  - Figure 3. East and North wall
  - Figure 4. South, West and North Walls

The partition wall to the adjoining dressing area has been opened up to fully expose the timber framing, enabling a continuous reading of the structure across the space. New interventions have been carefully positioned to avoid obscuring key elements, ensuring the timber frame remains the dominant feature. Lime plaster has been reinstated in a consistent and sympathetic manner, providing a clear contrast to the exposed timber and improving the overall legibility of the wall construction.
