**CUCKFIELD GOLF CENTRE**

**DRAINAGE STATEMENT**

Tumu Consulting have been appointed by Arena Global Management Ltd (AGM) to produce a drainage design to discharge Condition 5 and 6 of the Appeal Decision, REF APP/D3830/W/22/3310444. This development in comprises *“Change of use of land to storage in association with golf club and proposed erection of a storage barn for equipment and vehicles incorporating staff welfare facilities”* at Cuckfield Golf Centre, Staplefield Rd, Cuckfield, Haywards Heath, RH17 5HY.

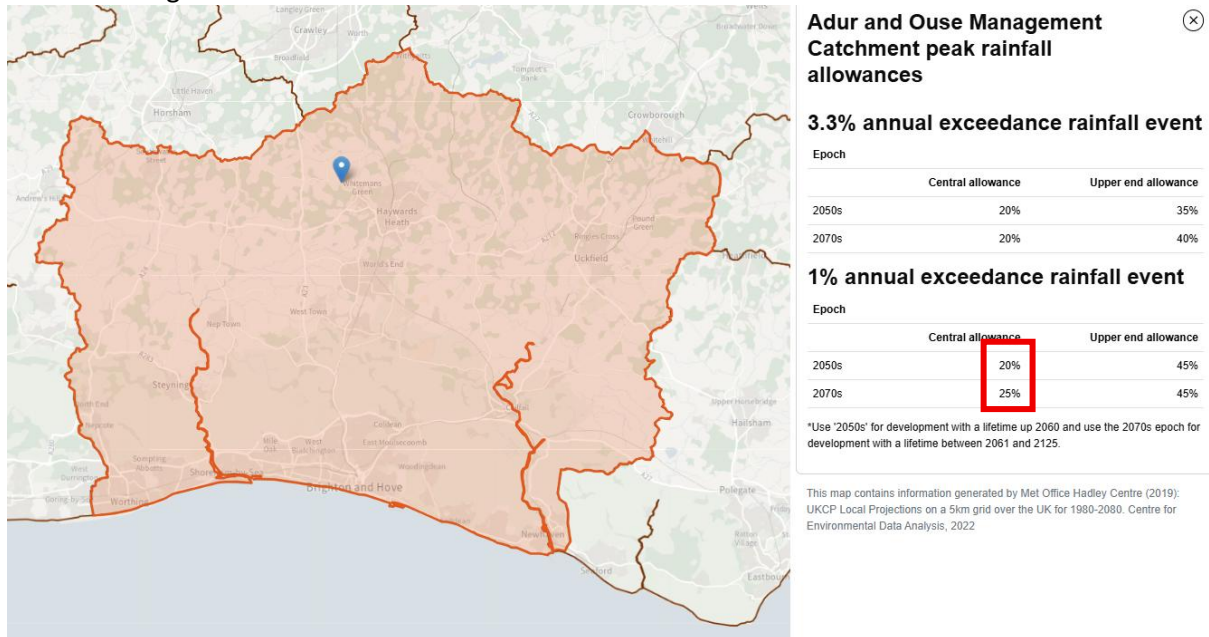
When developed (approximately 2025), the end of life can be estimated to be 2075. According to government guidance, a development with a design life concluding between 2061 and 2100 should use the central allowance for the 2070's epoch when considering peak rainfall climate change allowances. For the Adur and Ouse Management Catchment Area, the climate change allowances to consider should be 25% in the 1 in 100 year rainfall event, and 20% in the 30 year rainfall event. This is shown in Figure 1.

Figure 1 Adur and Ouse Management Catchment Peak Rainfall Allowances.

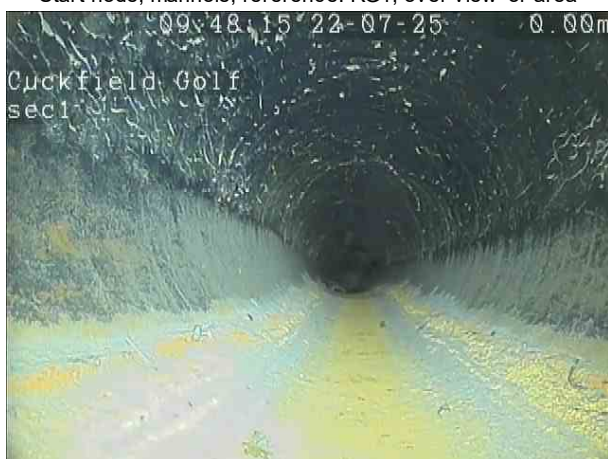
74d5215e-4af2-4574-927f-80b3f6335e12.png, 00:00:22, 0.00 m

Water level, 0% of the vertical dimension

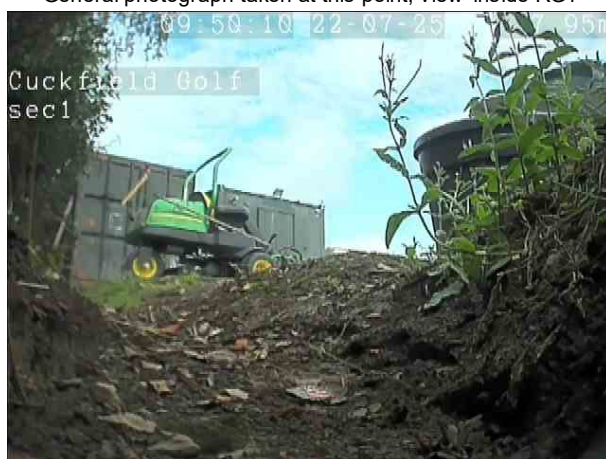
5eb6c42b-f8c3-4c8a-a2ea-ca089736e00a.png, 00:01:02, 8.00 m

Finish node, manhole, reference: Ditch A, ditch

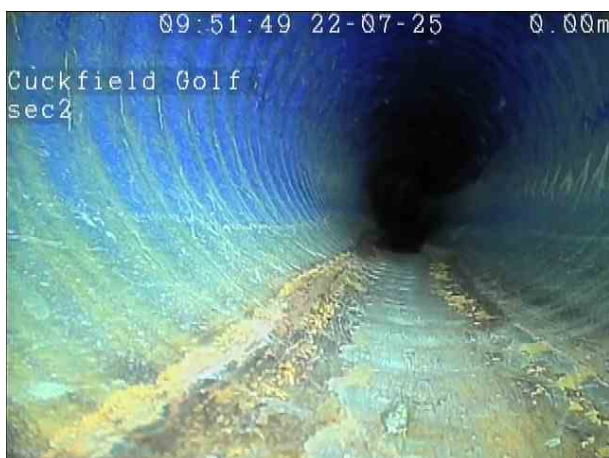
a4edd118-7aec-4612-b533-0756576d6adc.png, 00:00:04,  
0.00 m

Water level, 0% of the vertical dimension

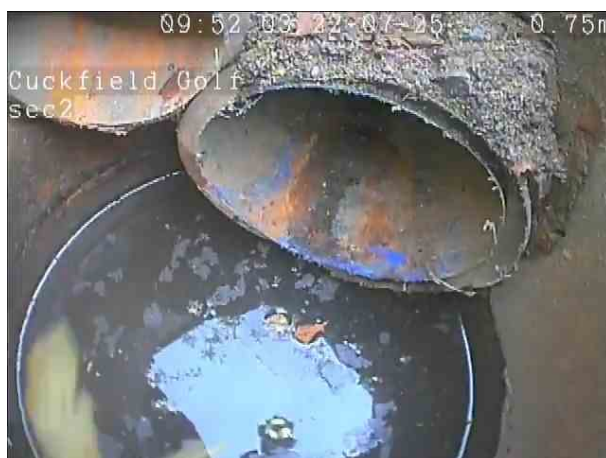
df3c7b7d-7d34-4e38-b4e3-a23fd54b943e.png, 00:00:17,  
0.00 m

General photograph taken at this point, inlet pipe

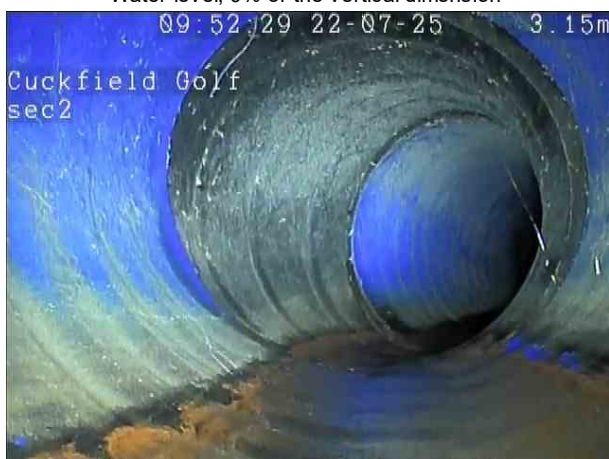
d1c4c6e6-1e47-4746-8f74-72e22359c63c.png, 00:00:44,  
3.50 m

Line deviates right, sharp bend

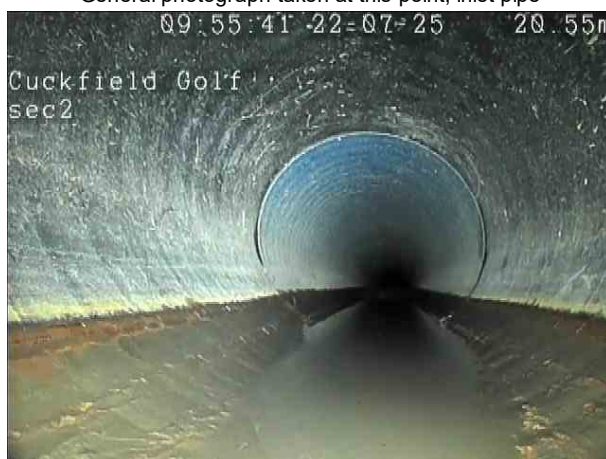
7ccfa104-20f5-43ec-bcc1-46658108f569.png, 00:01:47,  
20.60 m

Water level, 15% of the vertical dimension

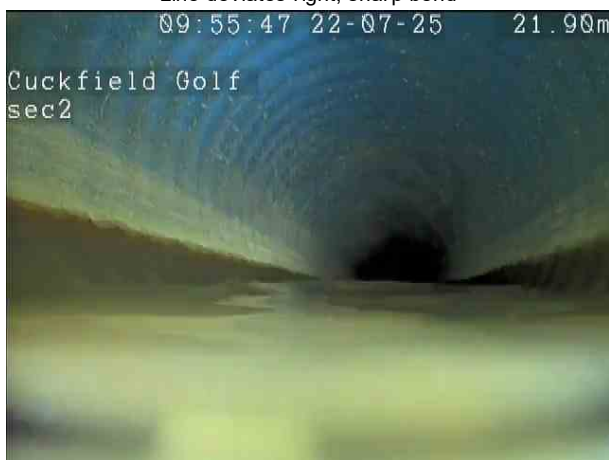
88b150ca-7647-46ac-bb2d-82cbb3f4845b.png, 00:01:47,  
22.00 m

Water level, 20% of the vertical dimension

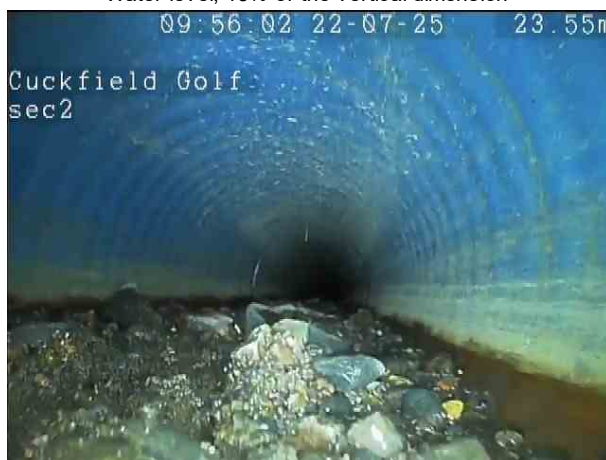
88a2c1d7-2060-4878-8fec-5230f2101c15.png, 00:02:02,  
23.50 m

Settled deposits, hard or compacted, 30% cross-sectional

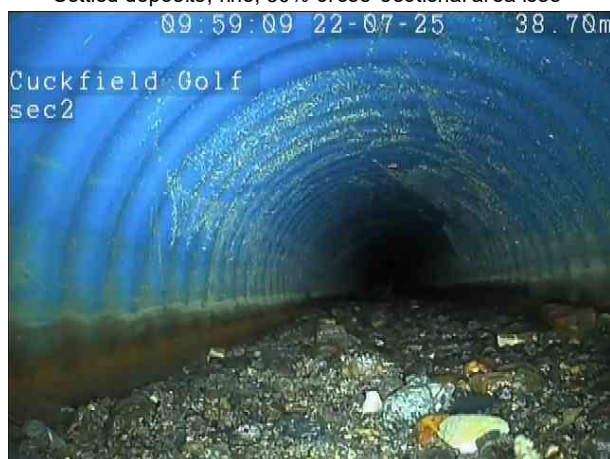
31119ecc-f182-46f0-9791-6ba20e9477e2.png, 00:03:13,  
38.80 m

Settled deposits, hard or compacted, 35% cross-sectional

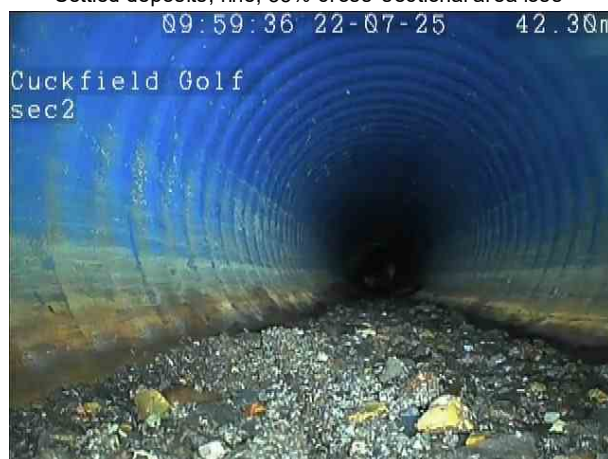
ee34ca2c-eb34-48f7-9efe-f92a0539bac2.png, 00:03:41,  
42.50 m

Settled deposits, hard or compacted, 25% cross-sectional

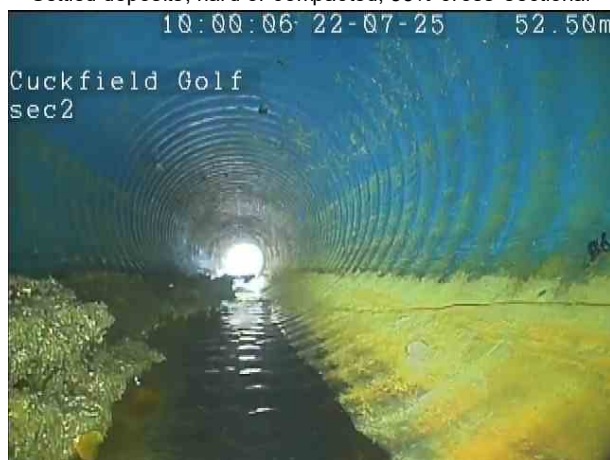
5c3cd240-2376-4013-a325-8accb645e568.png, 00:04:11,  
52.50 m

Settled deposits, fine, 20% cross-sectional area loss

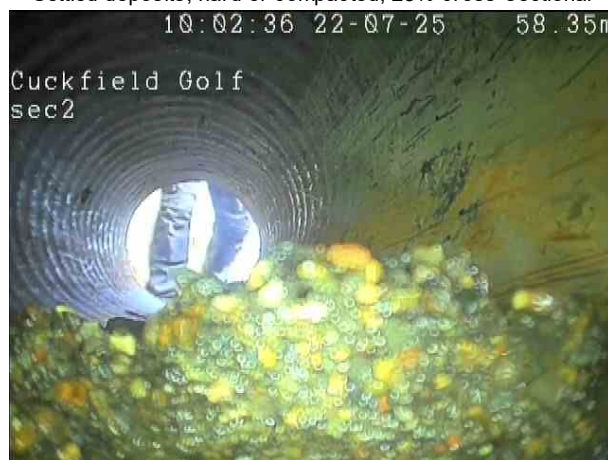
e9bcaed8-b34f-4a69-b927-3ebd2bedef4d.png, 00:06:16,  
58.40 m

Settled deposits, fine, 20% cross-sectional area loss

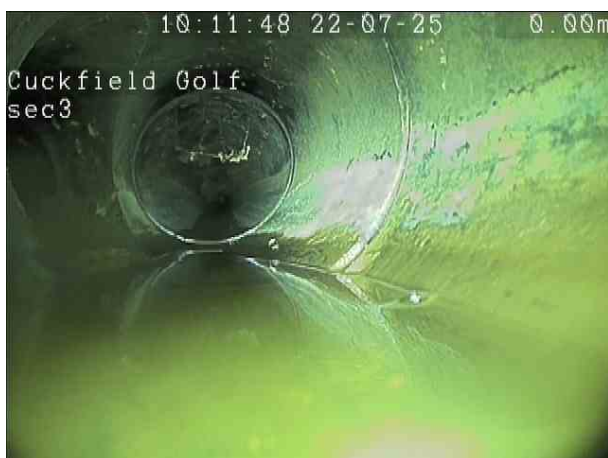
03b2521a-d32c-453b-a177-ab90a2747975.png, 00:00:26,  
0.00 m

Water level, 10% of the vertical dimension

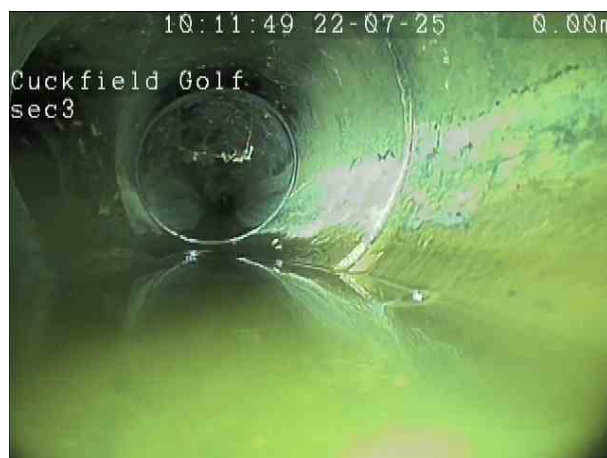
6f45082e-e59e-478d-a8fa-897857b64fbb.png, 00:00:26,  
0.70 m

Junction at 9 o'clock, 150mm dia, serves gully

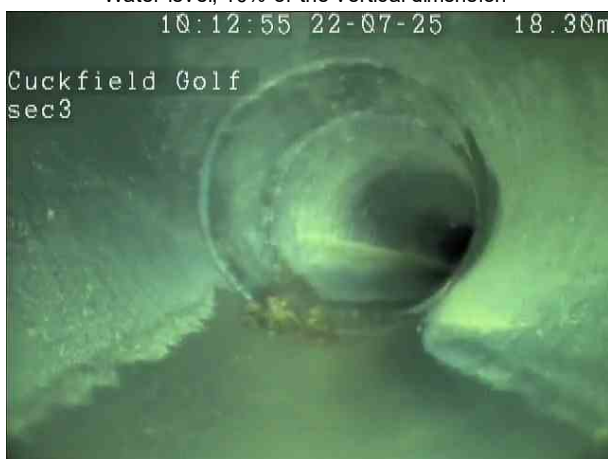
e6ff2a97-b2bb-4e16-b115-d03482d78be5.png, 00:01:33,  
18.50 m

Line deviates right, slight bend

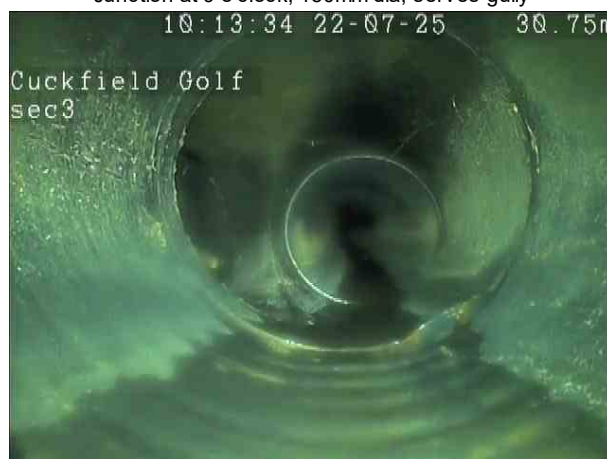
5aa9241a-334d-42bb-ae4c-3b8ae218ff69.png, 00:02:11,  
31.00 m

Junction at 9 o'clock, 150mm dia

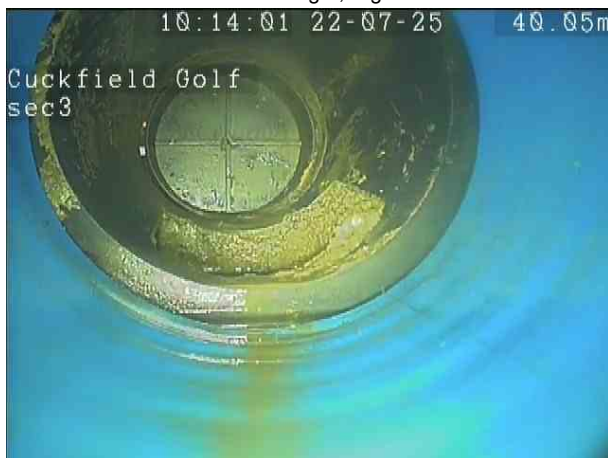
388beecd-281c-4c46-85f8-ed110143861d.png, 00:02:38,  
40.30 m

General photograph taken at this point, gully trap view

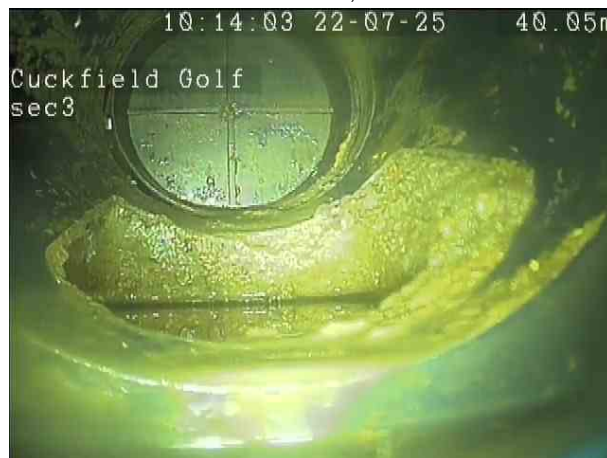
9a444b8d-a24a-4fb8-a809-d6ef139f8748.png, 00:02:40,  
40.50 m

Finish node, manhole, reference: RG2, Road Gully

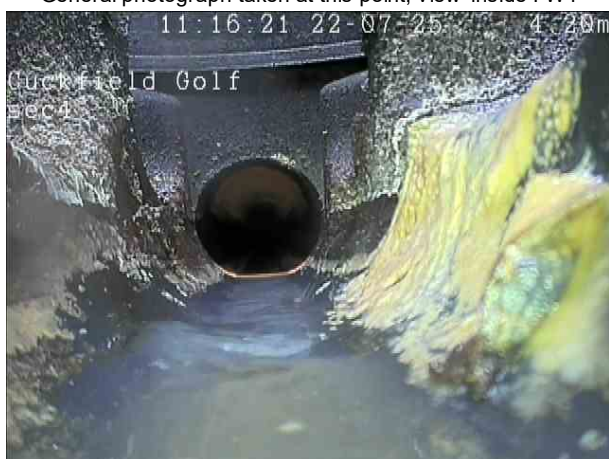
ac623c97-fdfd-42ed-b9e1-2b0d8381fd4f.png, 00:01:17,  
4.30 m

Finish node, manhole, reference: FW3

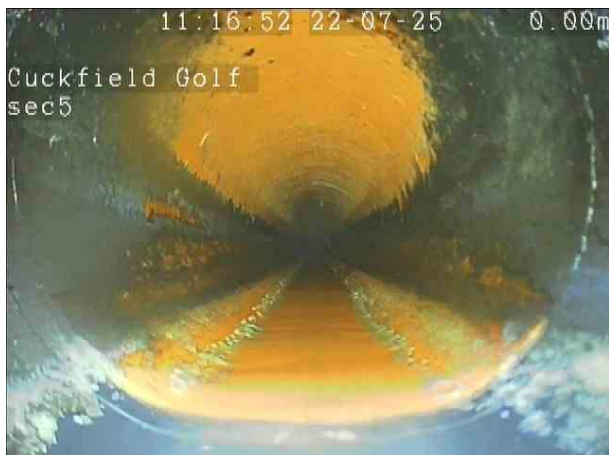
5305fd44-eca4-487d-8fef-add9c27a6ee5.png, 00:00:01,  
0.00 m

Water level, 0% of the vertical dimension

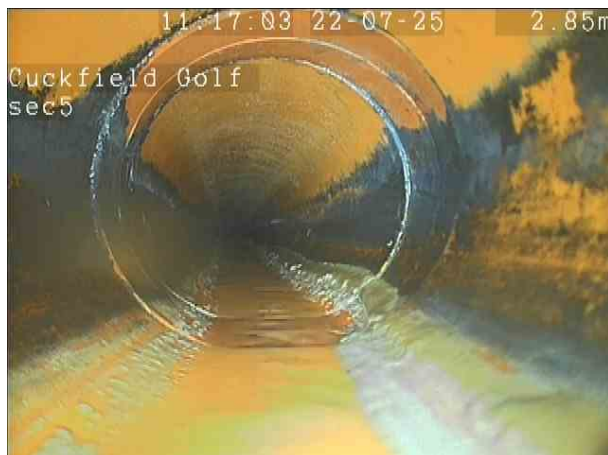
8e19c43c-1895-46db-befb-0f910d01ef53.png, 00:00:12,  
2.90 m

Line deviates left, slight bend

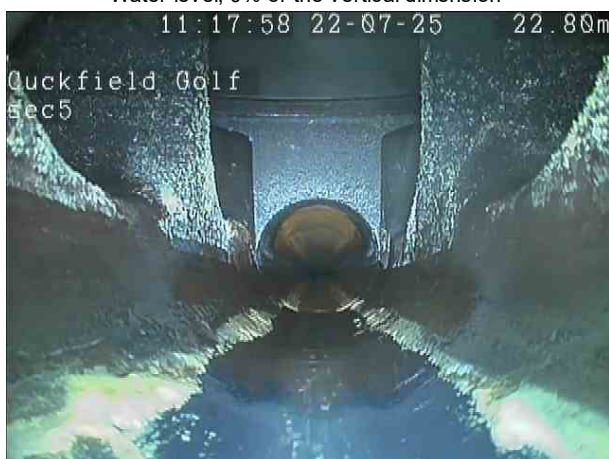
c52392b0-842e-422b-9f82-add555c06cc7.png, 00:01:08,  
22.80 m

Finish node, manhole, reference: FW2, buried manhole

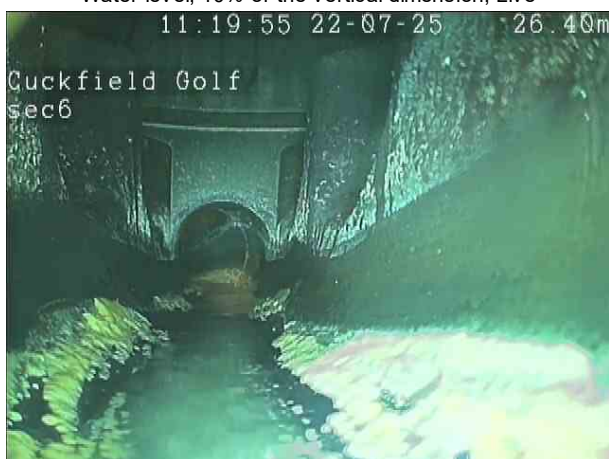
a9d6362a-80fd-49e1-8cc9-372bc11954c3.png, 00:01:11,  
26.50 m

Finish node, manhole, reference: FW1

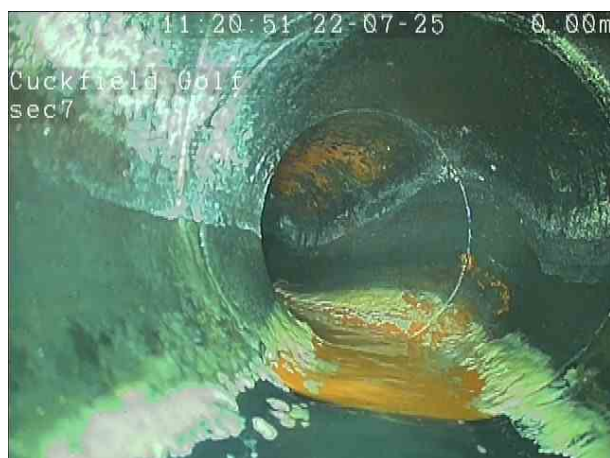
fb1cad0e-8387-4100-882b-ea01738581b2.png, 00:00:00,  
0.00 m

Water level, 5% of the vertical dimension, Live

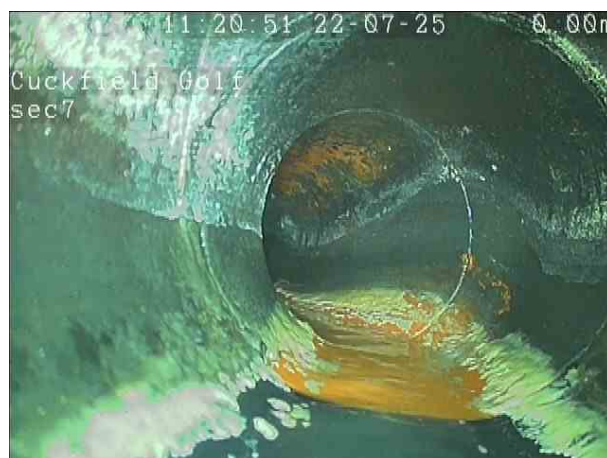
8103e7b3-e2fd-4822-a7e3-a4a5562fa1e2.png, 00:00:00,  
0.20 m

Line deviates left, sharp bend

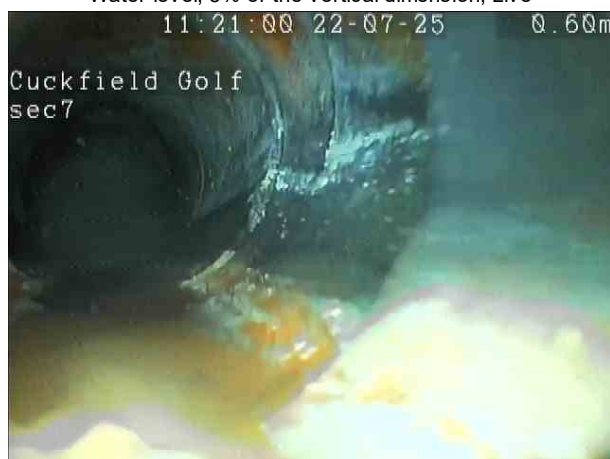
67716f44-f2f0-4ddf-91ff-c7e0a48b0ac2.png, 00:00:09, 0.70  
m

Line deviates left, sharp bend

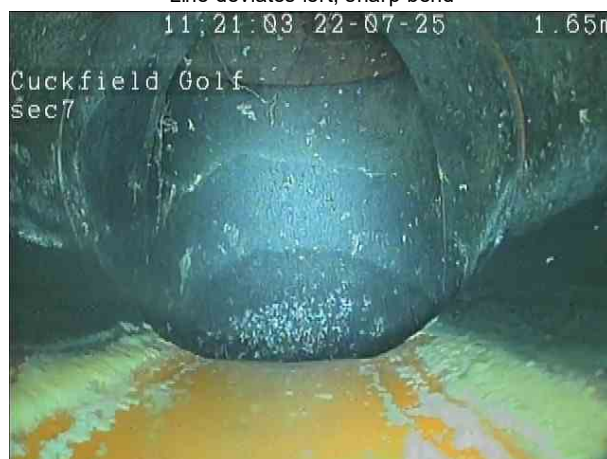
887c1253-bf89-4004-9db2-5562cd81f78d.png, 00:00:12,  
1.60 m

General photograph taken at this point, dipper pipe view

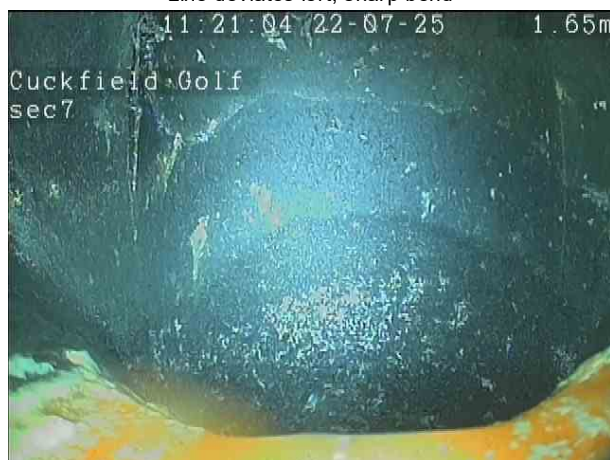
759bac1f-1cb7-4994-8361-0eb5bf734a80.png, 00:00:13,  
1.70 m

Finish node, manhole, reference: Treatment

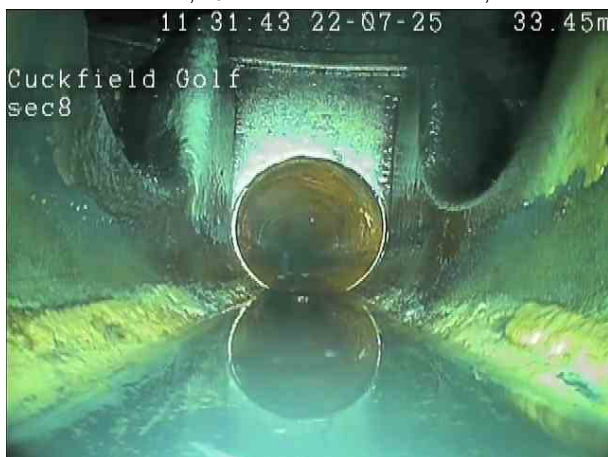
8b1e1425-0517-4f9f-834c-4cefb475c872.png, 00:02:40,  
33.50 m

Finish node, manhole, reference: FW5

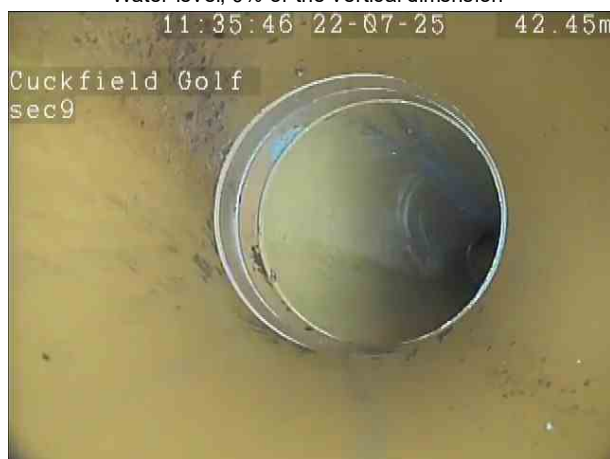
3697f238-552e-4284-8403-66d068a5303f.png, 00:02:06,  
42.50 m

Line deviates right, slight bend

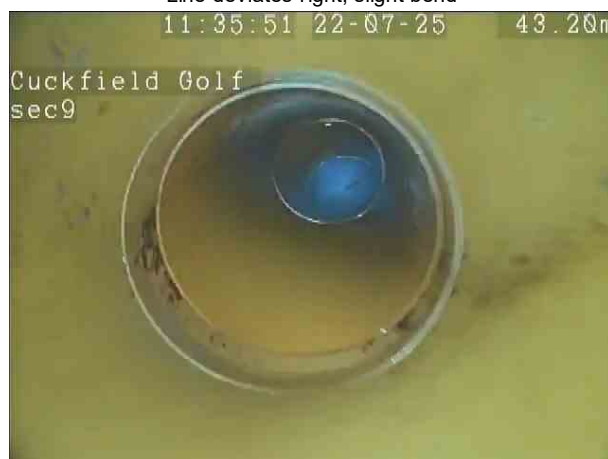
9e915fd2-1c0e-4434-82ac-976750f6493b.png, 00:02:11,  
43.30 m

Line deviates up, slight bend

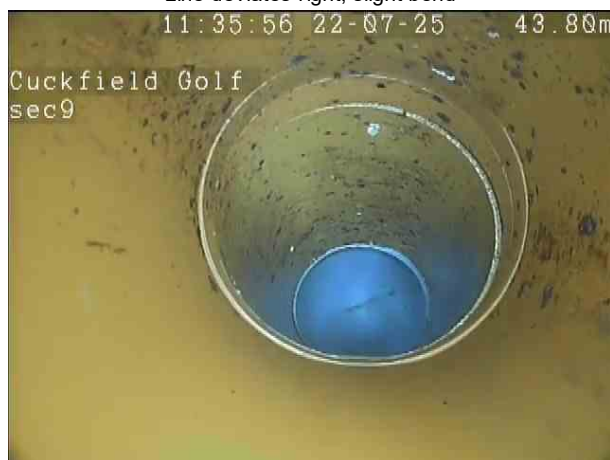
d26982e9-f13b-4297-b9c8-ab53bb30c3a6.png, 00:02:15,  
43.90 m

General photograph taken at this point, line straight

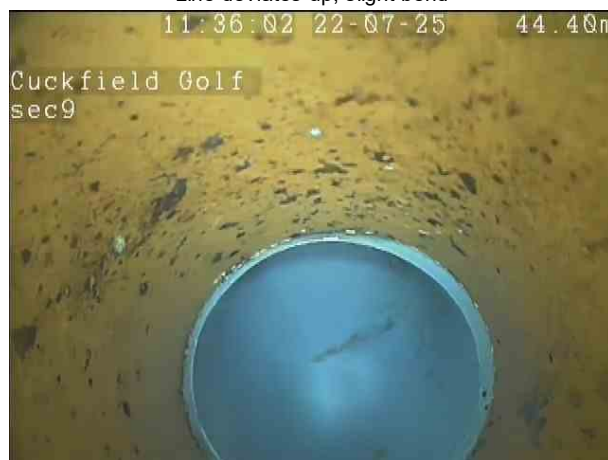
a76486c8-5073-4d95-8ba5-6240439f064c.png, 00:02:21,  
44.40 m

Line deviates up, base bend

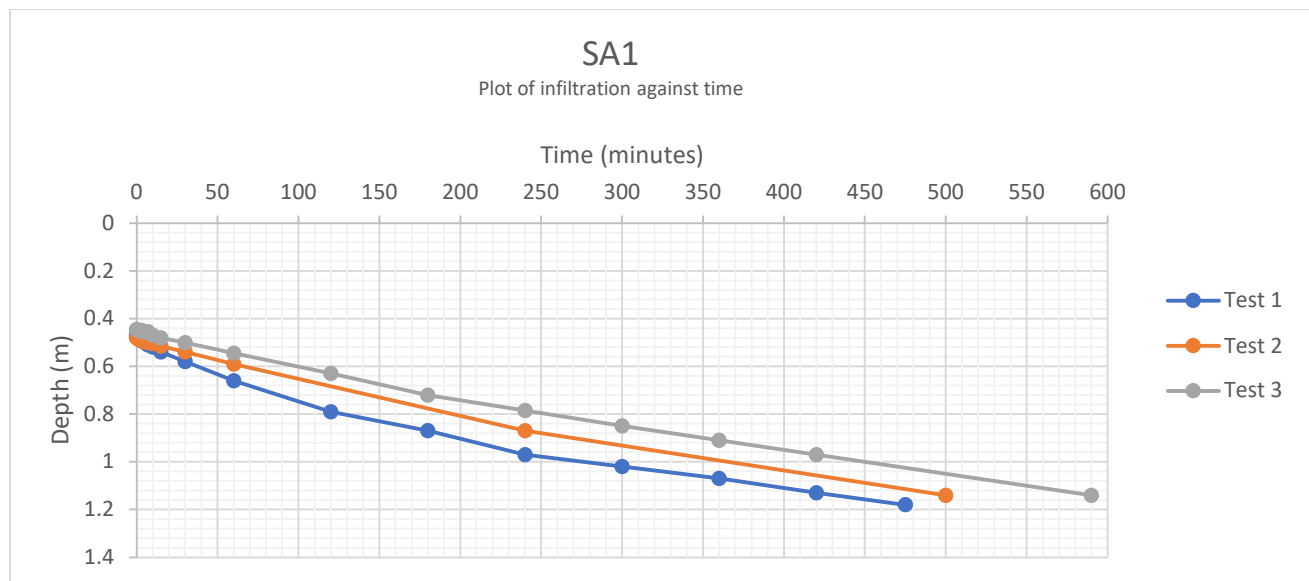
| | Test 1 (26.06.25) | Test 2 (26.06.25) | Test 3 (27.06.25) |
|---|---|---|---|
| Infiltration rate, $f$ (m/s) | $6.11 \times 10^{-6}$ m/s | $6.11 \times 10^{-6}$ m/s | <b><math>5.29 \times 10^{-6}</math> m/s</b> |

No groundwater was encountered in the pit.  
Weather was sunny.  
Pit was dug with a 8T Excavator.  
Pit was filled using a 1000Ltr bowser.  
Pit dimensions: **L 1.30m x W 0.56m x D 1.39m**  
NGR: **TQ 29559 25979**  
Slowest Infiltration rate is as above  **$5.29 \times 10^{-6}$  m/s**

As explained in the geology and hydrogeology section, soakaways will be an unsuitable drainage receptor for the drainage network due to the failure of one test pit and the low infiltration rate recorded in the other during BRE365 testing.

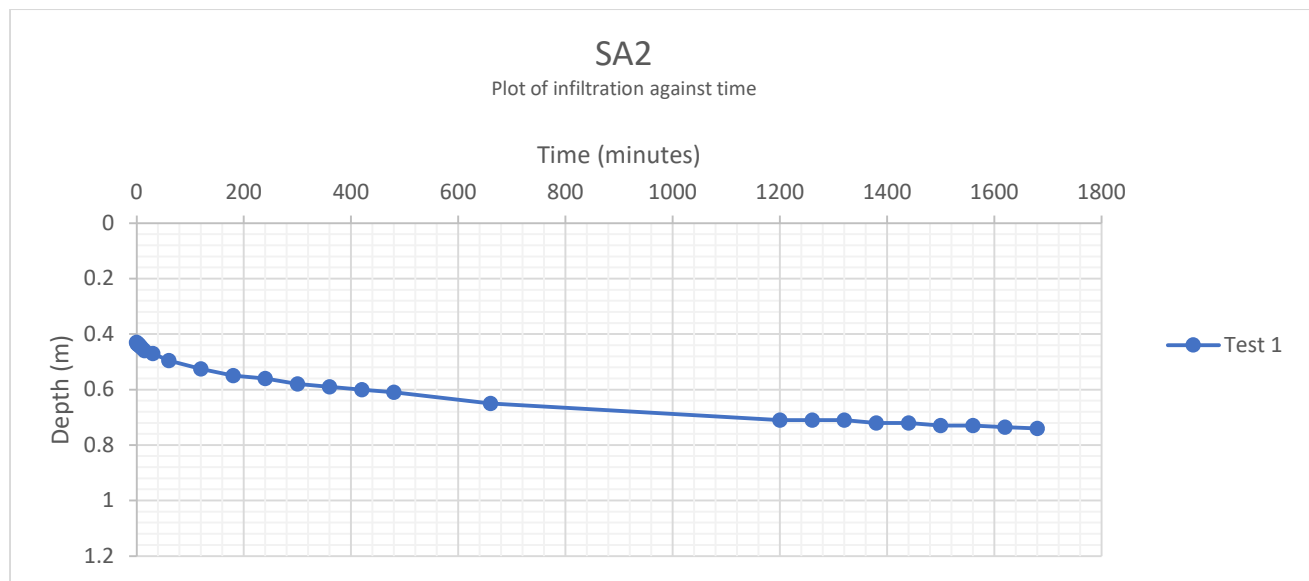
| | Test 1 (26.06.25) | Test 2 | Test 3 |
|---|---|---|---|
| Infiltration rate, $f$ (m/s) | NA | - | - |

**Unable to calculate an infiltration rate due to insufficient drainage.**

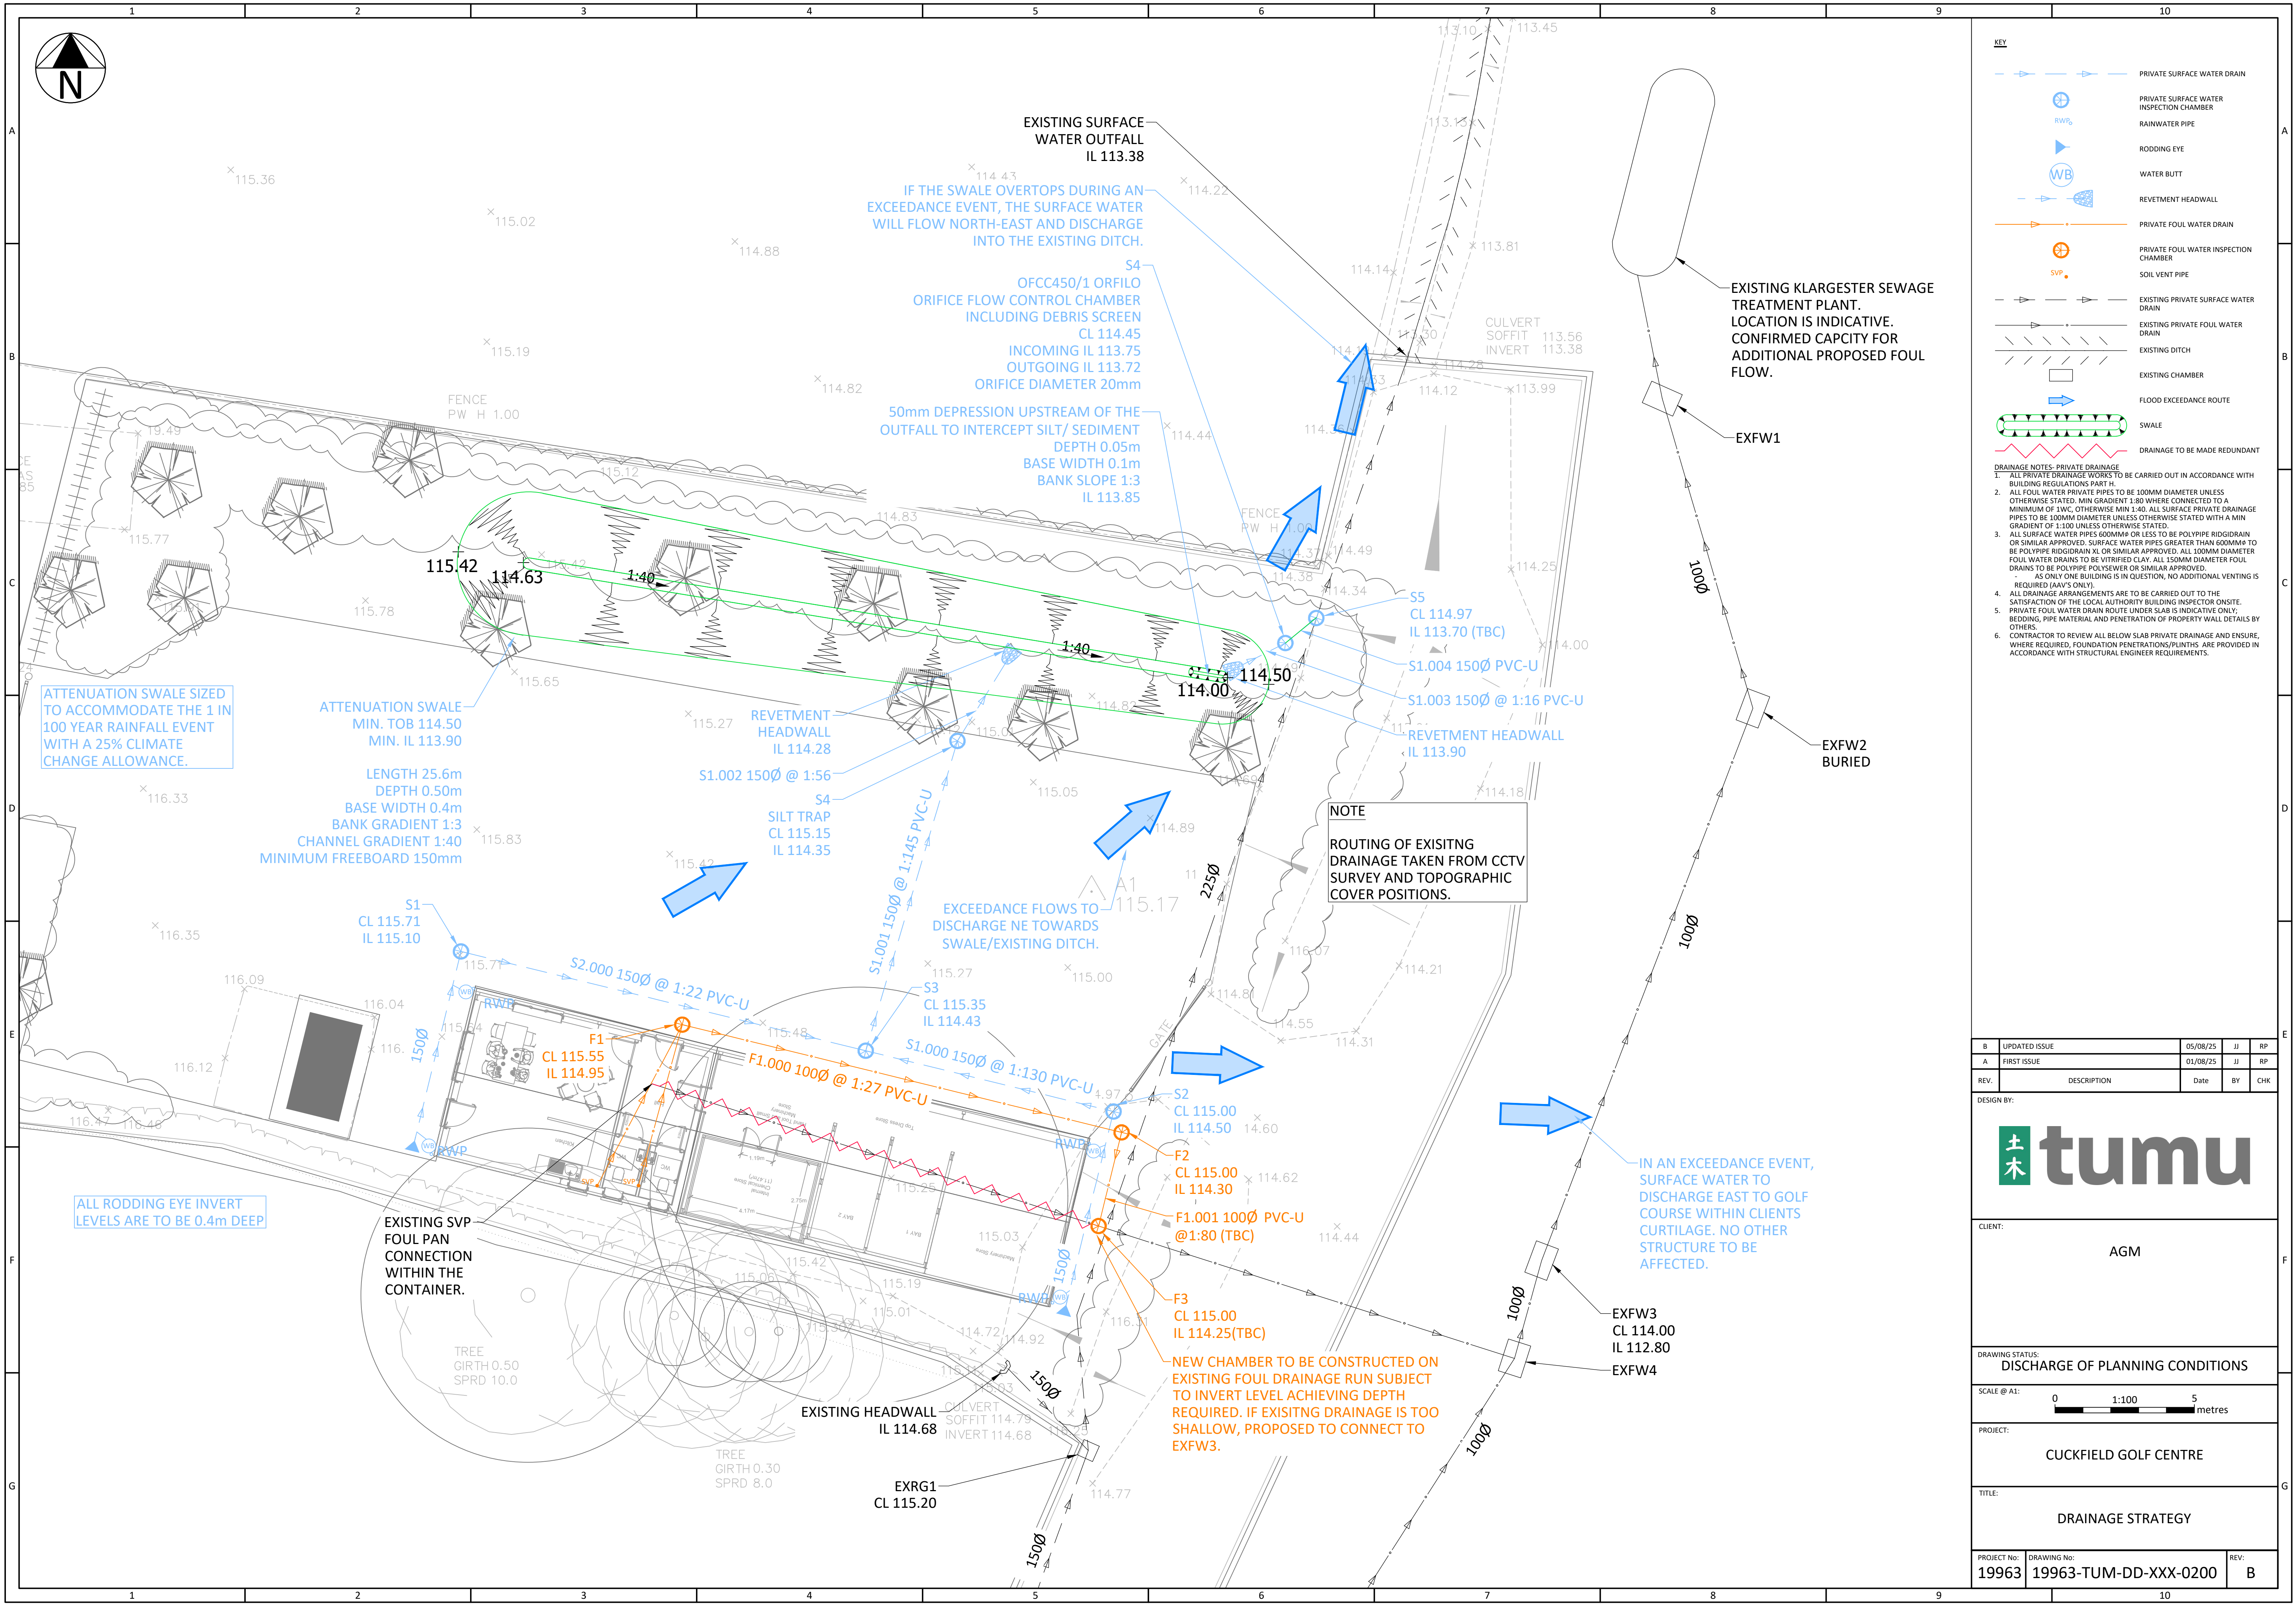
#### **Drainage Strategy**

- PRIVATE SURFACE WATER DRAIN
- PRIVATE SURFACE WATER INSPECTION CHAMBER
- RAINWATER PIPE
- RODDING EYE
- WATER BUTT
- REVTMENT HEADWALL
- PRIVATE FOUL WATER DRAIN
- PRIVATE FOUL WATER INSPECTION CHAMBER
- SOIL VENT PIPE
- EXISTING PRIVATE SURFACE WATER DRAIN
- EXISTING PRIVATE FOUL WATER DRAIN
- EXISTING DITCH
- EXISTING CHAMBER
- FLOOD EXCEEDANCE ROUTE
- SWALE
- DRAINAGE TO BE MADE REDUNDANT

If the drainage systems capacity is exceeded, or the drainage system fails, any exceedance flows will follow the natural contours of the land. Exceedance flows from the swale will discharge north-east via overland flow into the northern ditch. Overland flows from the drainage elements around the storage barn will for the majority discharge into the swale while some will discharge eastwards into the fields. Both routes do not increase flood risk for any other structures or properties.
