## Optera Structural Solutions

### SOW OPT-9332 Agreement to install a root barrier for Sedgwick.

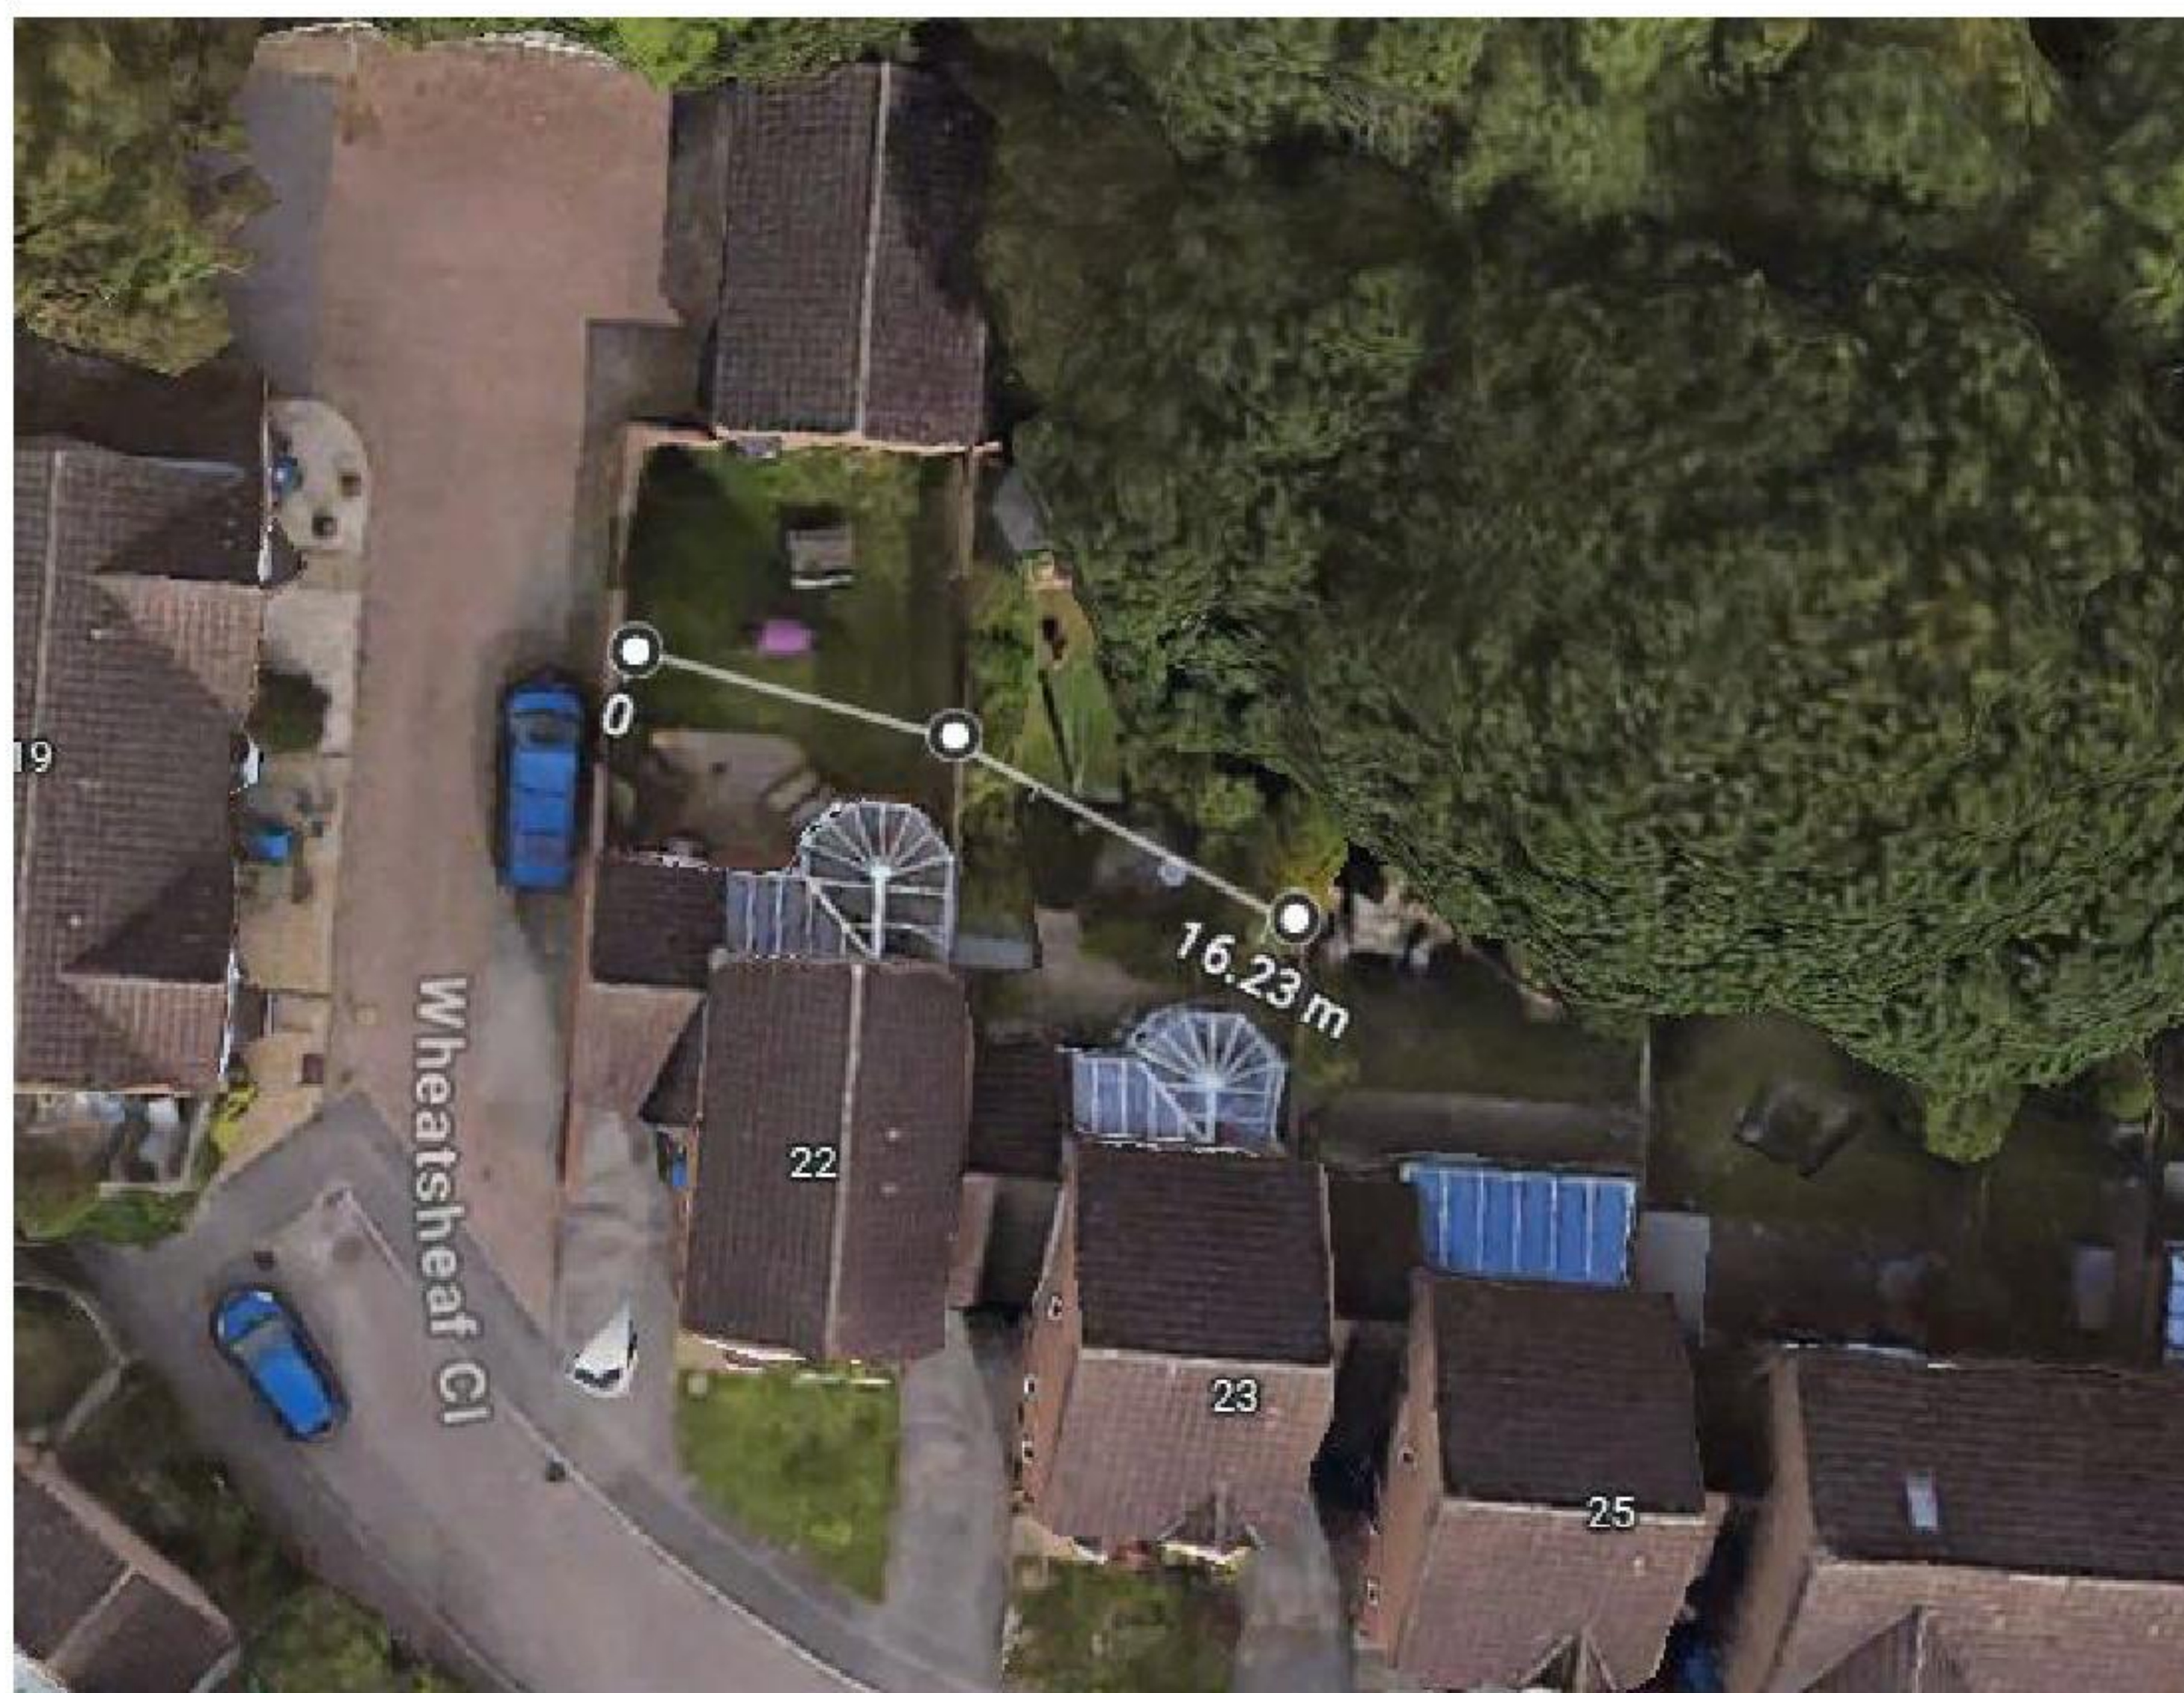
Aerial plan indicating proposed 18m length and alignment of barrier.

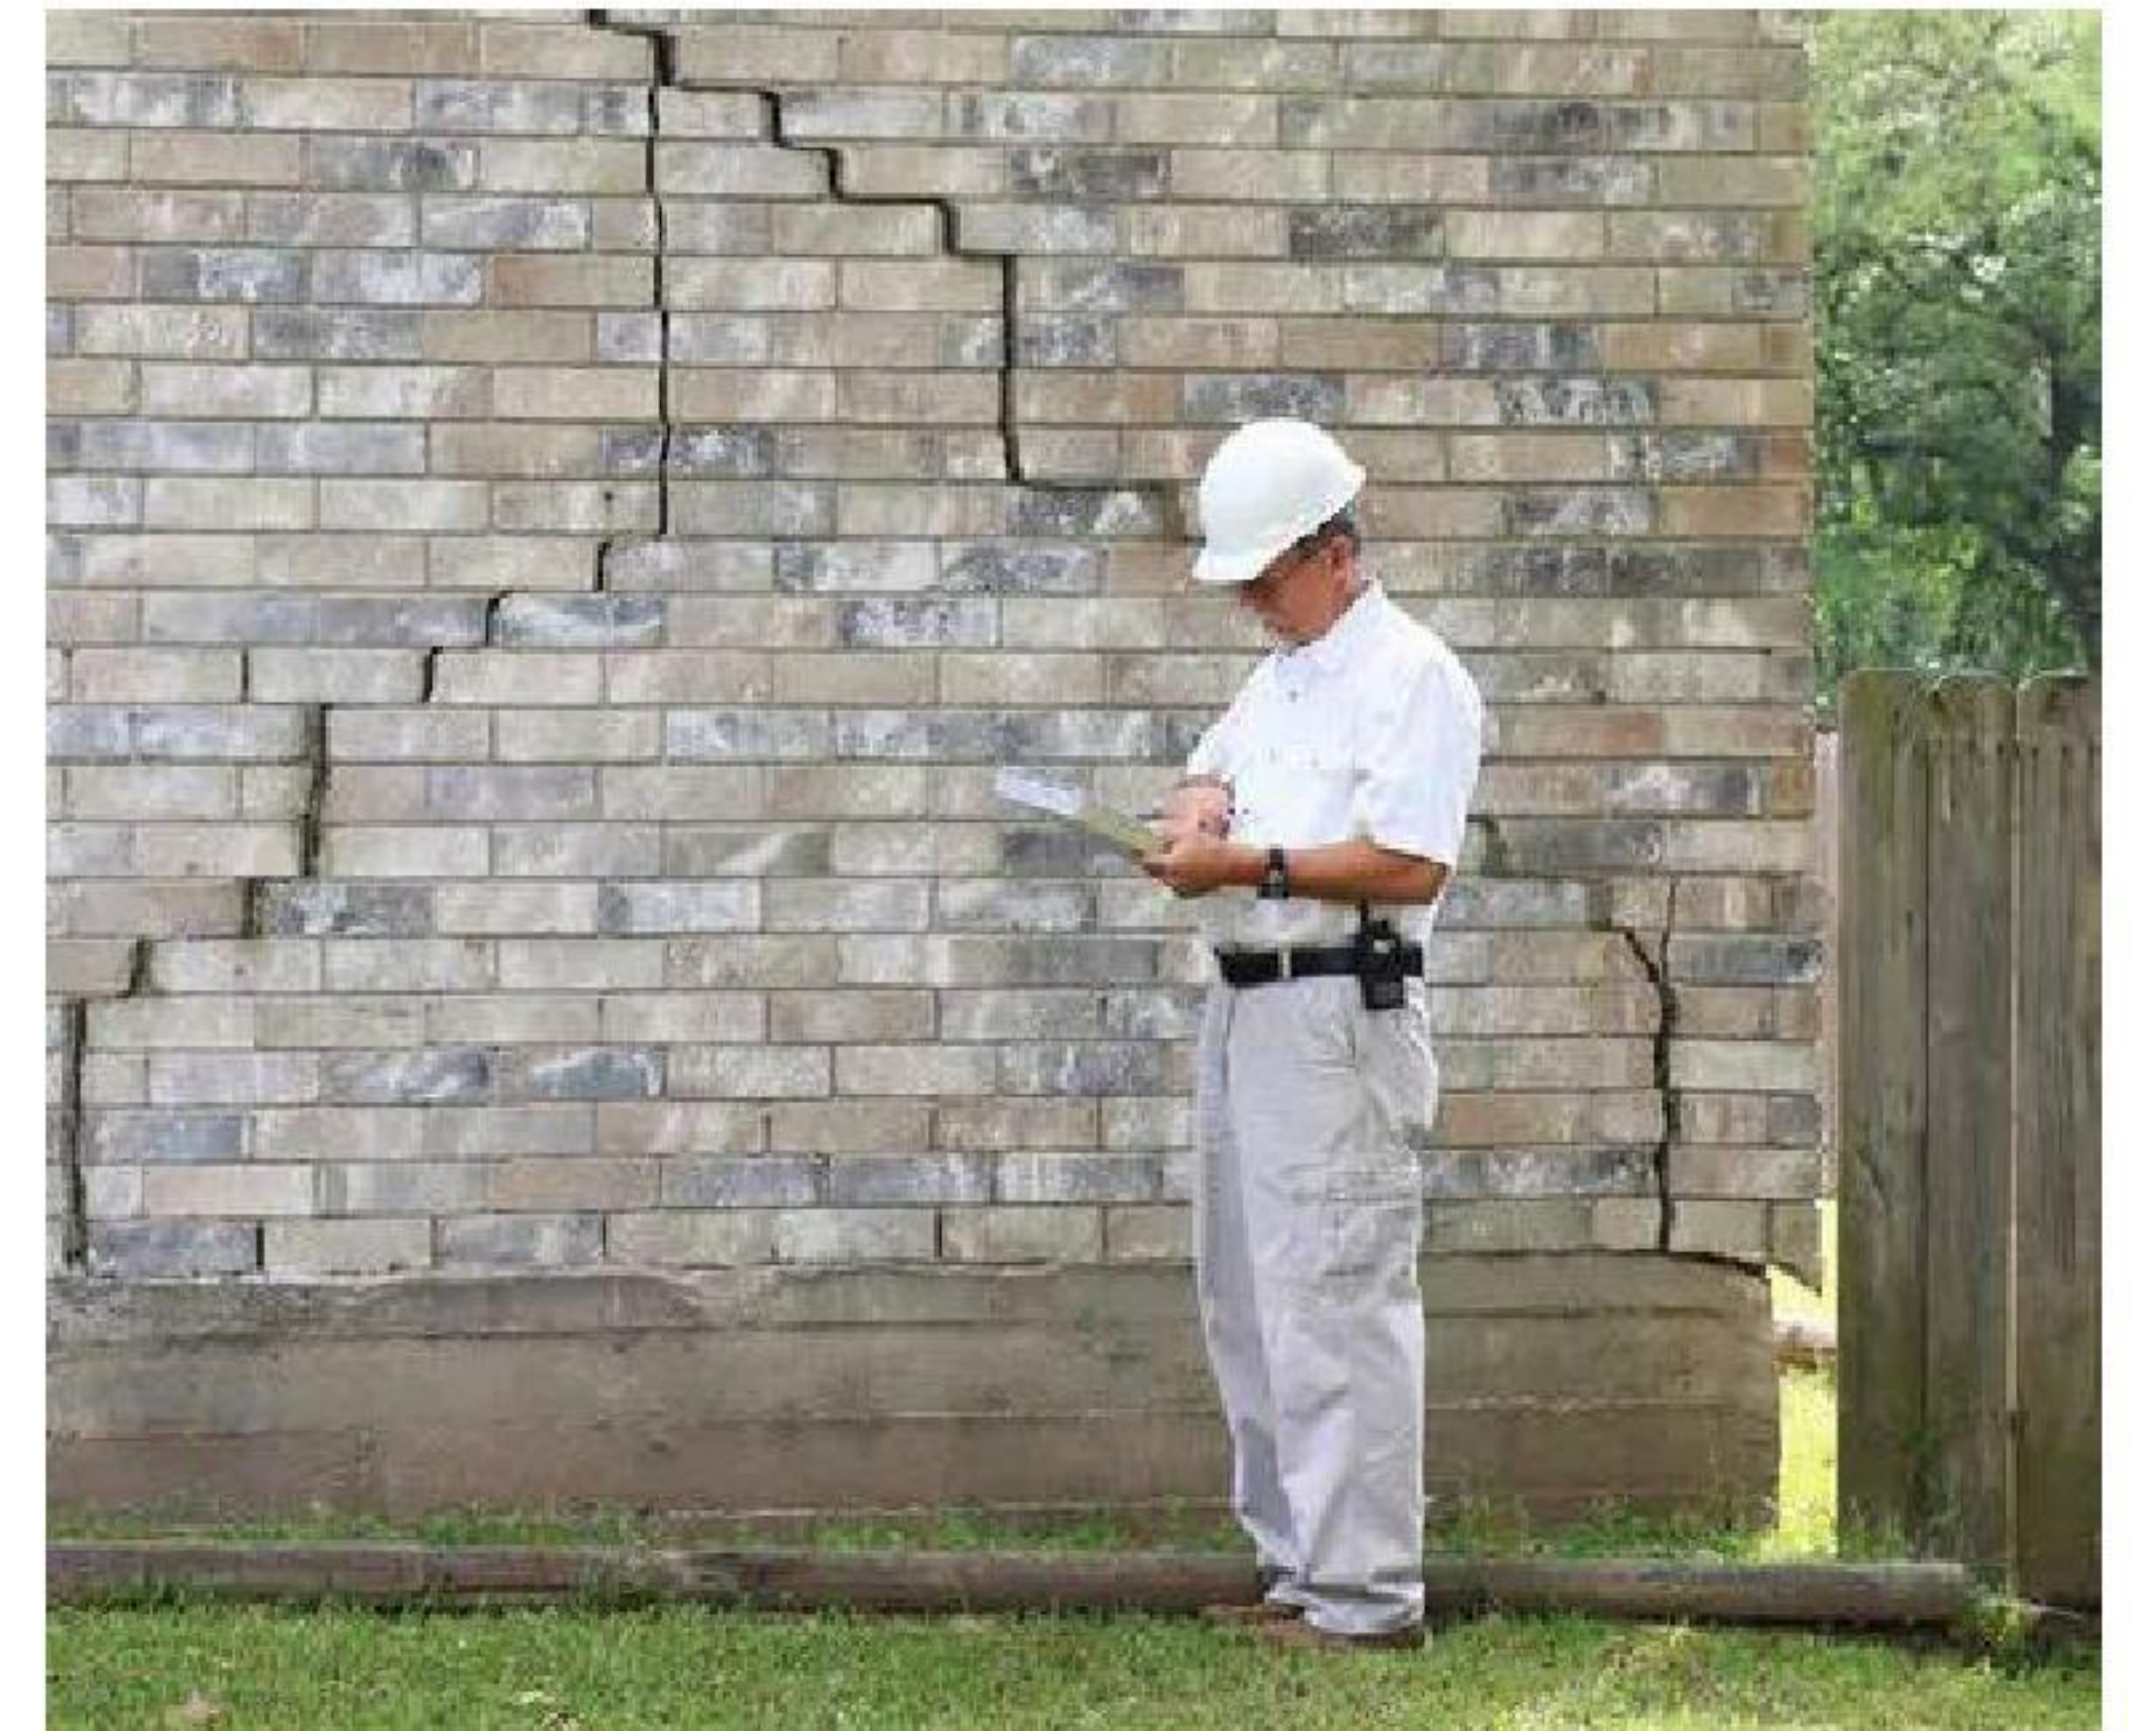
The barrier will be positioned between the offending tree(s) and the affected part of the building, and will be installed to a depth designed to cut the tree(s) roots between the tree and the foundations; the act of excavation severs the roots, causing any roots beneath the foundations to wither and die. This prevents the tree(s) from extracting moisture from the clay supporting the foundations, allowing the clay to rehydrate and recover their natural moisture levels. Naturally, there is a period of time required for the recovery process to take place, but repairs can typically be undertaken shortly after the installation is complete.

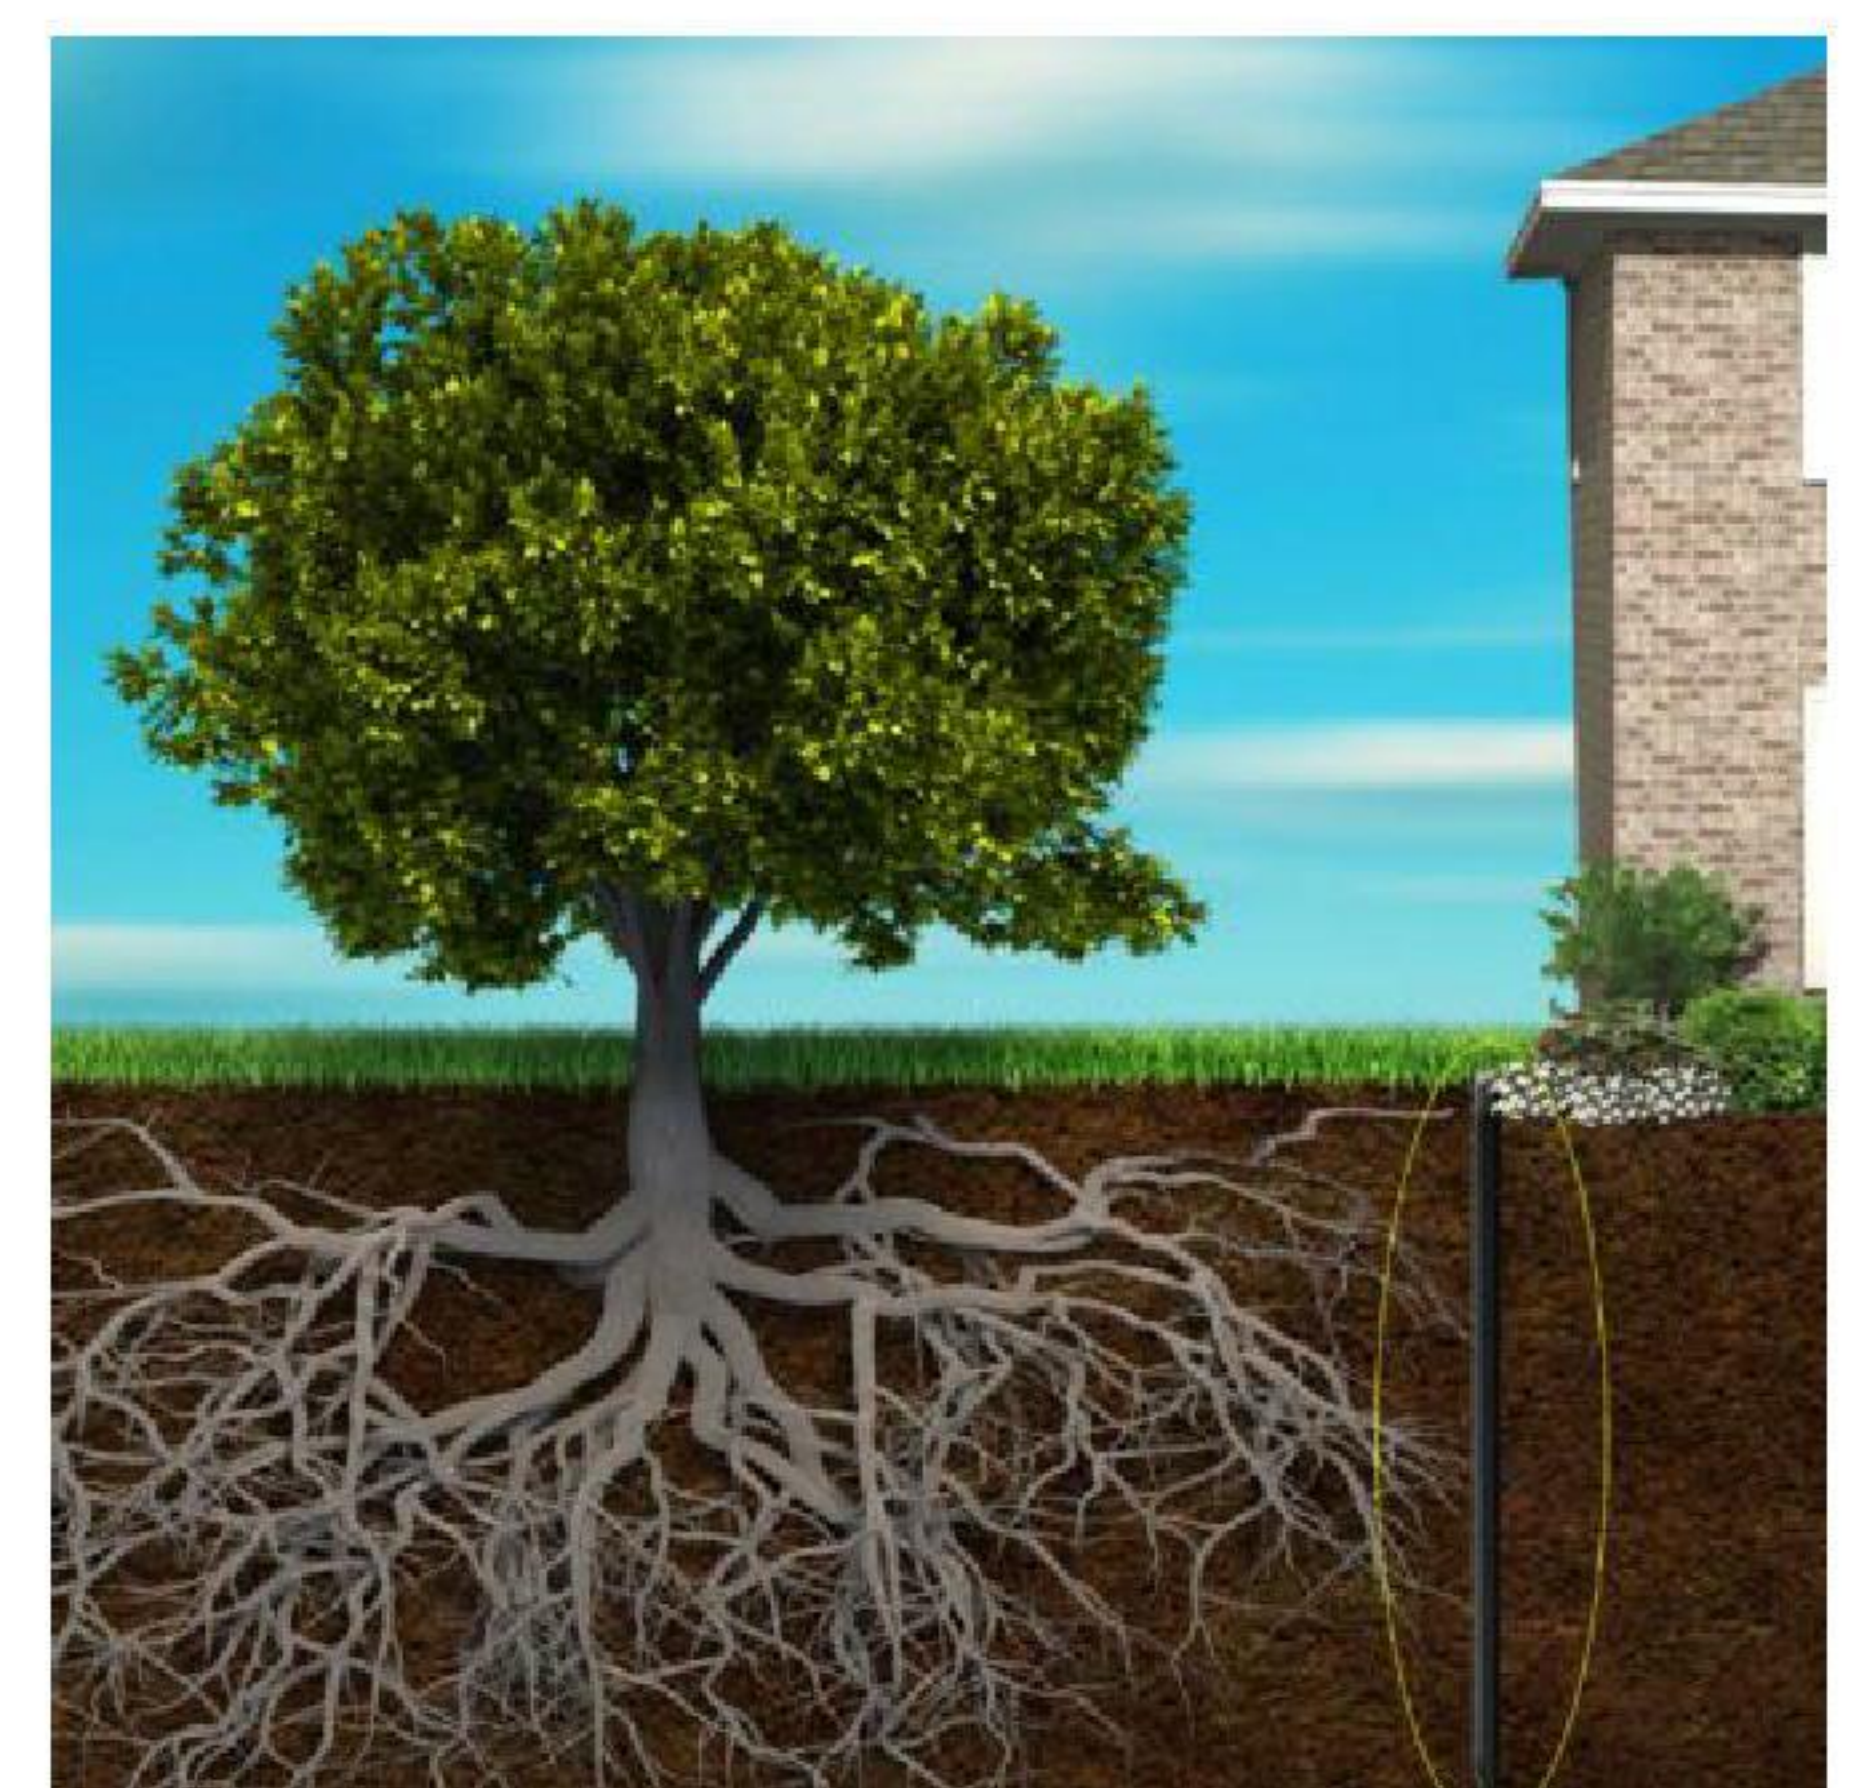
The moisture content of a clay soil tends to vary with depth. Closer to the surface there can be relatively large changes in soil moisture content between summer and winter as a result of evaporation from the ground surface, the drying effect of the Sun and general vegetation, including grasses. Such variations are normally confined to the upper 1m of the ground. However, where trees are growing within influencing distance of a building, then the soil moisture profiles will fluctuate much more widely through the seasons and to a much greater depth; in response, soil volume changes are amplified, and consequential building movements will be far greater.

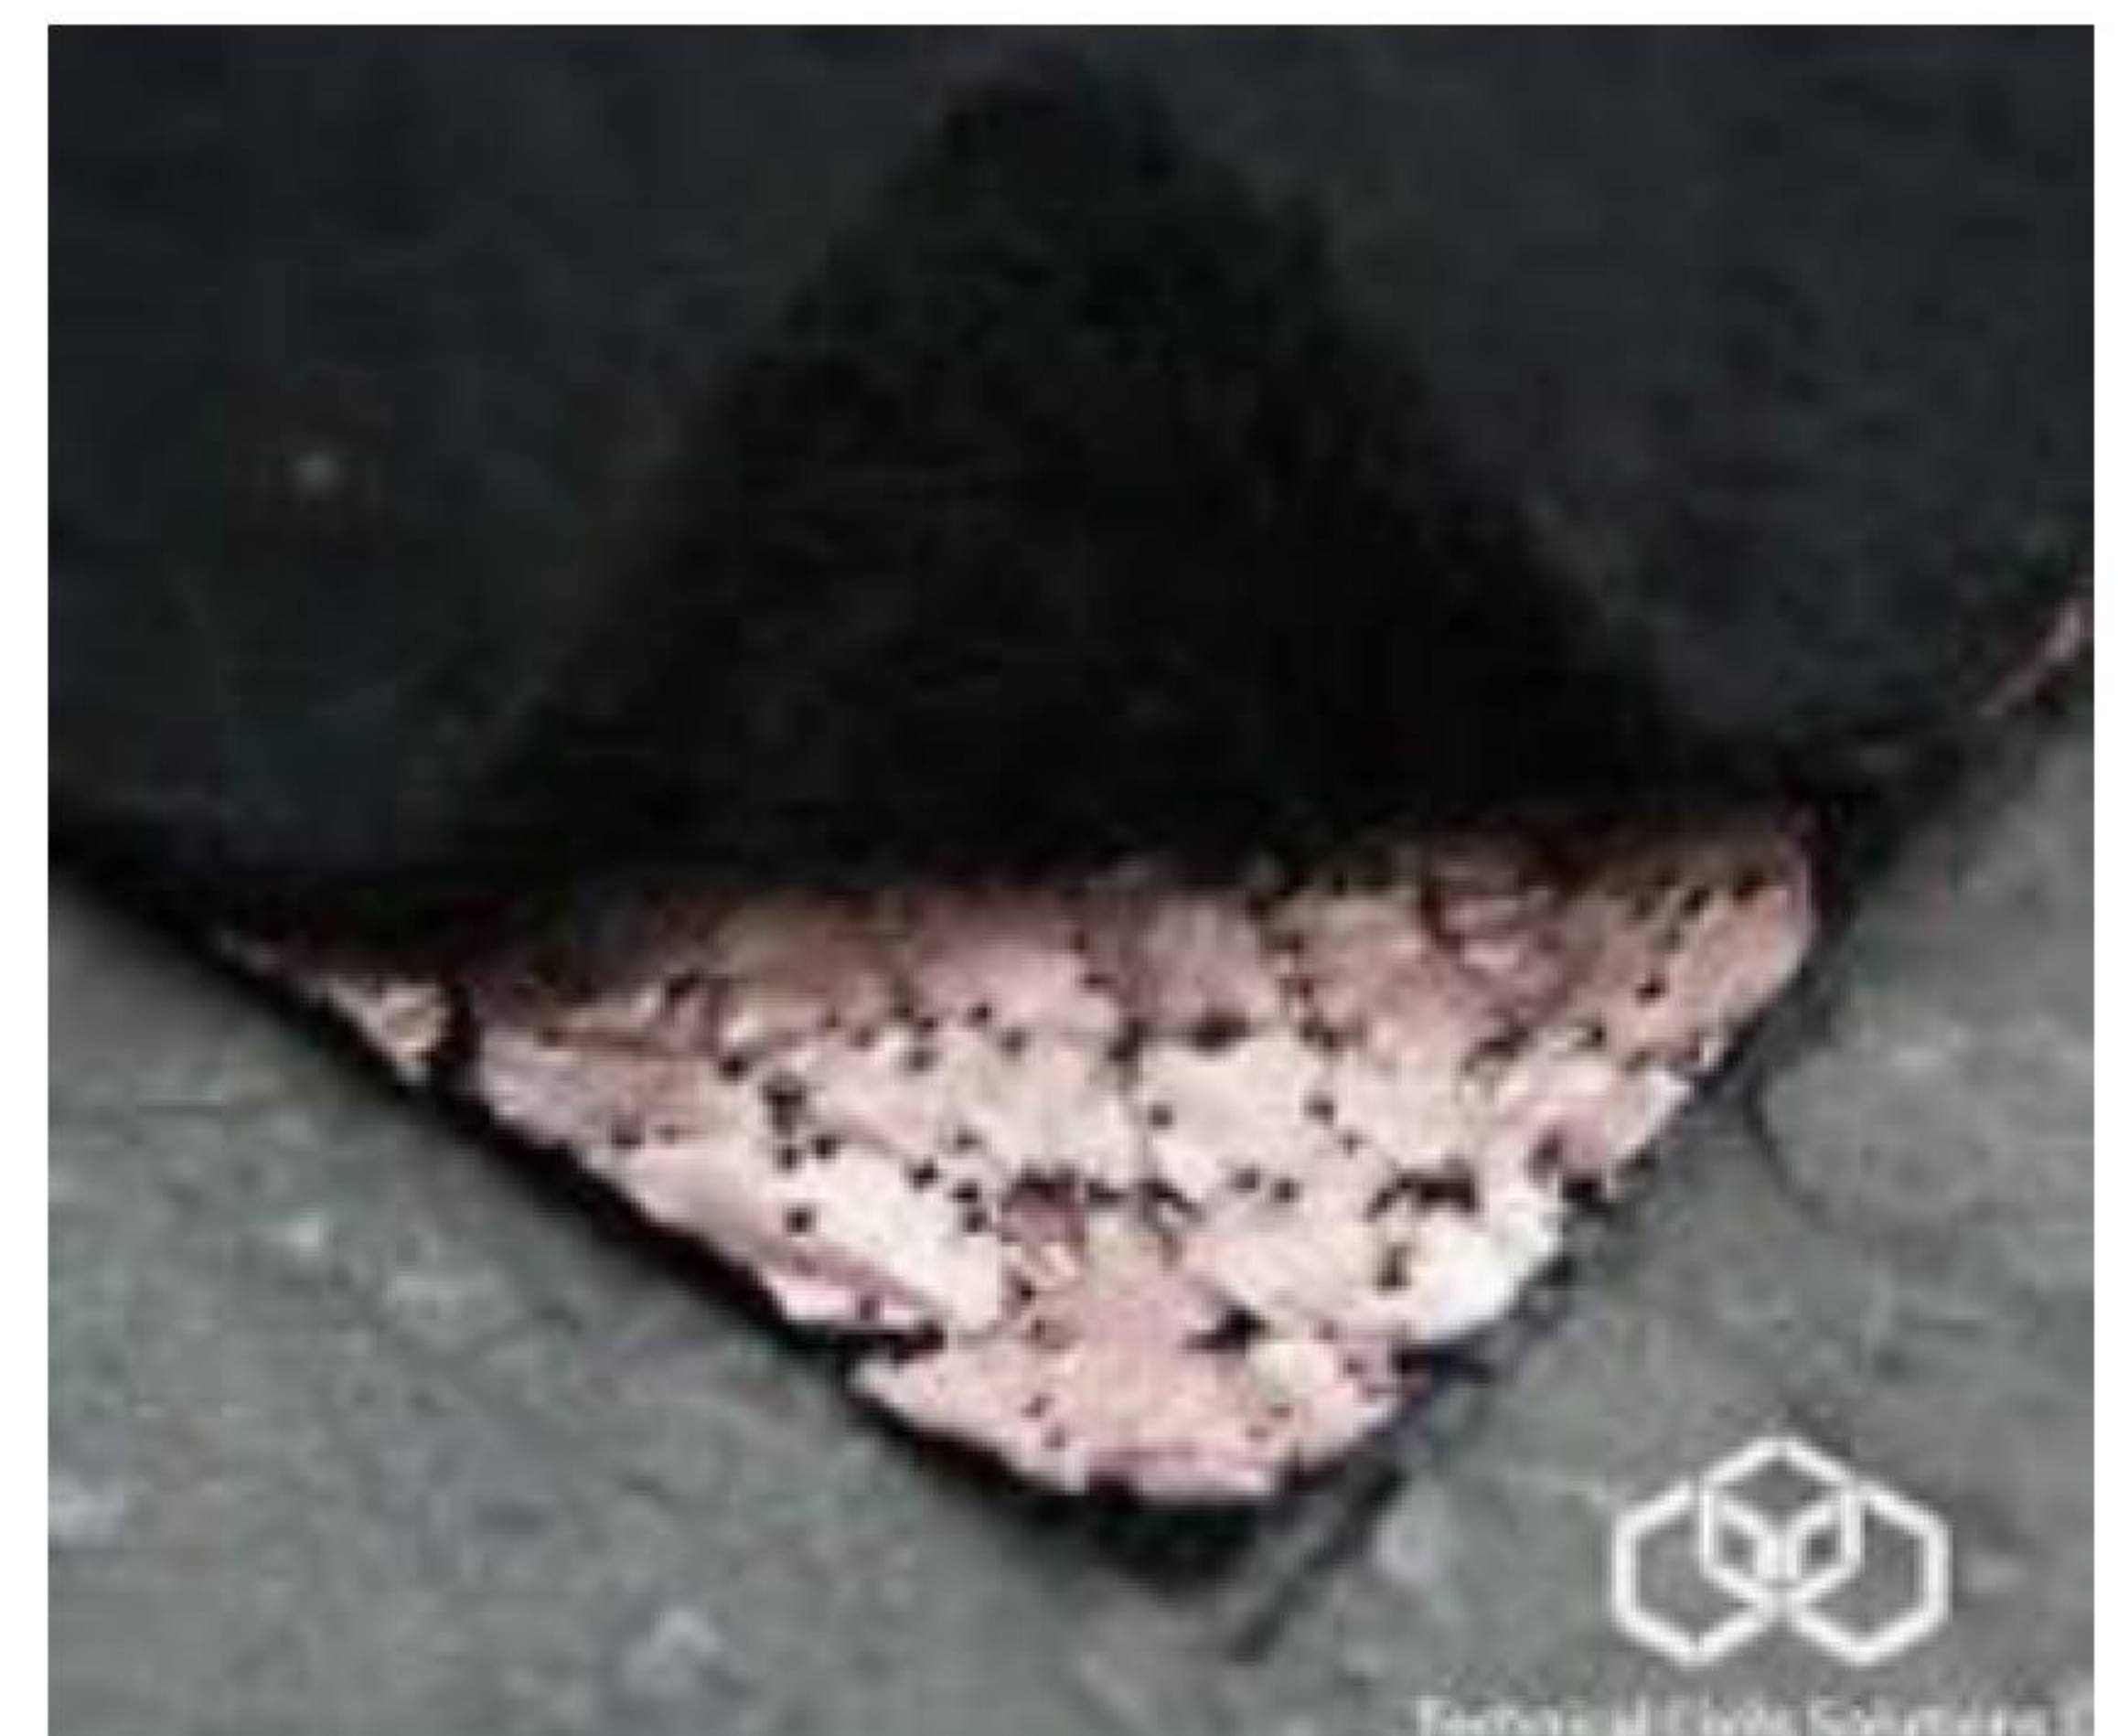
Outdated, impervious barriers divert rather than stop roots and may prevent the movement of groundwater causing unintended consequences. The use of Optera's permeable barrier stops roots both by forming a physical impenetrable obstacle and by acting as a chemical inhibitor to the reestablishment of roots.
