# Heritage Statement

Marlow House  
107 High Street  
Lindfield  
RH16 2HR

March 2026 | Project Ref 10899A

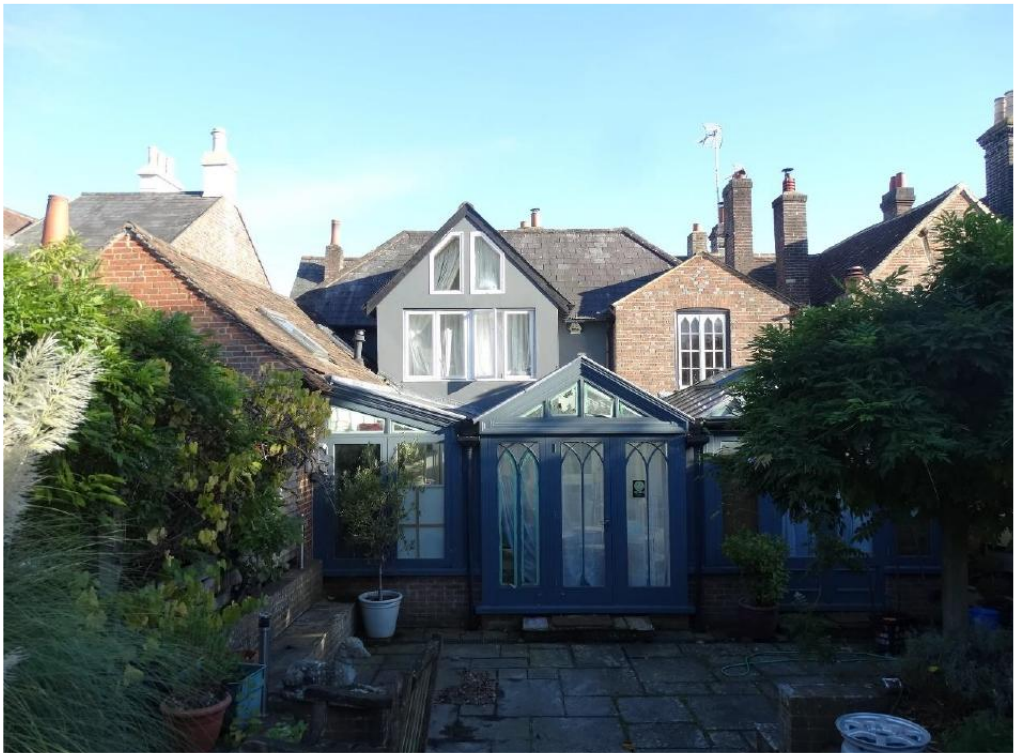
Figure 7: Marlow House, west elevation, prior to the commencement of the scheme as implemented

**3.44** The following sequence of OS Maps provides an indication of changes to the building footprint over time, demonstrating remarkably little change until the late 20<sup>th</sup> century. Prior to the implemented scheme, the west (rear) elevation (**Figure 7**) presented a very confused and confusing picture of the listed building. The jumble of gabled bays, roofs and lean-to extensions jostled for attention and did little to reveal or reinforce the building's special interest, as described in Section 4 below.

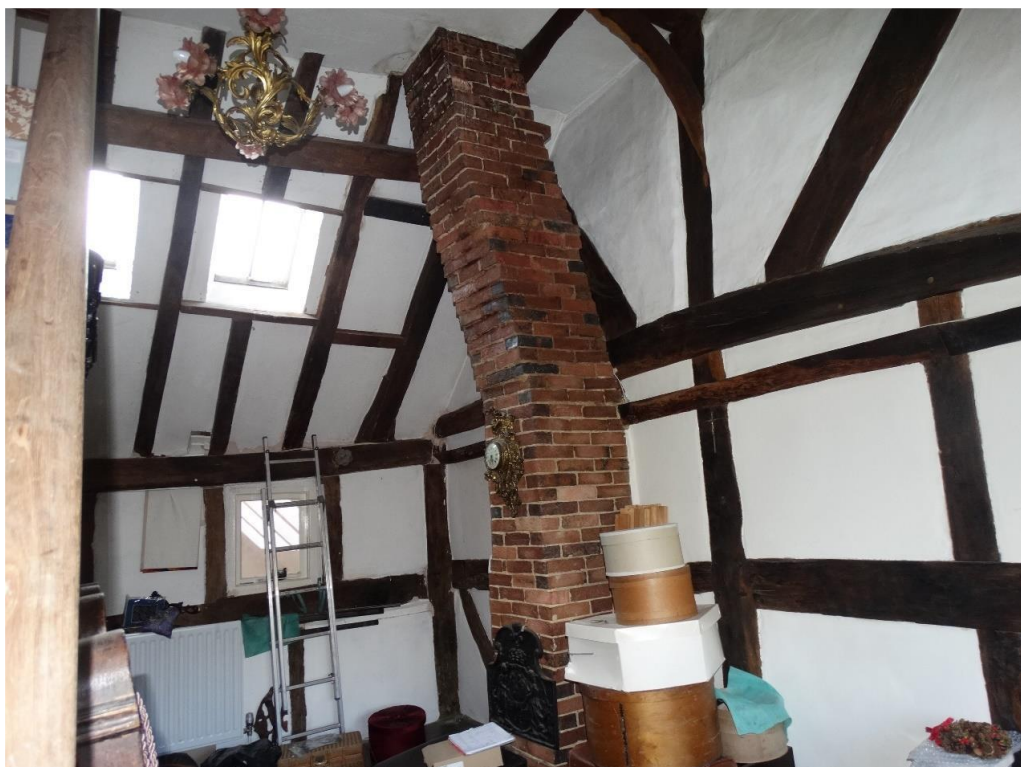
*Figure 9: 19<sup>th</sup> century brick stack adjacent to the north wall of the 15<sup>th</sup> century house prior to its removal. Source: Desbruslais Chartered Surveyors Statement of Heritage Significance of 13<sup>th</sup> October 2022*

**3.22** It is not known when this was carried out. However, this is presumably well after the early 19<sup>th</sup> century brick stack was inserted through the space (**Figure 9**).

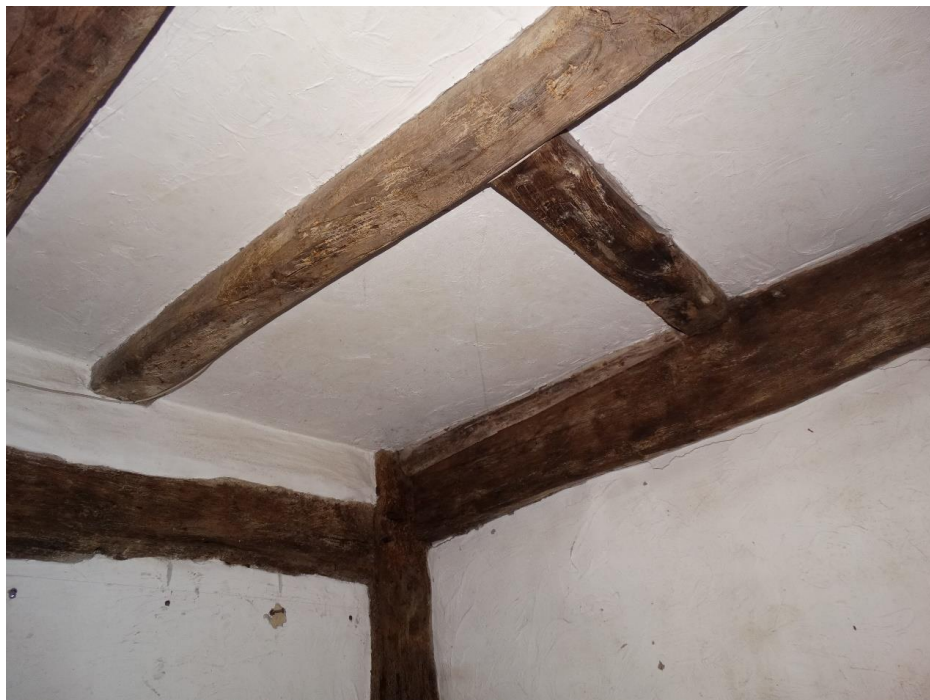
*Figure 10: Corner trimming for a ladder stair hole in the northwest corner and this is considered to be original. Source: Desbruslais Chartered Surveyors Statement of Heritage Significance of 13<sup>th</sup> October 2022*

- 3.26** Within the north bay, however, there is corner trimming for a ladder stair hole in the northwest corner and this is considered to be original (**Figure 10**).

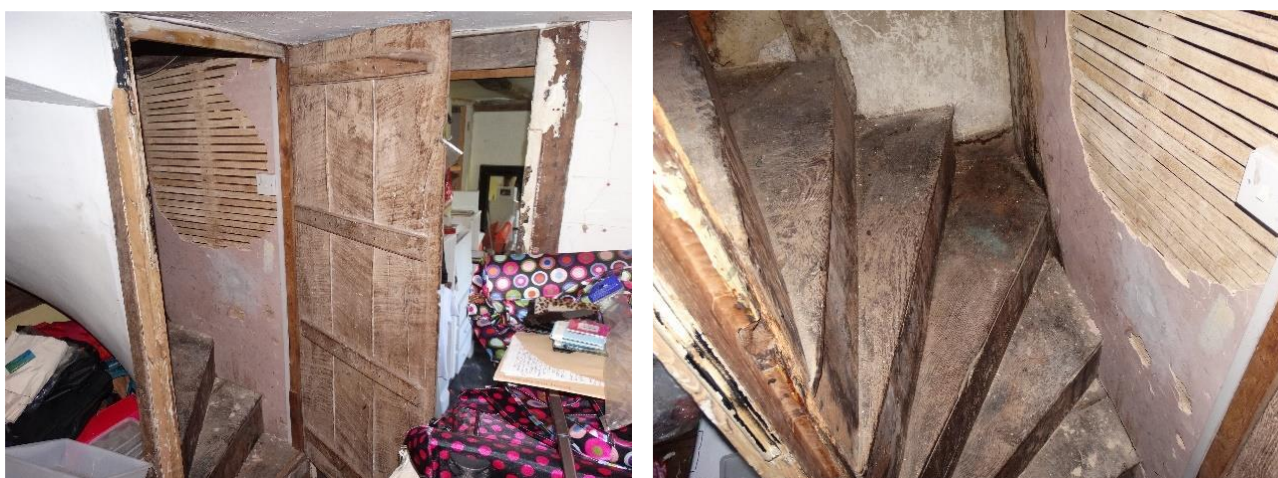
*Figure 11: Views of the 17<sup>th</sup> century upper flight of the corkscrew staircase. Source: Desbruslais Chartered Surveyors Statement of Heritage Significance of 13<sup>th</sup> October 2022*

**3.27** Later phases of stair have been added. The 17<sup>th</sup> century winding stair to the loft rooms was partially complete. The upper part from the landing to the second floor as shown in the images below was intact and showed no serious loss of material apart from wall plaster to the adjacent wall partition (**Figure 11**). The latter appears to have been modern gypsum plaster applied to a relatively recent lath system. Importantly, the staircase at first floor level had no enclosure the underside soffit, but was enclosed to the stair by means of a ledged, vertical plank door. Access to the attic had been sealed.

**3.28** The lower part of the stair to the ground floor was mostly replaced in modern timber and had been 'heavily butchered'<sup>15</sup> with little of the historic material remaining in situ. Historic planning drawings included at **Appendix 3** provide a strong indication that the lower flight of the stair was removed and replaced around 1999. Furthermore, the staircase was entirely redundant at this time, with the first floor sealed over (see items stored where the ground to first opening would have been at **Figure 11**, as found in 2022) with access to the attic also boarded over.

- Blocking of access via the 17<sup>th</sup> century staircase between ground and first and first to attic levels, making this feature entirely redundant in terms of historic circulation and accessibility (**Figure 11**);
- Blocking of an original door between the north bedroom and proposed en-suite which older plans from 1982, 1987 and 1996 (see **Appendix 4**) confirm was an original opening. A historic hinge was uncovered in the removal of modern plasterboard from this opening (see **Figure 38**);
- insertion of modern casement windows to the box framing on the west elevation (**Figure 29**); and,
- insertion of rooflights to various roof slopes, including the main west slope of the 15<sup>th</sup> century building (**Figure 30**) and south slope of the Bake House (**Figure 31**).

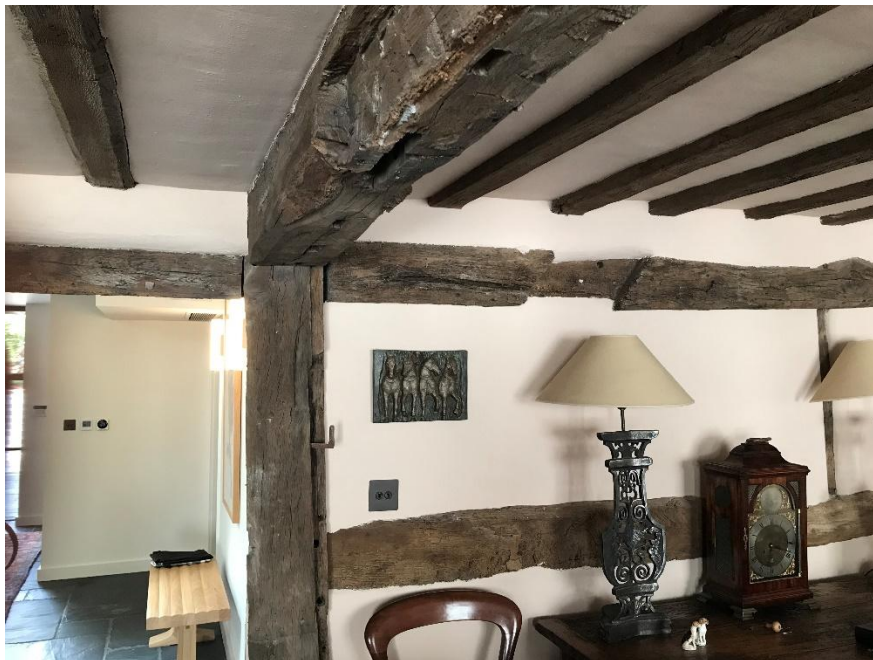
*Figure 12: main E-W ceiling beam to the living room showing the location of an original partition and doorway adjacent to the northwest wall. The timber jamb post and stud partition is proposed to be reinstated.*

**3.32** The ground floor central room has had much of the original timber lateral partitioning removed at some time in the past, as evident from the exposed mortices to the soffit of ceiling beams in the southern ground floor room and main living room north of the chimney breast (**Figures 12** and **13**). Whilst there is some central support in masonry, the joint where the axial first floor support beam crossed the tie is weak and has had to be propped with modern steelwork (**Figure 14**). The existing seasoned oak gunstock post which replaced the improvised support is shown at **Figure 15**.

**3.33** However, the underside of the tie does reveal the design of the partition in this instance, and the doorway at the end into the snug area looks to be in its original position (**Figure 12**).

- the removal of stud partitions which subdivided the southern ground floor room (making it an uncharacteristic linear open plan) as well as the main parlour to the north of the main chimney breast towards the centre of the original house (**Figures 12 and 13**);
- insertion of softwood casement windows and French Doors with faux gothic detailing to the 1830s rear range and Bake House respectively (**Figures 17 and 18**). Earlier plans from 1982, 1987 and 1996 found at **Appendix 4** clearly show there were no window openings to this part of the wall at first floor level;

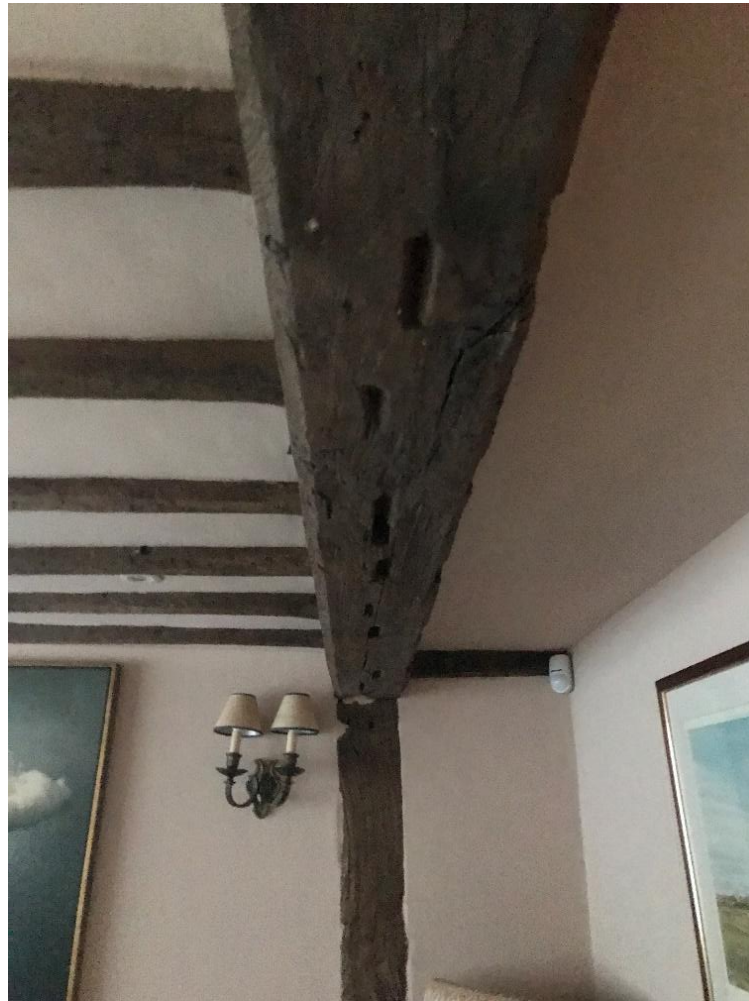
*Figure 13: N-S ceiling beam to the former dining room to the south bay with mortices indicative of historic partitioning within this space.*

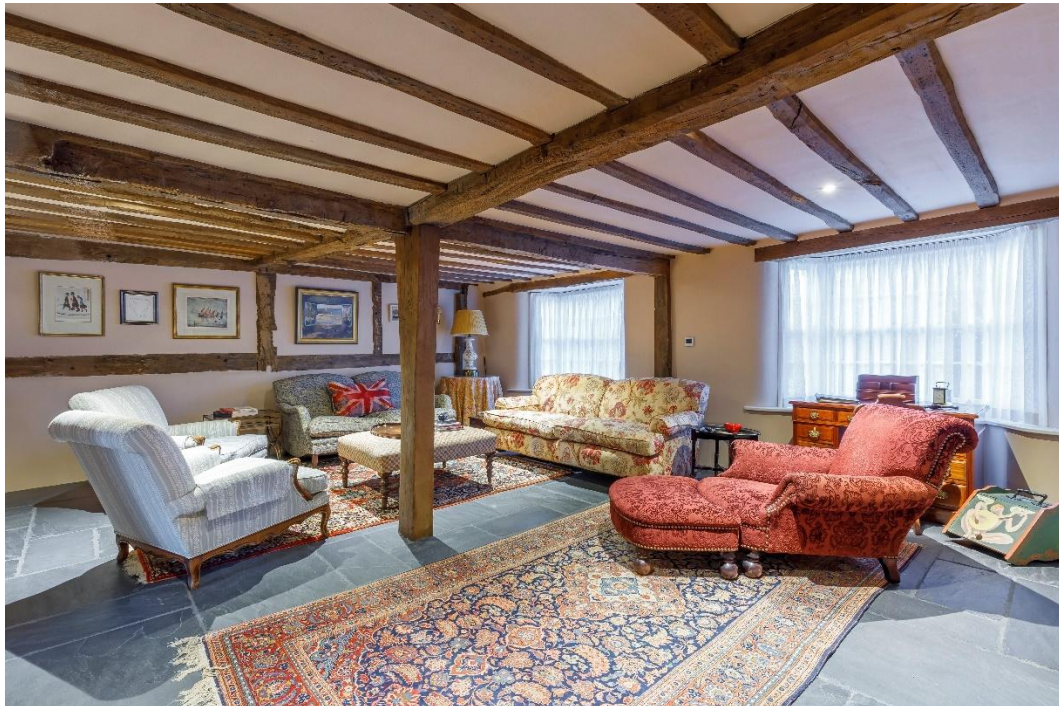
*Figure 15: Supporting timber post in seasoned oak as implemented*

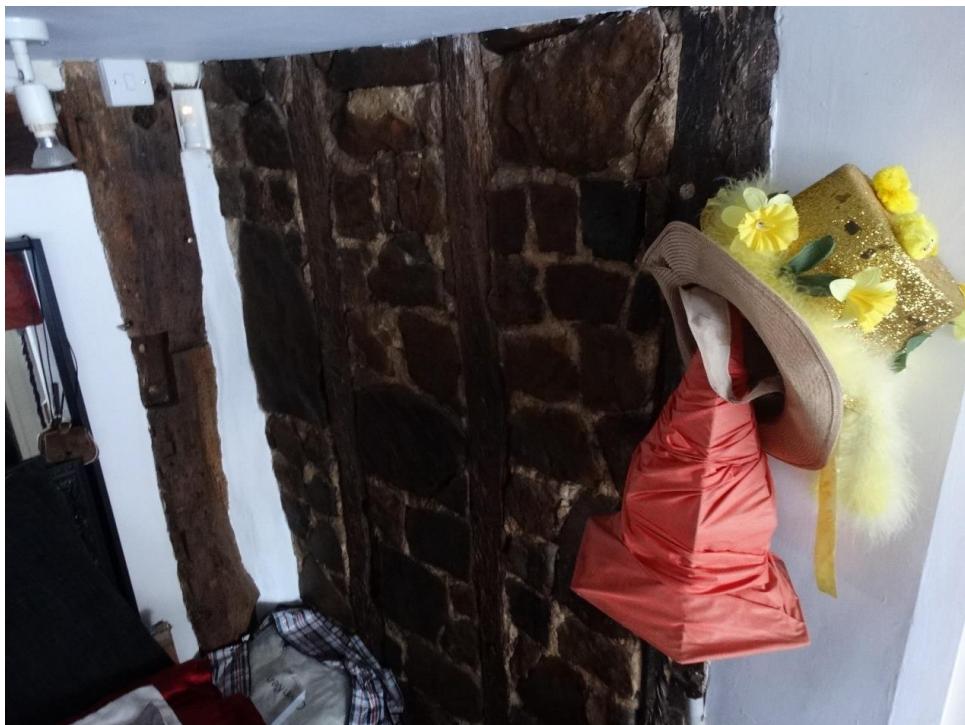
*Figure 16: feature wall to the partition between the entrance hall and southern bay dining room.  
Source: Desbruslais Chartered Surveyors Statement of Heritage Significance of 13<sup>th</sup> October 2022*

**3.34** One dining room wall which was contrived as a feature wall (**Figure 16**) was subsequently shown to be a cosmetic conceit with the stone 'nogging' applied as a form of cladding to underlying blockwork (cf. **Figure 37**).

**3.35** The studs are out of alignment with the main bay post of the lower end of the house and the wall looks to be a later infill at the end of the cross passage. The door positions to the lower end services are not visible and it may have been constructed to re-face the end of the passage and close off one of the service door positions. Being Sussex, it would be more common to see service end doors towards the outer bay positions rather than centrally placed, like is found the further east you go towards Kent.

*Figure 37: Blockwork construction underlying the cosmetic 'timber stud' wall with stonework nogging shown at **Figure 16***

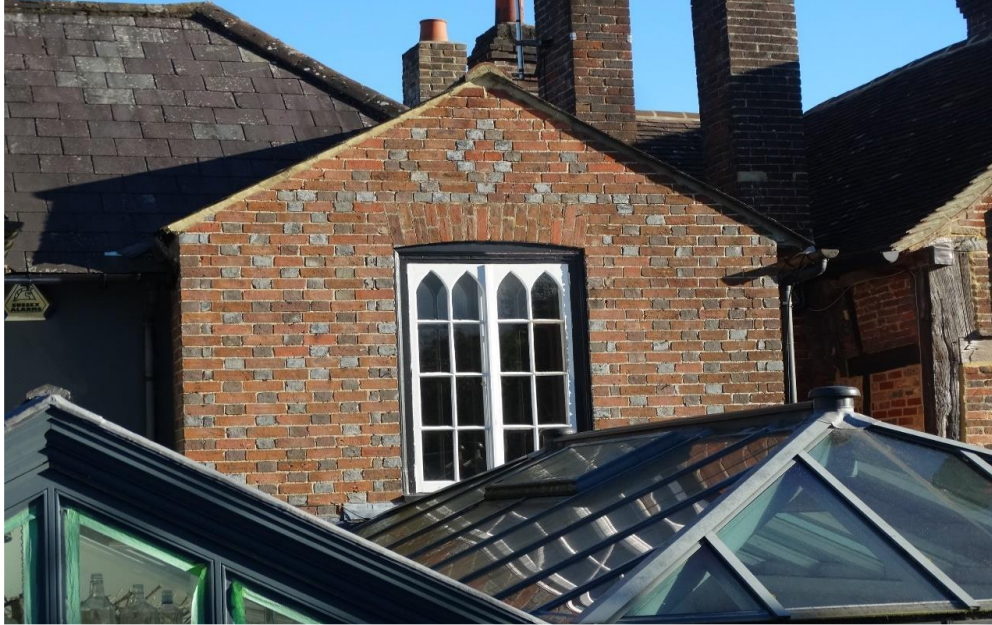
*Figure 17: 1830s gabled outrigger with vitrified blue brick header detailing. N.B. the double casement window is mid C20 with inserted softwood spandrels suggesting a gothic pointed arch head. The original windows was likely an eight-over-eight vertical sliding hardwood sash. Source: Desbruslais Chartered Surveyors Statement of Heritage Significance of 13<sup>th</sup> October 2022*

**3.40** The rear projecting two storey extension was added circa 1830. It is fabricated in solid brick masonry in a Flemish bond, showing off blue glazed headers (**Figure 17**). The gable features a modern softwood casement window with storm proof beading to the middle stiles and faux gothic spandrels to the upper lights. The original window was most probably a vertical sliding sash judging from the retained window frame joinery which indicate the presence of sash boxes.

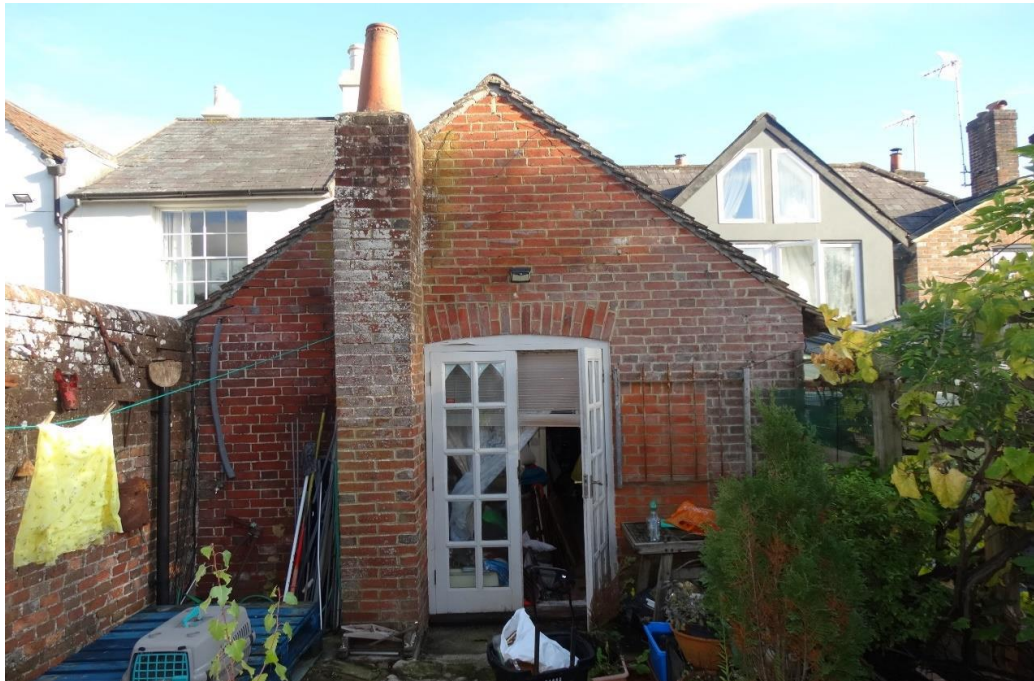
*Figure 18: View of the former Bake House from the west prior to dismantling. Source: Desbruslais Chartered Surveyors Statement of Heritage Significance of 13<sup>th</sup> October 2022*

**3.43** A Bake House was also added to the rear, of which only the outer walls remained in situ (**Figure 18**). The apex of the gable appears to have been rebuilt in stretcher bond. No internal features survived, and the interior linings and fixtures were

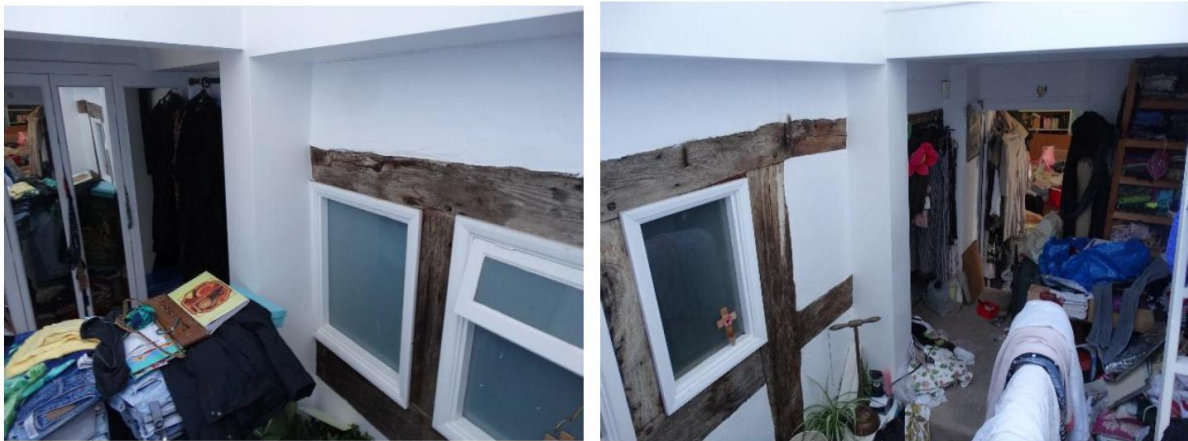
*Figure 29: Box framing to rear (west) wall of the 15<sup>th</sup> century house with internalised modern timber casement windows. Source: Desbruslais Chartered Surveyors Statement of Heritage Significance of 13th October 2022*

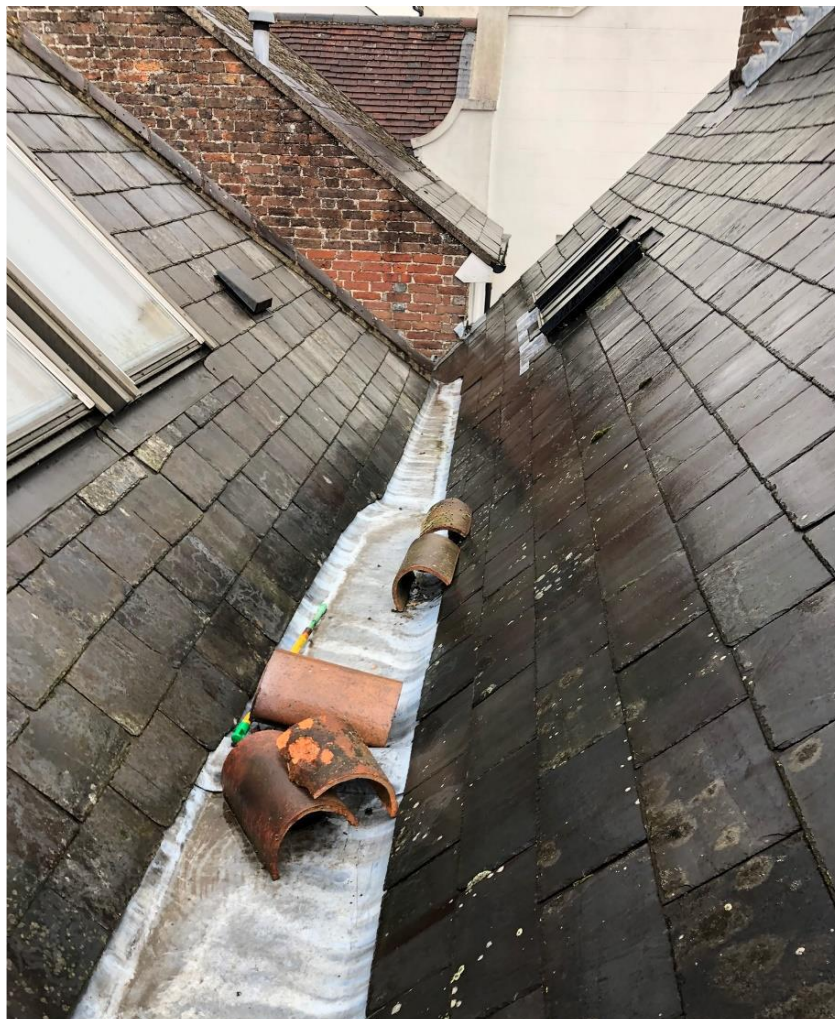
*Figure 30: the rear roof slope to the original 15<sup>th</sup> century building contained no less than 5 rooflights prior to their removal and slating over as part of the implemented scheme. Source: Gould Baxter Survey (October 2022)*

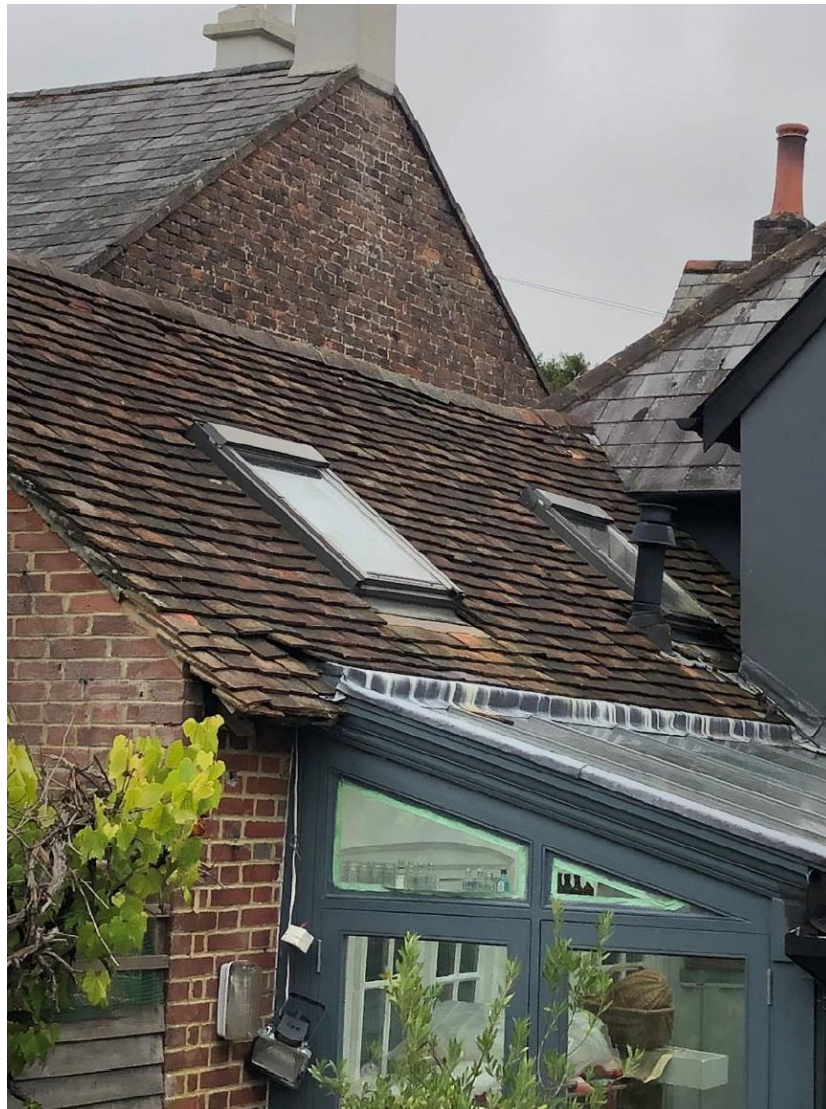
*Figure 31: Bake House roof (south slope) as seen in 2022 with 2 no. modern Velux rooflights.  
Source: Gould Baxter Condition Report*

- 1.10** The rebuilt Bake House is to be retained though the full height glazed break in the west elevation (as built) is amended to correspond to the size of the approved window opening, with Crittall windows adjusted accordingly. The Bake House (as re-built) also differs from the approved scheme in that the rooflights to the Bake House roof were omitted, these having been intended to replace two large Velux rooflights (*cf.* **Figure 31**).<sup>4</sup>

wholly modern. In 2022 the Bake House had a pair of large Velux rooflights to the south roof slope (see **Figure 31**).

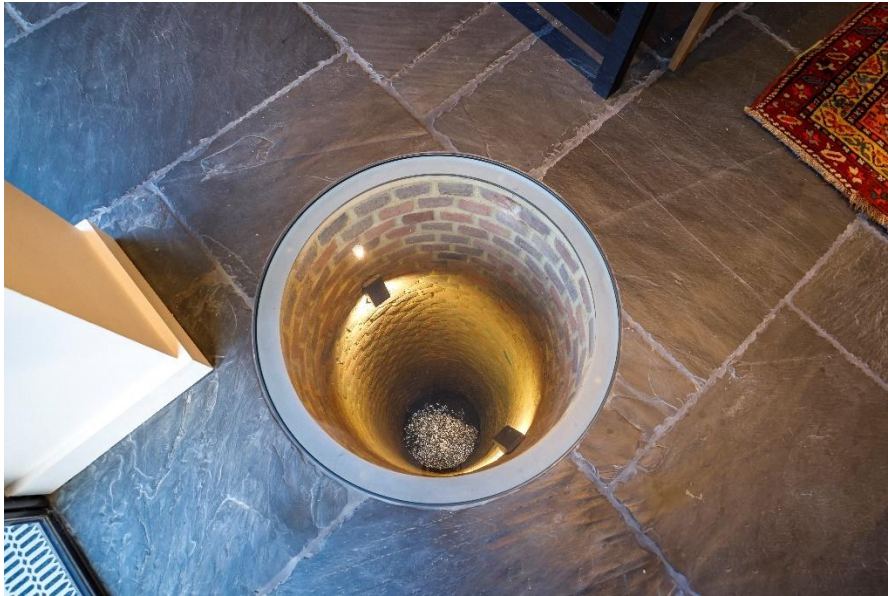
*Figure 32: Rediscovered well shaft (re-lined in handmade brick) and groundwater storage chamber within the kitchen area. See DAS for images of well as revealed and during construction phase*

- 4.16** Where physical evidence remains of changes to the building, and in the surviving historic fabric, there is some archaeological or evidential interest that retains potential for detailed understanding of the development of the building over time. The presence of a well shaft and water storage chamber to the underlying bedrock

within the original rear yard (now internalised – **Figure 32**) contributes to the archaeological interest of the Site and also the wider conservation area (see Section 5 below).

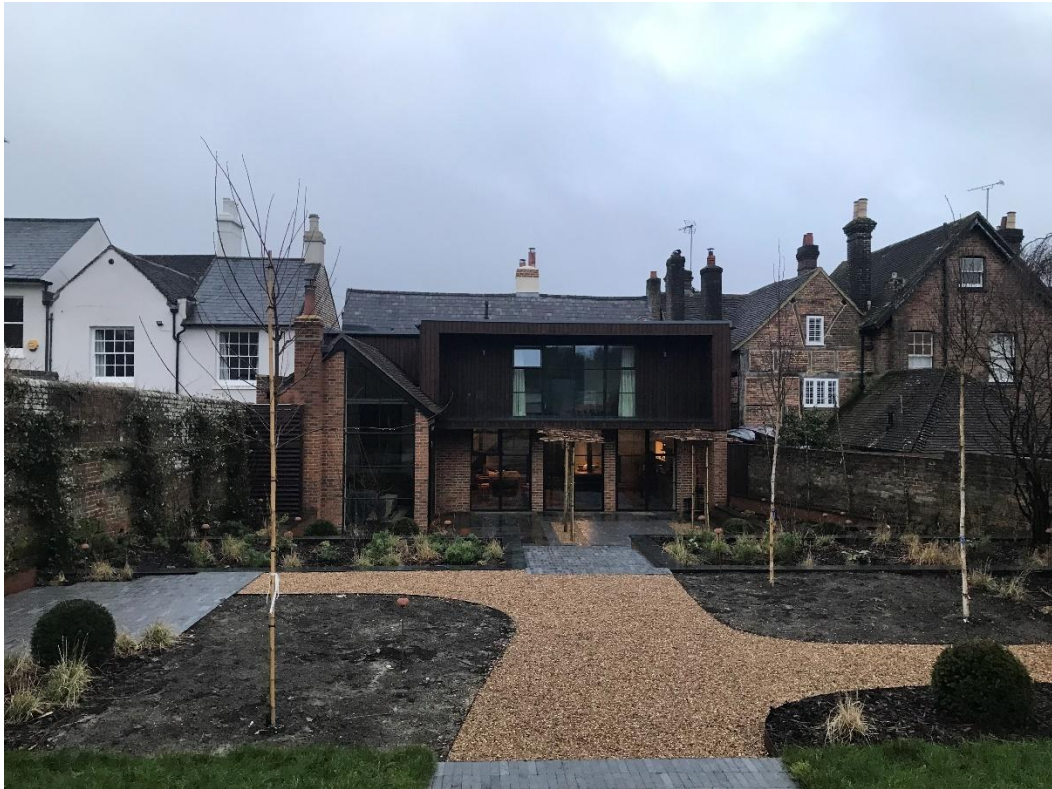
*Figure 33: View of Marlow House from the rear garden (west). Note the prominence of the restored 15<sup>th</sup> century roofscape compared to the prior situation shown at Figure 7.*

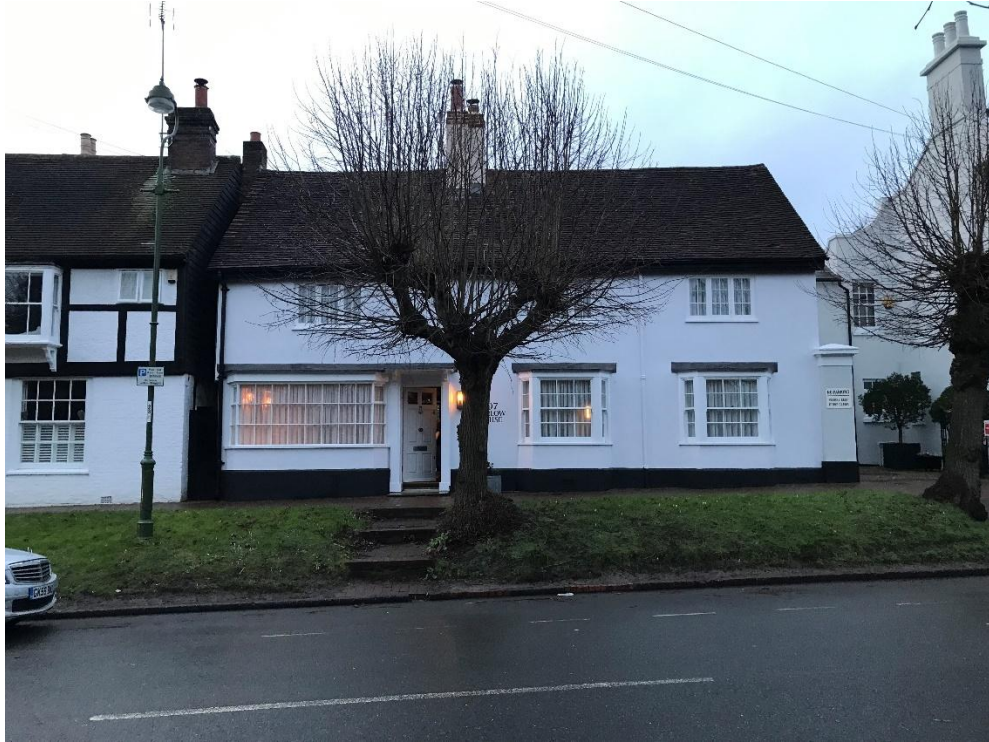
*Figure 34: Marlow House (107 High Street), main frontage to High Street*

**4.18** The frontage to High Street is of greater importance in relation to the public realm (**Figure 34**). The associated views contribute to an appreciation of the building's aesthetic value and historical interest as a former commercial property, both as a shop as far back as 1848, as a tea room during much of the 20<sup>th</sup> century and subsequently as a house in the present day.

- 5.5** The majority of the above external changes are captured in the photographic image at **Figure 34**.

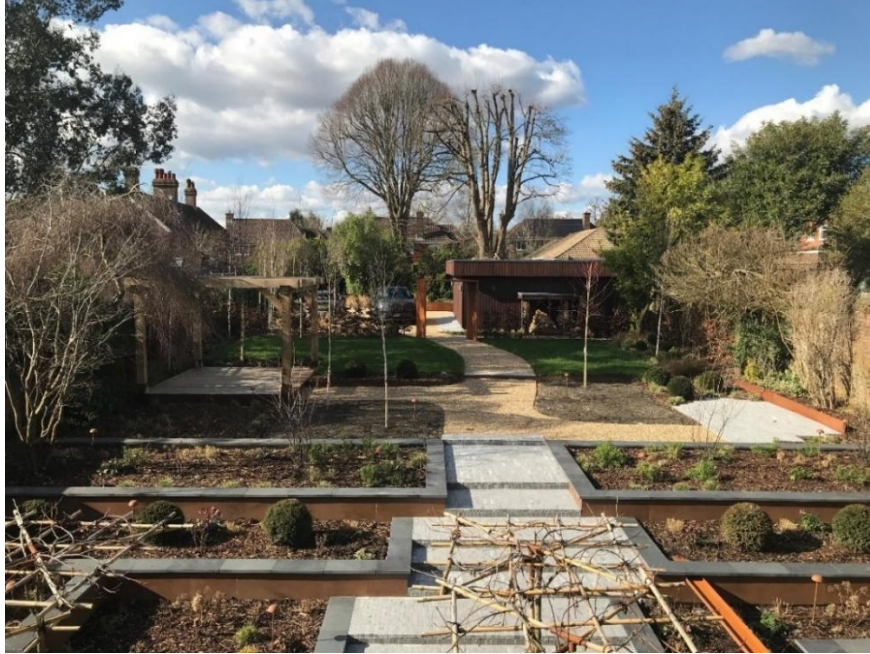
*Figure 35: View west from first floor bedroom window across the rear garden towards the garage (built as approved with lowered height log store).*

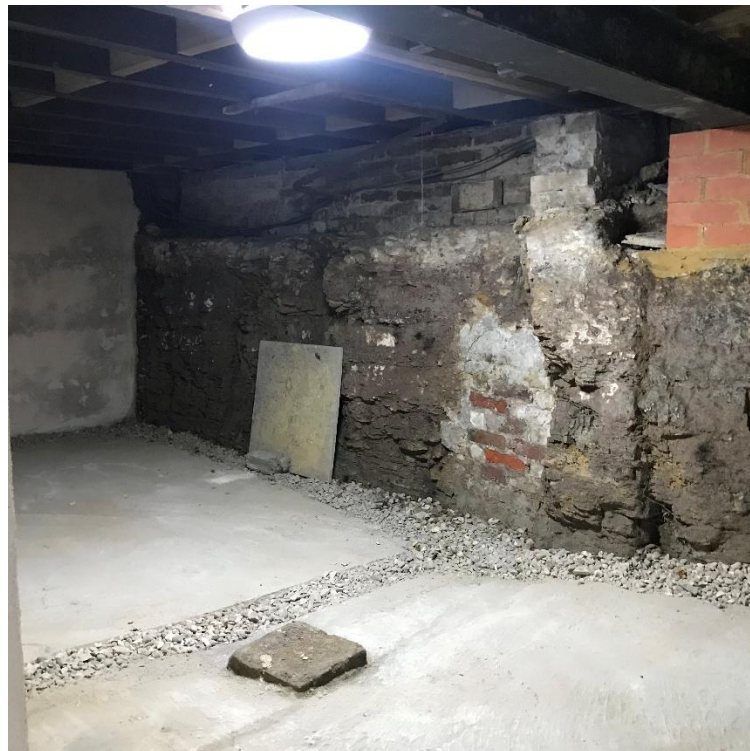
*Figure 36: Renewed steel beam with new noggings and joists at basement level. The pre-existing concrete floor has been augmented by a French drain and brick walls coated with breathable hydraulic lime render to regulate the damp.*

**5.23** An under-engineered steel beam (comprising a railway line steel) has been replaced with an appropriately specified rolled steel joist (**Figure 36**). Some modern softwood joists renewed in better quality timber. These works comprise a minor heritage benefit due to enhanced structural stability which contributes towards securing the building's long term conservation.

**5.24** A sacrificial coating of hydraulic lime render has also been applied to the north, west and south walls of the cellar with air circulation unit installed with a French drain soakaway for any condensation build up. Damp was previously a serious problem due to the pre-existing concrete floor and DPM. The cellar has now stabilised at a low level of relative humidity with no damp ingress. The impact of these works is beneficial to the historic fabric and its long term conservation, securing a heritage benefit of moderate weight.

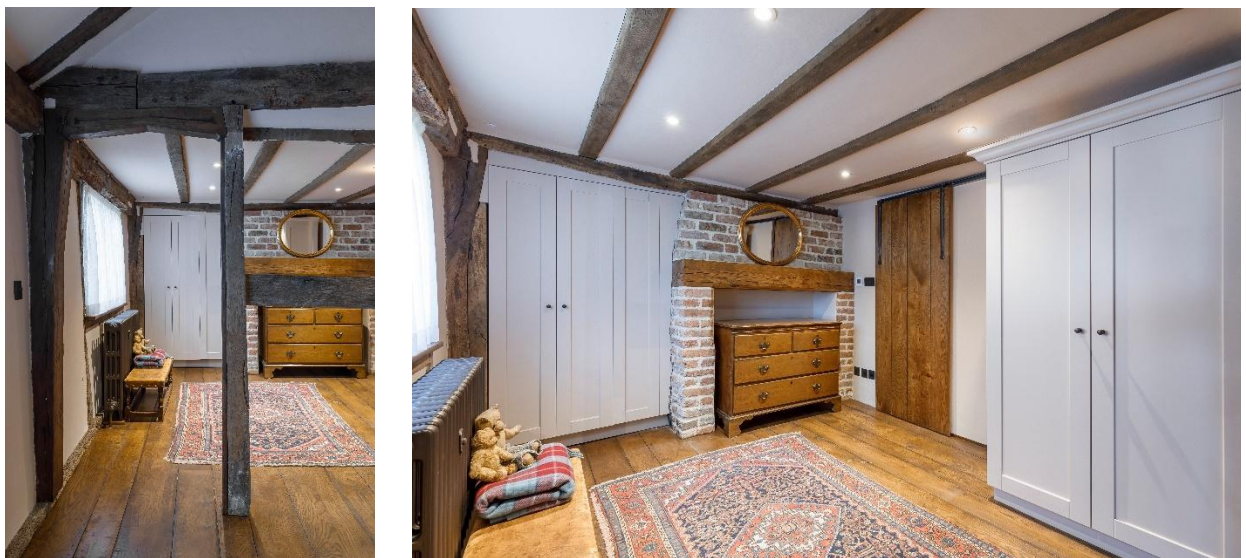
*Figure 38: First floor north bedroom as implemented*

- 5.33** A new partition to create an en-suite bathroom to the north bedroom is proposed in conjunction with the reinstatement of lime plaster infill panels to the historic spine to delineate the originally separate rooms as distinct spaces. The new bathroom partition has been sensitively designed with a sliding door and executed to a high standard (**Figure 38**) and merely follows the line of a historic, but possibly later,

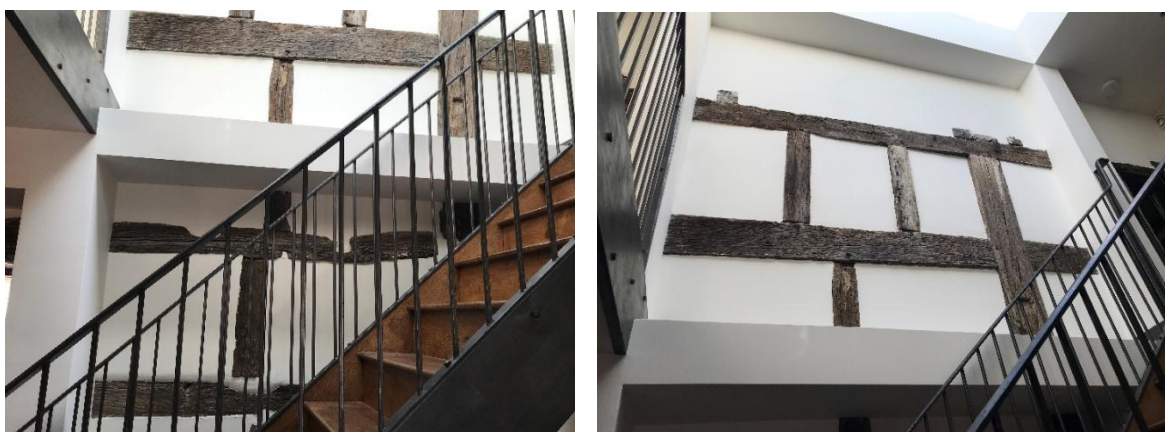
*Figure 39: Box framing to west wall of the 15<sup>th</sup> century house with internal windows infilled with wood wool panels and lime plaster.*

**5.37** The original window openings to the west wall of the house have long since disappeared. These modern windows do not represent the original window openings, the position of which is a matter of considerable conjecture. Approved drawings from 1982, 1987 and 1996 (see **Appendix 3**) all indicate that there were no windows in this rear elevation, the modern casements dating from after 1999. Any original windows would have been in the form of fixed and metal casement lights separated by oak staves or mullions. None of these windows remained in the property prior to the implemented scheme and there is no convincing evidence for their respective positions. The removal of the modern casements and infilling using breathable wood wool boards faced in lime plaster reverts to the pre-2000 baseline and serves to reveal and express the 15<sup>th</sup> century box framing much more clearly and is a significant heritage benefit of the Proposed Scheme (**Figure 39**). This should be weighted accordingly.

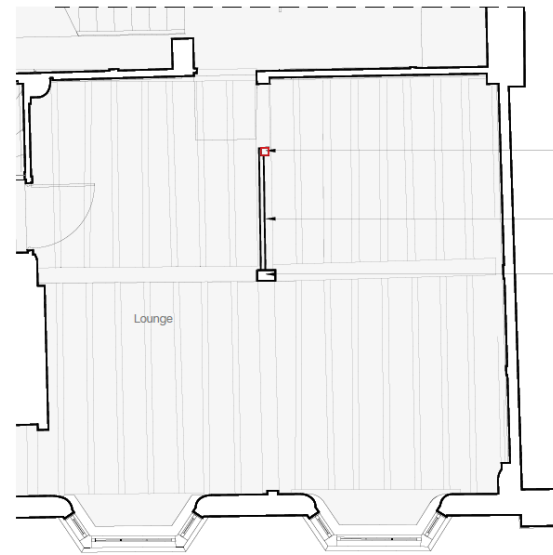
Proposed Scheme  
Ground Floor Plan  
Scale 1:25@A1, 1:50@A3

Previously removed door jamb to be reinstated to make legible an original stud partition which was heavily altered in the 20th century.

Historic horizontal timber frame member to be reinstated, secured to the post for stability

Existing timber gunstock post
