**Flood Risk Assessment**  
in support for the application for an  
a retrospective application for carpark alterations at  
Hurstpierpoint College,  
College Lane, Hurstpierpoint, West Sussex, BN6 9JS.

This statement is prepared on behalf of Hurstpierpoint College in support of a full planning application for the retrospective carpark extension and alterations.

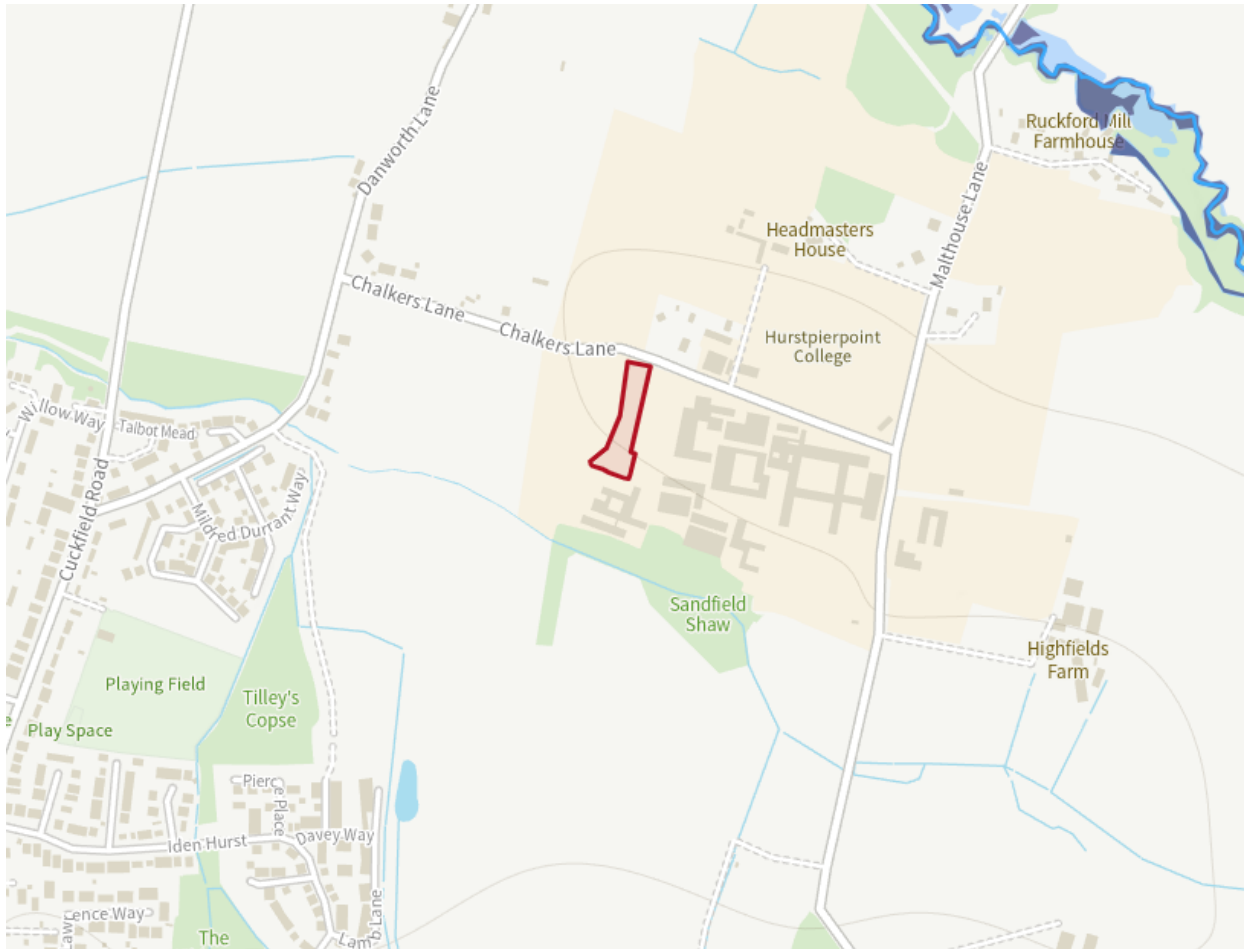
**Figure 2 – Extract from EA Flood Map for Planning**

The college site is located in Flood Zone 1 and therefore is classified as having a less than a 1 in 1000 annual probability (0.1%), of flooding from rivers or the sea. An extract of the flood map for planning is shown in Figure 2. with the full version included in Appendix A.
