## ARCHEOLOGICAL INTERPRETATIVE REPORT

**Property Address:** Bramblehill Farmhouse,

**Prepared by** Richard Pocock MSc MRICS

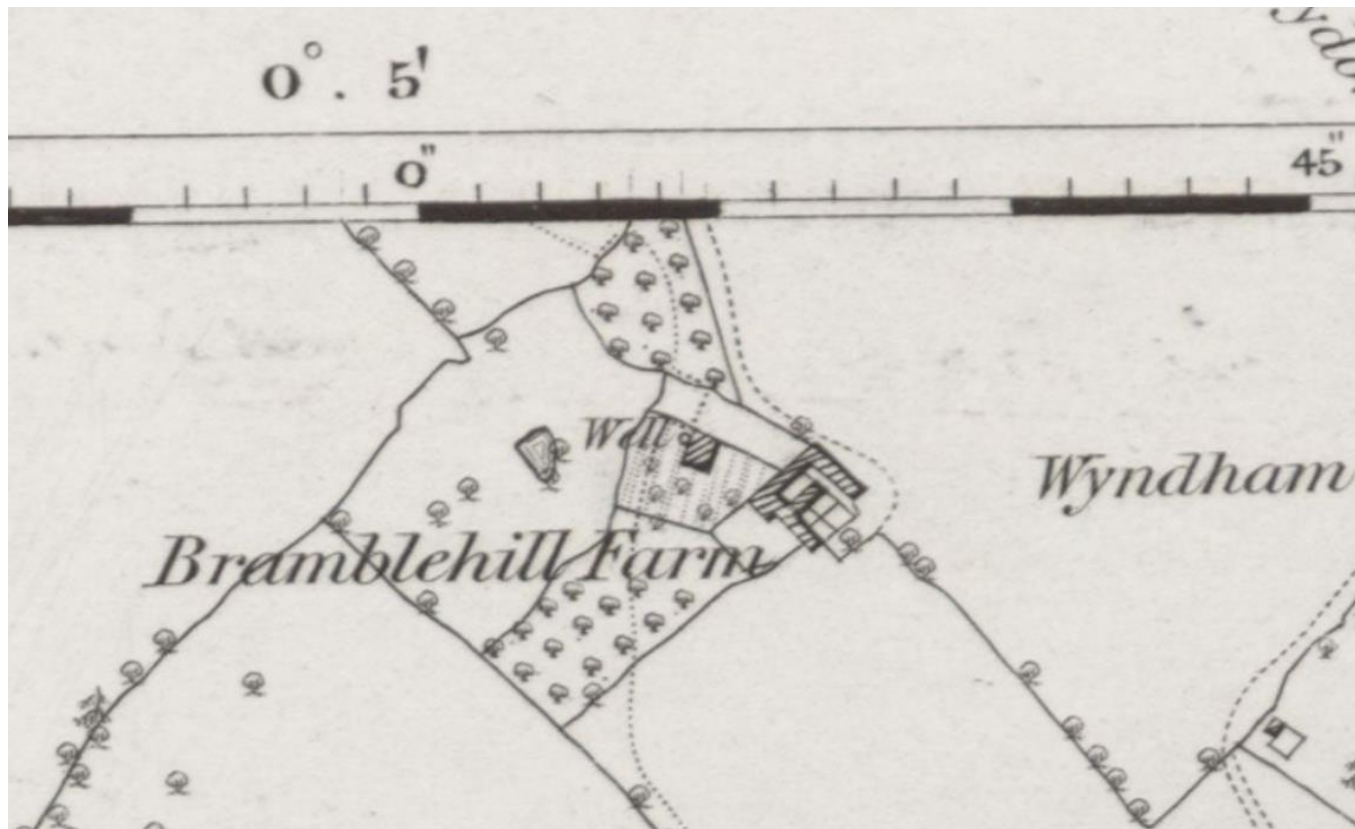
1874

The main house is shown in its unextended state, with a marked well to the rear. Outbuildings at this date comprise the former farmyard lying to the immediate east of the house where the modern car parking area is now.

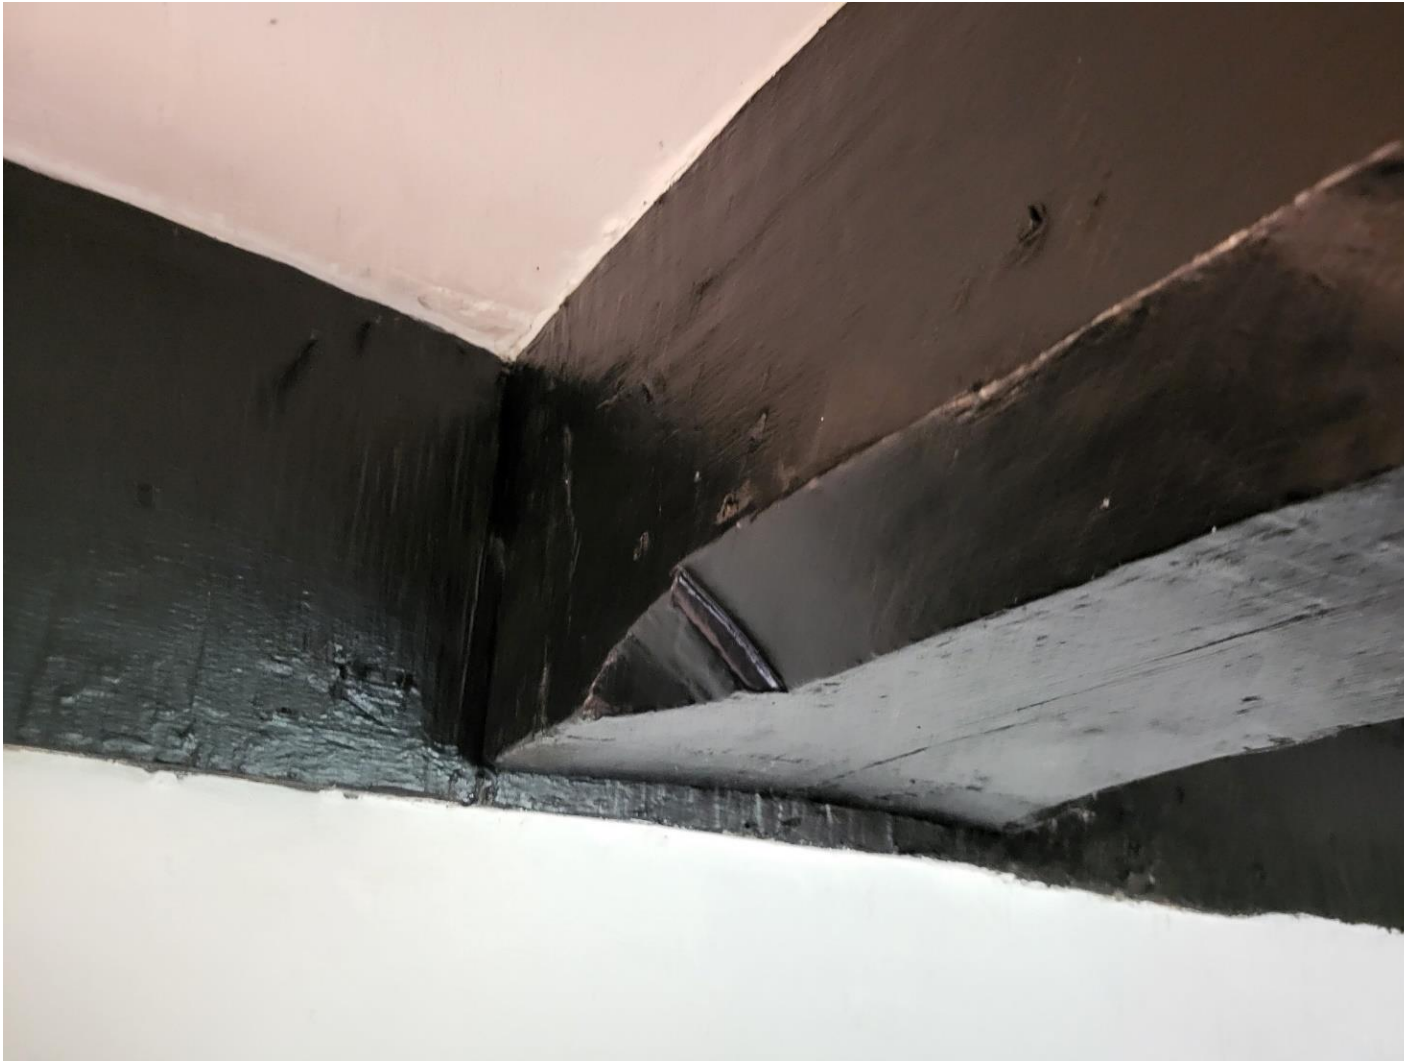
The ground floor is solid and was likely originally either stone slab, or rammed earth. The first floor structure comprises spine beams, with rib joists. The spine beams are chamfered and with stops that are a transition between lamb's tongue and curved step.

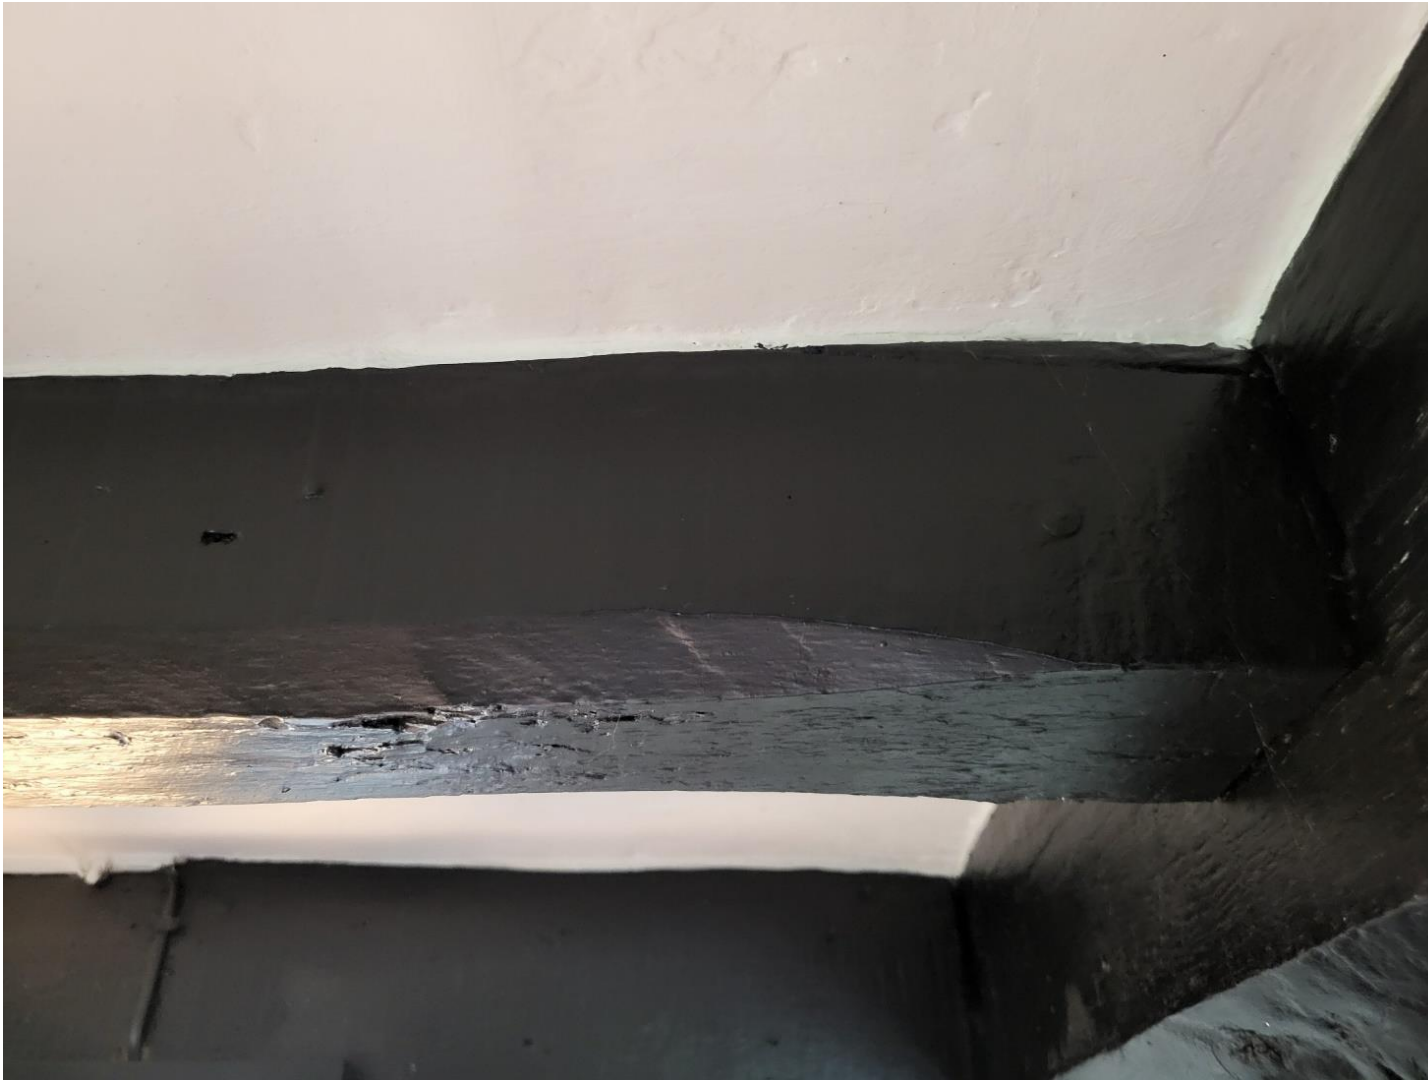
The joists are also chamfered, with run out stops.

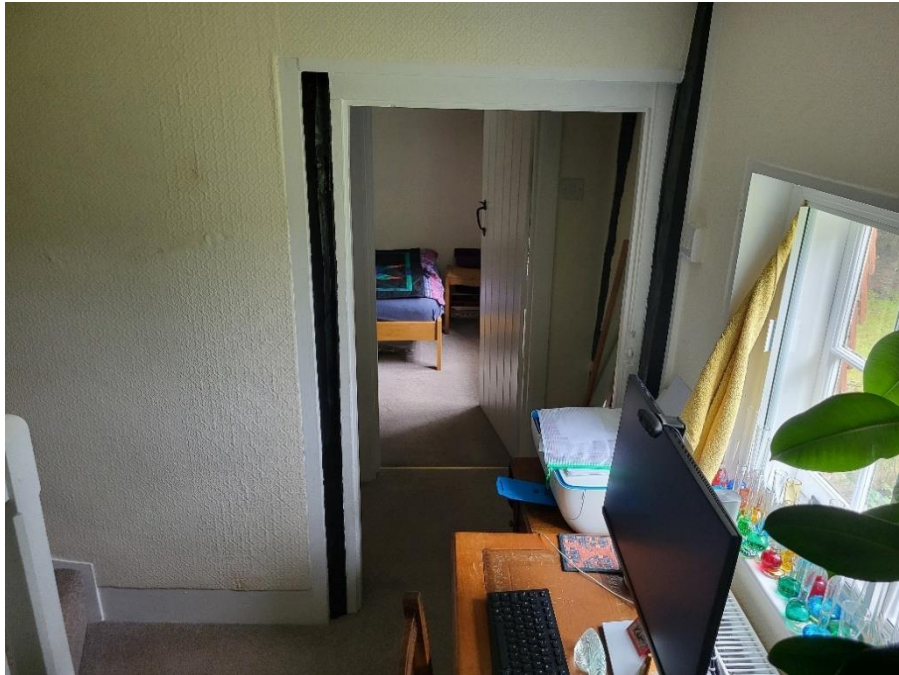
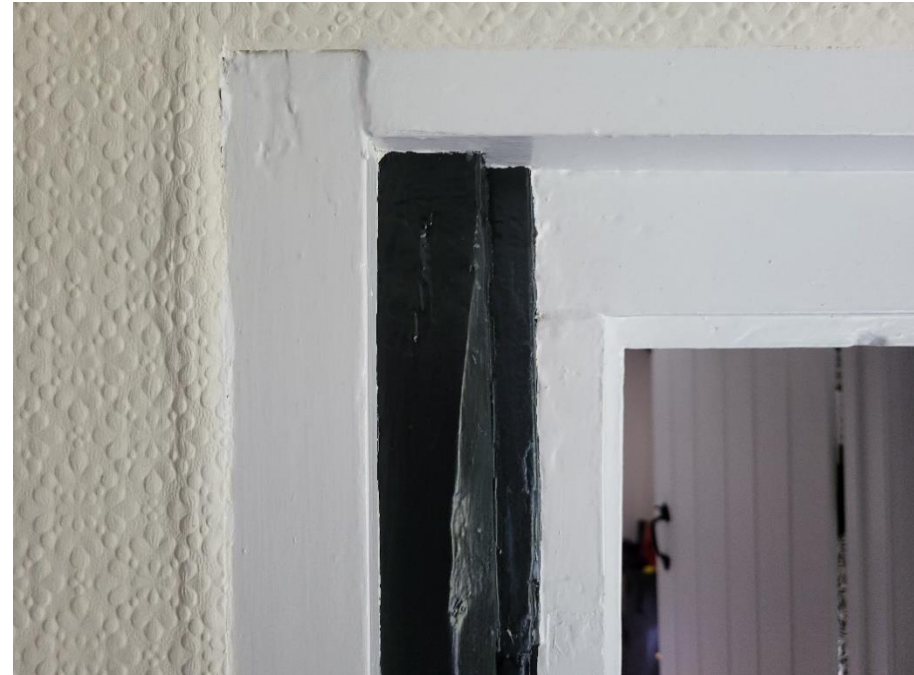
On the first floor, the room layout is similar to that of the ground floor. One original landing doorway remains in situ, but there was a further example opposite that has been infilled and for which there is now no sign. The original surviving landing doorway, shown below, is a pegged jointed oak insert, with run out stops visible that compliment those of the floor joists and can reasonably be considered contemporary.

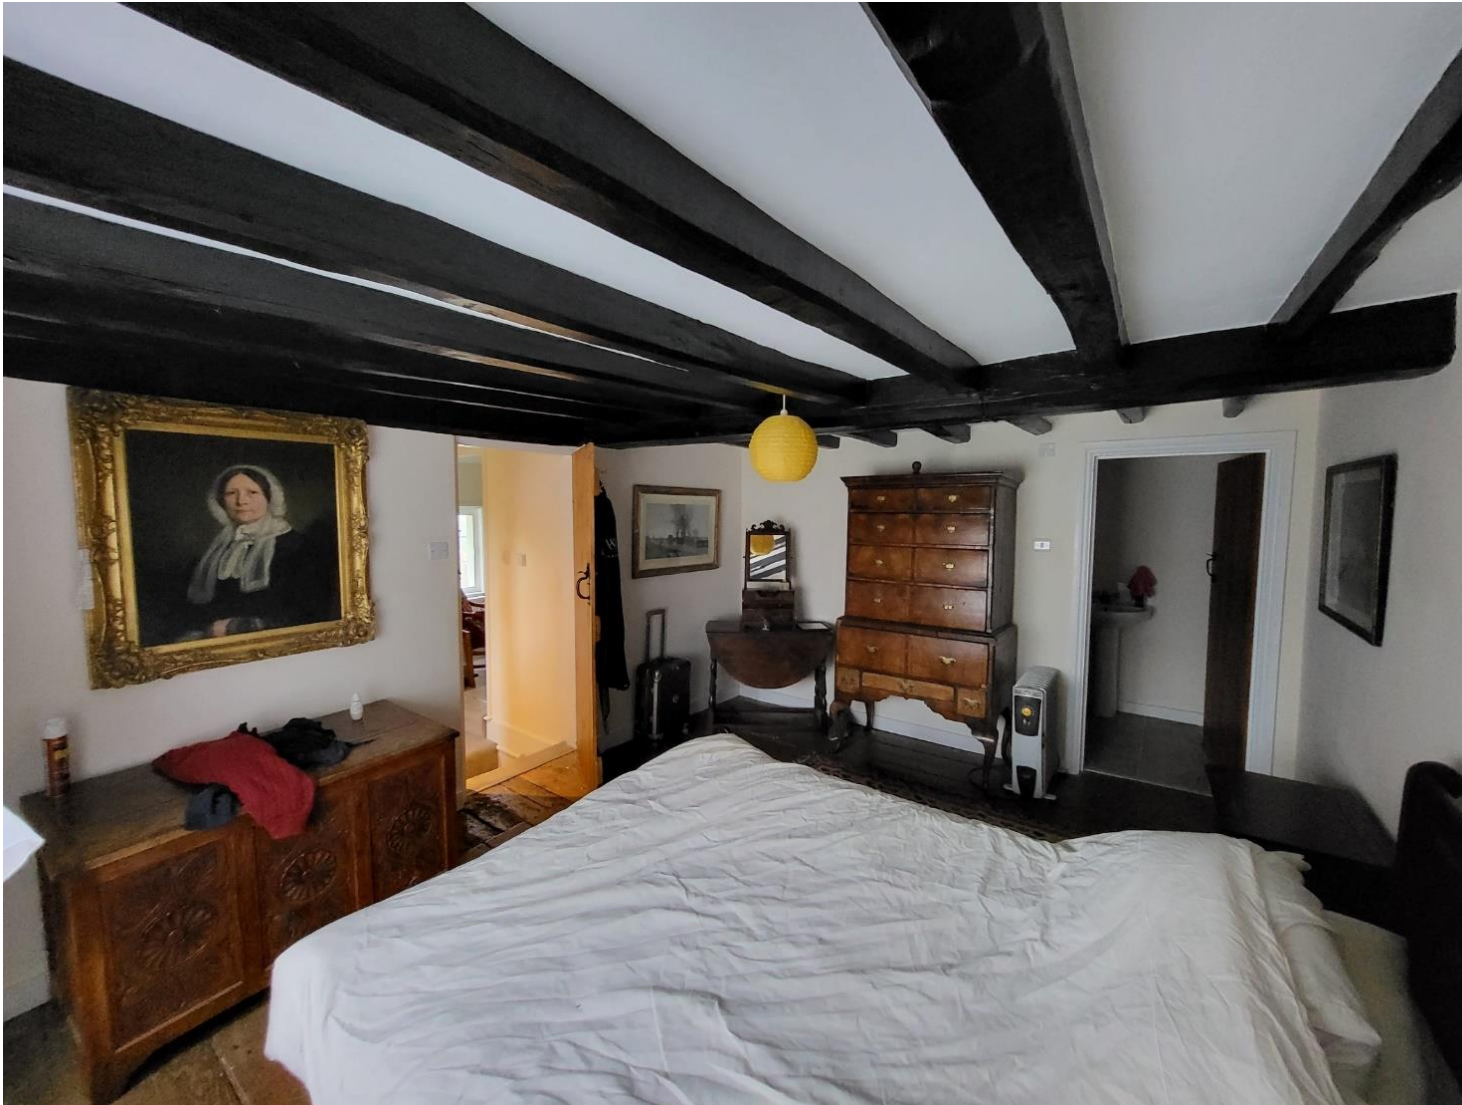
The south bedroom has a partition at the west end.

This is modern and crosses the joists and is clearly not of this phase. This was once one large room.

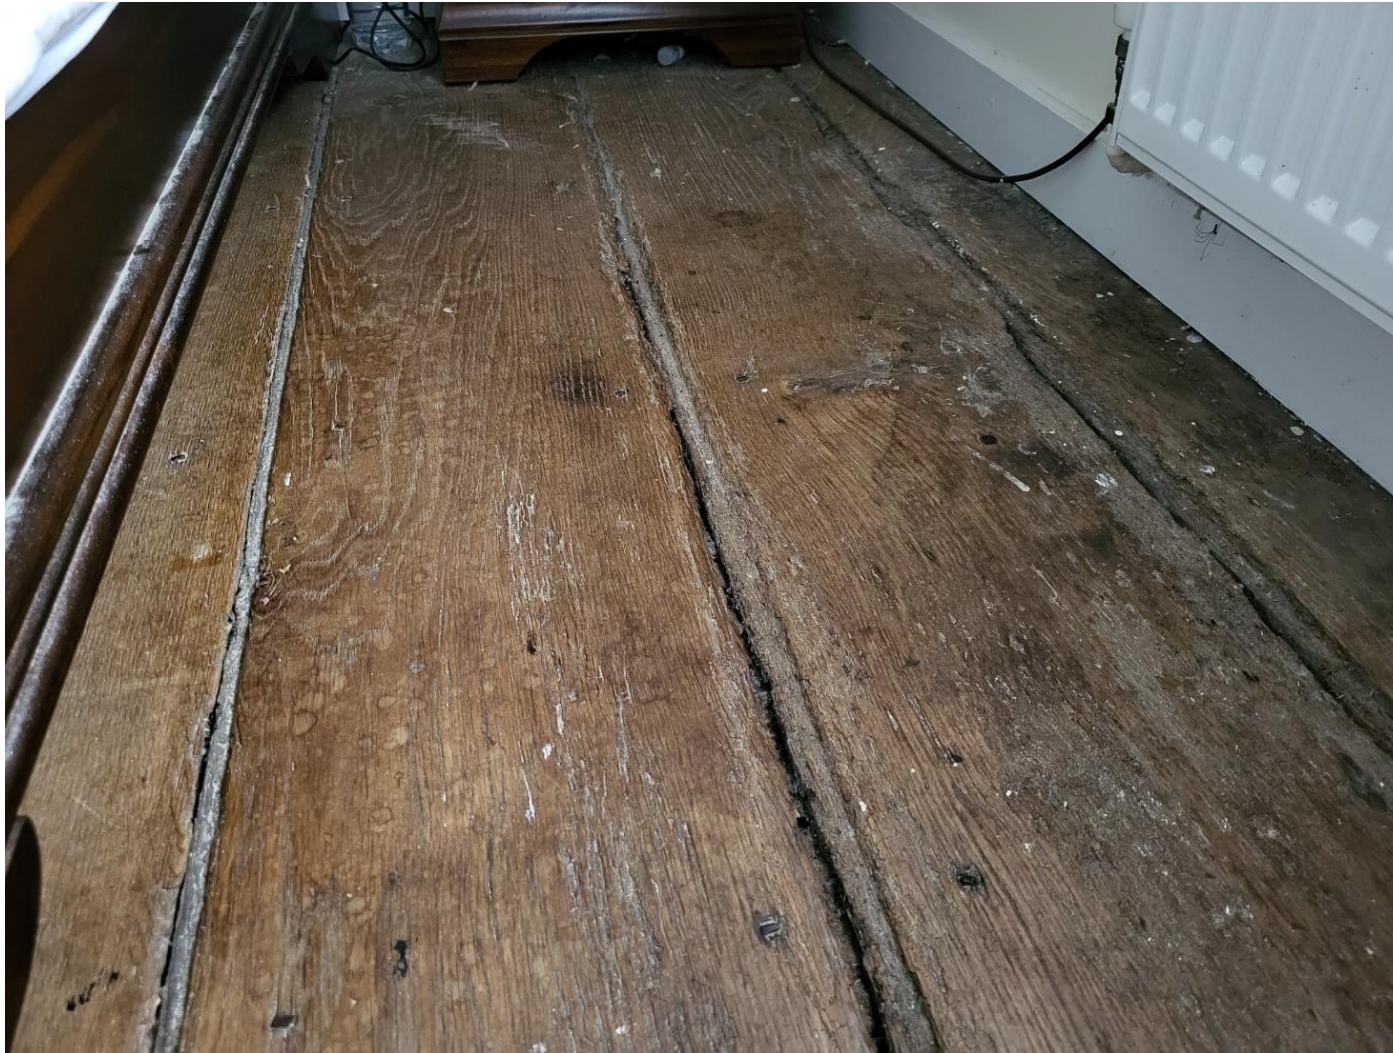
First floor boarding visible in the south bedroom comprises rebated tongue and groove wide plank oak boarding typical of the early to mid-17<sup>th</sup> century. Whether this extends to the north bedroom is not possible to ascertain without removing floor coverings.

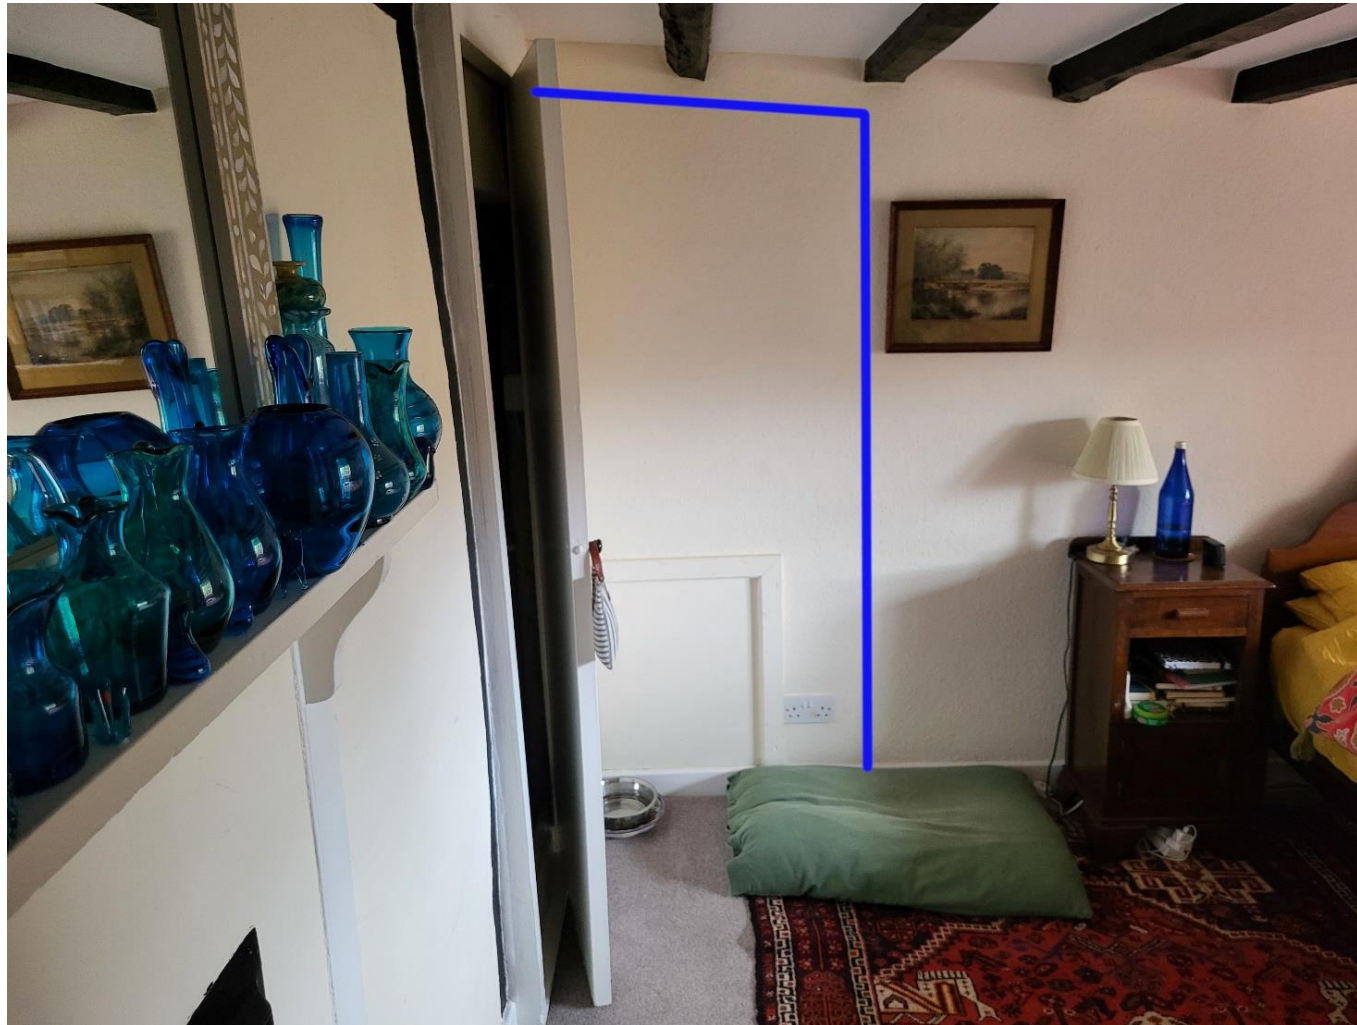
There is a rear facing doorway to the upper part of the outshot partially visible within the north first floor bedroom within the cupboard adjacent to the fire breast. The door would be in the position shown below, marked out in blue.

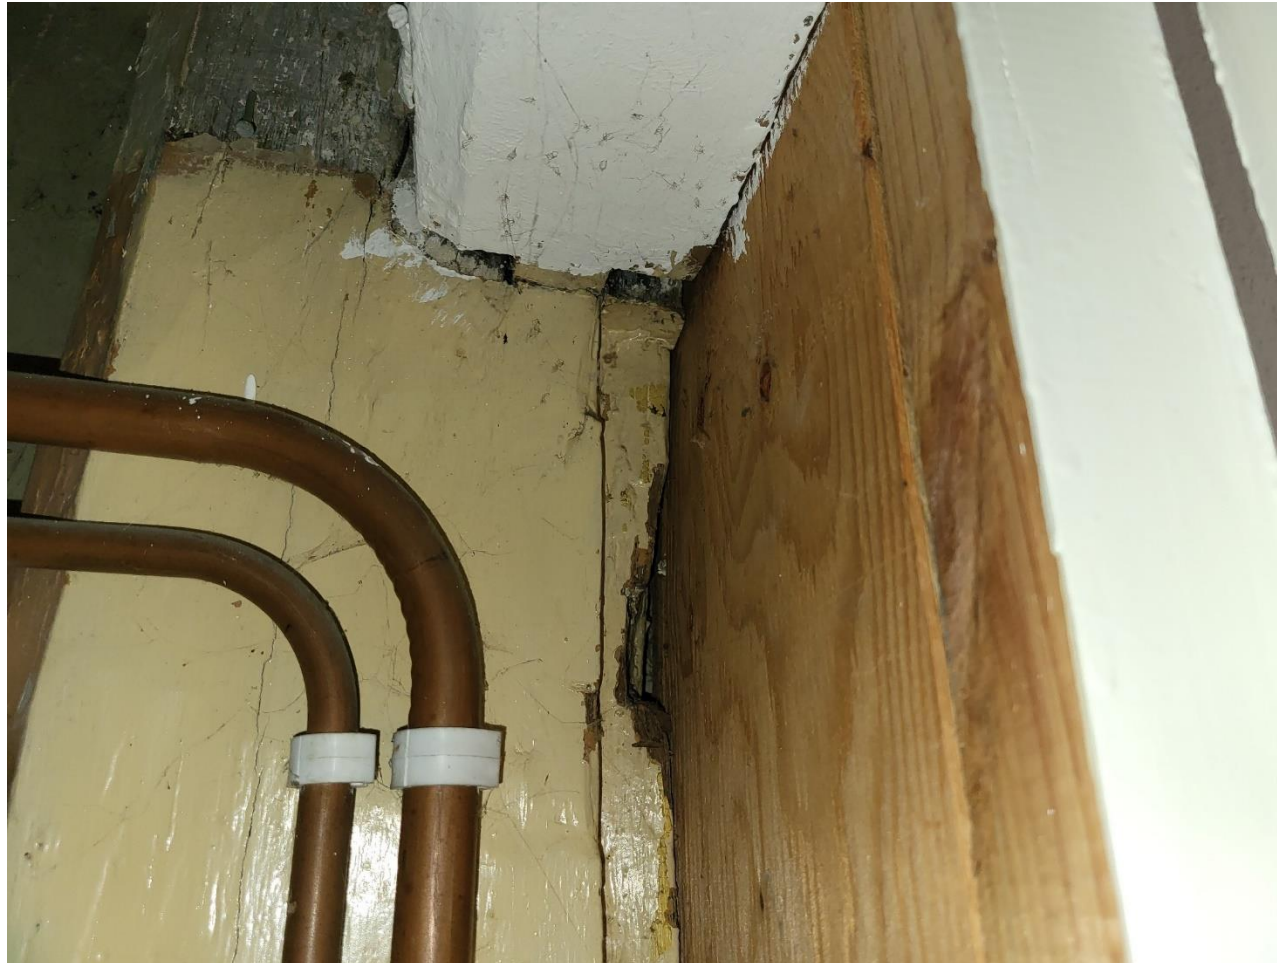
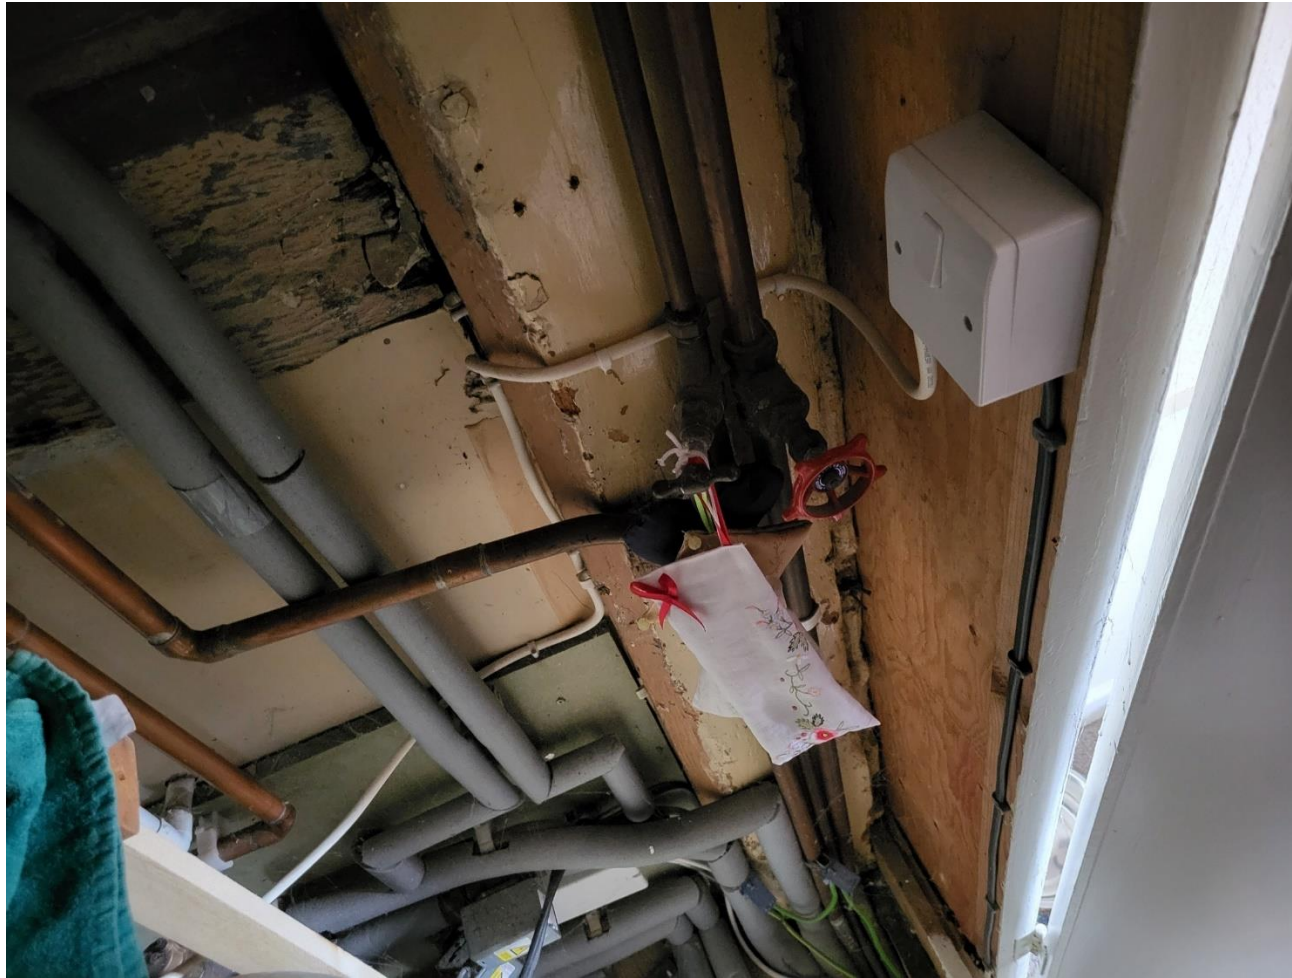
The evidence for a doorway is fragmentary at best and comprises a rebate carved into the main bay post visible against more modern lining.

There is no sign of an opening on the reverse side in the loft space of the outshot and the wattle and daub (whilst damaged by more modern service runs) does not appear to suggest that there was ever a void space opening into that upper area. The reason for the rebate carved into the bay post would indicate a door position, but it is probably a superseded attempt to latterly provide higher level access to the space at the top of the outshot rather than something provided at the outset. There is a mortised rail across this part of the frame, which would have also limited access. The date of the 'doorway' remains unknown.

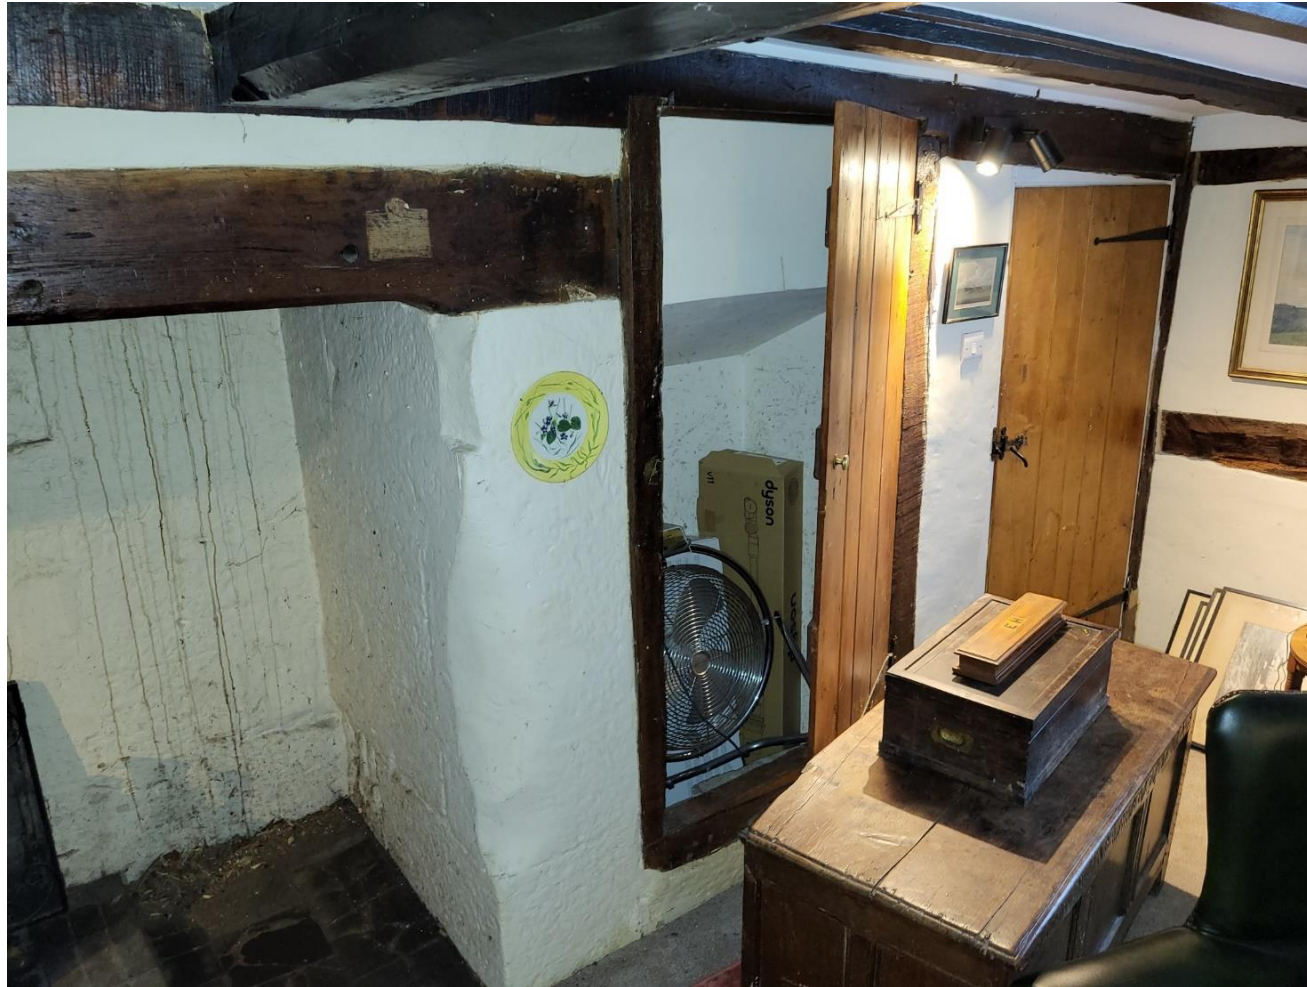
The original stair position is typical of the era, winding up against the fireplace. However, later alterations have led to the stairs being reversed on the ground floor when the building was converted to two dwellings. The former stair entry was in the larger of the two dwellings against the fireplace where the stair access door is still retained (albeit a later door with older strap hinges) and the area of the stair entry is now a cupboard.

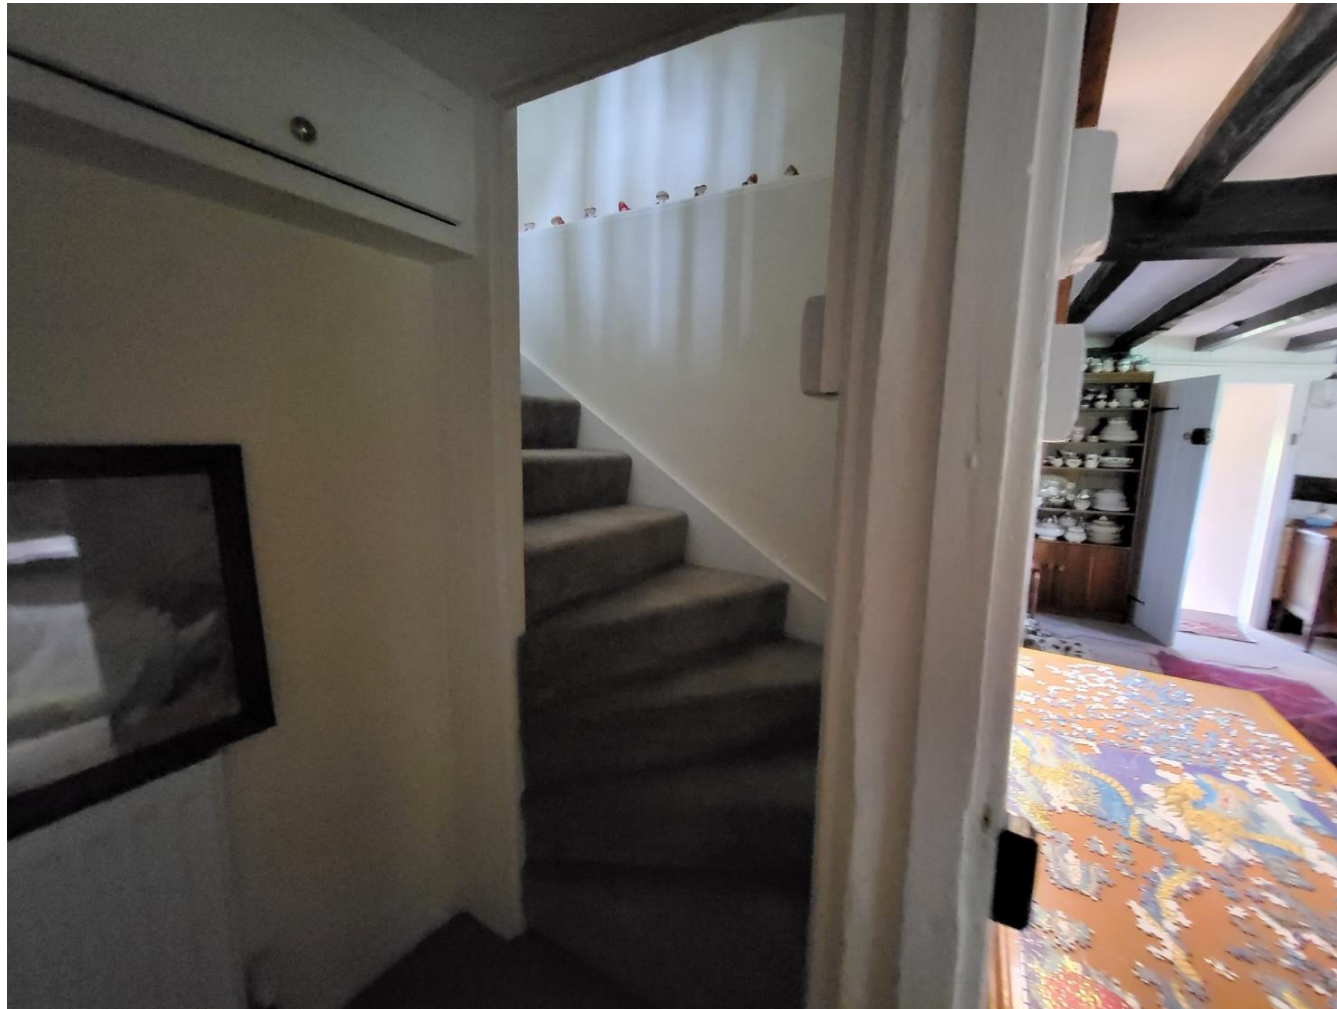
The present ground floor stair entrance is wholly reversed from the original and the doorway opening to the stair treads is a modern opening expected to date from the same time as the south extension due to the design of the upper parts of the stairs from the first floor up.

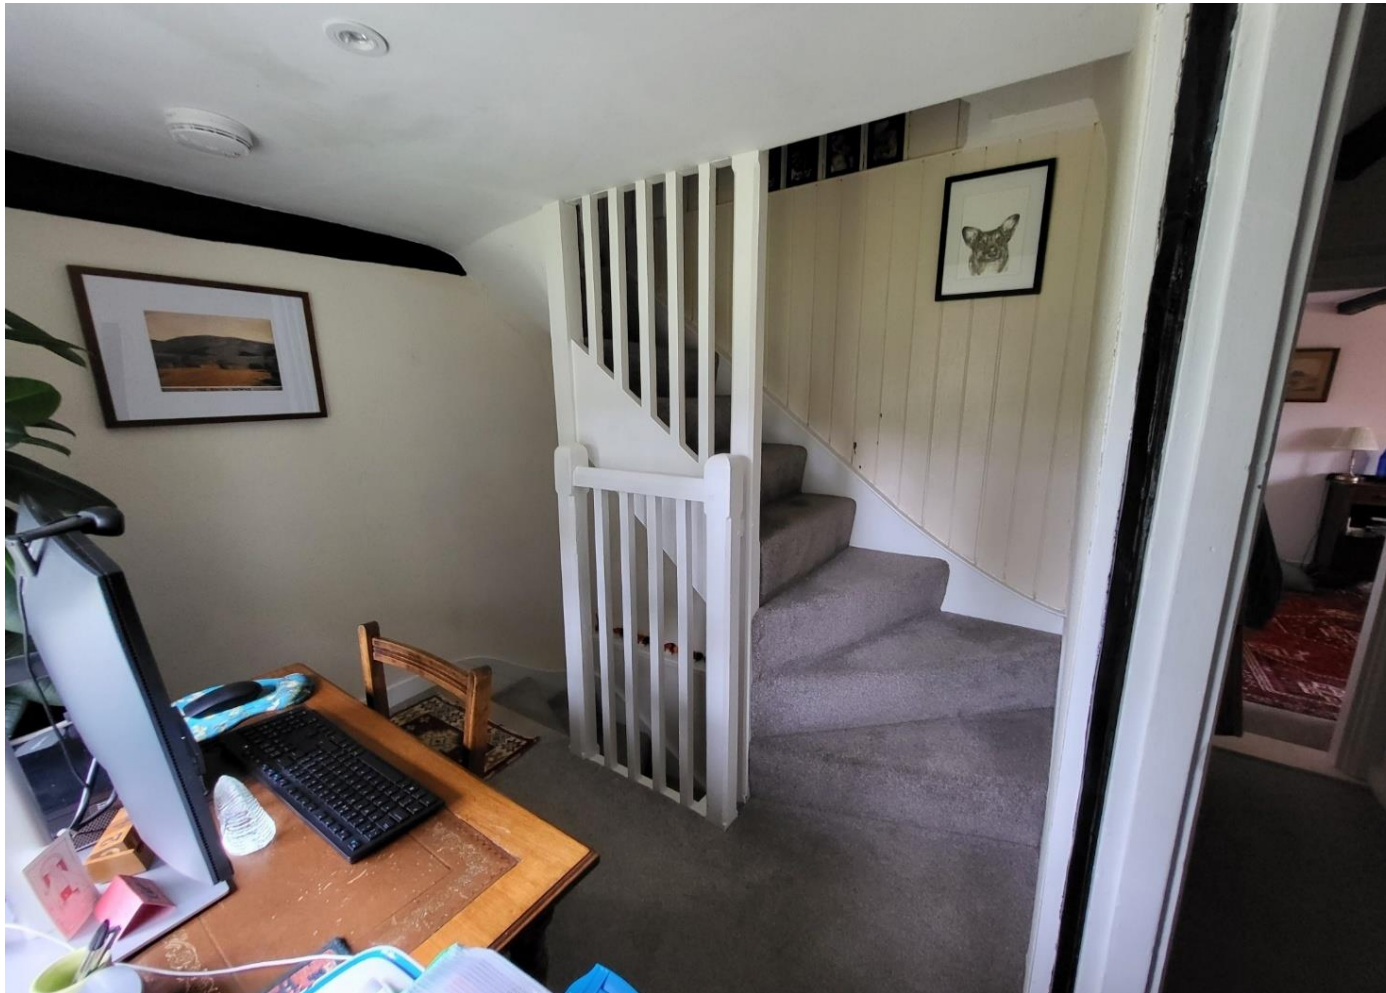
From the first floor upwards, the stairs follow the original wind and direction of rise, but have been replaced around the same time as the south extension, as the newel design is the same as the general decorative scheme of that extension.

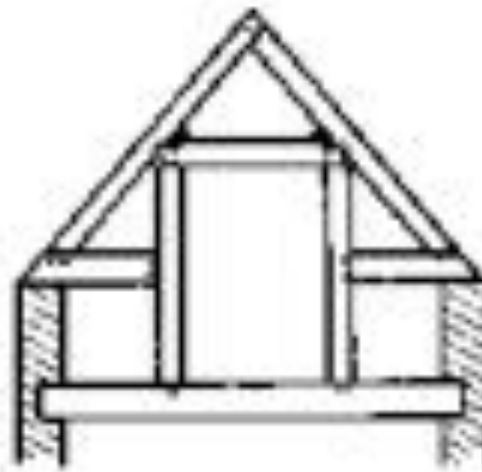
Dropped Tie Truss

The roof is a dropped tie fully trussed roof fabricated in oak.

The dropped tie is a variation of a trussed queen strut, side purlin roof, but its design allowed, by virtue of the dropped tie arrangement, for there to be a usable loft floor along with wider roof spans to be accommodated so that the house could be just that little bit wider than a standard farmhouse of the period. The fully trussed nature of the framing structure allowed load from the roof to be triangulated and distributed through the main ties and also the main bay posts of the house to the ground and also, by the nature of the main trusses, allowed for the roof rafter structure to be comparatively thin compared to older un-trussed roofing systems. The dropped tie arrangement allowed load to be distributed across the ties but left considerable lateral shear load being focussed upon the mortise joints of the secondary ties where they connect to the queen posts (below). This is typical of the design, as it was a compromise in respect of framing strength over span/use of the area which was not adequately resolved until butt purlin roofing was more common after the mid-17<sup>th</sup> century.

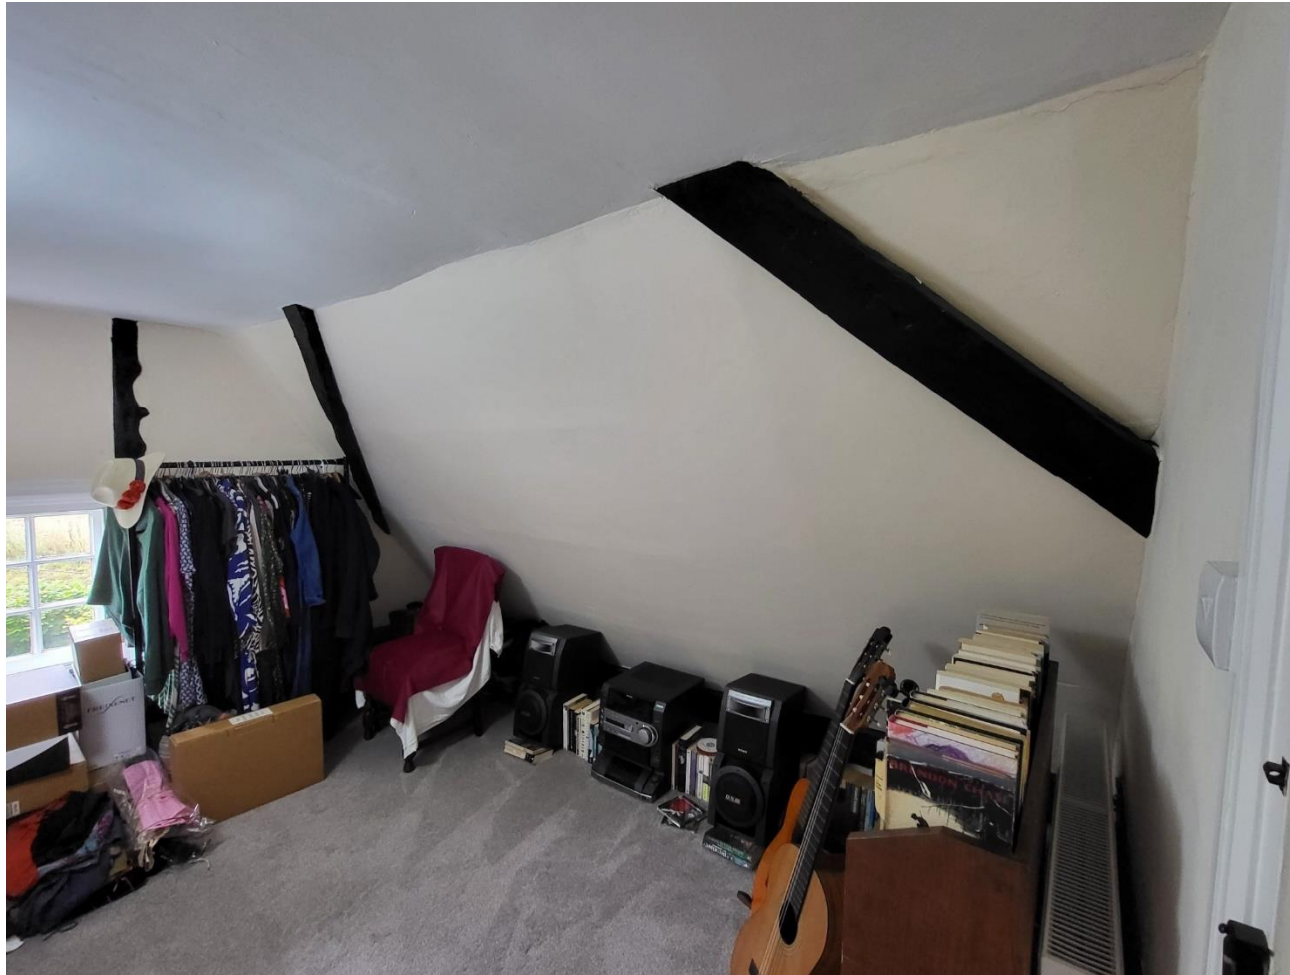
The roof frame has straight wind bracing to the two outer bays.

After 1600, it was increasingly uncommon to have wind bracing installed, with the straight brace design always that much later. The fabrication methodology suggests a date after 1600 and encompassing the first quarter of that century.

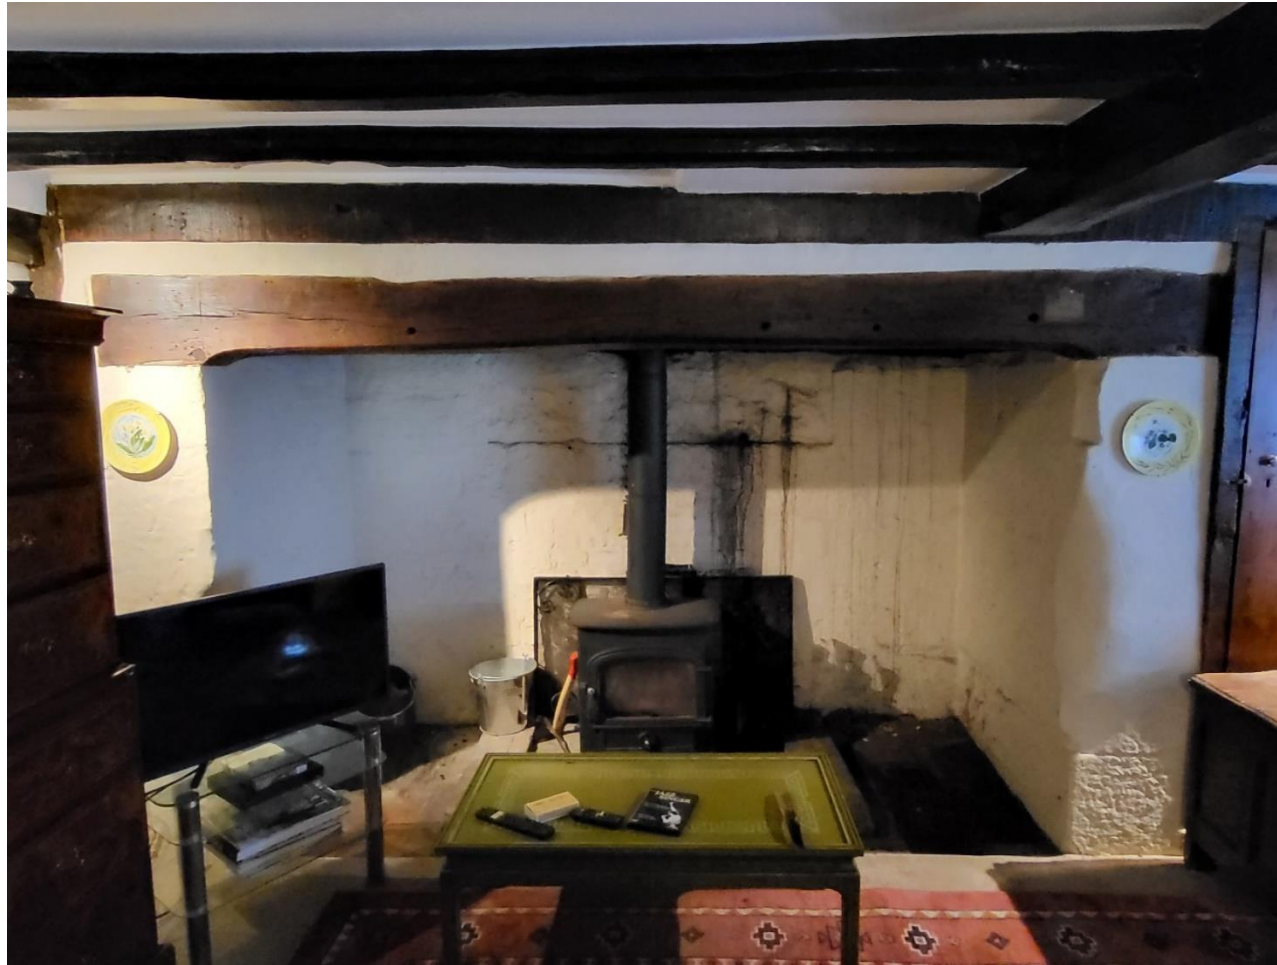
The primary kitchen fireplace is usually the larger example. In this case, notwithstanding the layout of the house, the kitchen can be identified as being within the southerly part of the property.

However, it is noted that this fireplace does not appear to have access to the bread oven, which is a feature only accessible to the parlour fireplace.

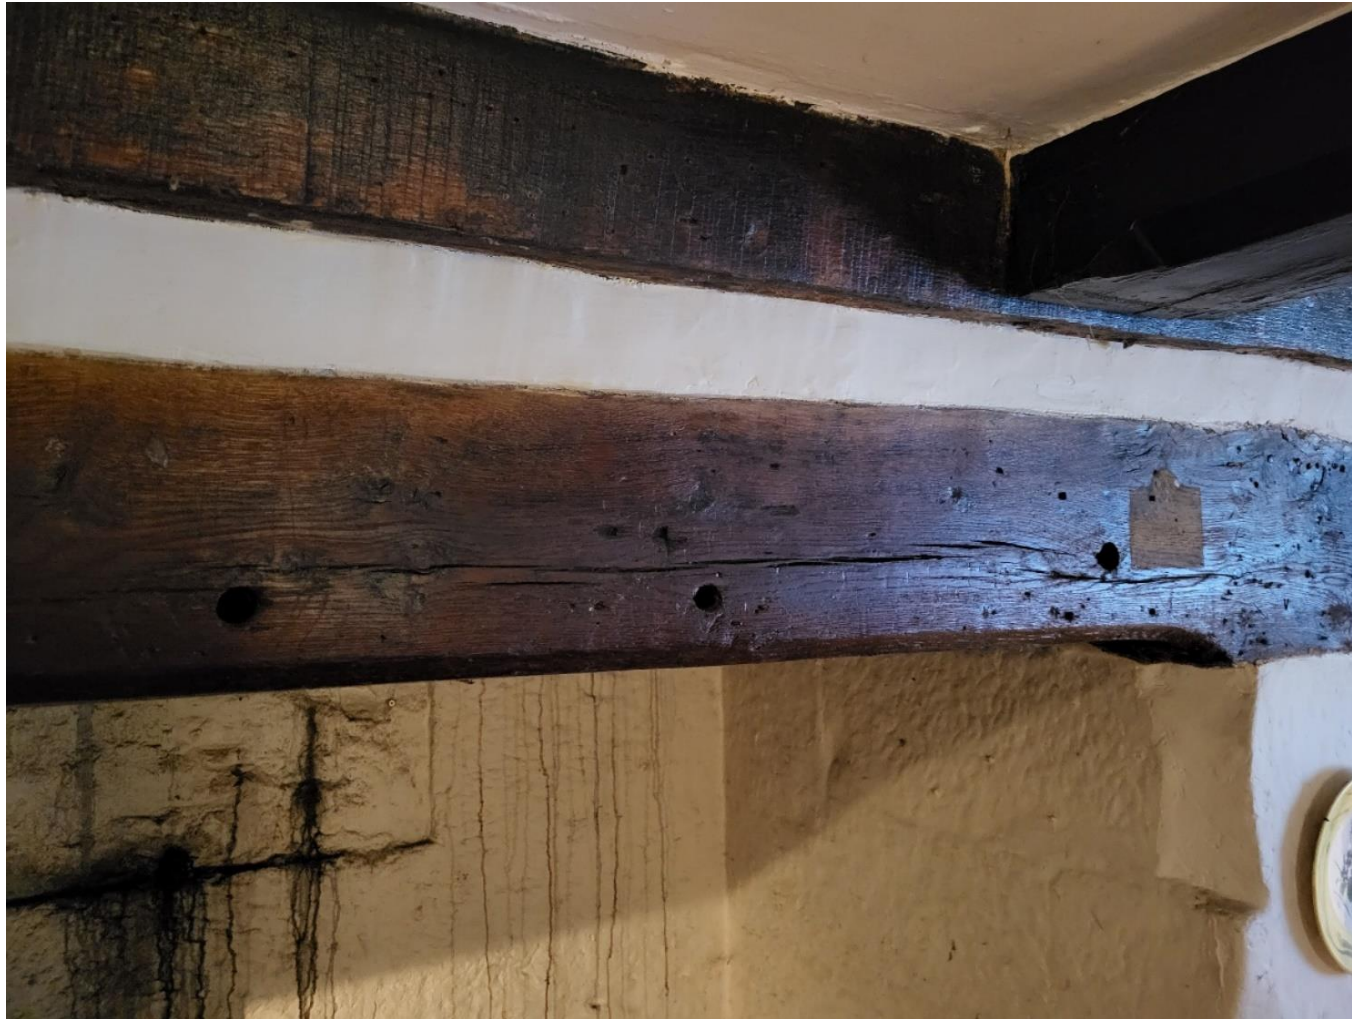
The present inglenook in the southern part of the house has multiple evidence of spitjack bolt positions, together with racking and other cooking ironwork that certainly suggests that this was the primary food preparation room and that the adjacent room (forming the more northerly living room area) was a parlour room.
