## ARCHEOLOGICAL INTERPRETATIVE REPORT

**Property Address:** Bramblehill Farmhouse,

**Prepared by** Richard Pocock MSc MRICS

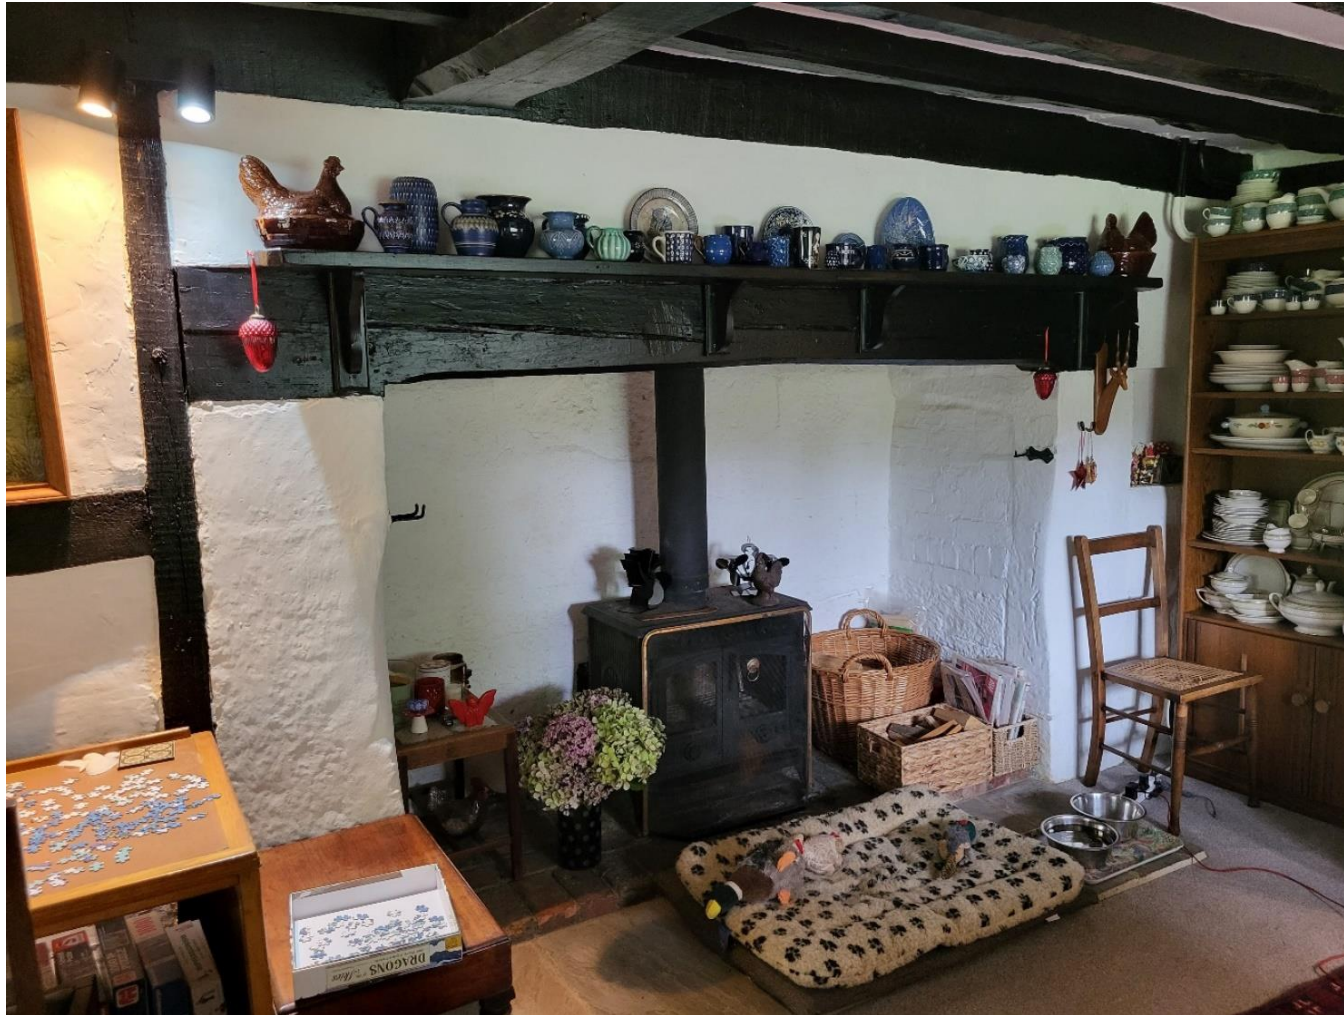
The parlour inglenook is much smaller and less deep and is typical in size and scale to parlour rooms.

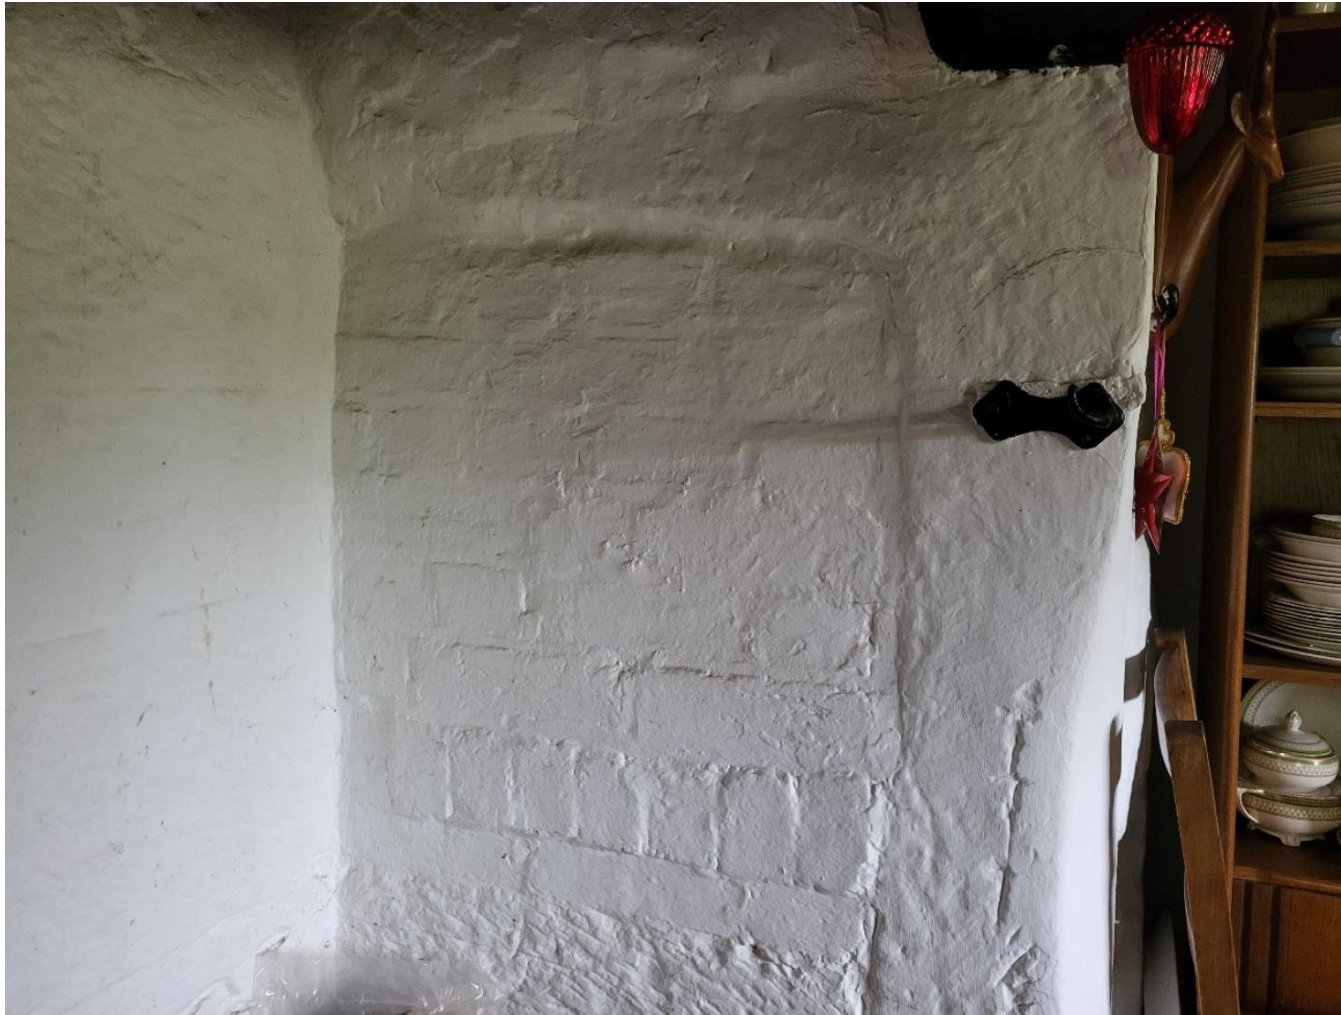
However as noted above, the bread oven lies in this area and not accessible from the primary kitchen side. The bread oven once extended towards the outshot and its bricked-up opening can be seen below.

It seems highly likely that, given the oven's position set back from the line of the rear wall, its structure will probably remain mostly intact behind the brick infilling to the mouth of the opening. The soldier course of the oven floor bricks can clearly be seen.

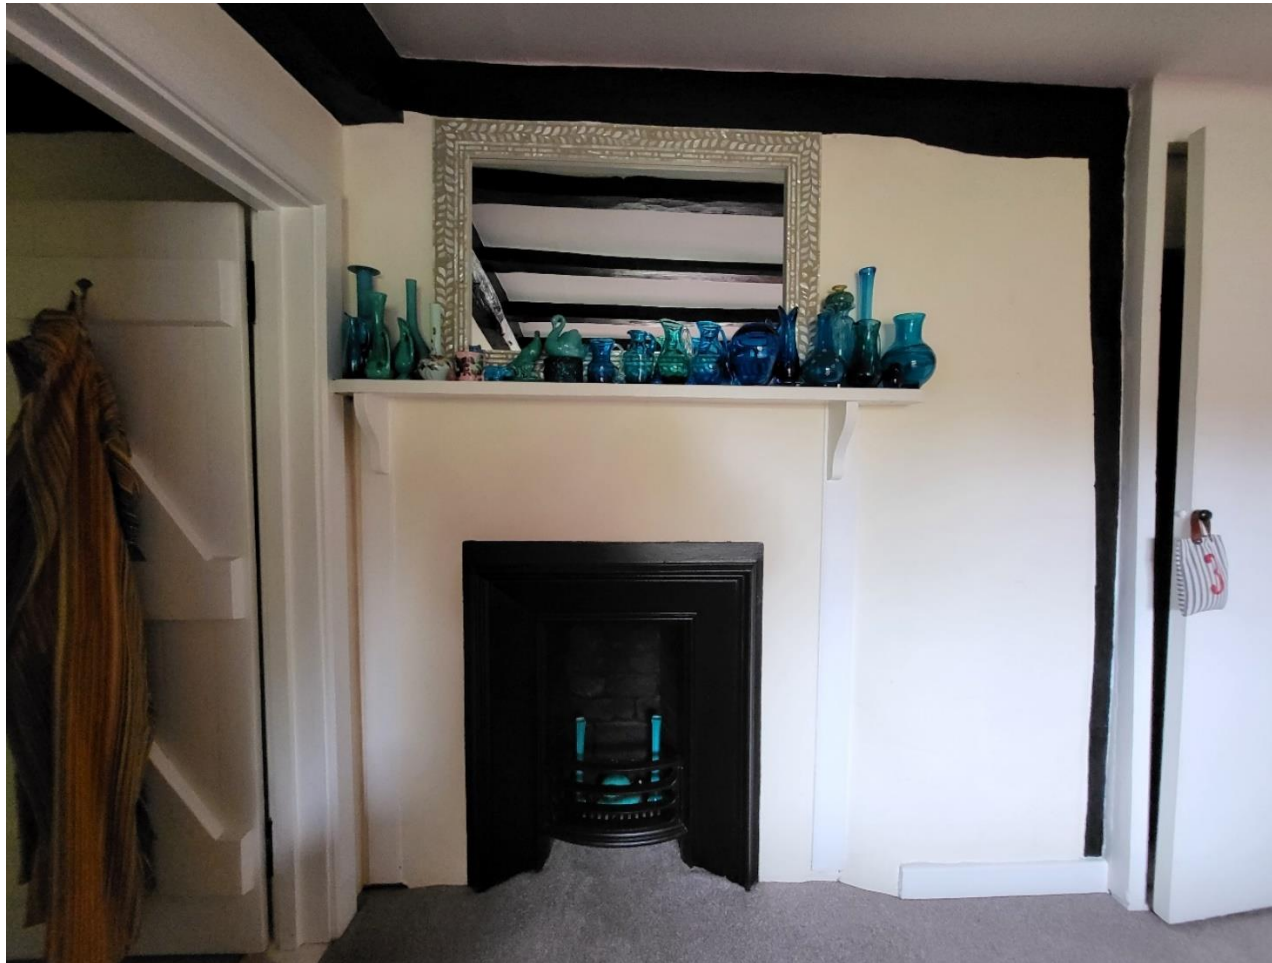
The first-floor fireplaces look to have been added later in the building's life. Indeed, whilst the interior flue brickwork cannot be assessed, it is possible that these might well have been added during the main phase of early modern works, for instance, an 18<sup>th</sup> or early 19<sup>th</sup> century addition (as is often the case).

Opening the enclosure of the flue at some point in the future would reveal the interior flue buildup and study of the bricks and how the upper floor fireplaces have been added to the main flue run will allow further consideration of phasing that is not possible at present.

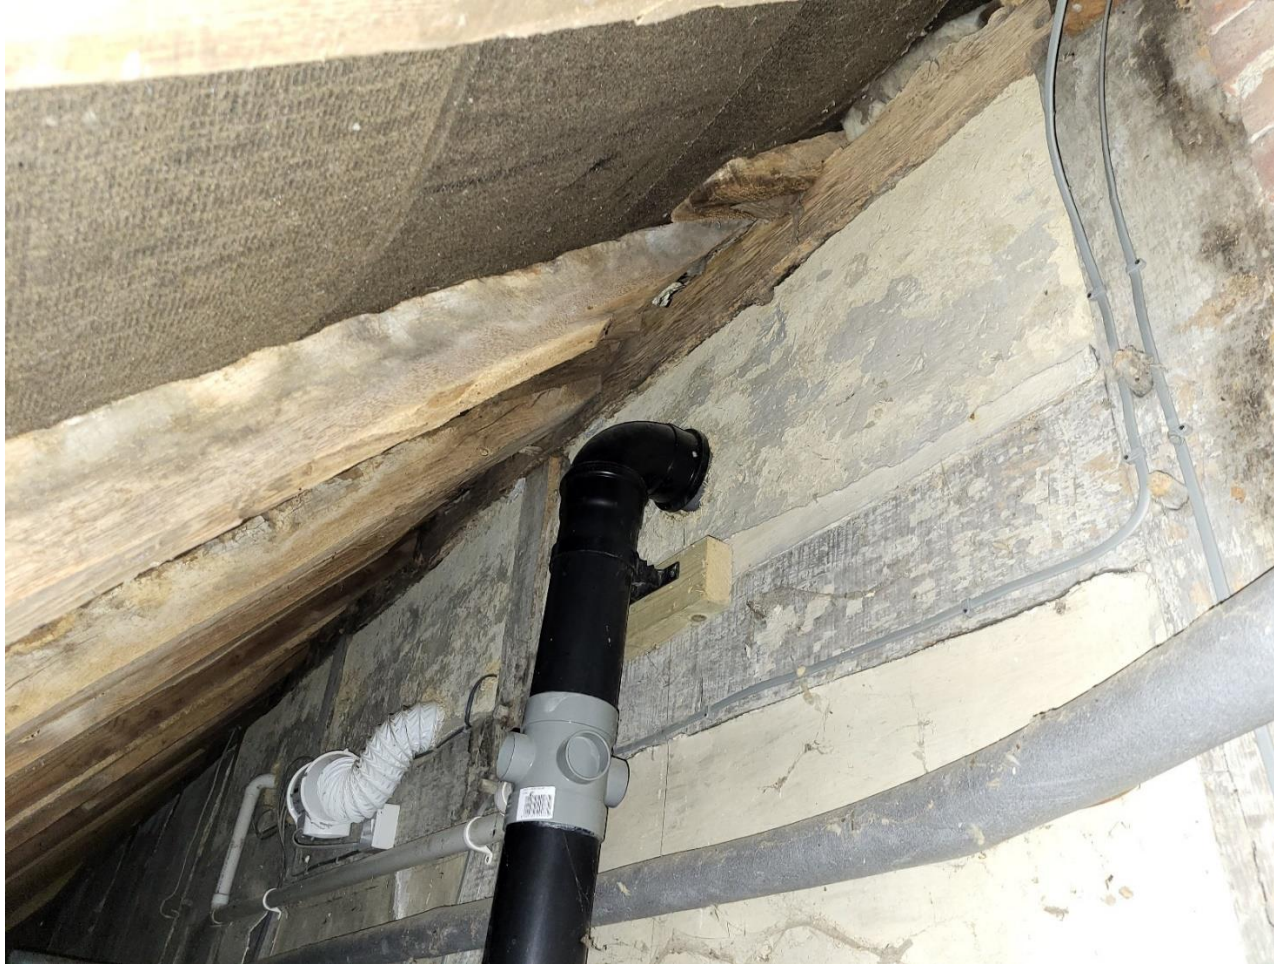
A timber framed outshot was added to the rear. Often these are slightly later than the house frame, but there is no evidence of a substantial time passing between the house being built and the outshot being added. This is evidenced by the complete lack of appreciable weathering to the rear face of the building inside the outshot roofline. Had there been even 50 years, signs of weathering would be obvious. Whilst the

mortise attachments to the outshot are small and shallow, this does not detract from the fact that it would appear that the structure must be contemporary with the main house frame. Pegs are unworn, timberwork shows both unweathered carpenter's assembly marks and also the saw marks where the lumber was shaped. This all shows that the outshot structure must be contemporary with the main house build.

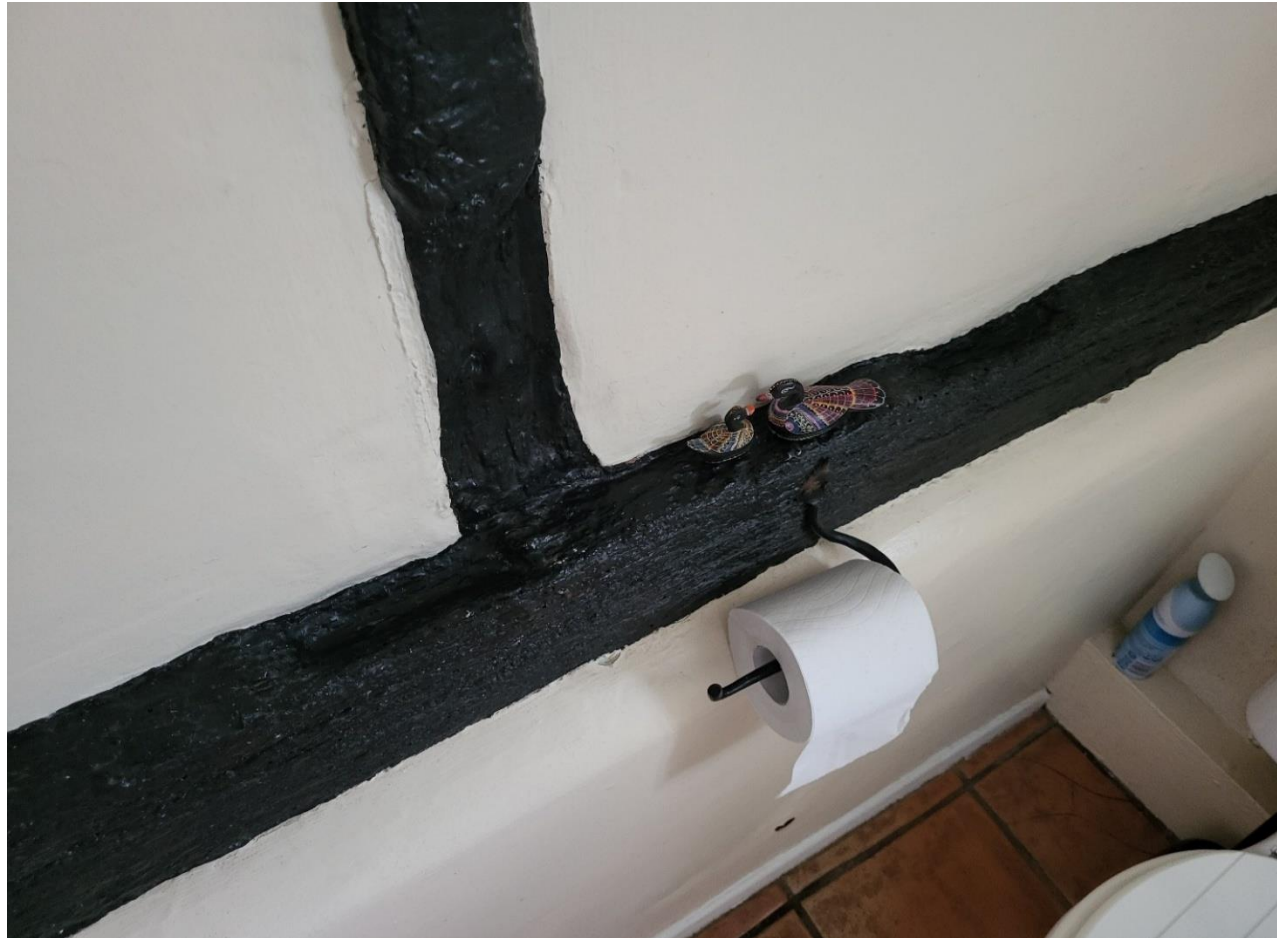
Interestingly, the outshot is one of the only parts of the building where there is evidence of re-use of previously cut material. Whilst the main house is primarily virgin timber, the outshot has a number of re-used pieces, some of which are identifiable as from a previous domestic setting.

Above, the lower rail is clearly a wall plate, with the typical birdsmouth seats for rafters noted. The fact that much of the outshot is re-used timber is not to be considered evidence for re-building, alteration, or a comment on soundness/importance. It is merely a nod to the need to economise where possible.

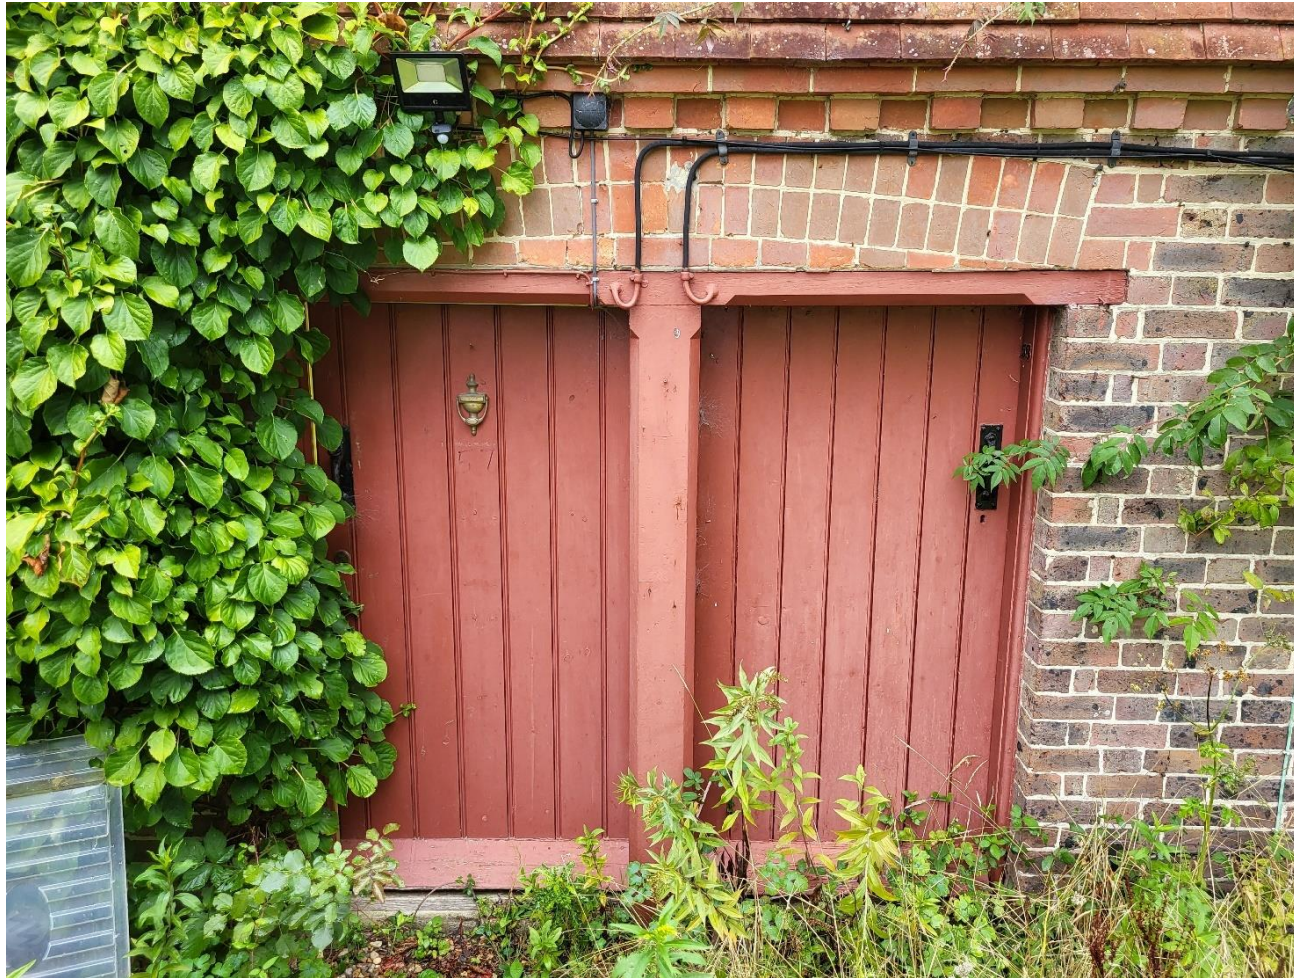
This, in turn is also identical to the door frame detailing of the modern double front door position.

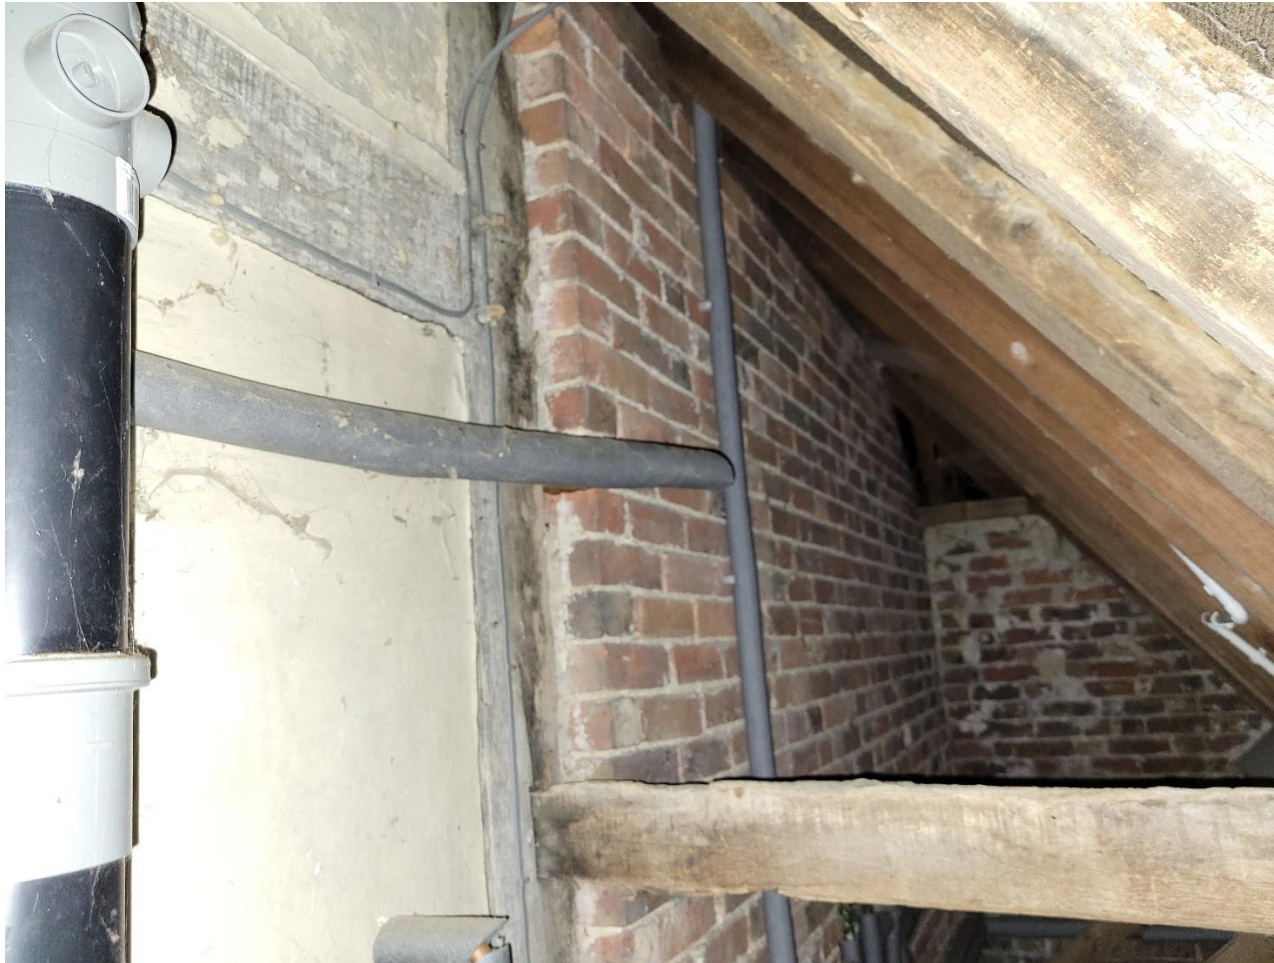
The outshot was lengthened when the extension was added to the house. The structure was extended in brick masonry which is to be seen within the void above the outshot.

Rafters were infilled in softwood and are quite distinct from the older examples adjacent.

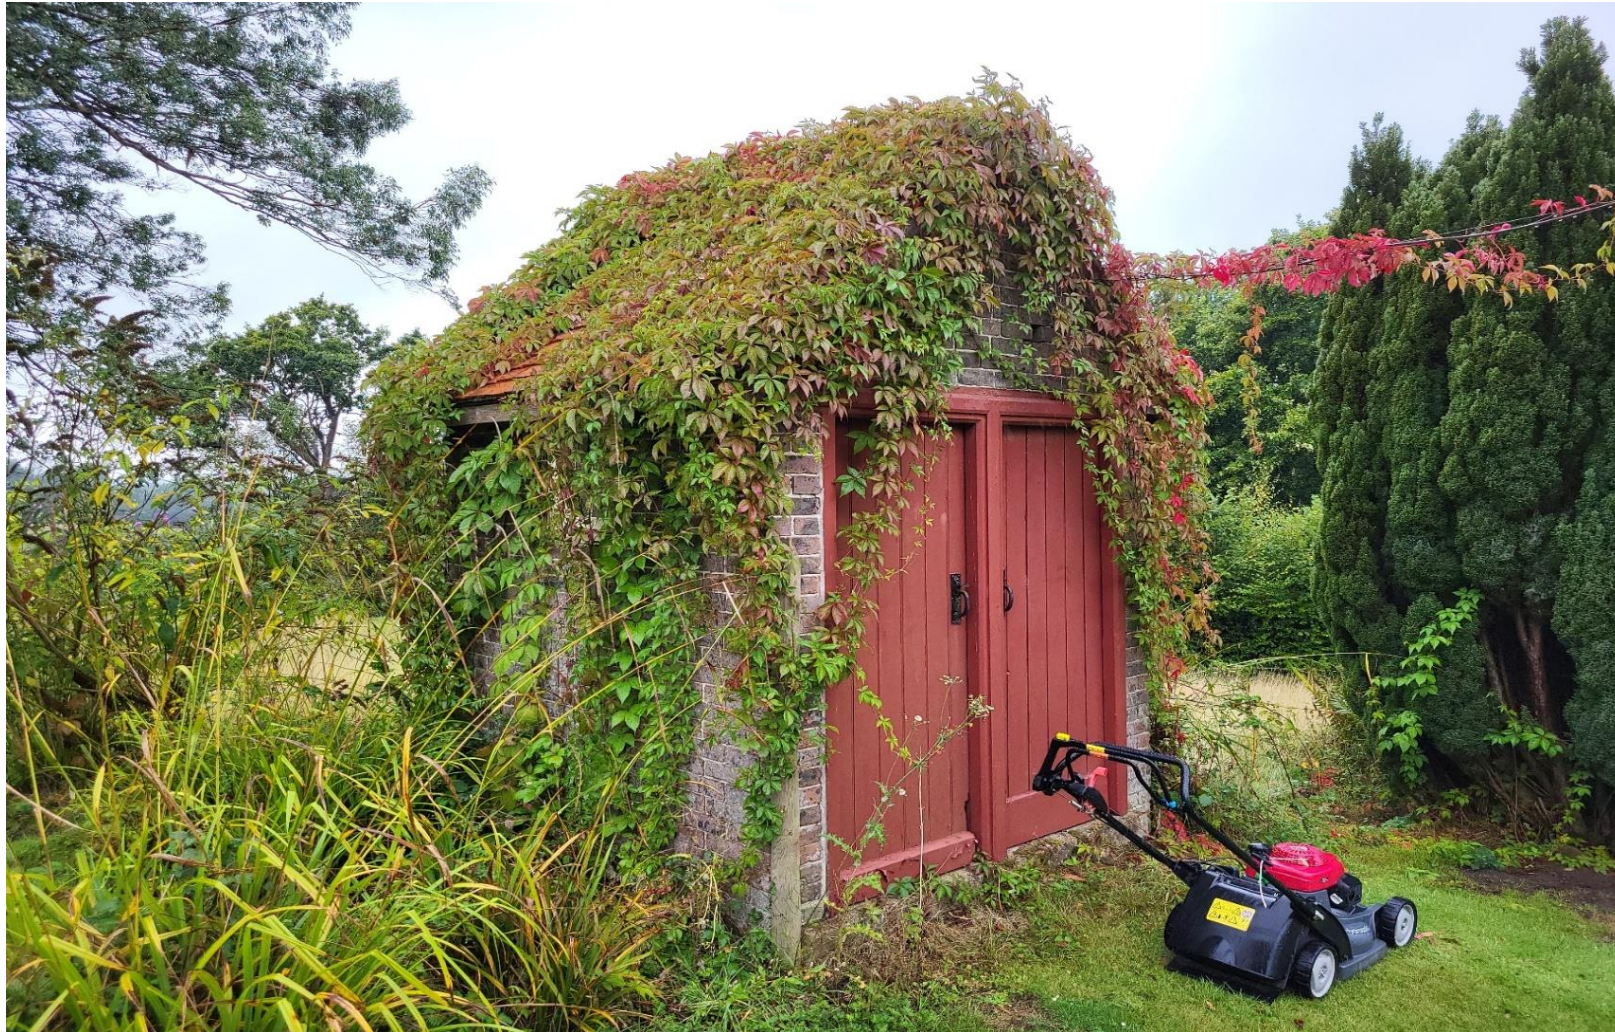
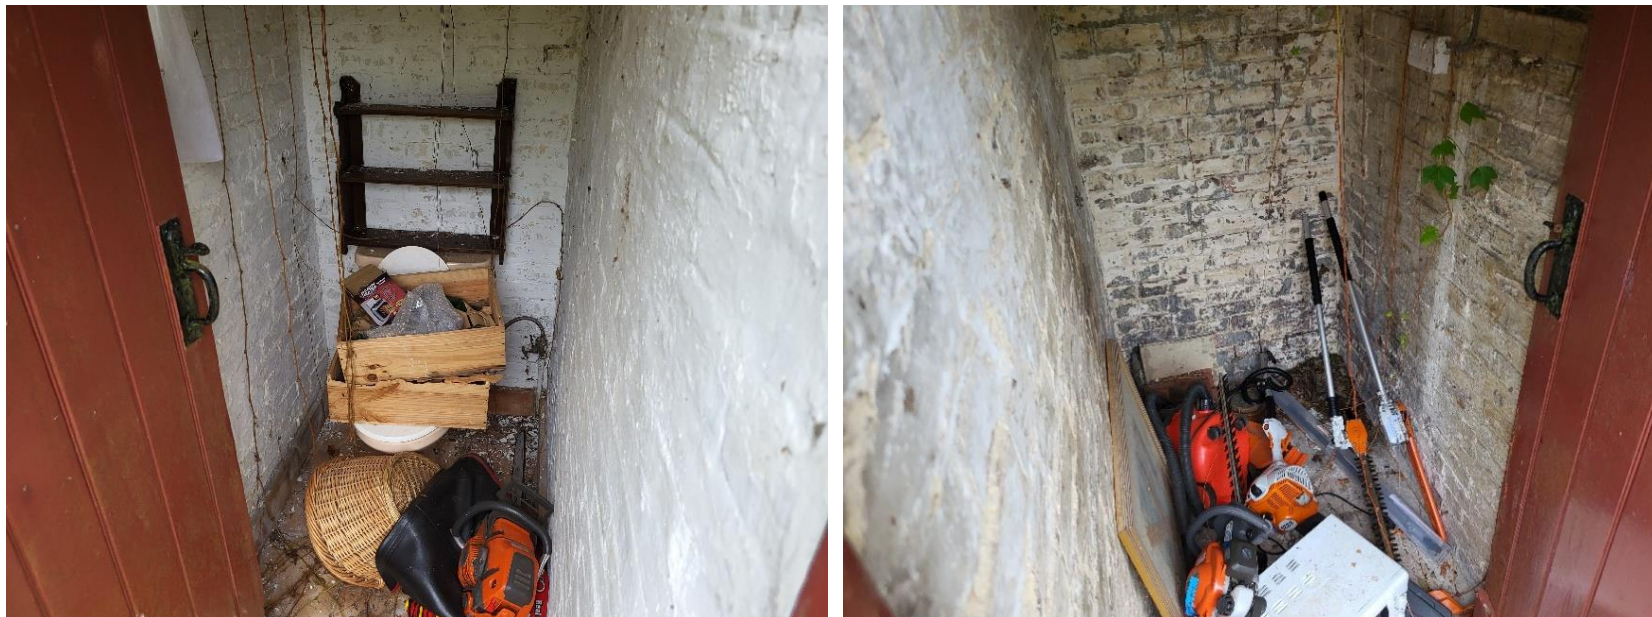
**Impact:** The primary element of impact will be the demolition of a small double privy outbuilding to the south of the house.

This outbuilding is fairly similar in style to the alterations within the main house and seem likely to relate to the conversion of the property, with one WC for one cottage and one for the other. These will have been the only sanitary facilities. The building has been a garden store/potting shed for a while. However, a single WC remains in situ, albeit replaced with a 1980s pan and cistern. It remains functional.

The removal of this outbuilding is not considered controversial in context. The unit is within the curtilage of the listed asset and will be subject to curtilage listing restrictions accordingly. However, its import in respect of the overall site is limited and its loss is not considered to affect the historicity of the asset adjacent.

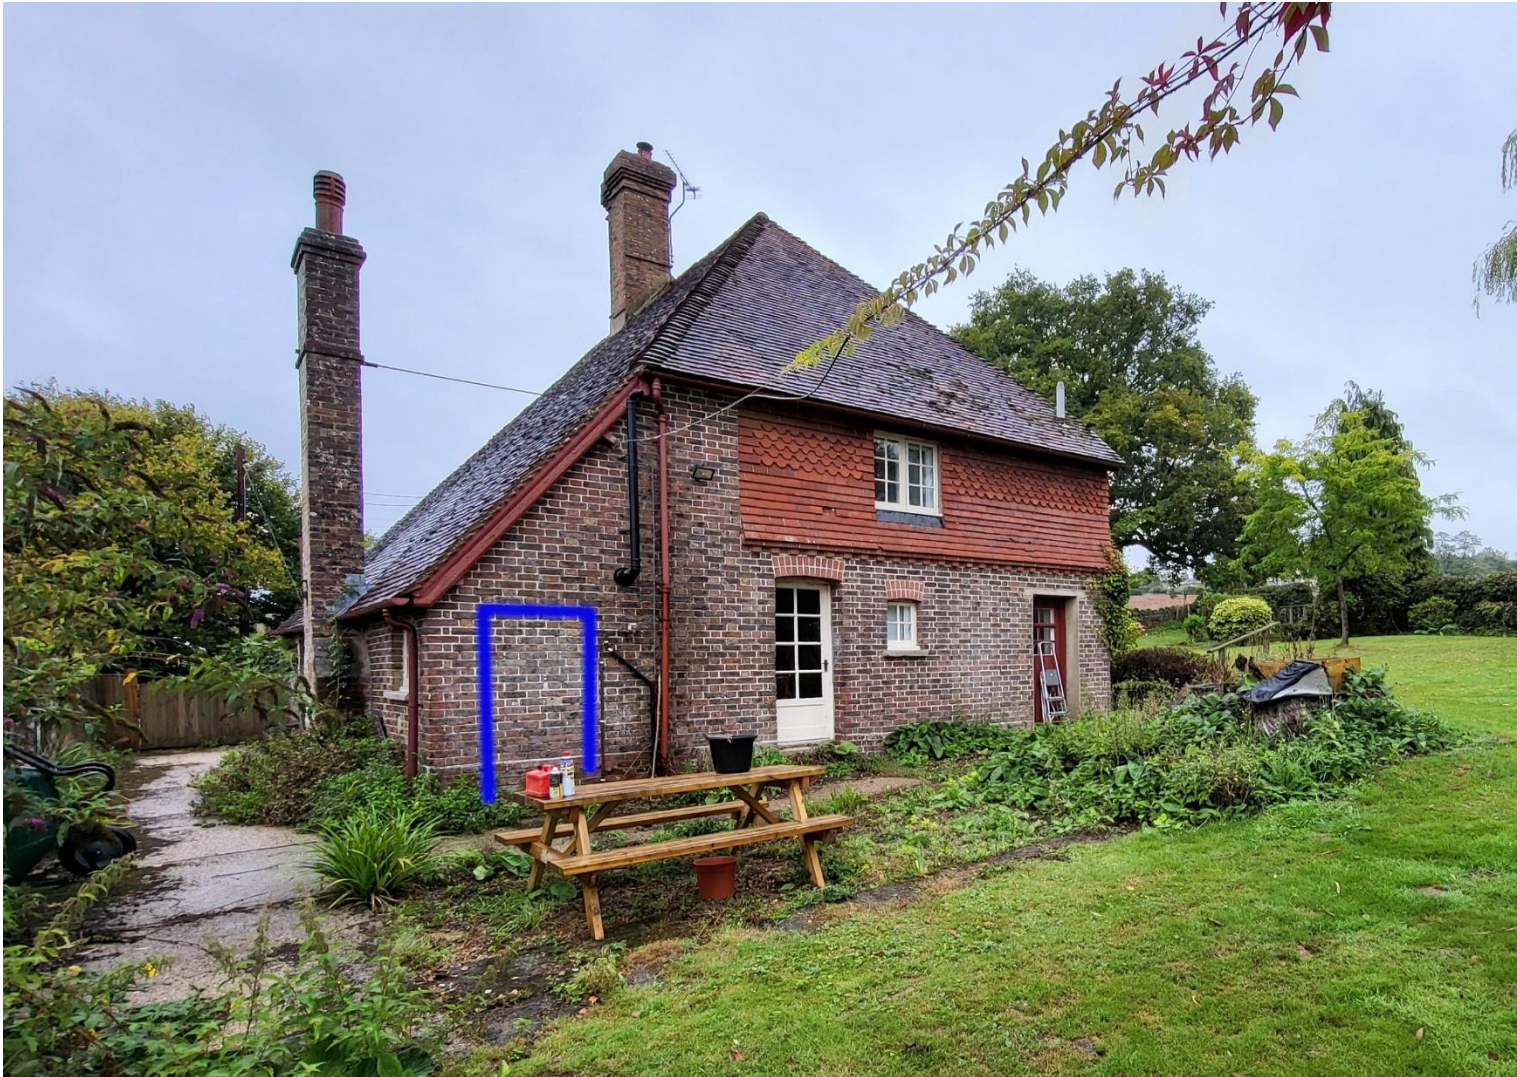
This will result in the loss of the brickwork to the door opening itself, the area of which is depicted in the image below.

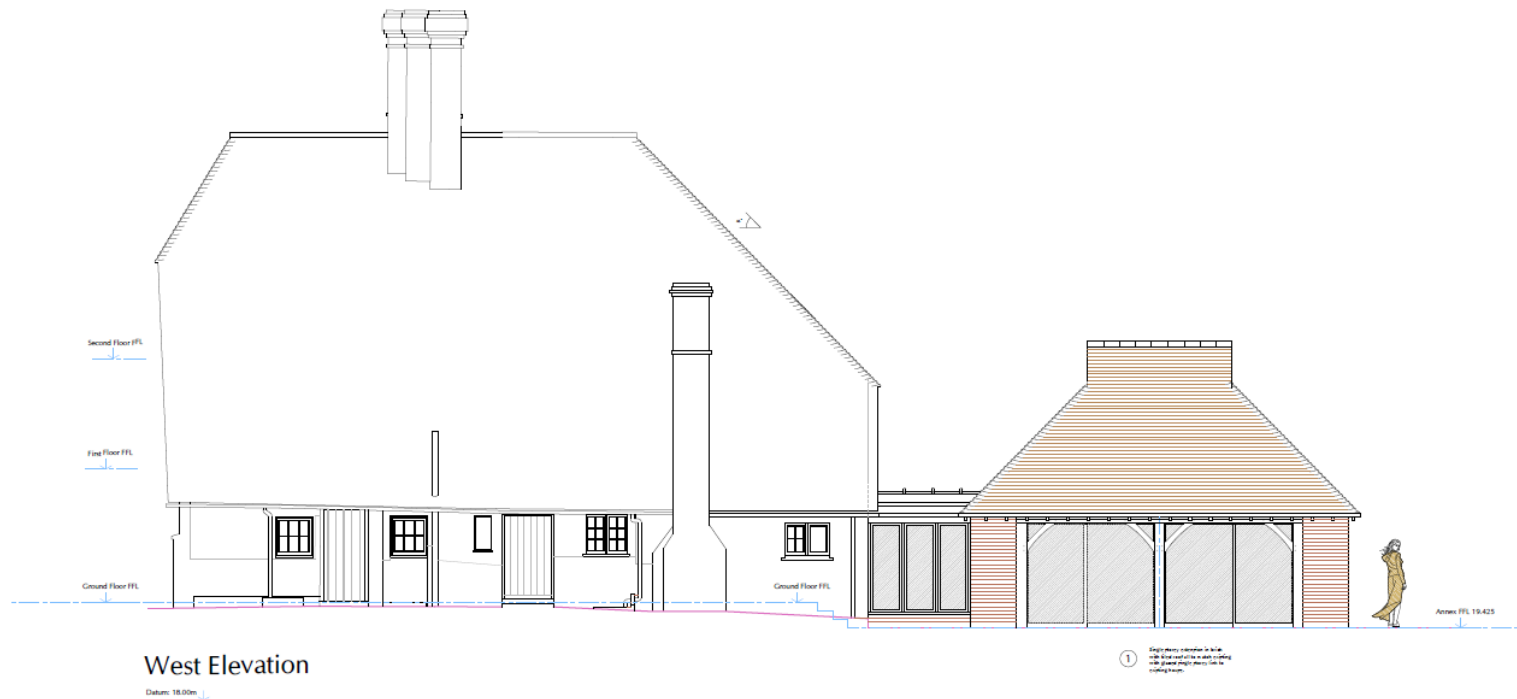
In appearance, fenestration and other detailing will be directly complementary to that of the main house, providing visual uniformity.

The glazing to the rear is more substantial, but allows reading of the modern elements and reduces possible issues of overbearance.

Roofing is plain tiled and the shape of the roof is designed to partially reflect that of the main house.
