### The Pool House

The Pool House

# Fabric Performance

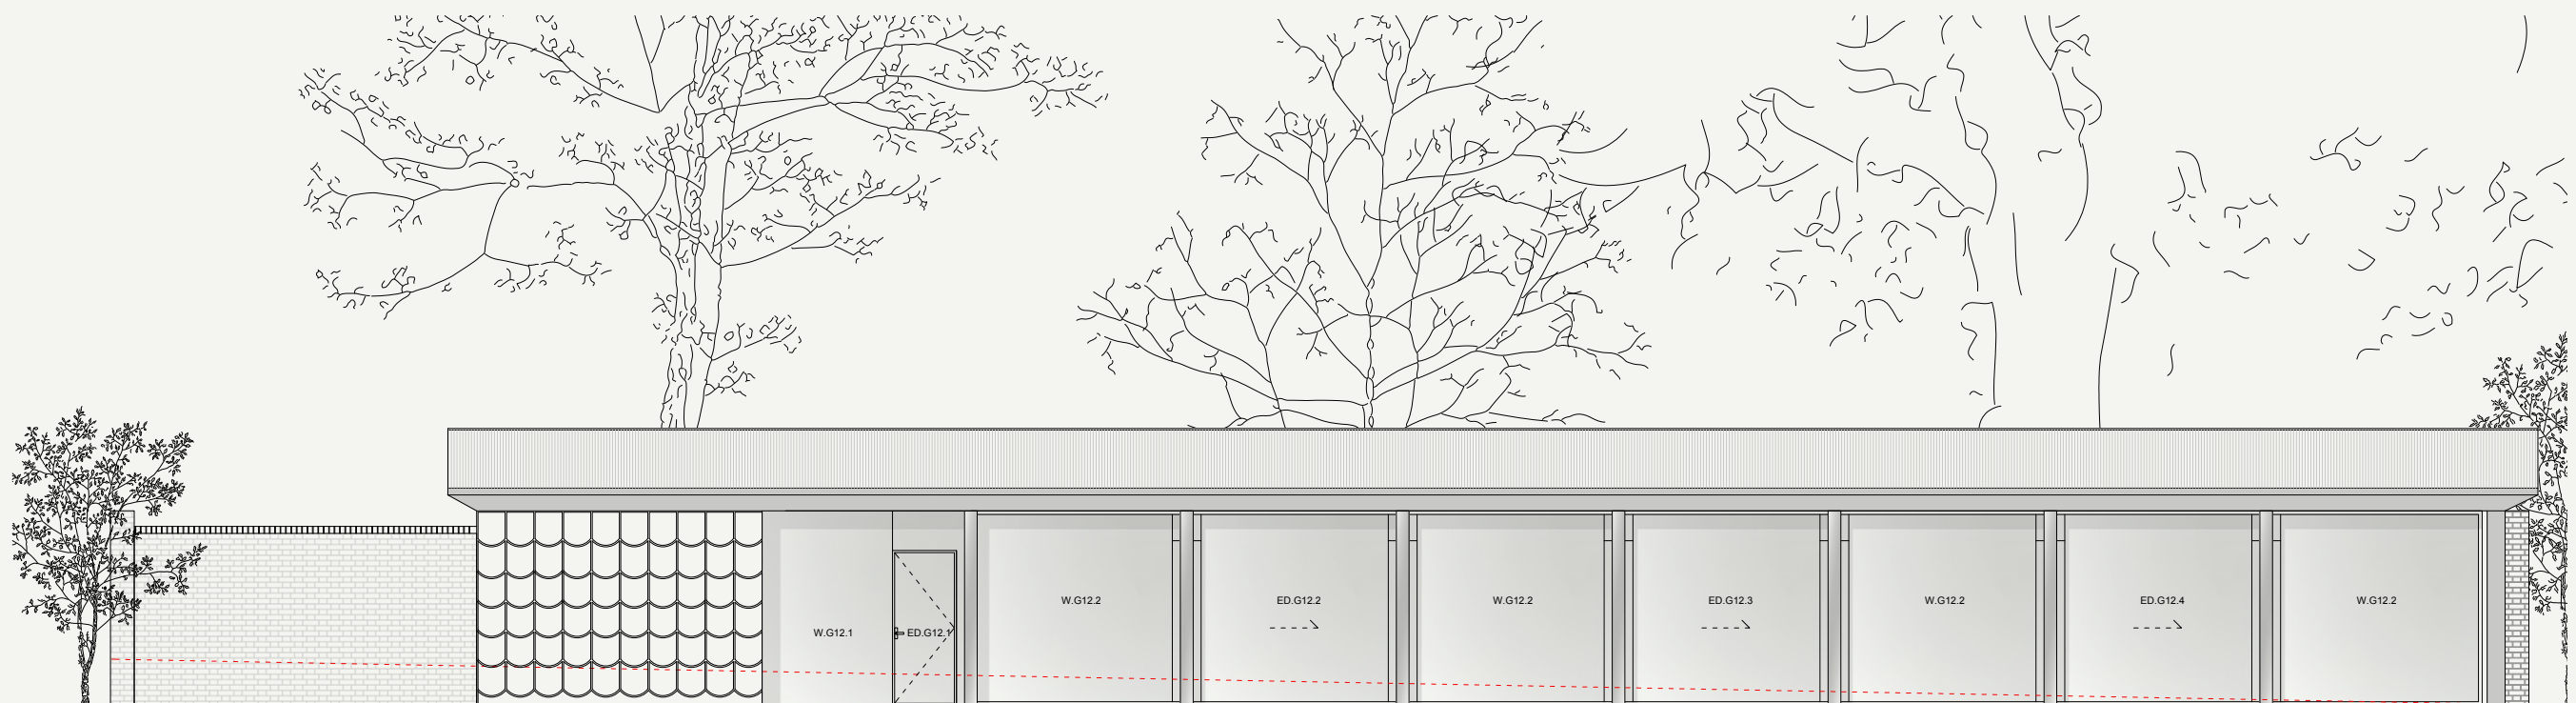
PROPOSED SOUTH ELEVATION @ 1:100

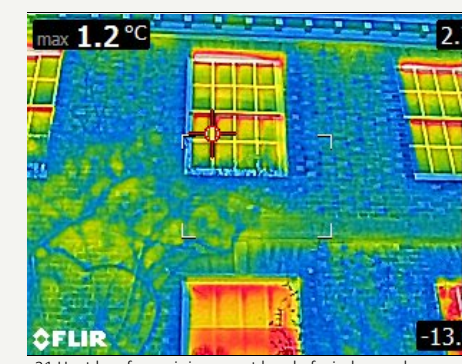
21 Heat loss from air ingress at head of window and horizontal sash junction.

- Significant heat loss through windows, and air infiltration through sash windows.

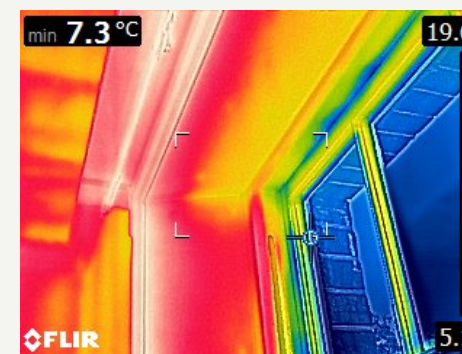
82 Limited thermal bridge around window. Air ingress to perimeter of sash.

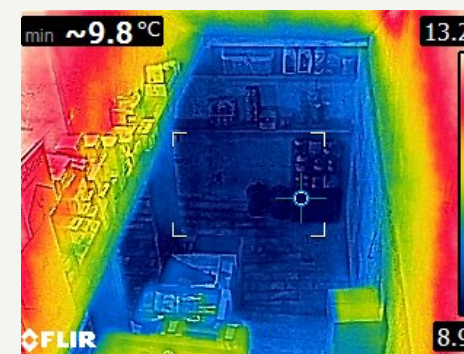
135 Temperature change below ground floor level evident.

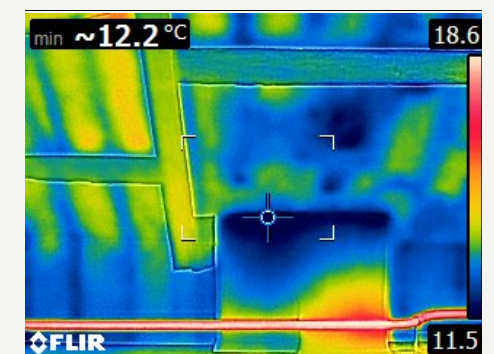
266 Very poor levels of insulation to vertical surfaces. Chimney is a significant thermal bridge where it passes through the roof. Evidence of damp in chimney breast. Likely to be condensation as often below dew point.
