STAFF ACCOMMODATION AT RUCKFORD HOUSE, HURSTPIERPOINT COLLEGE

FLOOD RISK ASSESSMENT AND DRAINAGE STRATEGY

JULY 2025

Ref: 12337/17/FRA

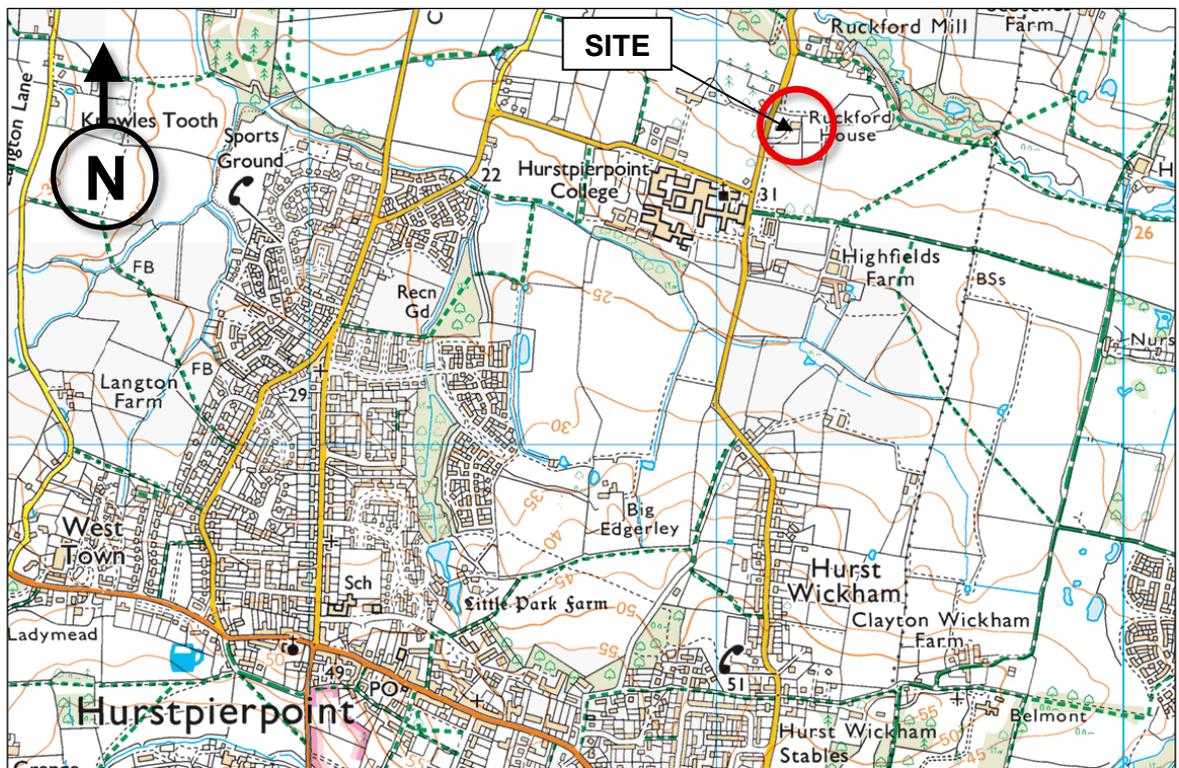
Figure 2.1 Site Location Plan

- 2.1 The proposed buildings and parking area, henceforth referred to as the development site, are located approximately 1.5km northeast of the village of Hurstpierpoint in West Sussex and 300m northeast of the main HPPC site (shown in Figure 2.1). The surrounding land use is predominantly agricultural with school playing fields bordering the site to the north, and two existing school-managed residential buildings to the southwest and southeast.
- 2.2 The development site is currently occupied by a carport, rough surfacing for parking formed of rough asphalt, compacted aggregate and soft landscaping/vegetation.
- 2.3 The site address is: Ruckford House, Malthouse Lane, Hurstpierpoint, West Sussex, BN6 9JX. The site's grid reference is: 529182E, 117808N.

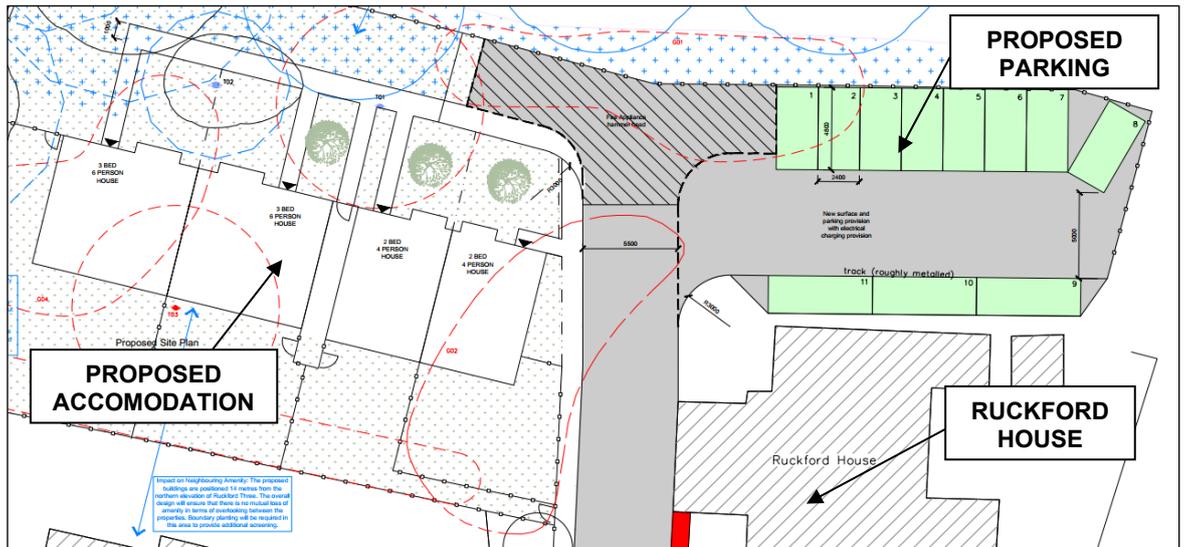
Figure 3.1 Extract of proposed development site layout (BSC)

- 3.1 The development proposals are to construct 4 No semi-detached properties for the housing of college staff as shown in Figure 3.1. Additionally, the existing vehicle and pedestrian routes and car parking facilities are to be improved.
- 3.2 The total development area is to include the proposed buildings, external areas surrounding Ruckford House and the access drive leading from Malthouse Lane.

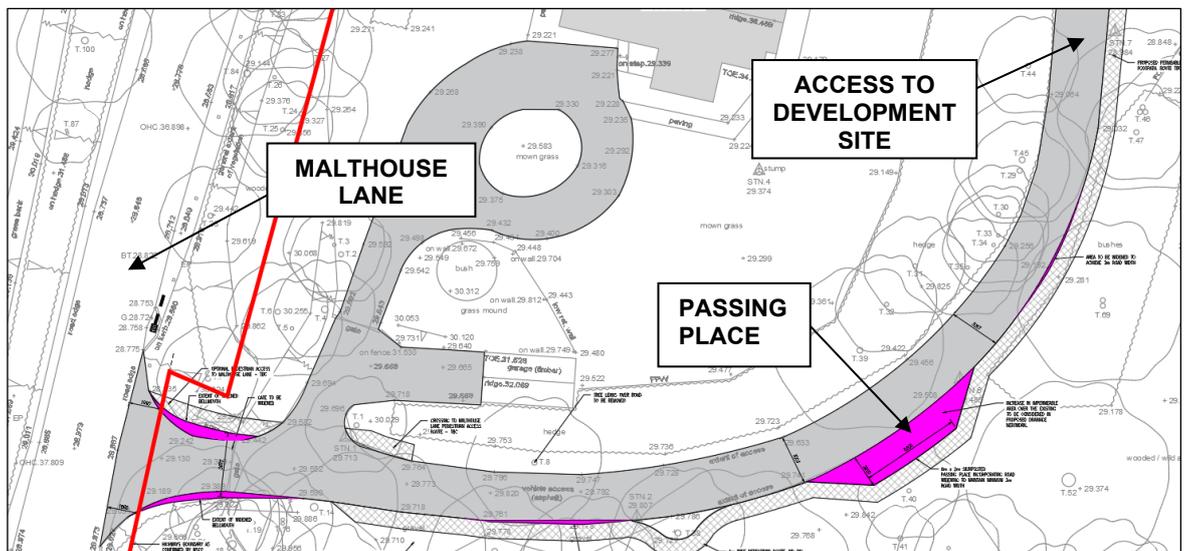
Figure 3.2 Extract of proposed access enhancements (HOP)

- 3.3 The site access improvements are to consist of a widening of the entrance bellmouth within the boundary of HPPC land and the addition of a passing place at the bend in the drive. These improvements are to provide a minimum 3m road width, facilitating improved fire vehicle access. A pedestrian footpath is to be added approximately following the road, improving safety by separating pedestrians and vehicles. The access proposals are illustrated in Figure 3.2 below. Further architectural proposals for the full site are included in Appendix A.

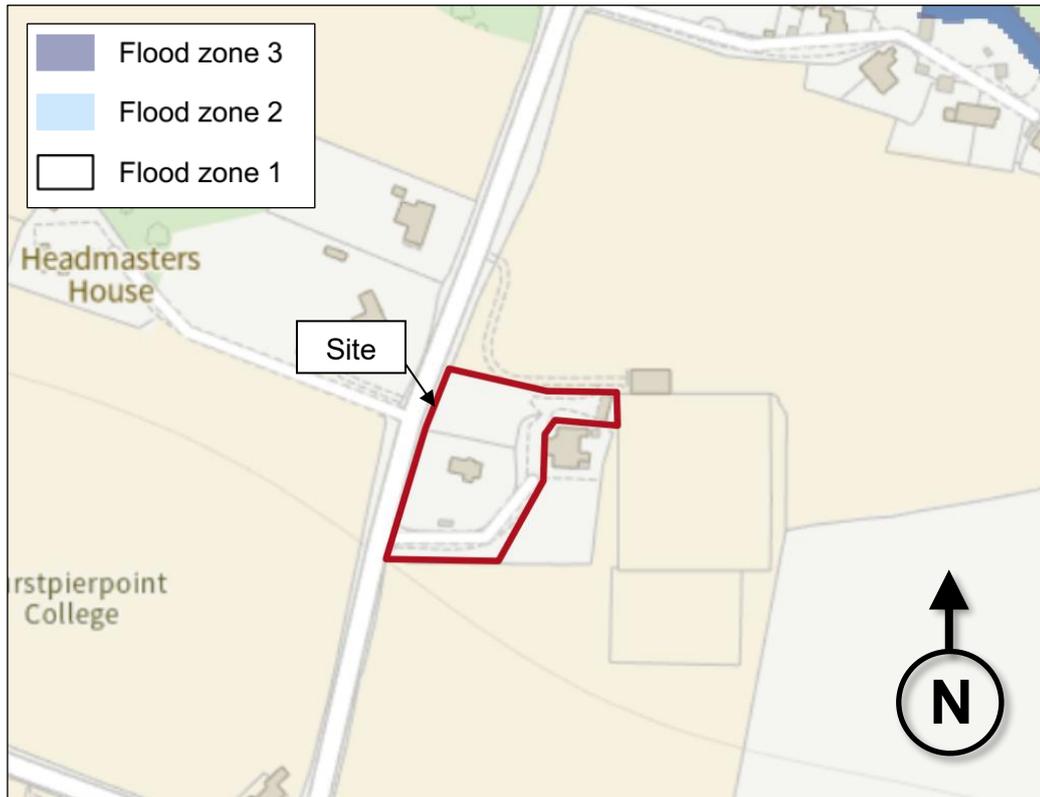
Figure 5.1 Extract from EA Online Flood Zone Map

5.1 Flood risk data for the site has been obtained from the online EA Flood Map, an extract of which is shown in Figure 5.1. The mapping shows the site to be located entirely within Flood Zone 1. The PPG to the NPPF defines Flood Zone 1 as having less than 1:1000 annual probability of river or sea flooding (less than 0.1%).

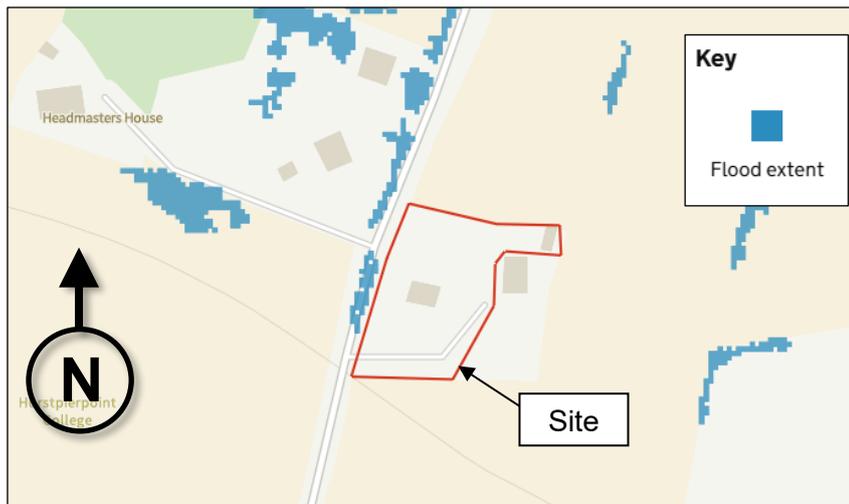
Figure 5.2 Extract from EA Surface Water Flood Map (100 year event)

- 5.3 The EA has produced surface water flood maps which show no areas of surface water flooding within the site boundary. An area of localised surface water flooding is identified in Malthouse Lane to the west of the site. The road is at a lower elevation to the site with runoff contained within the highway boundary. The site walkover identified this stretch of road to be served by highway gullies that drain into the highway ditch network to the northwest of the site.

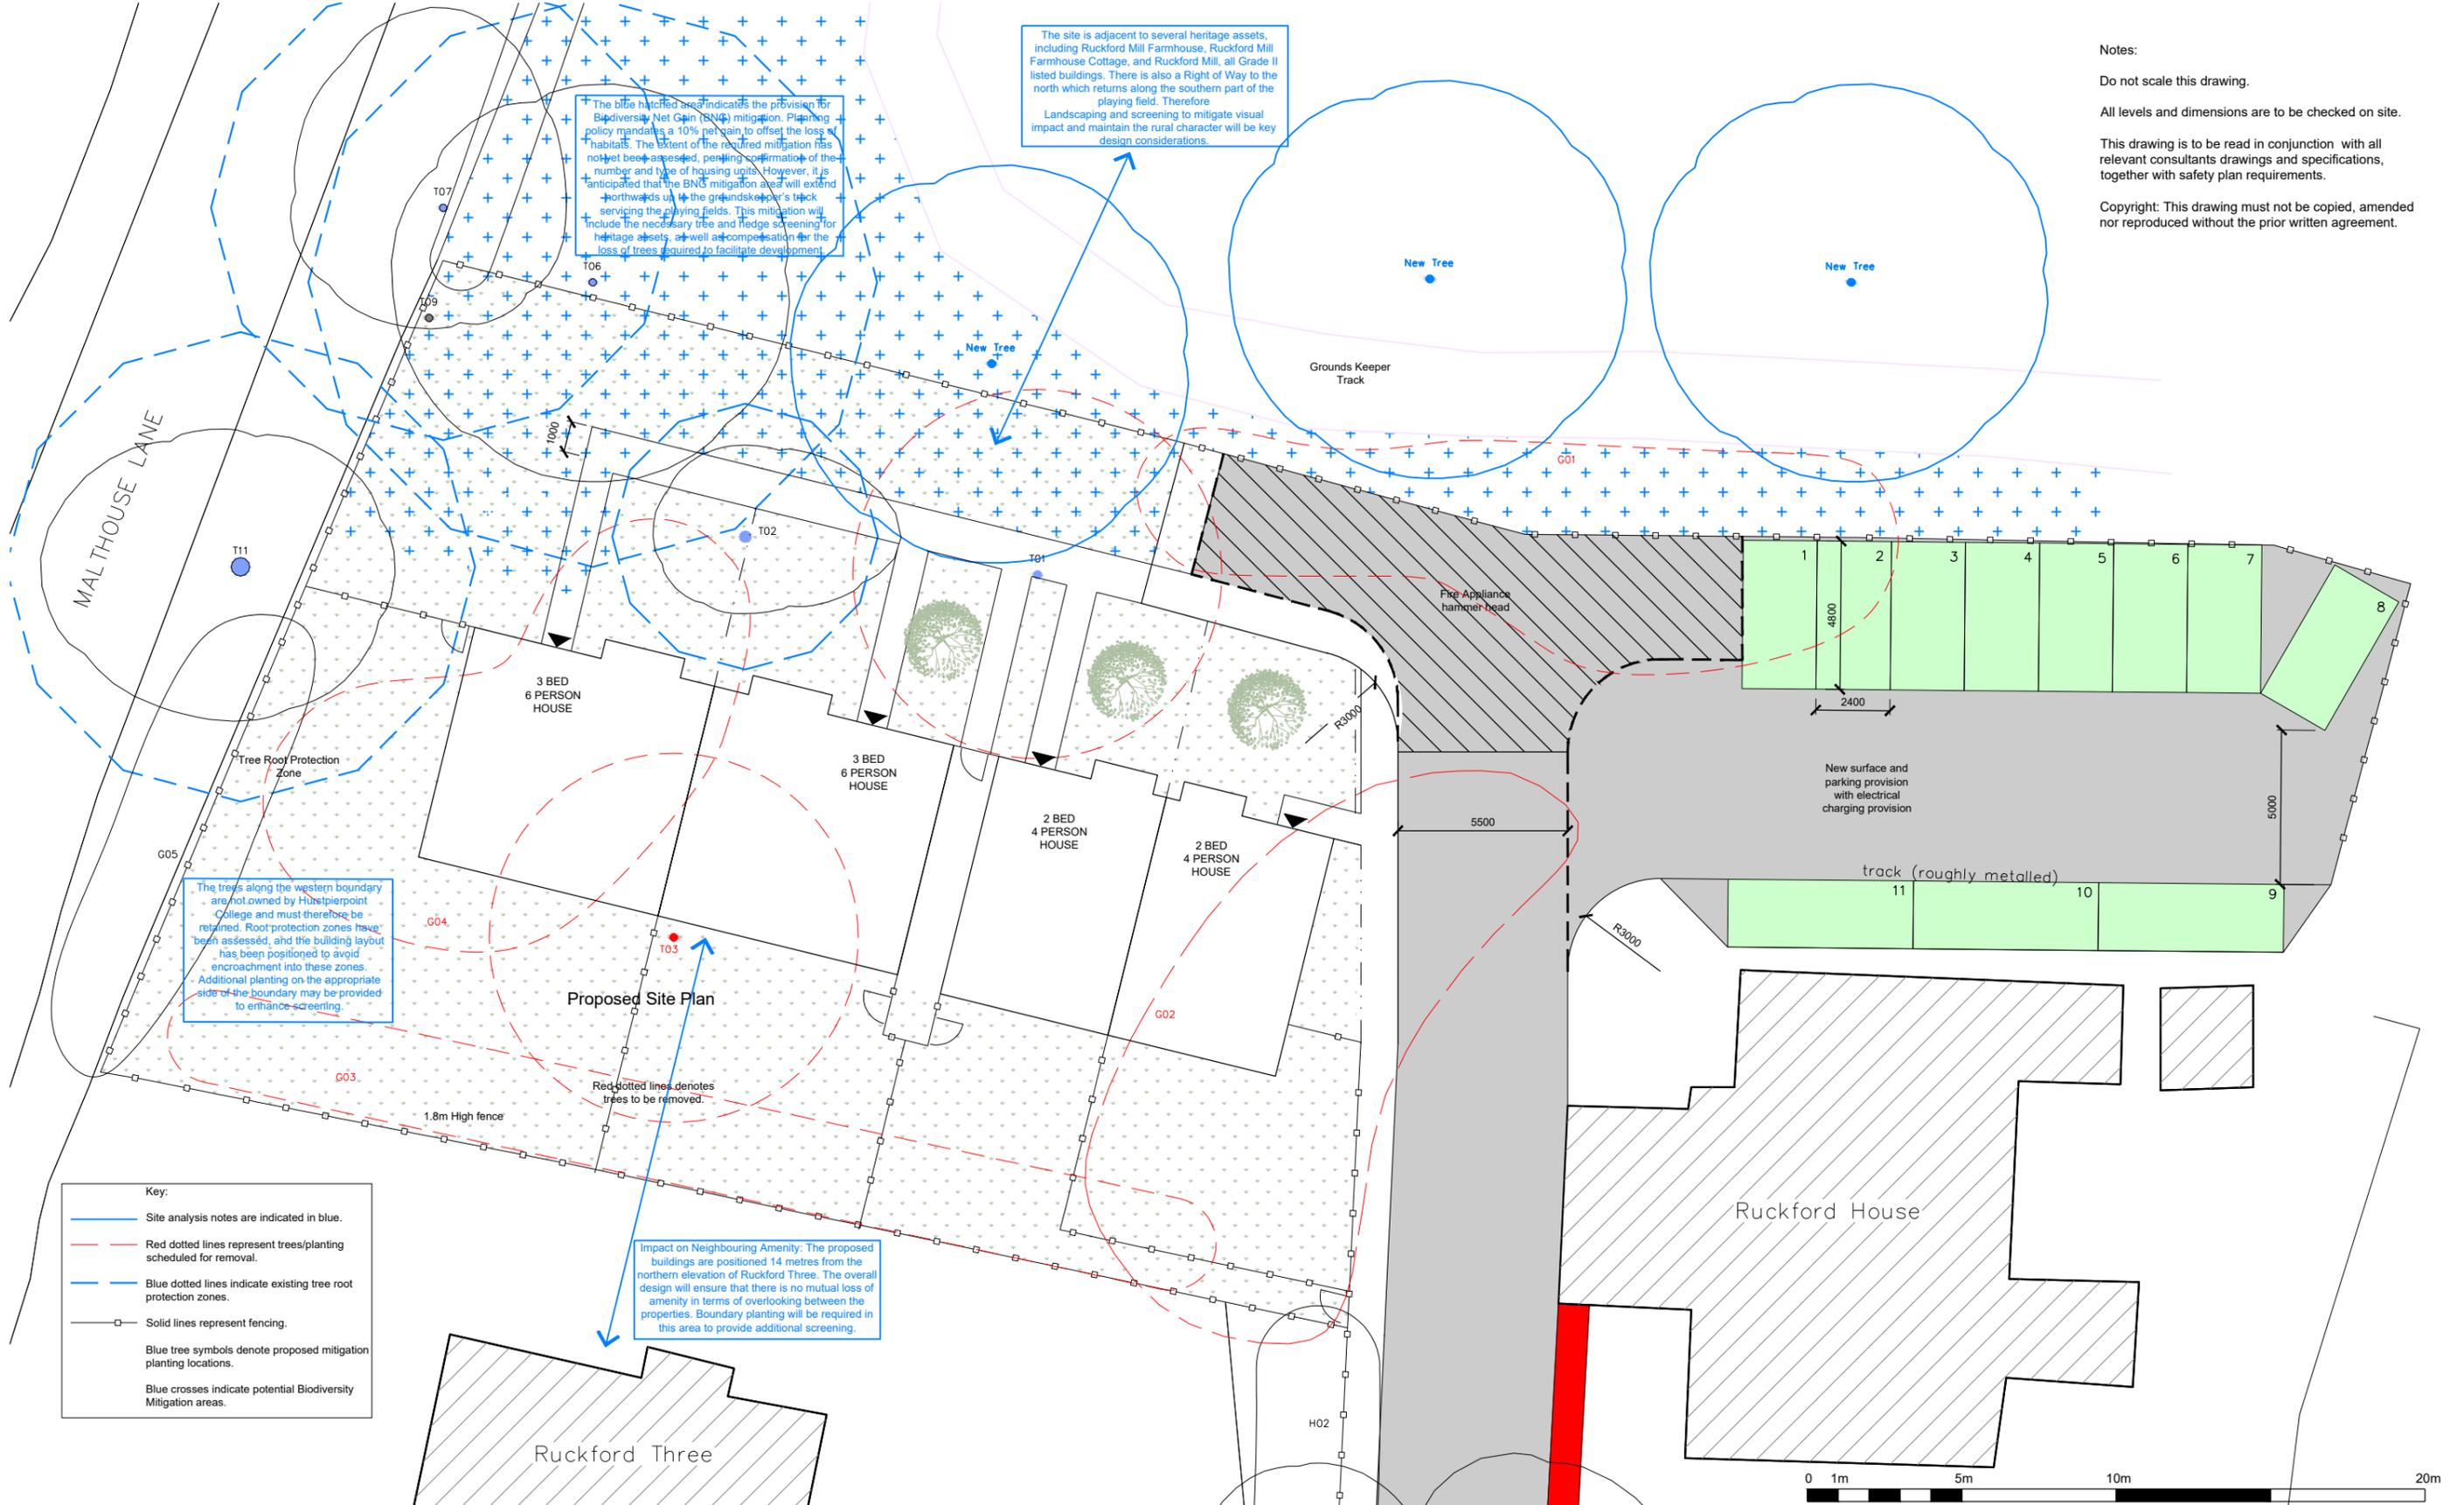
The blue hatched area indicates the provision for Biodiversity Net Gain (BNG) mitigation. Planning policy mandates a 10% net gain to offset the loss of habitats. The extent of the required mitigation has not yet been assessed, pending confirmation of the number and type of housing units. However, it is anticipated that the BNG mitigation area will extend northwards up to the groundskeeper's track servicing the playing fields. This mitigation will include the necessary tree and hedge screening for heritage assets, as well as compensation for the loss of trees required to facilitate development.

The site is adjacent to several heritage assets, including Ruckford Mill Farmhouse, Ruckford Mill Farmhouse Cottage, and Ruckford Mill, all Grade II listed buildings. There is also a Right of Way to the north which returns along the southern part of the playing field. Therefore Landscaping and screening to mitigate visual impact and maintain the rural character will be key design considerations.

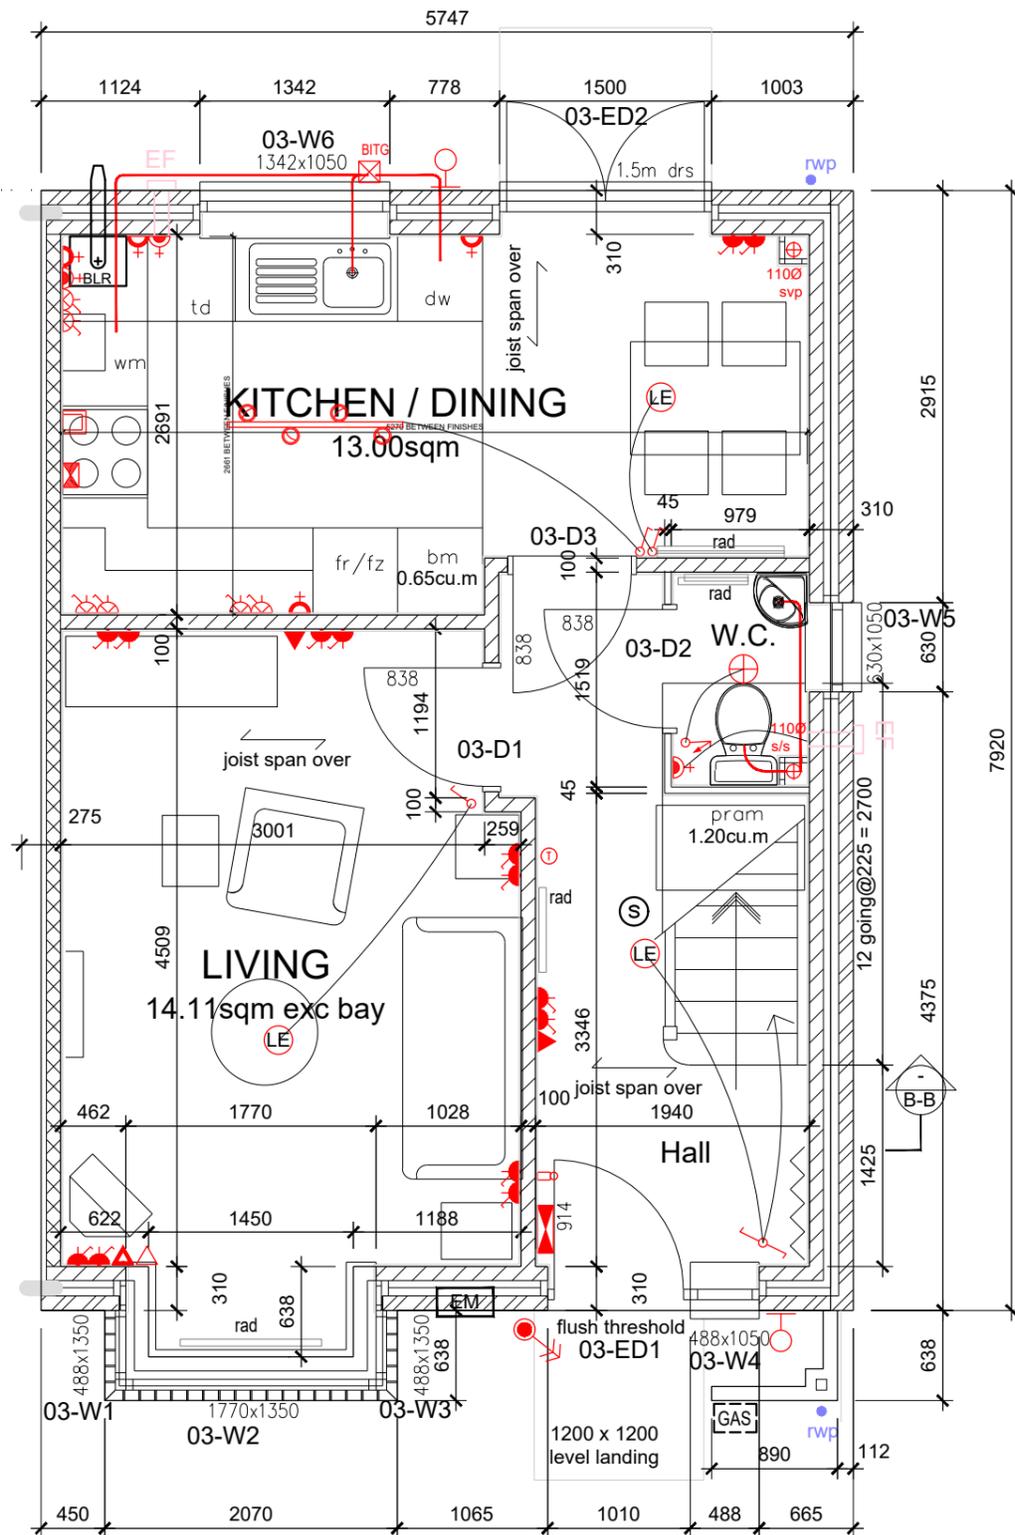
GROUND FLOOR PLAN
1:50

PROJECT New Staff Accommodation, Hurstpierpoint College			
DRAWING Proposed Site and Floor Plans			
STAGE Stage 2 Output			JOB NO. : 675
			DATE : 09/05/2025
DWG NO. SK.04	SCALE 1:200 @A3	REVISION : a	DRAWN : DB
Do not scale: use figured dimensions only; check dimensions on site; notify BSC of any discrepancies; copyright BSC Ltd.

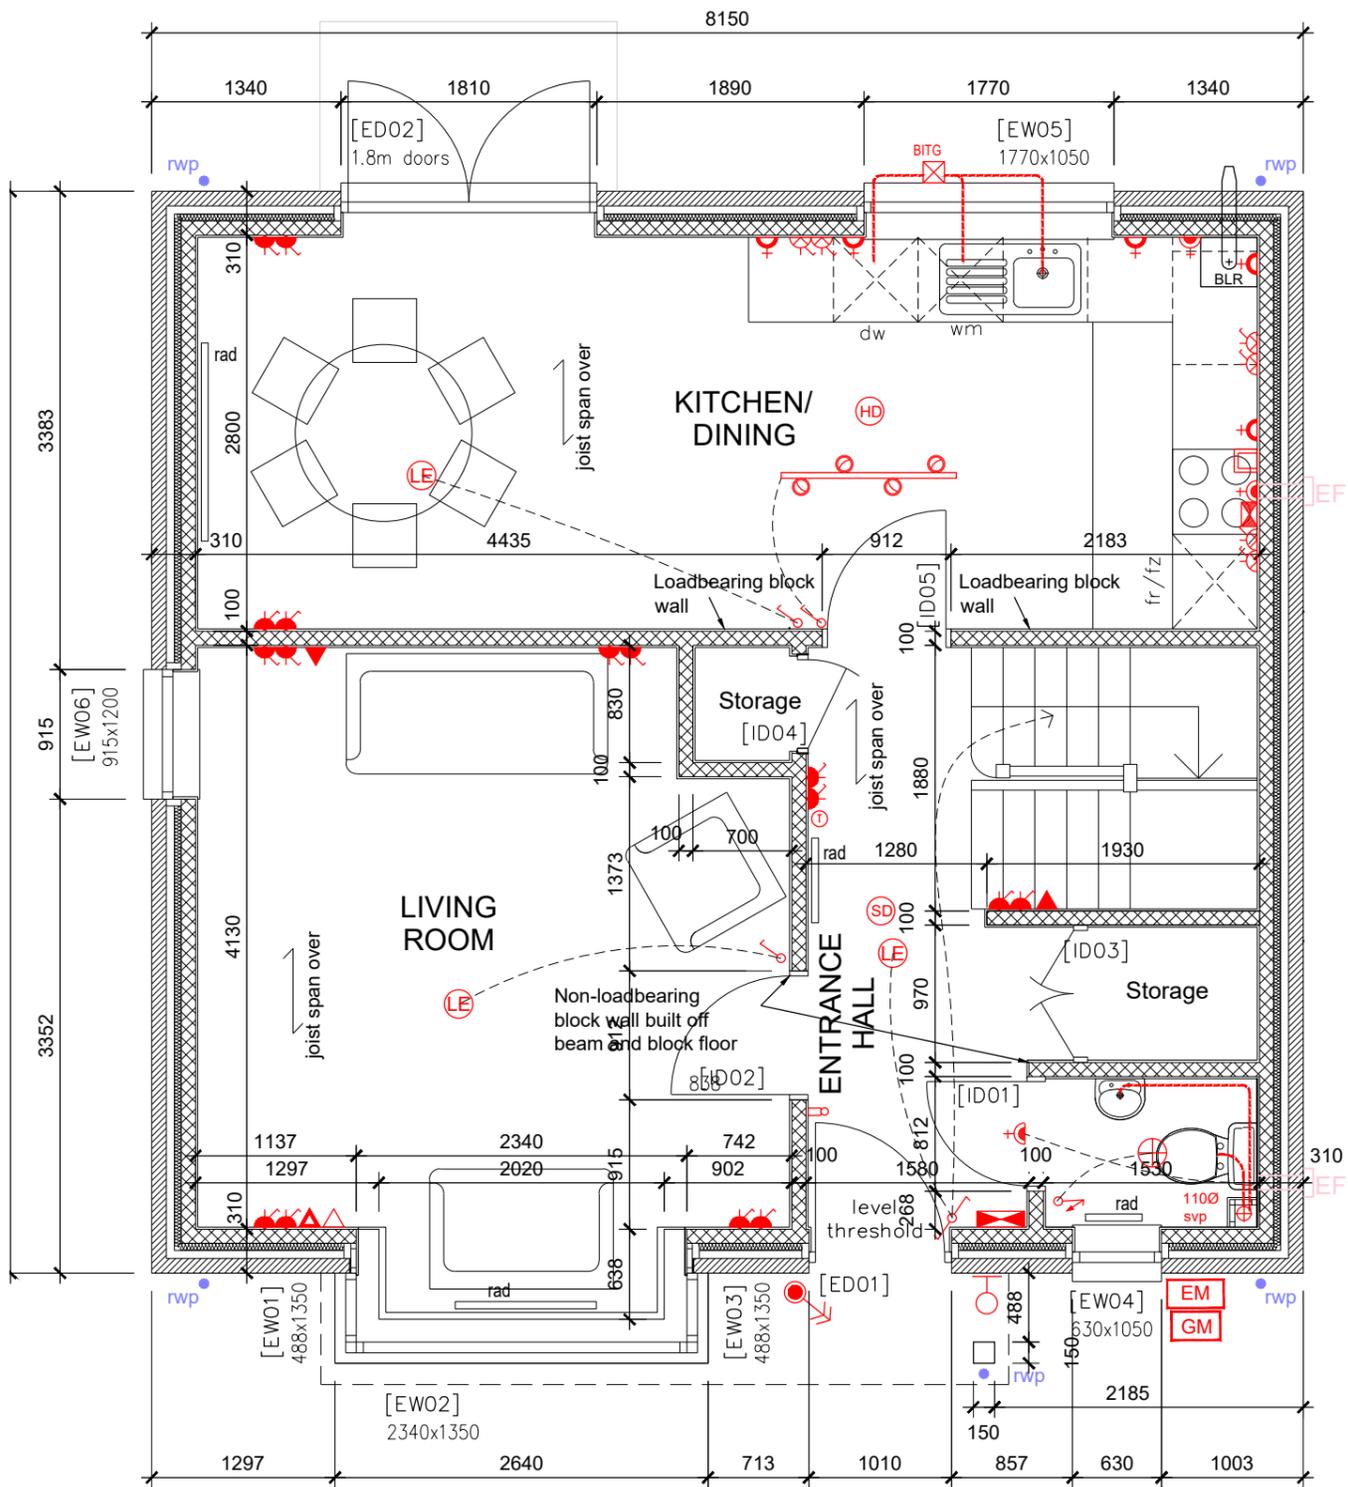
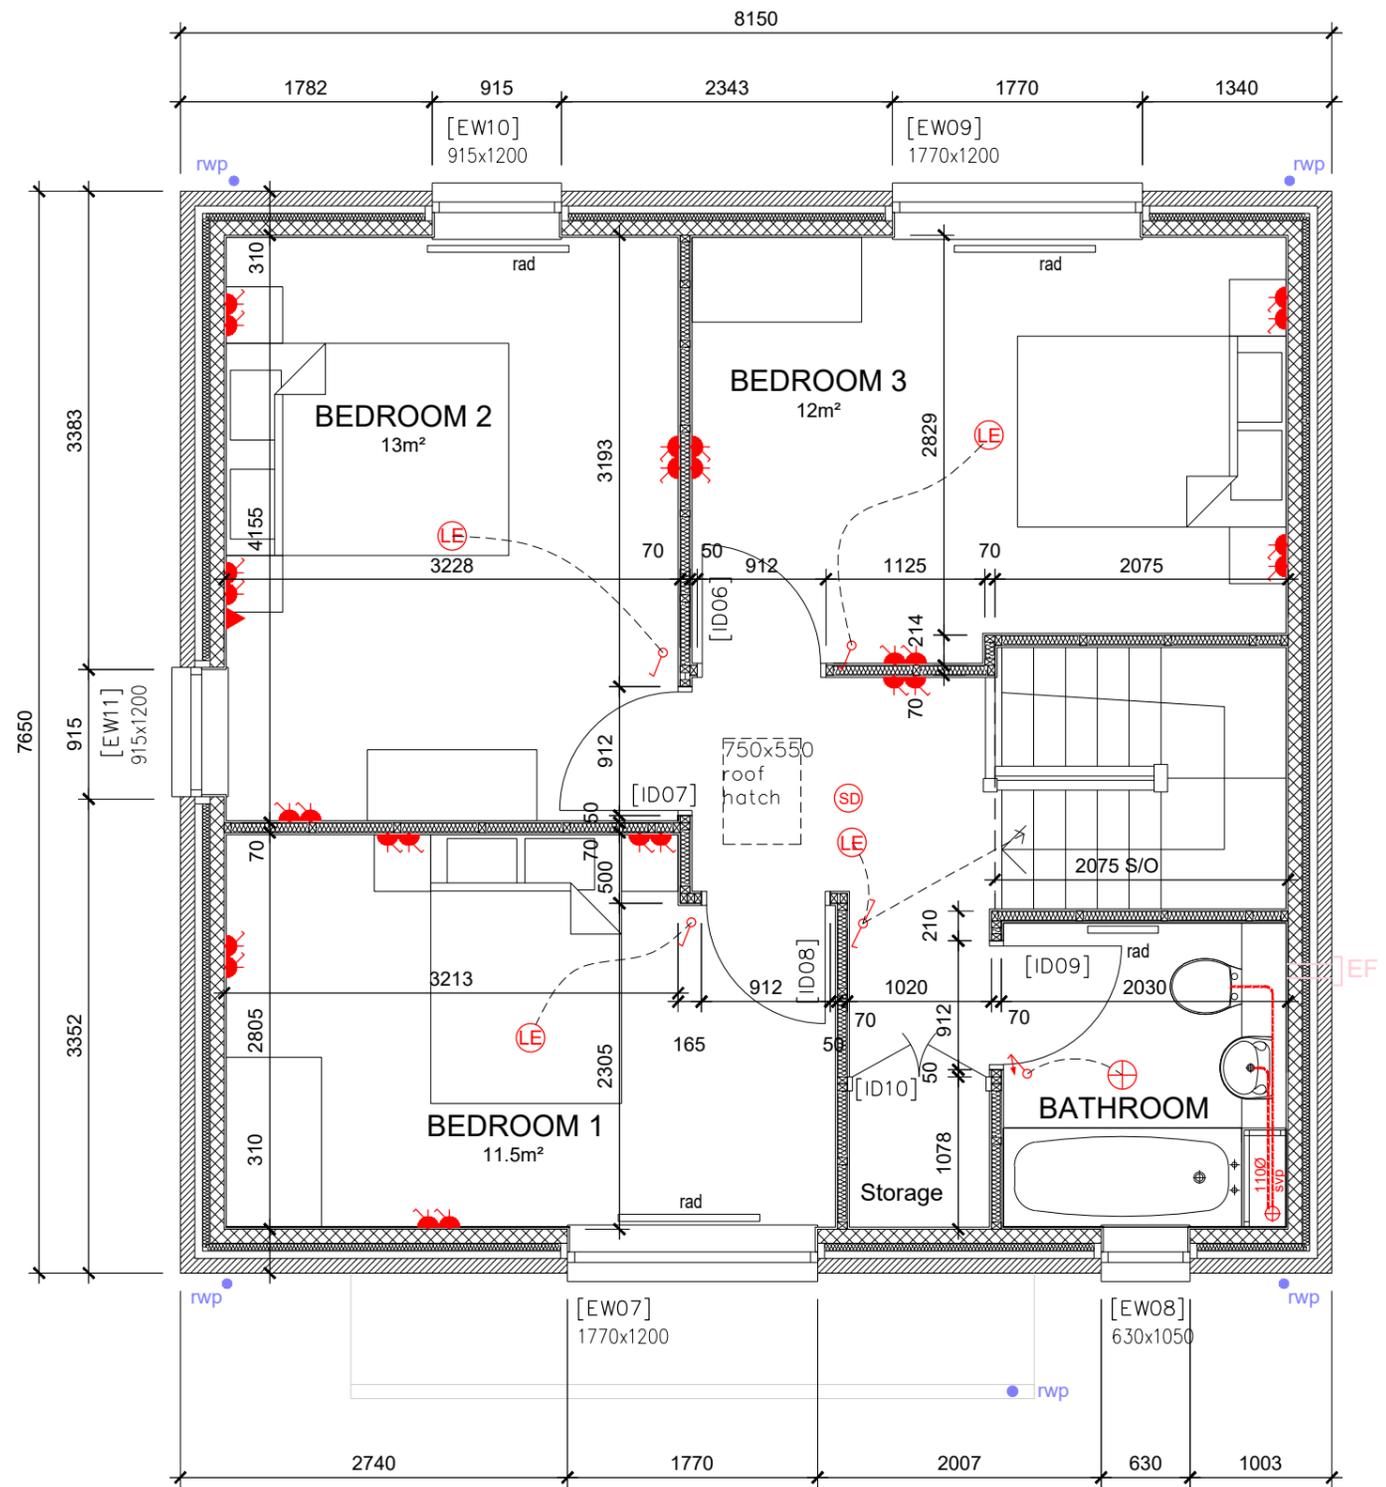
PROJECT New Staff Accommodation, Hurstpierpoint College			
DRAWING Typical Floor Plans (2B4P)			
STAGE DRAFT - For Discussion Purposes			JOB NO.: 675
			DATE : 18/03/2025
DWG NO. SK.05	SCALE 1:100 @A3	REVISION : -	DRAWN : DB
Do not scale: use figured dimensions only: check dimensions on site: notify BSC of any discrepancies: copyright BSC Ltd.

GROUND FLOOR PLAN 1:50

FIRST FLOOR PLAN 1:50

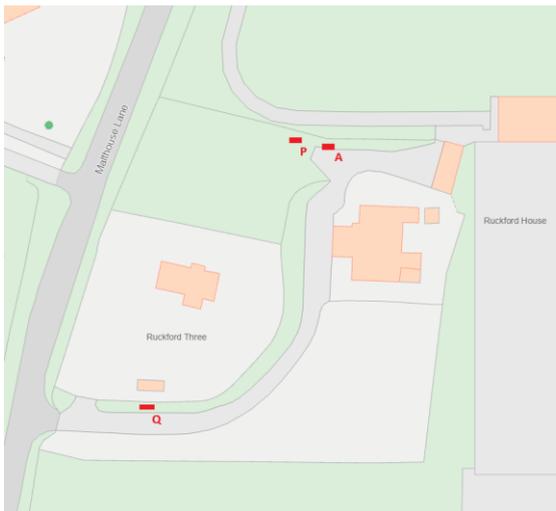
Figure 1 OS Map with pit locations

Soak Services was instructed by the client to carry out infiltration testing to BRE 365 in a parcel of land adjacent to Ruckford House (1 & 2) and Ruckford 3 off Malthouse Lane. The land is mostly grass ringed by hedge and mature trees with a short gravel drive/parking area. The land very gently slopes downwards from west to east. (Figure 1)

Pits were dug on 25/6/2025 (see Figures 1, 2 and 3 above for locations) with a 3-ton excavator using a 300mm wide bucket. The preceding months had been exceptionally dry and no rain had fallen on this site in the few days before testing. On the morning of testing the ground remained firm and the soil excavated remained dry at the upper levels of all pits. Pit (Q) was surprisingly damp below 0.5m and ground water was eventually encountered at 2.2m. The weather was warm and sunny (see photo 16).

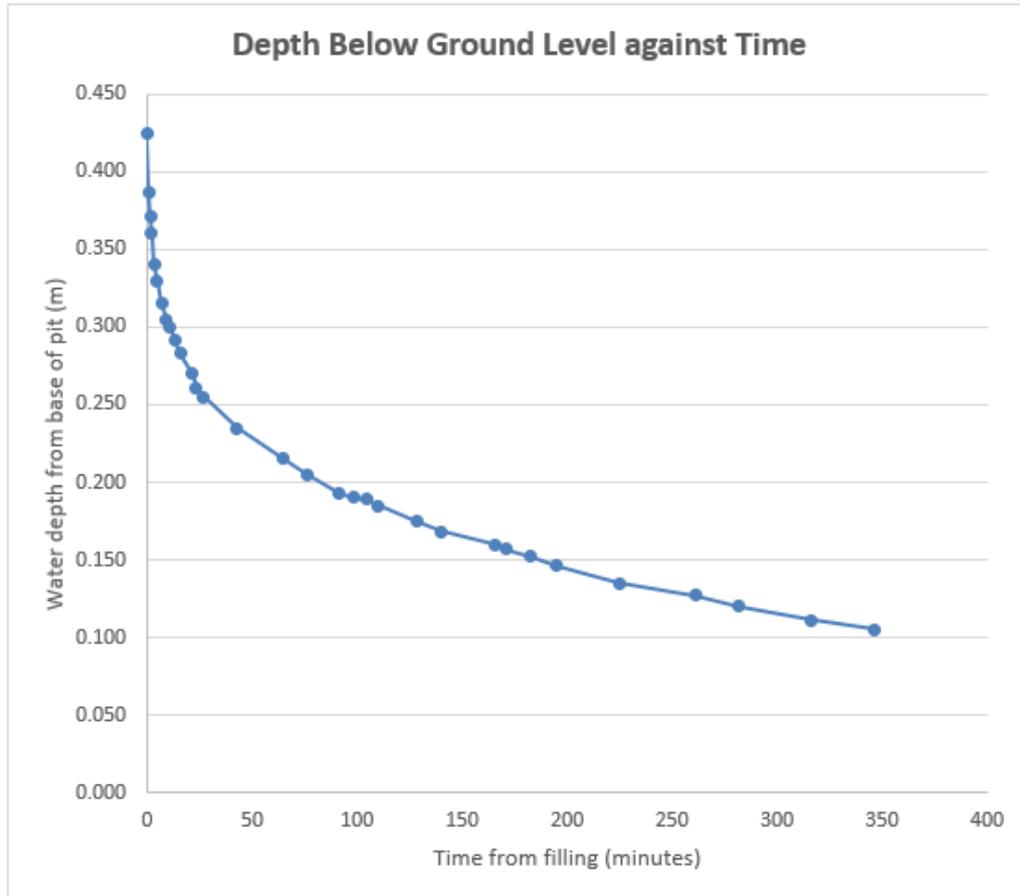
Appendix 1: Test data, pit P test 1

Pit length 0.860 m
 Pit width 0.360 m
 Pit depth 0.525 m

Max water depth 0.425 m

Infiltration rate 3.968E-06 m/s

Test Pit P. Only one test was possible in the day due to slow infiltration. BRE 365 requires 3 tests to be made but this would not have been possible to complete in a day.

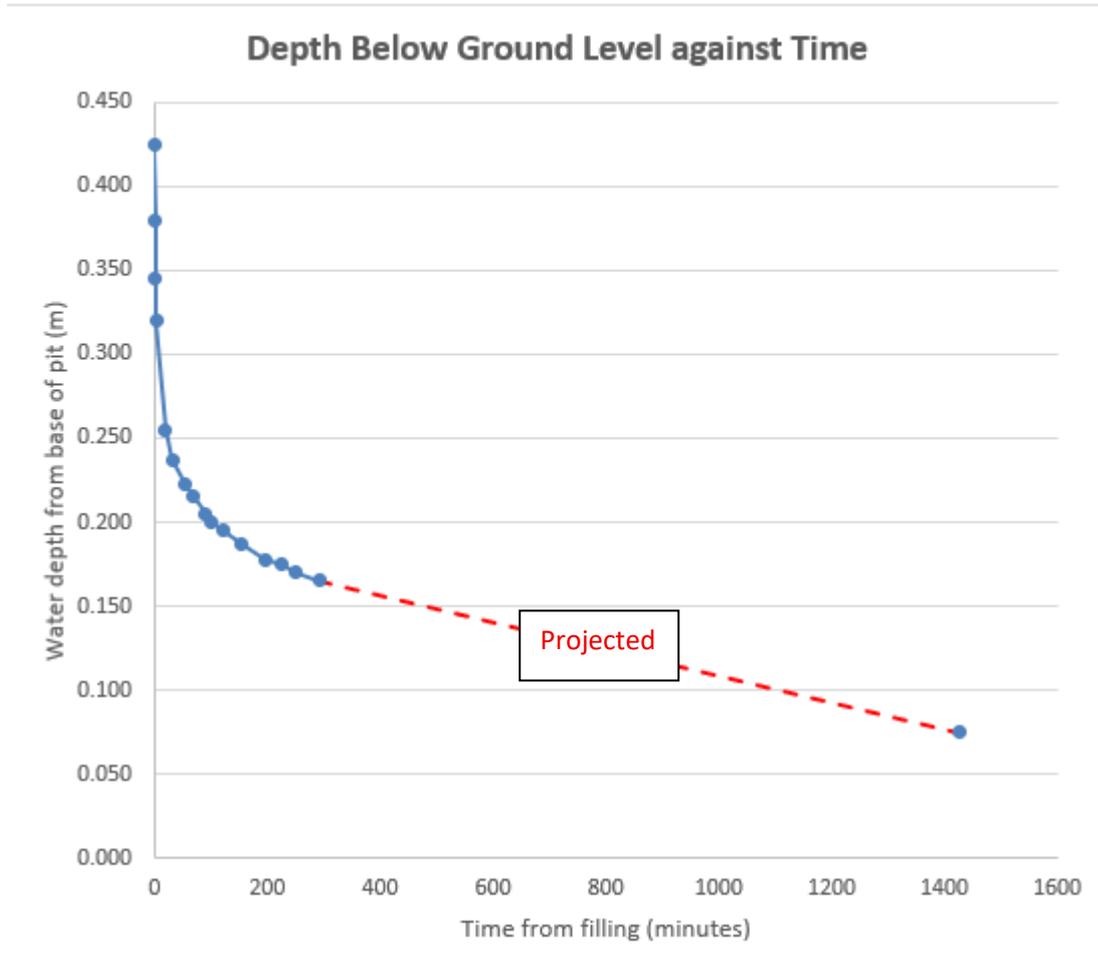
Appendix 1: Test data, pit Q test 1

Pit length 0.970 m
 Pit width 0.320 m
 Pit depth 0.555 m

Max water depth 0.425 m

Infiltration rate 1.316E-06 m/s

Test Pit Q. Only one test was possible due to very slow infiltration and a projected measurement was made to achieve 75% drainage.

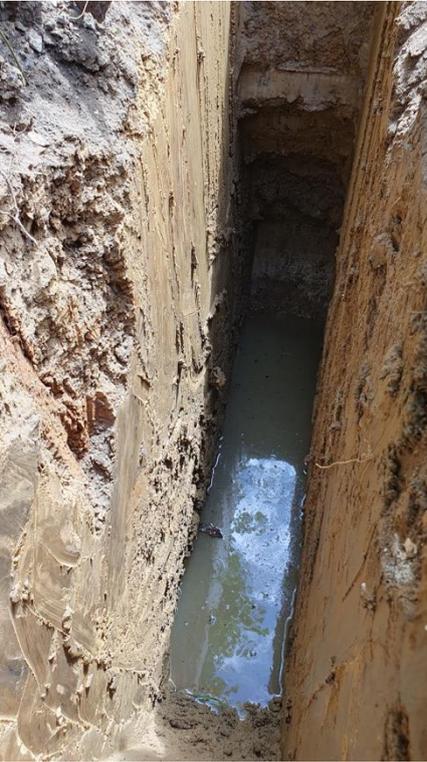
Photo 3 Pit A ground water

The test pit (pit A) was excavated to 2200mm. Water was observed lining the bottom of the pit almost immediately. After one hour this had risen to a depth of 234mm. Further testing for this pit was therefore cancelled.

Test pit A. It was not possible to measure infiltration at this pit as ground water was encountered at 2.2m. After 1 hour ground water had filled the bottom of the pit to a depth of 254mm.

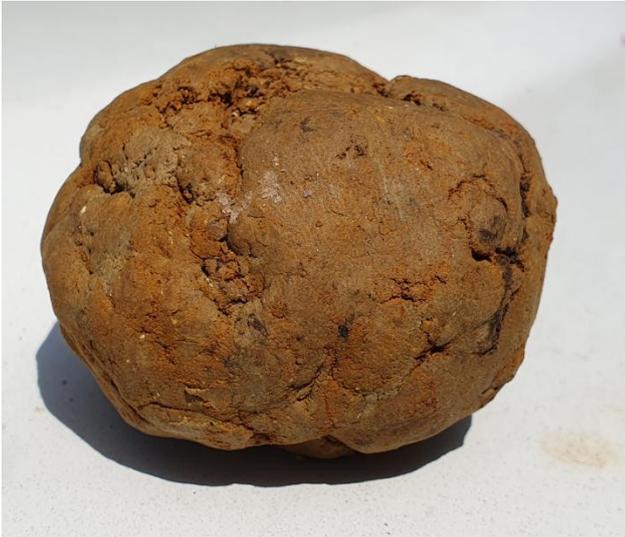
Photo 4 Pit A extracted clay mouldable by hand and damp.

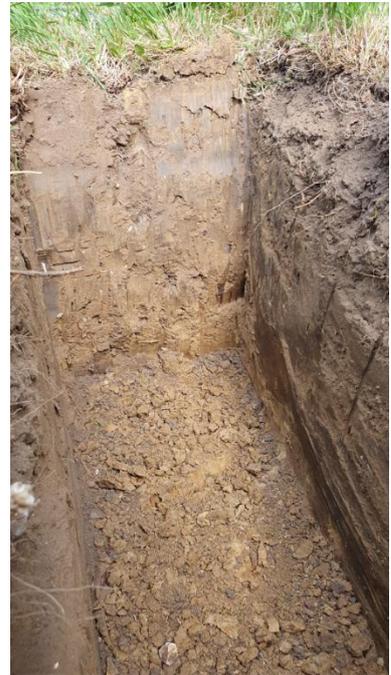
Photo 6 Pit P side elevation

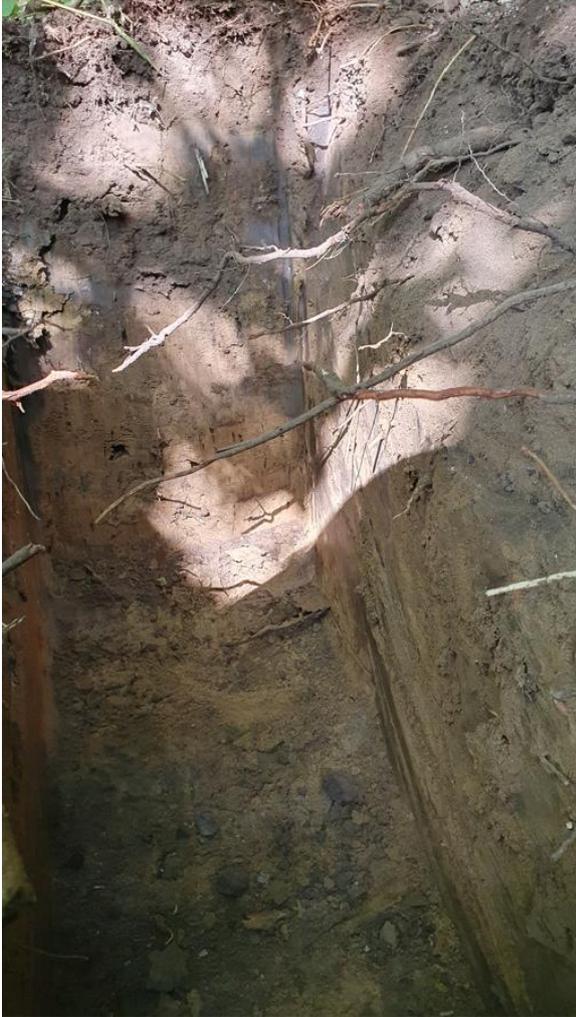
Photo 12 Pit Q side elevation

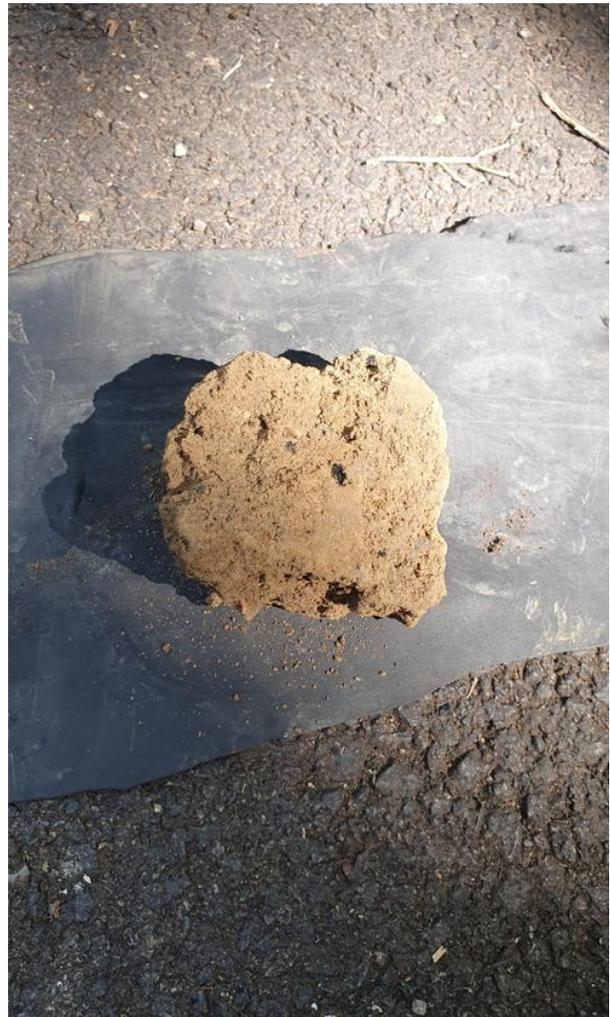
Photo 13 Pit Q clay excavated
