## Optera Structural Solutions

### SOW OPT-9120 Agreement to install a root barrier for Crawford and Co.

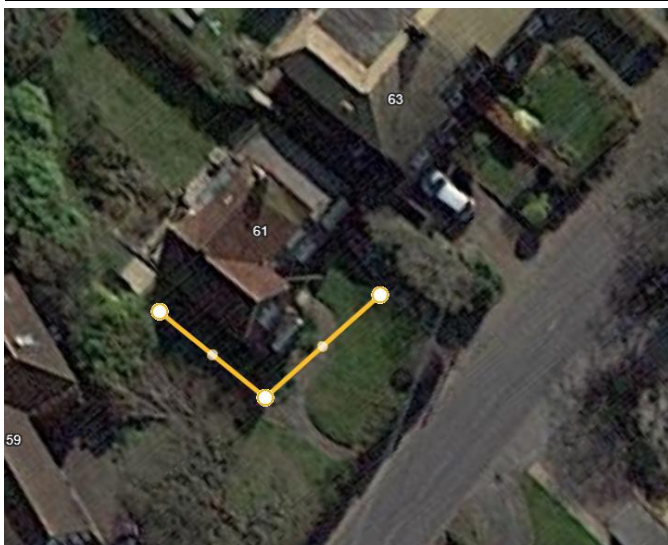
Aerial plan indicating proposed 20m length and alignment of barrier.

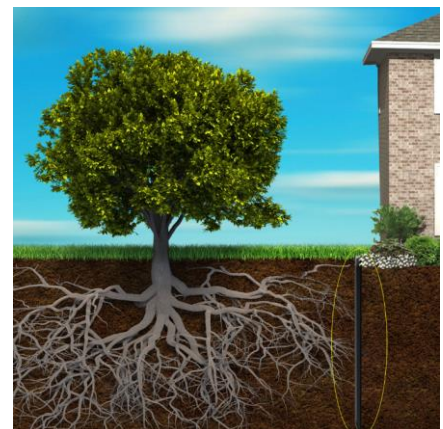
The moisture content of a clay soil tends to vary with depth. Closer to the surface there can be relatively large changes in soil moisture content between summer and winter as a result of evaporation from the ground surface, the drying effect of the Sun and general vegetation, including grasses. Such variations are normally confined to the upper 1m of the ground. However, where trees are growing within influencing distance of a building, then the soil moisture profiles will fluctuate much more widely through the seasons and to a much greater depth; in response, soil volume changes are amplified, and consequential building movements will be far greater.

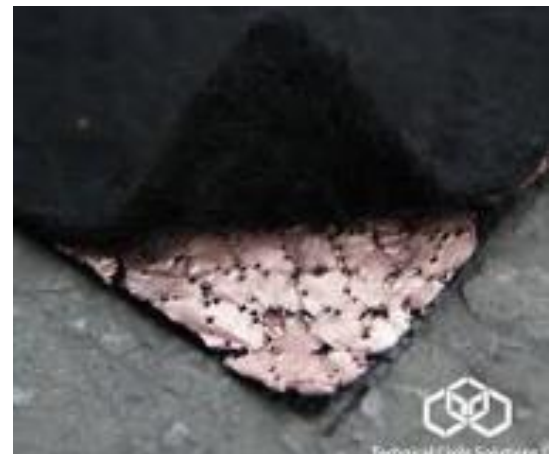
Outdated, impervious barriers divert rather than stop roots and may prevent the movement of groundwater causing unintended consequences. The use of Optera's permeable barrier stops roots both by forming a physical impenetrable obstacle and by acting as a chemical inhibitor to the reestablishment of roots.

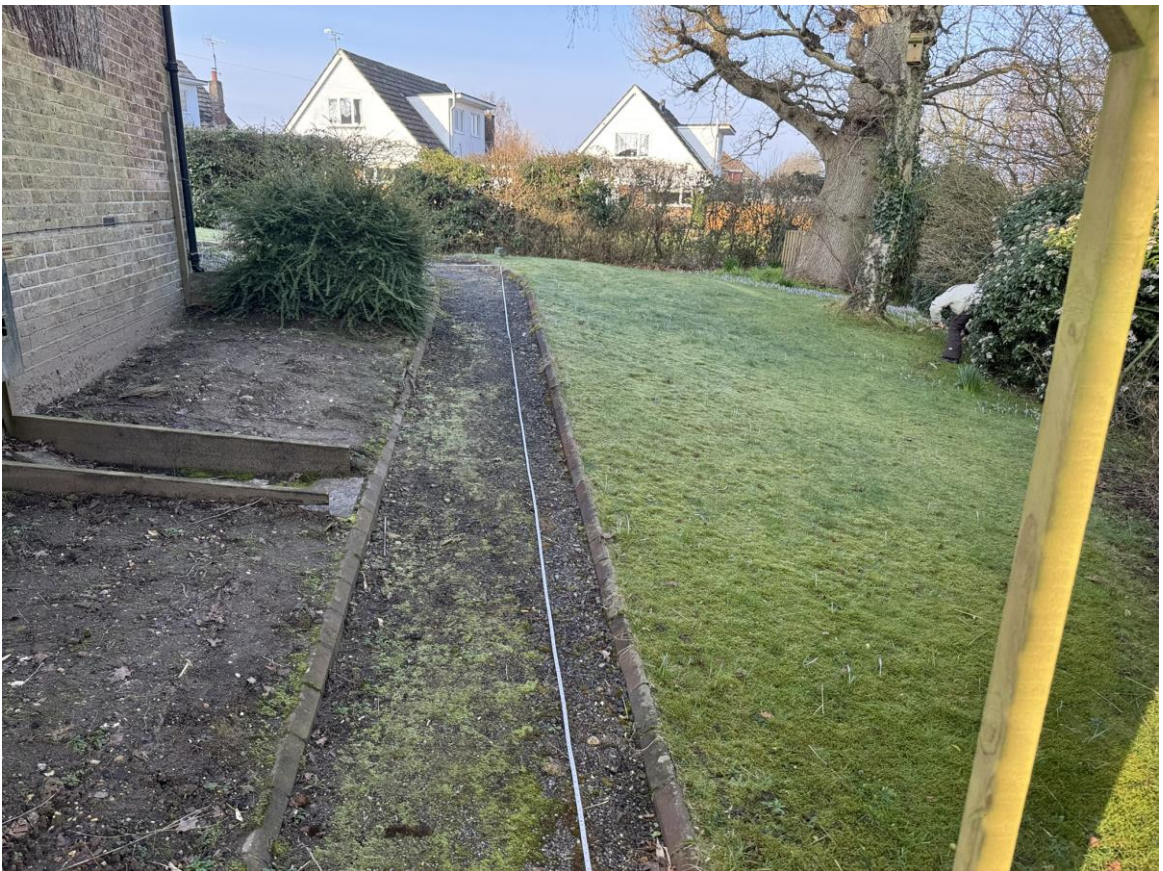
Image 1 shows the position of the barrier on the path to the outside of the existing drainage run.

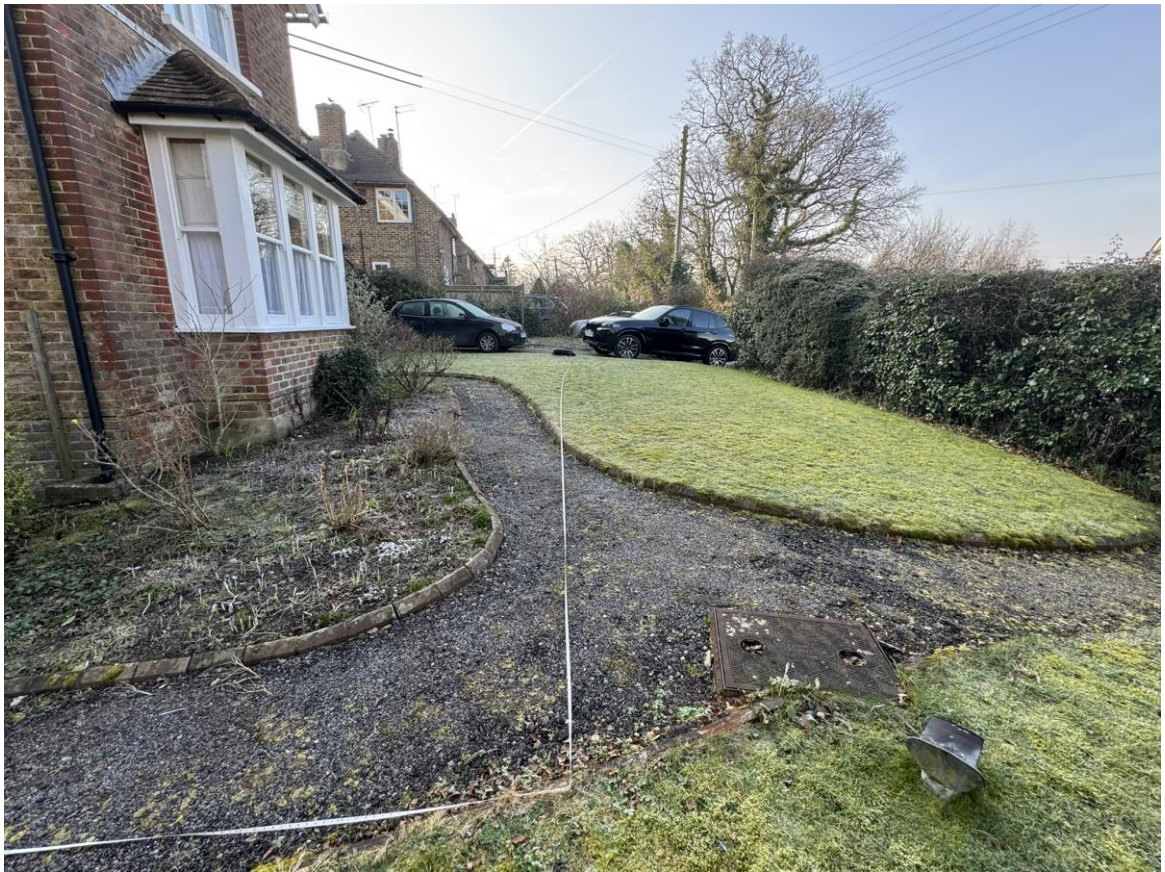
Image 2 across the front shows the 23m length, stopping short of the driveway

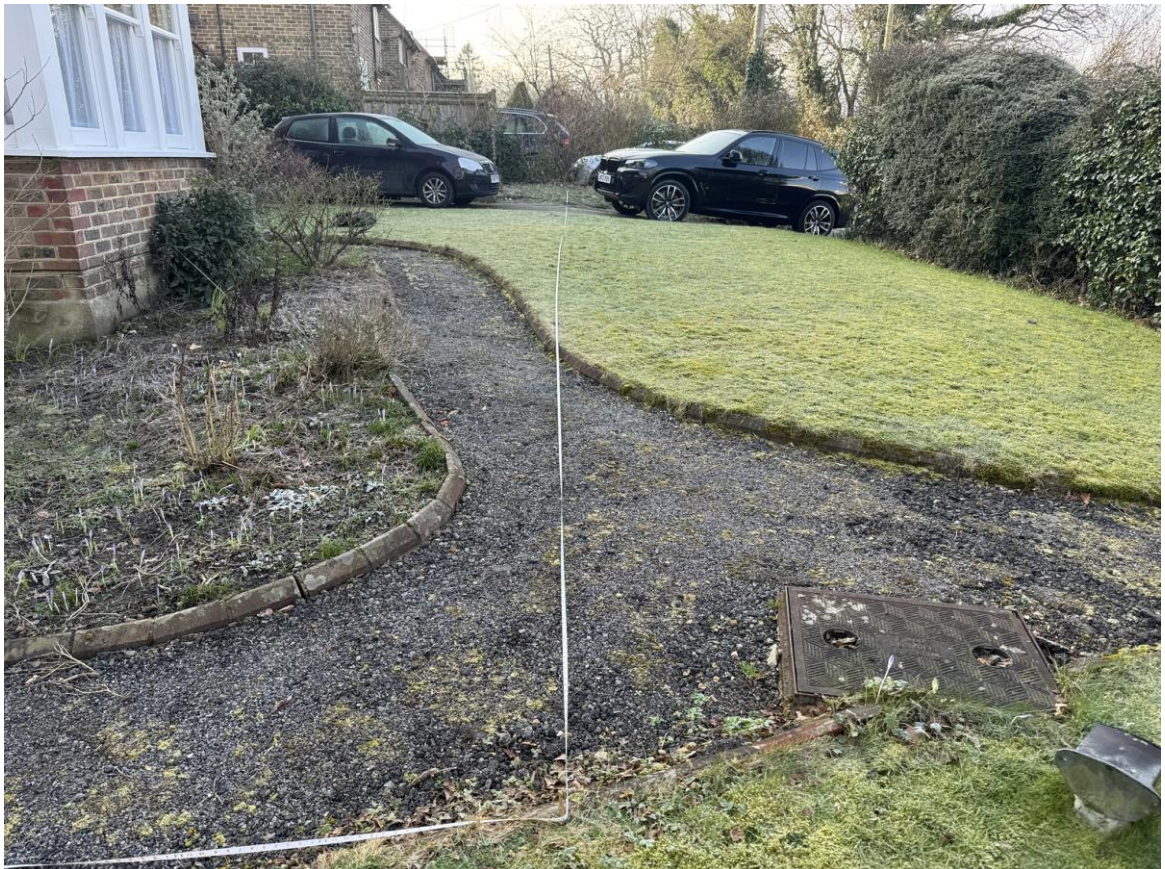
Image 3 shows the longer section with barrier extended across the driveway
