SOW 6700 for Agreement to install a root barrier for Crawford and Company

# Report

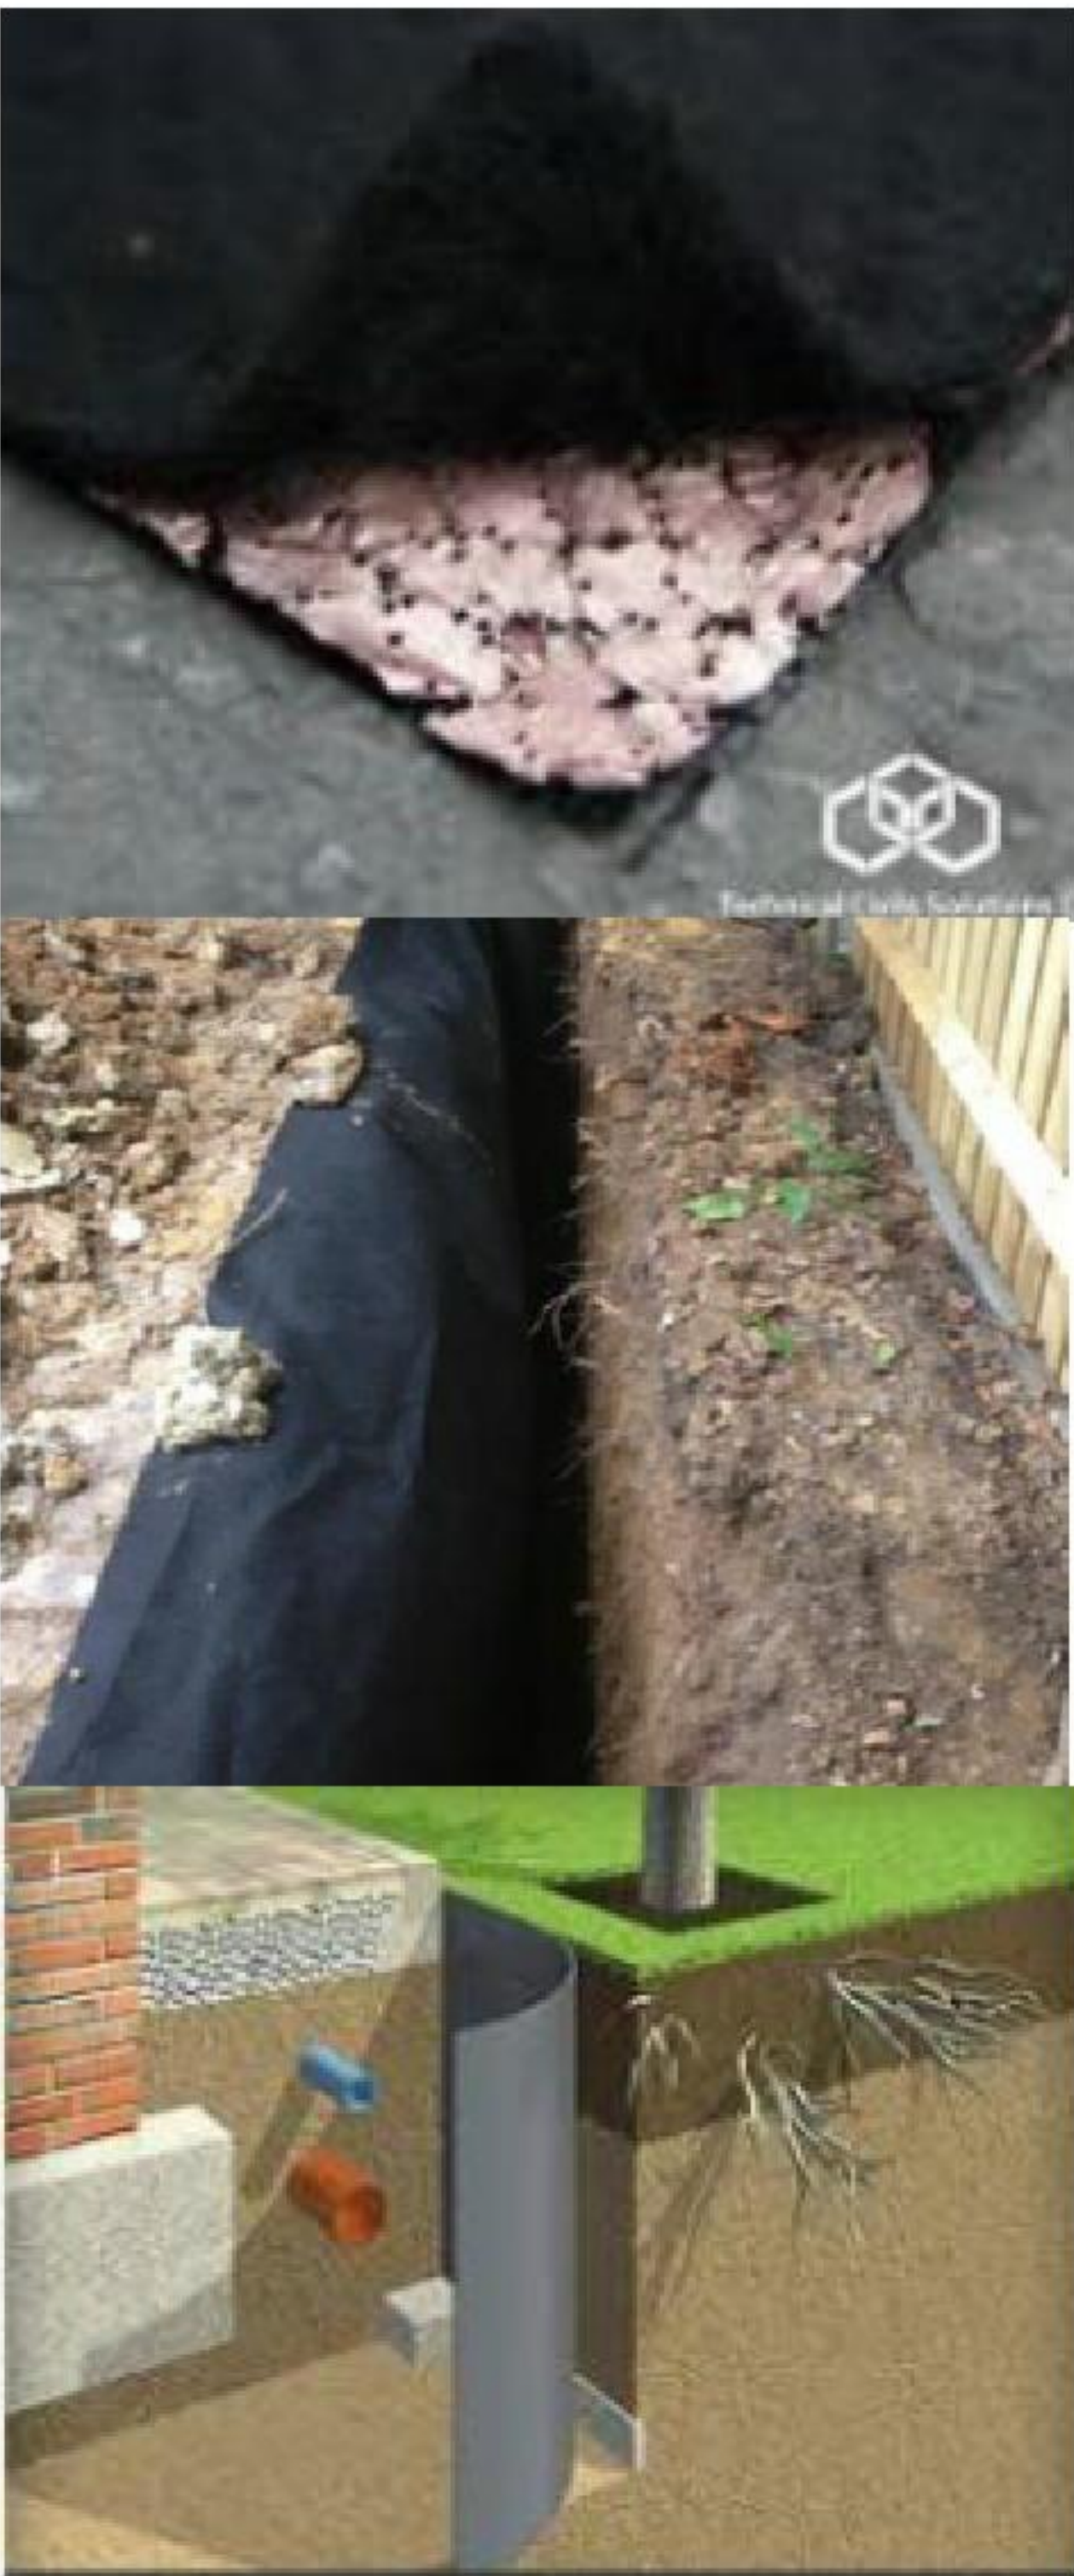
The Copper signal barrier details a cooper foil securely bonded between porous geotextile, releasing copper ions and forming copper carbonate (verdigris) that signals an adverse reaction to roots deflecting them away from the barrier. The presence of copper does not constitute an eco-system burden or impact on groundwater.

This solution is multipurpose and ideally suited to the current application. Traditional impervious barriers divert rather stop roots and may block moisture movement. Also, roots getting under such barriers can grow back to the surface. Therefore, the use of this permeable barrier stops roots either by engaging and constricting them or by chemically inhibiting them.
