## Optera Structural Solutions

### SOW 6700 for Agreement to install a root barrier for Crawford and Company

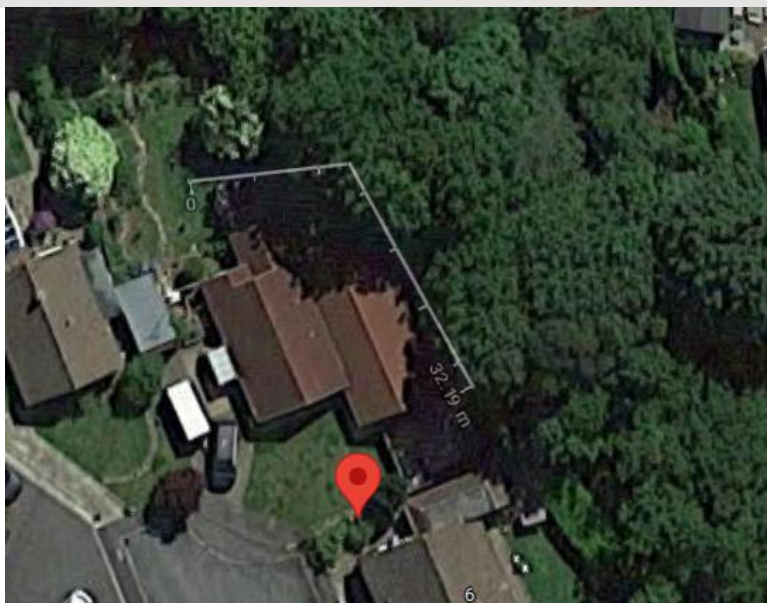
Aerial plan indicating proposed size and alignment of barrier

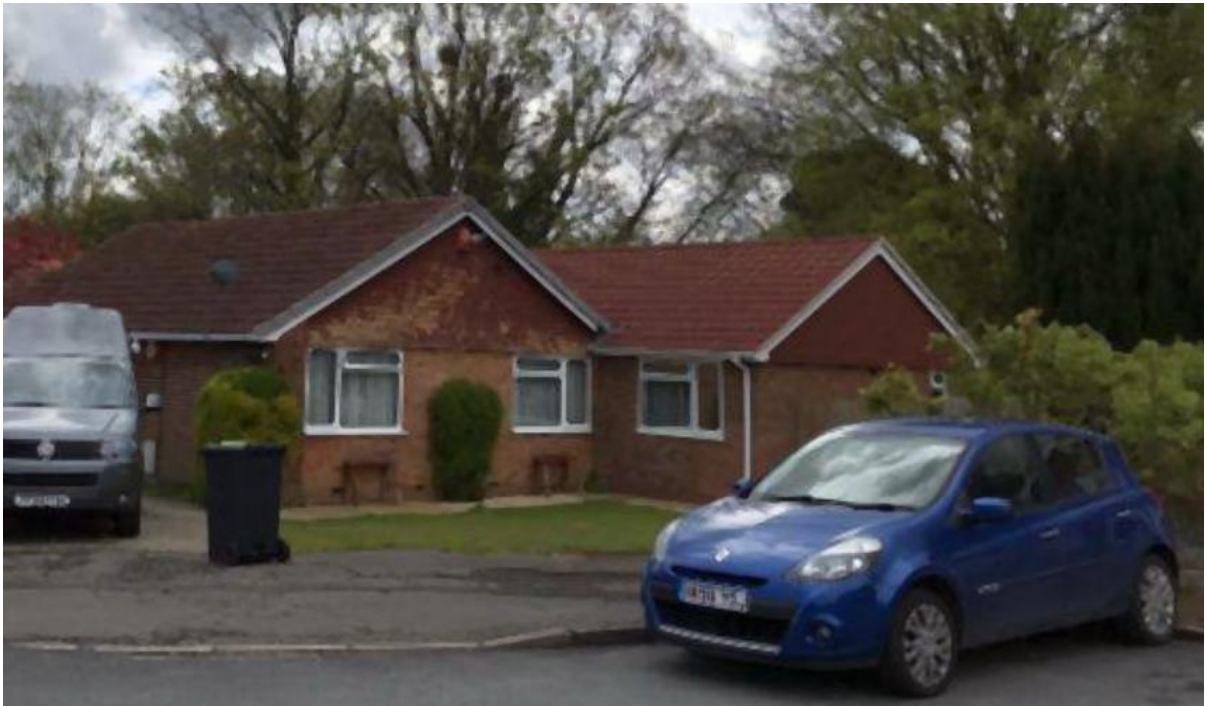
Front elevation of property.

The property is a single storey detached bungalow of traditional construction with assumed cavity brick walls surmounted by a pitched tiled roof. The property has been extended to the rear prior to the insureds occupation of the property in circa 1991 and the kitchen is situated within the rear extension. Alterations in 2018 included an extension to the right hand side on a piled raft foundation which remains unaffected by the recent movement.

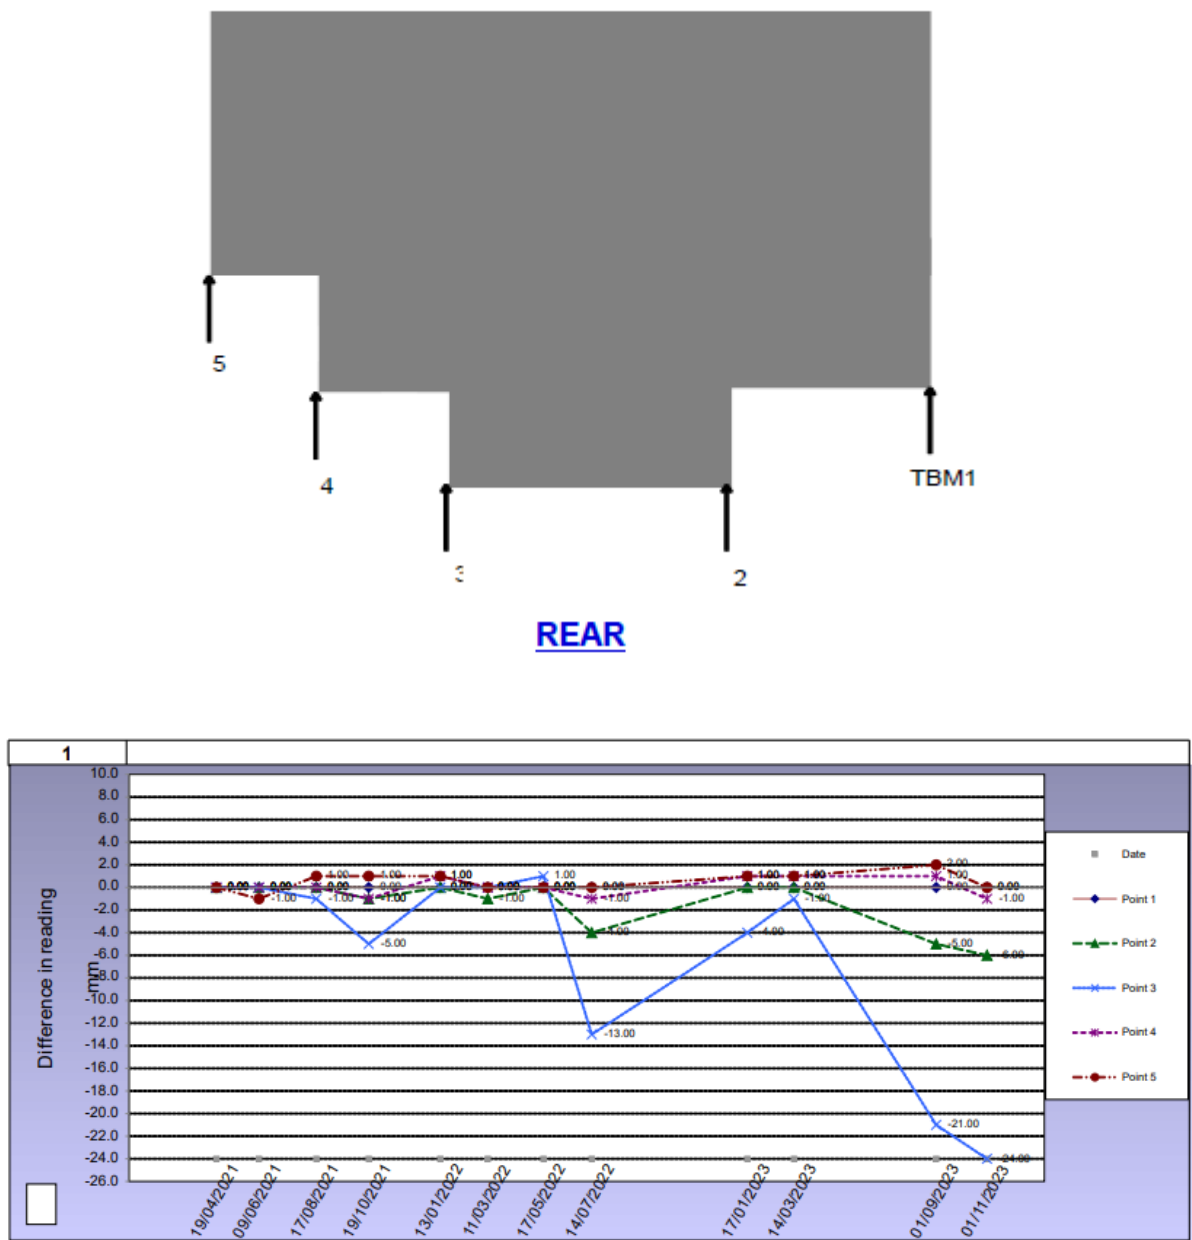
The level monitoring indicates a cyclical pattern of movement which shows both downwards movement during the drier summer months; when trees are in leaf and actively demanding moisture from the ground; and subsequent recovery and upward movement during the wetter winter months when the trees lose leaf and become dormant. Patterns of movement such as those observed at the risk address are consistent with clay shrinkage subsidence and are only consistent with the effects of shrinking and swelling of clay soils exacerbated by the presence of roots.

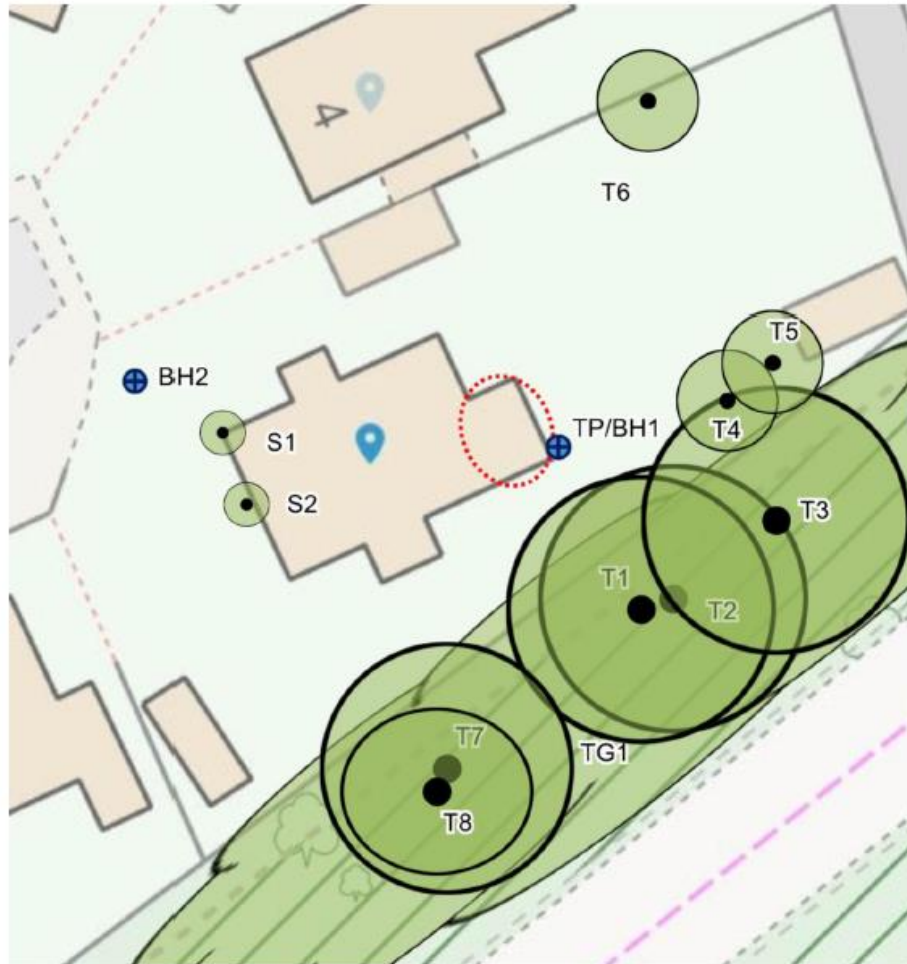
Whilst roots were identified as oak, the density of planting may mean that adjacent trees share root systems and felling those implicated may not have the desired effect of abating further moisture extraction. The piled extension, whilst close, remains unaffected due to the depth of the footings, but equally does nothing to prevent root ingress to the area of concern. The site plan overleaf indicates the size and position of the trees, relative to the affected extension.

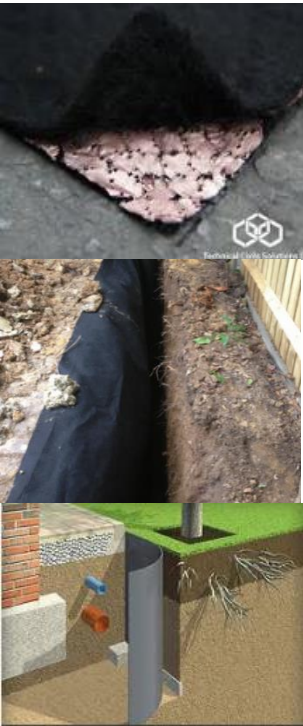
The Copper signal barrier details a copper foil securely bonded between porous geotextile, releasing copper ions and forming copper carbonate (verdigris) that signals an adverse reaction to roots deflecting them away from the barrier. The presence of copper does not constitute an eco-system burden or impact on groundwater.

This solution is multipurpose and ideally suited to the current application. Traditional impervious barriers divert rather than stop roots and may block moisture movement. Also, roots getting under such barriers can grow back to the surface. Therefore, the use of this permeable barrier stops roots either by engaging and constricting them or by chemically inhibiting them.

effect. The solution adopted in this case seeks to decrease water uptake by the trees thereby lessening subsidence risk by conserving soil moisture and reducing clay subsoil shrinkage. This aim is to achieve an impairment to root growth by the focused introduction of a proprietary Bioroot-shield that offers all the benefits of being both flexible and permeable. In addition it works as a biological repellent.

The benefits of such a shield are its dual protection both physical and biological. The multi-layered sheets can be welded together whilst retaining its flexible qualities, i.e. can be cut and effectively resealed to fit round services and foundations, inert with a 50-year service life expectancy. Equally the solution inhibits root growth on the barrier face which is often problematic with conventional barriers where increased moisture levels can cause root growth to become more prolific on the face of a traditional barrier. Research has shown that the use of the recommended style of copper-based screening has greatly reduced the effects of root growth when compared to other traditional physical barrier installations.
