# DRAINAGE STATEMENT

Ote Hall Farm  
Jane's Lane  
Burgess Hill RH15 0SR

**Ref:** 2021-103  
**Issue:** 2  
**Date:** 27 November 2024

***GEOTECHNICAL GROUND INVESTIGATION REPORT***

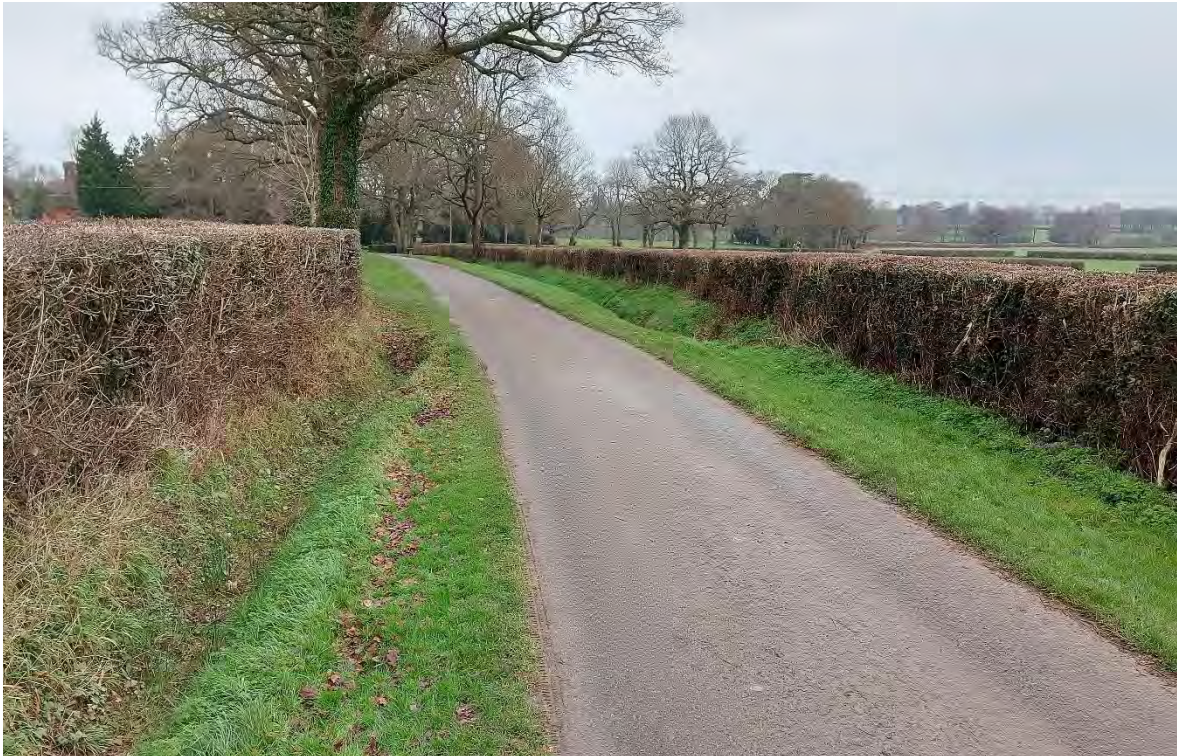
**Photo 1:** Looking north along access road with receiving ditch on left hand side

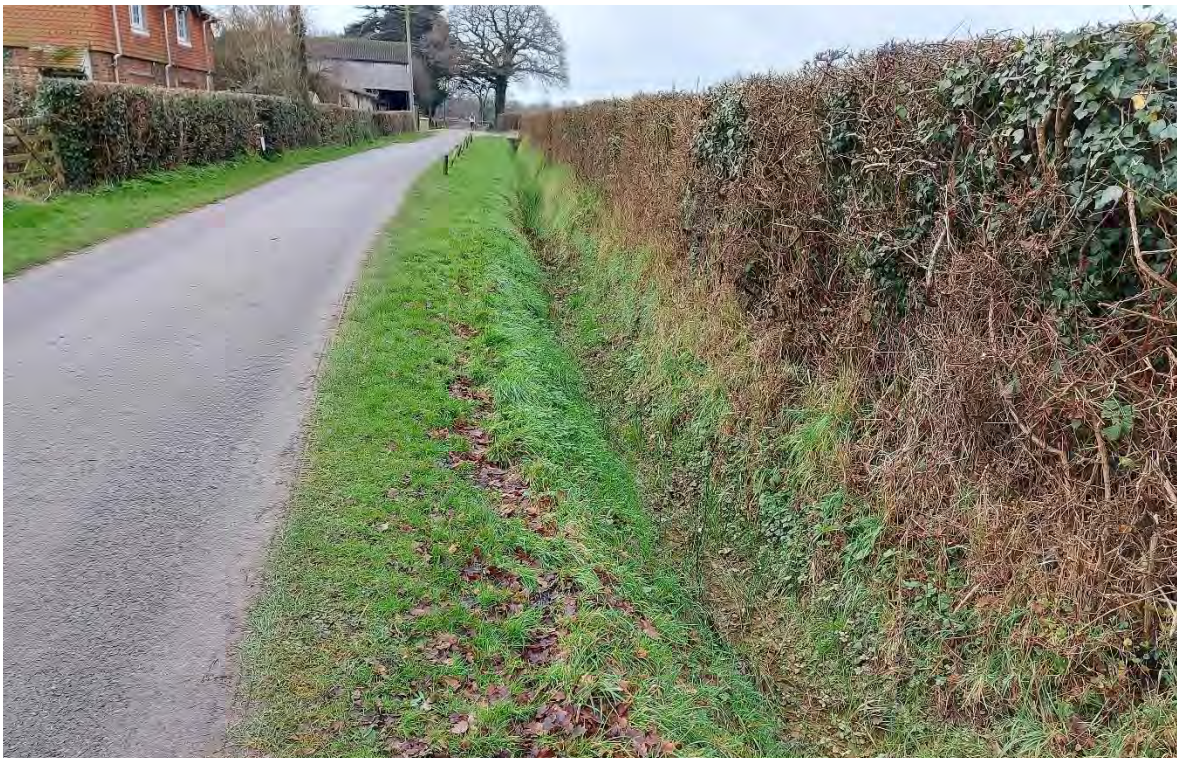
**Photo 2:** Looking south along access road with receiving ditch on right hand side

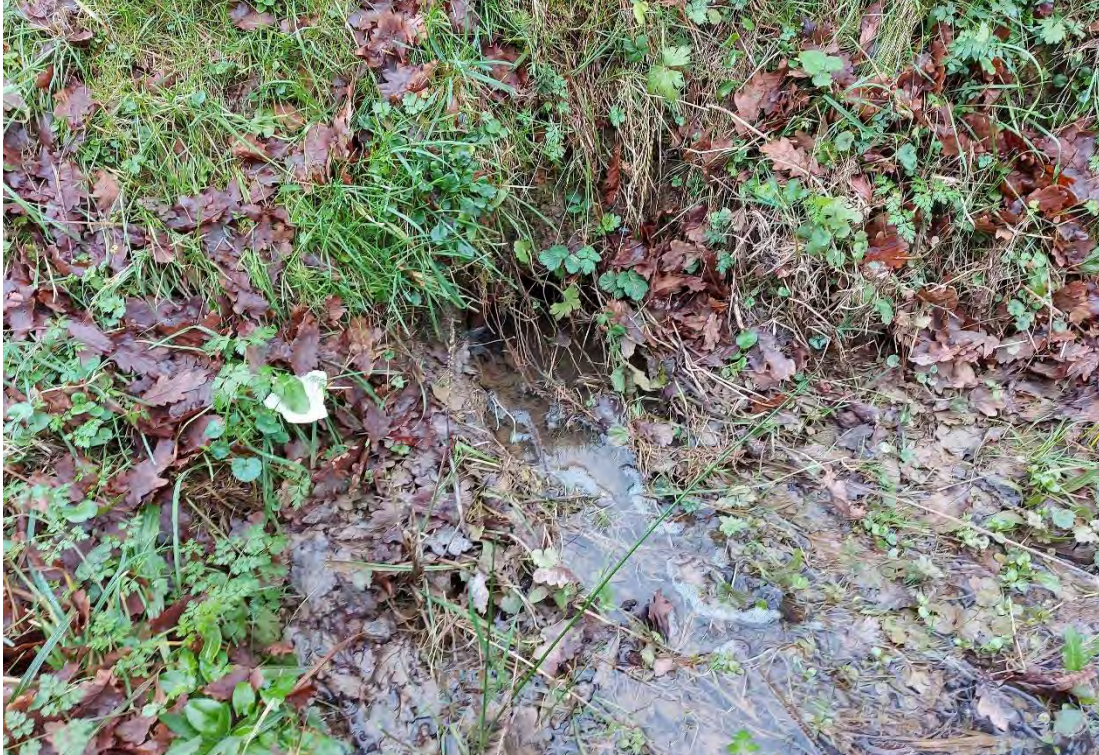
**Photo 3:** Culvert outlet from receiving ditch entering ditch on opposite side of access road, viewed from the east

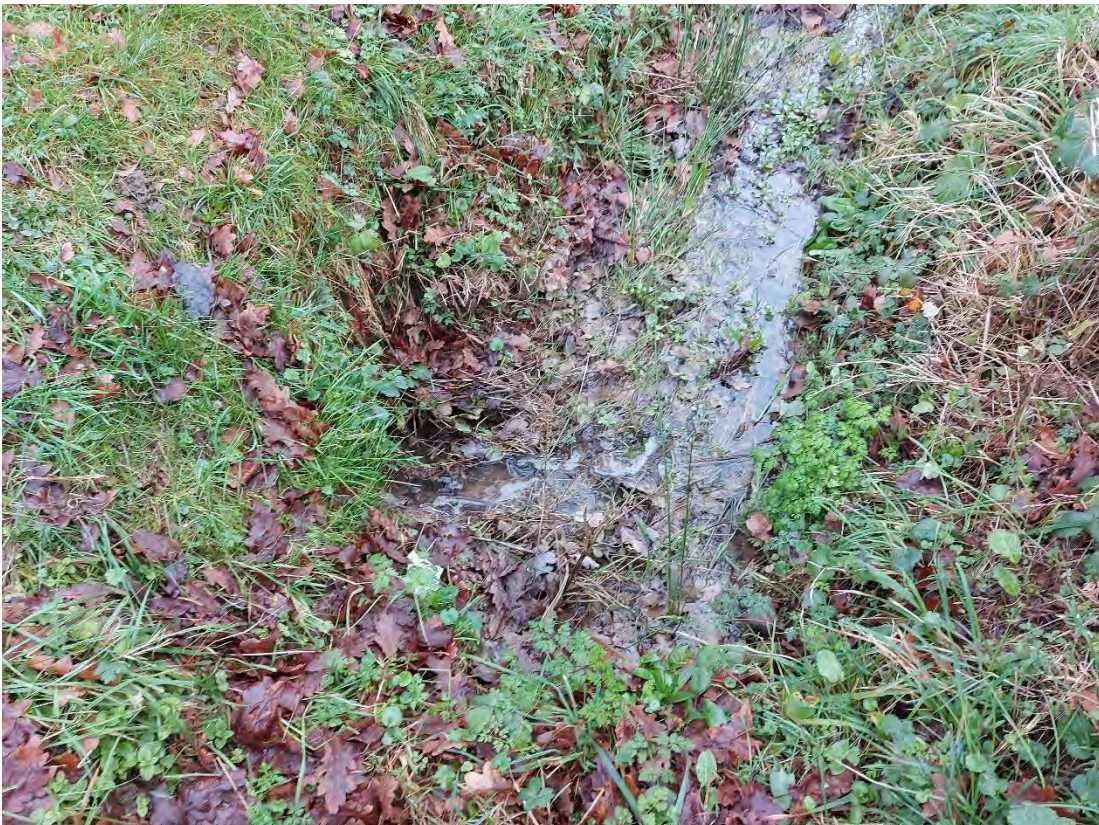
**Photo 4:** Culvert outlet from receiving ditch entering ditch on opposite side of access road, viewed from the south

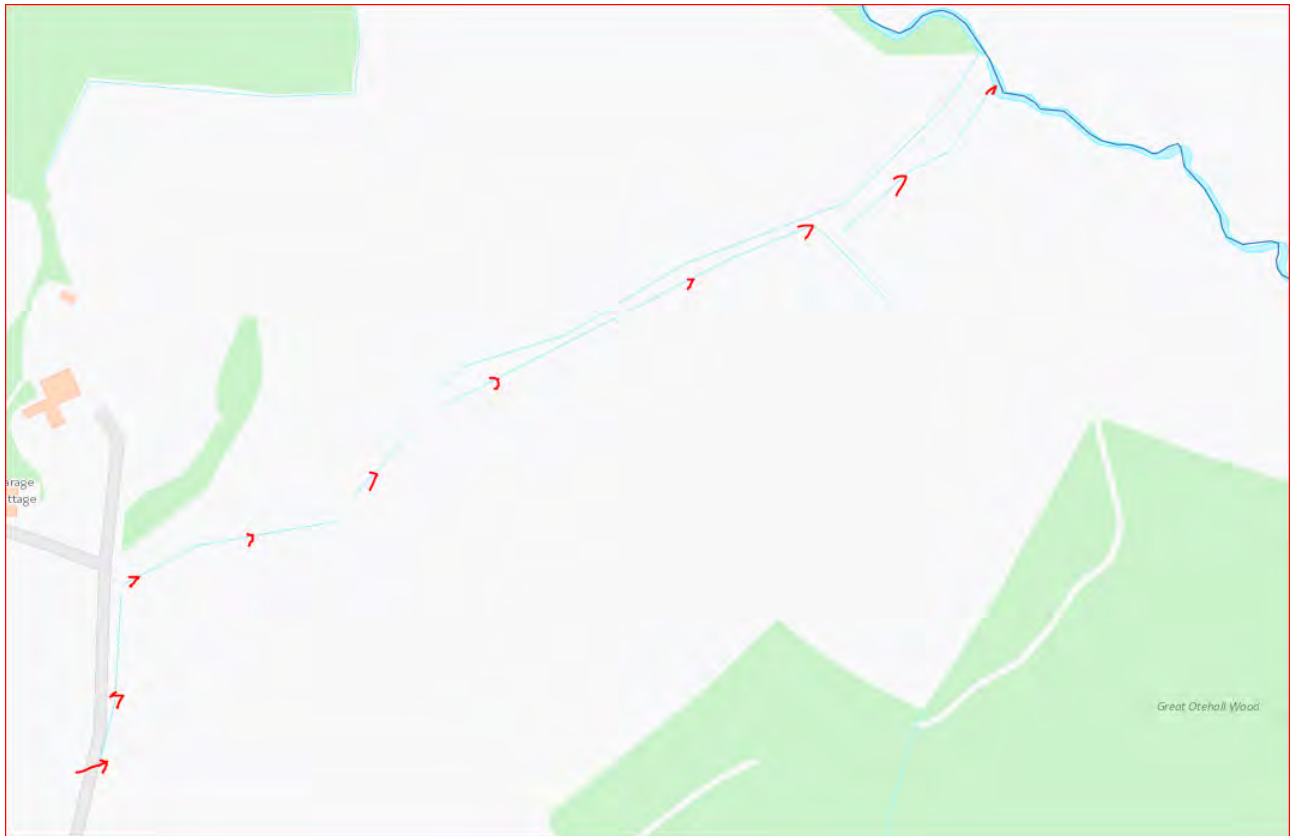
**Screenshot:** Extract from the EA's online mapping showing the ditch on the opposite side of the access road draining north and then northeast to connect to World's End Stream (a tributary of the River Adur).

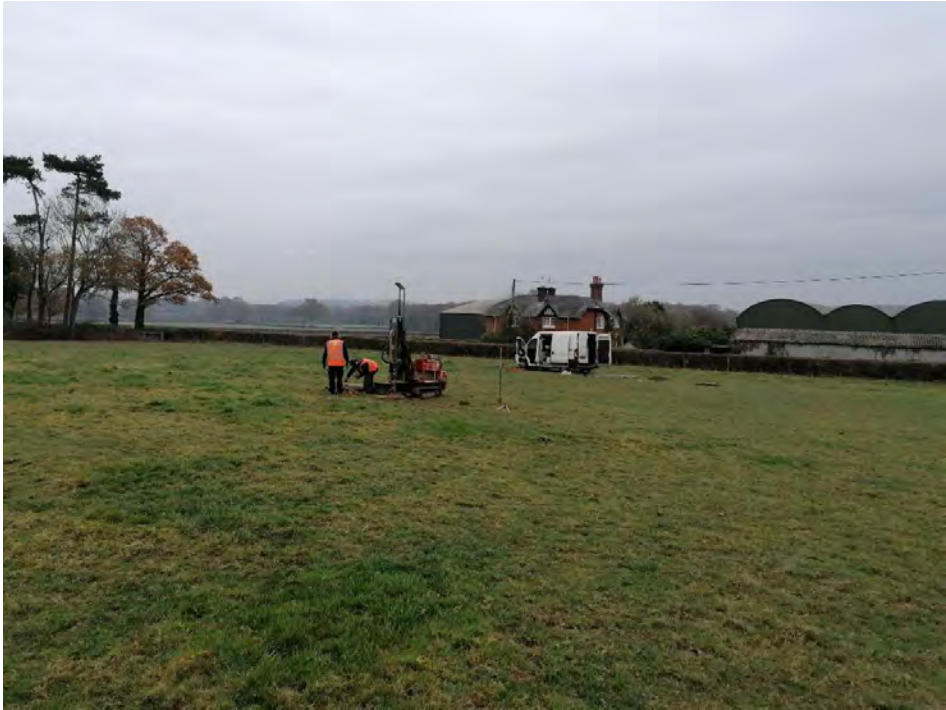
| <b>Description:</b><br><b>Terrier Rig Performing<br/>Drilling at the location</b> | | | | | |

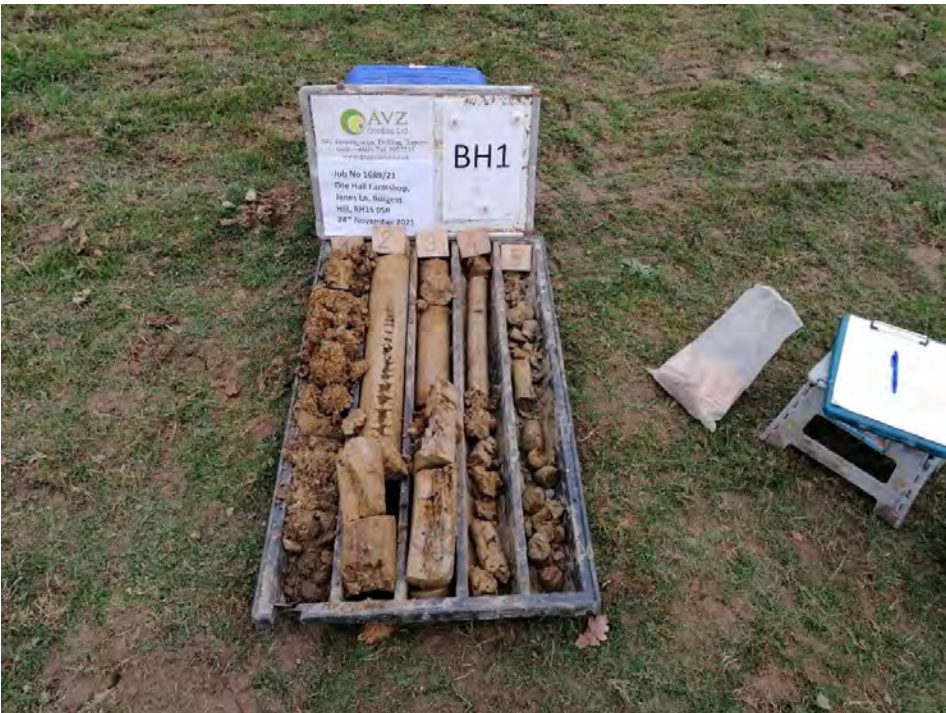
| <b>Description:</b><br><b>Core Recovered<br/>From BH1</b> | | | | | |

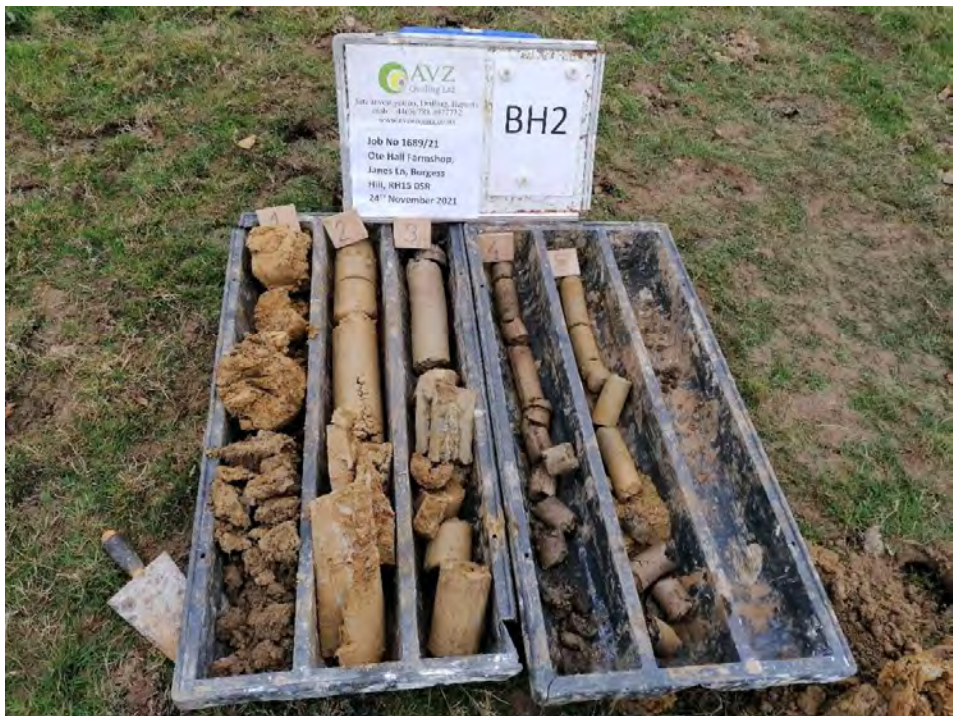
| <p><b>Description:</b><br/><b>Core Recovered From BH2</b></p> | | |

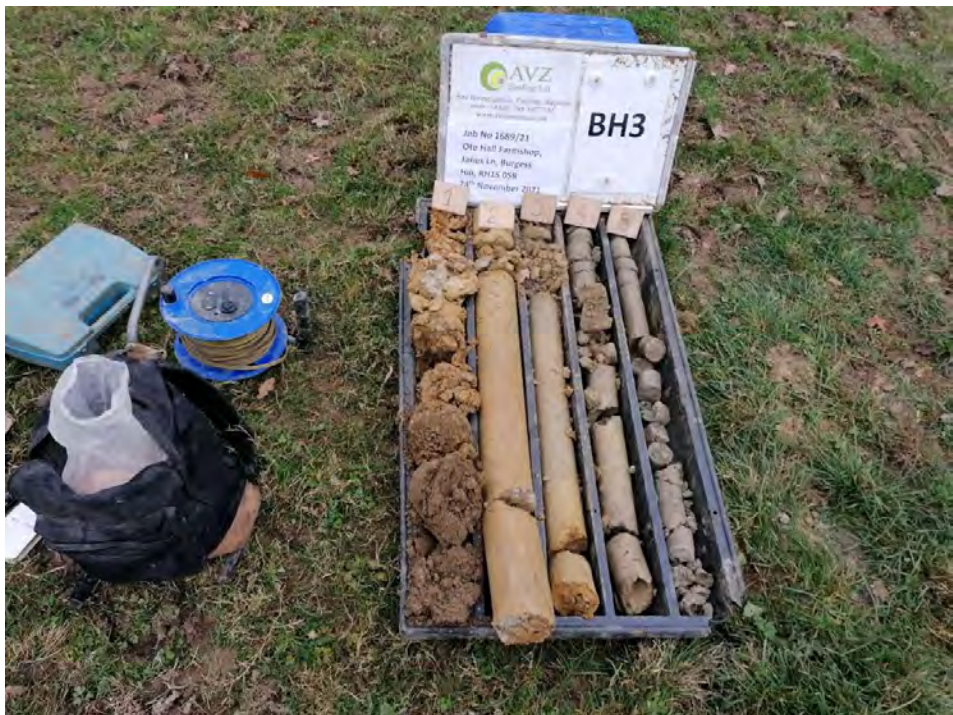
| <p><b>Description:</b><br/><b>Core Recovered From BH3</b></p> | | |

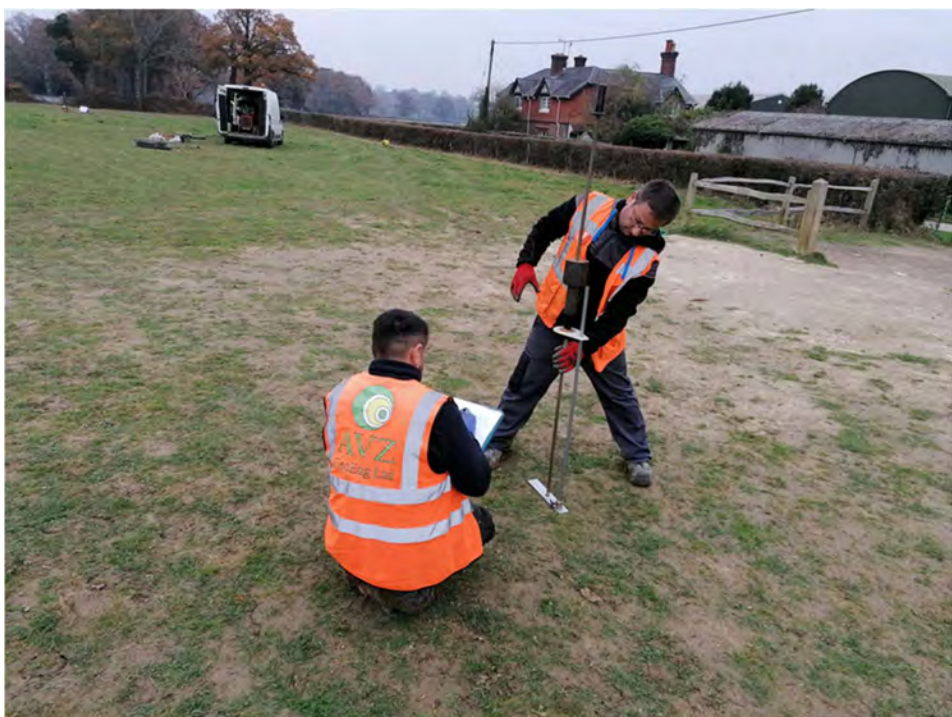
| Description:<br>CBR Test | | |

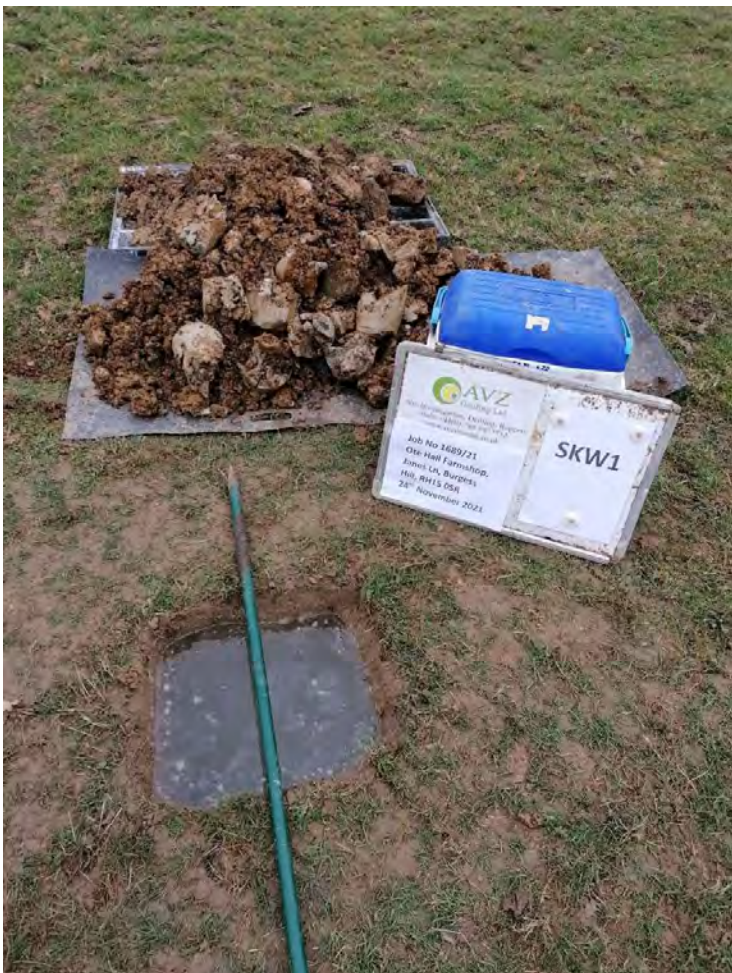
| <p><b>Description:</b></p> <p><b>Core recovered from<br/>Soakaway test</b></p> | | |

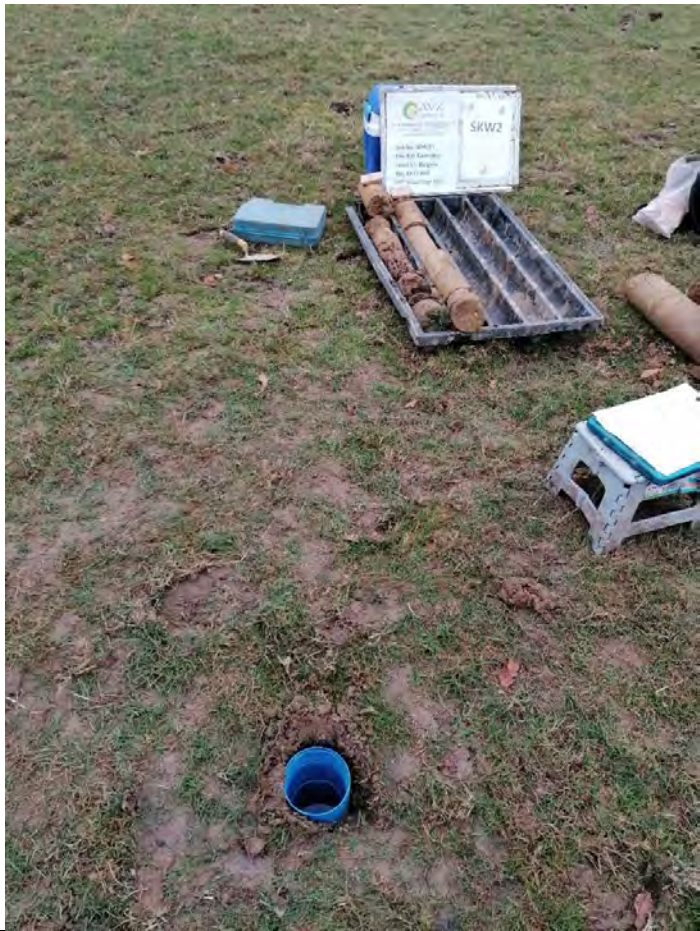
| <p><b>Description:</b><br/><b>Core recovered from</b><br/><b>Soakaway test</b></p> | | |
