### The Farmyard Proposals

## Cottage - Proposed Works:

#### SELECTED REFURBISHMENT WORKS TO COTTAGE

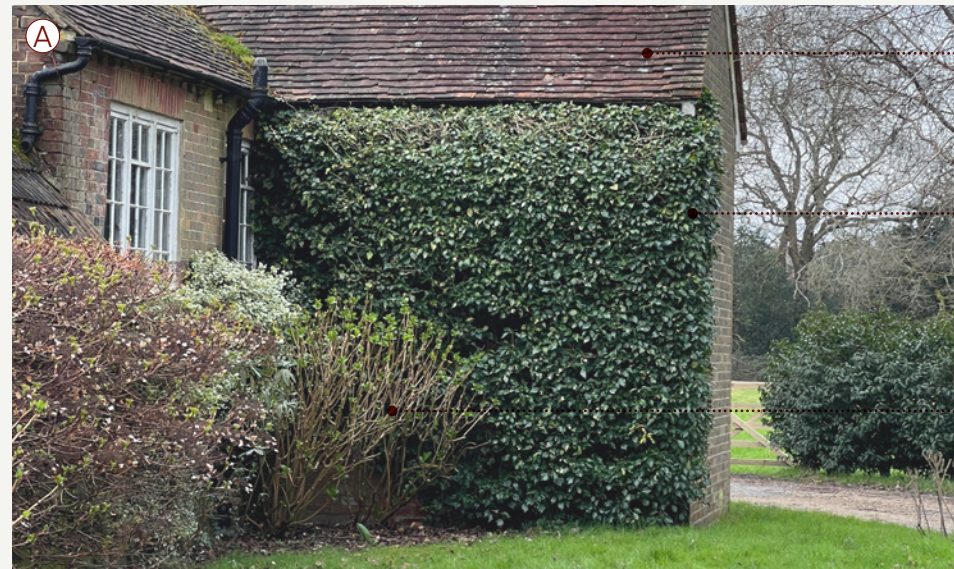
COTTAGE EAST ELEVATION - ROOM G09

Cottage roof to be repaired and made good using materials to match existing, ensuring continuity of appearance and weatherproofing. Cold roof insulation above ceiling level.

Existing greenery removed. New opening created for proposed glazed double doors providing access to the north-facing rear garden. Doors to match existing fenestration in style and finish.

Proposed stone steps to garden.

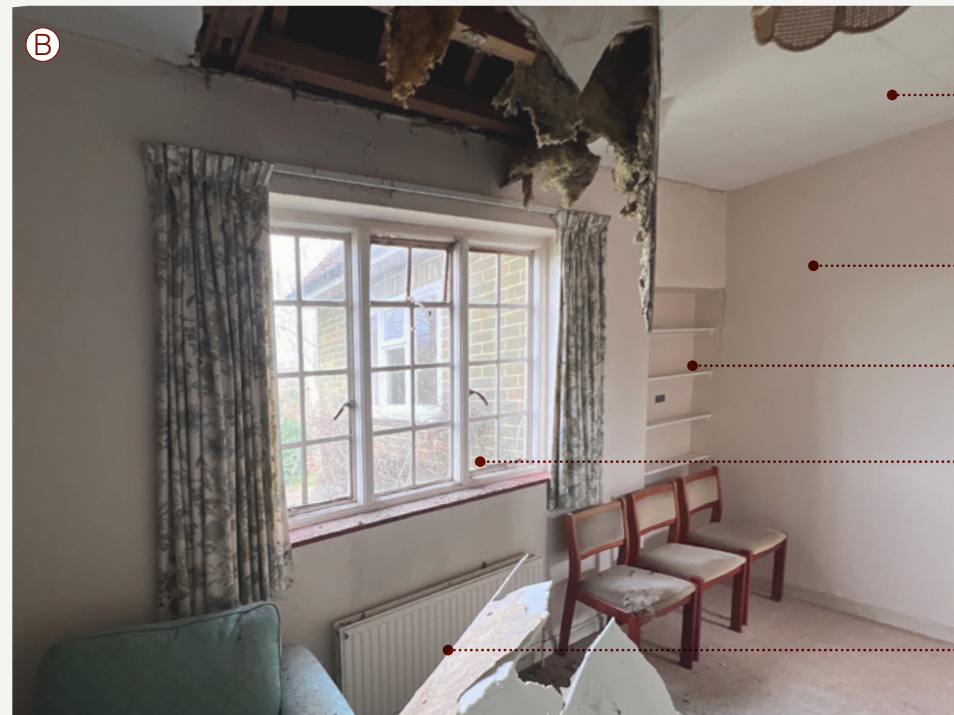
ROOM G07 LIVIGN - WINDOW G05.4

Existing acoustic tile ceiling, currently in advanced state of decay, to be removed and replaced with a new plasterboard ceiling, including insulation within the cold roof space above.

Partition to be demolished. Surrounding areas to be made good to match existing finishes.

Modern joinery to be removed in areas of proposed works.

Repairs, alterations of windows and doors to be carried out as required or to match existing.

Modern central heating radiators replaced. Existing pipework to be reused where possible. Any new runs to utilise the void between floor and ceiling joists.

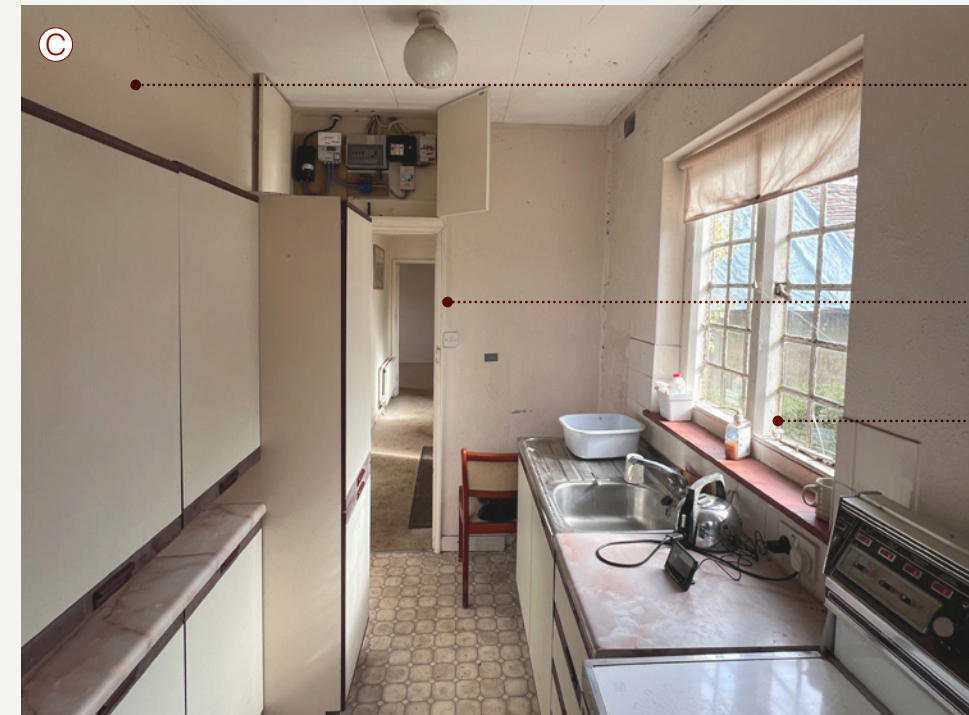
COTTAGE KITCHEN - WINDOW WG05.2

Modern kitchen joinery and partition to be removed. Surrounding areas to be made good to match existing finishes.

Partition and door to kitchen to be removed.

Repairs, alterations of windows and doors to be carried out as required or to match existing.

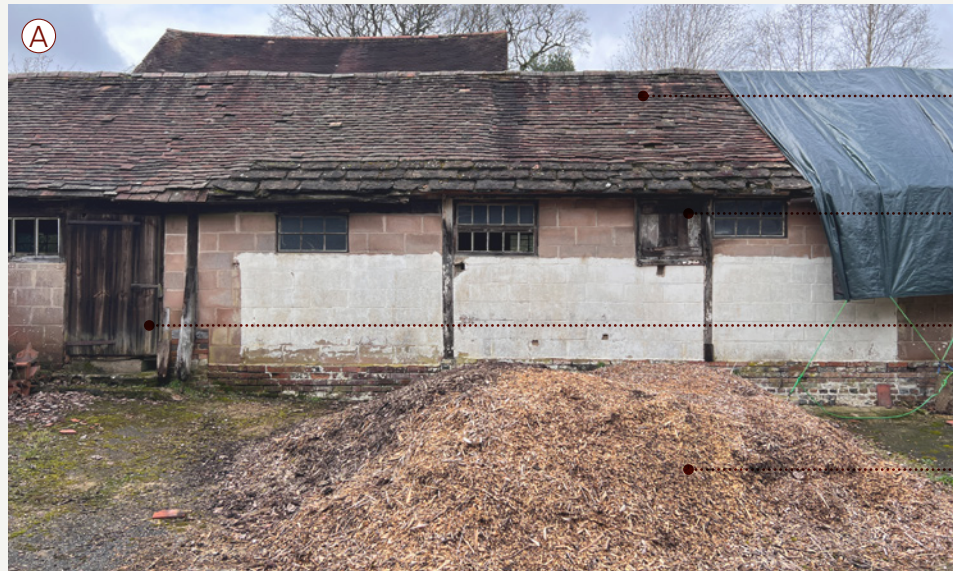
COWSHED EAST ELEVATION

- Existing cowshed roof, currently in a derelict condition, to be carefully refurbished and re-tiled to match original materiality. Horsham stone detail at eaves to be reinstated and continued along the full length of the roof.
- Existing poor-quality blockwork infill walls to be removed, with original timber framing retained where possible. Proposed replacement walls to be insulated masonry with a brick plinth and vertical tongue-and-groove timber boarding.
- Existing poor-quality doors and windows to be removed and replaced with appropriately detailed, minimally framed glazing, complemented by carefully designed timber shutters and louvres to maintain the vernacular and agricultural character.
- Existing poor-quality farmyard surfaces to be cleared, with deteriorated concrete removed. Proposed ground level to be consolidated to improve accessibility and ensure drainage permeability.

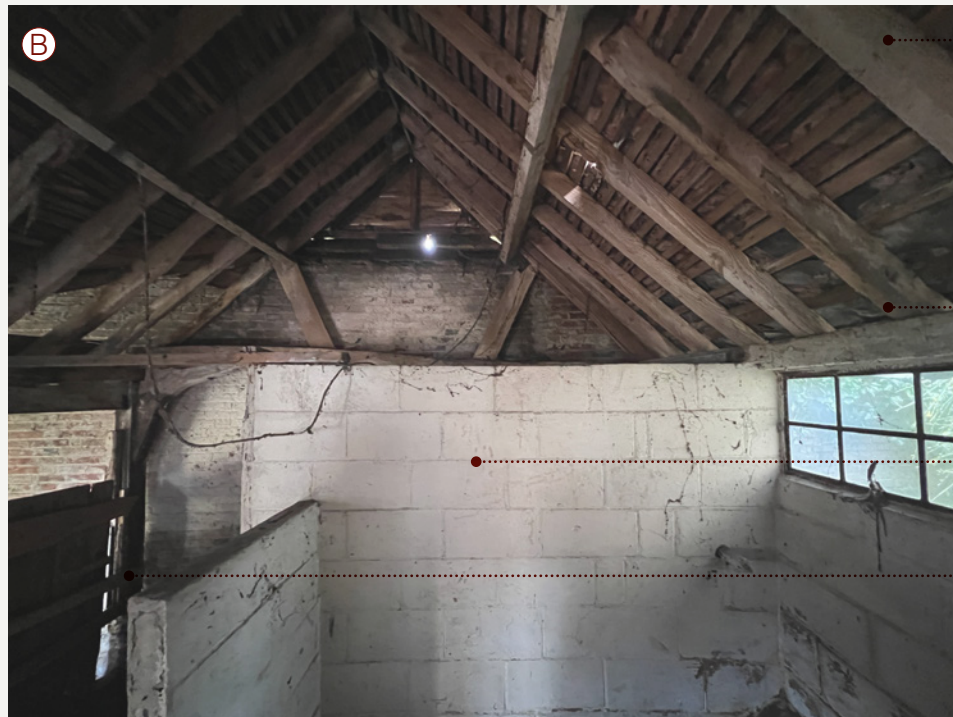
G06.1 COWSHED - WINDOW WG06.1

- Existing cowshed roof to be carefully refurbished and re-tiled to match the original materiality. Where feasible, existing clay and Horsham stone tiles will be reclaimed and re-used. Roof to be insulated above the existing internal timber trusses and structural frame to maintain their visibility within the interior.
- Existing timber trusses and primary structural frame to be retained and refurbished where structurally viable. These elements will remain exposed within the cowshed interior.
- Poor-quality blockwork walls to be removed. Surrounding areas to be made good, respecting existing materials and finishes.
- New insulated floor slab, screed, and finishes to be installed throughout cowshed. Existing uneven ground to be carefully levelled and excavated as required to accommodate new slab.

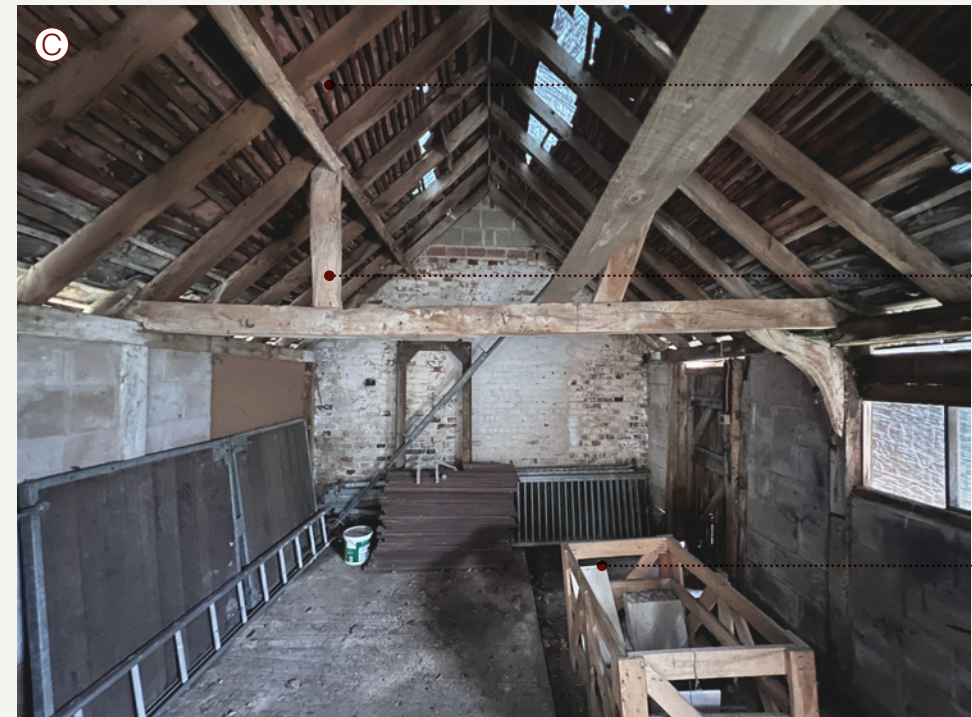
G06.2 COWSHED - WINDOW WG06.9

- Proposed openable conservation rooflight to cow-shed roof.
- Timber framing cleaned & treated for infestations throughout prior to carrying out isolated repairs and reinstatement of framing elements as required.
- New insulated floor slab, screed, and finishes to be installed throughout cowshed. Existing uneven floor finish to be carefully levelled and excavated as required to accommodate new slab.

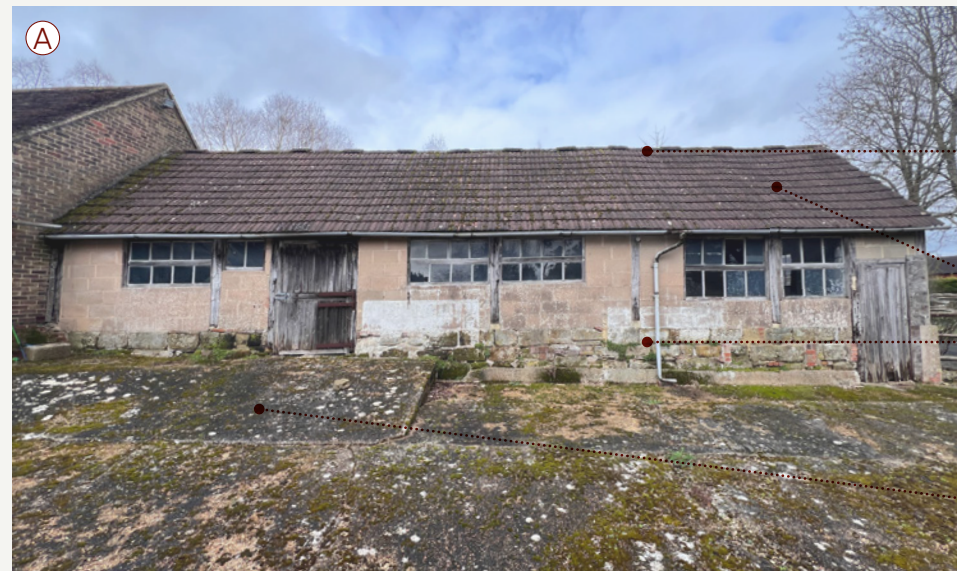
STABLES - SOUTH ELEVATION

- Existing stables roof to be insulated and re-tiled throughout with slate tiles in keeping with existing farmyard materiality. Inappropriate concrete pantiles to be removed. Roof to be insulated above the existing internal timber trusses and structural frame to maintain their visibility within the interior.
- Proposed area of roof to be fitted with solar panels.
- Existing blockwork infill walls to be removed, with original timber framing retained where possible. New insulated timber-framed external wall envelope to be constructed, incorporating a new seasoned oak wall plate to receive cut-back ends of existing or replaced posts. Existing sandstone plinth wall to be repaired and stabilised.
- Uneven concrete slope to be demolished and replaced with new stone steps. Surrounding areas to be made good and resurfaced.

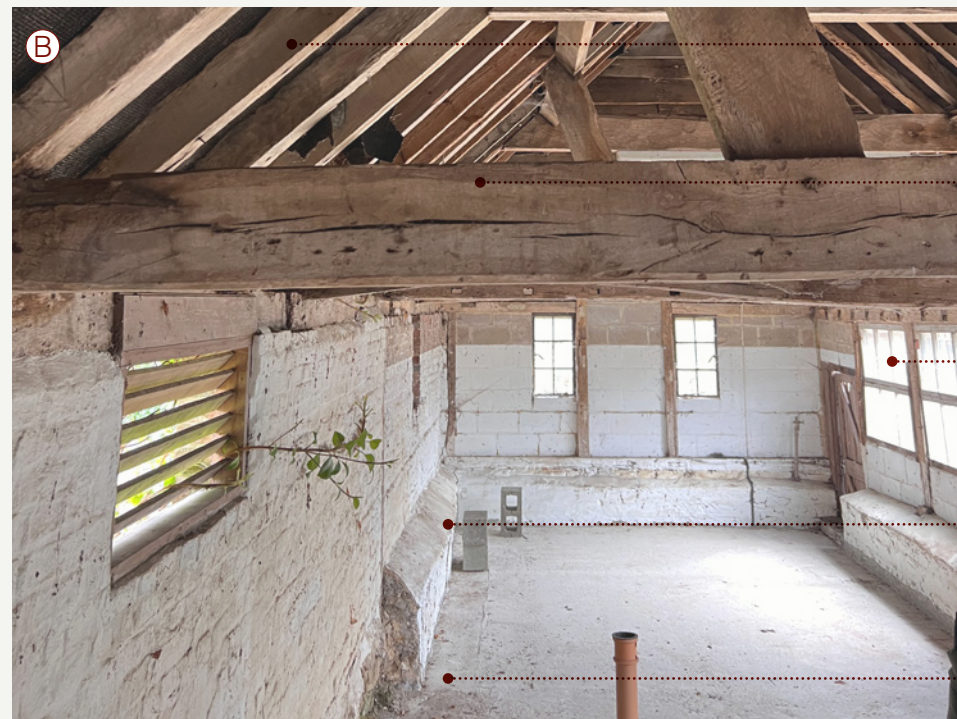
G17 - STABLES ROOM 2

- Existing stables roof to be insulated and re-tiled throughout with slate tiles to match existing farmyard materiality.
- Existing timber trusses and primary structural frame to be retained and refurbished where structurally viable. These elements will remain exposed within the cowshed interior.
- Existing poor-quality windows and doors to be removed and replaced with minimally framed glazing, detailed appropriately and complemented by timber shutters and louvres designed to reflect the vernacular and agricultural character.
- New insulated dry lining to be applied to the solid brick wall. Projecting concrete and sandstone elements to be carefully cut back, and wall surface stabilised.
- Existing concrete slab to be removed (if not possible to insulate and re-use), floor level excavated and prepared. New insulated floor slab, screed, and finishes to be installed throughout the stables.

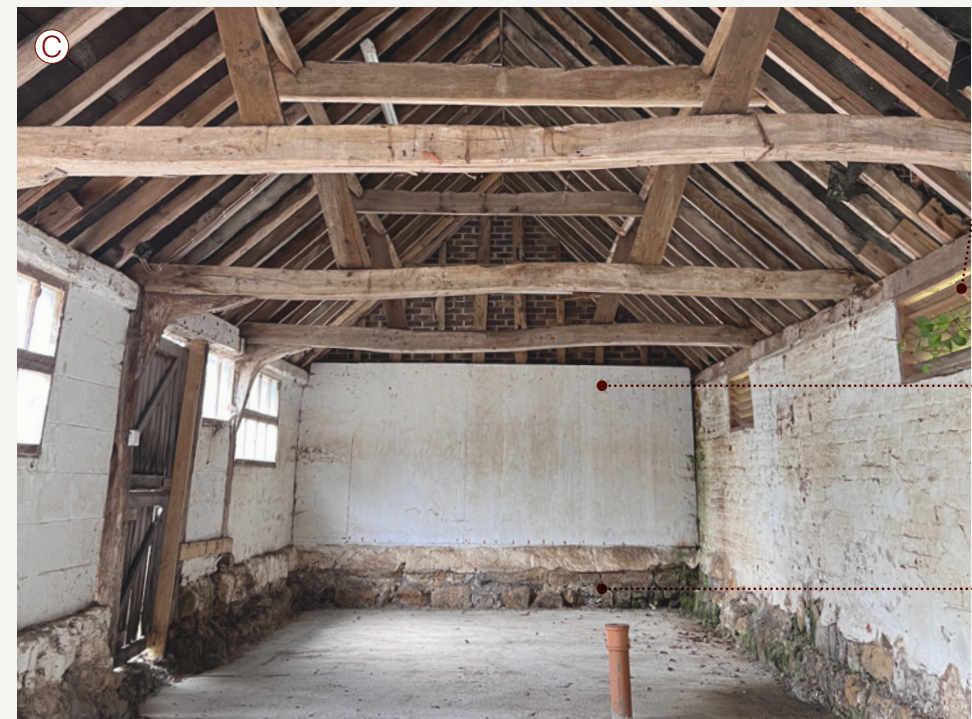
G15 - STABLES ROOM 1

- Existing timber louvred openings in the stables to be infilled with brickwork to match the existing wall.
- Painted timber panel over the cottage gable end wall to be removed. Wall to be made good, insulated, boarded, and re-finished to an appropriate standard, such as lime plaster or similar.
- Existing sandstone plinth wall to be repaired and stabilised.

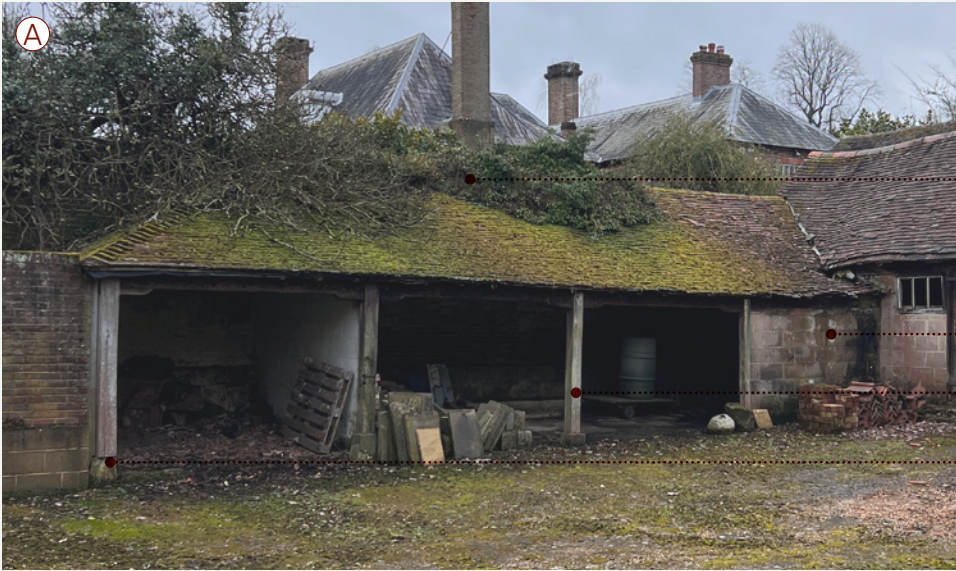
BYRE - VIEW FROM NORTH-EAST

- Existing byre roof, currently overgrown and in poor condition, to be fully refurbished and re-tiled throughout using materials matching the original.
- Blockwork wall infill to be removed. New brick plinth detail to match that of the cow shed, with proposed cladding in vertical tongue-and-groove timber boarding.
- Proposed timber doors to existing byre bays
- Existing timber posts and staddle stones, currently in poor condition, to be replaced with timber posts of matching style to preserve the original agricultural character.

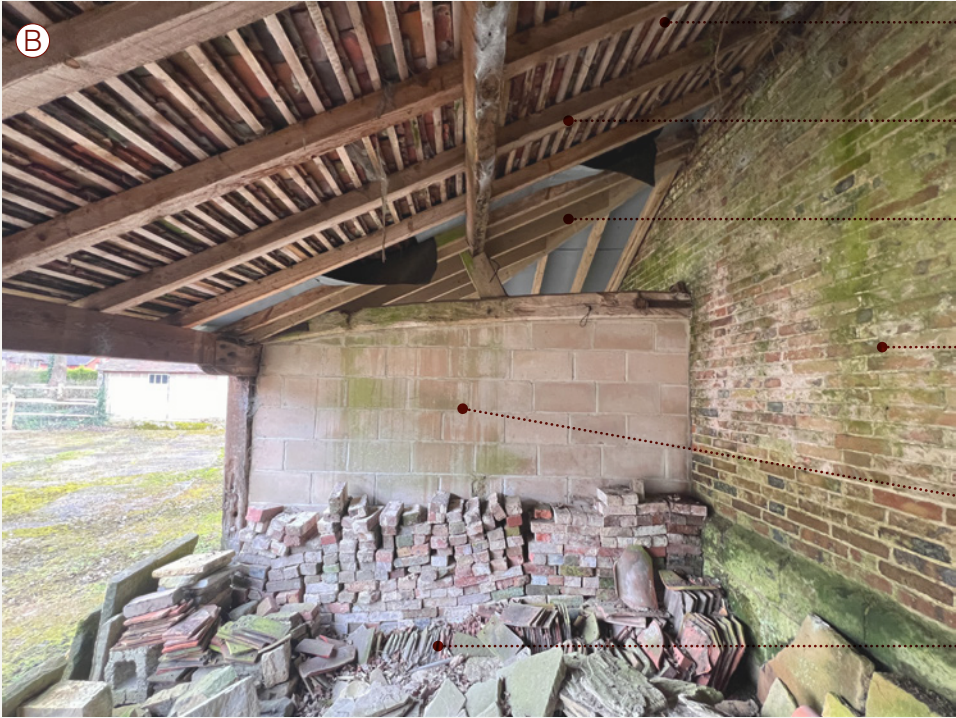
G18 - BYRE LOOKING EAST

- Original roof frames, consisting of raking beams with props to the purlin, to be repaired and reinstated.
- Existing byre roof to be refurbished, re-tiled to match the original materiality.
- Modern section of roof to be retained, subject to confirmation of proposed roof loading and careful removal of vegetation. Structural strengthening may be required.
- These two bays are to remain outside of proposed “thermal envelope”, as they are going to be adapted as simple storage spaces, with timber doors. Brick wall to be cleaned and retained as existing.
- Internal walls to consist of lightweight blockwork with timber infill above raking beams, supporting purlins, or timber studwork.
- Floor: Existing uneven concrete slab to be carefully excavated and levelled as required to accommodate new slab. New insulated floor slab, screed, and finishes to be installed throughout byre.

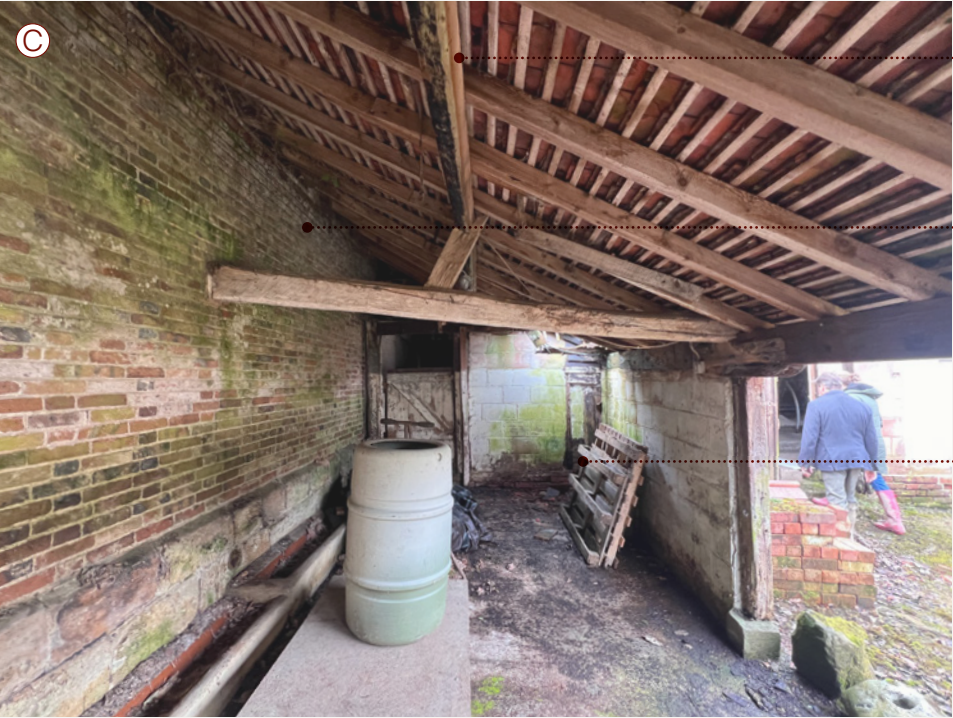
G03 - BYRE LOOKING WEST

- Existing byre roof to be refurbished, re-tiled to match the original materiality, and internally insulated between rafters.
- Breathable internal build-up comprising lime plaster and compatible insulation applied to internal face of existing brick wall.
- New insulated masonry wall and door to be constructed with appropriate detailing and finish. Existing blockwork infill and poor-quality timber to be removed and replaced. New steps to provide access to cow shed; floor finishes to be levelled throughout.

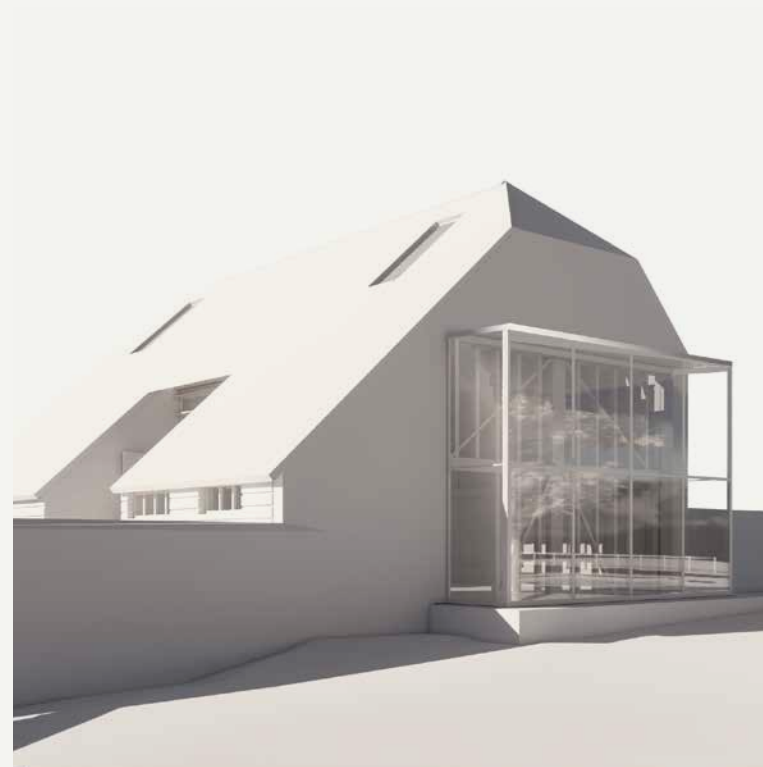
2-Storey Flat Roof Glazed Extension - discarded design test

In response to previous pre-application feedback, we produced a series of 3D studies exploring a flat-roof option. It was determined this would be less successful than the proposed design, which sympathetically continues the existing hipped roof form and provides a more unified visual impression in keeping with the current scale of the Barn.

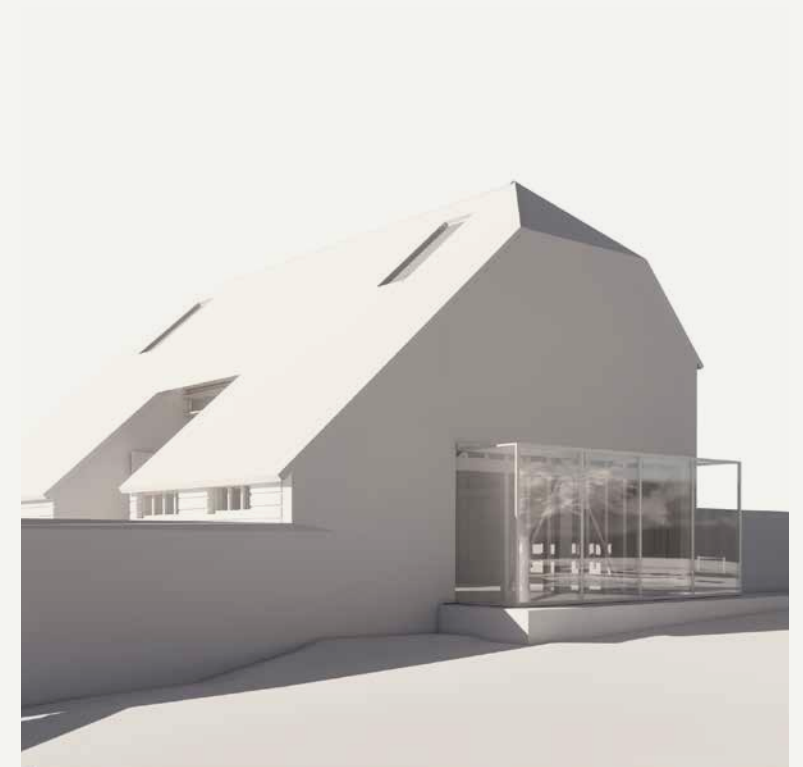
1-Storey Flat Roof Glazed Extension - discarded design test

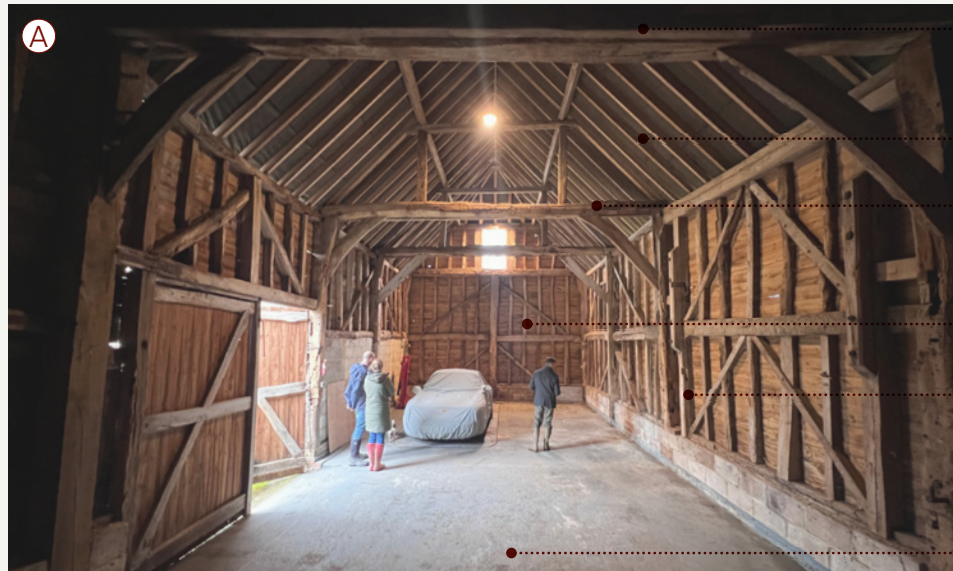
BARN G01 - ELEVATION A

- Existing barn roof to be re-tiled throughout with clay tiles to match existing, reusing original tiles unless unsuitably degraded. Proposed openable conservation rooflights installed within select roof locations.

- New Wood-burning stove to be installed in location specified on plan.
- Existing timber trusses and primary barn frame to be retained and expressed internally. Insulation fitted above and between rafters, with ventilated zone added under tiling.

- Proposed Mezzanine
- Existing barn walls to be externally insulated and re-clad with horizontal timber weatherboarding. Existing boards to be reclaimed where possible; new boards to match in profile and finish. Modern concrete blockwork plinth to be removed and replaced with a brick plinth detailed to suit the building's character.

- Existing non-historic barn floor to be excavated and replaced with new insulated slab incorporating underfloor heating. Finished floor level to match existing.

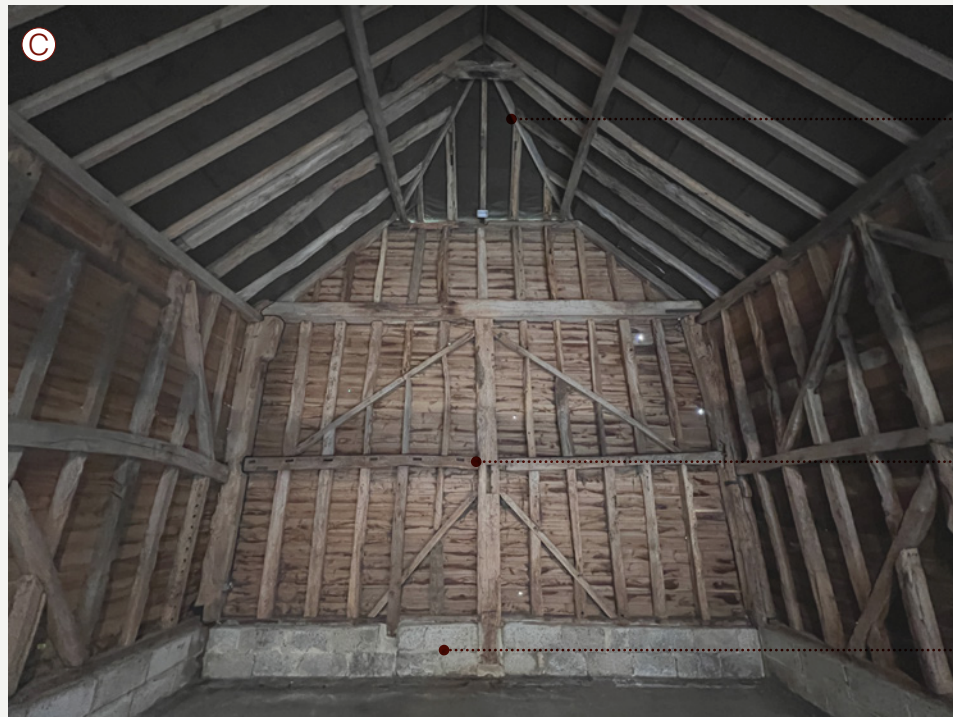
BARN G01 - ELEVATION C

- Proposed southward roof extension with construction and clay tiling to match existing. Roof to be insulated and detailed for appropriate weatherproofing.
- Existing weatherboarding to be removed and set aside for re-use; primary timber frame at gable end to be retained and expressed, with new openings formed on either side to access proposed extension.
- Modern concrete blockwork plinth to be removed. Existing non-historic barn floor to be excavated and replaced with new insulated slab incorporating underfloor heating. Finished floor level to match existing.

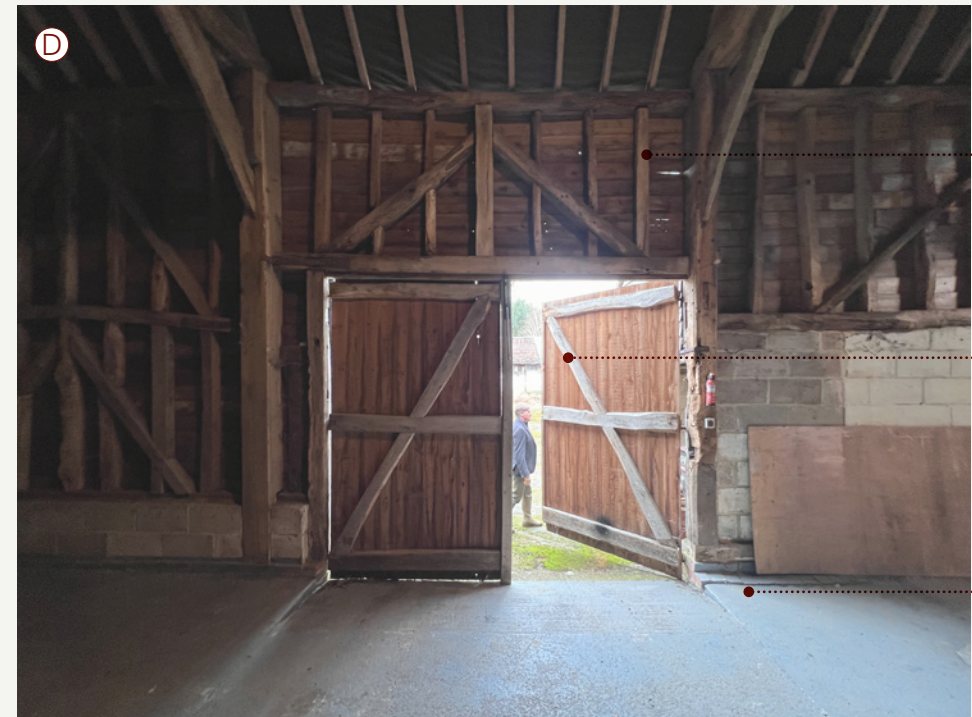
BARN G01 - ELEVATION D

- Existing weatherboarding to be removed. Timber frame to be retained with new glazing installed proud of structure with louvres above existing timber barn doors.
- Existing timber barn doors to be retained. New glazed entrance door to be set within a framed glazed infill, forming the new main entrance to the barn.
- Existing floor screed to be removed and ground excavated to form new insulated slab with underfloor heating and new floor finish
