Main House Proposed North Elevation  
1:50 @ A1; 1:100 @ A3

Planning

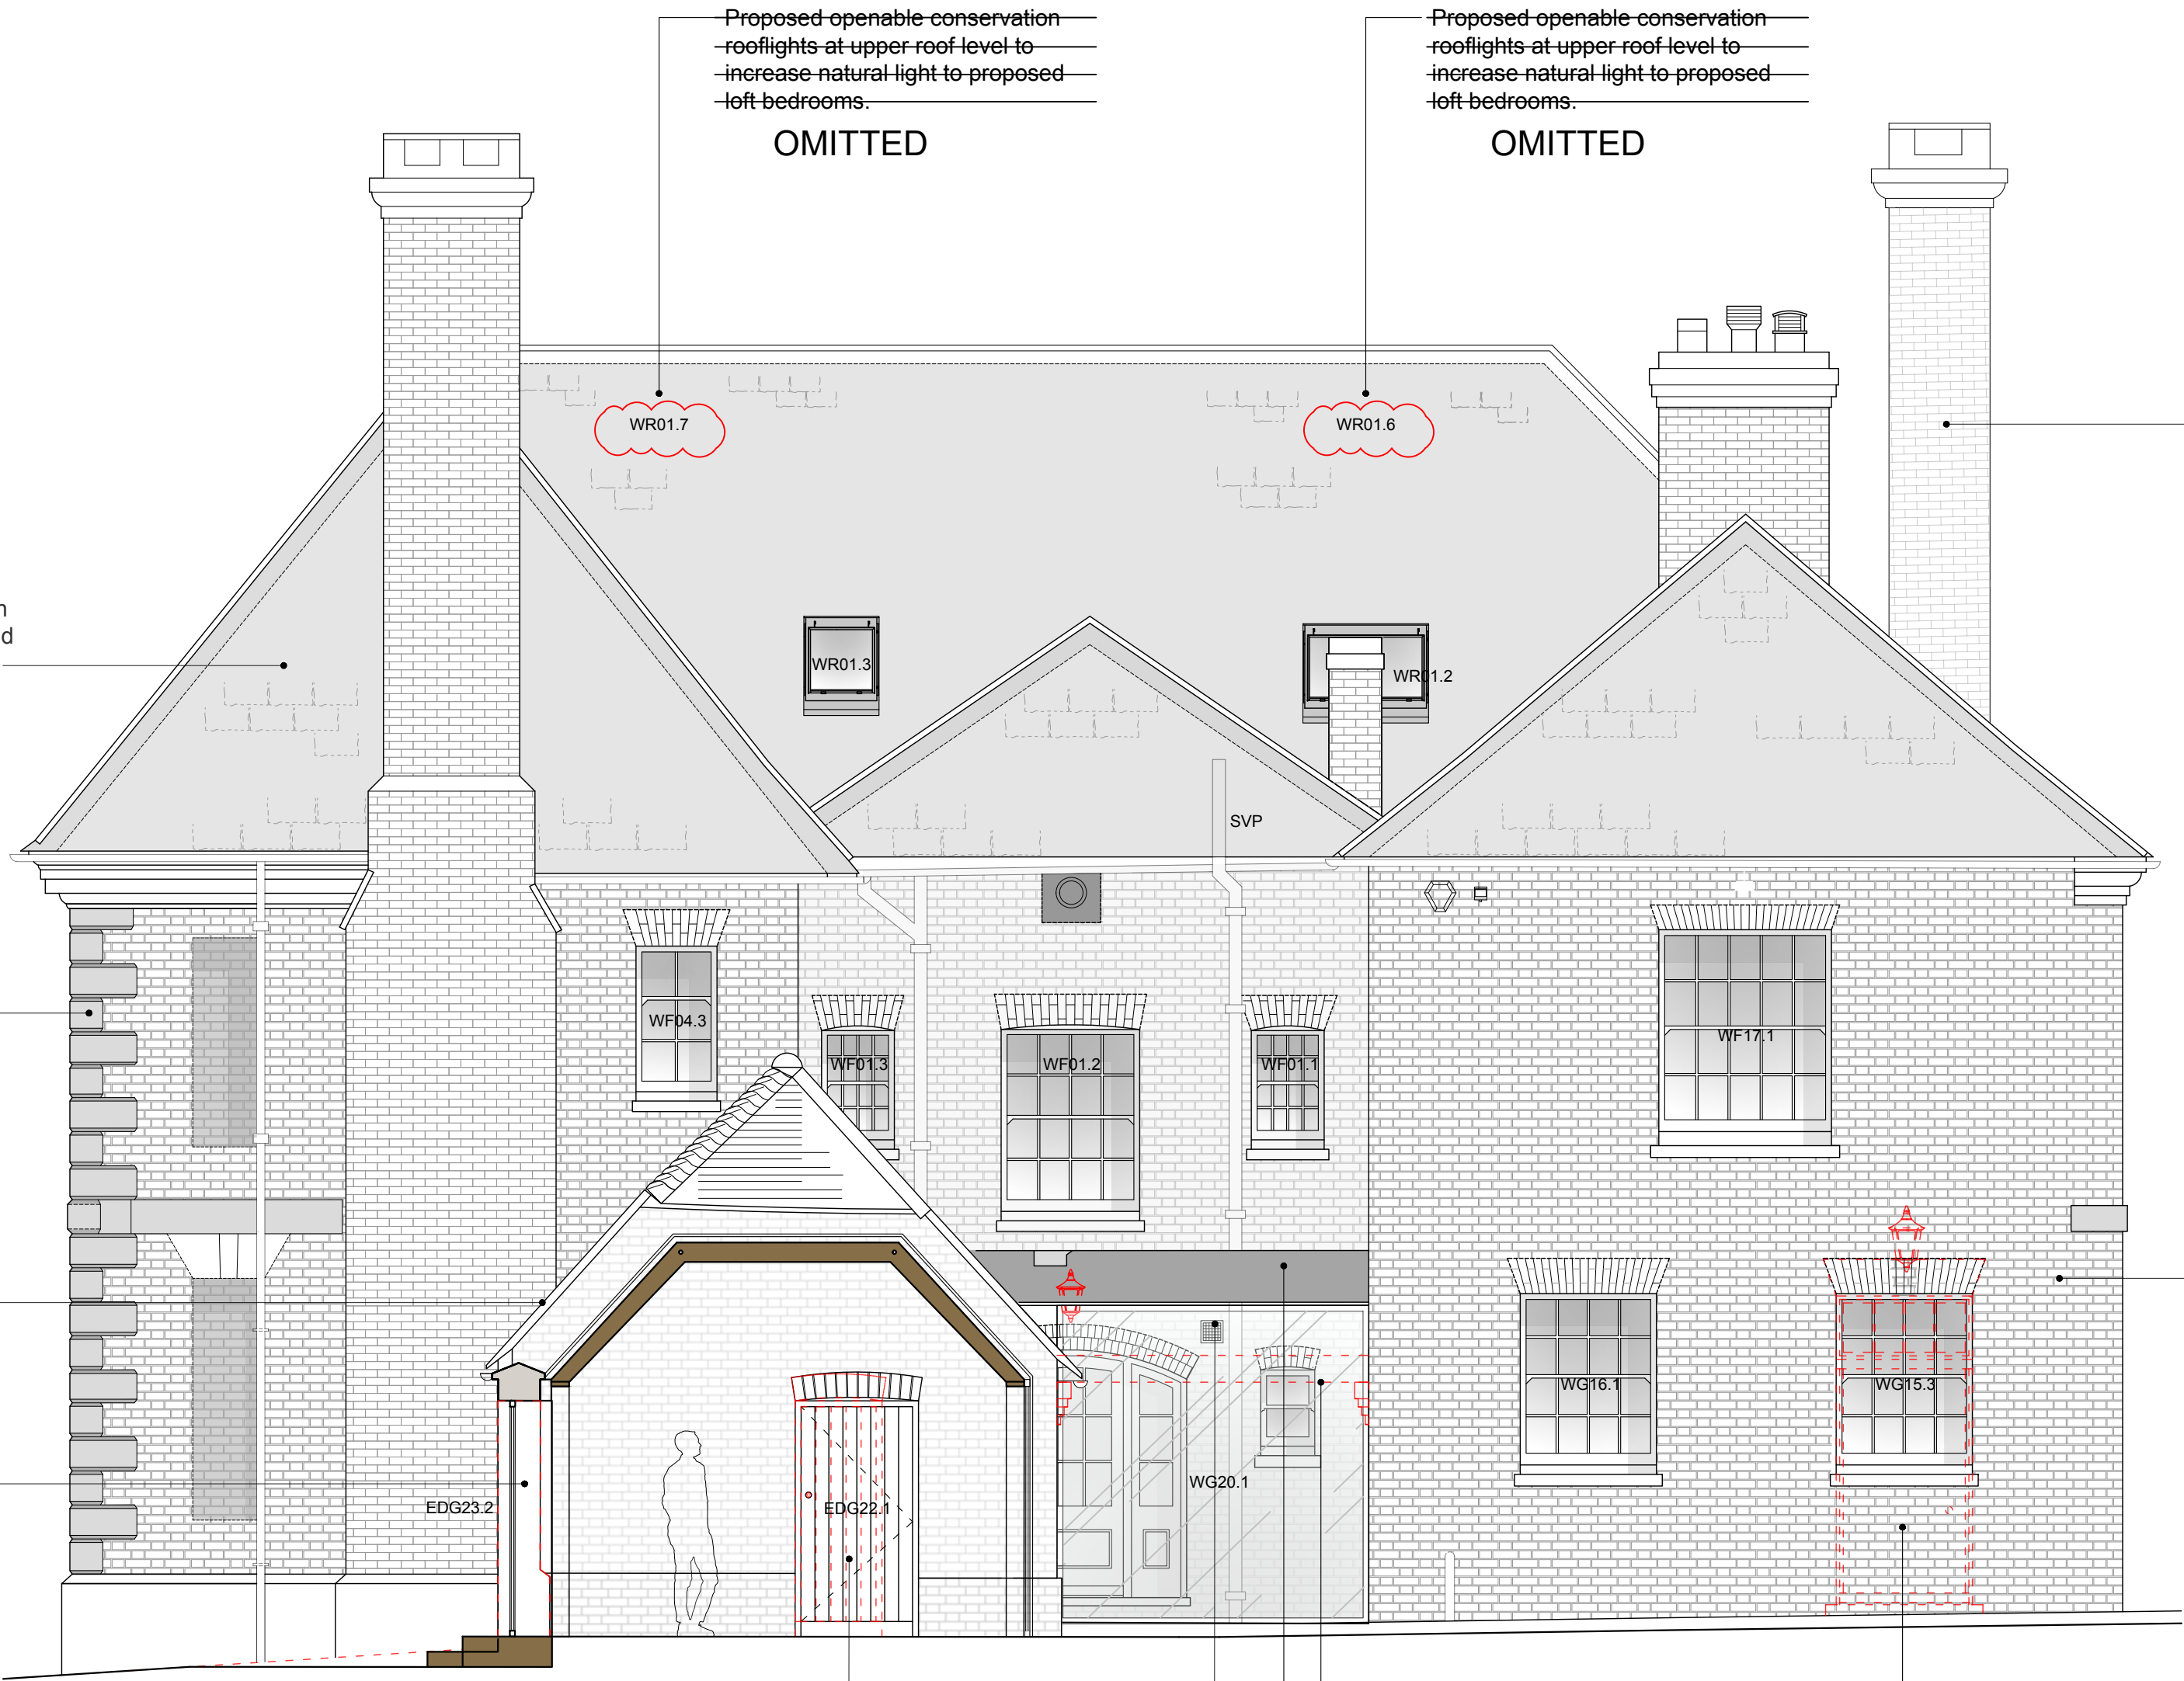
Extg roof coverings to be recorded, carefully lifted and set aside to allow installation of of new breathable insulation between rafters and ventilation zone above. Extg tiles to be reinstated in original location, overhauled and steam cleaned to remove all algae, moss, fungi and later paint coatings. Cleaning methods to be tested on a limited area before application. Damaged roofing to be replaced like for like where required including damaged tiles, flashings, dressings and valleys.

Extg stone quoins and all other stone elements, including sills, steps, plinths, cornices, decorations, mouldings, etc to be steam cleaned to remove all algae, moss, fungi and later paint coatings. Cleaning method to be tested on a limited area and to be modulated to ensure the removal of damaging substances without altering the stone historic patina. All damaged, loose, missing or discoloured stone joints to be repointed with lime mortar to match. All missing/damaged elements to be replaced with new stone sections to match extg.

Existing Dairy Roof to be extended as per proposed plans to form enclosed courtyard: G20 Breakfast Room. Extension to feature a pitched roof matching the existing Dairy in clay tiles and detailing. The new structure will abut the chimney breast of the existing north-east wing.

Existing Garden Wall blocked up door to be re-opened to form new access between gardens and proposed G23 Covered Entrance.

Extg door opening to be enlarged, brick lintel to be re-built and extg door to be replaced with new timber door to match existing appearance and detailing.

Extg air brick to be replaced with new heritage cast iron ones.

Extg timber beam and brick shelves to be removed

Proposed Zinc Clad Flat Roof over enclosed courtyard Breakfast Room G20. Proposed new fixed glazing WG20.1.

Existing non historic external door EDG15.1 to be removed. Extg door opening to be infilled with bricks to match extg to form new window opening, retaining extg lintel. New timber sash window to be re-instated within existing opening to match existing window WG16.1.

Extg brick wall, lintels and chimney stacks to be cleaned to remove all algae, moss and fungi. Cleaning method to be tested on a limited areas before application. All damaged, loose, missing or discoloured brick joints to be repointed with lime mortar to match.

Chimney stacks to be inspected for structural stability and repaired accordingly
