## HERITAGE IMPACT ASSESSMENT

**Property Address:** Lywood Barn, Lindfield Road, Ardingly,  
Haywards Heath, West Sussex, RH17 6SW

**Prepared by** Richard Pocock MSc MRICS

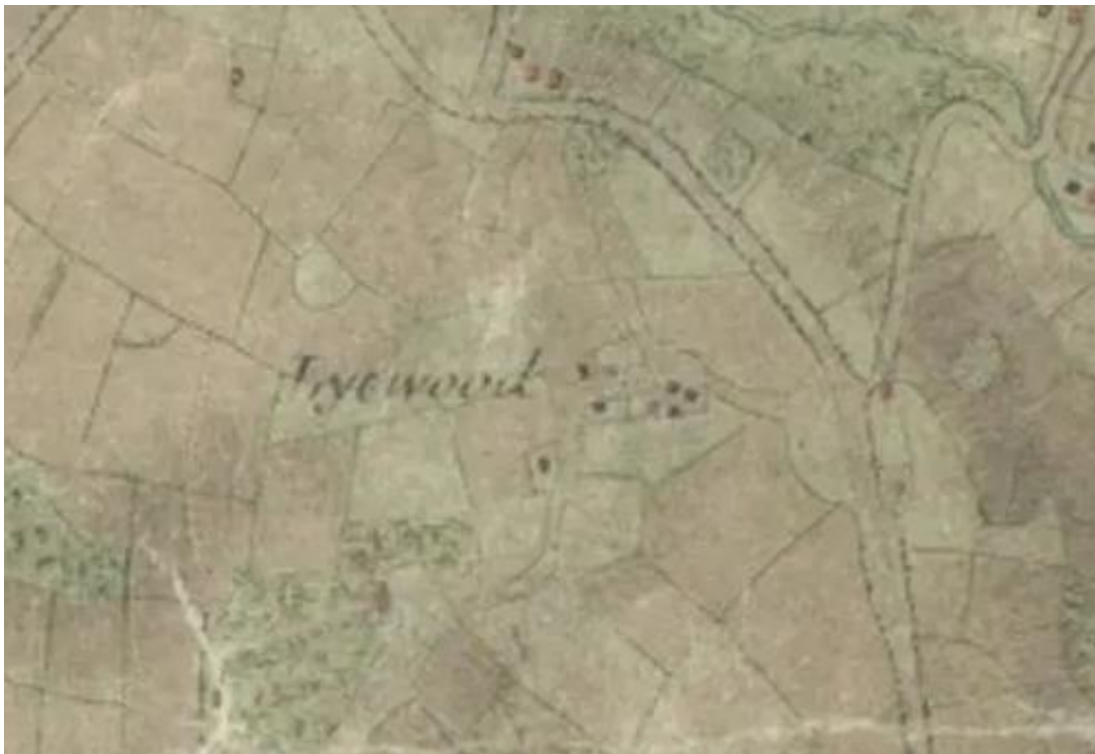
**1797**

The 1797 map is the earliest publicly available map identified that appears to show the farm and its buildings in context. There are other maps that are earlier, but these do not give rise to any contextual information about the farm buildings that will be of any additional use in respect of this report – their scale is just too large.

The map clearly shows a number of distinct features and is broadly a very accurate rendition of the area. The common land to the east (Lywood Common) is shown, along with the approach road to the farm (which changed little even to the present day).

Lywood House is depicted and remains a cluster of three main buildings that are then recognisable on all later historic mapping, despite early 20<sup>th</sup> century examples showing the loss of some surrounding buildings.

The farmhouse of Great Lywood is also visible, along with a western outbuilding that is also identifiable on later mapping.

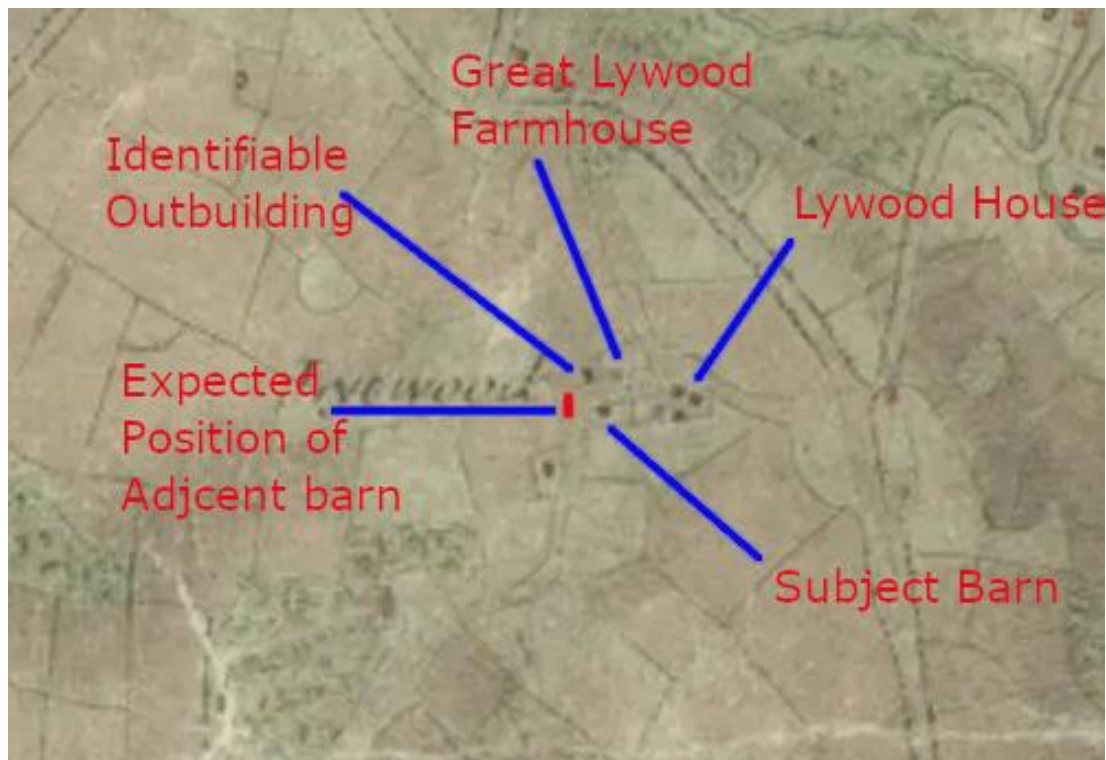
The above gives positions for the known buildings and a high degree of correlation is indicated to most of the buildings, but there is nothing whatsoever for the adjacent barn. We have indicated in red where the barn should be in relation to the other buildings, but it is not depicted.

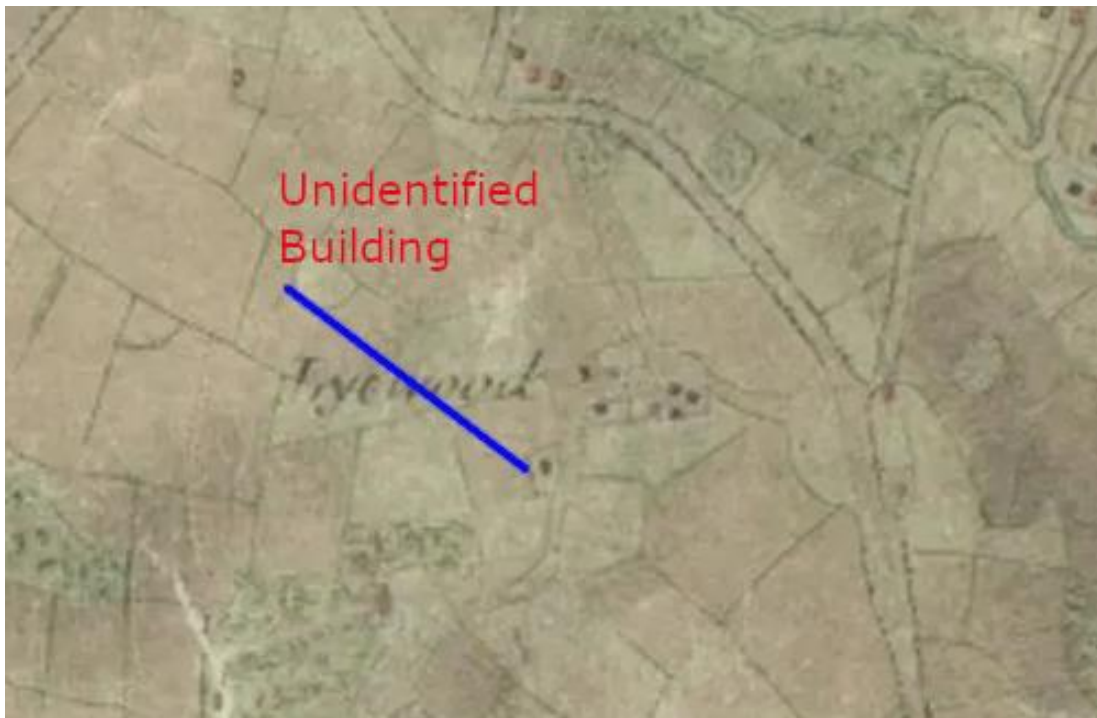
This is a building of unknown size and type (the buildings on this map are not given scale, or shape).

The building is likely of some size and importance as there is also an enclosure like a garden around it. This could be a barn but could just as easily be a farm cottage that is no longer in existence. What is clear, however, is that it rests far too far south of the main site to be the adjacent barn unless the cartographers were highly inaccurate for this one particular building. A further point of note is that this building is also depicted in exactly the same position in the slightly later map (below).

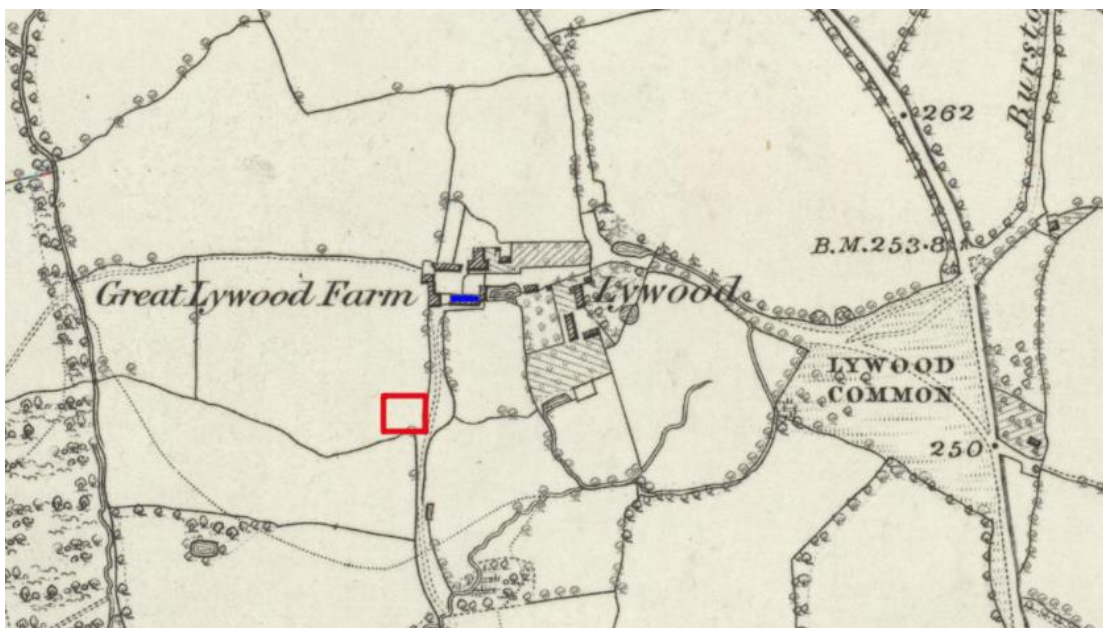
When direct comparisons are made to the very accurate 1874 map, the position of this building can be reasonably deduced by its position relative to other buildings on the earlier map and also to field and land boundaries common to the maps. The building would stand somewhere within the red box shown in the map below.

This is certainly not the position of the adjacent barn west of the subject barn (the subject barn being shown in blue).

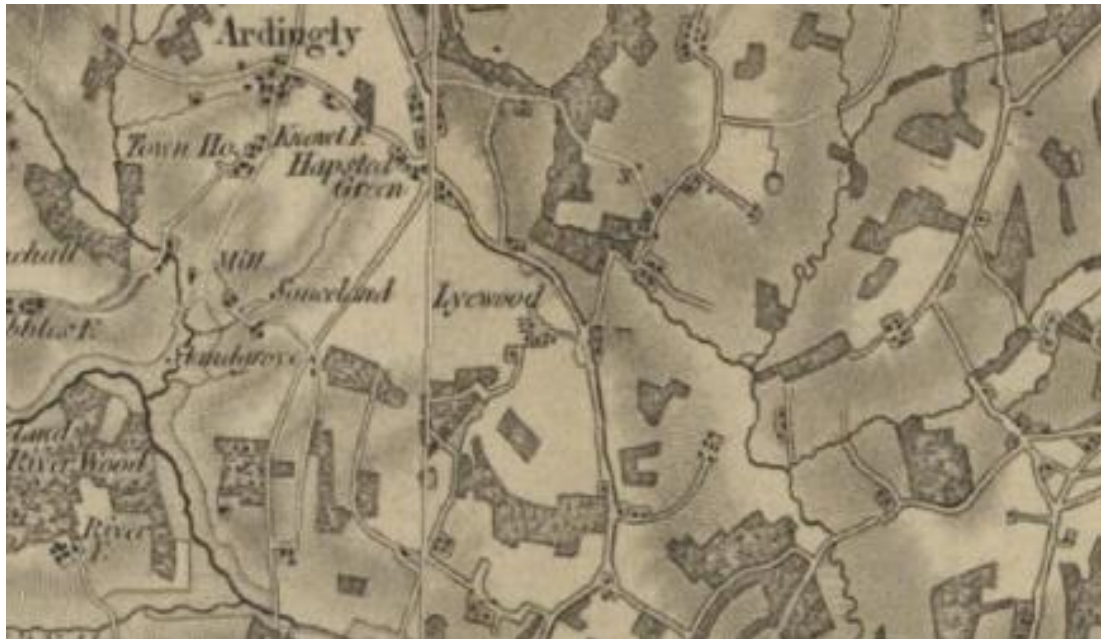
1805

This map is very similar to the 1797 version, though the scale is slightly larger. Nonetheless, the cluster of buildings making up Lywood House and also Great Lywood Farm are identifiable and compare well to the 1797 map and also to plotted positions on the 1874 map. Once more, however, the western barn adjacent to the subject barn is not depicted – only the unidentified southern building down the lane.

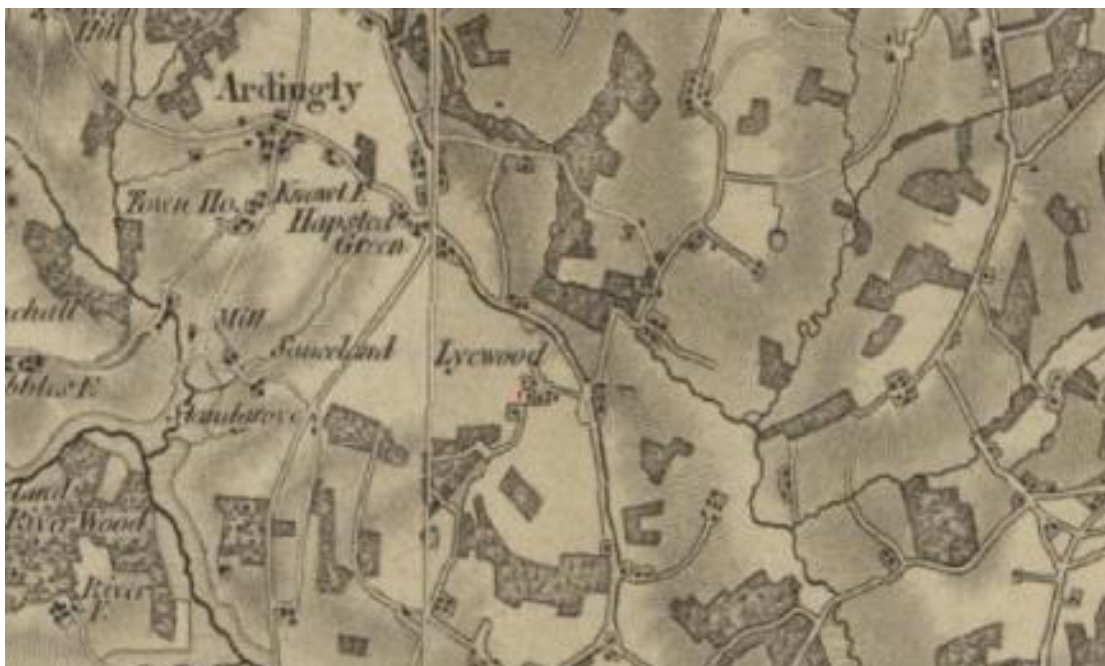
Again, the expected position of the adjacent barn is indicated on the annotation below by the red dot.

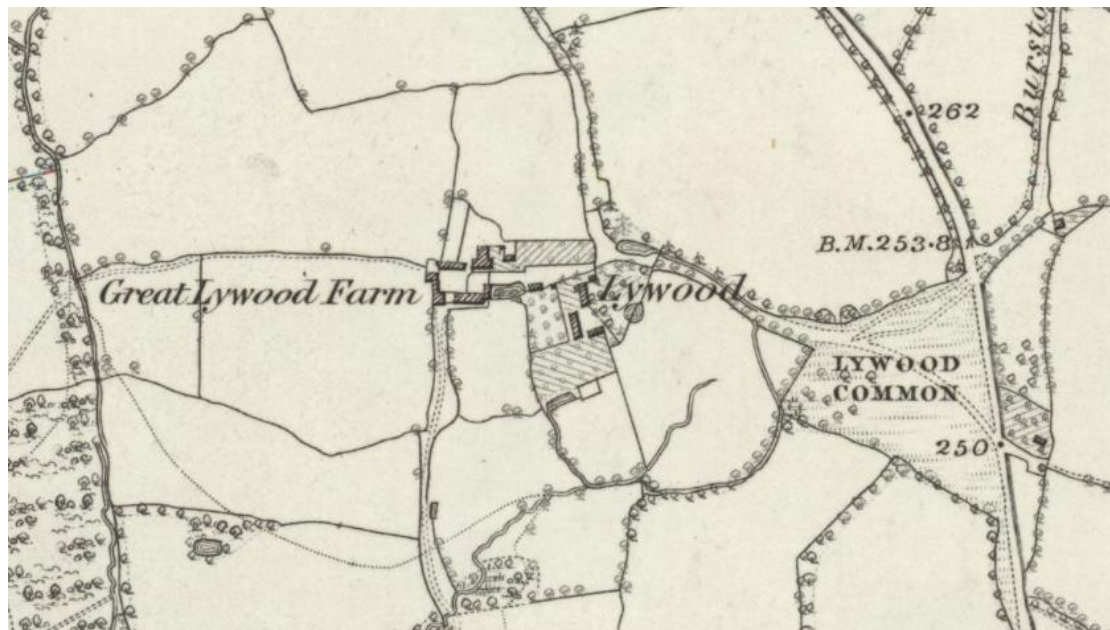
1874

This is the first of the highly accurate OS type maps available to view and depicts Great Lywood Farm and Lywood House, with the common land and also shows the southern field prior to the land that land being obliterated by the coming of the railways.

What is immediately evident is the west barn adjacent to the subject barn. Furthermore, the smaller unidentified outbuilding/cottage to the south is also no longer in existence and neither is its rather clearly depicted garden enclosure by this date.

A few other minor differences are the perpendicular outbuilding to the subject barn (which is today an inline building) and also Farm Pond which stood to the west of the subject barn, and which is only ever depicted in this map. It seems to become filled in and disappears by the 1896 map.

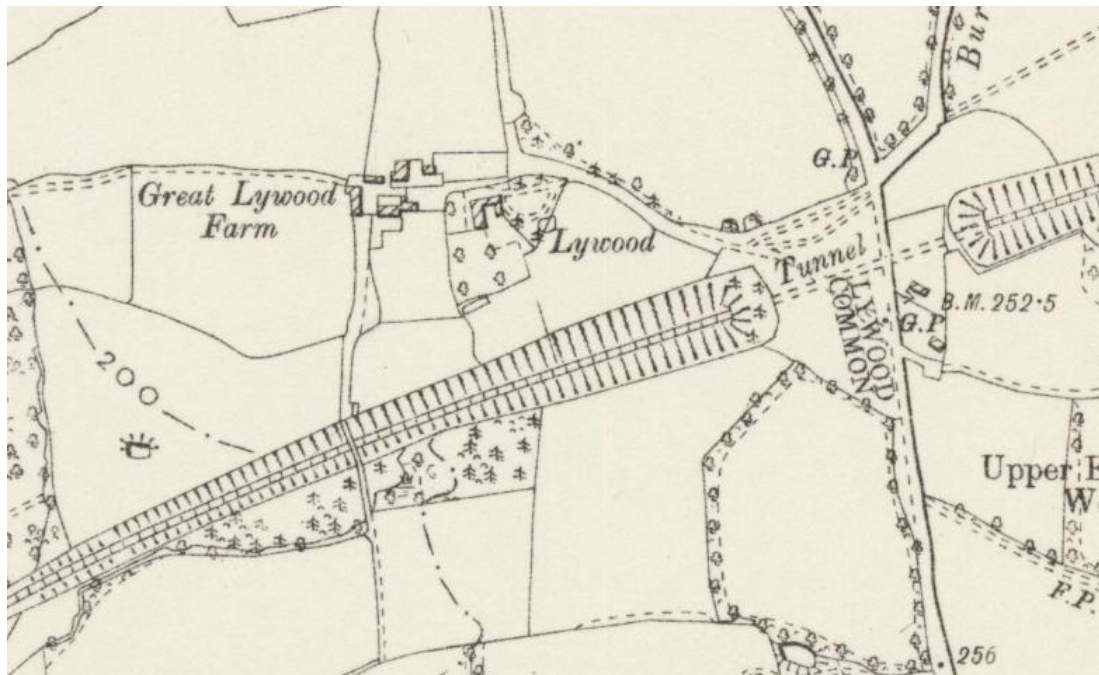
Again, the buildings are identifiable, but the far eastern building does look to have now been turned inline and may indicate that this element of the subject building was re-erected upon that alignment between the 1874 map and the issue of the 1896 version.

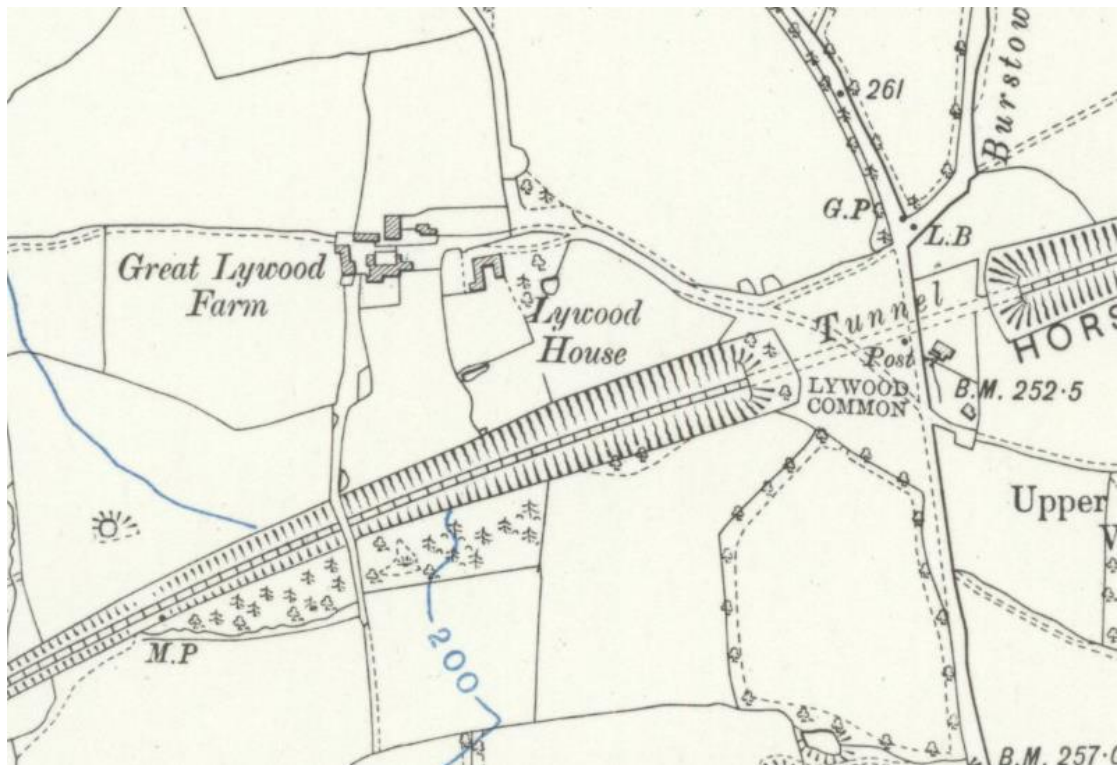
The 1909 map shows that the subject barn had northern outshot projections of some sort, though these do not survive.

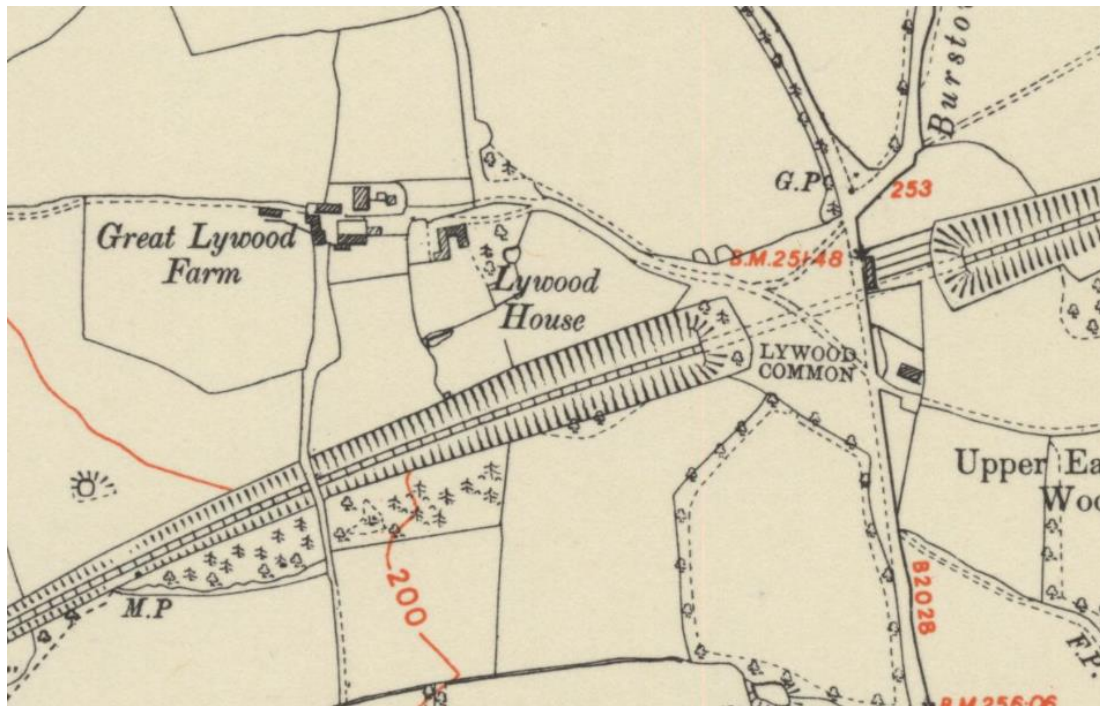
By 1947 these projections are gone again. and the building broadly retains the shape that it now enjoys today.

The railway line is long gone, although the trackway formed from the track bed is a path and leads up towards the northeast to the Bluebell Railway.

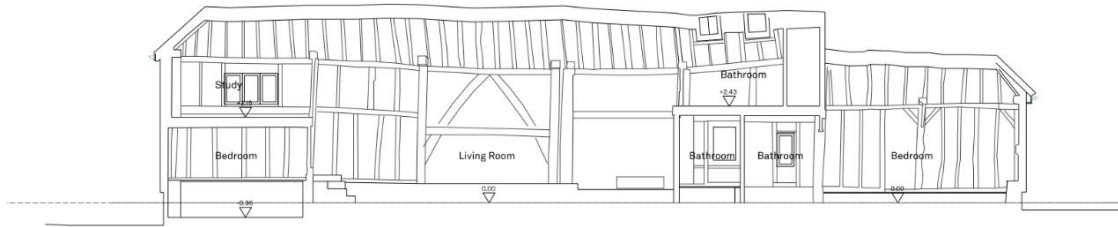
The drawing below indicates the present frame arrangement.

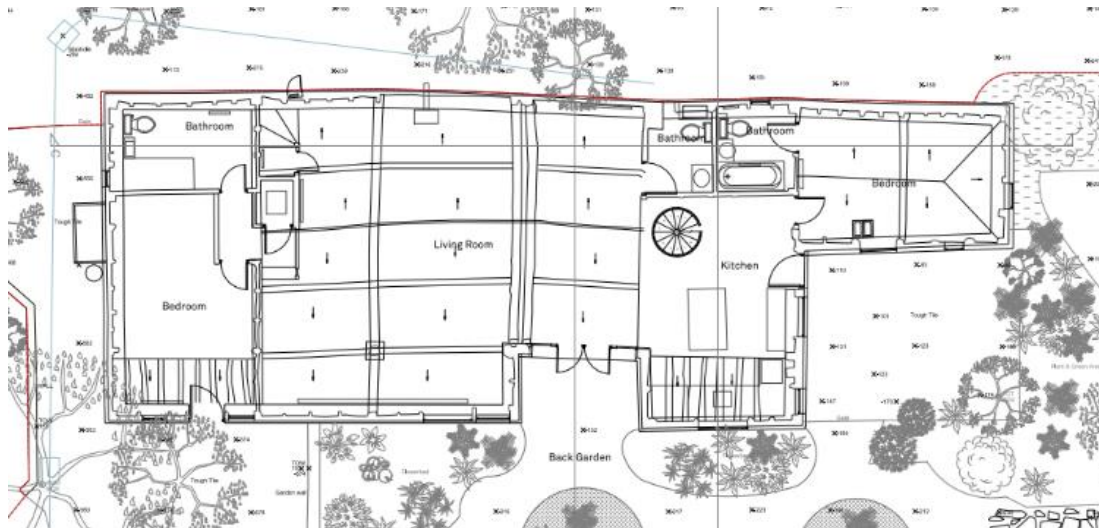
**Ground**

The floor plans below shows the interior layout on the ground and first floors.

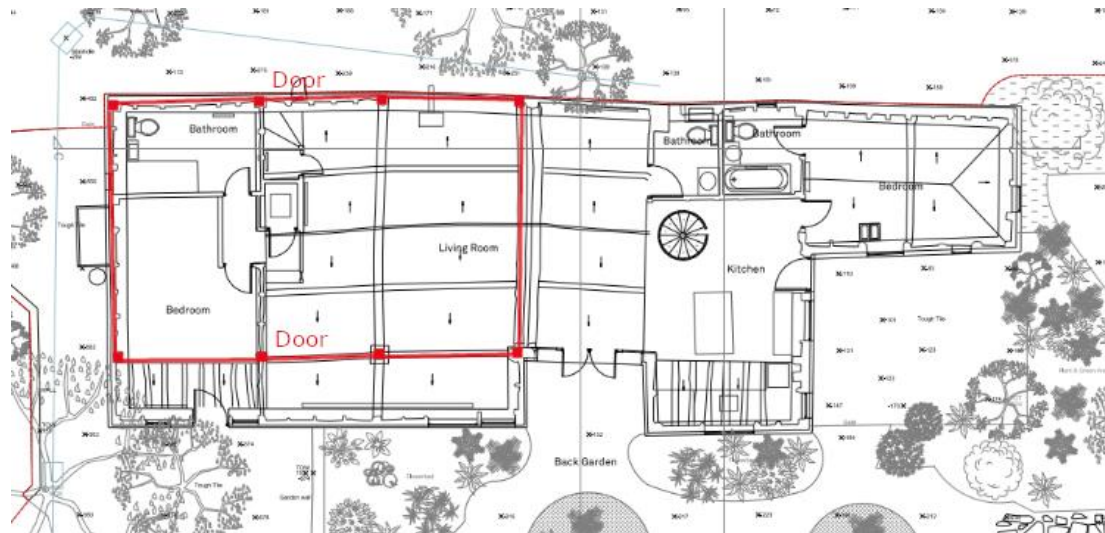
The plan below indicates the original layout of the barn in red.

The barn had central doors on the north and south sides (though little evidence remains for them due to later alteration).

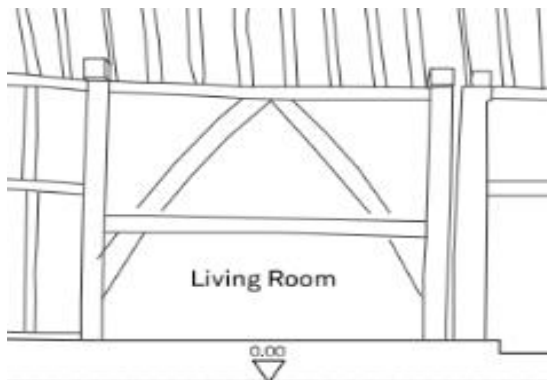
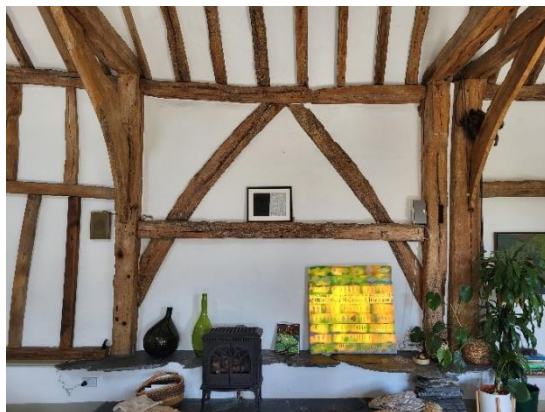
As depicted on the drawings, the bays had long passing braces arching from the lower bay posts up to the underside of the wall plates.

These long passing braces are placed outside the line of the inner girdings at midrail level. The girdings themselves and also the underside of the wall plates are notched and grooved for studs and wattles.

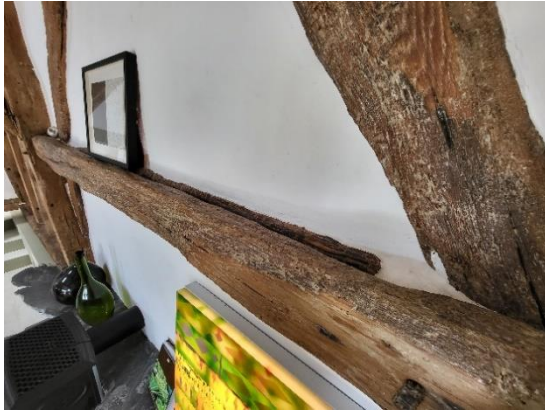
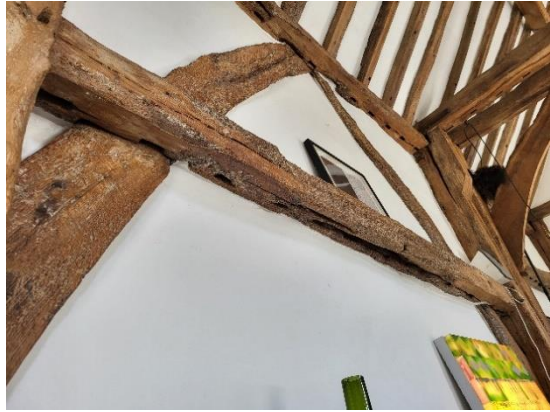
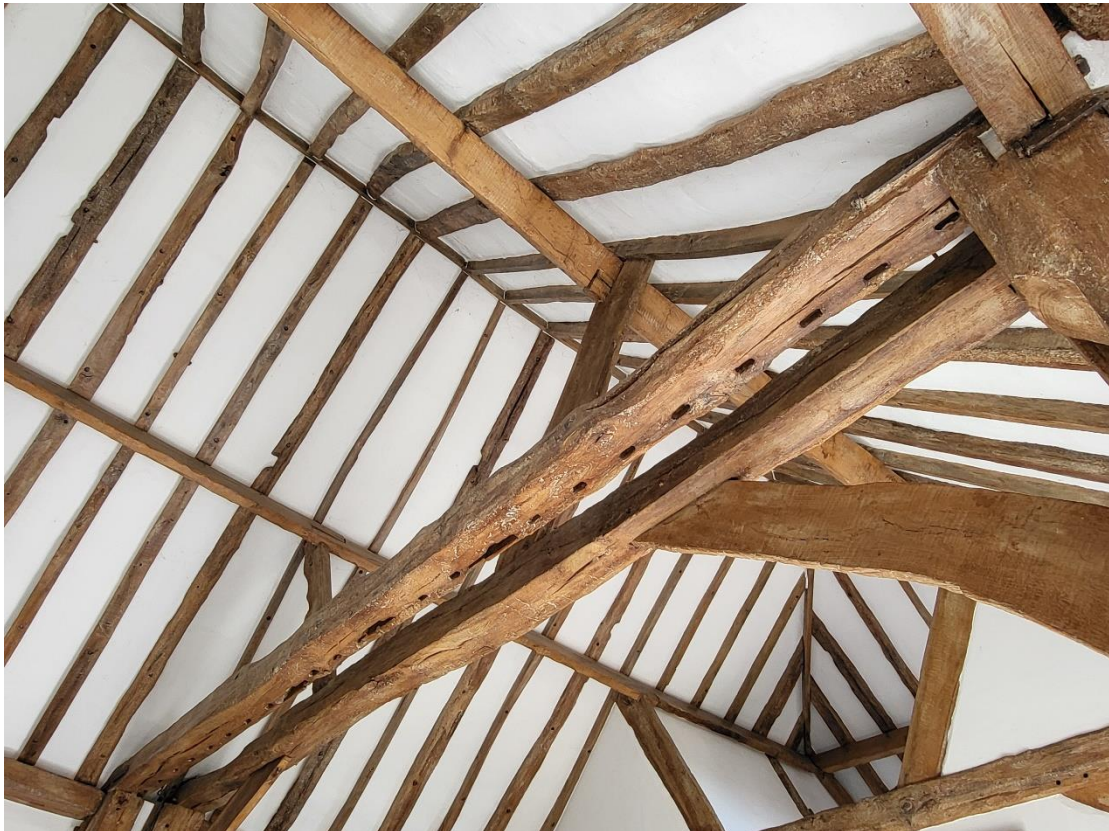
This studding and grooving is remarkably consistent around the building.

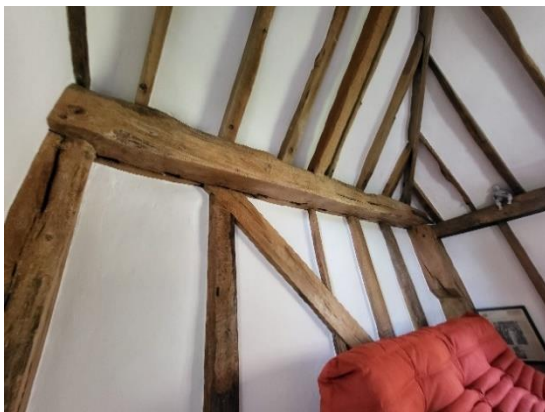
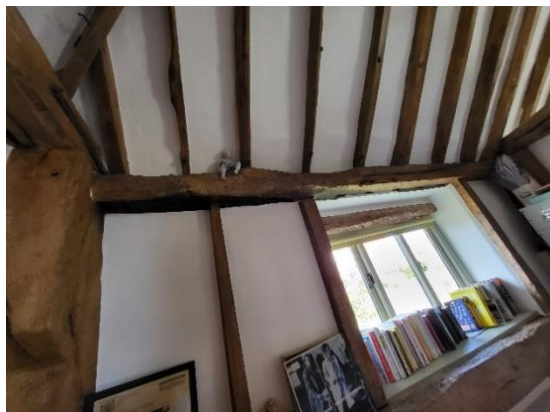
Not only this, but the empty mortises for the up braces and their upper mortise sockets in the wall plates are also consistent all around the original building despite later infill.

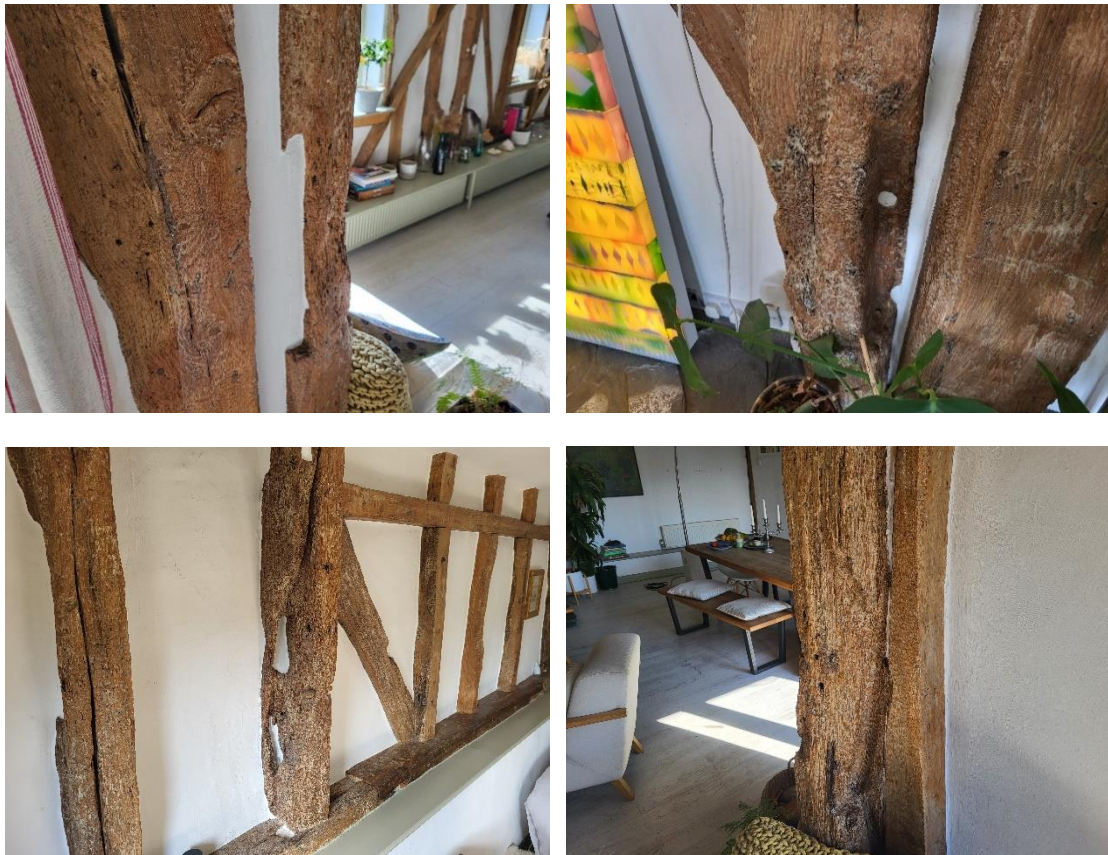
The barn, when built, had these double passing braces on every wall. The studs and wattles were affixed into the mid rails and their use indicates that the barn was formerly wattle and daub paneled and not weatherboarded. The design would have meant that the passing braces would have been visible externally, with the wattle and daub probably flush with the face of the braces, or the braces slightly proud. The exterior design would have been quite striking.

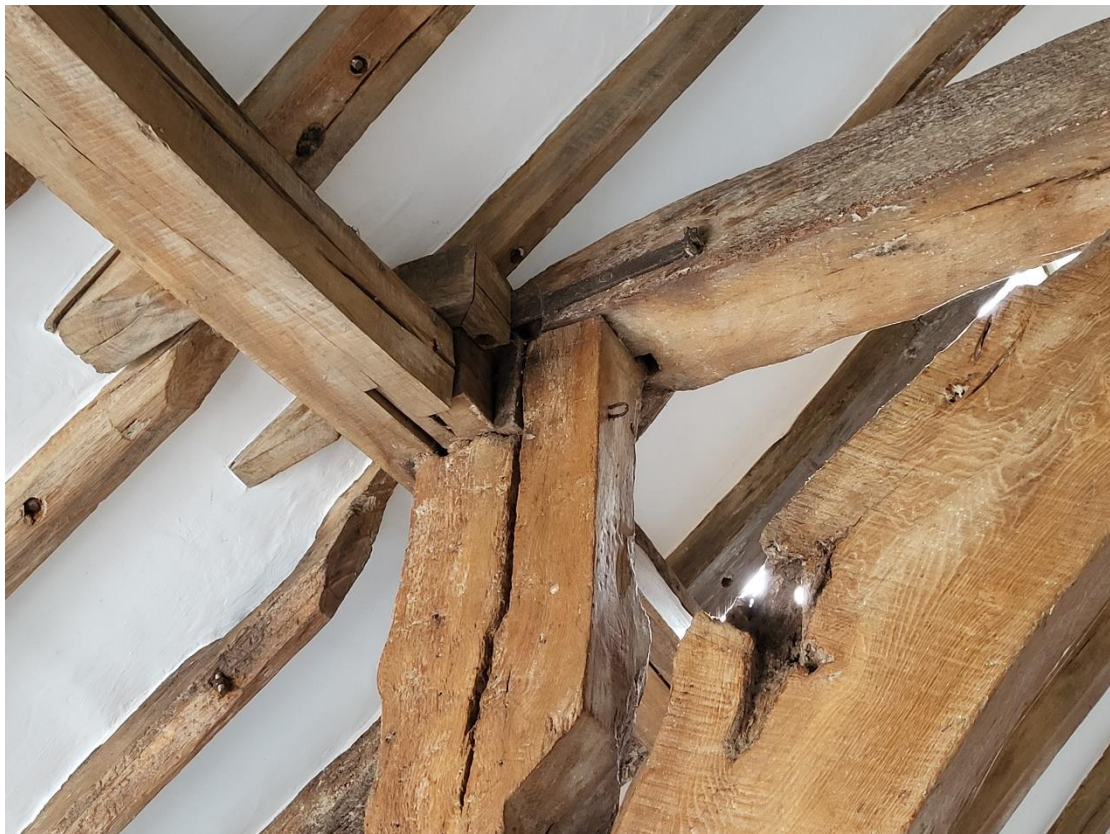
The lateral tie beams are also consistent in design and do not appear to have been replaced.

The original roof structure is lost. Replaced when the two bay extension was added. However, it can reasonably be deduced from the retained tie beams that the roof must have been a side purlin variant. Empty mortises are visible and in line with each other across all tie beams in the original part of the building. These have been superseded by the raking struts of the present roof design, but these struts do not use the same mortises, leaving the older examples open.

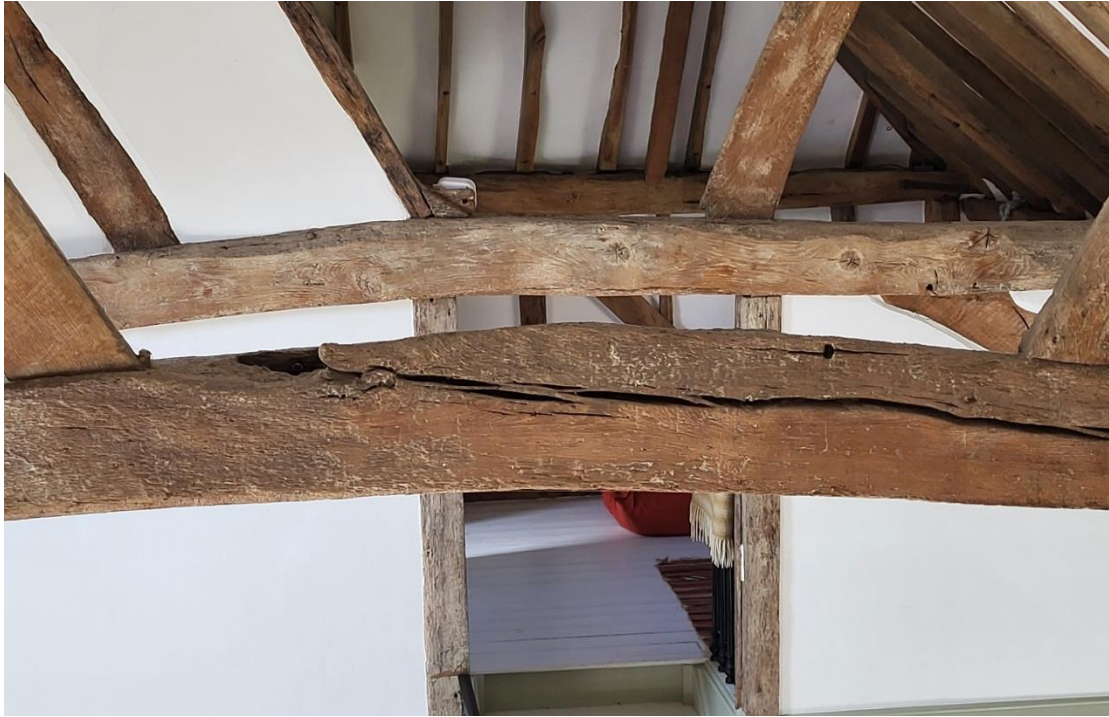
The most noticeable thing about the mortises is that they are central and close together.

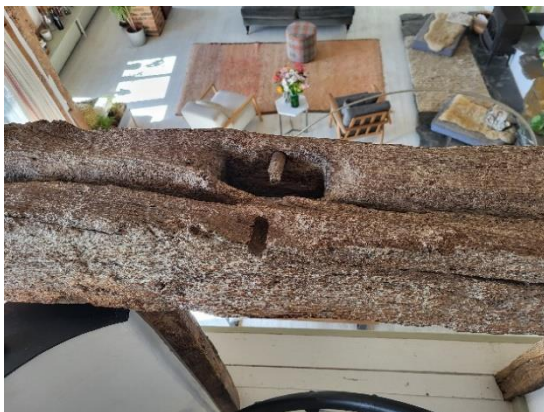
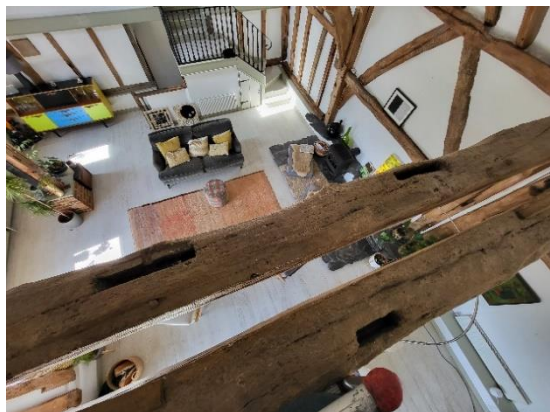
A standard queen strut roof frame would have to be exceptionally/abnormally shallow in pitch to accommodate the distance between the mortises in this instance. Therefore, the roof frame must have been a variant of the raking queen strut much like the present roof.

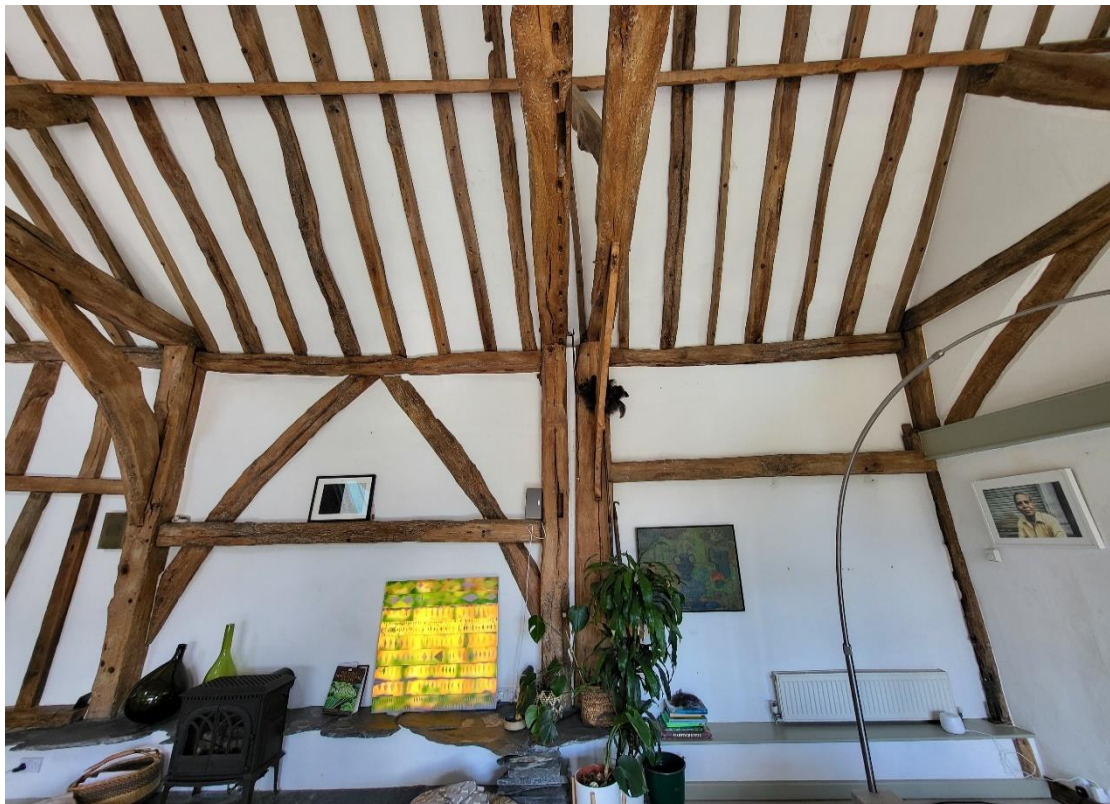
The extension was achieved by the building of two bays taken from another barn building (utilising varying reclaimed timber parts) up against the existing barn. The bay posts of the new barn are adjacent to those of the older example.

The timber used in the two additional bays varies in date but is mostly also of some age. The jowls are sizeable, as is the general scantling (sectional size) of the timber. The ties are also showing signs of being formerly installed in a barn that had an alternate footbraced crown post roof which would allow for at least 16<sup>th</sup> century dating for most of the timber. However, the provenance of these two bays will likely never be known.

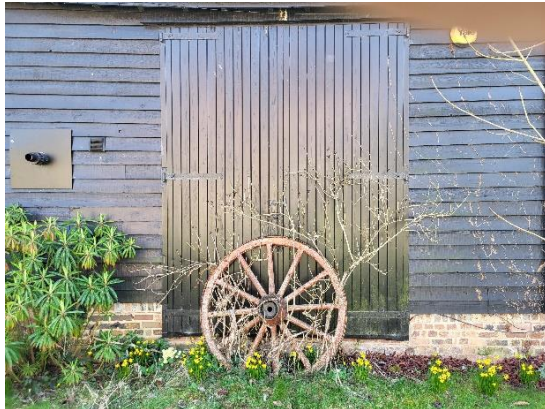
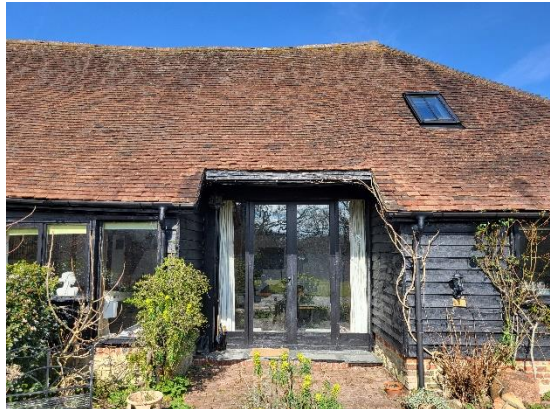
The original barn was then altered significantly to accommodate the addition of two bays. The east flank wall studding and infill was removed including the passing braces. Both original doors were removed, as the two new bays were now going to hold the barn door openings.

At this stage, the barn will have become a threshing barn, but with the doors offset in bay four (the first of the extended bays, rather than centralised). No trace survives of either 19<sup>th</sup> century doorset, with the external doors being modern timber examples, the south set being glazed.

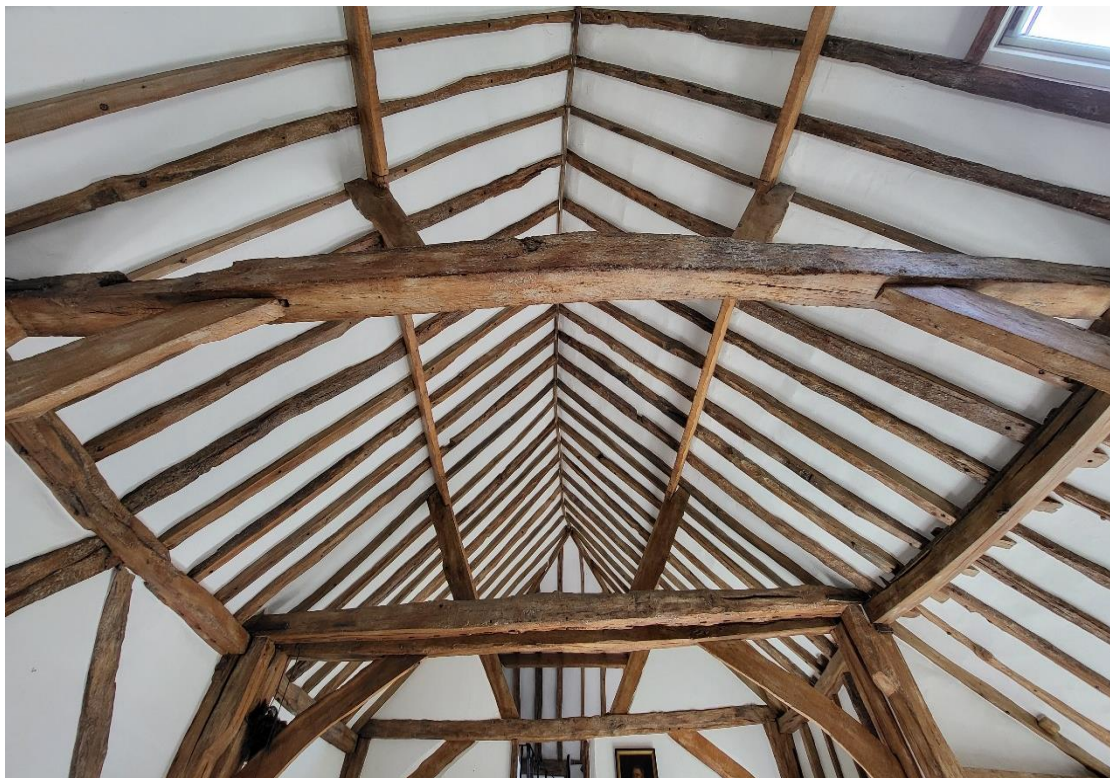
The entire roof frame was then removed from the original barn building and replaced with the present example (re-using some older timbers).

The roof must have been renewed at the time of adding the two-bay extension, as the present roof is consistent along the length of the two barns to cover them both as a single unit and weathering them both without doing so would have been near impossible. The decision must have been taken to extend a new roof frame over both barns rather than trying to find a way to extend that of the original barn. Furthermore, if the original barn still had thatch, this would have been a hindrance to weathering the additional bays effectively and further goes to suggest the need to reframe both ends. Indeed, this later roof frame shows signs of being designed well after 1750-1800 with the type of ridge board and purlin size – which would again suggest the right date for this to have occurred.

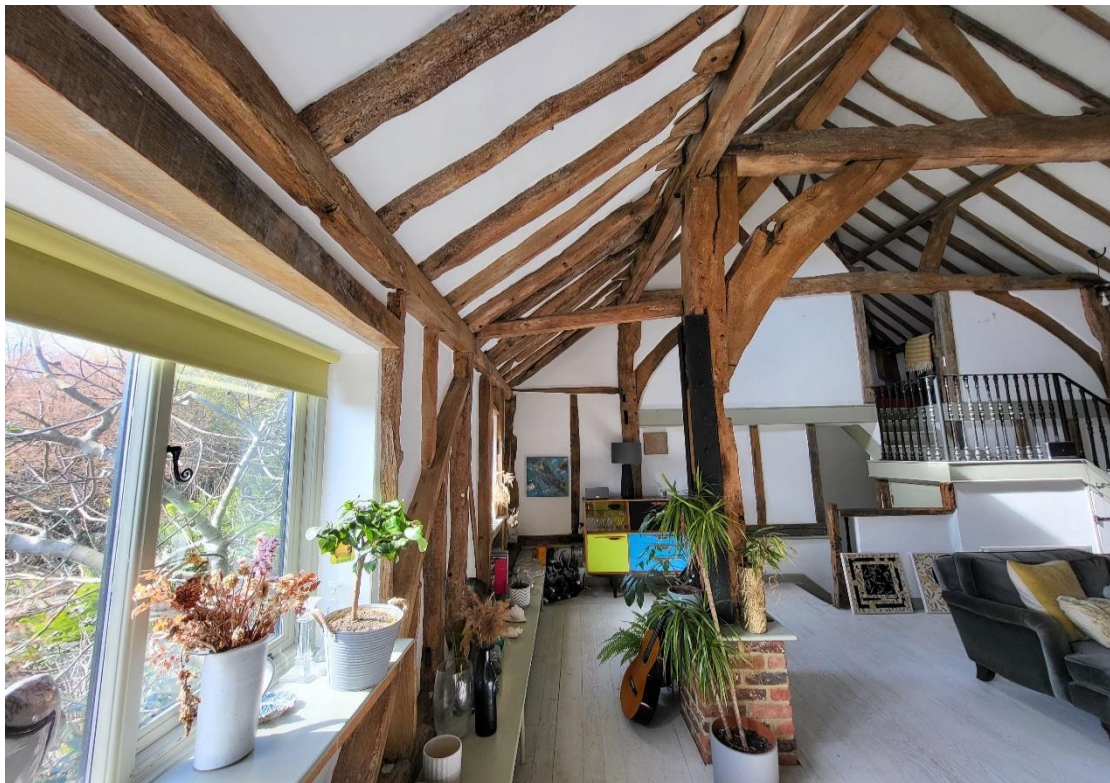
The south aisle was seemingly also added at this date, or at around the same time, The framing is typically late 18<sup>th</sup> century, to early 19th century and may actually be the more certain indicator of how close to 1800 the original barn was extended.

At some stage in the 19<sup>th</sup> and early 20th centuries all of the wattle and daub infill panelling was removed and disposed of. Many of the studs, wattles and passing braces were also removed. Much of this must have been carried out due to the deteriorating condition of the lower mortises of the passing braces. Many are heavily degraded and suggest that such work was needed, as opposed to being a conscious aesthetic decision. Again, whilst impossible to ascertain exactly, what replaced the infill was studding that could easily be early to mid 19<sup>th</sup> century in date. The exterior timber cladding is mostly very modern, with little showing signs of being much more than mid 20th century in date.

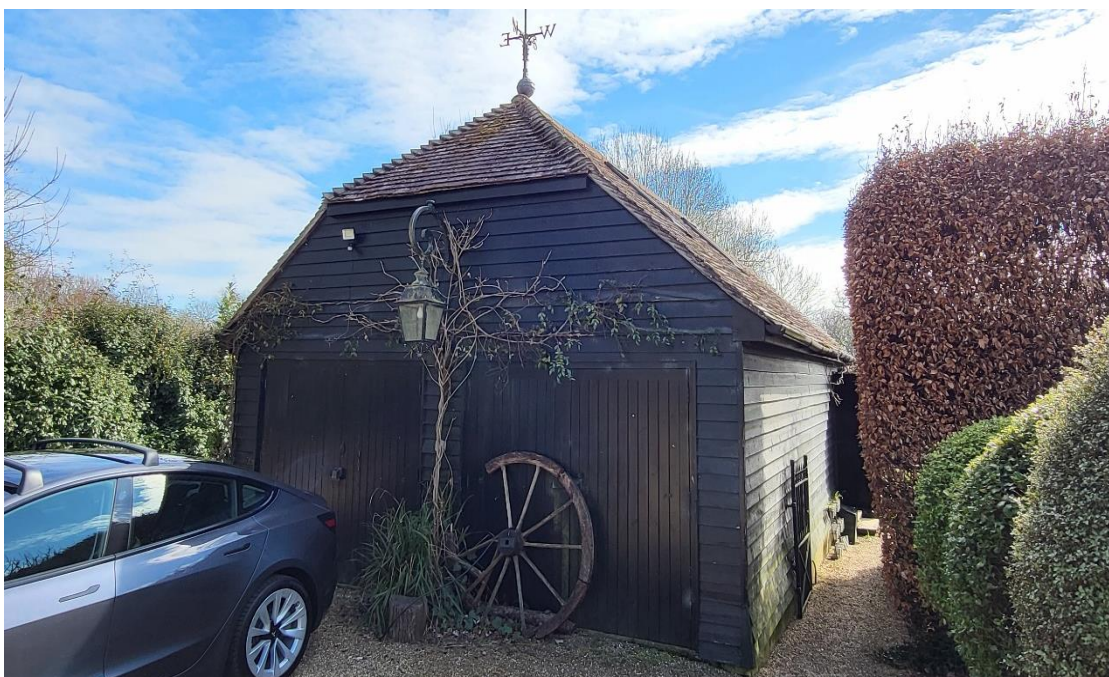
#### **4.3 The Garage**

This building was constructed in the late 20<sup>th</sup> century.

Walls are block masonry.

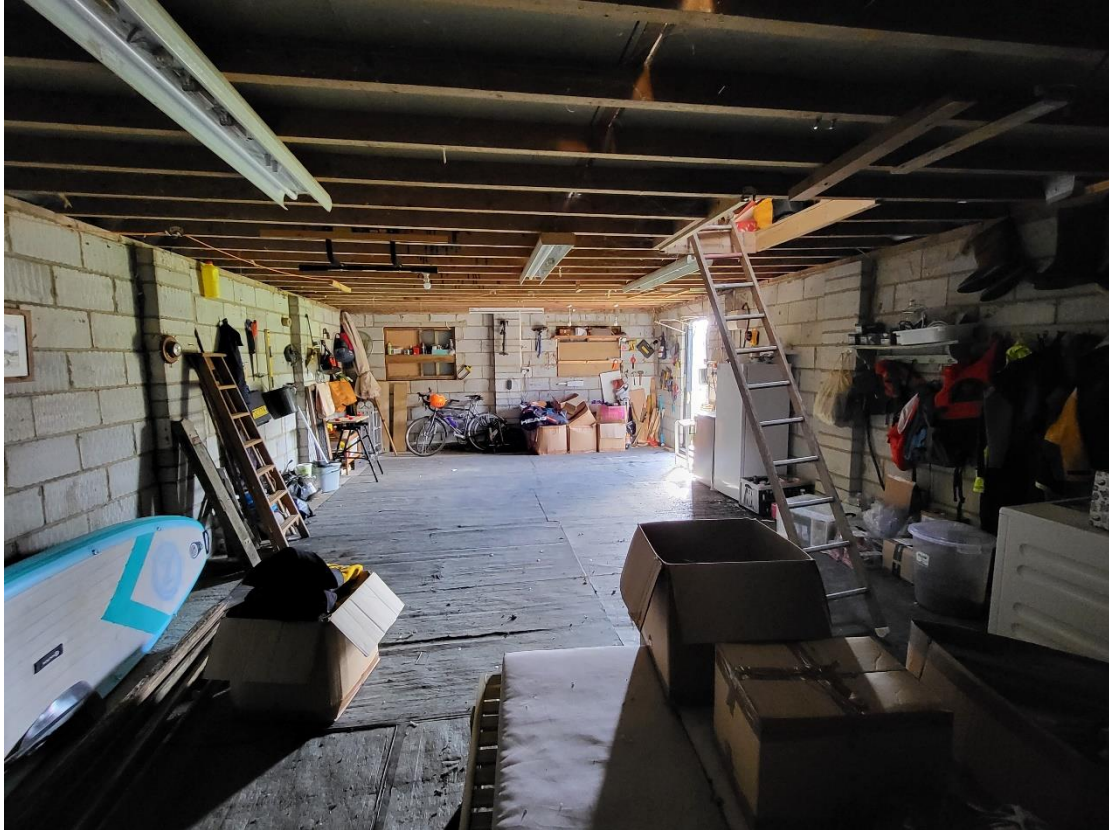
The roof is a simple softwood rafter frame.

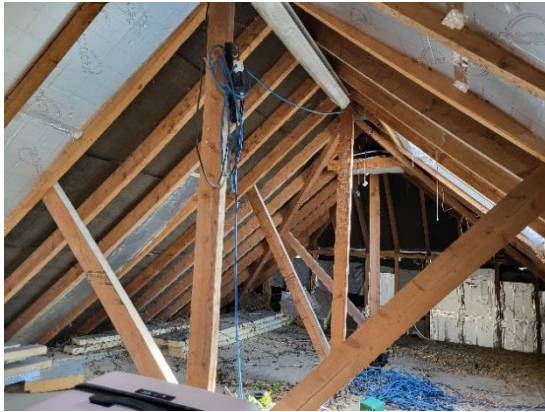
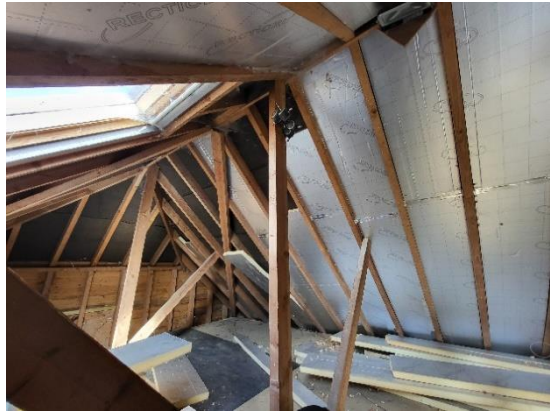
There is no historic fabric with which to note in this report.

Externally, the unit is tile clad to the roof, with weatherboarding to broadly match the main barn conversion. There is a small conservatory to the rear (south face).
