## HERITAGE IMPACT ASSESSMENT

**Property Address:** Lywood Barn, Lindfield Road, Ardingly,  
Haywards Heath, West Sussex, RH17 6SW

**Prepared by** Richard Pocock MSc MRICS

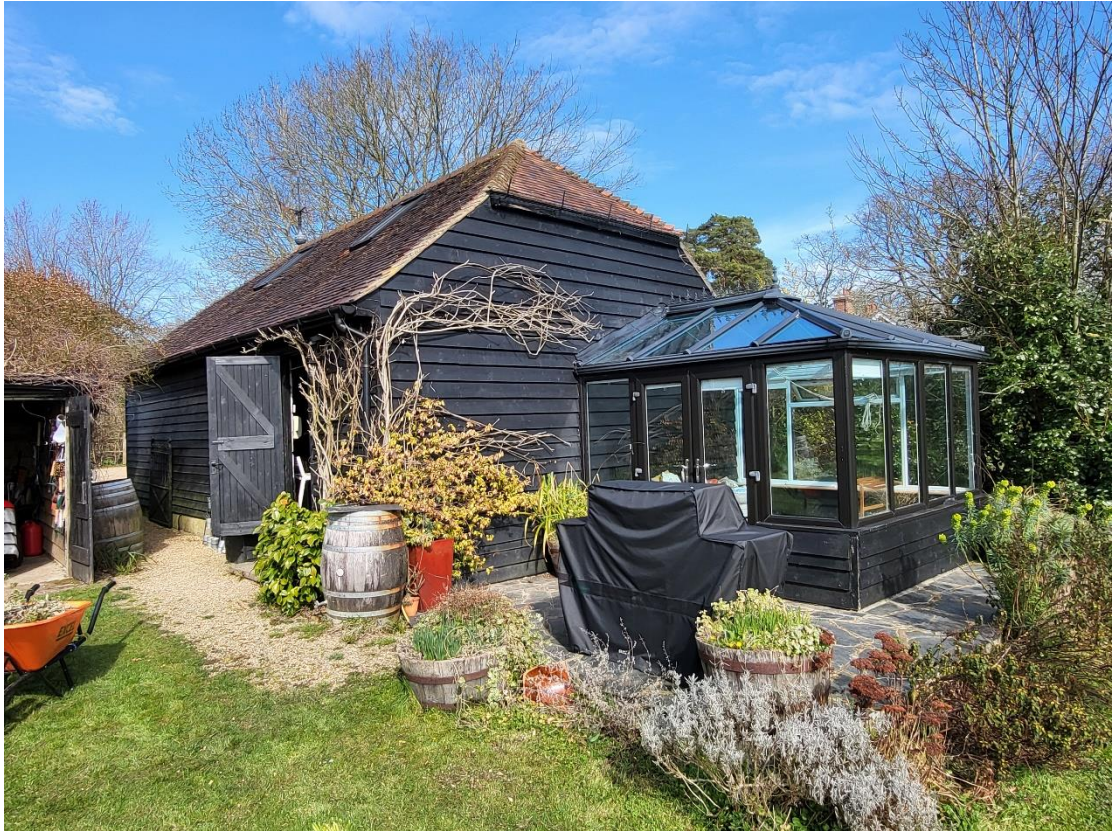
An open loggia is also standing nearby and forms a group.

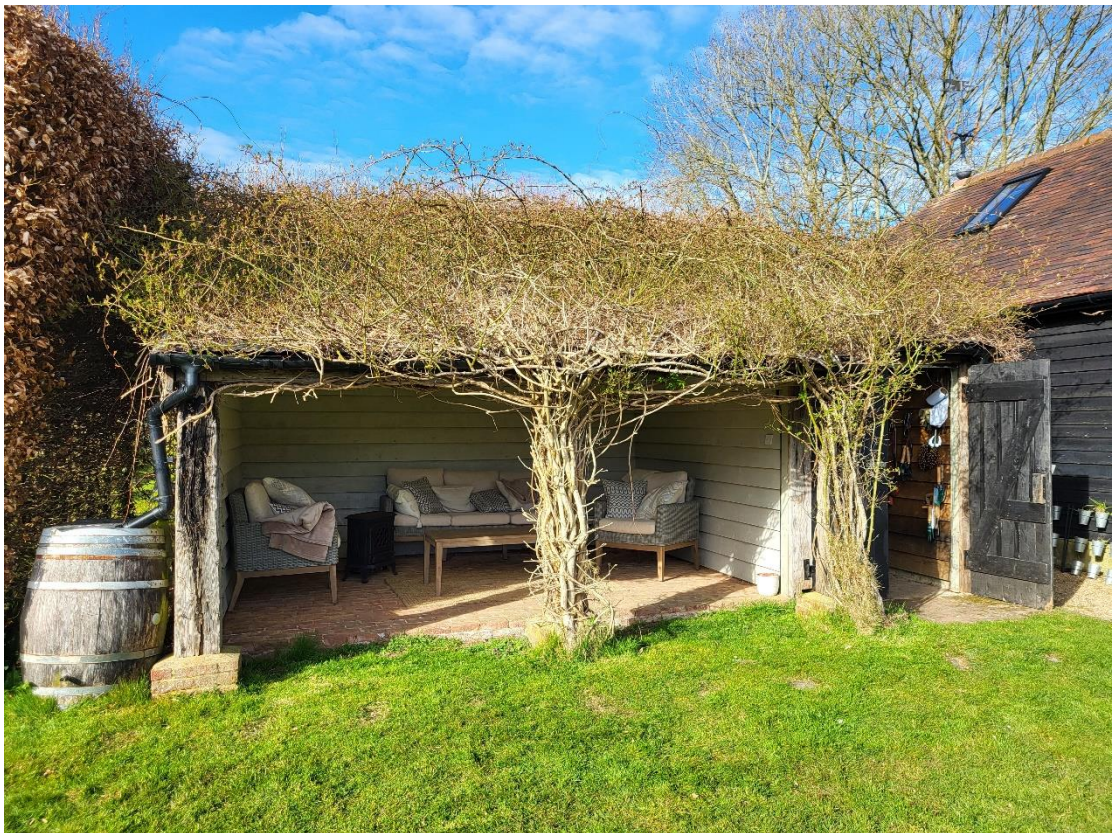
Whilst fabricated from older material, the structure is modern and was probably assembled when the garage was built.

The heritage significance of both the garage and loggia derive solely from their proximity to other listed assets and any alteration will solely be limited to external appearance in this instance and generalised impact upon adjacent assets by virtue of that appearance and proposed usage profile. The fabric within will not be afforded any specific conservation consideration.
