# **Planning, Design and Access Statement**

83 High Street, Lindfield

Programme of repairs and enhancements to the fenestration of 83 High Street, including repair and redecoration of all existing timber joinery, installation of double-glazed panes to existing frames, replacement lead roofing and timber cladding, repointing of brickwork, roofing repairs, and replacement of all existing rainwater goods. Fenestration enhancements to the rear outbuildings, to include re-roofing and roofing repairs, and repair and redecoration of timber joinery. Removal of the existing dilapidated timber outbuilding. Rebuilding of partially-collapsed existing garden wall

July 2025

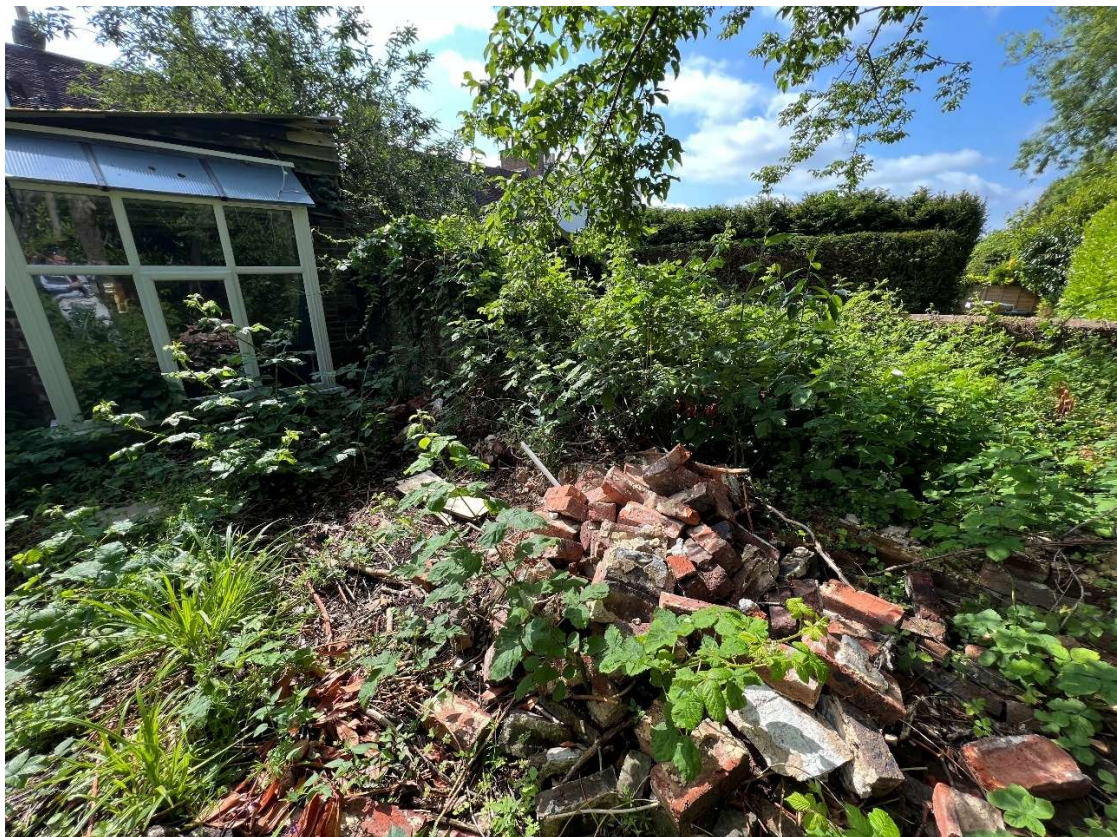
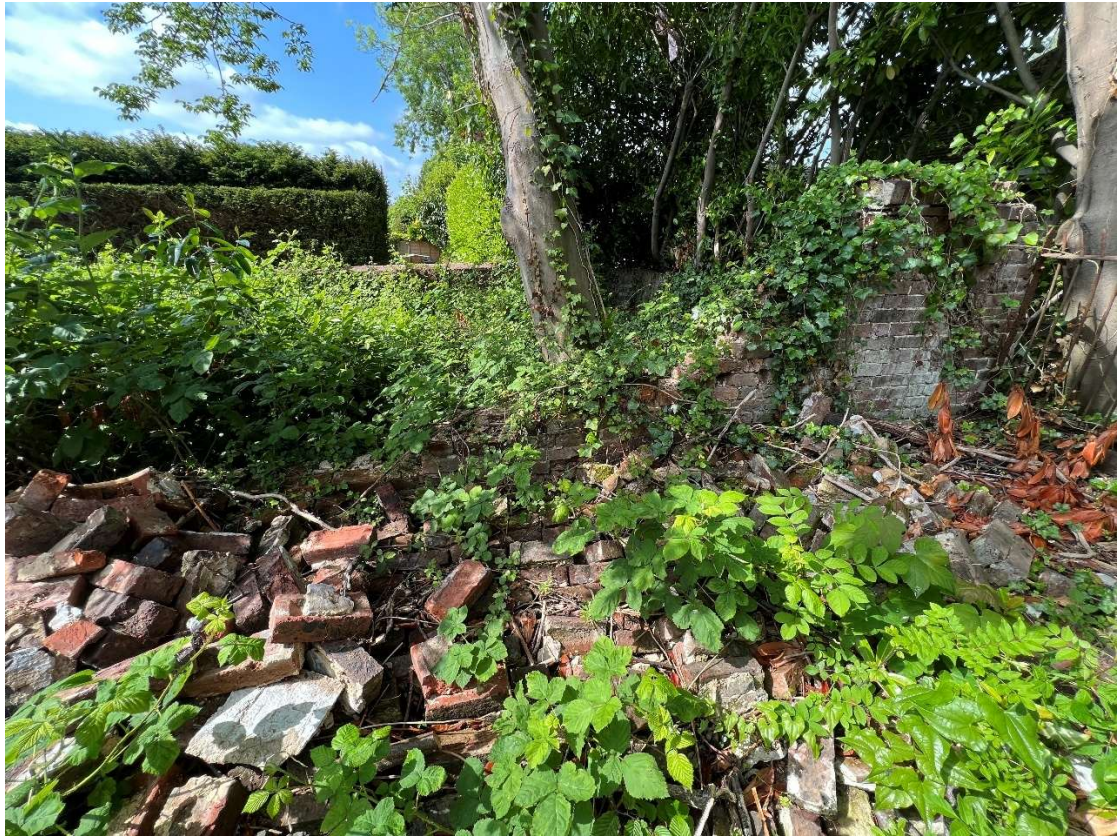
- 5.10 The dilapidated and partially-collapsed southern boundary wall visually detracts from the quality of the building and the wider Conservation Area setting. The cause of the collapse is unknown, but the photographs below show that the wall has fallen into No. 83:

- 5.11 The proposals seek to rebuild the boundary wall using as many of the existing bricks as possible, with any new bricks to match the existing as closely as possible. The mortar should also match the existing in terms of its material, colour, and pointing finish. The height of the rebuilt wall will be no higher than the intact portions.

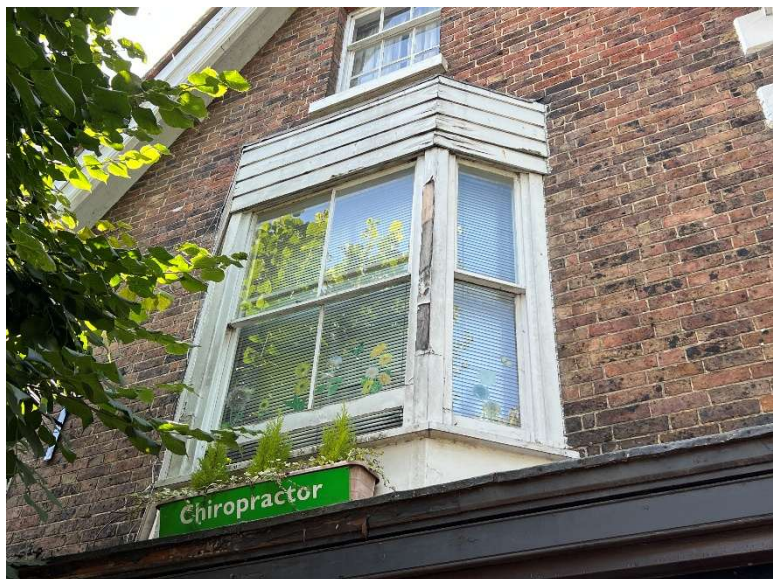
- 8.2 The existing lead-covered flat roofs to the shopfront and front first floor bay window will be replaced, using traditional lead detailing of mopstick rolls and drips. The works will ensure appropriate ventilation is provided to the underside of the roof deck, and incorporate thermal insulation for the front first floor bay window roof.

- 8.3 As can be viewed in the above photograph, the existing timber is in a poor condition, likely exacerbated by the absence of a suitable drip, thus causing water from the roof to drip down the face of the timber cladding. The existing timber cladding over the front first floor bay window will therefore be replaced with new shiplap timber cladding to match the profile of the existing. The existing joinery has received a very basic repaint since the above photograph was taken, to protect the bare wood, but the rot behind remains untreated. To ensure the long-term preservation the structure it is considered more appropriate to replace it in full. The cladding will be painted in white to match the existing.

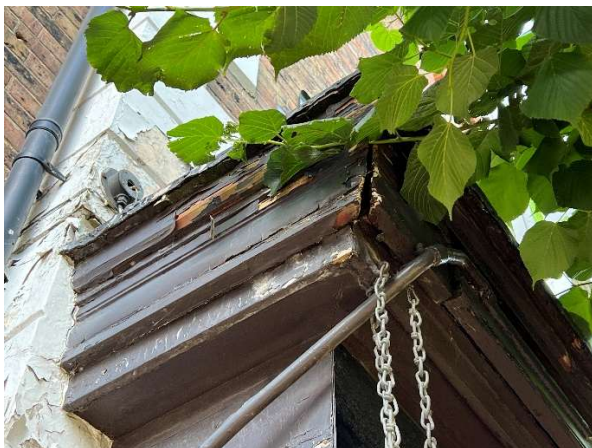
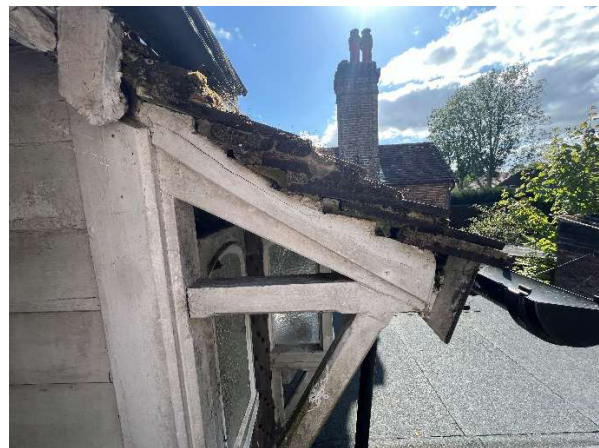
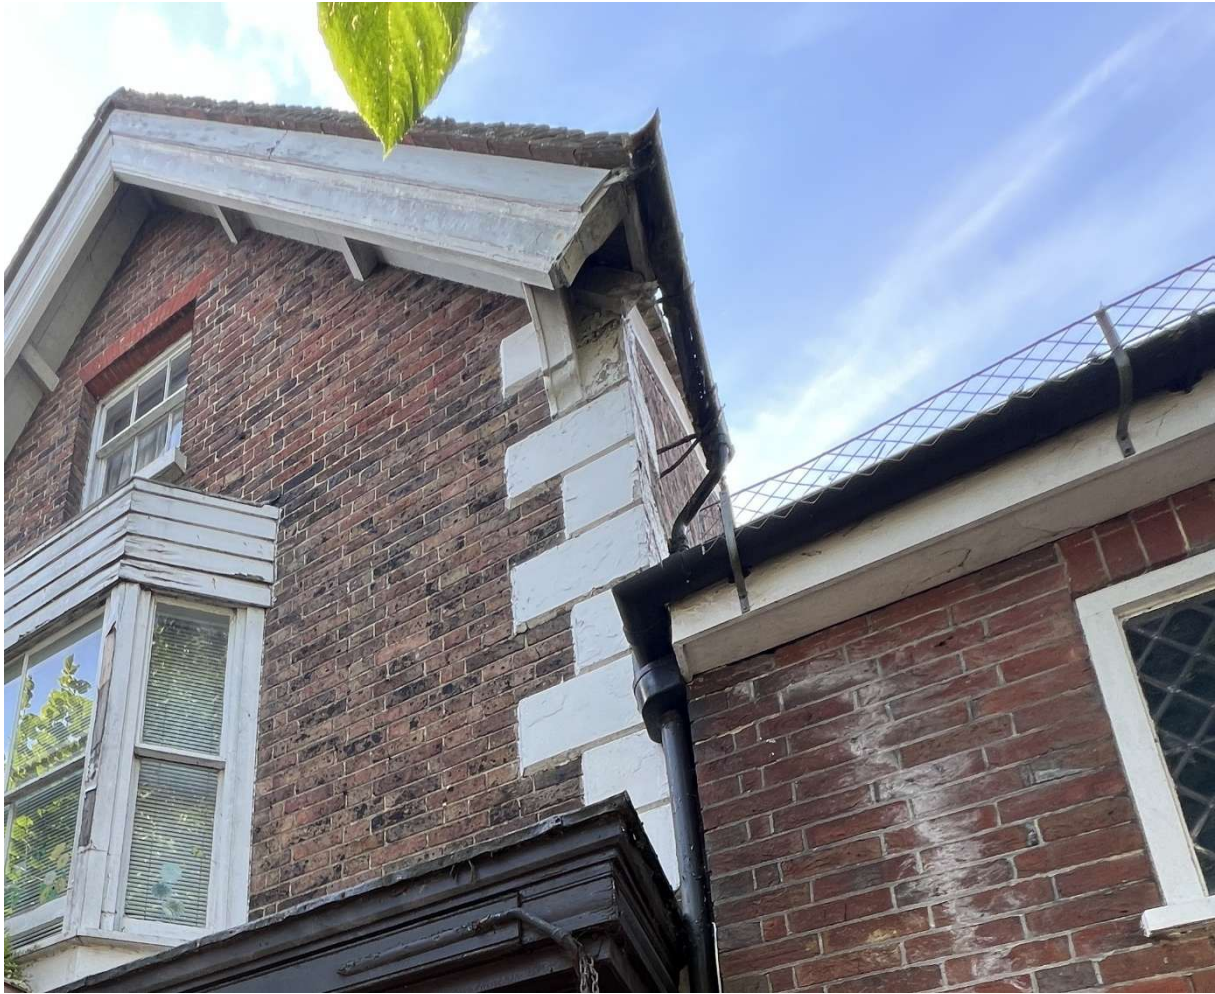
- 8.6 The existing timber fascias, soffits, barge boards, and brackets require elements of repair and redecoration owing to their current condition. Where necessary, rotten elements will be cut away and new timber elements applied in their place, thus ensuring the quality of the existing detailing is retained. The below images illustrate the current condition of some of these elements:

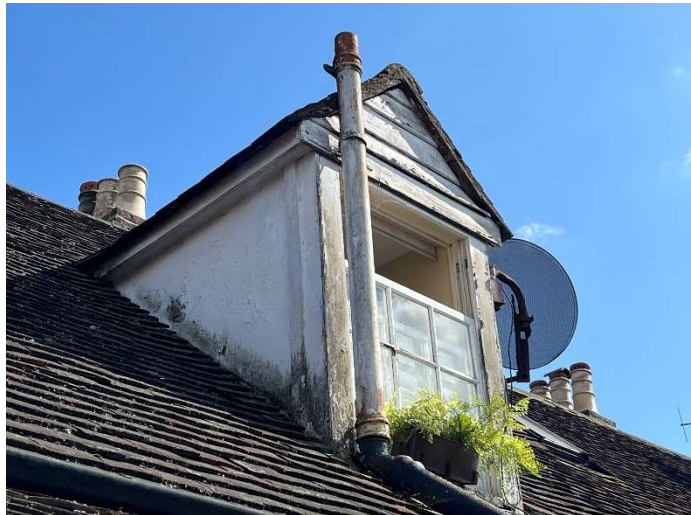
8.10 The repair and redecoration of the existing dormer to the rear elevation will result in a significant enhancement owing to the deterioration evident. The joinery will be repaired and repainted in a colour to match the existing. The side cheek walls will be dressed in lead, ventilated to the top and bottom, and insulated internally to reduce heat loss. The provision of sealed unit double glazed panes and draught-proofing to the existing sliding sash window will further enhance its appearance, preserving for the future. In addition to improving the dormer, the existing soil vent pipe will be replaced with a new cast metal pipe. The pipe will receive a powder-coated finish in black, and be fitted with a cowl to prevent the ingress of vermin.

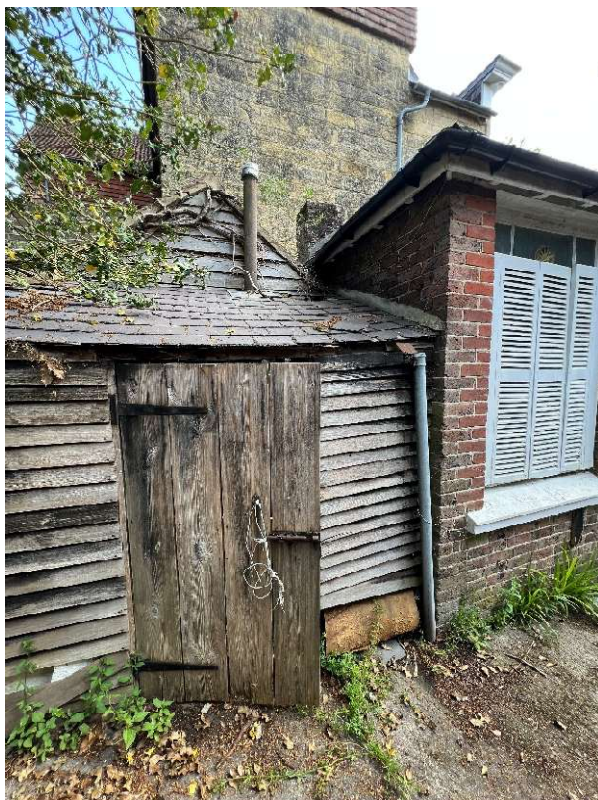
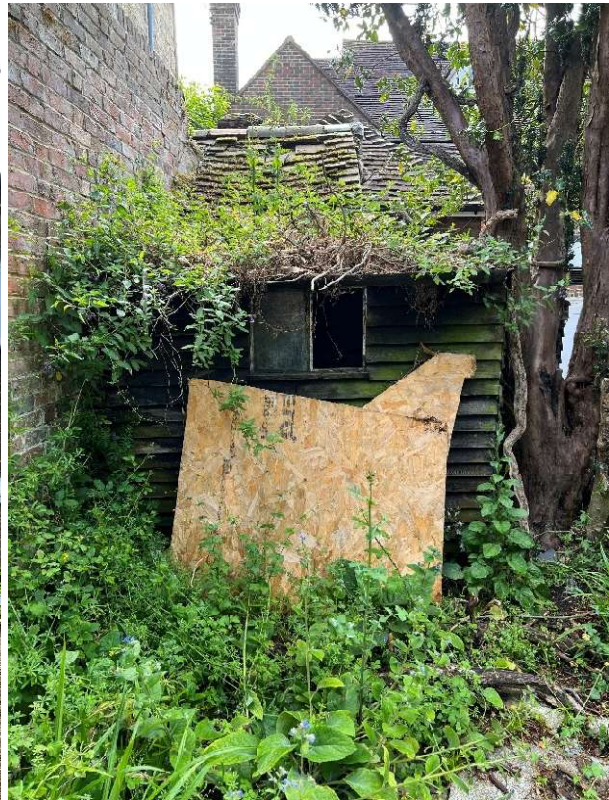
8.11 The removal of the existing dilapidated timber outbuilding is required owing to its condition being beyond economic repair:

8.12 Its removal will open up views to the existing building, revealing quality brickwork.

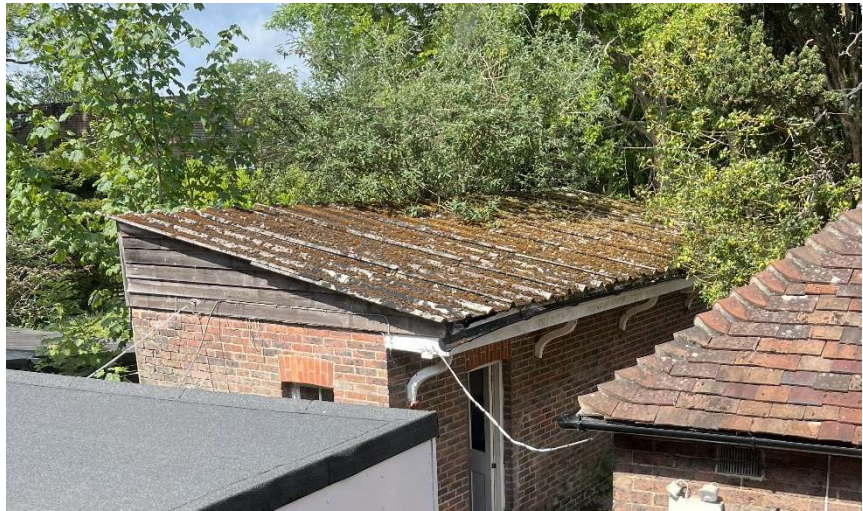
- 8.14 To the largest rear outbuilding, the existing asbestos roof covering will be replaced with an insulated profiled metal sheet system in black. This will provide a durable, virtually maintenance-free covering to suit the very

shallow pitch. The existing rainwater goods are in black plastic, and these will be replaced like-for-like to suit the replacement roof finish.

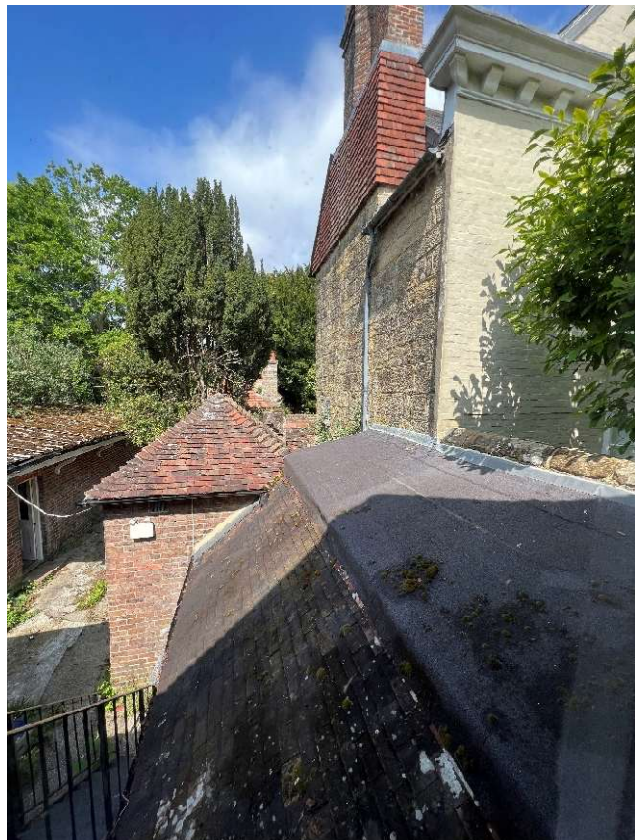
- 8.15 The existing felt flat roof adjacent to the northern boundary wall, shown in the photograph to the right, will be removed, revealing the existing plain clay tiled roof beneath it. It is proposed to form a lead valley at a lower level to prevent water from entering the gap between the boundary wall and No.83.

- 8.16 The photograph illustrates how the form of the roof, and its use of felt, is unsympathetic in this setting.
