FARMHOUSE AT GREAT WALSTEAD SCHOOL,  
EAST MASCALLS LANE, LINDFIELD, RH16 2QL

## HISTORIC FARMSTEAD CHARACTER & PRELIMINARY BUILDING ASSESSMENT

HERITAGE STATEMENT & IMPACT ASSESSMENT

Report No. 2026647

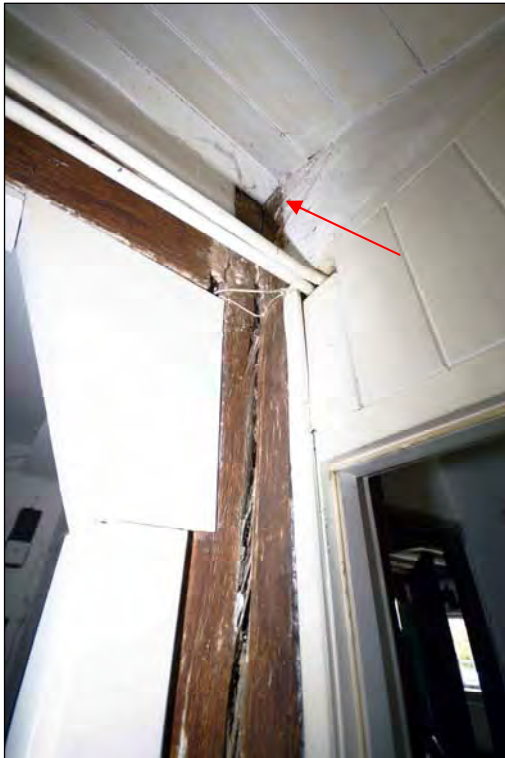
Plate 1: Detail of the L-shaped post at the junction of the main range and its integral cross-wing (arrow)

- 5.1.6 It is clear that the rear wing had been an integral part of the household from the outset, this is evidenced by the inclusion of a principal post that is L-shaped in section as it formed the eastern side of the T4 truss in addition to the western end of the northern elevation of the rear wing (Figure 2; Plate 1). Further, the wall-framing, where it survives is entirely consistent with that of the main range, as is the fragmentary roof structure still *in situ* with the chimney bay at the junction of the two ranges (discussed below).

- 5.2.14 The rear wing had been an integral part of the house as first built; this is particularly clear in the inclusion of a principal post that is L-shaped in section at the junction of the two ranges (Plate 1). On the exterior, the only extant timber-framed elements are those associated with the chimney bay, at the junction of main range and within the building the fabric is concealed in its entirety with later finishes.

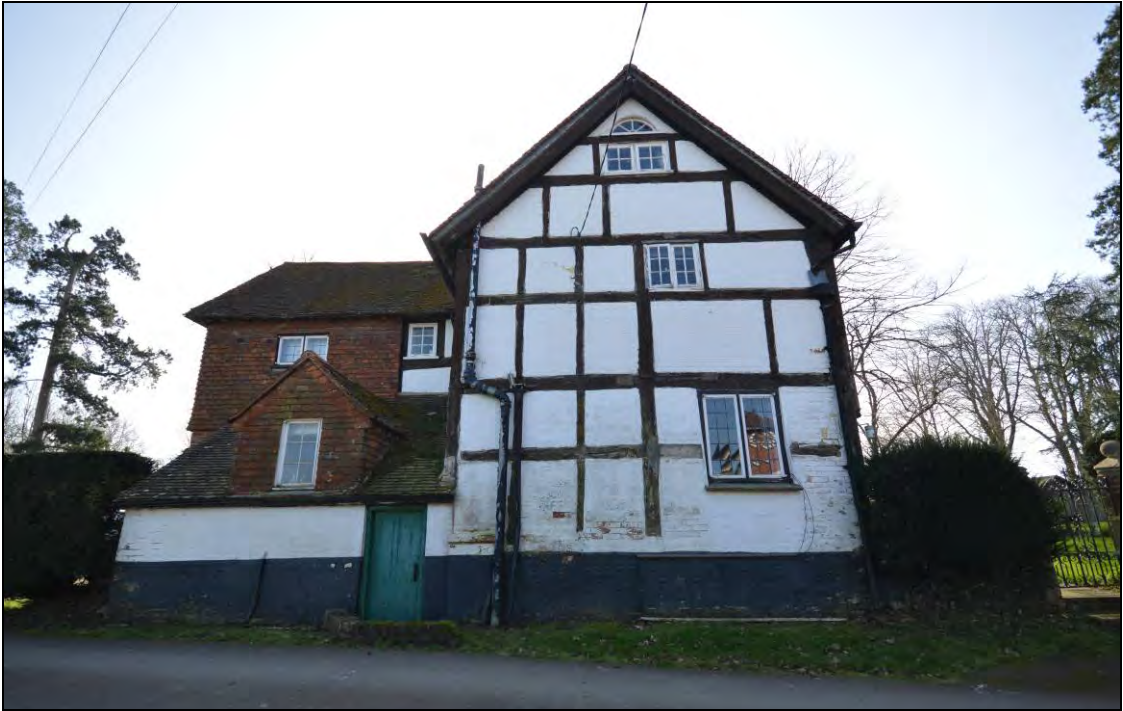
Plate 2: Small panel framing to the north end of the house

- 5.1.10 The wall construction is of small-panel type with no extant evidence of bracing (Plate 2 and Plate 3). The framing is consistent throughout the house on its external and internal walls. Carpenter's marks are also extant, again consistent in style throughout the main range; these comprise markings scored into the timber using a race knife. The markings on the T3 truss on the ground floor, north side include atypical arrow markings, while others include compass-drawn circles (Plate 4 and Plate 5).
- 5.1.11 The original infill to the small panels is lath and daub with a lime-skim finish that may have been the intended finish at the outset. Several areas retain comb-decorated daub: this can be seen on the walls at first floor level within bays 3 and 4 (Plate 6).

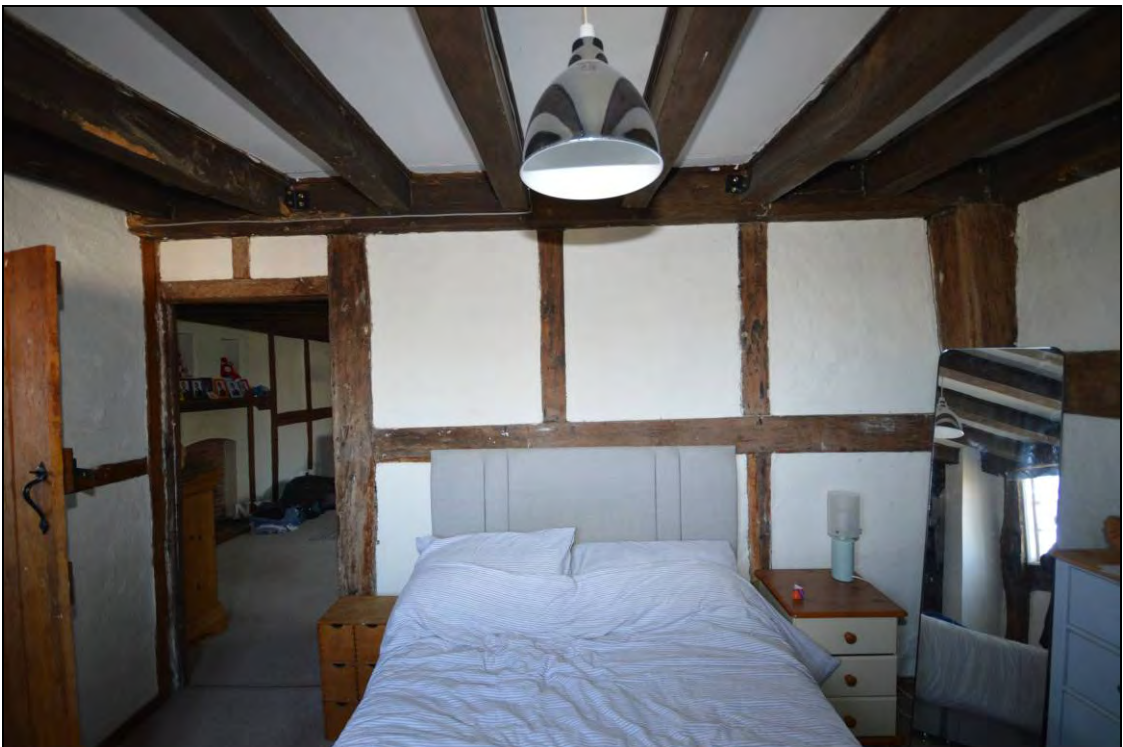
Plate 3: Small panel framing in the T4 truss between bays 3 and 4 on the first floor

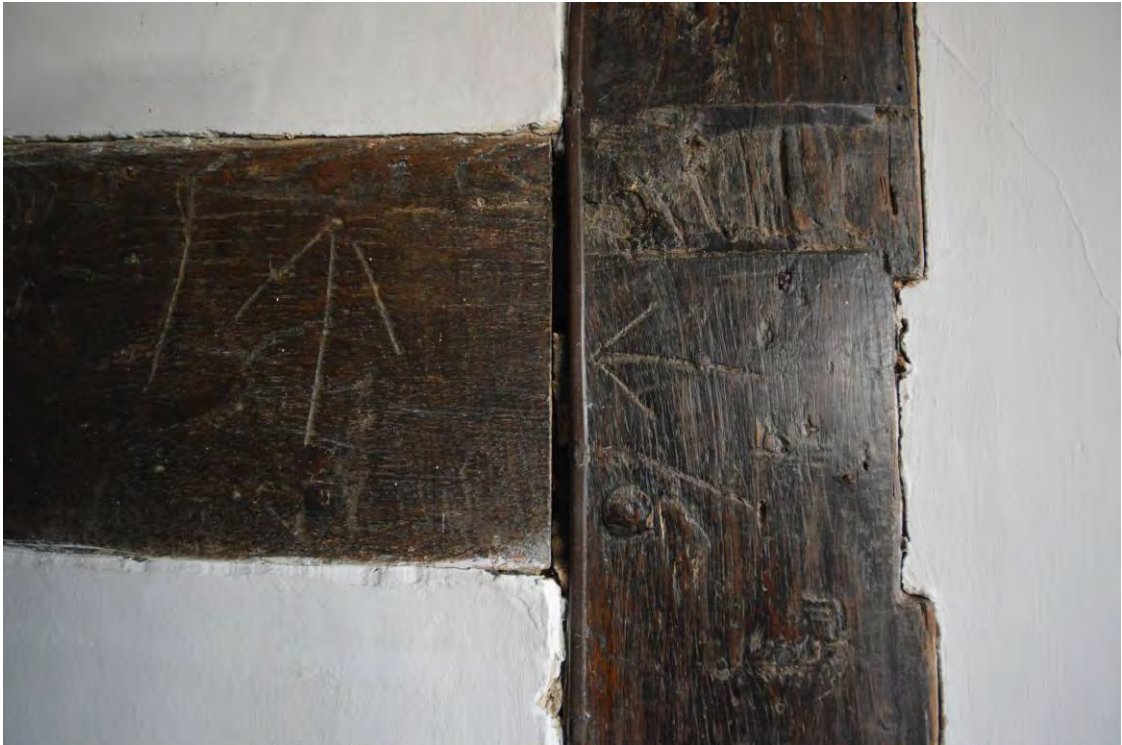
Plate 4: Example of the carpenter's marks on the T3 truss facing north into bay 3

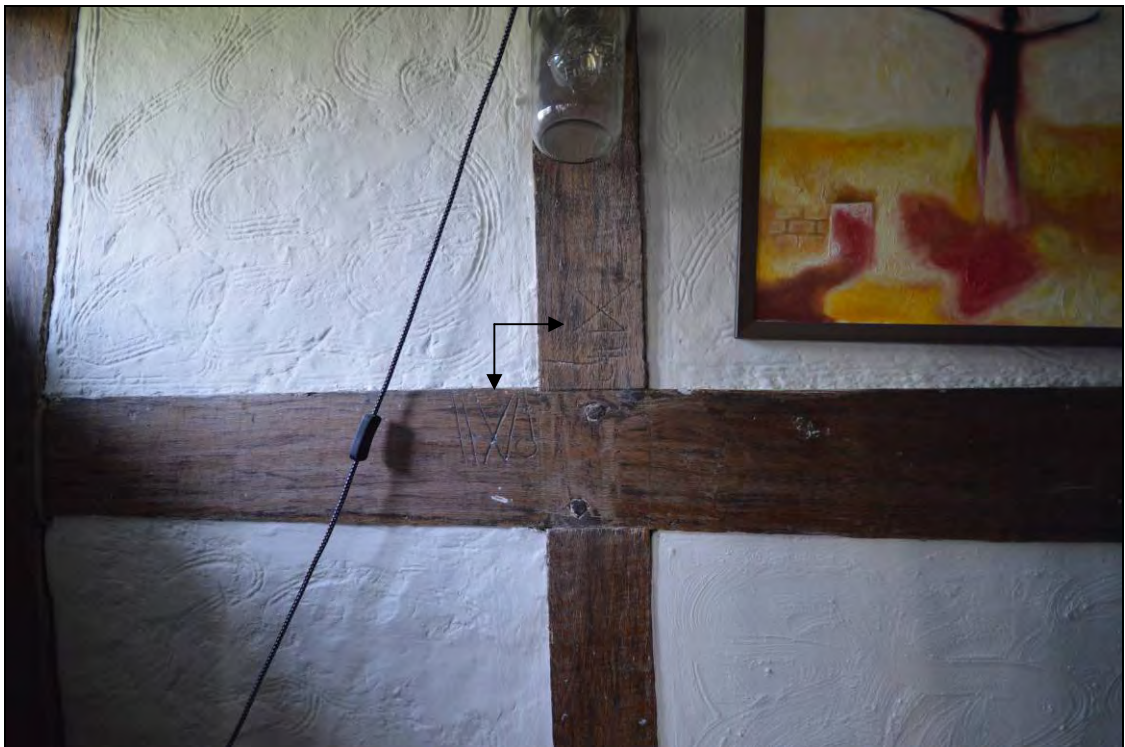
Plate 5: Comb-decorated daub with lime-skin on the south side of the T4 truss facing into the hall chamber in bay 3. Note also the carpenter's marks at the junction of the rail and studs (arrow)

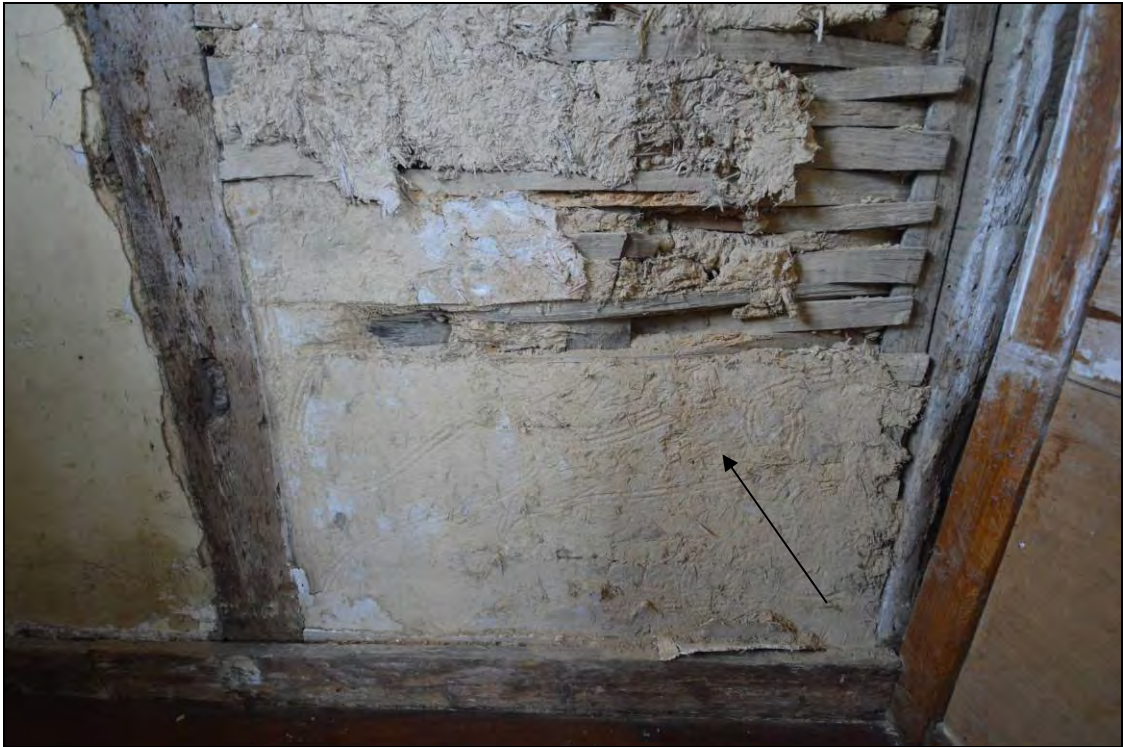
Plate 6: Lath and daub within the panels of the T4 truss (now within a bathroom) showing the remains of the comb-decorated daub (arrow)

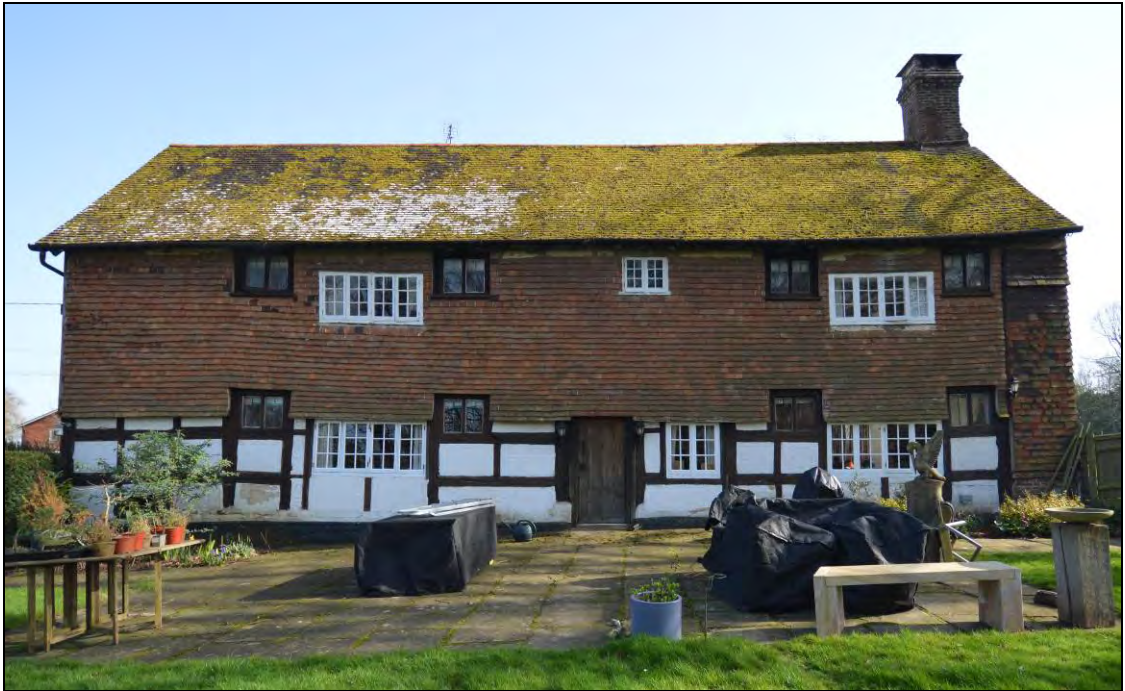
Plate 7: Eight surviving ovolo-moulded-mullioned windows on the west elevation of the main range

- 5.1.13 The main range has a high degree of survival of original doorways and windows. This is clear in the survival of eight, two-light, ovolo-moulded-mullioned windows on the west elevation of the house (Plate 7). The surviving windows are flanking windows, that is, they had flanked much larger central windows that have since been replaced. The rare survival clearly indicates display fenestration for the west side of the main range, the publicly-visible elevation that is viewed on the approach to the property from the highway.

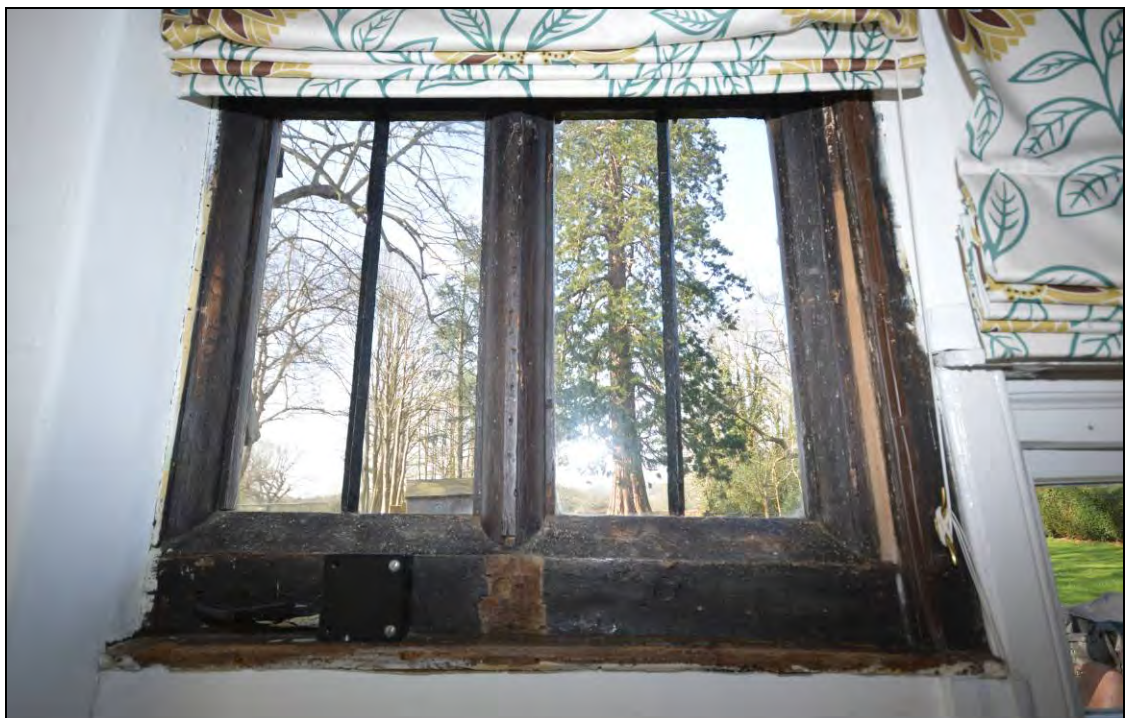
Plate 8: Detail of one of the two-light ovolo-moulded windows

- 5.1.14 The surviving windows include applied ovolo-moulded frames and diamond-section iron stanchions centrally situated to each light, intended to anchor leaded glazing (Plate 8). The glazing has been replaced with plain glass, and the survival of a regular arrangement of nail-holes on the mullions suggest that the flanking lights had been lath-and-plastered over to modernise the appearance of the house, later reinstated to reveal the fixtures perhaps as part of a late 19<sup>th</sup> and early 20<sup>th</sup> century building campaign.

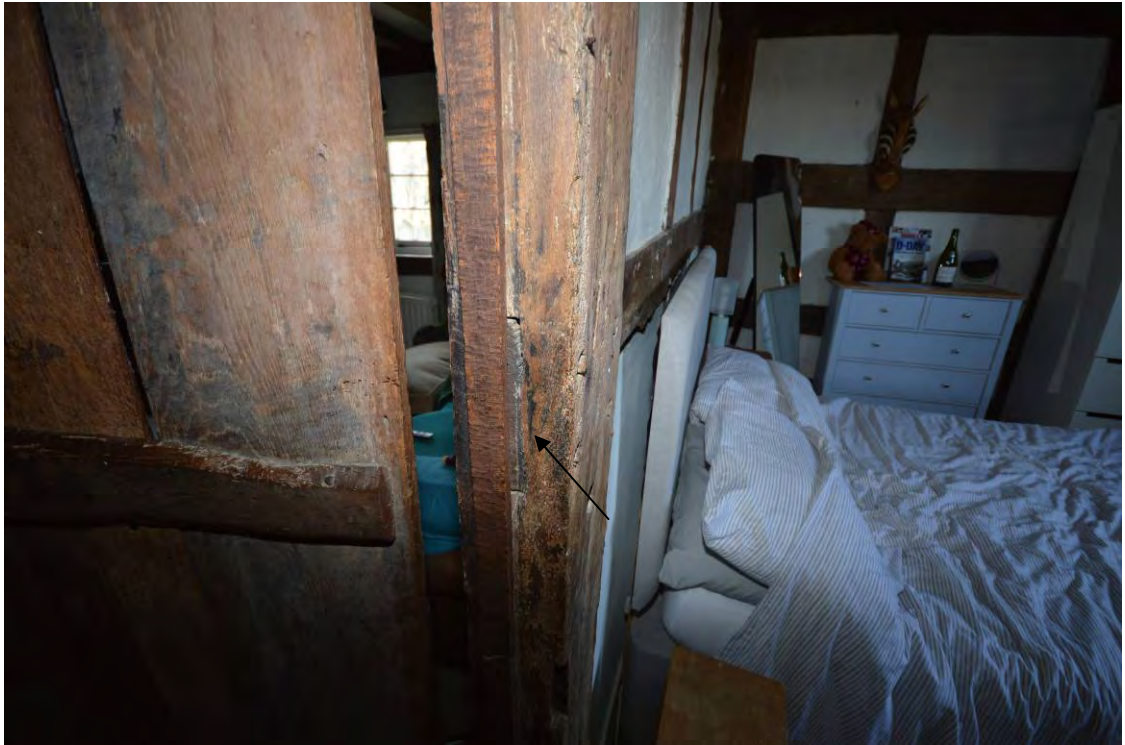
Plate 9: The mortise and tenon for the continuation of the rail (arrow), exposed when the rail was removed to create a doorway between the bay 3 and 4 first floor rooms

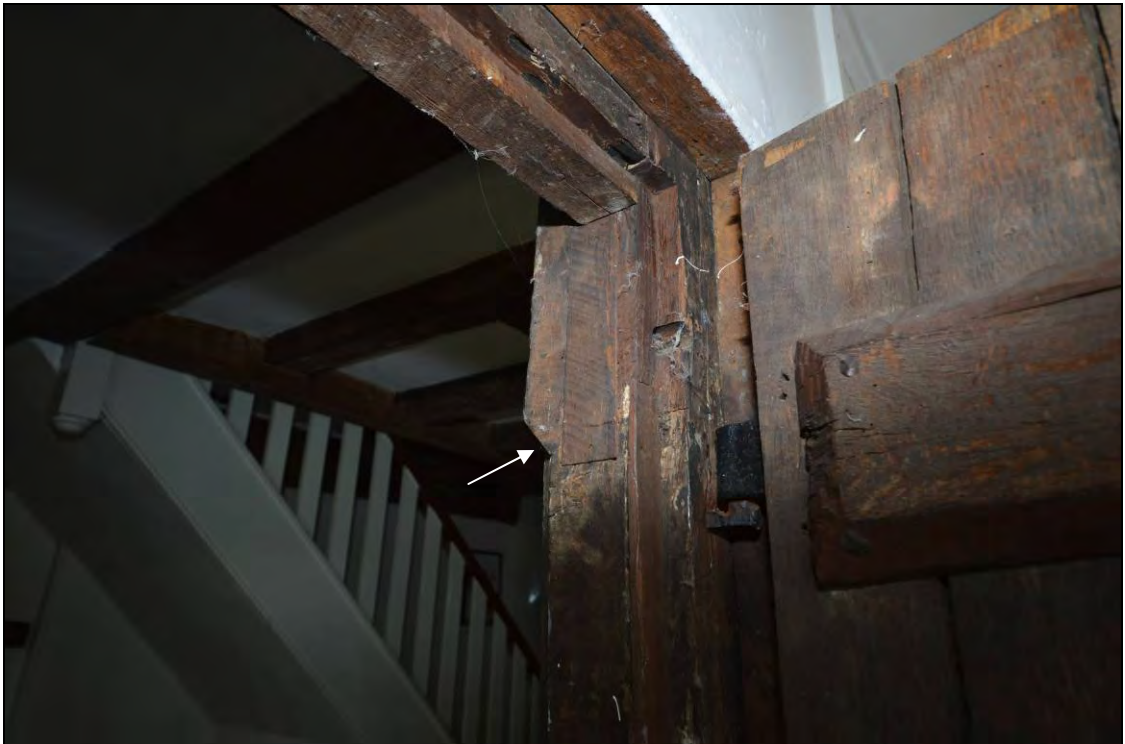
Plate 10: The mortise and tenon for the door-head of the ground floor doorway in the T2 truss, note also the mitred corner still visible at the top of the chamfer, indicating the level of the soffit of the door-head (arrow)

- 5.1.16 The doorway in the T2 truss on the ground floor and the two doorways, one each in the T2 and T3 trusses on the first floor, in addition to the entrance in the partition within bay 2 leading to the current first floor bathroom, are in their original locations. In all examples excepting the T2 truss doorway at first floor level and within the

partition in bay 2, the door-heads have been cut out to increase head-room (Plate 10).

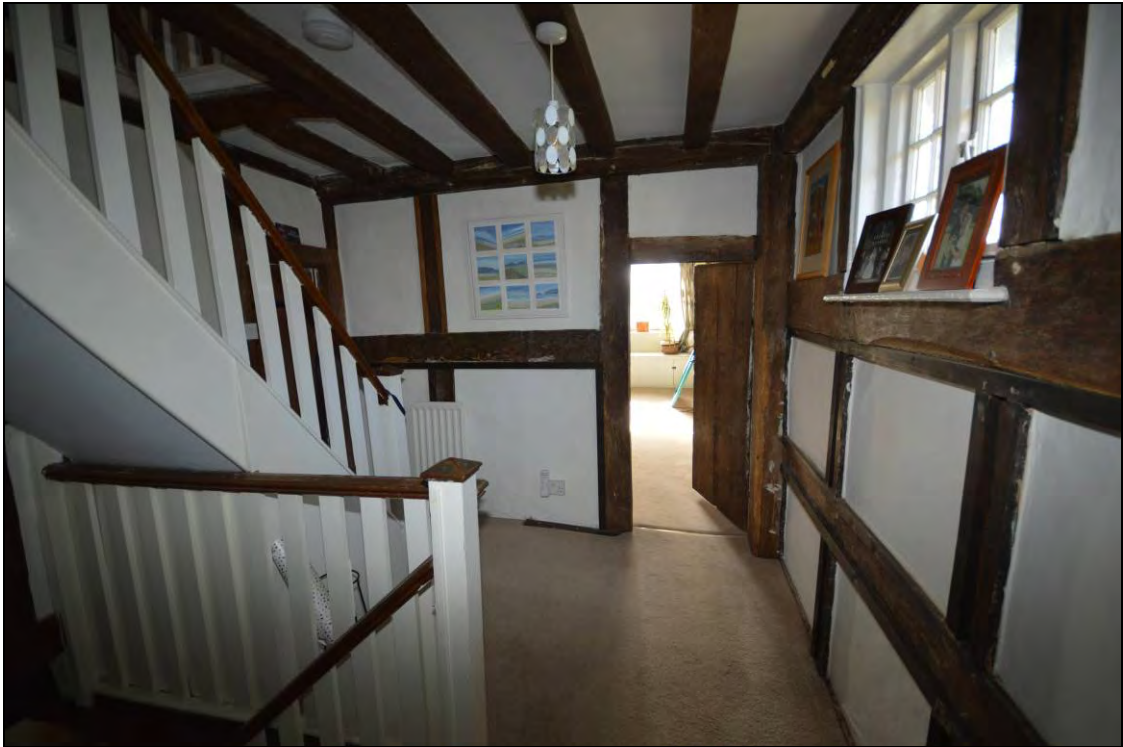
Plate 11: The *in situ* and unaltered doorway in the T2 truss on the first floor

- 5.1.17 The surviving door-head in the T2 truss leading to the south chamber in bay 1 is plain and unadorned on its northern side (Plate 11): its southern side is concealed behind a later doorcase. The very well-preserved original bay 2 partition doorway on the first floor has chamfered edges terminating in chamfer stops at the base of the jambs, and the junction of jambs and door-heads are finished in neat mason's mitres (Plate 12).

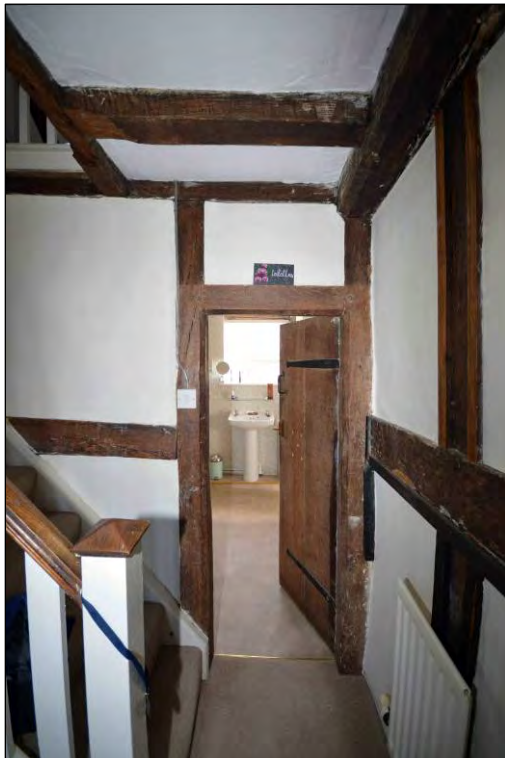
Plate 12: The original and unaltered doorway in the bay 2 partition at first floor level

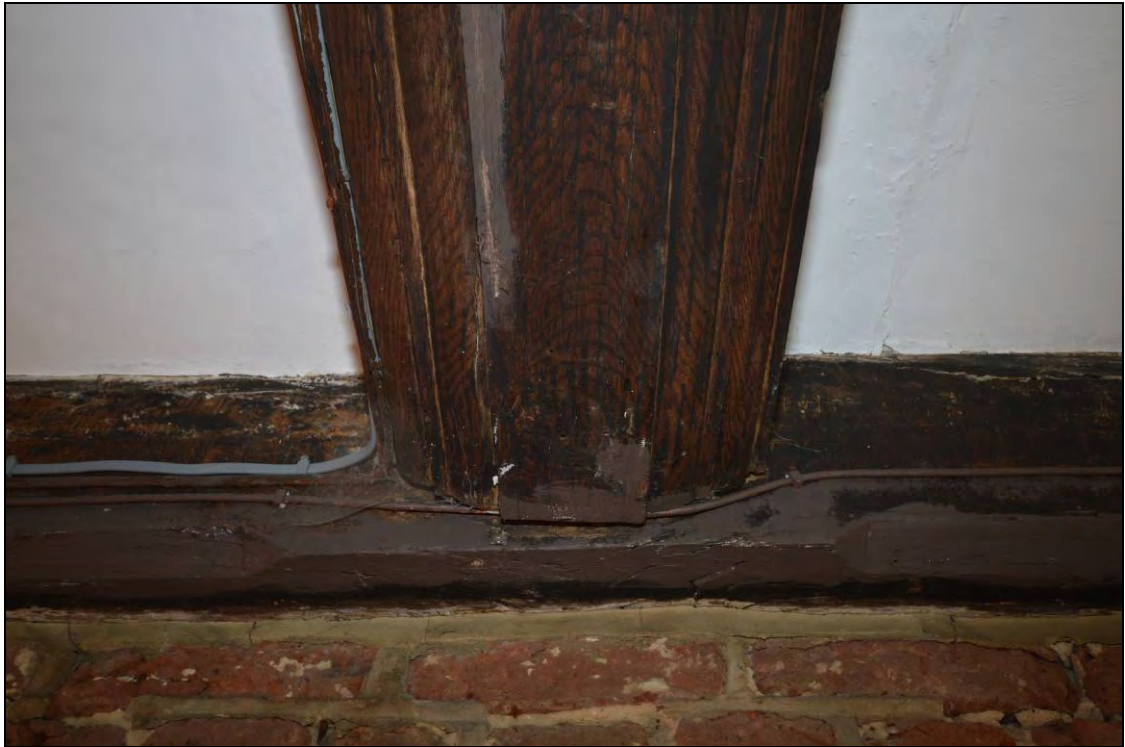
Plate 13: Double ovolo-mouldings to the girder in the ceiling over the parlour in bay 1

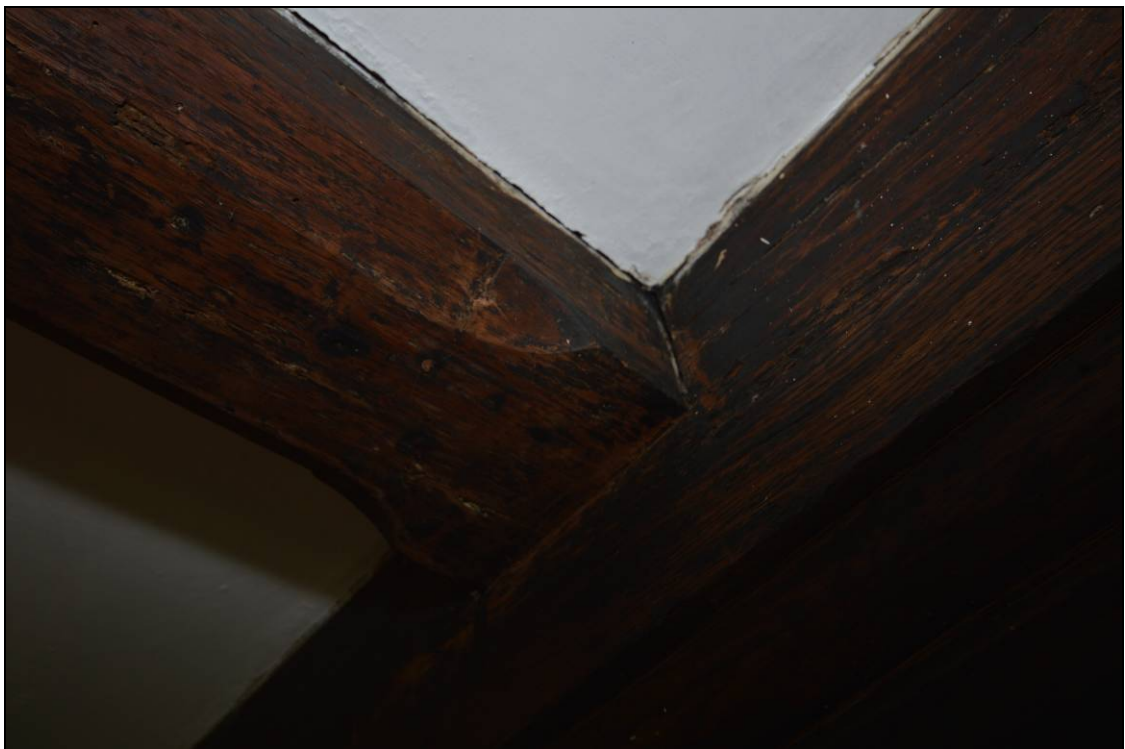
Plate 14: Step-and-hollow chamfer stop to the bays 1 and 3 joists (ground floor)

- 5.1.21 The same arrangement exists on the first floor, bays 1 and 3 have central girders, bays 2 and 4 lack girders and incorporate north-south oriented joists spanning the bay lengths (Figure 2). The girders are chamfered and stopped, the stops are step-and-hollows and all of the joists in the four bays are plain and unadorned. The attic rooms had been open to the roof.

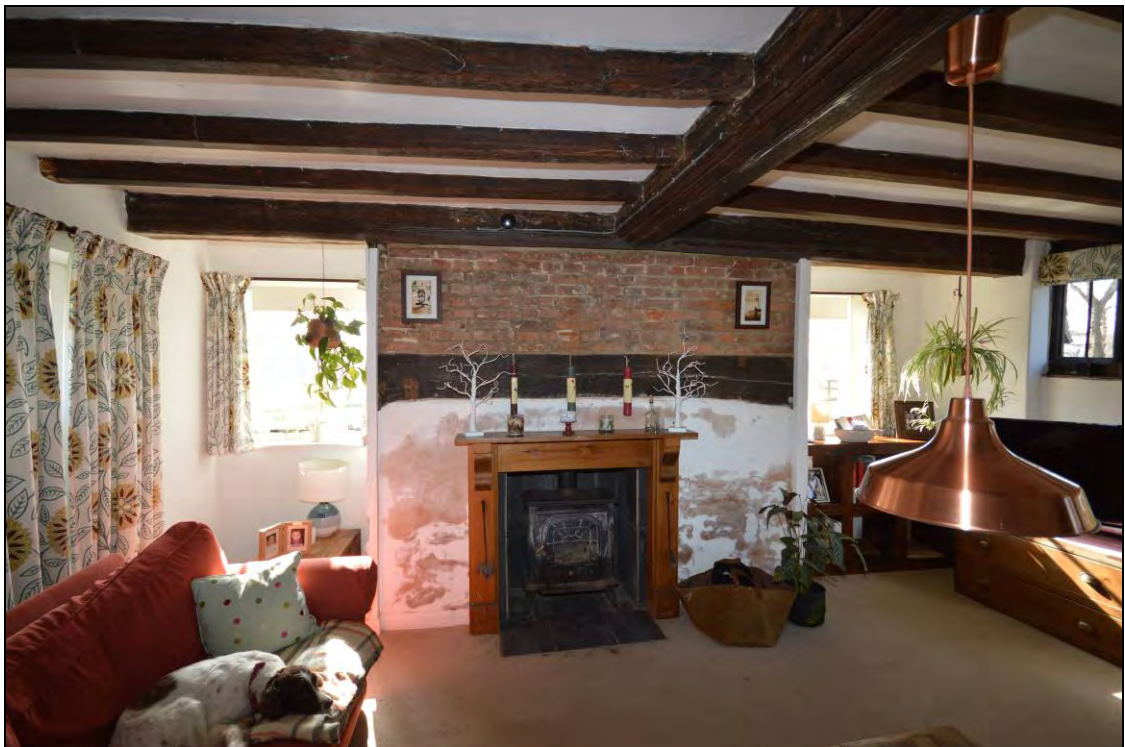
Plate 15: The ground floor fireplace in bay 1 with the bressumer of a much larger fireplace above the later insertion

- 5.1.23 The bay 1 fireplaces have been altered historically, however, for the ground floor fireplace the still *in situ* bressumer indicates the size of the original hearth (Plate 15). A similar situation had occurred within the bay 3 (rear wing) fireplace, albeit it is the first floor hearth that has been in-filled, its original extents indicated by the still *in situ*

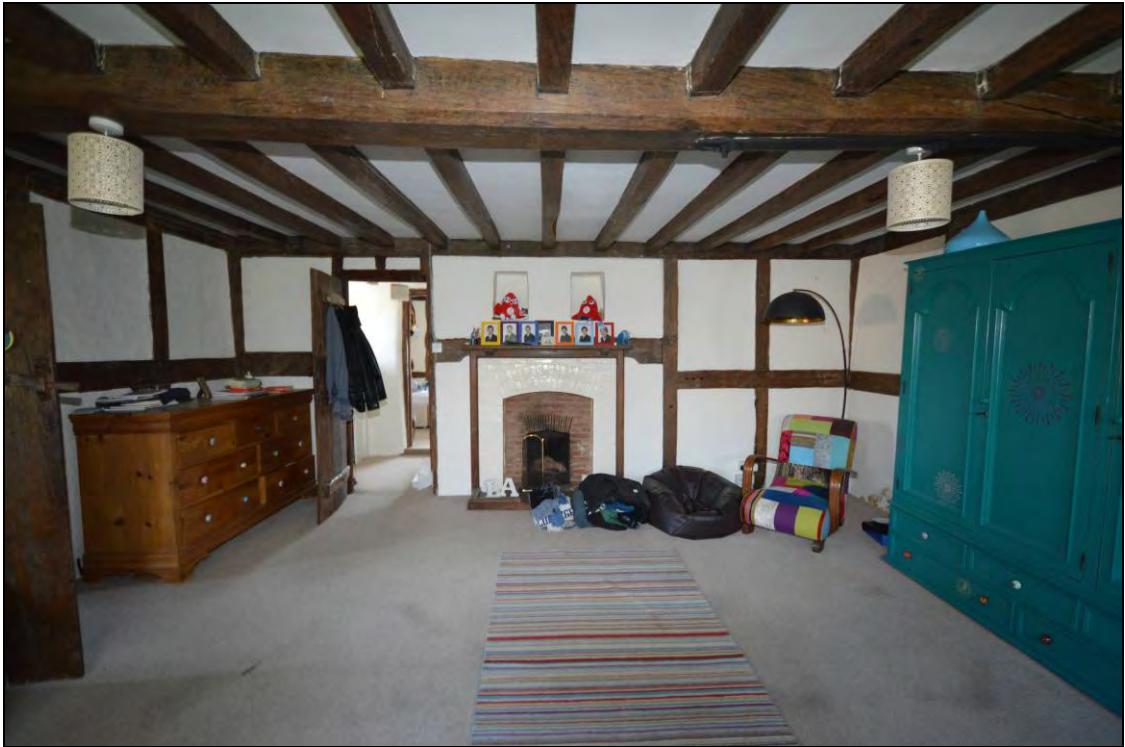
Plate 16: The bay 3 first floor fireplace, with glazed brick insert surmounted by the bressumer of the original opening

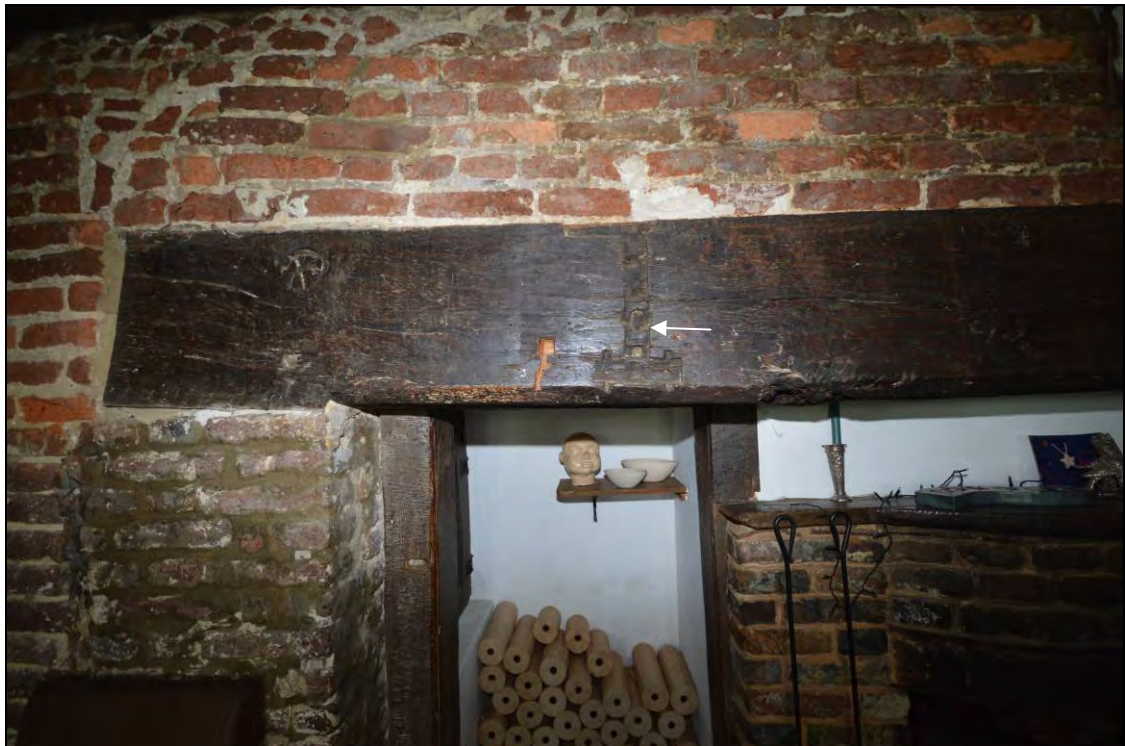
Plate 17: Detail of the bressumer over the bay 3 ground floor fireplace showing the scar made by the removal of the clock jack (arrow)

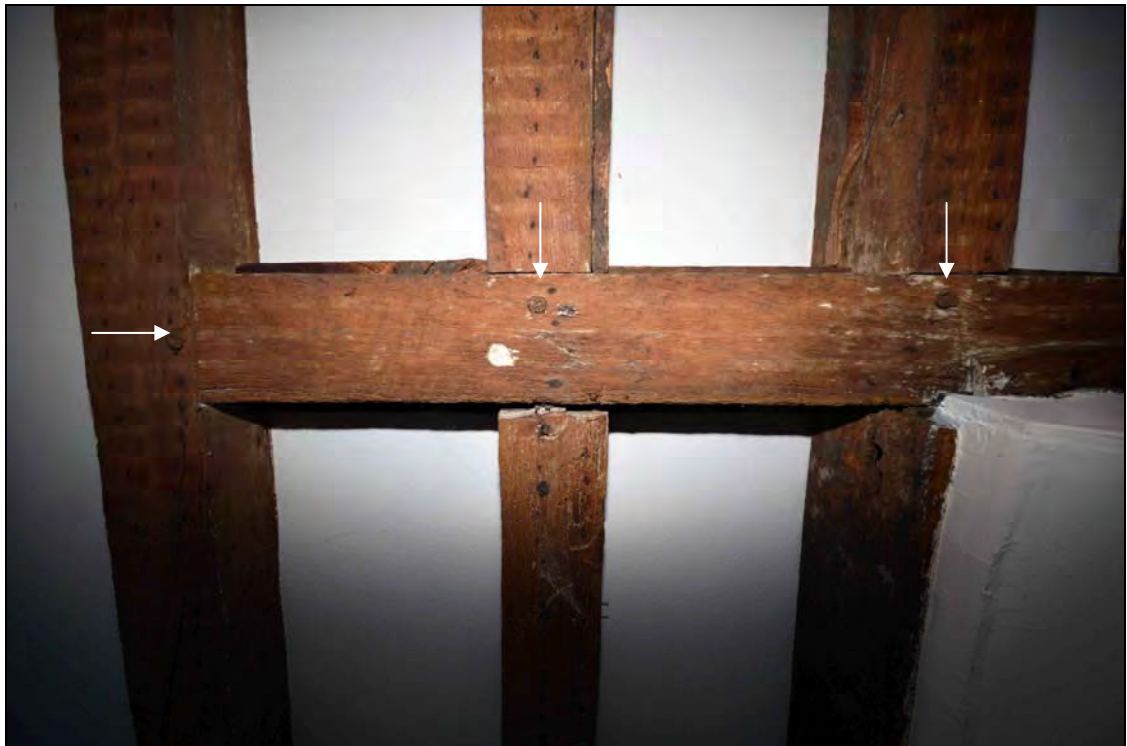
Plate 18: Detail of the original *in situ* trimmer for the staircase in bay 4, between ground and first floors, all original members are jointed and pegged in place (pegs indicated by arrows)

- 5.1.25 The trimmers for the stair traps in bay 4 are *in situ* and include, despite minor modifications to fit the current staircase, clear evidence of their original construction, extant in the jointed and pegged junctions of the joists to the trimmers (Plate 18).
- 5.1.26 Within bay 2, the extant stair trap is the result of later alterations, however, the joist mortises integral to the T3 cross-beam have a gap of c. 800 mm that lacks any evidence for a joist, suggesting that there had been another staircase in that location (Figure 2). With no access to bay 3 at first floor level from the staircases integral to bay 4, access would have been by means of a staircase accommodated within bay 2: this lead to a large lobby on the western side of bay 2 at first floor level. The first floor lobby included a pair of doorways within the flanking trusses (bays 1 and 3) on the

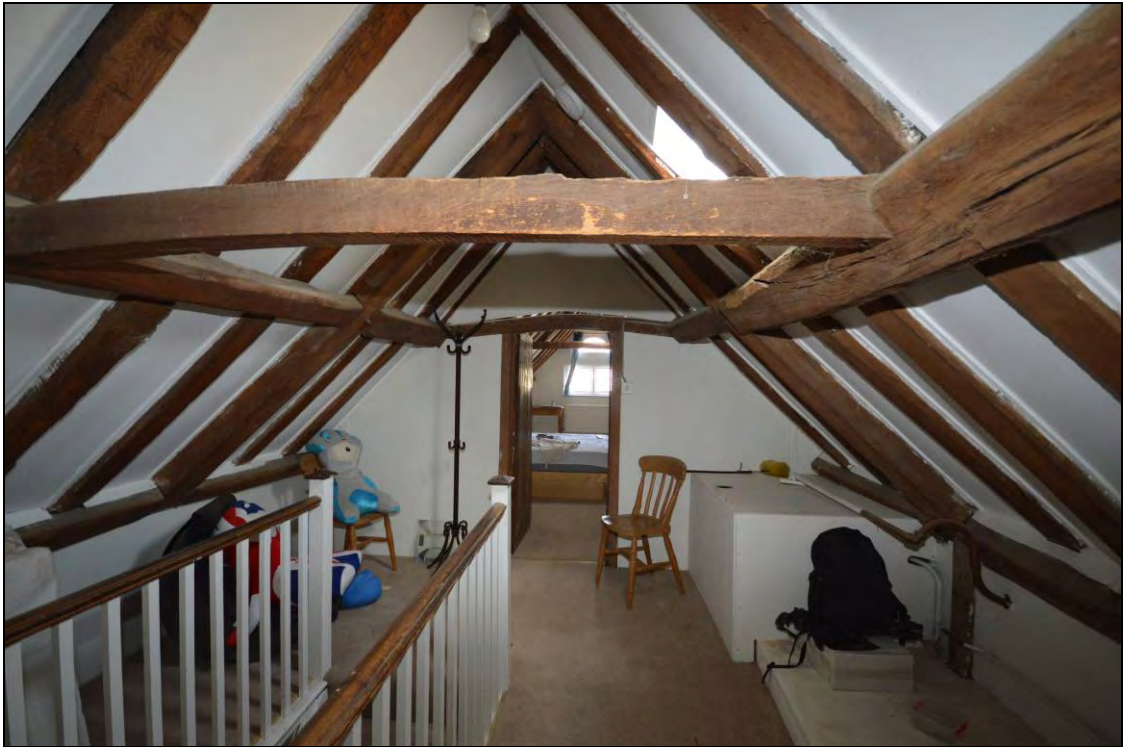
Plate 19: Two tiers of butted side purlins in the main range roof

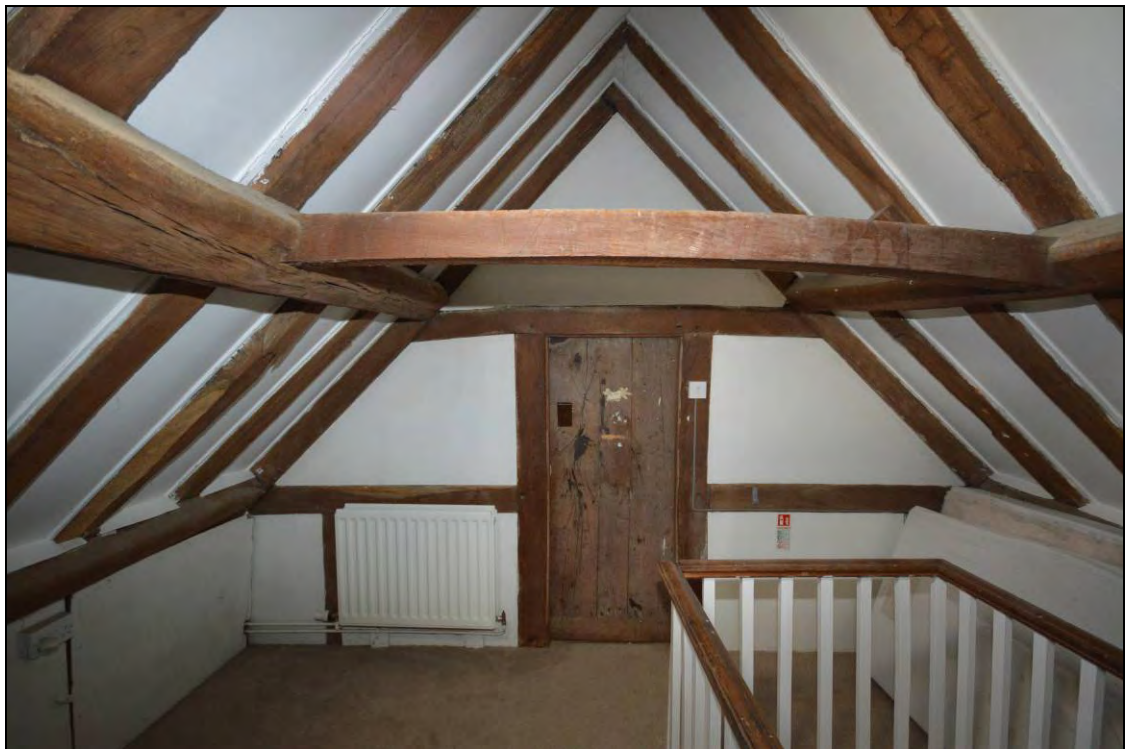
Plate 20: The T2 partition truss of queen stud type

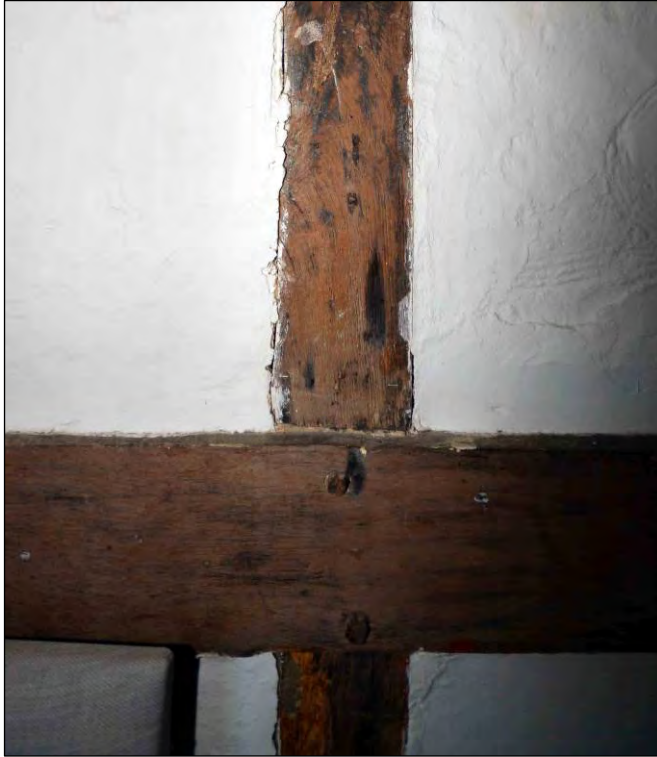
Plate 21: Two taper burns on the north side of the T4 truss in the first floor room

- 5.1.31 It is worth noting that there are taper burns, or burn marks, within some of the timbers in this building. Two taper burns are within the frame of the T4 truss in the north room at first floor level (bay 4; Plate 21). A further single taper burn is situated on the north side of the T3 truss within the hall chamber.

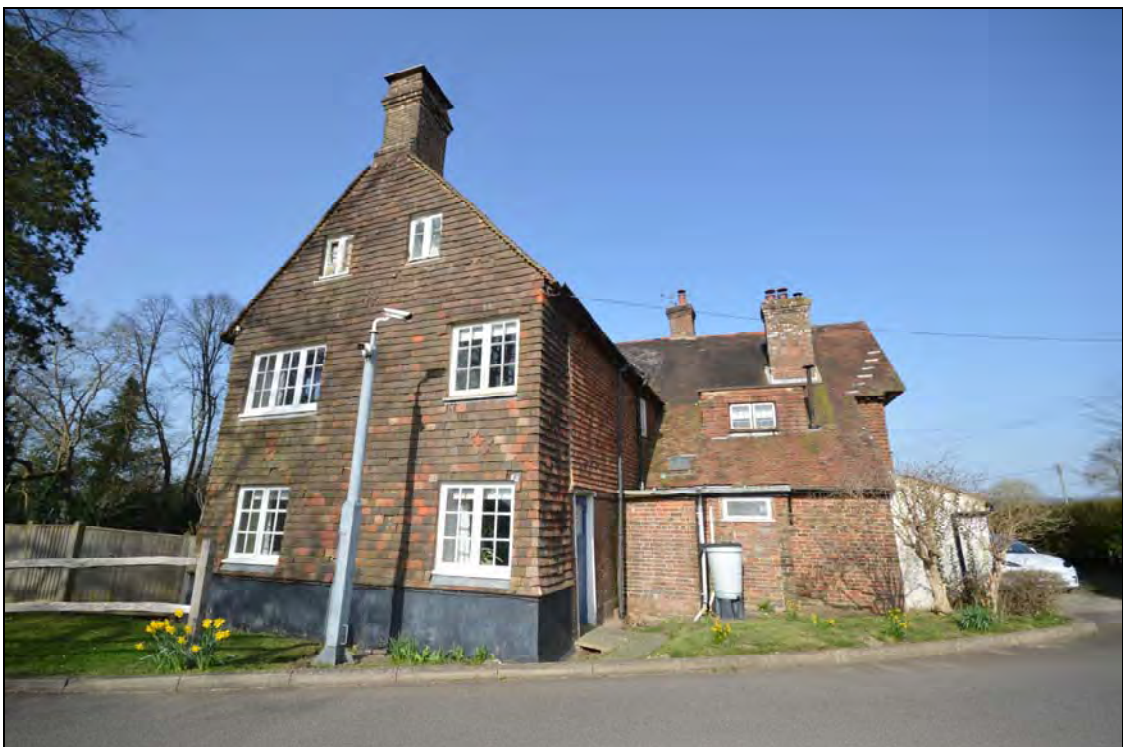
Plate 22: The south end and part of the east elevation of the main range showing the tile-hanging

- 5.2.12 On the exterior of the house, the addition of tile-hanging to the timber-frame, particularly to the publicly visible south and west elevations indicate the intention to modernise the appearance of the building to conceal the archaic timber frame. It is possible that the tile-hanging was applied during the Georgian era, if not during the 19<sup>th</sup> and early 20<sup>th</sup> centuries. The less publicly visible northern side of the house, and the remnants of the northern side of the rear wing, retain their extant timber-frame, concealed from public view.
- 5.2.13 Overall, the clay tiles appear to be of 19<sup>th</sup> and early 20<sup>th</sup> century origin, although those to the southern end elevation had been added, or renewed, in the mid-20<sup>th</sup> century (Plate 22).

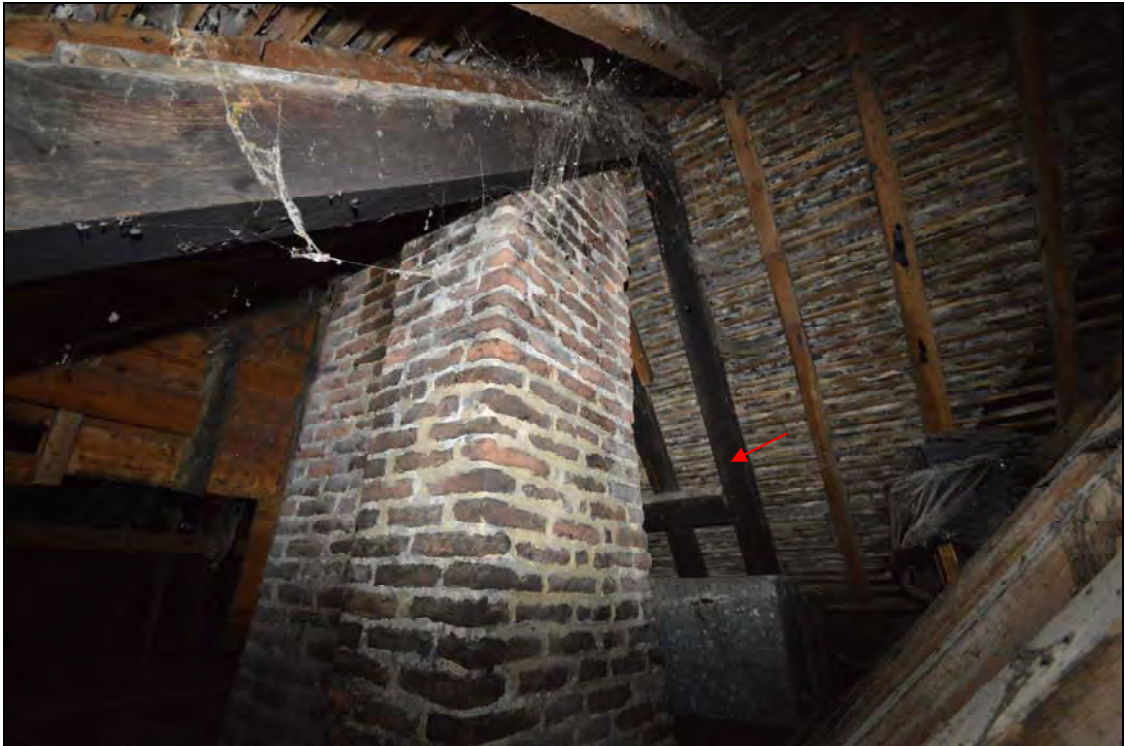
Plate 23: The chimney bay at the junction of the main range and its rear wing showing the remains of the original roof structure, rafter pairs and a butted-side-purlin on the south slope of the roof (arrow)

- 5.2.15 Within the roof, as outlined above, only the roof structure associated with the chimney bay survives (Plate 23), the remainder having been rebuilt to the east, and to the valleys at the junction with the main range, in the late 19<sup>th</sup> and 20<sup>th</sup> centuries (Plate 24). It is of interest to note that the footprint of the building as depicted on the tithe map of 1845 does not appear to show the full extent of the wing as it now stands: this may indicate that the eastern part of the building had been taken down by that stage in the development of the building, rebuilt to its current extents between 1845 and 1874.

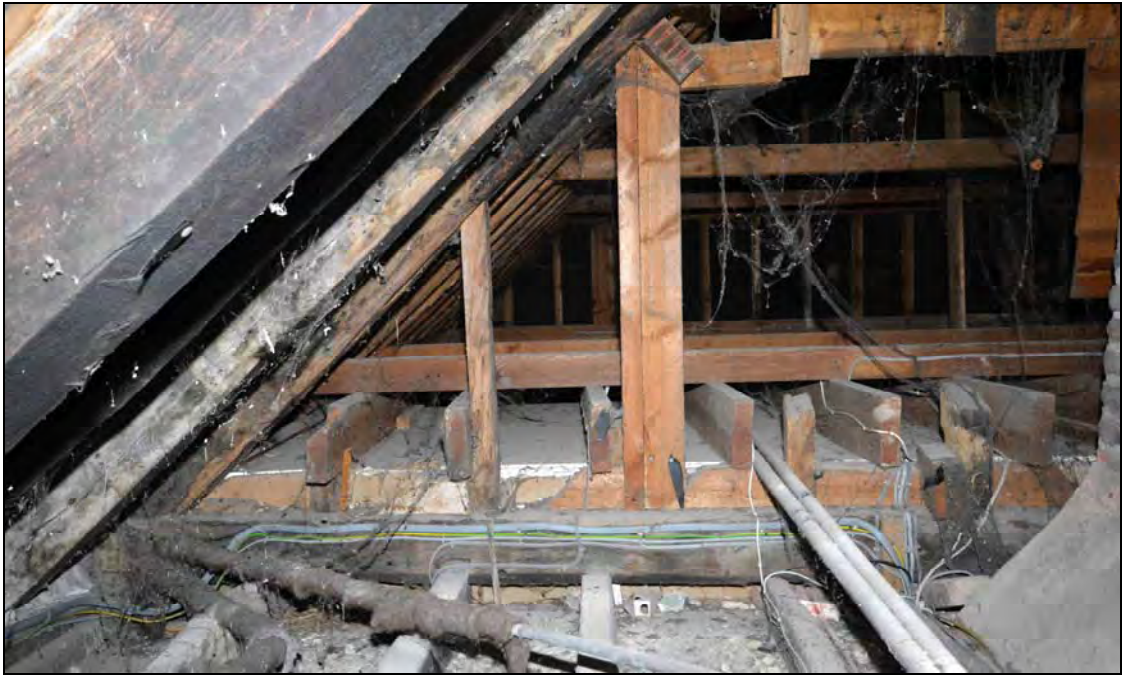
Plate 24: View into the rebuilt roof at the eastern end of the rear wing

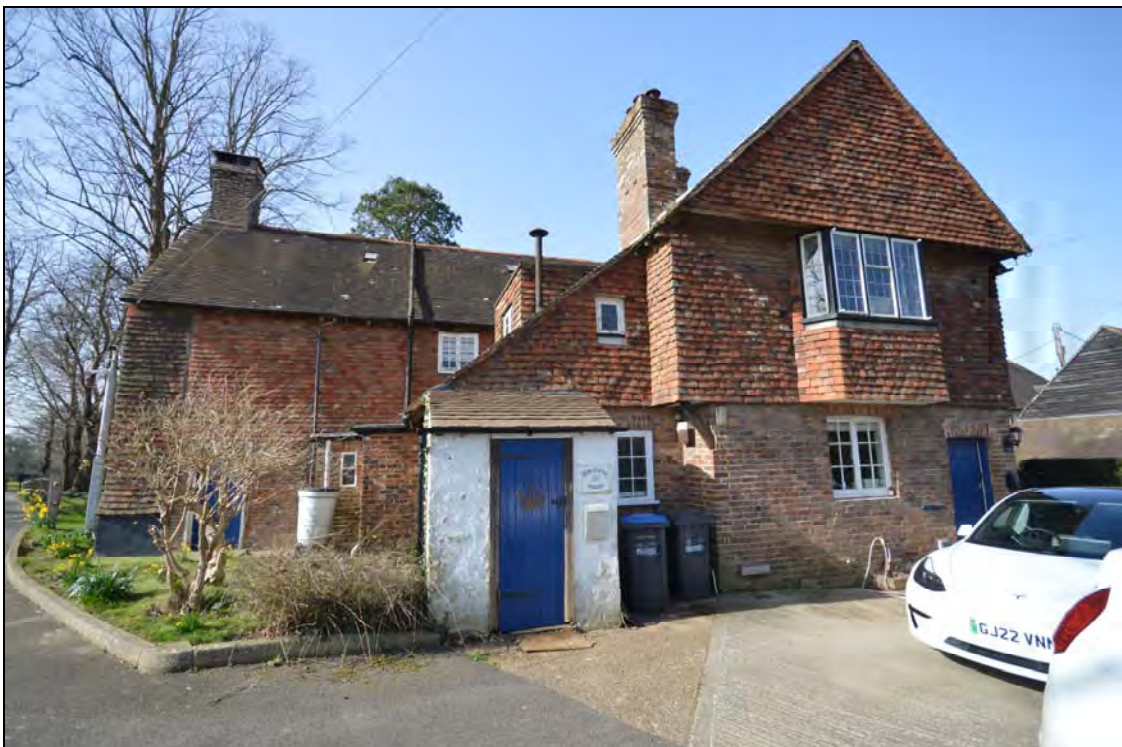
Plate 25: The rebuilt eastern end of the rear wing and the extensions added to it

- 5.2.16 The fabric used in the reconstruction of the eastern end of the rear wing, and the lean-to outshot that is situated against its southern side comprises walls laid in Sussex bond brickwork to the ground floor, with the upper floor, oriel window and over-sailing gable clad in plain clay tile (Plate 25). The rebuilding event, including the timbers on all excepting some in the western wall of the first floor room, is commensurate with an early 20<sup>th</sup> century building campaign. As such, the lack of depiction of the rear wing on the tithe map issued in 1845, and its appearance on the
