FARMHOUSE AT GREAT WALSTEAD SCHOOL,  
EAST MASCALLS LANE, LINDFIELD, RH16 2QL

## HISTORIC FARMSTEAD CHARACTER & PRELIMINARY BUILDING ASSESSMENT

HERITAGE STATEMENT & IMPACT ASSESSMENT

Report No. 2026647

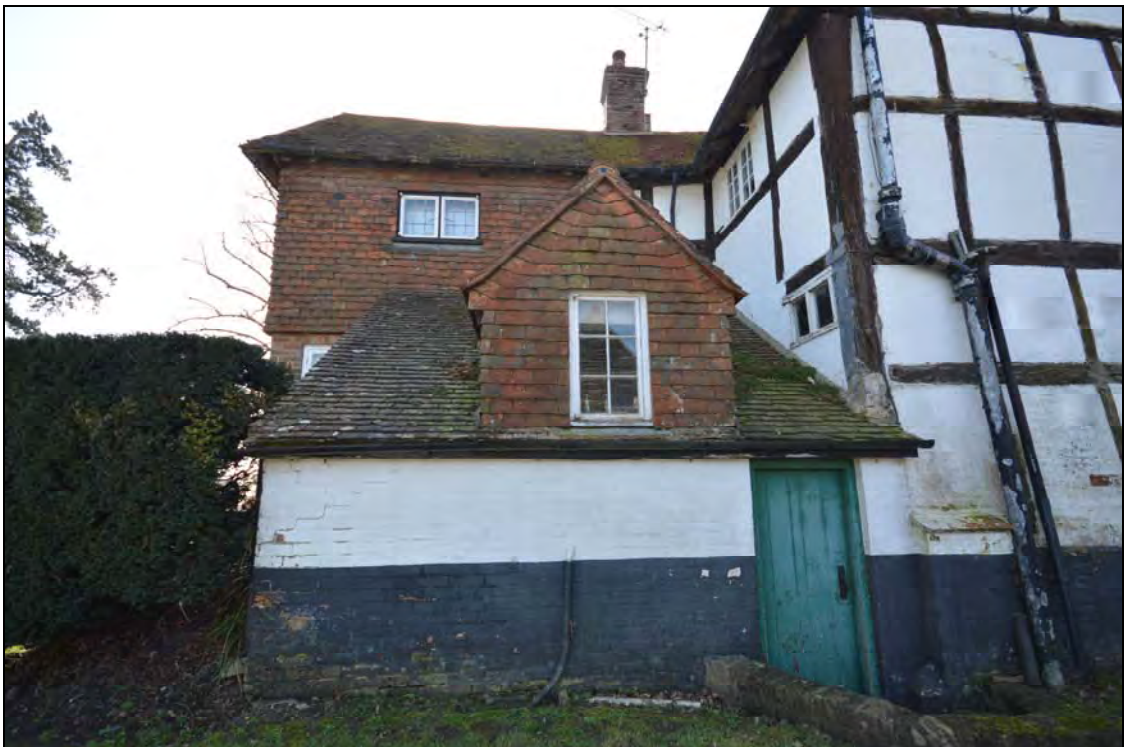
Plate 26: The current structure at the junction of the main range and rear wing at the north end of the house: the doorway provides access to the cellars, the dormer window lights a ground floor room, illustrating the sloping topography of the site

- 5.2.18 The current lean-to outshot that surmounts the cellar replaces any predecessor, its construction in Sussex bond brickwork to the north, and stretcher-bond to the east, the latter including an integral (now blocked) cellar window (Figure 3; Plates 26 and 27). An external entrance in the north side leads to the cellars and a set of timber steps rising to the ground floor of the remainder of the group: the steps are in front of an earlier brick-built set that may have been integral to the cellar and any lean-to above it, as first built.
- 5.2.19 A small ground floor room is situated above the cellars; this is lit by a dormer window in the roof of the western part of the extensions (Plate 26). The loft-like nature of what is essentially a ground floor room further emphasises the sloping topography of the site, one that was used to advantage to create the cellar facilities.

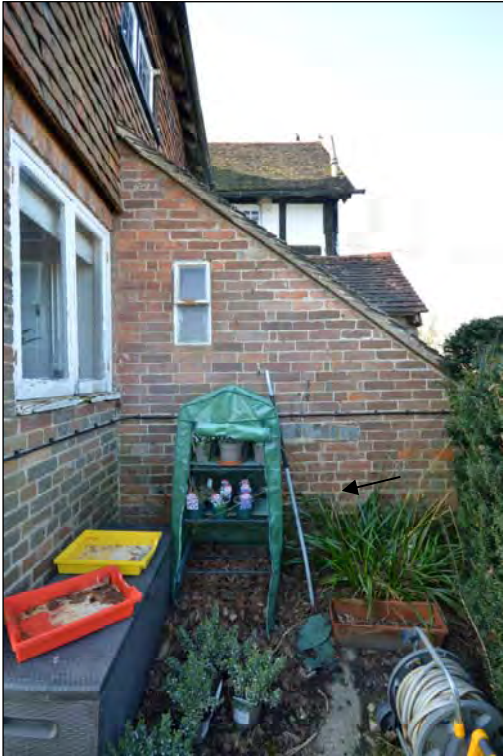
Plate 27: The east end of the group, in stretcher bond brickwork with the blocked cellar window at the base indicated by the over-fired headers of its arch (arrow)

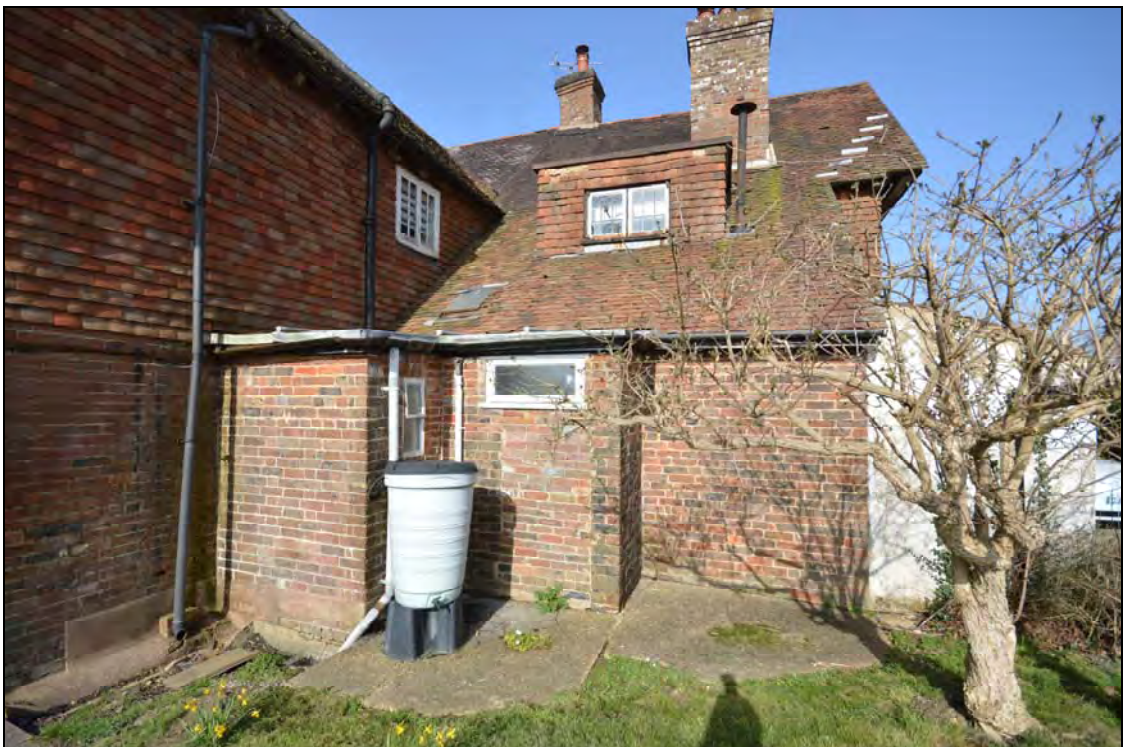
Plate 28: The south extensions with their flat-roofs, added to the group after 1968, in addition to the flat-roofed dormer inserted into the earlier lean-to that abuts the rebuilt rear wing

- 5.2.21 The remaining extensions comprise a flat-roofed, slightly L-plan, single-storey structure built against the south wall of the lean-to that had been added with the rebuilt rear wing. The flat-roofed extension includes evidence of a blocked-doorway at the eastern end of its south elevation (Plate 28). A further, compact, single-storey extension had been added to the eastern side of the rear-wing's south lean-to; both additions are the result of alterations undertaken after 1963 (discussed below).
- 5.2.22 It is clear that the eastern side of the house had undergone significant changes over time, evidenced by scars in the brickwork on the exposed underbuilt eastern side of the main range, and supported by the historic map evidence.

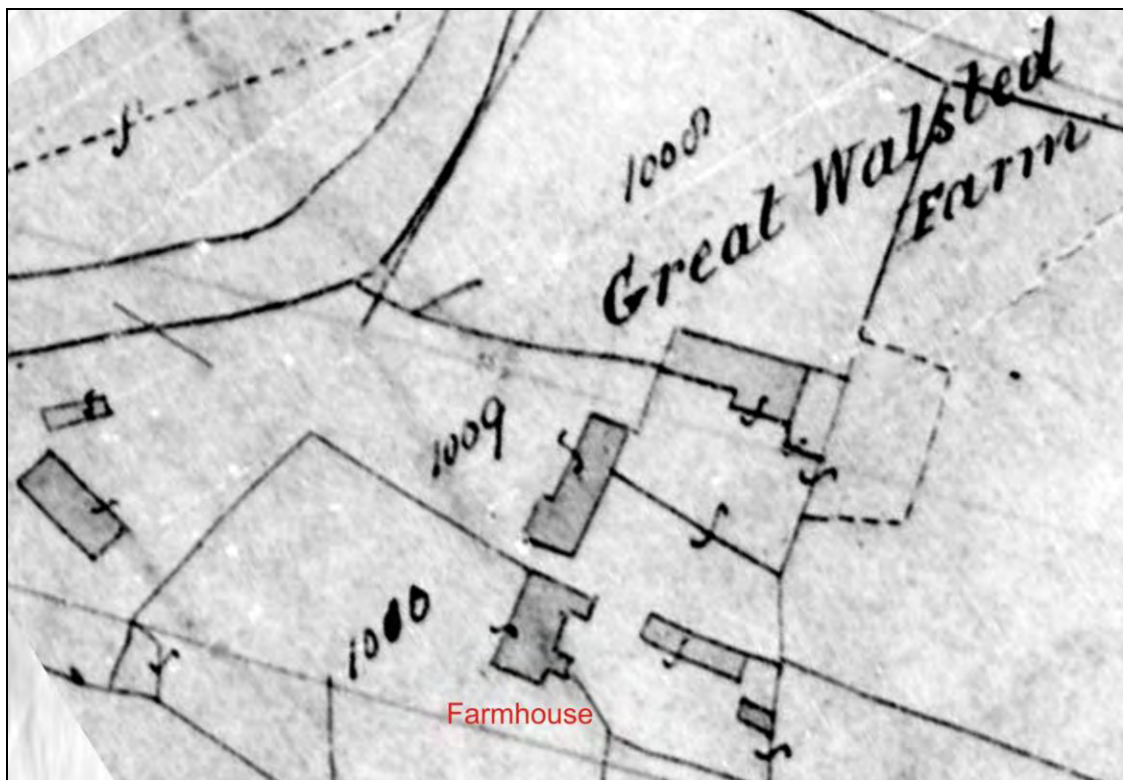
Plate 29: Extract of the Lindfield tithe map, showing the farmhouse and its farmstead in 1845

- 6.1.1 As touched on above, the house is shown to a rectangular-plan footprint with two short projections on its eastern side, one at its northern end and the other off-set from its southern end (Plate 29). The footprint is at odds with the historic fabric of the building as there had clearly been a wide, integral, rear range, off-set from flush with the north end of the main range as first built. It is important to note that the expense of preparing the tithe maps was levied on the landowners, in addition to the fact that tithe maps were intended to assess land holdings for the purposes of determining tithes due and indeed, the accuracy of the map depended on the skill of the surveyor. As such, buildings were not always a true and accurate depiction of the structure on site as may be the case here.

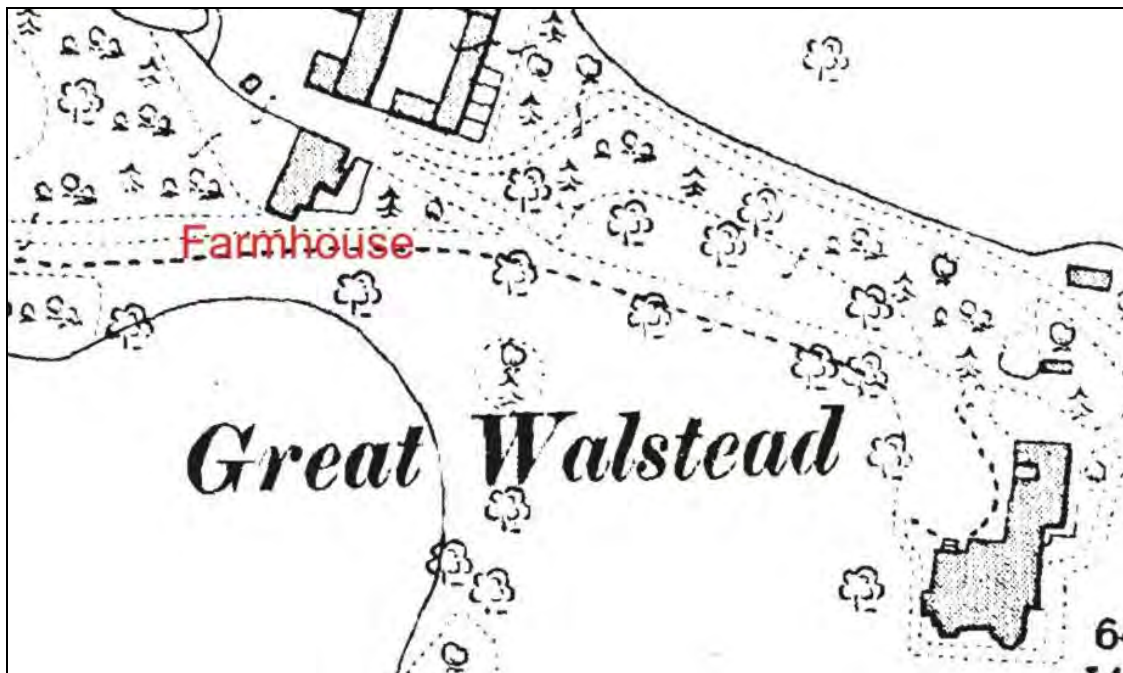
Plate 30: First edition 1:2500 Ordnance Survey map (1:2500), 1874

- 6.2.1 The first edition Ordnance Survey map surveyed in 1874 shows the rear wing *in situ* and off-set from flush with its northern end: commensurate with the standing fabric of the building and the probable inclusion of a north lean-to outshot overlying the cellar. An extension is indicated to the rear of the main range, to the south of the rear wing, stopping short of the south end of the house (compare Plate 29 and Plate 30). The new 19<sup>th</sup> century house, Great Walstead, is shown to the southeast of the farmhouse.

- 6.2.2 The first and second revision Ordnance Survey maps, surveyed in 1895 and 1909 show no external changes to the farmhouse and few to the agricultural group (compare Plate 30 and Plate 31).

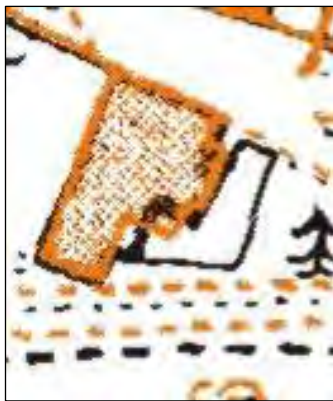
Plate 34: Detail showing an overlay of the 1938 edition map on the 1909 edition map, highlighting the changes to the east elevation that had occurred during the 29 years between the two surveys

with the features and stylistic details of the standing fabric of the building (Plate 32, Plate 33 Plate 34).

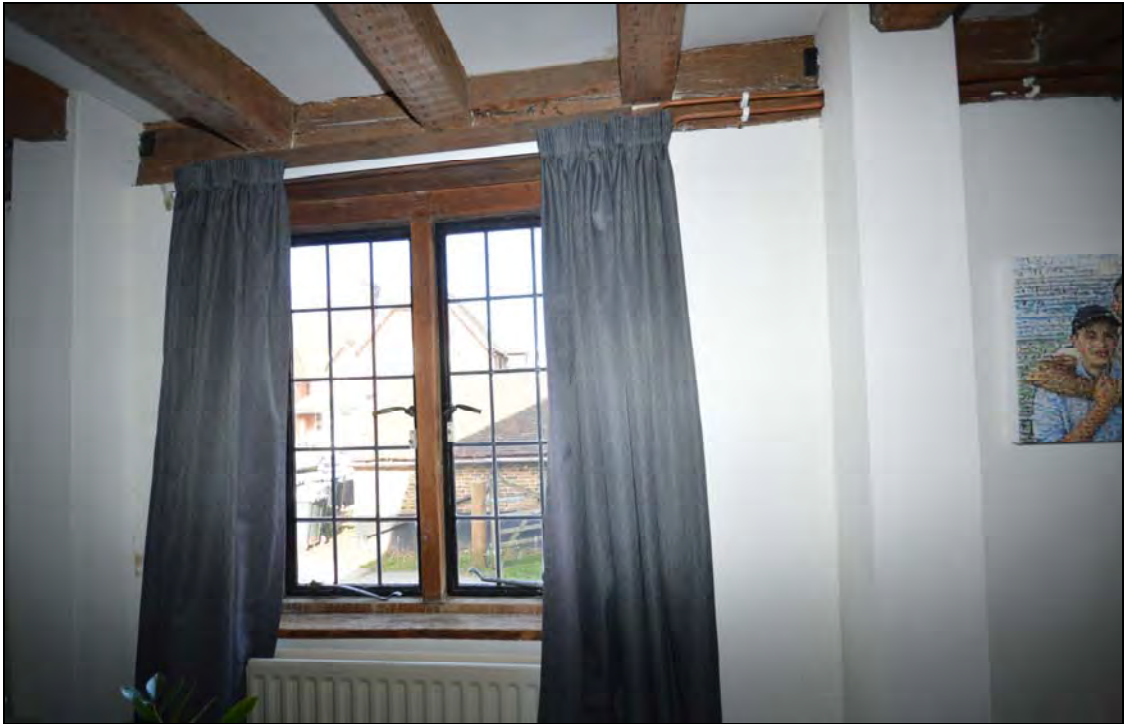
Plate 36: Intervention to strengthen the south end of the main range, ground floor

- 6.3.4 A pair of vertical piers had been added against the north end of the main range, strapped to the frame rising through the ground and first floors of the building terminating in the attics (Plate 36 and Plate 37)

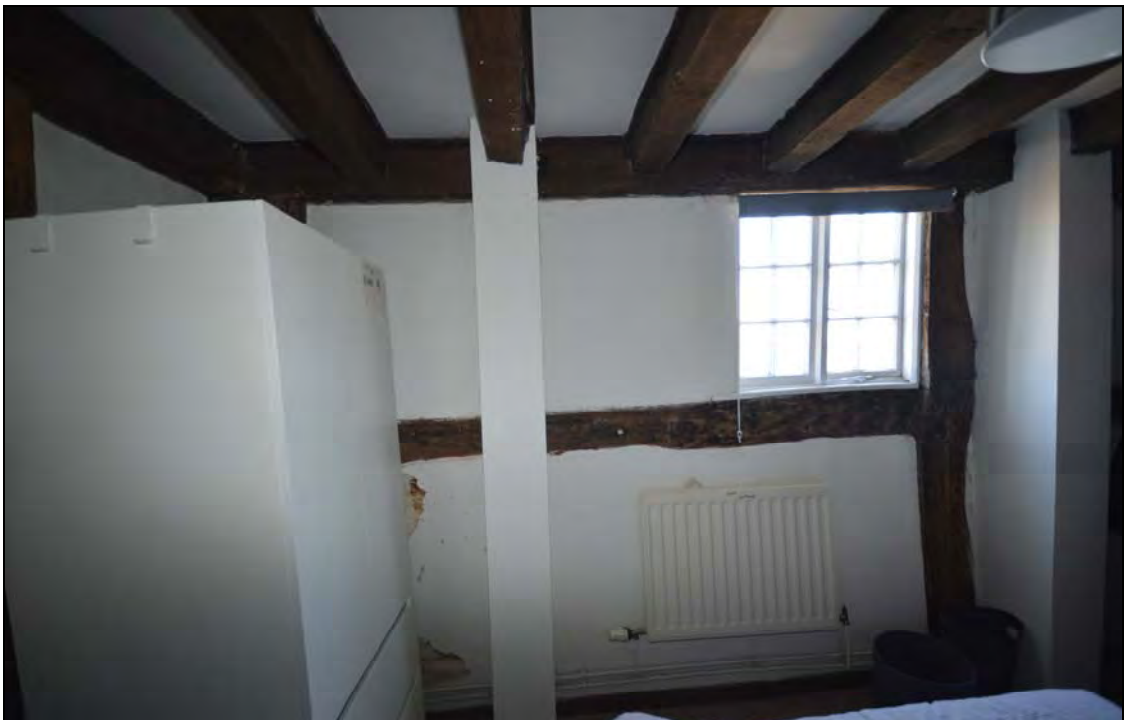
Plate 37: The continuation of the inserted supports at the south end of the main range on the first floor

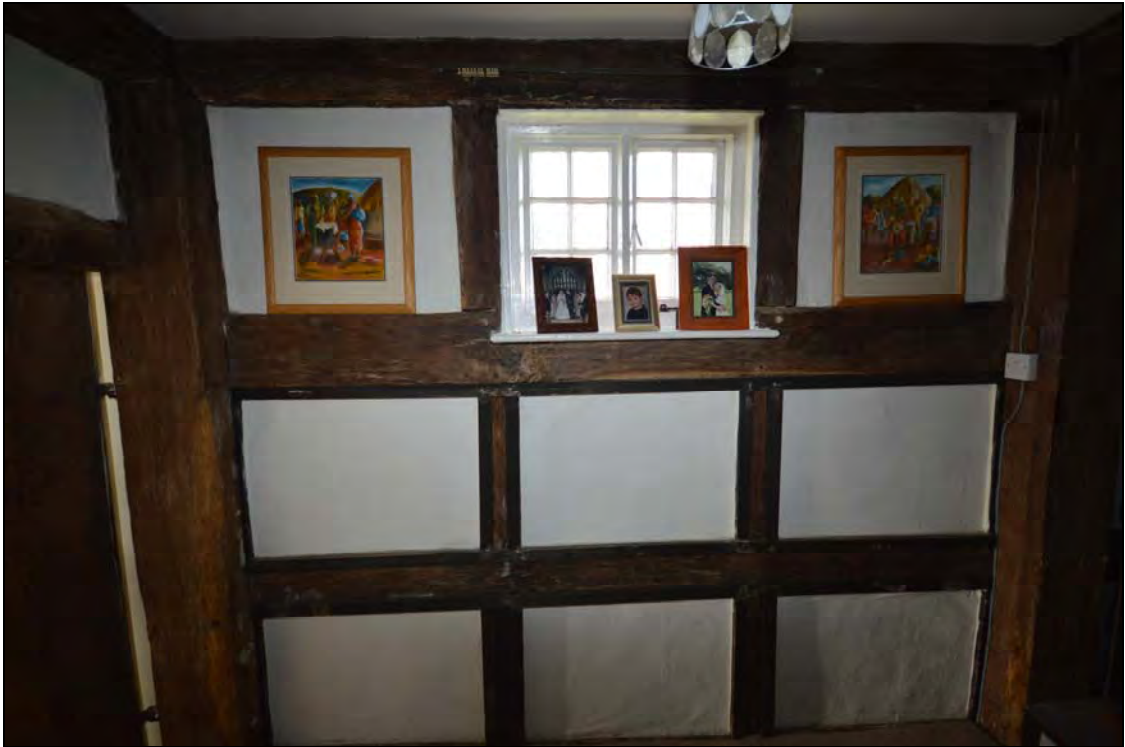
Plate 38: Metal strapping on the frame to the west side of bay 2, first floor

- 6.3.5 Metal strapping had been added to the frame at first floor level within bay 2, west side (Plate 38)
