**Penland Farm, Hanlye Lane,  
Haywards Heath**

**Arboricultural Implications Assessment and  
Method Statement**

**Revision A**

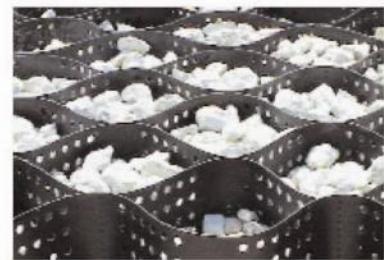
**CellWeb Tree Root Protection System provides a flexible and permeable solution for protecting tree roots while creating a strong stable surface for traffic.**
