## HERITAGE IMPACT ASSESSMENT

**Property Address:** Marshalls Manor, High Street, Cuckfield, Haywards Heath, RH17 5EL

**Report Date:** **Original:** 6<sup>th</sup> October 2022  
**This Revision:** 16<sup>th</sup> September 2026

**Prepared by** Richard Pocock MSc MRICS

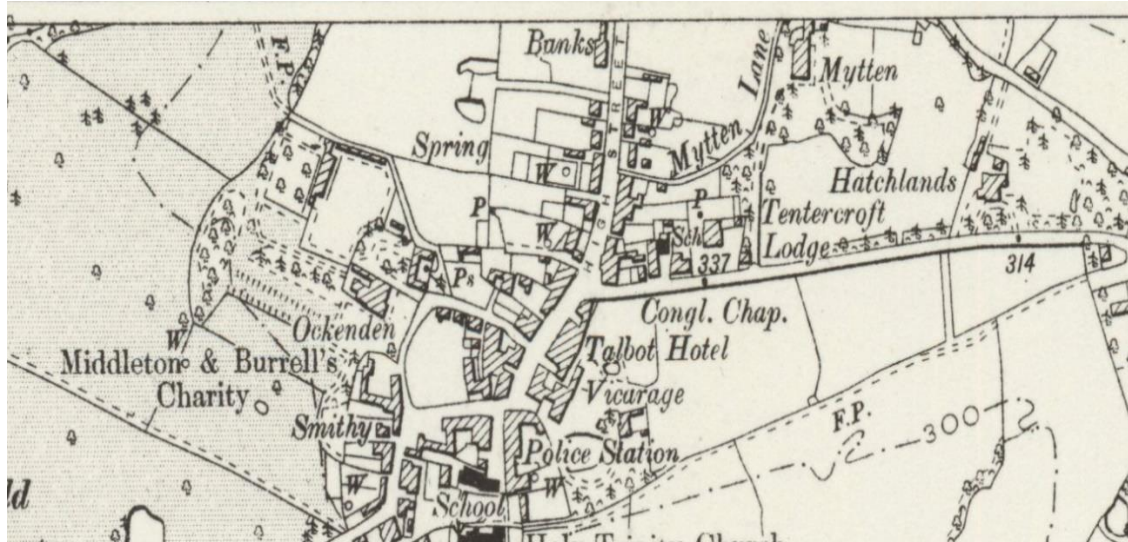
1896

By the later 19<sup>th</sup> century, little has evidently changed. However, the well is clearly indicated.

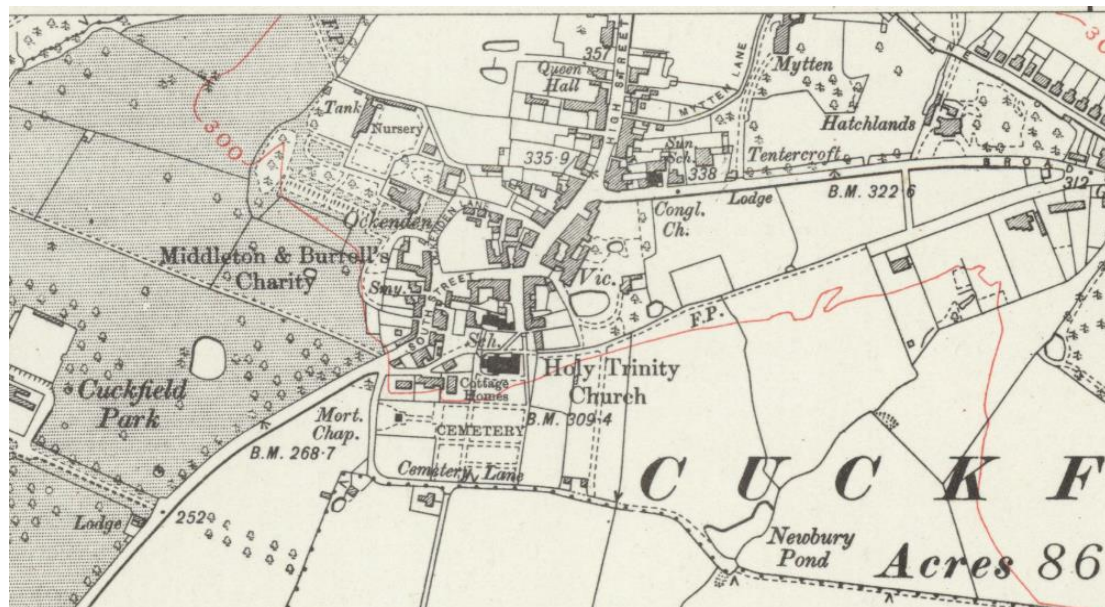
1909

By 1909, the well has gone – perhaps superseded by more modern plumbing installations.

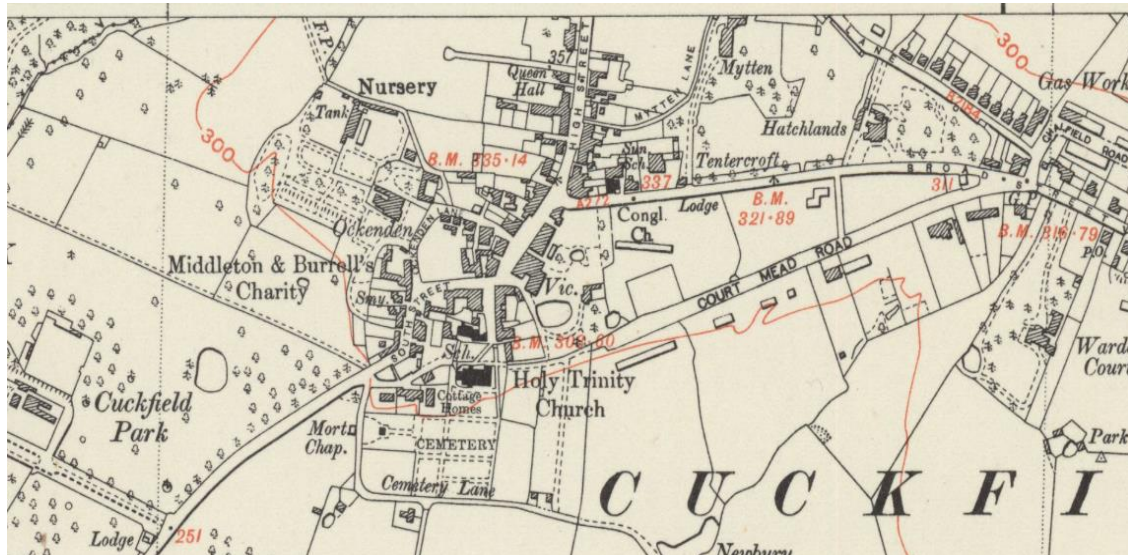
By 1938, there are still no additional outbuildings and the property is broadly unchanged on the maps. At this date, there is still no sign of the garage.

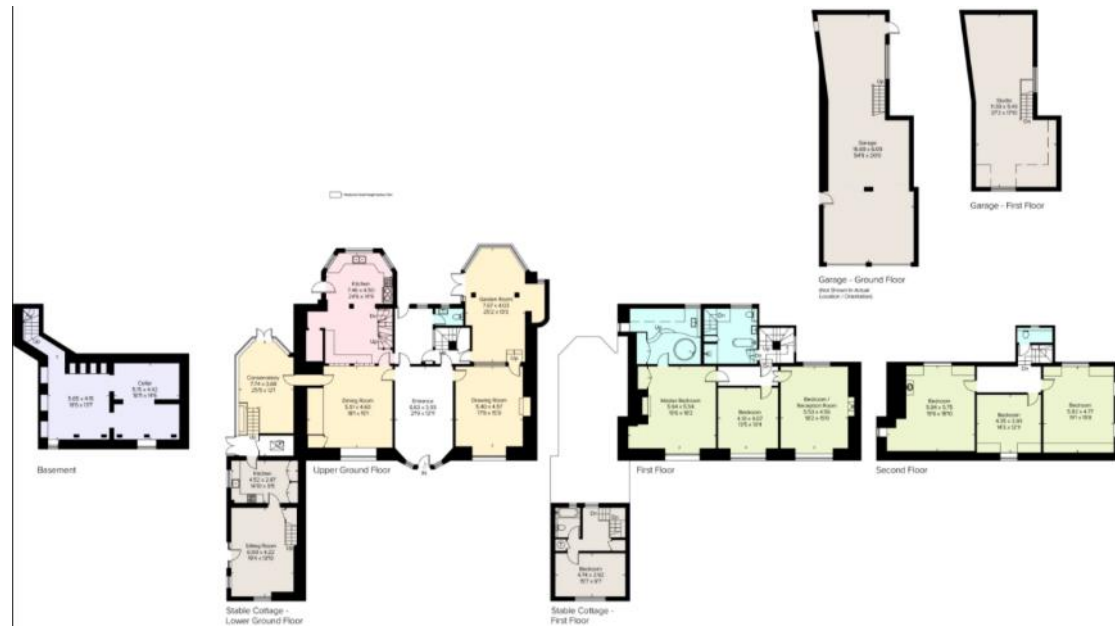
An internal floor plan has been attached for reference.

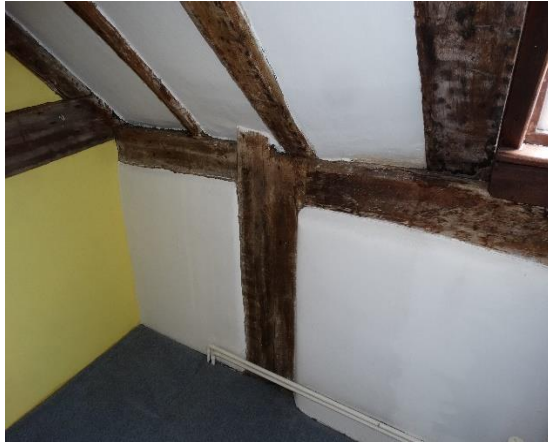
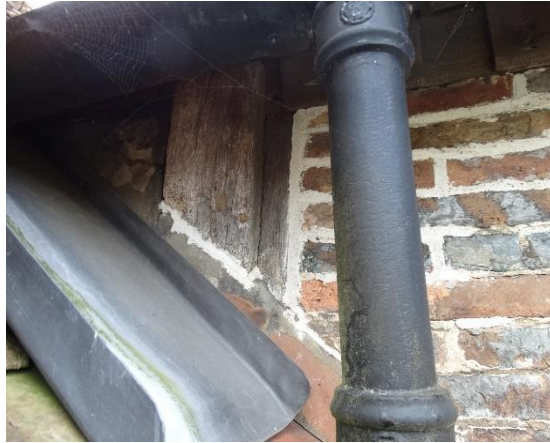
The bay post that intersects with the vyse framing extends above the wall plate and is pegged on its outer extent on all floors.

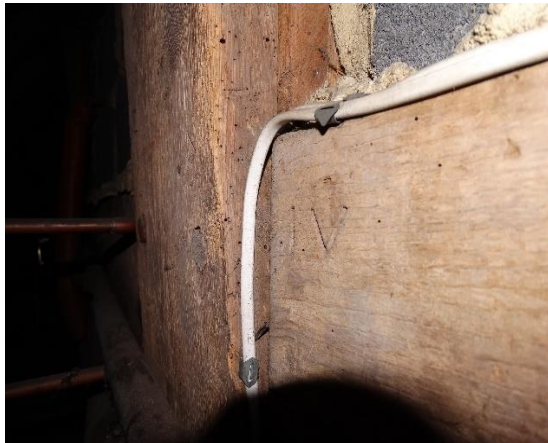
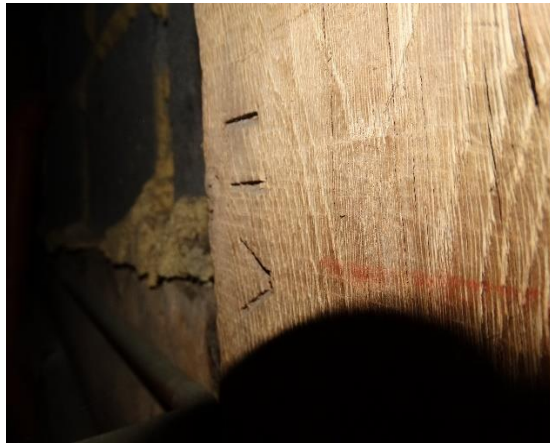
This and remaining bay posts are sequentially numbered with the lateral girding rails and show no later alteration, or previous use, brace positions, or terminations.

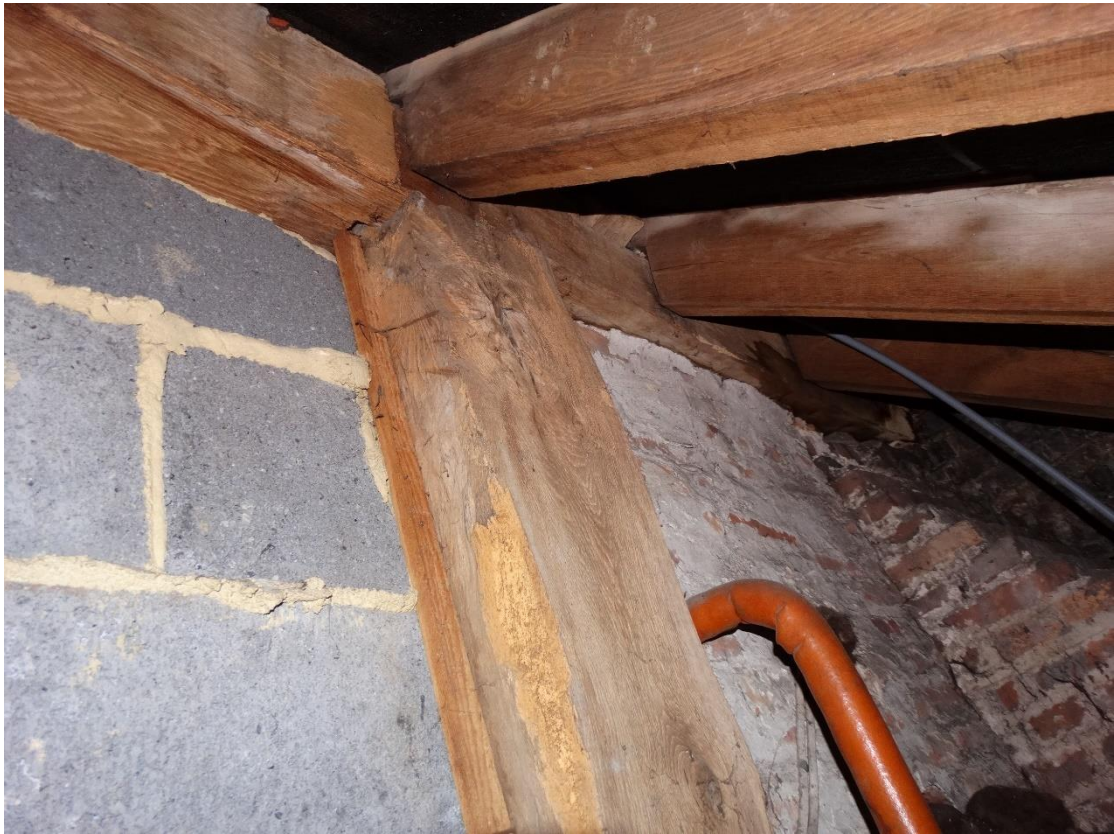
Whilst there has been a suggestion that the frame has been later wrapped around by the present stone and brick exterior walling to the front and flanks, the pegged wall plate detail to this rear wall oversails the end bay posts by an amount requisite for the masonry and shows no sign of later alteration.

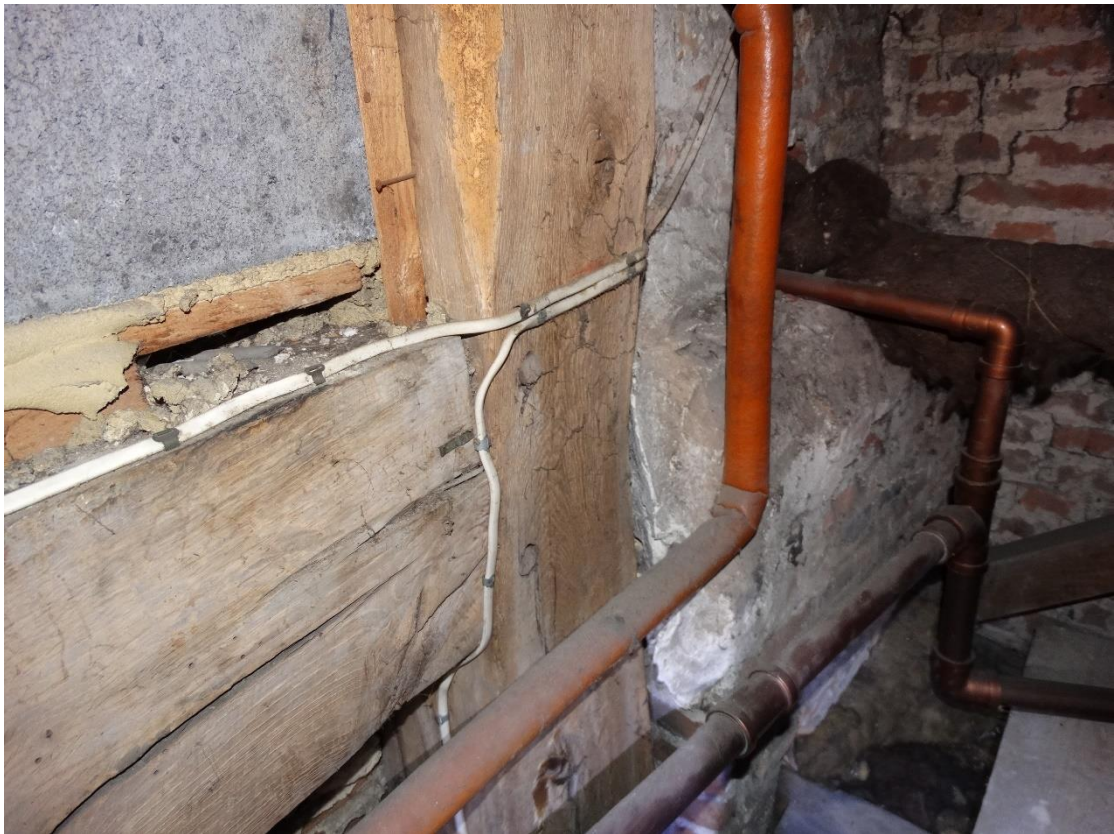
Indeed, the end bay posts are clear of any return, or onward sockets to indicate that the building terminated in any way other than the present masonry terminations at both rear corners.

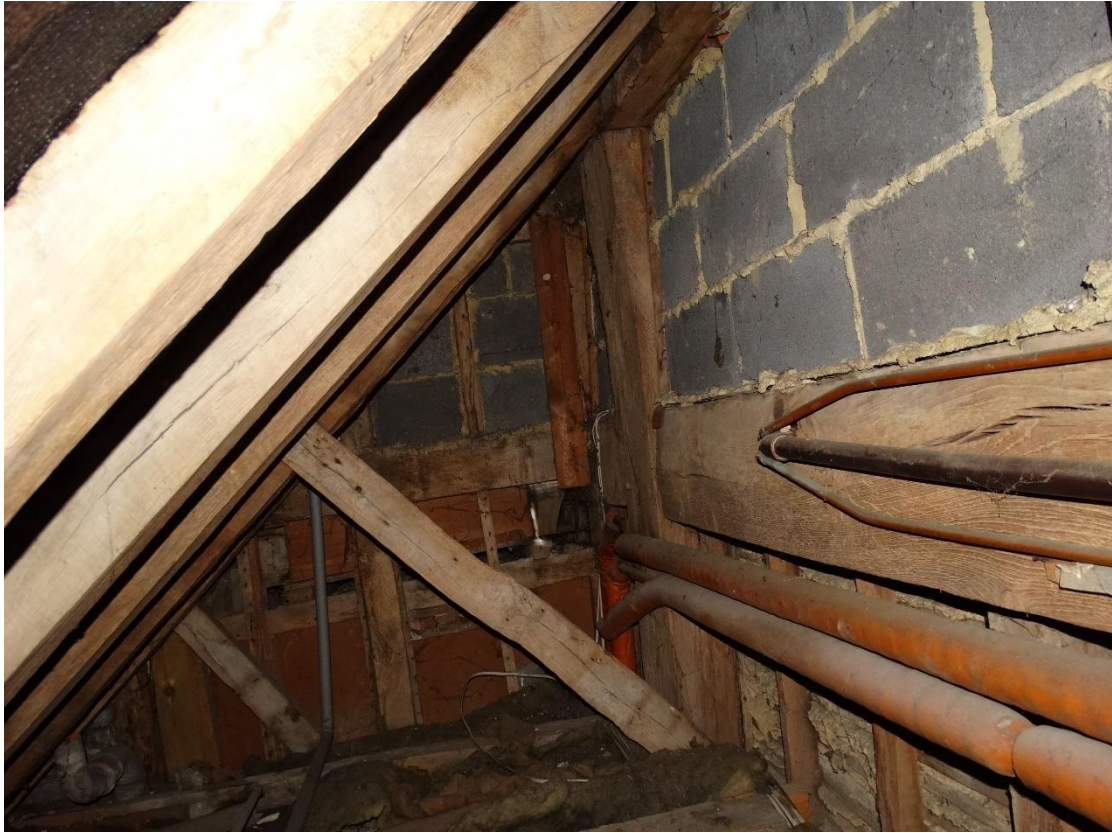
The stair vyse also has evidence of being built from the outset, with the extended main frame bay post being used as the primary support and the remainder of the south flank framework being fabricated from mortised intermediate studs visible within the outshot void.

Such construction methodology can only suggest that the vyse dates from the same construction phase as the rear wall.

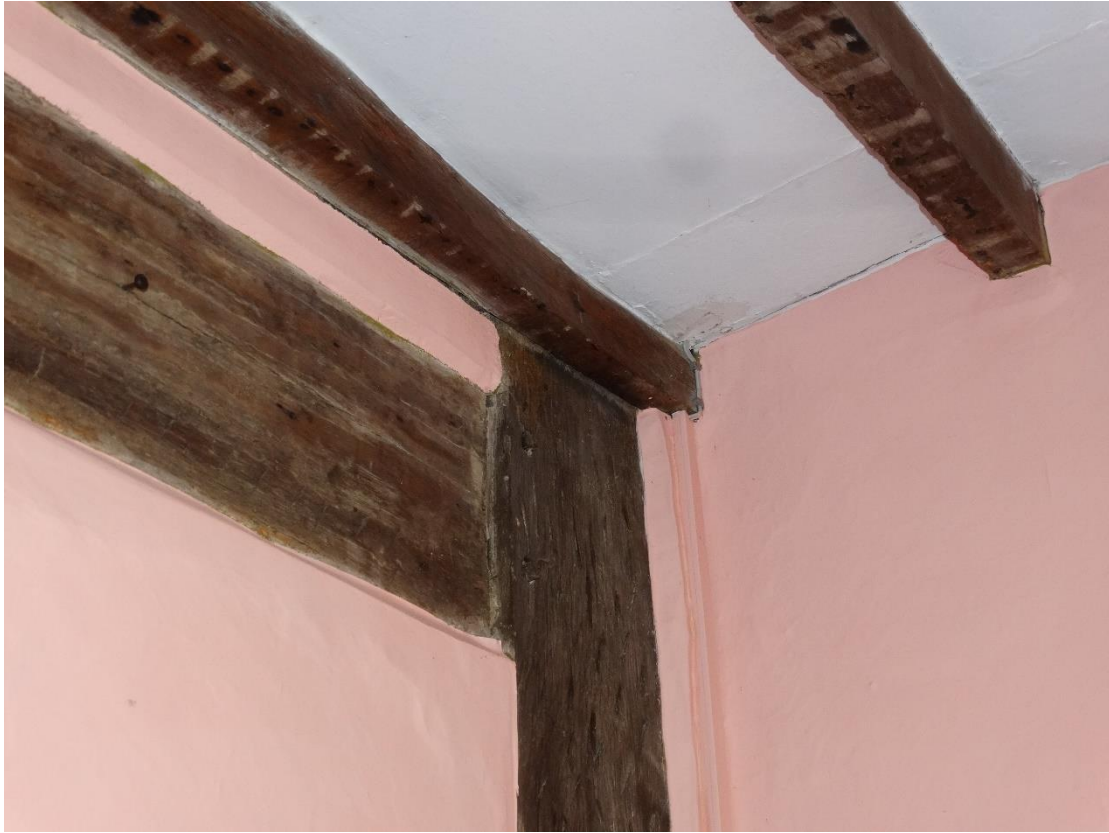
The floor design is of a spine beam and rib joists, devoid of decoration. What is interesting is that the floor, where visible, oversails the terminal bay posts, though there is no suggestion that the floor has had to be altered, or re-framed in the past, and the joists terminate into the masonry.

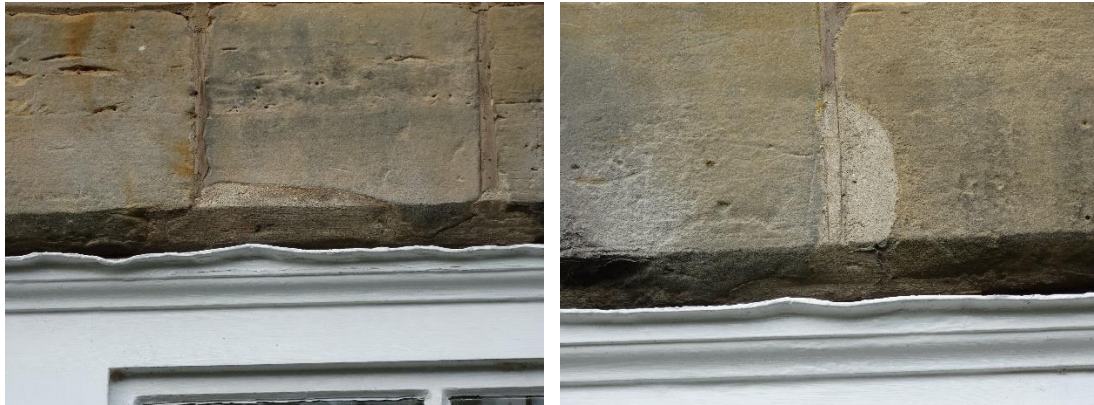
Evidence for earlier windows comes from close inspection of the ground floor window heads, where the stone above the sashes has been made good where the central mullion mouldings have been chipped out to allow for the insertion of the sashes.

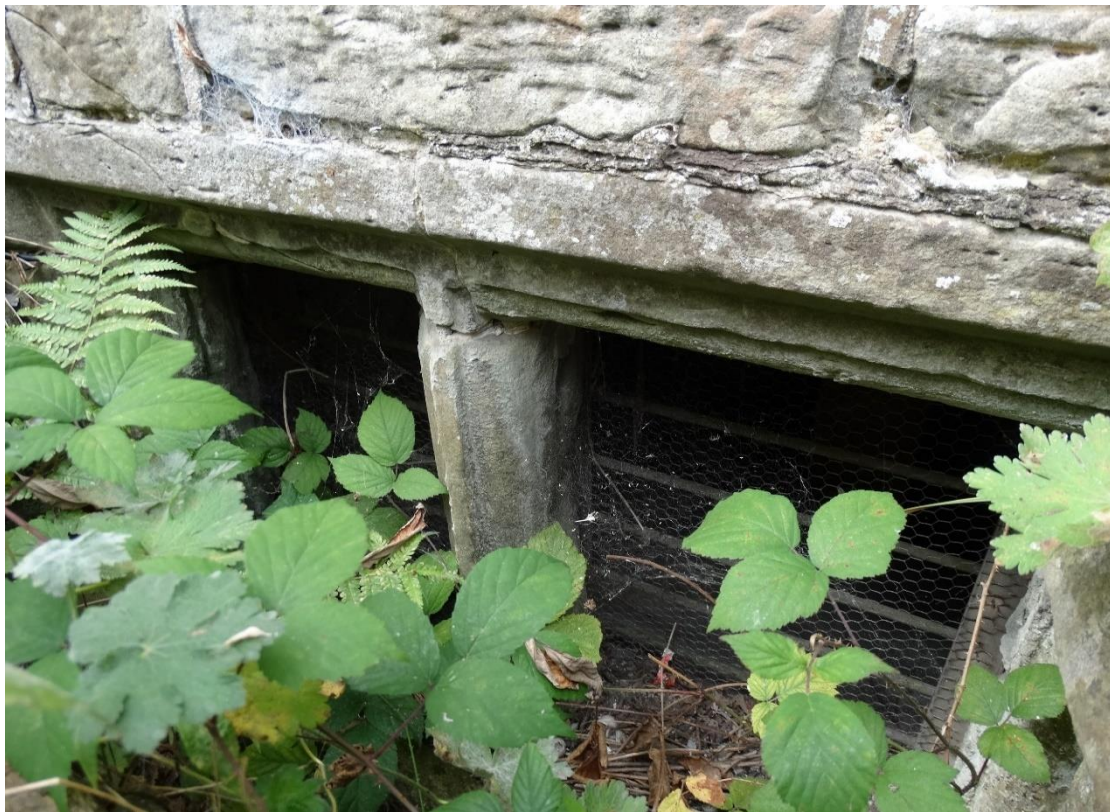
It is notable that the design of these earlier windows can be reasonably re-constructed. There are a number of contemporary small flank windows and also the two cellar windows that remain in situ.

These are original and it is notable that the design mirrors the two striking timber mullion windows that are still in place within the high end ground floor parlour and its corresponding bedroom above.

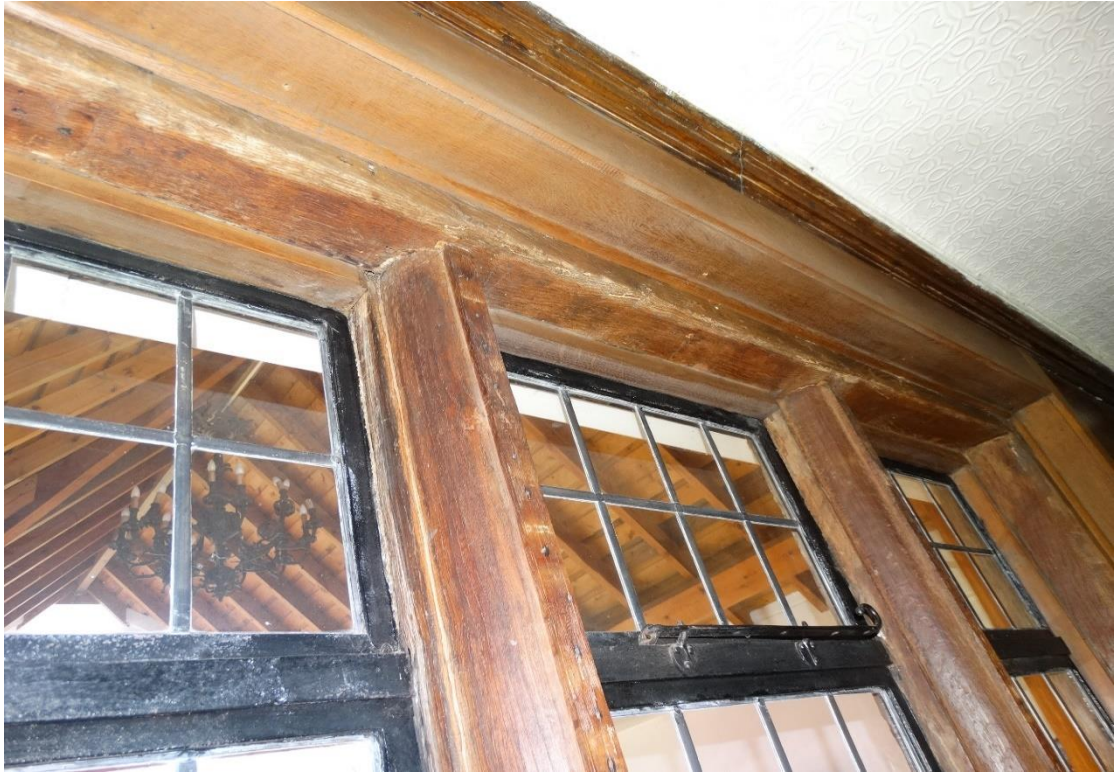
Again, these timber windows are not later insertions – their studs and framing elements being contemporary with the construction of the rear frame itself.

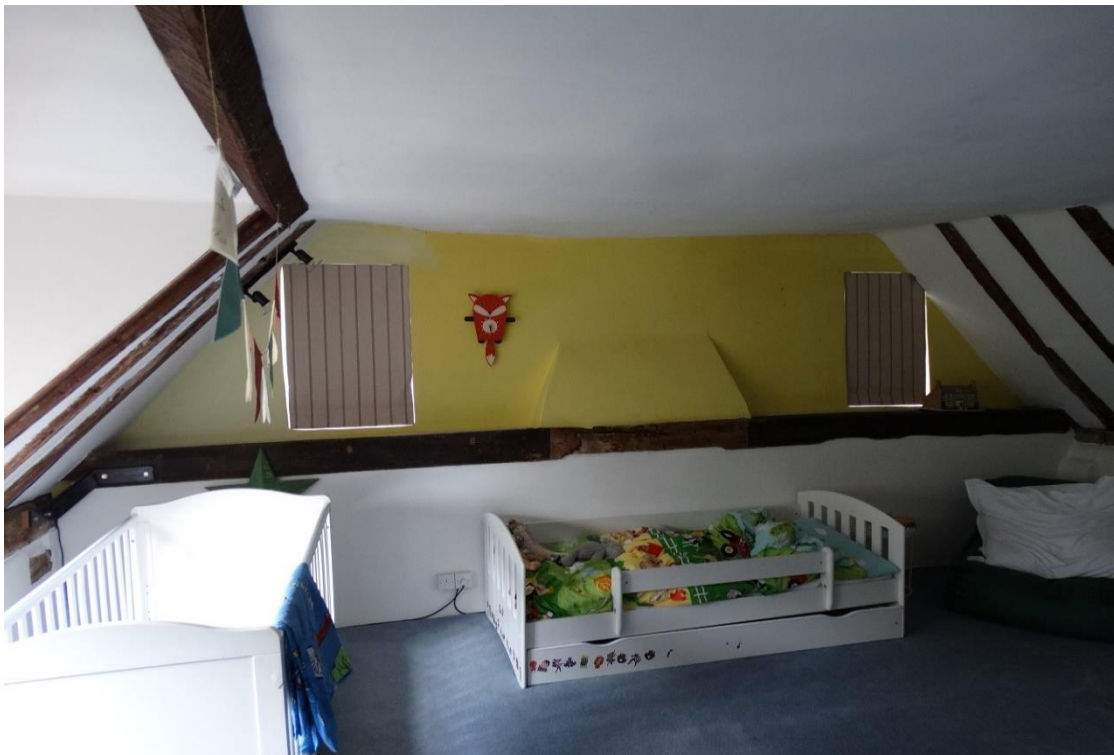
The roof structure of the building utilises some older timber. Indeed, these elements and also one lateral overmantel tie on the south end first floor are the only timber elements from an earlier building. However, none of the examples of re-use are in situ. The roof examples are the two far end lateral ties inside of the two flank walls within the garret rooms. Whilst the north end example is re-used, it remains indistinct as to previous use.

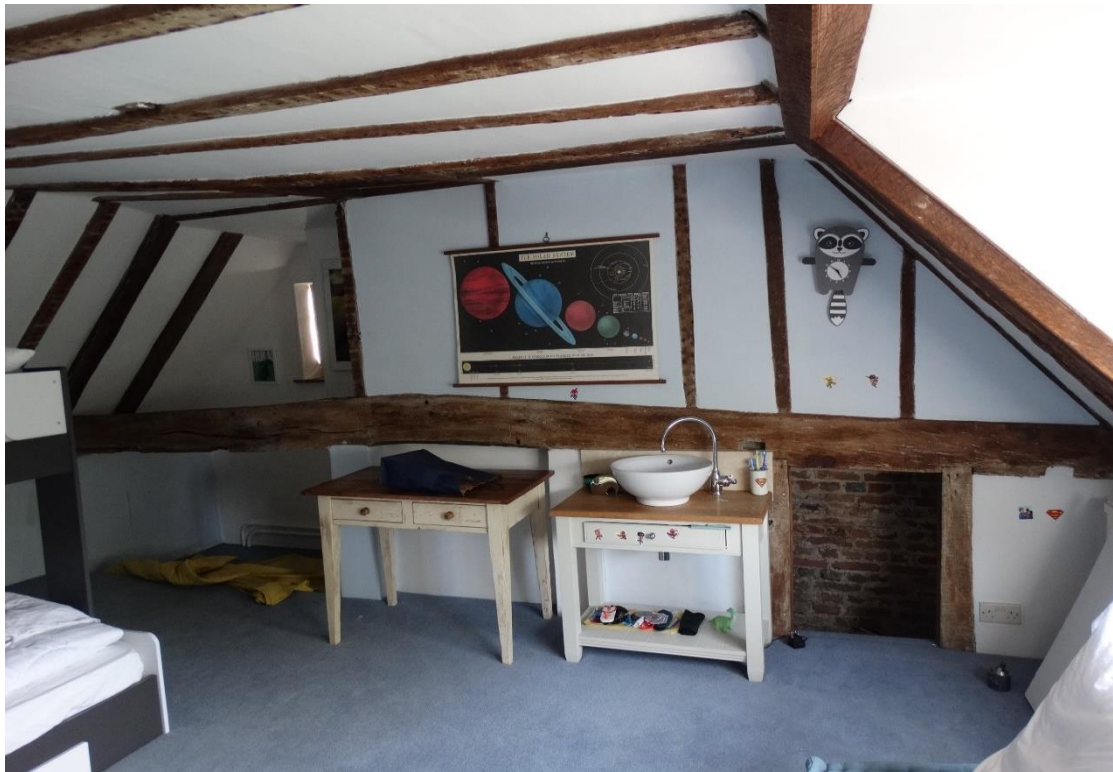
However, the south end example is quite clearly a canted tie beam from a residential house that once had a three strut queen strut roof frame.

The tie is the wrong way round. Its inner side faces the flank wall and not the house interior.

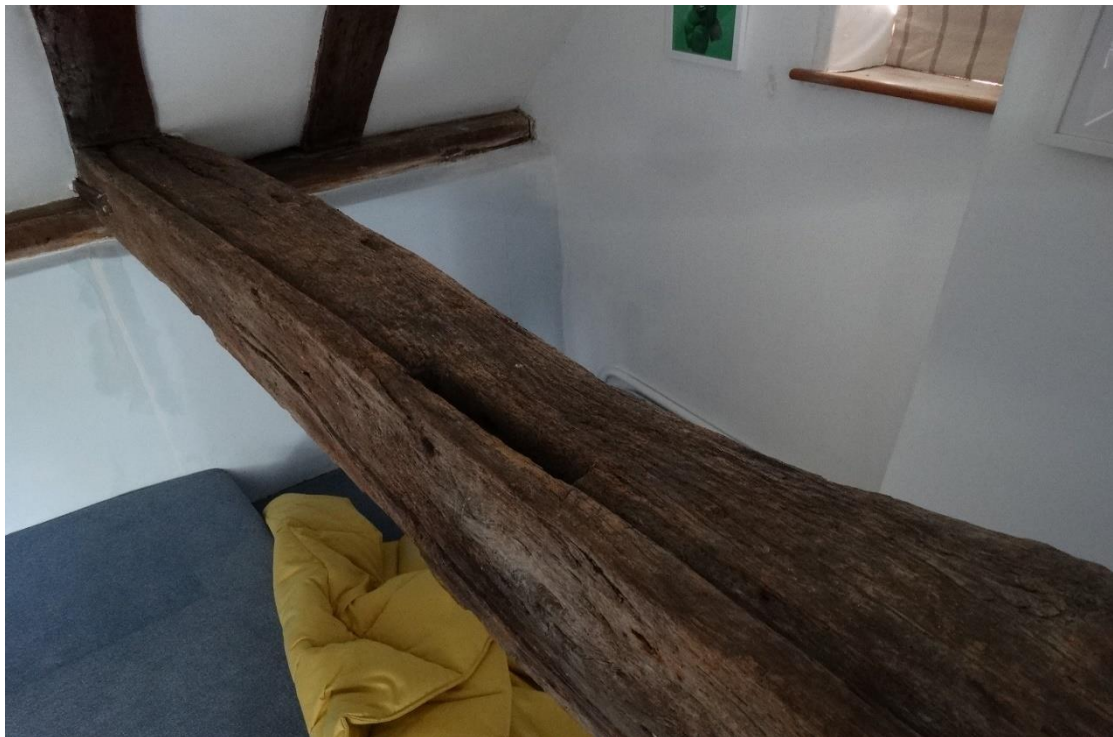
Its beam ends have been altered and shortened and the terminal mortising has been altered to accommodate the need to face mount the tie onto the wall plates front and back. It is merely a re-used tie and cannot be considered either as in situ, or representative of a previous build phase.

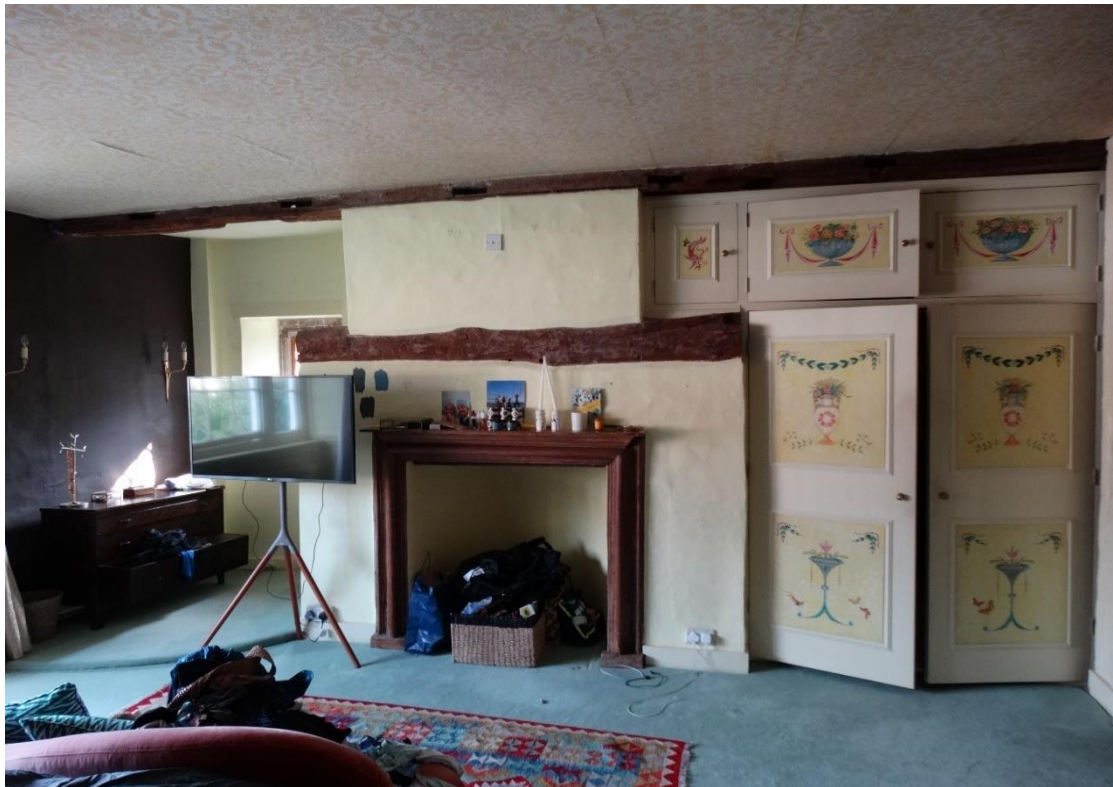
The overmantel tie example on the first floor (shown laterally close to the ceiling in the image below) is also from a residential house which could well have been the same date as the tie described in detail above.

It has indication of being from a residential context and has a rather well formed shutter rail carved into it, which once served an extended run of windows.

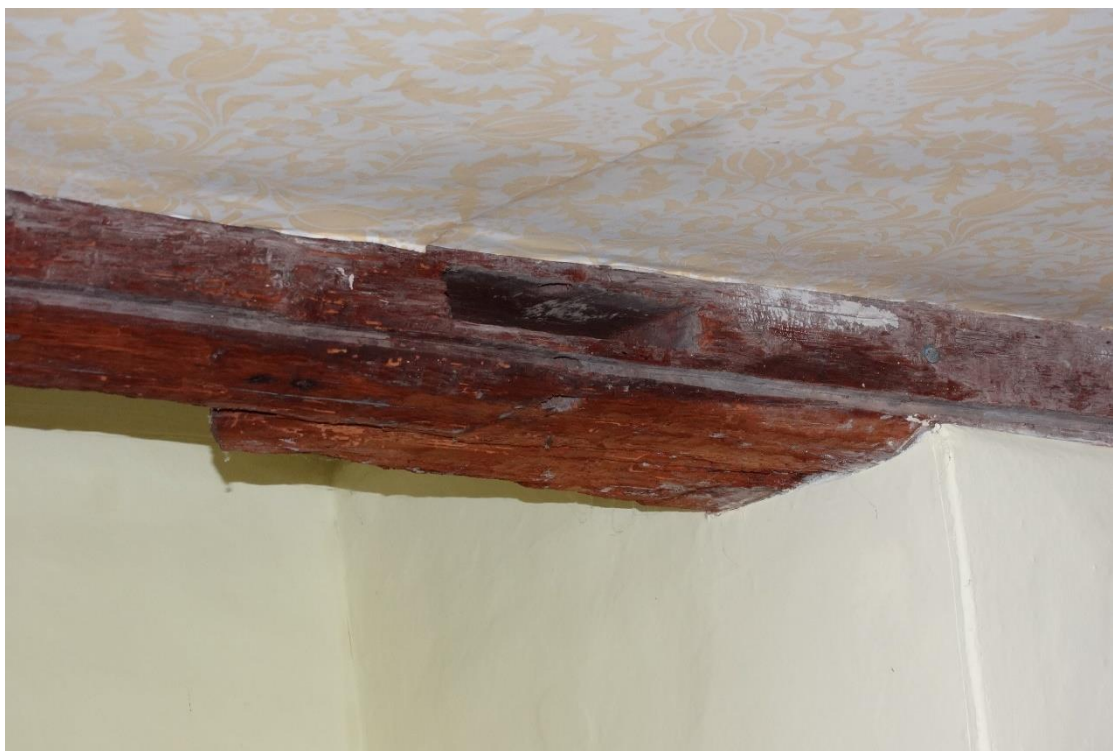
However, it has been turned on its side by a half turn and is, once more, not in situ.

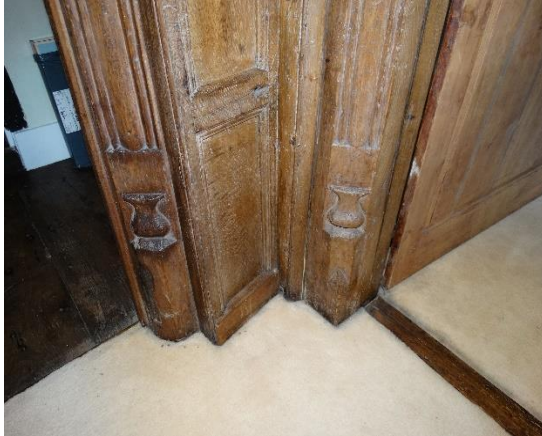
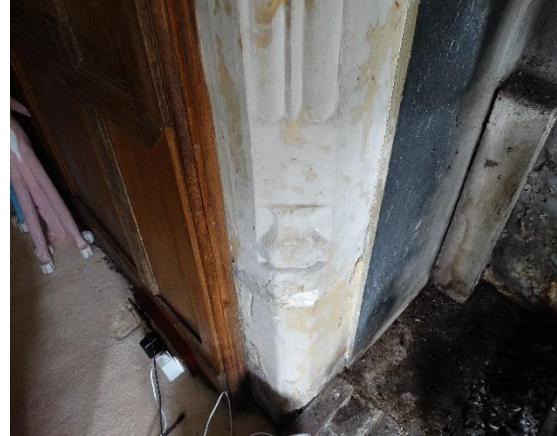
Decorative elements within the house are also to be considered consistent with an earlier 17<sup>th</sup> century date. Repeated around the house, are tulip head designs, both in the fireplaces and also the door cases/jambs.

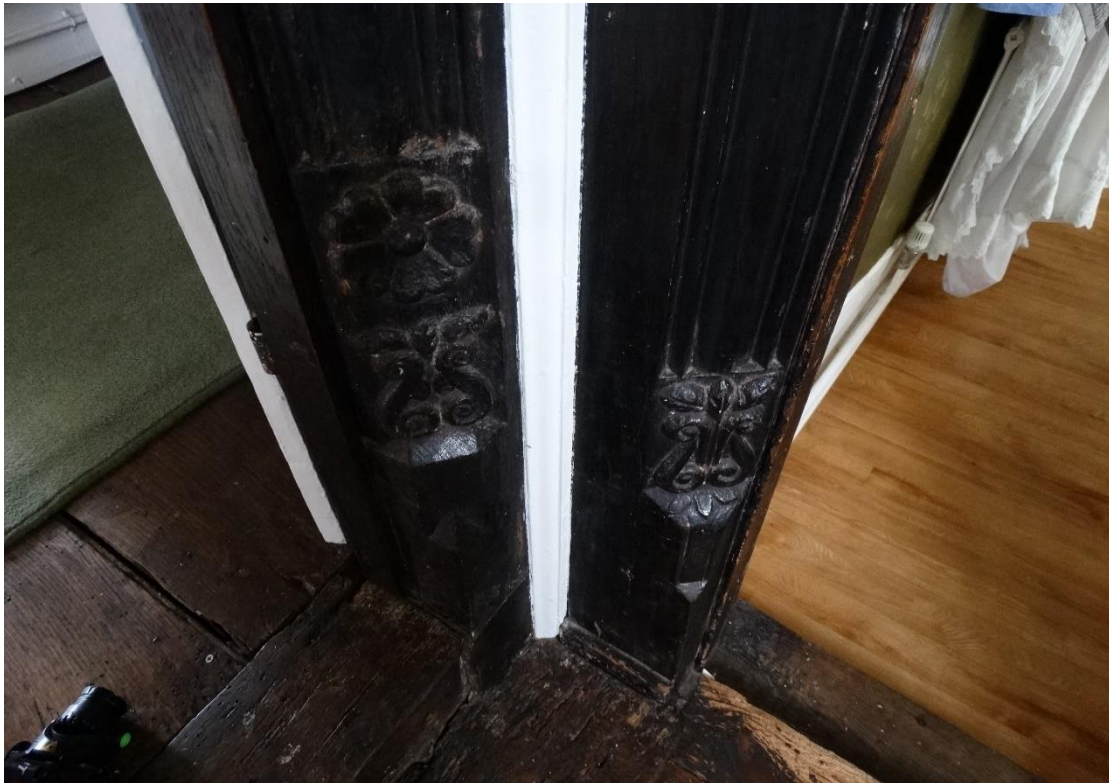
There is variation in design on the first floor to include other flower designs that have been classed as 'Tudor Rose' designs, as is mentioned in the listing narrative.

Whilst there is a passing similarity to a Tudor Rose design, the examples on the first floor of the house are not sufficiently close enough in design to suggest that these are of 16<sup>th</sup> century date and are more likely to represent a poppy flower than a rose. Poppies were common design features in both carvings and drapery from the early to mid 17<sup>th</sup> century onwards and what is seen within Marshall's Manor is certainly more representative of this decorative phasing than attempts to associate with Tudor Roses.

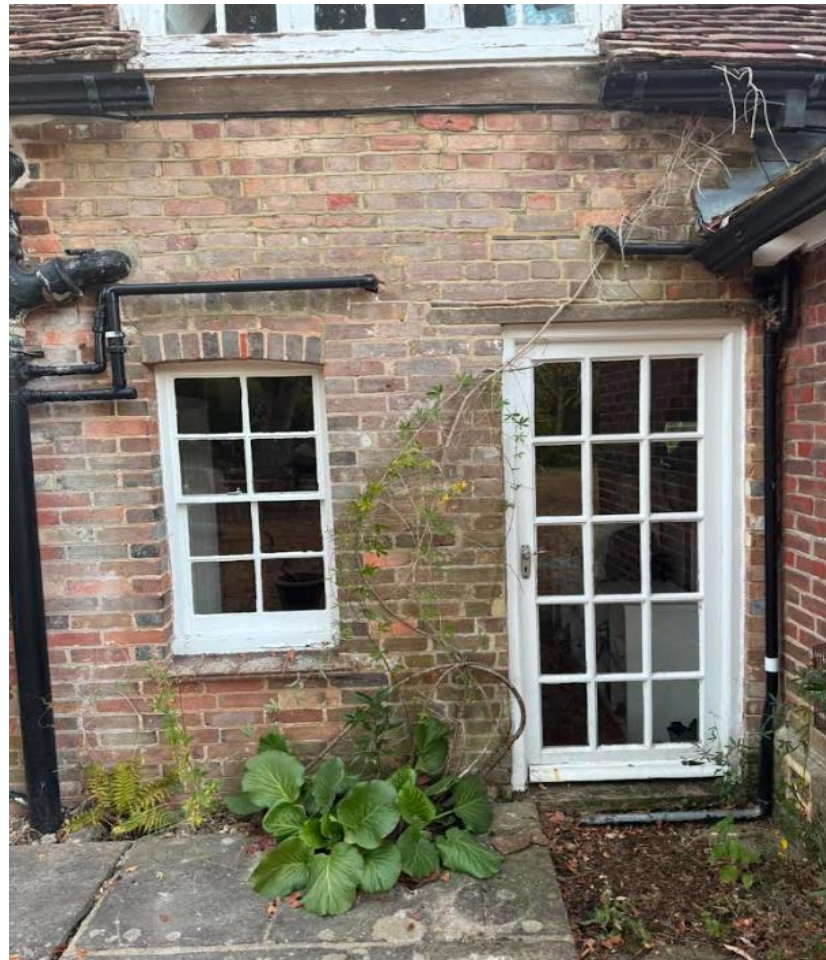
Item 1 involves opening the brick wall rear of the outshot element of the property. Inspection of this section of wall reveals this to be of demonstrably modern brickwork, heavily patched and of no notable heritage value.

The lintel above the main door opening in this area is an unsightly concrete plate lintel and not in keeping with the building as a whole.

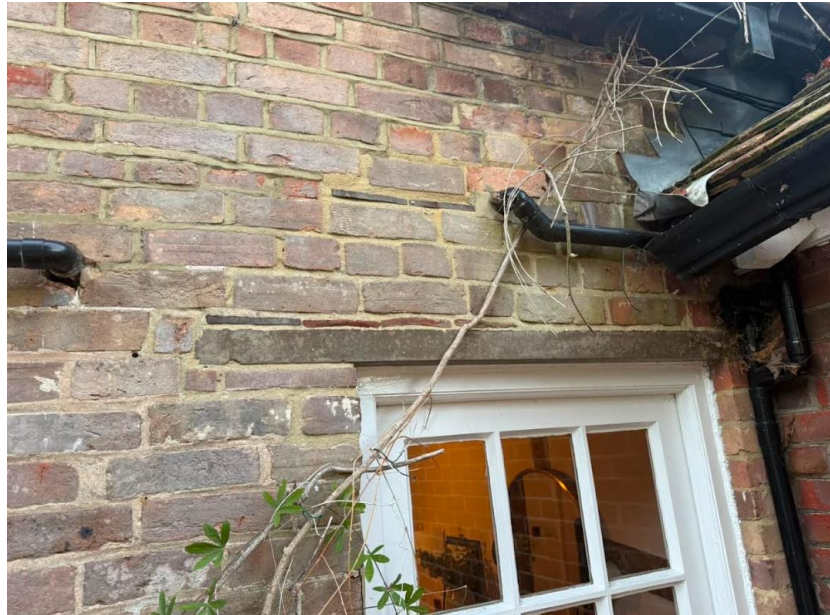
Masonry is of mixed brickwork, with a mixture of coursing ranging from attempts at English bond and then some garden wall type bonding where bricks have been infilled.

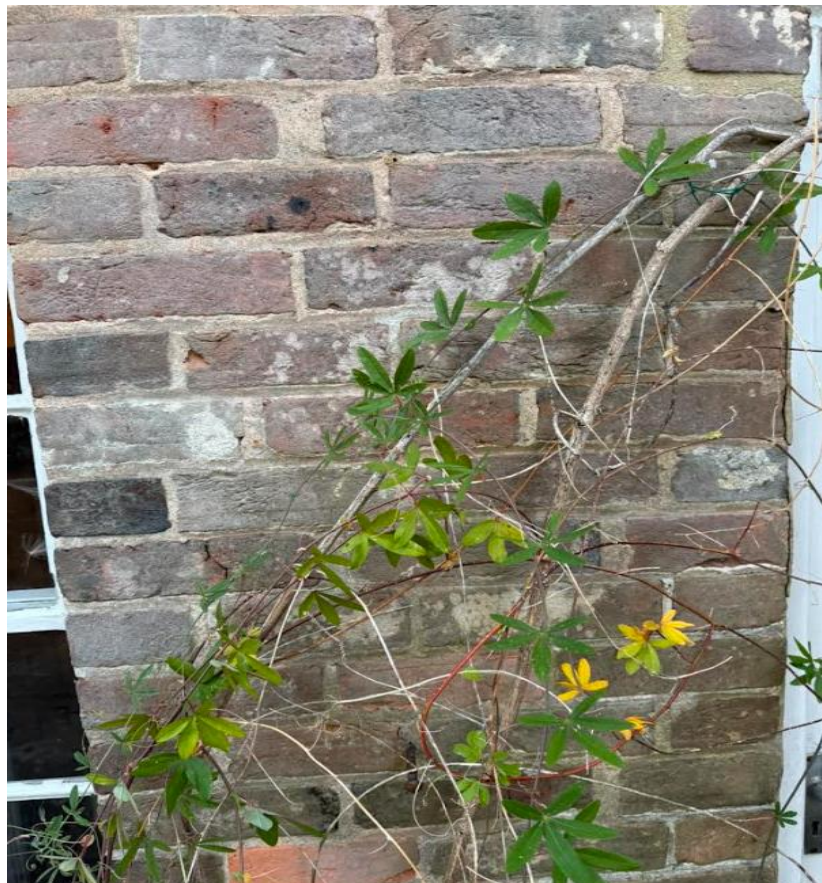
The wall is essentially a modern infill, of poor quality. It is of low significance when compared to the rest of the building.

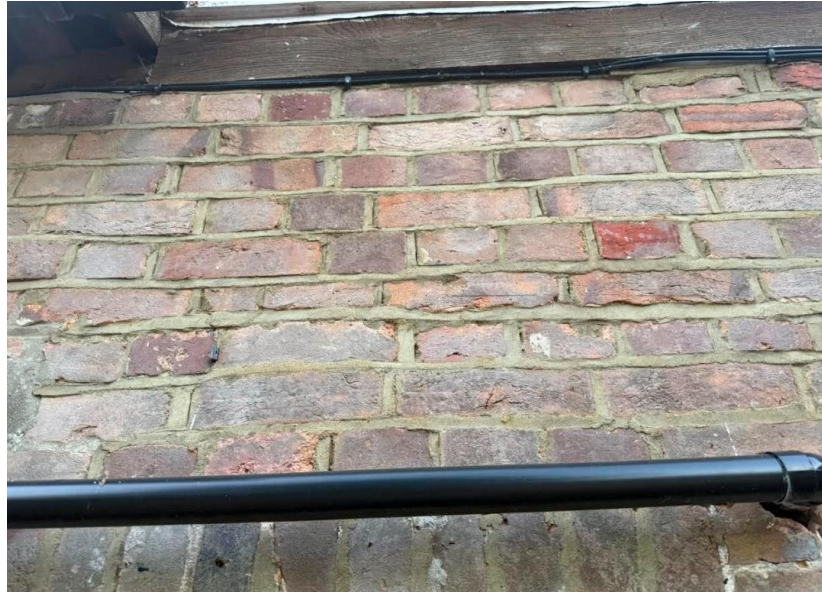
Pointing is mostly unacceptable later cementitious varieties.

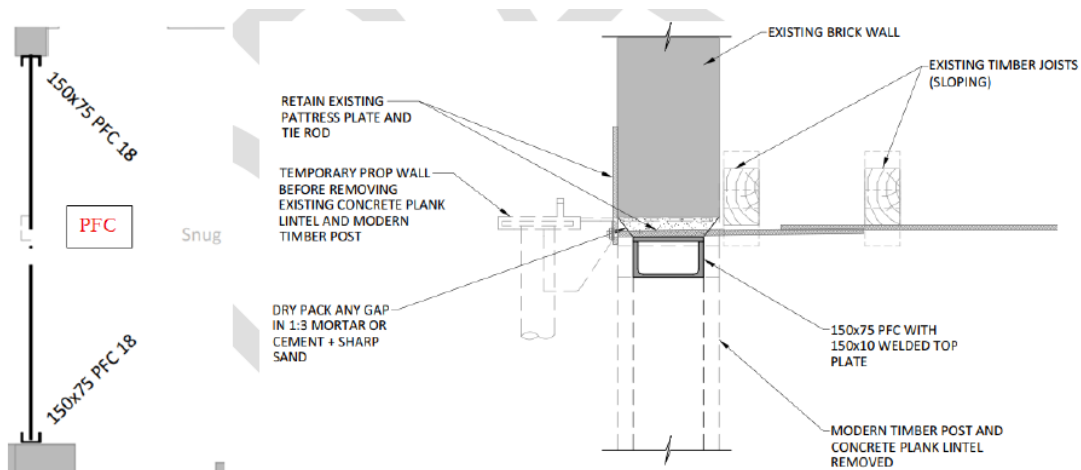
Figure 7 - Post removal structural details

Item 2 involves the removal of a single timber post likely installed in the 1980s/90s to support an opening within the existing wider kitchen area. The impact of the removal will open a question as to the provision of support to the opening if the post is indeed removed. The removal is not contentious. The method of support appears appropriate and we have no heritage related concerns. The structural detail is reproduced below:

Figure 8 - Kitchen post structural section

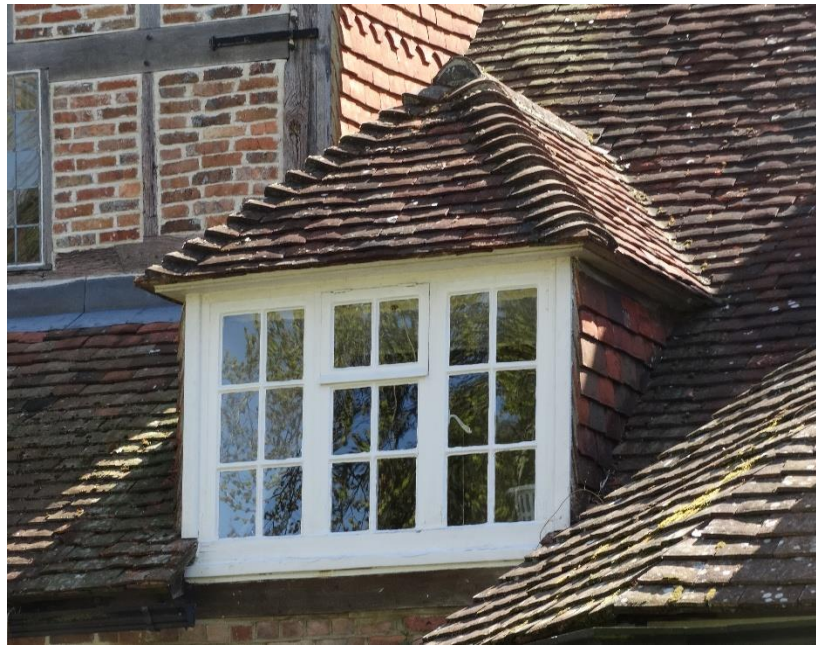
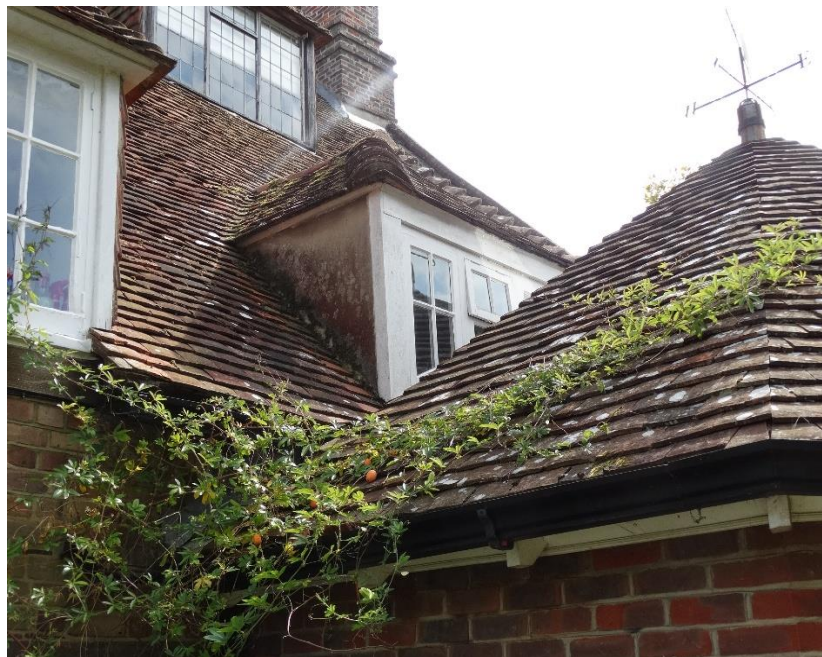
Items 3 & 4 refer to alterations to existing consents. The previous consent was to match the dormers. The new proposal is to replace the existing glazing to both dormers to better compliment glazing in other parts of the building. This will result in the loss of existing glazing to these parts. In terms of impact,

the windows are not matching and are both relatively modern in date

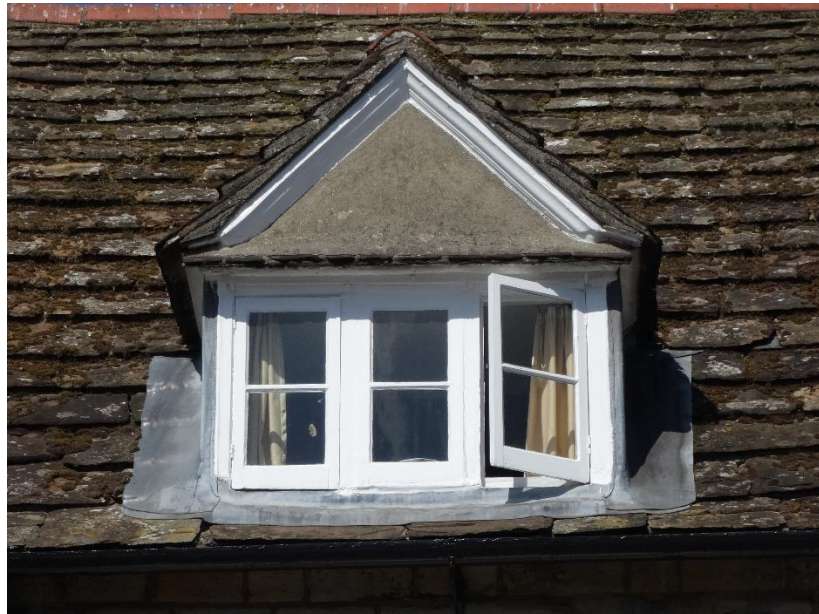
Neither of the windows are of particular heritage significance. They are proposed to match more closely the windows to the front dormer elements:

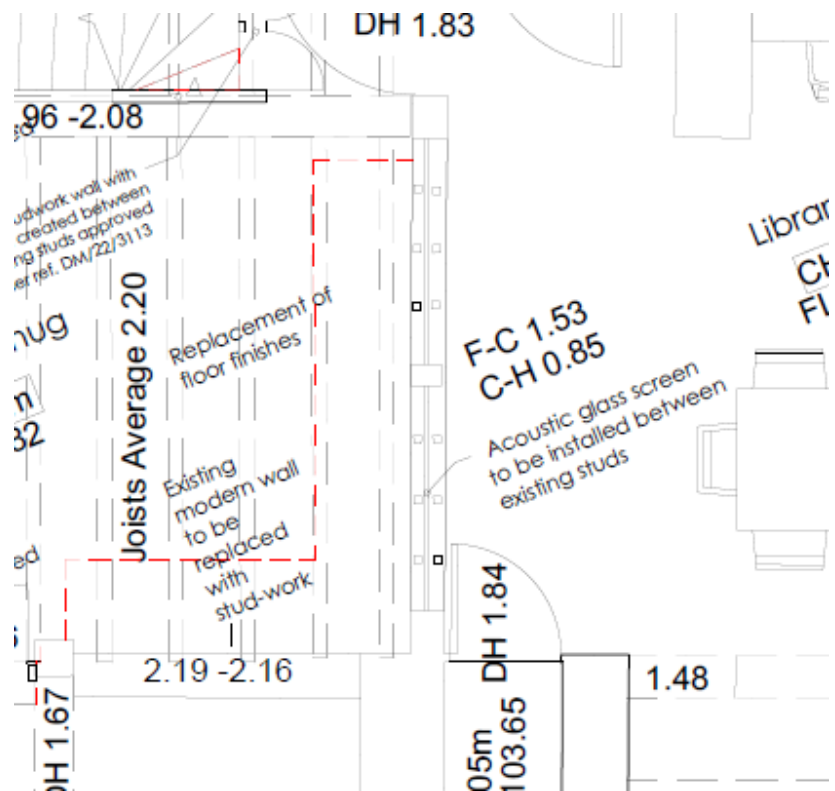
Item 5 refers to the application of glazing between the mullions of the kitchen/diner screen. We have included the area of the proposal below:

The proposal does not affect the fabric directly and the mullions remain unmolested with glass inserted between in sections. The exact means of holding the glazing in place is not definitively defined, but is likely to be a mastic fixing that would be easily removeable and would not affect materials to which it is applied.

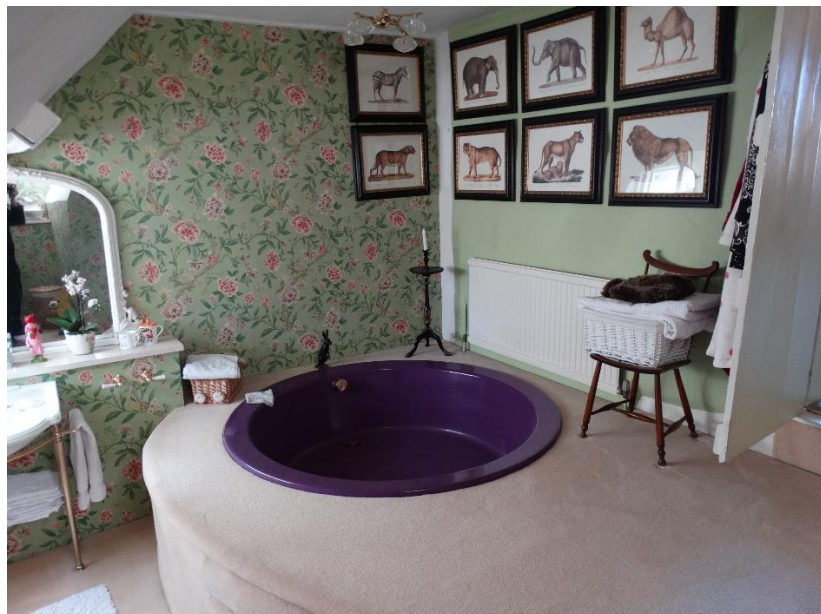
*Existing Bathroom*

**Impact:** These works are most certainly impactful, but there is, primarily, continuity of use for the area concerned and, therefore, there is no impediment to the prima facie continued function as a bathroom. There is no question of change of use. All of the fabric within the room that relates to bathroom usage is modern (late 20th century).
