## HERITAGE IMPACT ASSESSMENT

**Property Address:** Marshalls Manor, High Street, Cuckfield, Haywards Heath, RH17 5EL

**Report Date:** **Original:** 6<sup>th</sup> October 2022  
**This Revision:** 16<sup>th</sup> September 2026

**Prepared by** Richard Pocock MSc MRICS

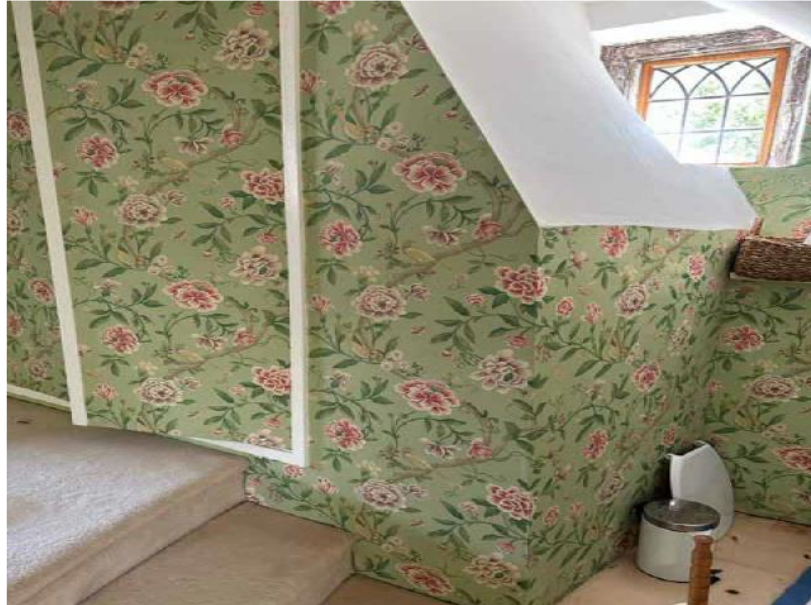
*Cupboard*

The cupboard adjacent to the window in the flank wall is simply timber framed and dates from around the same installation date

as the bathroom (so probably 1970s). Reducing the width to allow for a straight reveal to the window does have its advantages and shows the window far better. In any case, the removal of side wall of the cabinetry is not to be considered contentious in light of the fabric itself and there is no heritage value in the cabinetry fabric.

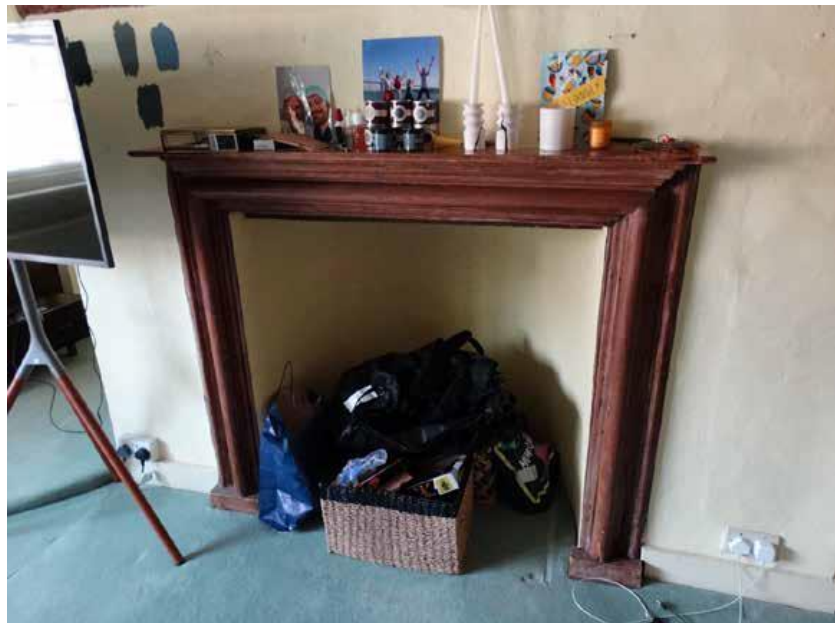
*Master Bedroom Fireplace*

**Impact:** The proposal to remove carpet and modern chipboard hearth infilling is not contentious. An assessment will need to be made of what substrate there is under the modern infilling. It seems doubtful that the original hearth remains under the chipboard infilling. However, it is entirely possible that some form of flush hearth remains and this should be ascertained before consenting to the proposed reinstatement.

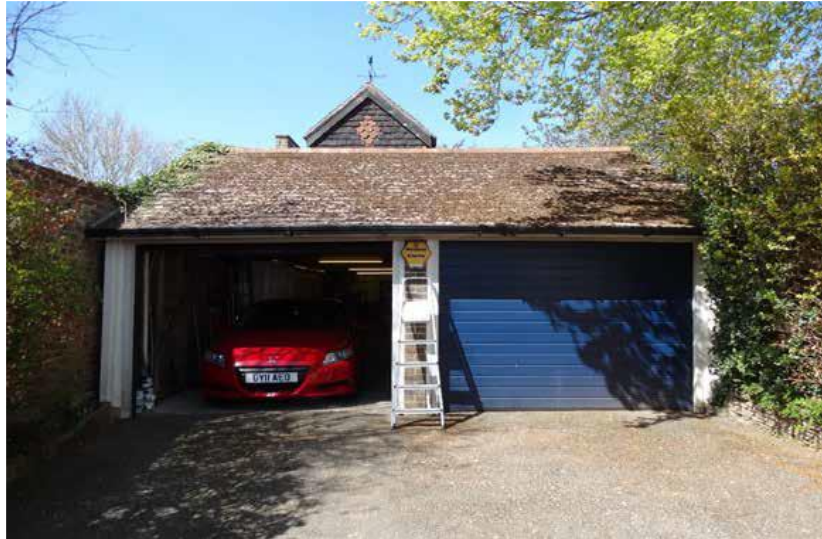
*The Garage Frontage*

**Impact:** The demolition of the garage frontage merely serves to set the deeply recessed garage structure further back from the current High Street driveway entrance. There is little specific impact either to surrounding views or buildings, or even to the overall structure of the outbuilding itself. Indeed, setting the garage frontage even further back into the curtilage of the property marginally reduces the overall visual impact of the outbuilding when viewed from any direction. The building to the south has a high brick wall directly adjacent to this garage structure with only the apex of the garage roof poking up above it. Its removal can be considered to be a good visual impact when taken in consideration of views of this masonry wall.

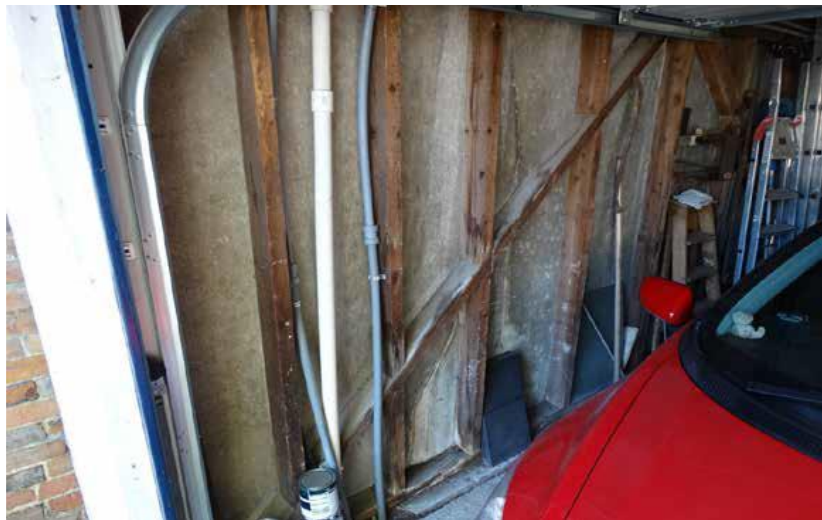
*The wall construction of the Garage Frontage*

**Compensation:** The demolition of this garage removes hazardous/controlled material from the site. A good majority of the wall cladding is of cement asbestos sheet. It is considered of benefit to remove this material.

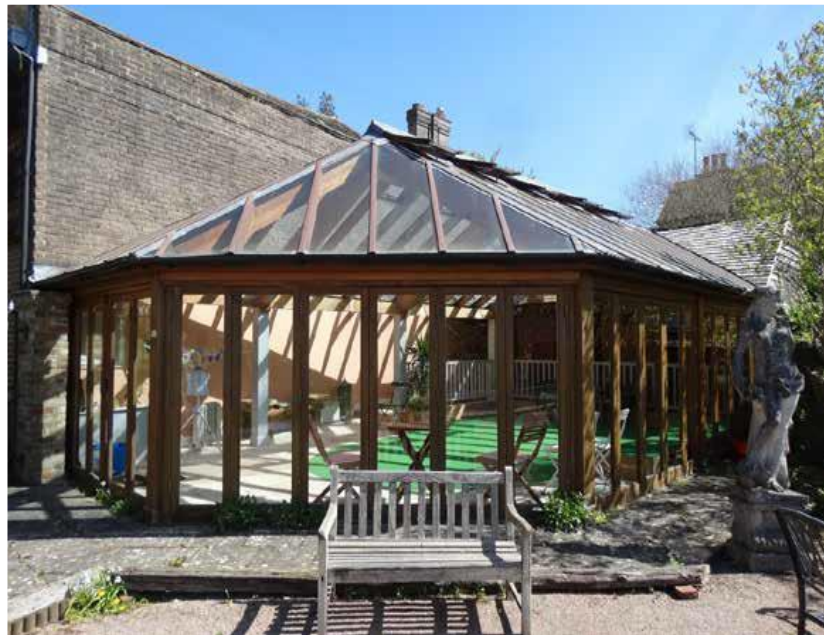
*The Pool House*

**Impact:** The existing pool house is situated in a position where it is effectively and wholly obscured on its north flank and also its east side. Views from the courtyard area in front of the structure show that from the west and south, there are no direct line of sight views from neighbouring houses, but some indirect possible views from neighbouring rooflight windows.

**Outcome:** The existing pool house is both redundant and in increasingly poor condition. It is very effectively screened by the rest of the outbuilding in terms of the main house and primary garden. Views from the south are minimal, with no significant line of sight matters and only indirect sightlines from rooflights worth taking into consideration. The lowering of the proposed roofline will again, reduce any perceived impact still further. The replacement building will tidy this area of the overall property effectively and will be in general keeping with the finishes of the remaining building to which it is attached.

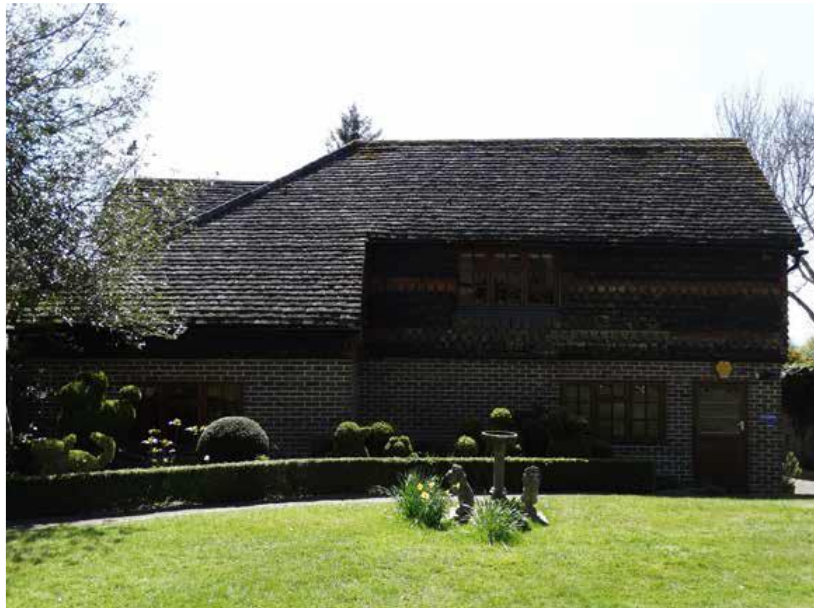
*Existing North Elevation*

**Impact:** The fenestration changes are to replace existing fenestration within this building to a different style, change the size of some units concerned and change the position/number of window units, especially in relation to the south elevation of the building.

Physical impact to the subject building is N/A. This is a modern outbuilding. Visual impact to the adjacent Listed asset is negligible. Reduction of the existing door and adjacent window, with their replacement fenestration units reduces visual impact from the house and from any neighbouring views and one of the ground floor windows is being removed entirely and blocked up.

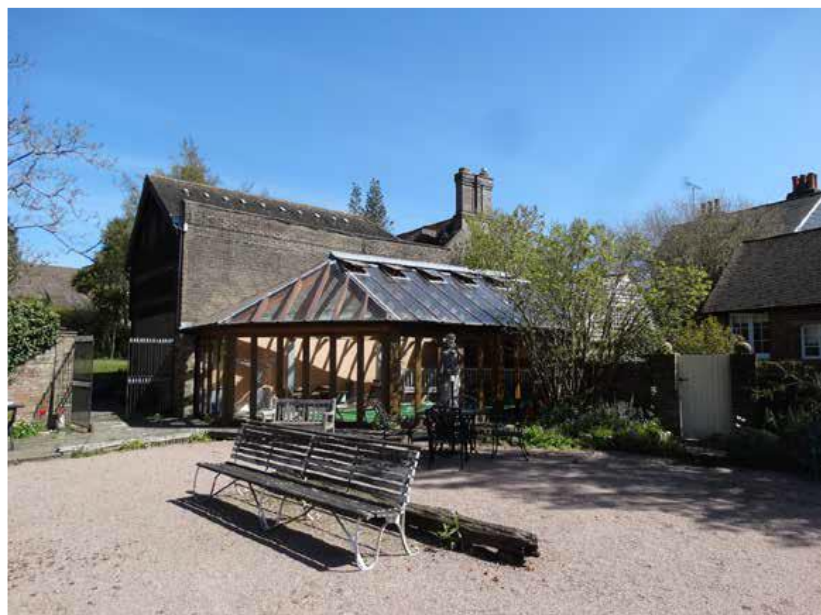
*Existing South Elevation*

To the south elevation, fenestration is increased both to the ground and first floor, but the net increase to the ground floor is negligible, as what is being replaced was a fully glass conservatory pool structure. The glazed surface area is, thereby, a net decrease in glazing.
