## HERITAGE IMPACT ASSESSMENT

**Property Address:** Lywood Barn, Lindfield Road, Ardingly,  
Haywards Heath, West Sussex, RH17 6SW

**Prepared by** Richard Pocock MSc MRICS

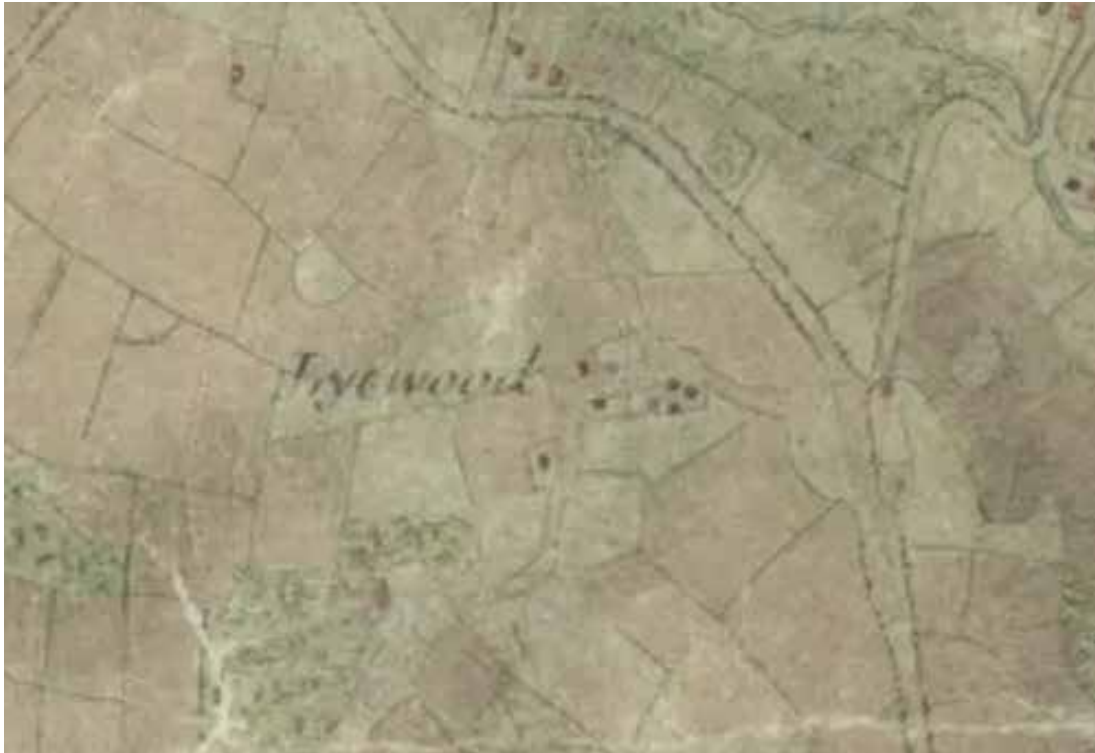
**1797**

The 1797 map is the earliest publicly available map identified that appears to show the farm and its buildings in context. There are other maps that are earlier, but these do not give rise to any contextual information about the farm buildings that will be of any additional use in respect of this report – their scale is just too large.

The map clearly shows a number of distinct features and is broadly a very accurate rendition of the area. The common land to the east (Lywood Common) is shown, along with the approach road to the farm (which changed little even to the present day).

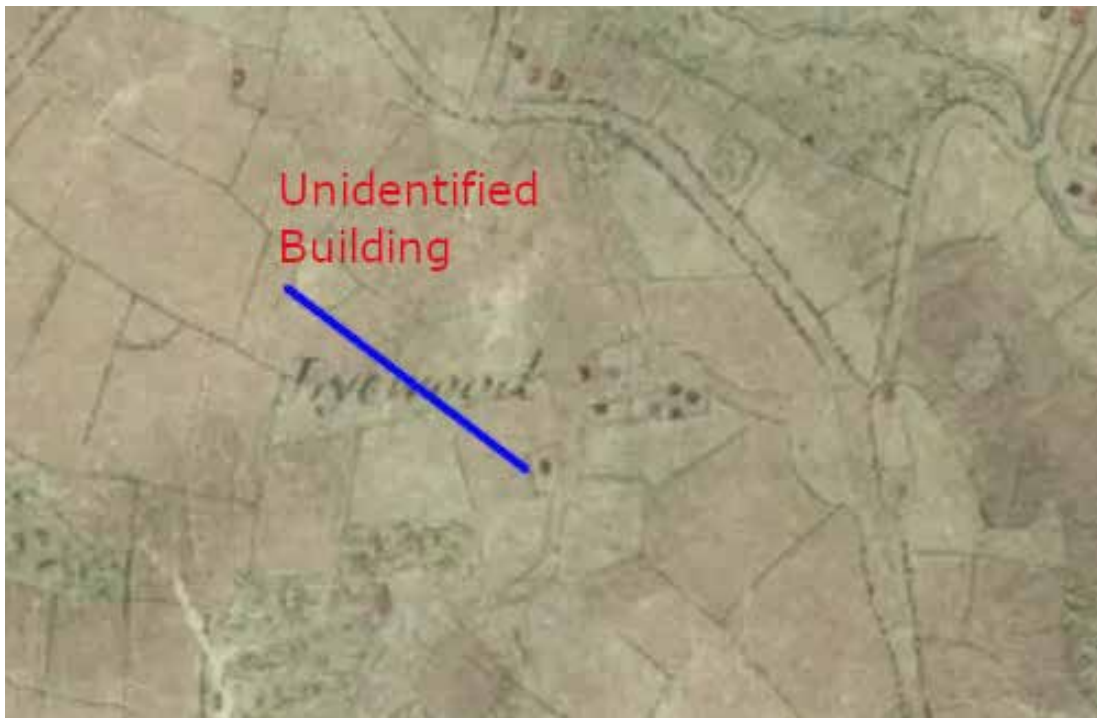
This is a building of unknown size and type (the buildings on this map are not given scale, or shape).

The building is likely of some size and importance as there is also an enclosure like a garden around it. This could be a barn but could just as easily be a farm cottage that is no longer in existence. What is clear, however, is that it rests far too far south of the main site to be the adjacent barn unless the cartographers were highly inaccurate for this one particular building. A further point of note is that this building is also depicted in exactly the same position in the slightly later map (below).

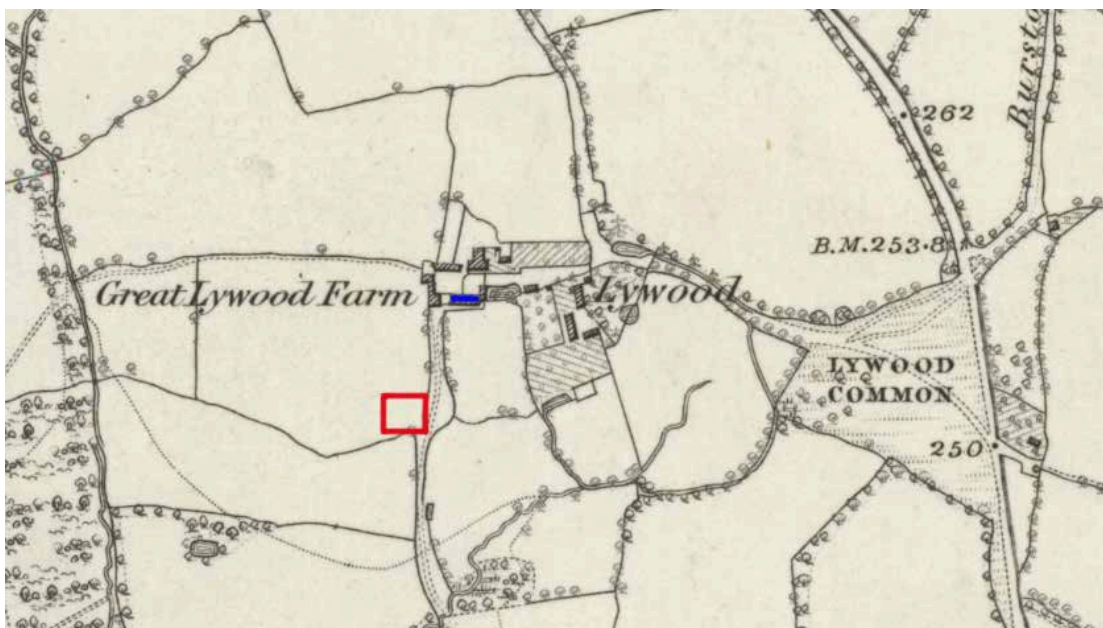
When direct comparisons are made to the very accurate 1874 map, the position of this building can be reasonably deduced by its position relative to other buildings on the earlier map and also to field and land boundaries common to the maps. The building would stand somewhere within the red box shown in the map below.

This is certainly not the position of the adjacent barn west of the subject barn (the subject barn being shown in blue).

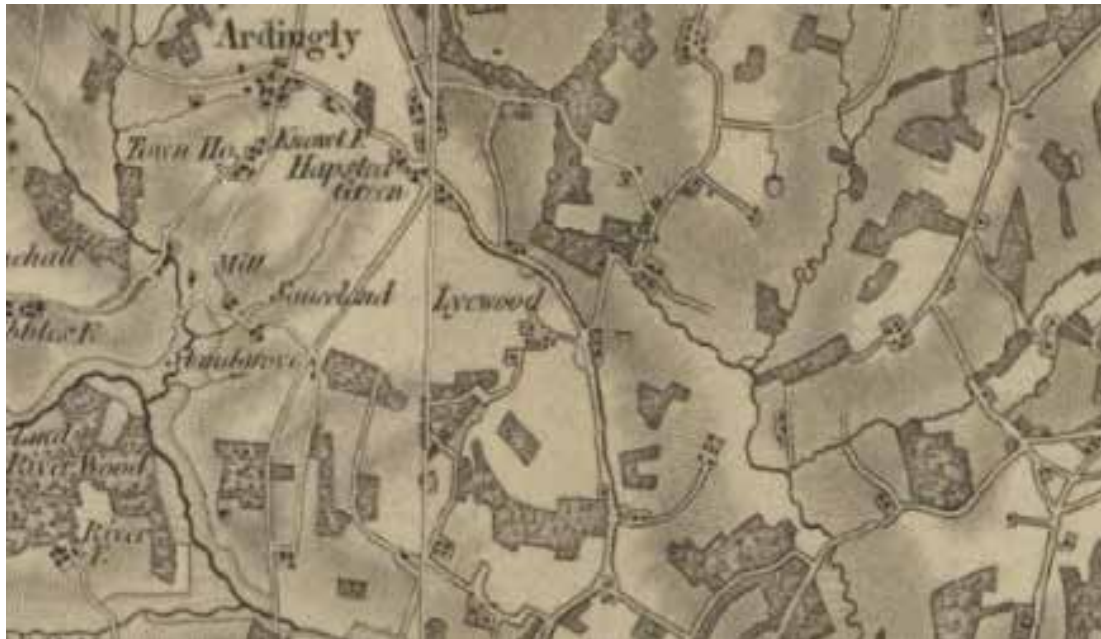
1805

This map is very similar to the 1797 version, though the scale is slightly larger. Nonetheless, the cluster of buildings making up Lywood House and also Great Lywood Farm are identifiable and compare well to the 1797 map and also to plotted positions on the 1874 map. Once more, however, the western barn adjacent to the subject barn is not depicted – only the unidentified southern building down the lane.

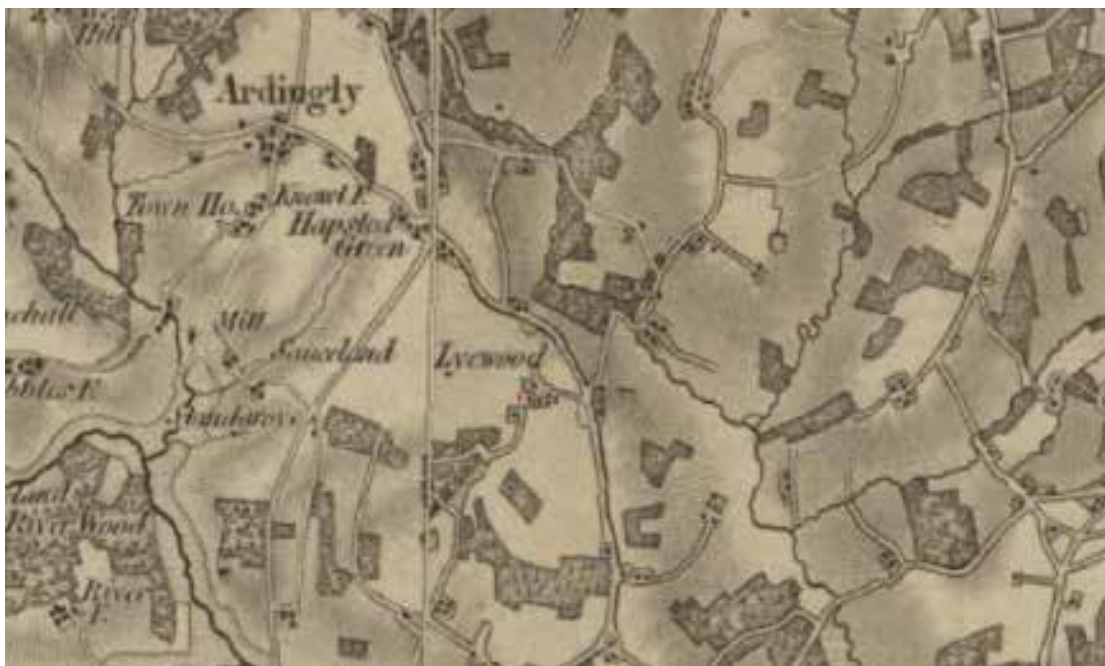
Again, the expected position of the adjacent barn is indicated on the annotation below by the red dot.

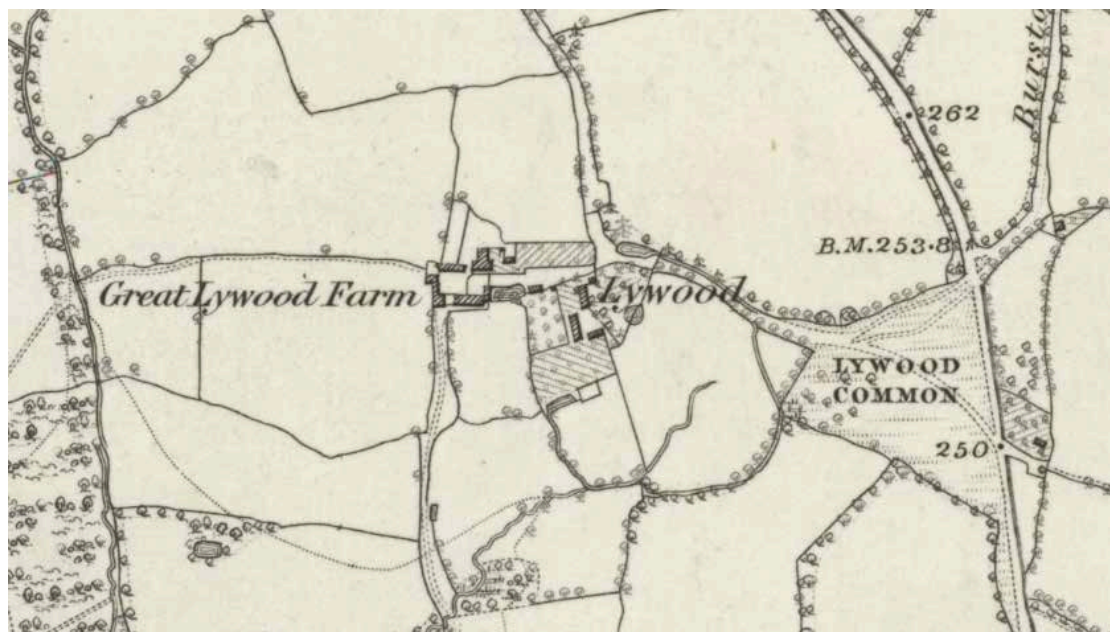
1874

This is the first of the highly accurate OS type maps available to view and depicts Great Lywood Farm and Lywood House, with the common land and also shows the southern field prior to the land that land being obliterated by the coming of the railways.

What is immediately evident is the west barn adjacent to the subject barn. Furthermore, the smaller unidentified outbuilding/cottage to the south is also no longer in existence and neither is its rather clearly depicted garden enclosure by this date.

A few other minor differences are the perpendicular outbuilding to the subject barn (which is today an inline building) and also Farm Pond which stood to the west of the subject barn, and which is only ever depicted in this map. It seems to become filled in and disappears by the 1896 map.

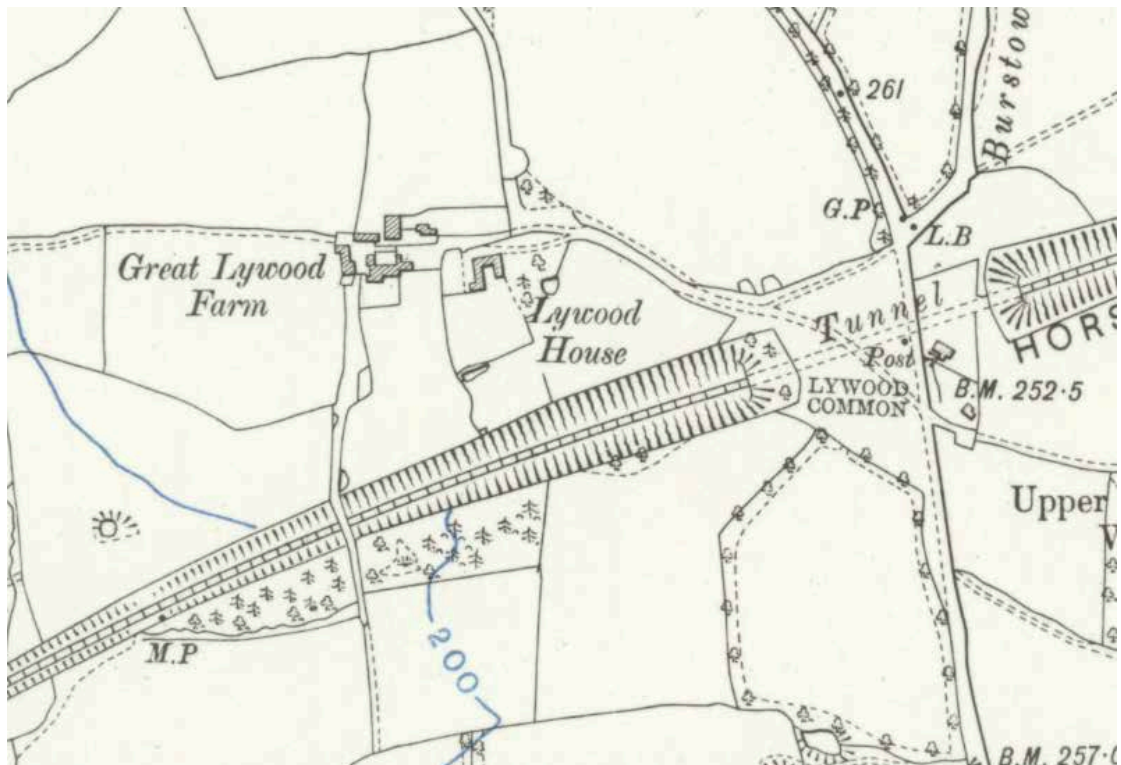
The 1909 map shows that the subject barn had northern outshot projections of some sort, though these do not survive.

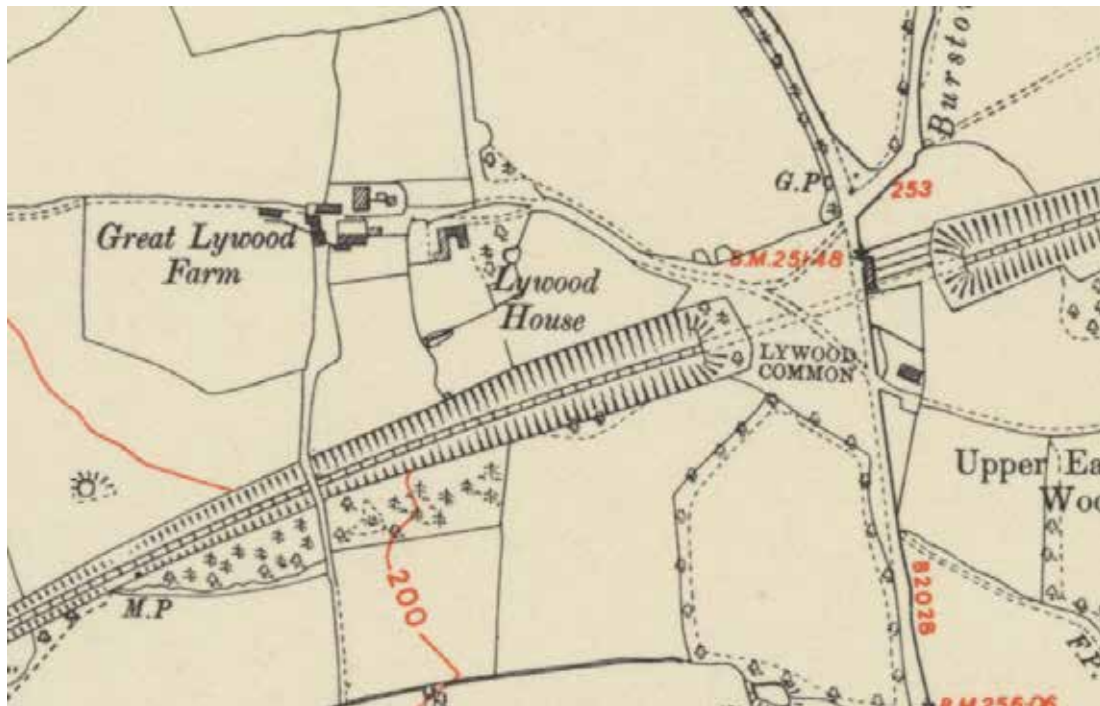
By 1947 these projections are gone again. and the building broadly retains the shape that it now enjoys today.

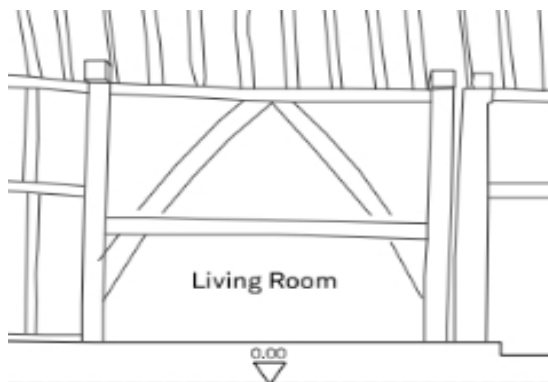
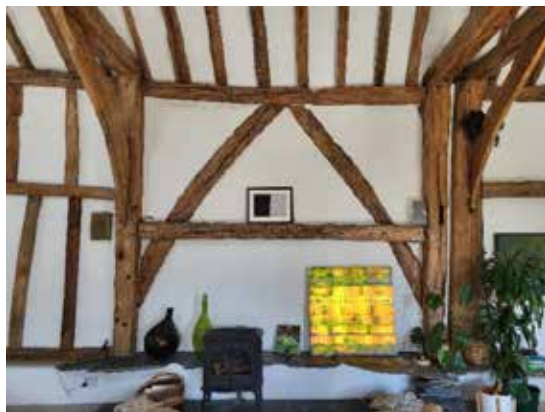
As depicted on the drawings, the bays had long passing braces arching from the lower bay posts up to the underside of the wall plates.

These long passing braces are placed outside the line of the inner girdings at midrail level. The girdings themselves and also the underside of the wall plates are notched and grooved for studs and wattles.

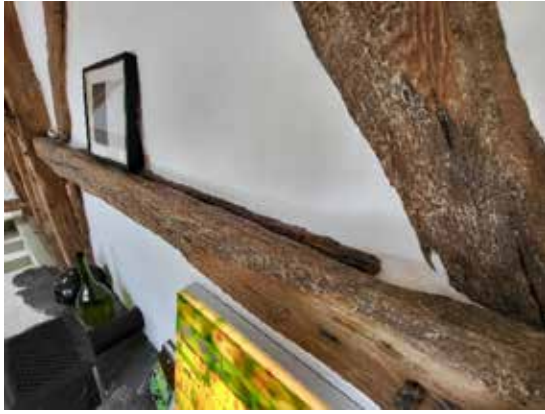
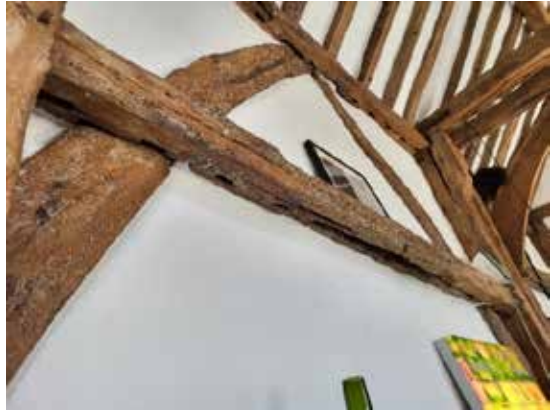
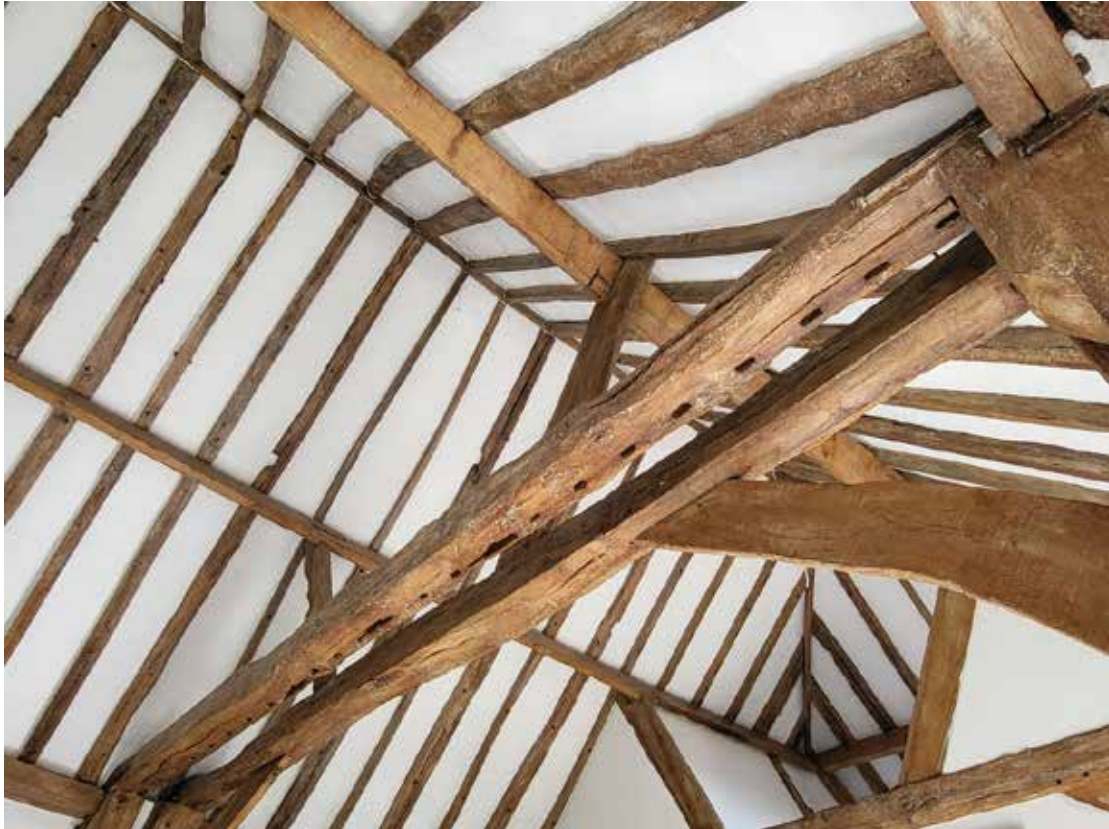
This studding and grooving is remarkably consistent around the building.

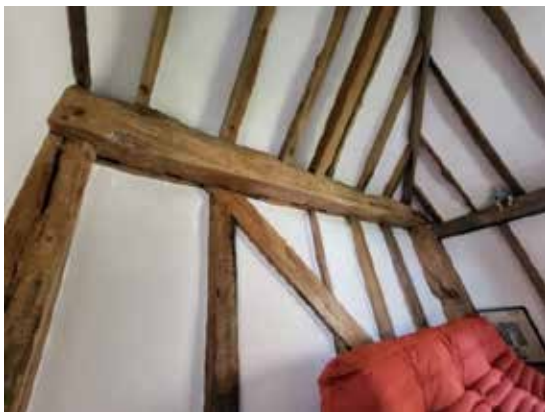
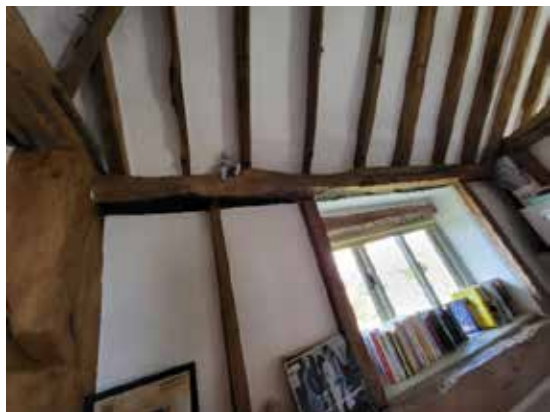
Not only this, but the empty mortises for the up braces and their upper mortise sockets in the wall plates are also consistent all around the original building despite later infill.

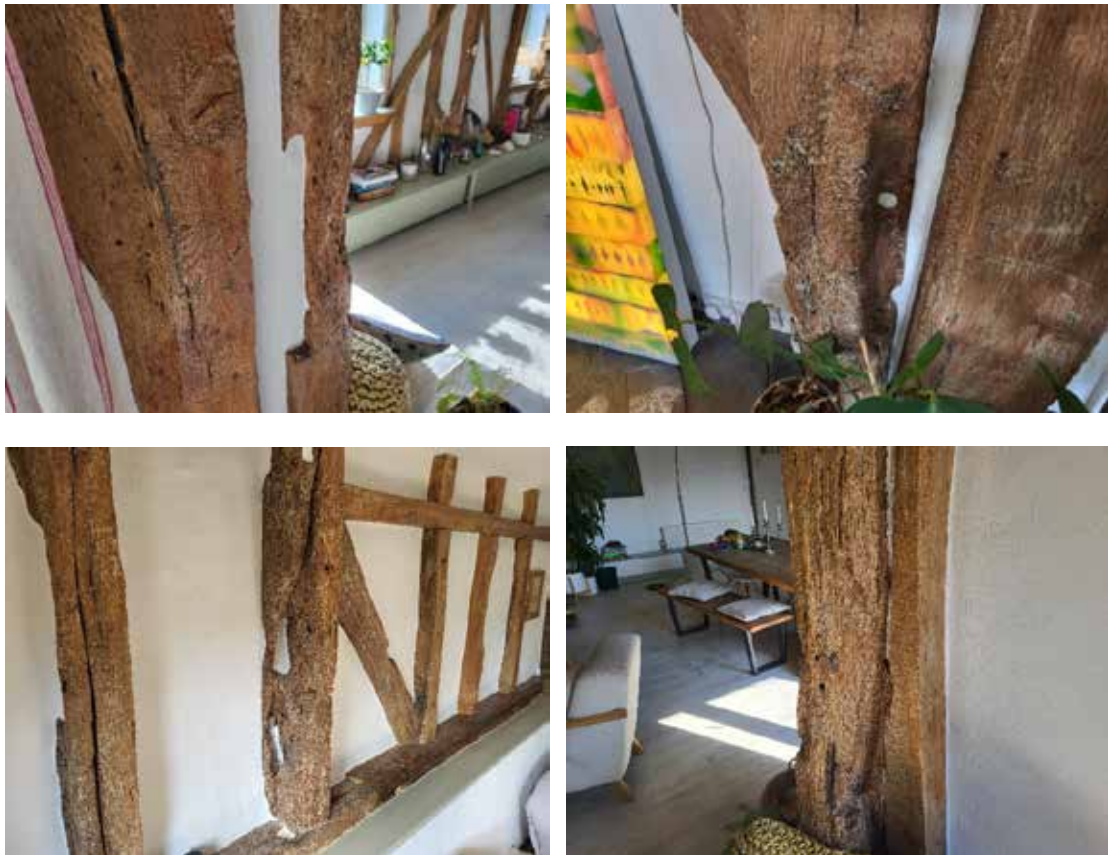
The barn, when built, had these double passing braces on every wall. The studs and wattles were affixed into the mid rails and their use indicates that the barn was formerly wattle and daub paneled and not weatherboarded. The design would have meant that the passing braces would have been visible externally, with the wattle and daub probably flush with the face of the braces, or the braces slightly proud. The exterior design would have been quite striking.

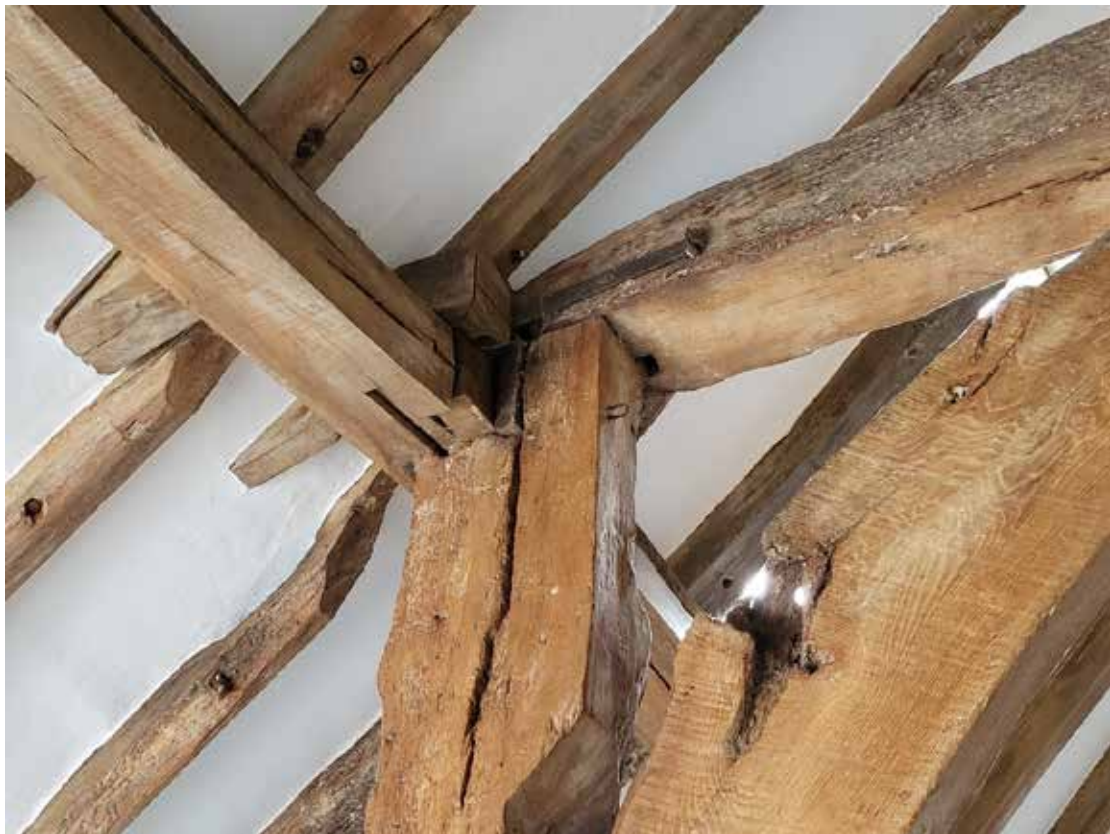
The lateral tie beams are also consistent in design and do not appear to have been replaced.

The original roof structure is lost. Replaced when the two bay extension was added. However, it can reasonably be deduced from the retained tie beams that the roof must have been a side purlin variant. Empty mortises are visible and in line with each other across all tie beams in the original part of the building. These have been superseded by the raking struts of the present roof design, but these struts do not use the same mortises, leaving the older examples open.

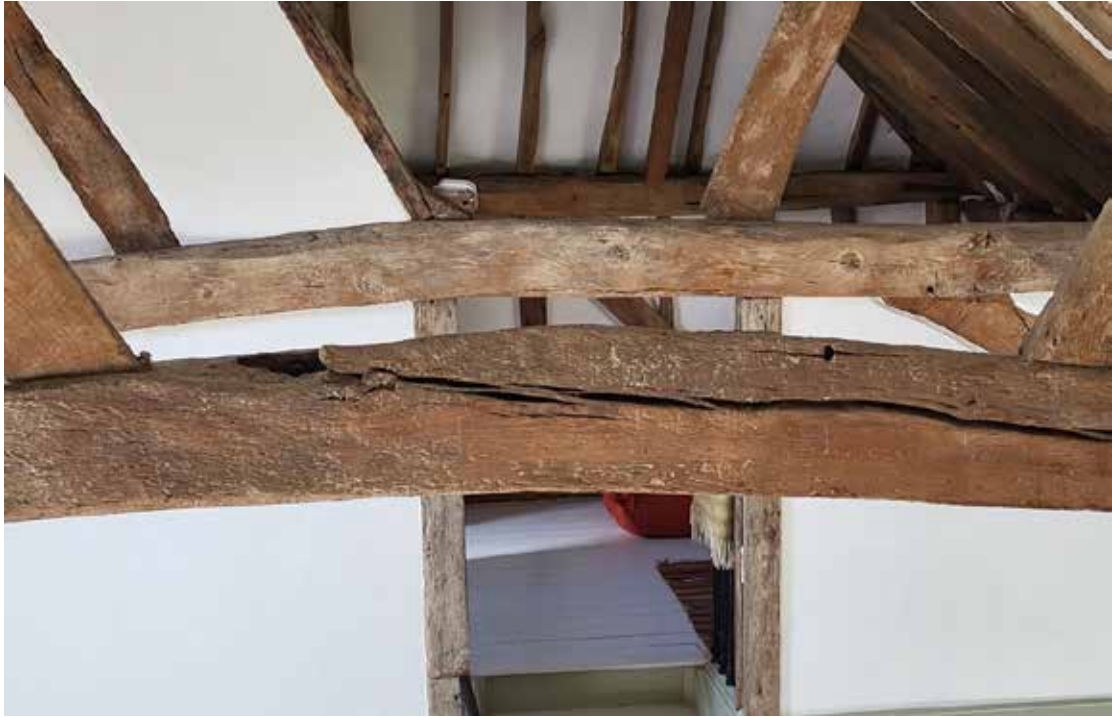
The most noticeable thing about the mortises is that they are central and close together.

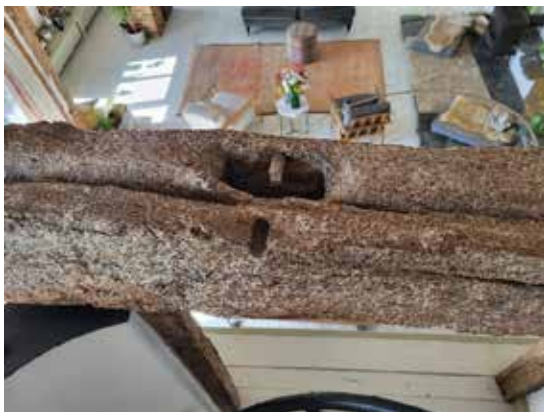
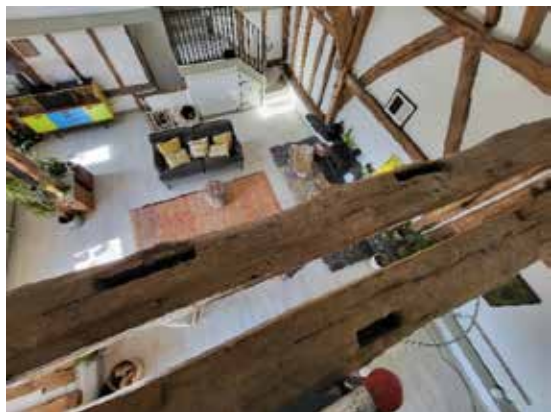
A standard queen strut roof frame would have to be exceptionally/abnormally shallow in pitch to accommodate the distance between the mortises in this instance. Therefore, the roof frame must have been a variant of the raking queen strut much like the present roof.

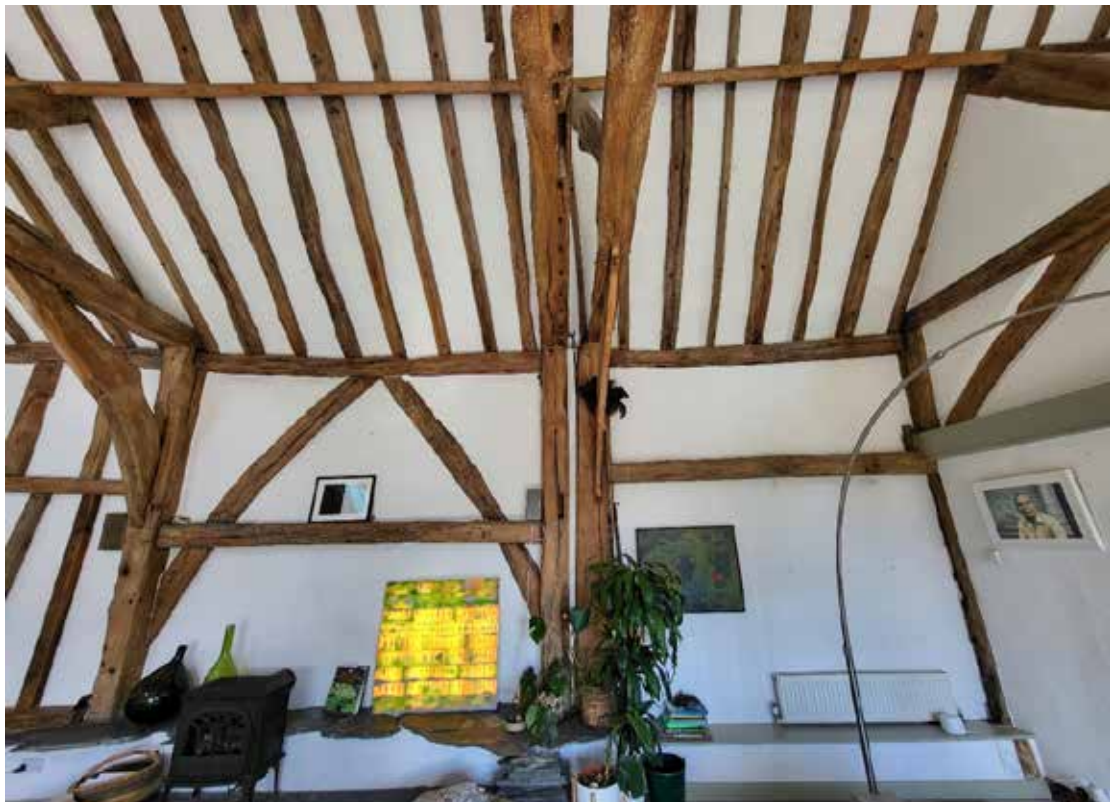
The extension was achieved by the building of two bays taken from another barn building (utilising varying reclaimed timber parts) up against the existing barn. The bay posts of the new barn are adjacent to those of the older example.

The timber used in the two additional bays varies in date but is mostly also of some age. The jowls are sizeable, as is the general scantling (sectional size) of the timber. The ties are also showing signs of being formerly installed in a barn that had an alternate footbraced crown post roof which would allow for at least 16<sup>th</sup> century dating for most of the timber. However, the provenance of these two bays will likely never be known.

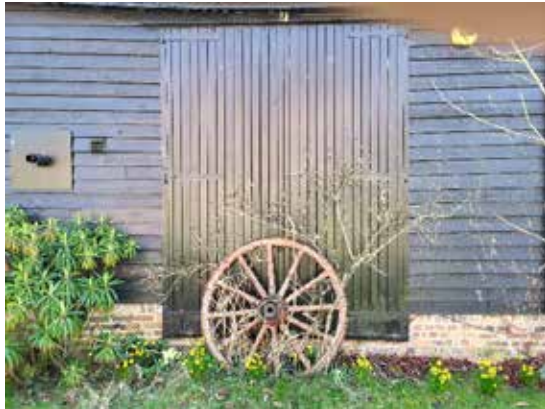
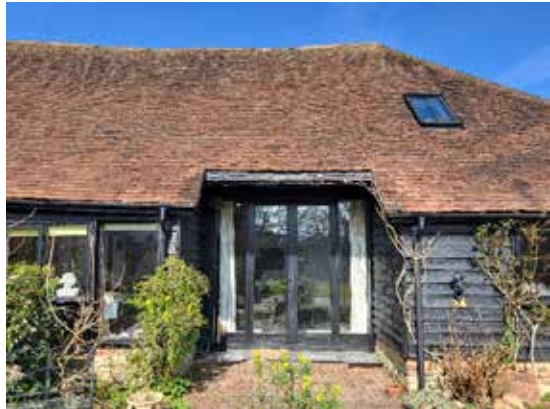
The original barn was then altered significantly to accommodate the addition of two bays. The east flank wall studding and infill was removed including the passing braces. Both original doors were removed, as the two new bays were now going to hold the barn door openings.

At this stage, the barn will have become a threshing barn, but with the doors offset in bay four (the first of the extended bays, rather than centralised). No trace survives of either 19<sup>th</sup> century doorset, with the external doors being modern timber examples, the south set being glazed.

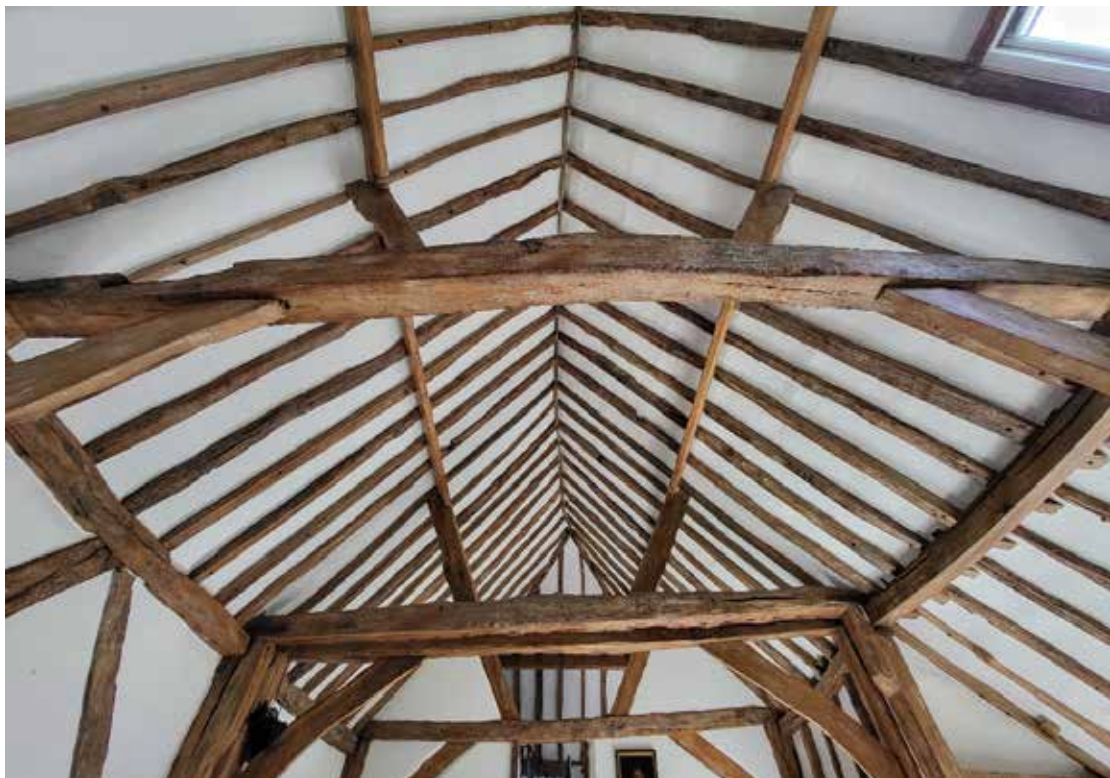
The entire roof frame was then removed from the original barn building and replaced with the present example (re-using some older timbers).

The roof must have been renewed at the time of adding the two-bay extension, as the present roof is consistent along the length of the two barns to cover them both as a single unit and weathering them both without doing so would have been near impossible. The decision must have been taken to extend a new roof frame over both barns rather than trying to find a way to extend that of the original barn. Furthermore, if the original barn still had thatch, this would have been a hindrance to weathering the additional bays effectively and further goes to suggest the need to reframe both ends. Indeed, this later roof frame shows signs of being designed well after 1750-1800 with the type of ridge board and purlin size – which would again suggest the right date for this to have occurred.

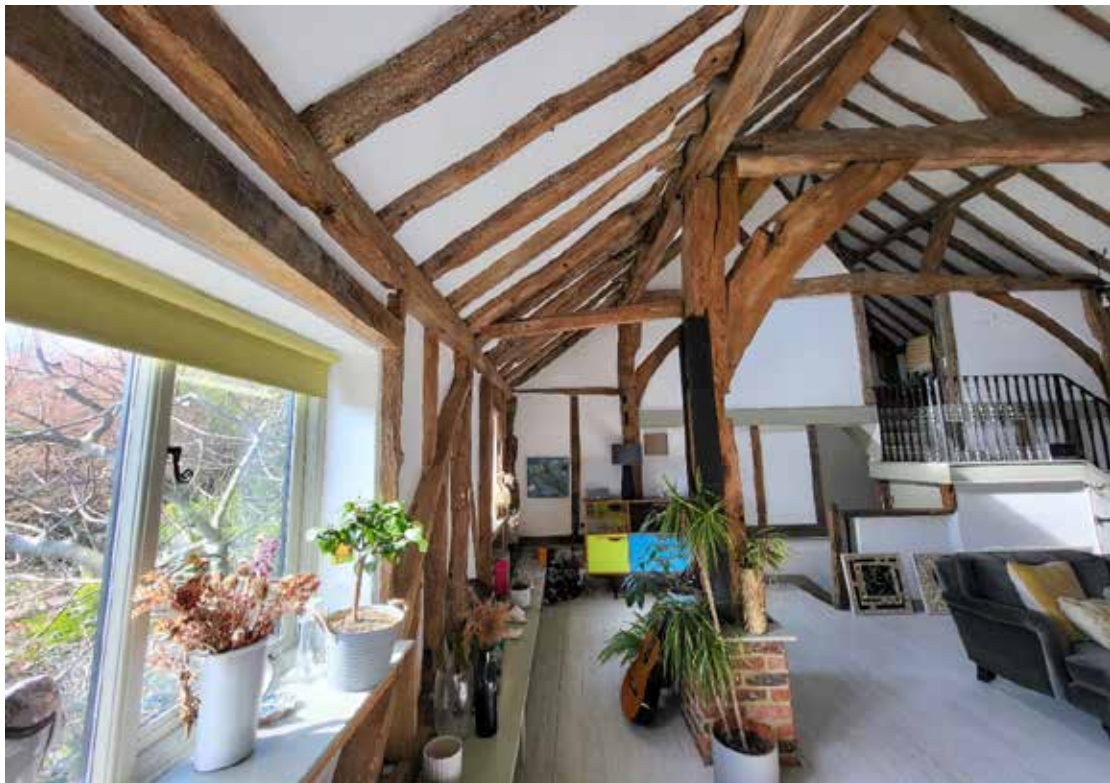
The south aisle was seemingly also added at this date, or at around the same time, The framing is typically late 18<sup>th</sup> century, to early 19th century and may actually be the more certain indicator of how close to 1800 the original barn was extended.

At some stage in the 19<sup>th</sup> and early 20th centuries all of the wattle and daub infill panelling was removed and disposed of. Many of the studs, wattles and passing braces were also removed. Much of this must have been carried out due to the deteriorating condition of the lower mortises of the passing braces. Many are heavily degraded and suggest that such work was needed, as opposed to being a conscious aesthetic decision. Again, whilst impossible to ascertain exactly, what replaced the infill was studding that could easily be early to mid 19<sup>th</sup> century in date. The exterior timber cladding is mostly very modern, with little showing signs of being much more than mid 20th century in date.

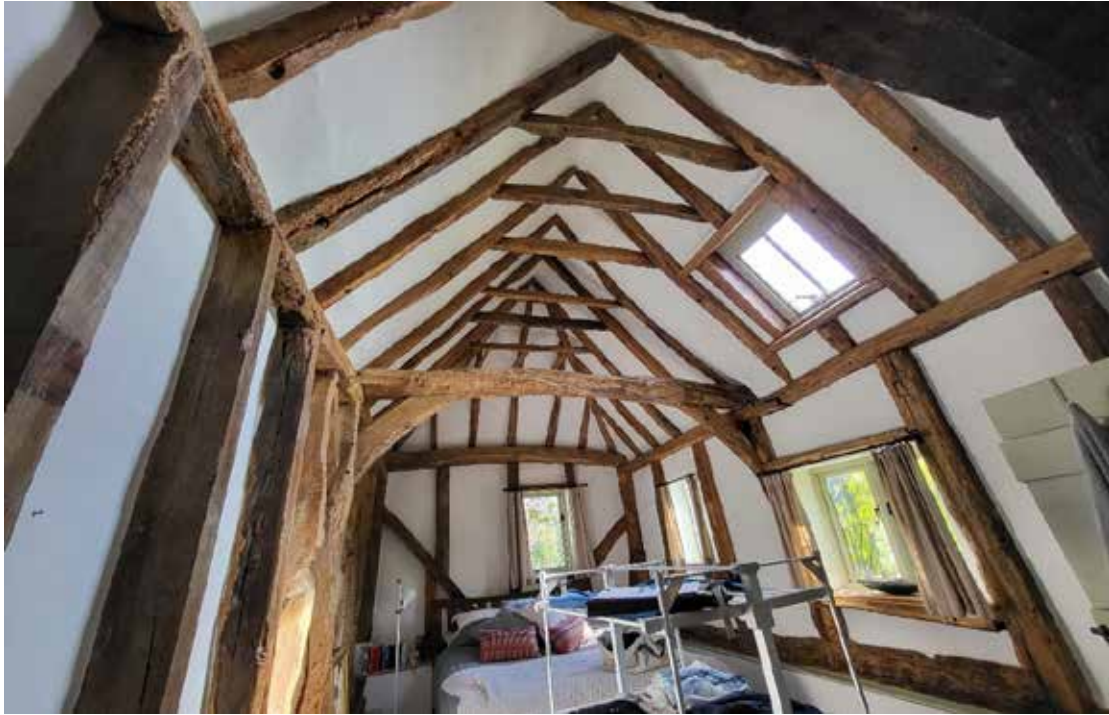
Undoubtedly it contains many re-used and older timbers. But it would seem to be of probable 19<sup>th</sup> century date, despite couple rafters for instance. Collars are nailed and would not have been constructed in this manner, for example.

A loft was added to the west end, but which has been extensively re-built – though it is 19<sup>th</sup> century in date.

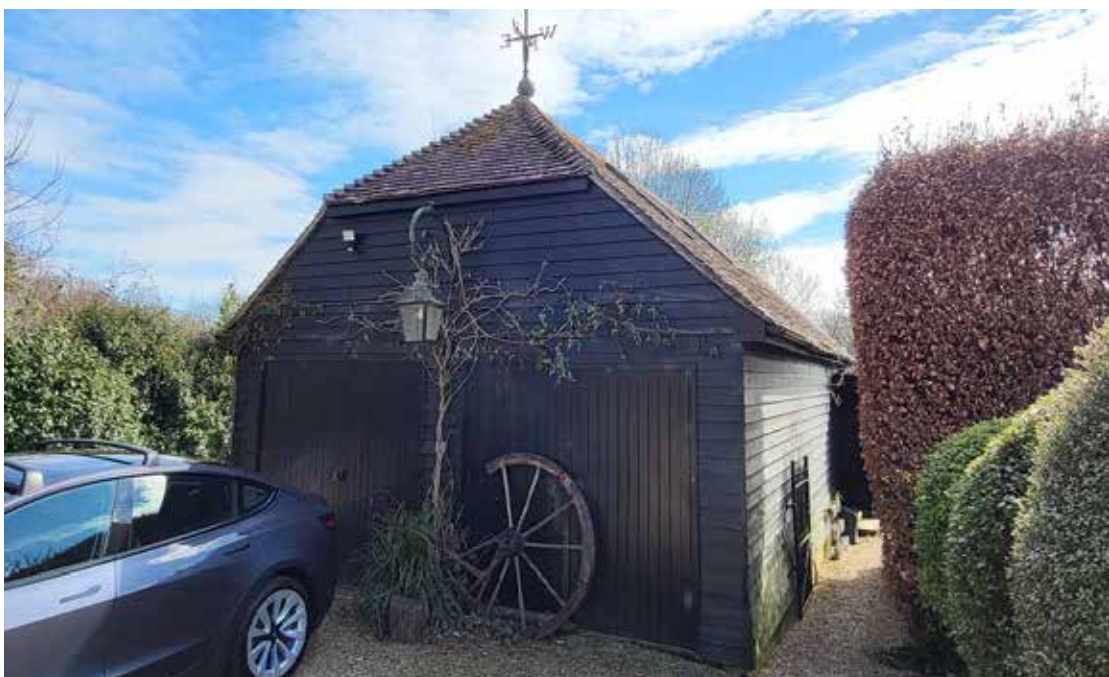
This building was constructed in the late 20<sup>th</sup> century.

Walls are block masonry.

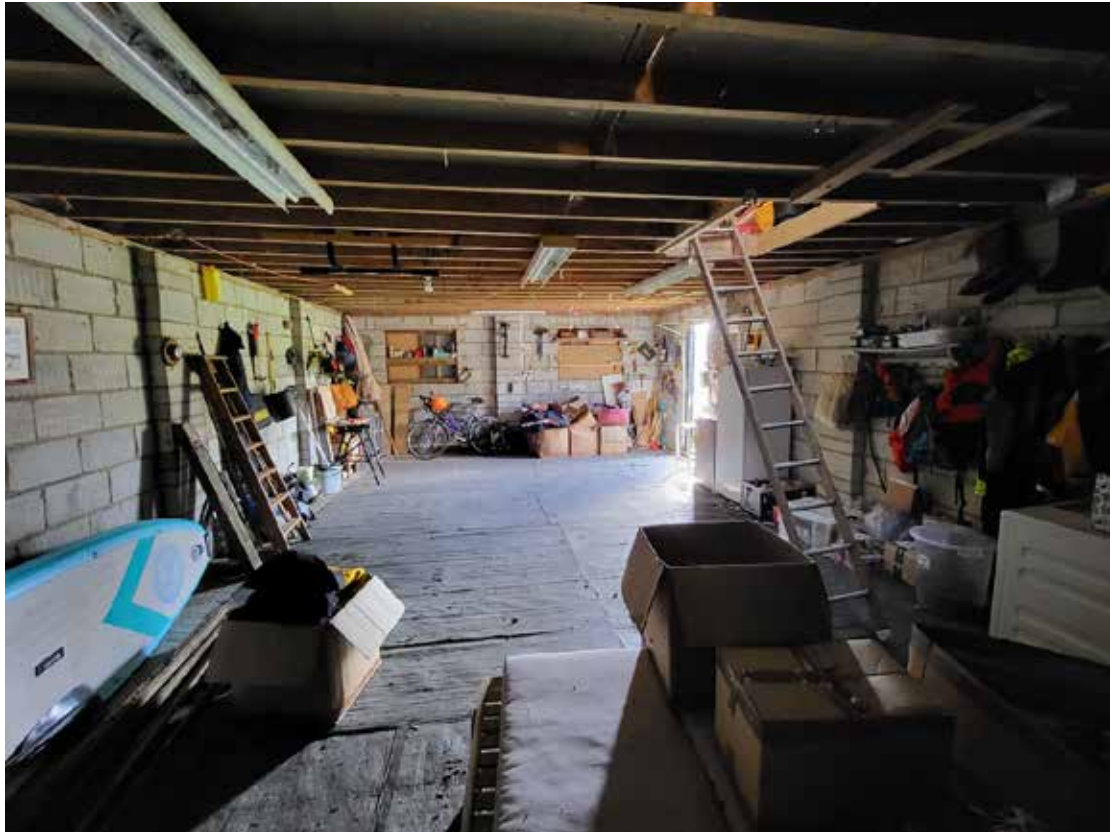
The roof is a simple softwood rafter frame.

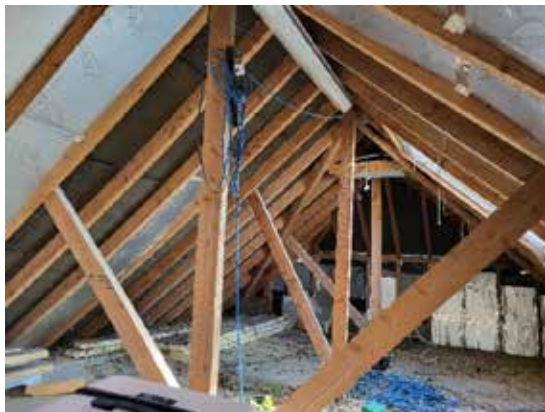
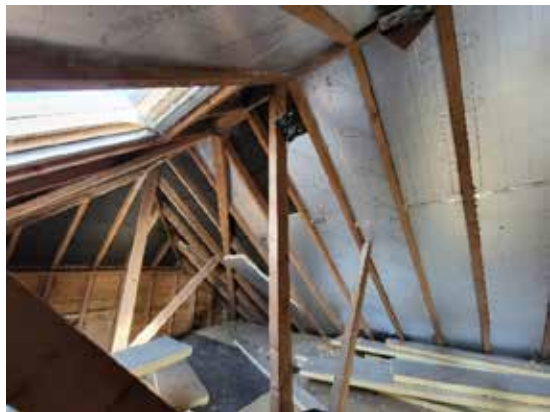
There is no historic fabric with which to note in this report.

Externally, the unit is tile clad to the roof, with weatherboarding to broadly match the main barn conversion. There is a small conservatory to the rear (south face).

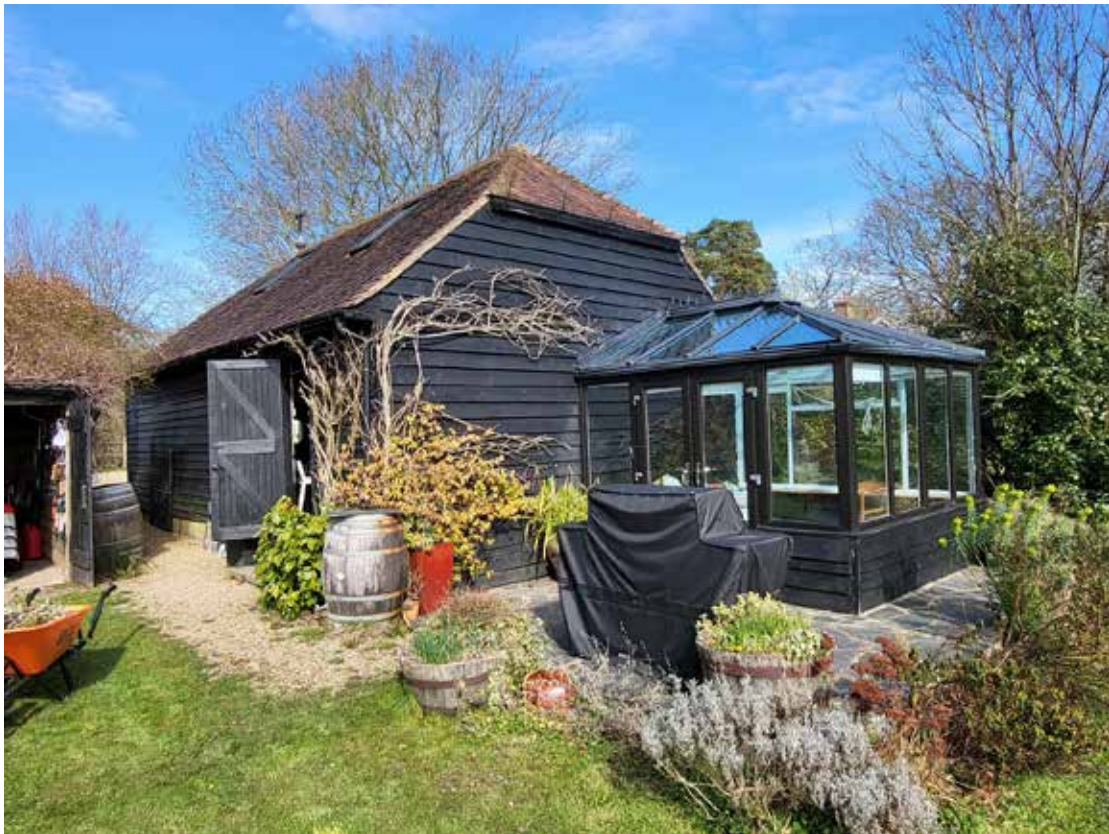
An open loggia is also standing nearby and forms a group.

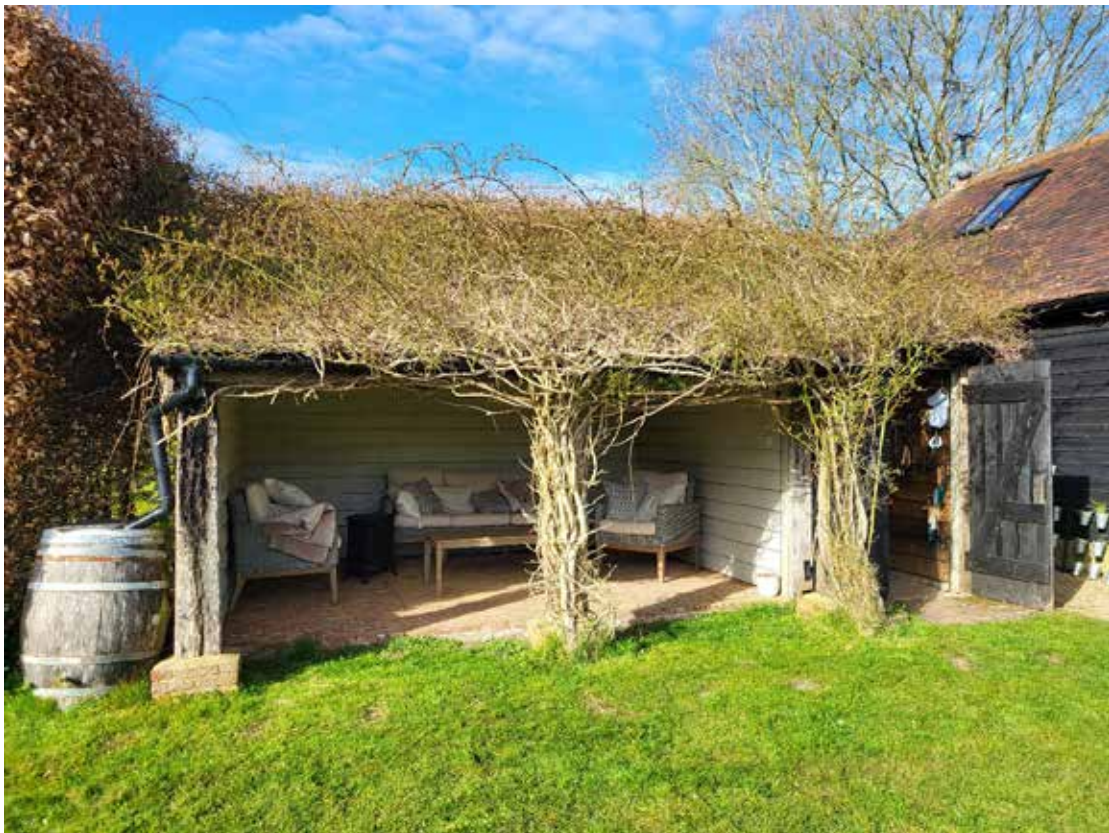
Whilst fabricated from older material, the structure is modern and was probably assembled when the garage was built.
