# **Addendum to Heritage Impact Assessment**

## Extension to listed dwelling & internal alterations

Red House  
Cowfold Road  
Bolney  
West Sussex  
RH17 5S

July 2025

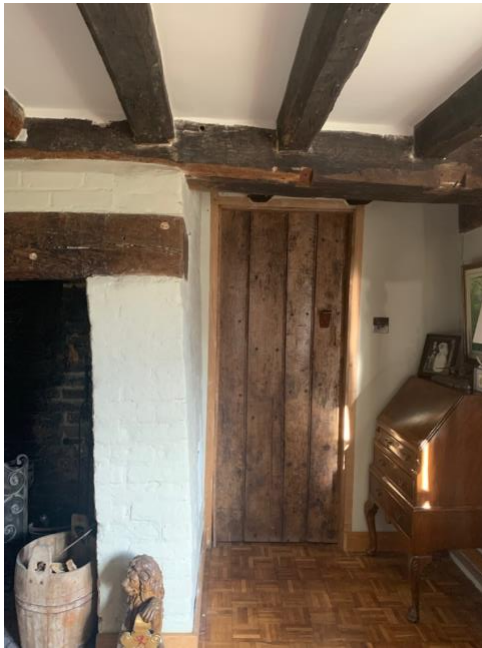
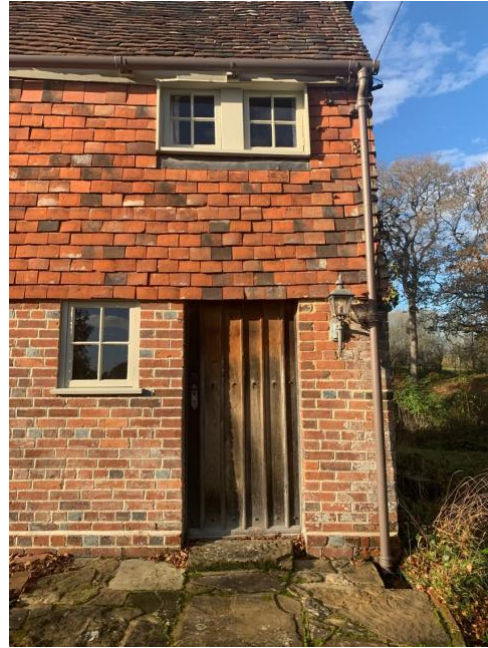
*Baffle entry created by introduction of inglenook but later relocated to the service bay.*

- 2.8 The introduction of the inglenook created a baffle entry correlating with the main door being within the service bay. The former baffle entry is not visible from the exterior, but evidence exists to the interior face and underside of the side girt. A modern partition, door and frame now abut the east side of the inglenook providing access to the altered service bay. Evidence of a doorway from the baffle is noted to the south face and underside of the C-C crossbeam. The addition of a new exterior brick skin would have covered over a lot of historic evidence as well as the introduced fireplace which butted against the west side wall of the hall, concealing a former door.

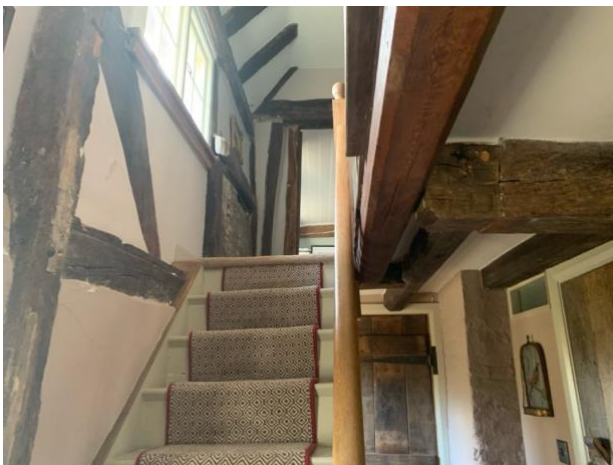
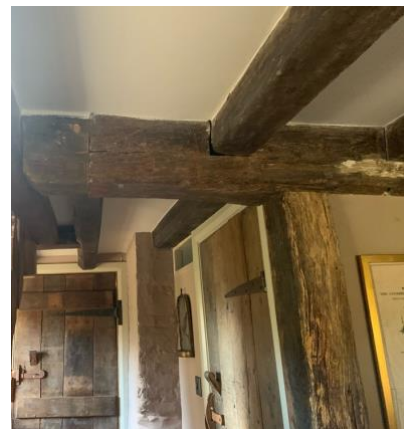
*Service bay with modern staircase, truncated crossbeam C-C and joists with diagonal brace to post as opposed to a down brace. Note the split rail below the window. Also, the lower section of the post sees a filled in mortice where the crossbeam would have been tenoned into.*

- 2.9 The 'front' door was moved to the service bay where and upon entry, the modern stair rises to a landing at first floor level. This is evidenced by the removal of a stud to the side girt within the service bay, alteration to the ceiling joists and stair trimmers. Generally, the service rooms and stair would have had partitions between. Originally the stair would have risen against the east wall, rising to the north, and would have landed in the service chamber with access across the hall chamber to the solar chamber. It lands in the hall bay. The northern 'service' bay now accommodates a wc, bathroom and a large entrance hall area spanning the depth of the bay. This bay has been heavily altered, sections of wall rebuilt, the frame disrupted and concealed, and stairs changed. It also has a lower floor level.

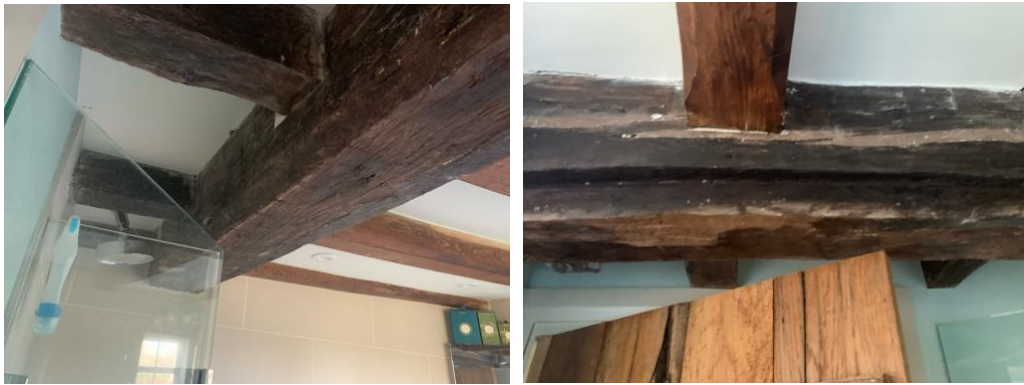
*Continuation of crossbeam C-C through partition to west side of gf bathroom. Evidence of former door from hall passage.*

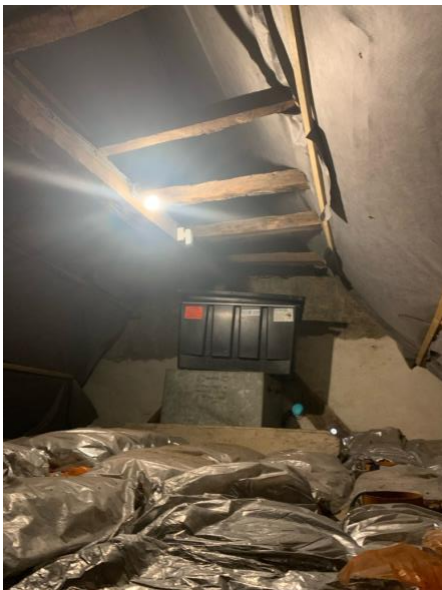
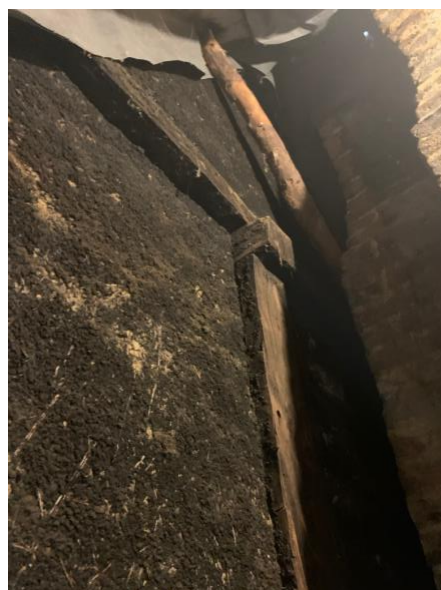
*B-B South face Crown Post obscured. B-B North Face. The brick stack sits close Down braces are just visible. to the soot blackened daub and collar.*

- 2.17 The reduced space available within the hall bay and room above was also open to the underside of the roof. Accessed via a ceiling hatch, the north face of partition B-B within the hall bay, reveals the soot blackened wattle and daub panels and timbers. The crown post and a collar purlin are visible, albeit blackened. It is noted that the collar purlin has been truncated due to the intrusion of the brick chimney stack. To the north side, the collar purlin is embedded into the brick stack. A tree branch forming a rake is noted between the partition and stack but appears to have been inserted at a later date as some form of rudimentary support. Close inspection of the daub also reveals the presence of straw in the mix.

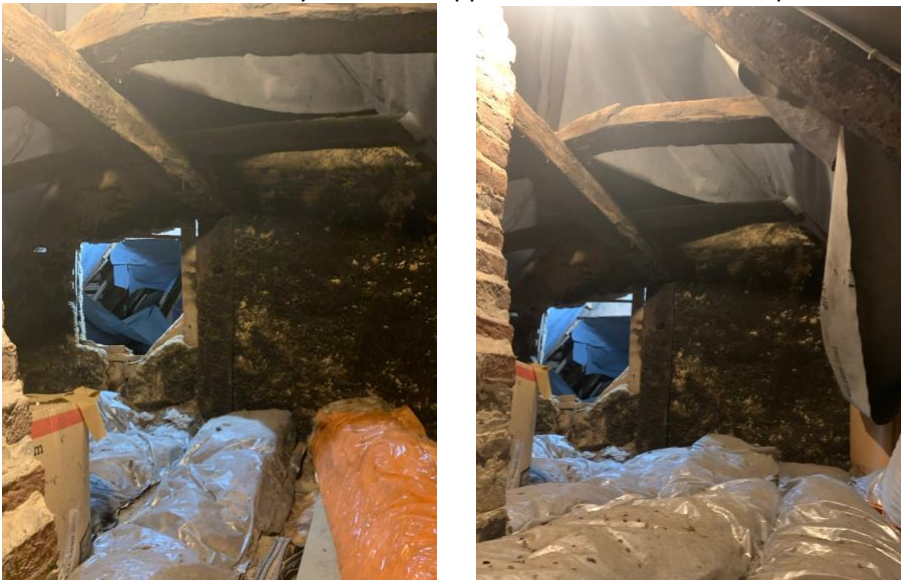
*Partition at C-C with a breach through. The collar purlin is present with collars above, one of which is broken. The collar purlin runs into the crown post. Down braces are visible.*

- 2.18 The partition at C-C to the north with B-C forming the attic to the hall bay chamber, as shown in the photos below, sees sooted wattle and daub panels and timbers. Where fragmented, the wattles can be seen. The spine beam to the first floor ceiling is partly concealed and has also been interrupted by the stack. It remains present and is noted to sit above the tie beam which is visible to the first floor bedroom below.

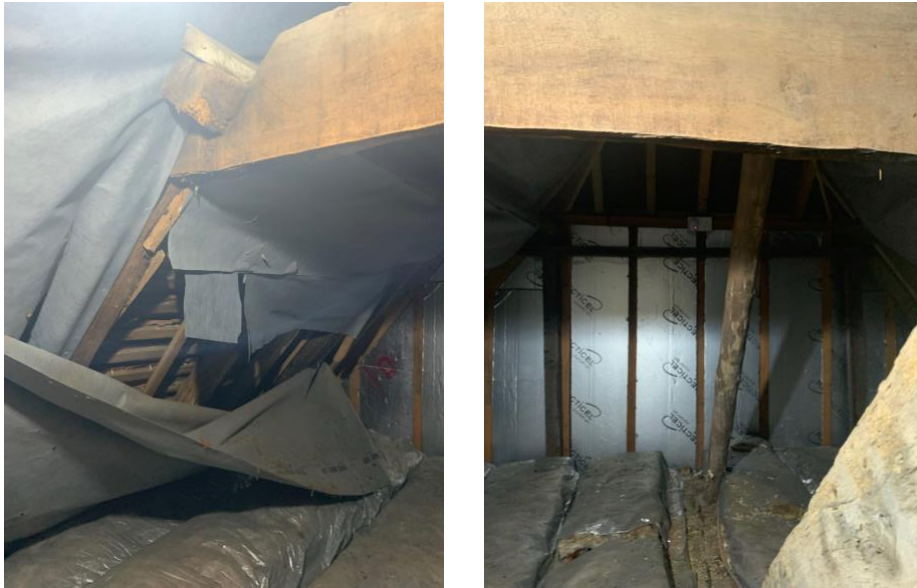
*Collar clasp side purlin (truncated) above service chamber. Evidence of Victorian and 20<sup>th</sup> century timbers. Note the bark stripped branch acting as a supporting rake.*

- 2.19 An opening has been formed within partition C-C allowing access, albeit restricted to the attic over the service bay chamber. As with the other attics, modern insulation and lining has been used throughout this end section. The service bay has a side clasped purlin roof with the purlin clasped by the collar. The collars differ dimensionally and in age compared to those to the roofs above the solar and hall bays. The west side purlin has also been cut midway along its length with a softwood purlin sitting above. The east side of the roof slope is concealed. There is evidence of modern softwood to the inner face of the half hip to the northern gable and between the hip rafters. Above the gable wall, the rafters are modern. Some rafters to the west roof slope appear to have been reused whilst others appear to date from the mid 20<sup>th</sup> century. A bark stripped branch rakes back to partition C-C.

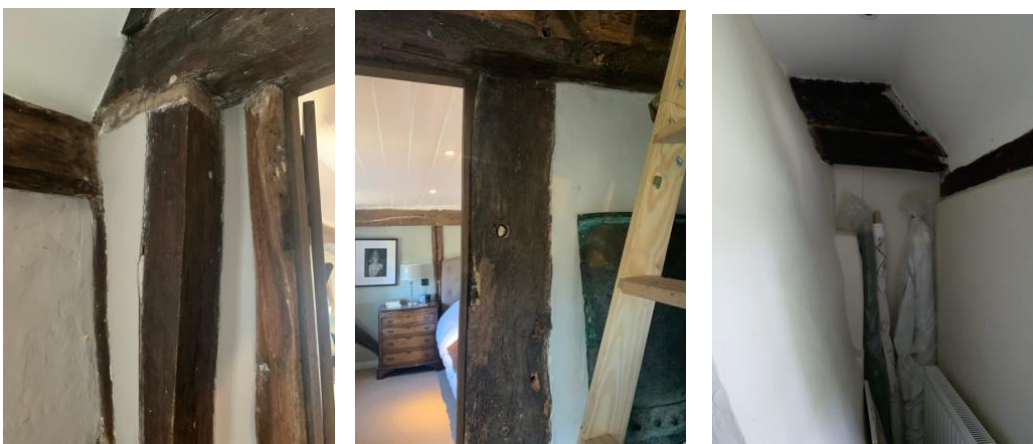
*First floor hall chamber - Partition B-B at first floor level. The cross-beam sits above the post which is concealed behind plaster. The doorway has been altered but the studs survive for the door opening. The cross-beam is concealed by the brick chimney stack placed but it is visible to the solar chamber.*

- 2.21 A post is visible to the east side of the B-B partition, but this appears to have been 'introduced' as it sits forward of the junction between the cross beam, wall plate and post. A small piece of a post is visible but is concealed. The post in view and is inset from where the post would have been and is a later insertion, possibly around the time that the hall saw a first floor being introduced. This arrangement differs from that at C-C where there the jowl post is splay cut and is of a standard assembly – the tie beam is dove-tailed over the wall plate and the both wall plate and tie beam are independently morticed-and-tenoned on the principal post.

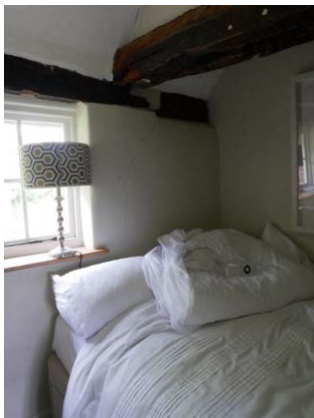
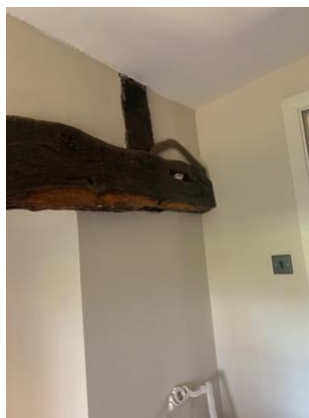
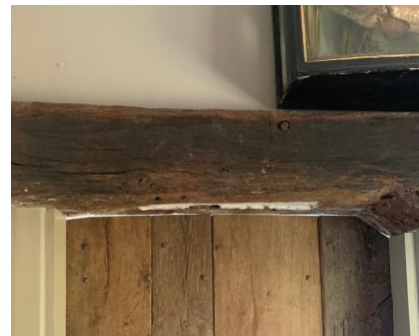
*Partition C-C at first floor level where the middle bedroom saw the removal of the studs with the room being enlarged. The cross beam continues through the stud wall to the landing and across the post at the east side. Empty mortices to the underside of the cross beam at C-C relate to positions of previous studs for wattle and daubs panels, now altered with the change to the arrangement in this area.*

- 2.23 The crossbeam continues through the partition across the hallway and door to the north end service chamber (bedroom). At the east side the principal post is a swell jowl noted above as being of a standard construction. The crossbeam also provides evidence of a mortice above the inserted door to the service chamber that would have held a framing element. Stud marks are present for infill panels. No spine beam visible in the hall chamber – it has been covered over by the modern ceiling as it exists in the attic. The photographs of the arrangement for C-C are provided below

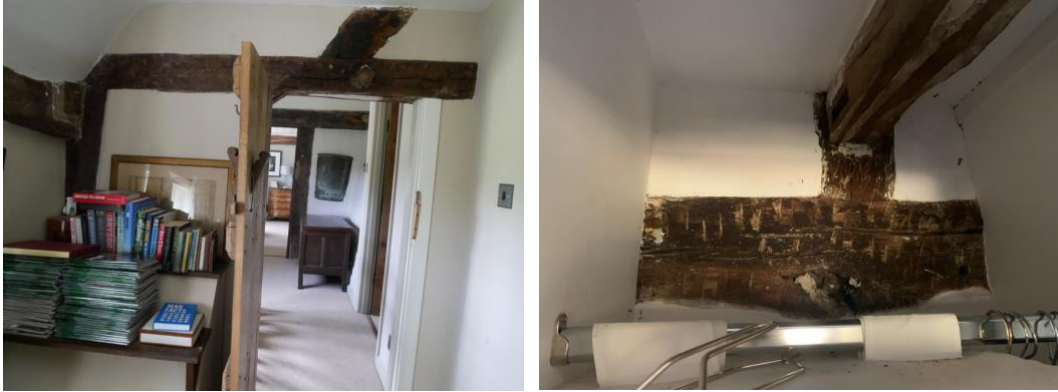
*North side of partition C-C where the cross-beam runs through the stud partition which sees the middle bedroom intrude into the service chamber.*

- 2.24 From the north side, partition C-C is interrupted by the stud walls for the enlarged hall chamber. The cross beam is clearly visible with the down brace above the later door opening. The crown post is viewed inside a cupboard with the spine beam. There are empty mortices for joists which have been removed and together with the alteration of the northern gable, no post is visible above the end wallplate. No posts are visible to the corners of the end wall, D-D. Strapping is noted and the diagonal raking strut which is similar to the strut to the south side of the swell jowl at C-C east.

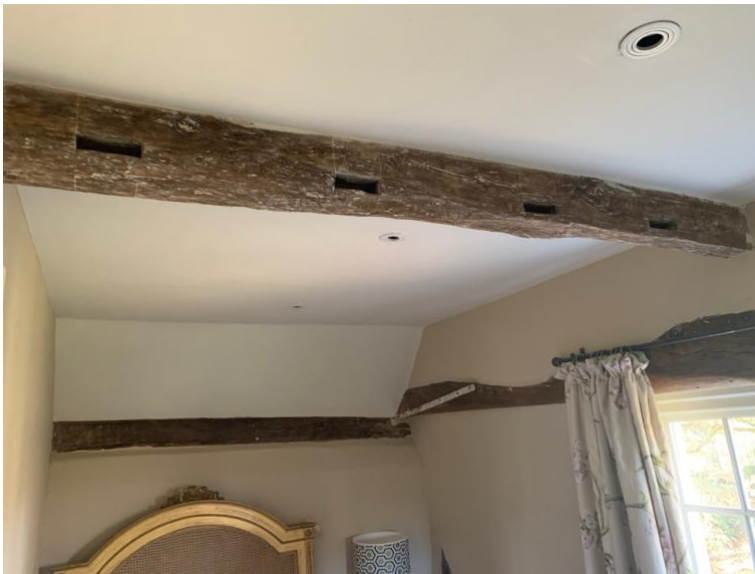
*Altered north end service chamber which and along with the service bay to the ground floor, stairs, east wall, and hall chamber, has seen extensive change.*
