## Heritage Statement

REV A  
A1173  
Bowders Farm  
Balcombe  
May 2025

Bowders Farm is located approximately 600m north west of Balcombe Place and 1.3km south of the village of Balcombe, West Sussex. The site has a mix of historic and modern agricultural buildings. Of particular importance, the farmhouse is a Grade II Listed building, its list entry is found below. The purpose of this report is to understand the history and significance of the farmstead, specifically the collection of buildings at the front of the site. The report will also establish if this collection of buildings should be curtilage listed or considered as a non-designated heritage asset.

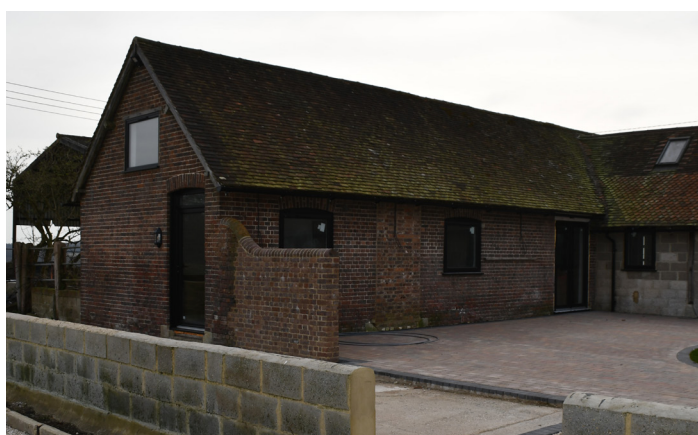
The stable block is oriented along its long axis east to west. The roof ridge of this building is higher than the other two buildings attached. To its east elevation there is a central opening at high level, thought to have been used as access to the hay loft. Whilst there is no evidence of external access, it is likely that there was internal access through a trap door and a ladder within the stable.

*Fig 3, The Stable, North & East Elevations*

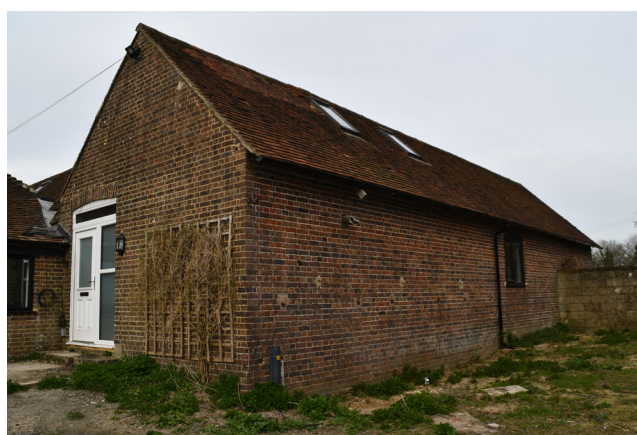
*Fig 4, The Stable, South & West Elevations*

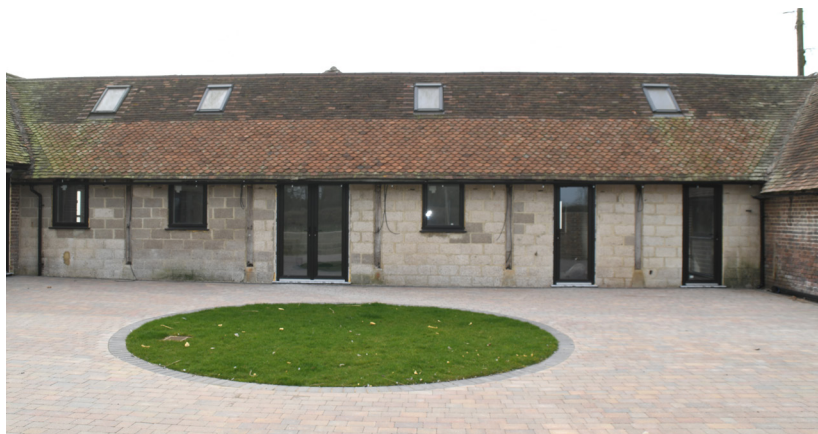
The cart sheds sit at a right angle to the stables from its west end, there are 6 bays which have been infilled with modern blockwork, carried out in the late 20th century/early 21st century. The timber posts and staddle stones are still visible. The rear of the elevation is brick. Original openings can be identified where queen closers have been used, whilst other openings have been crudely cut across the brick bond and can be determined to be later openings.

*Fig 5, Cart Shed, East Elevation*

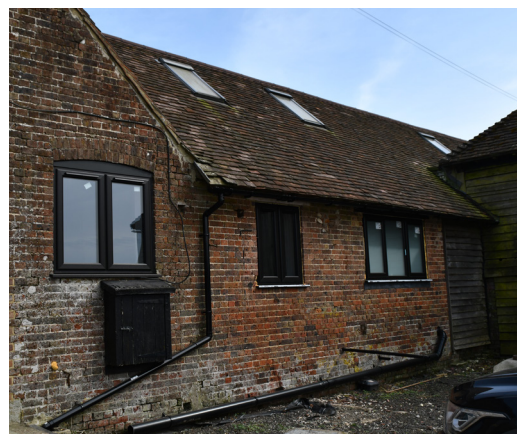
*Fig 6, Cart Shed, West Elevation*

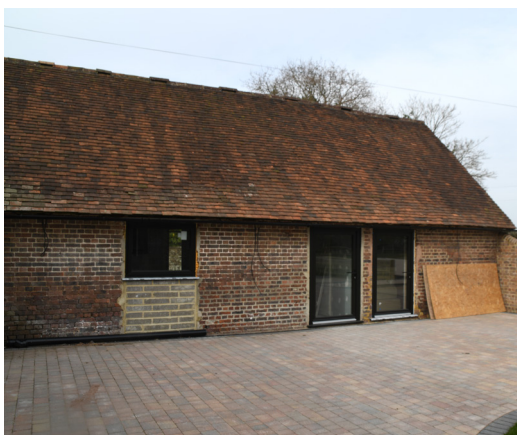
This cart shed flanks the north of the courtyard. The original openings are on the north elevation, facing the farmhouse. These openings were been infilled with blockwork in the late 20th century/ early 21st century but there is some evidence of the posts from looking at the roof structure. There are three openings which face into the courtyard, these are not original as the brick has been cut / there are no queen closers, also a early 21st century alteration.

*Fig 7, South Elevation of Cart Sheds*

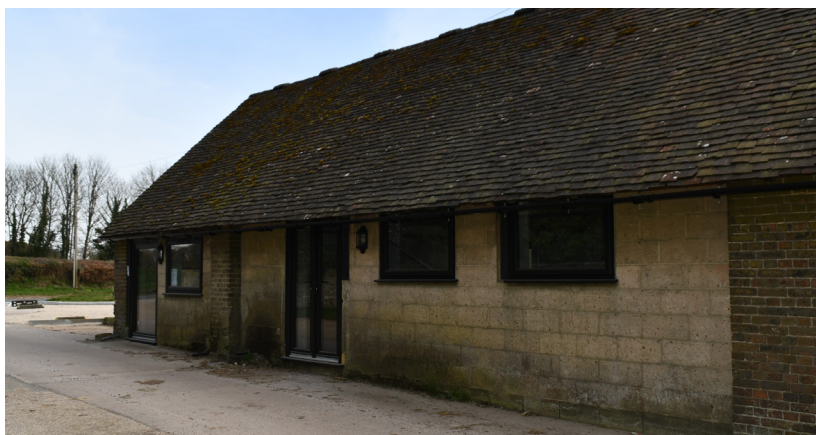
*Fig 8, North Elevation of Cart Sheds*

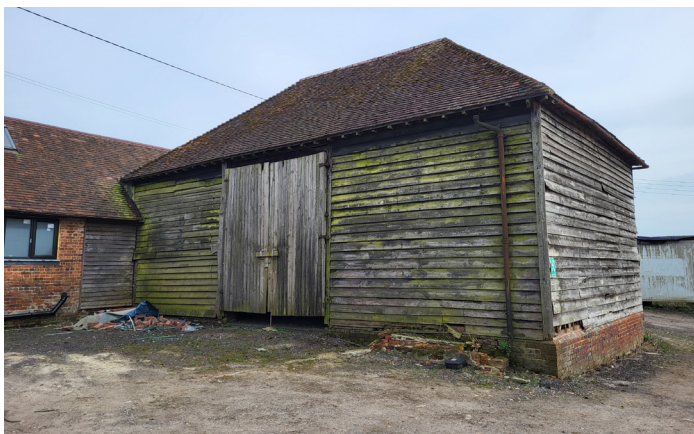
The barn is currently used to store farming equipment. The barn has a combination of kings post trusses and fink trusses which have been reinforced with modern timber. The roof structure has been fully replaced and the south opening has been boarded up. Externally the barn is clad with horizontal timber boarding and the frame is sat on a low brick plinth.

*Fig 9, The Barn, North & West Elevation*

| Description of proposed works | Impact on historic fabric | Impact on setting of heritage asset | Overall impact on significance | Extent of impact |
|---|---|---|---|---|
| | <p>Given the age of the barn, it appears to be in fair condition. The timber boarding requires maintenance therefore repairing and replacing boarding where necessary will have a positive impact on historic fabric and will ensure the longevity of the building. Where re pointing is necessary, a lime mortar to match existing will be used.</p> | | | |

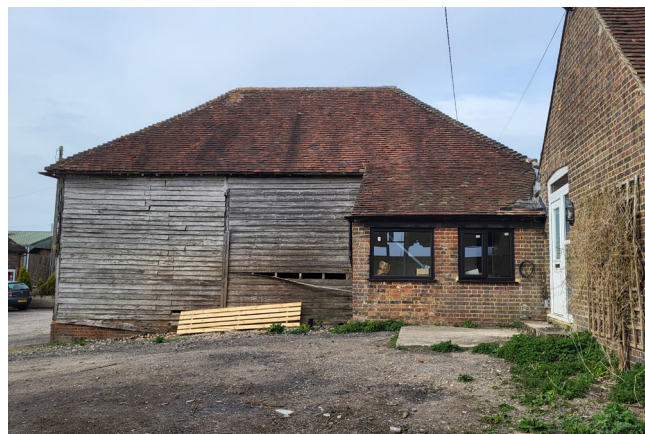
*Fig 10, The Barn, South Elevation*

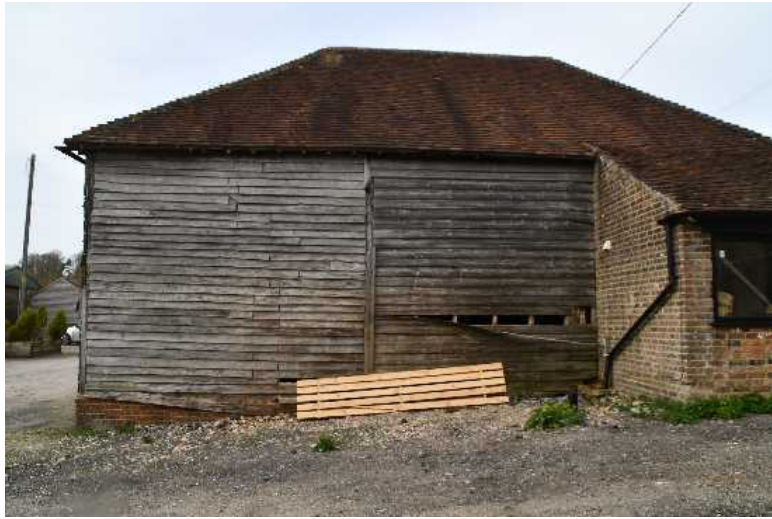
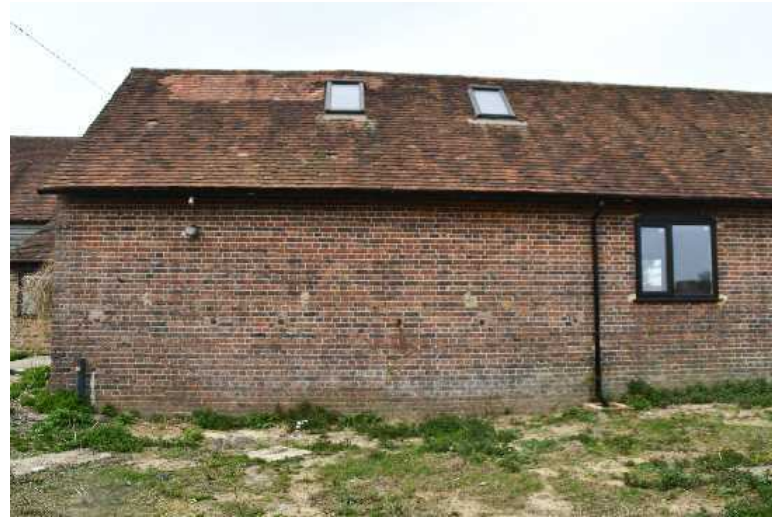
The boarded up opening to the barn demonstrates its change of use and it is no longer need to be open. The barn currently stores farming equipment.

The window openings have been replaced with uPVC in black wood grain effect as part of this scheme.

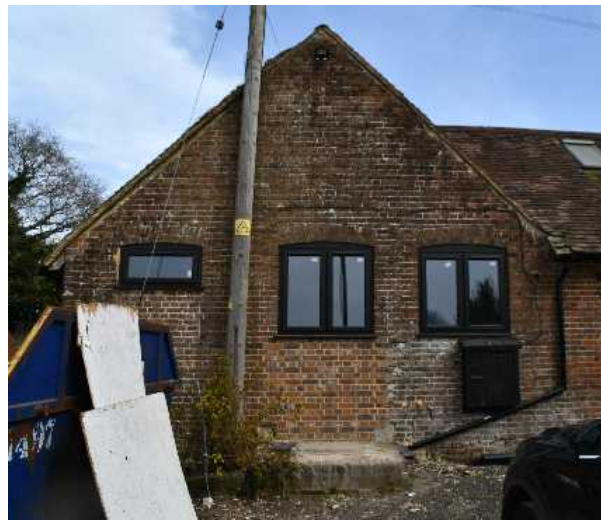
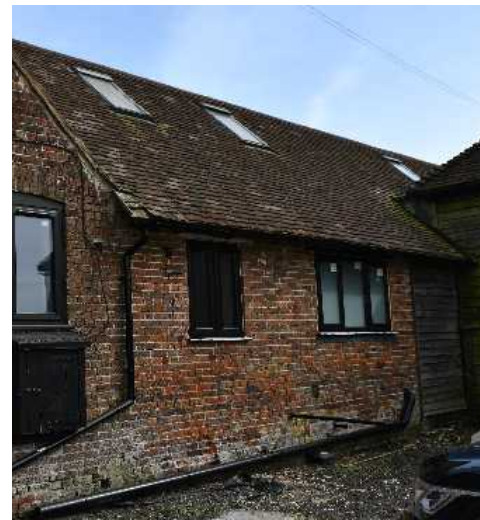
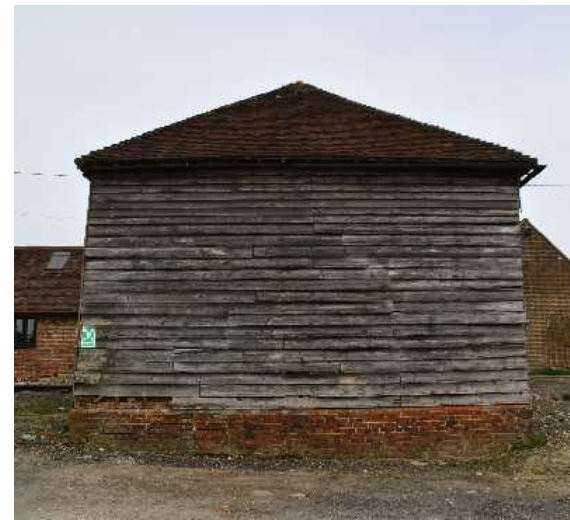
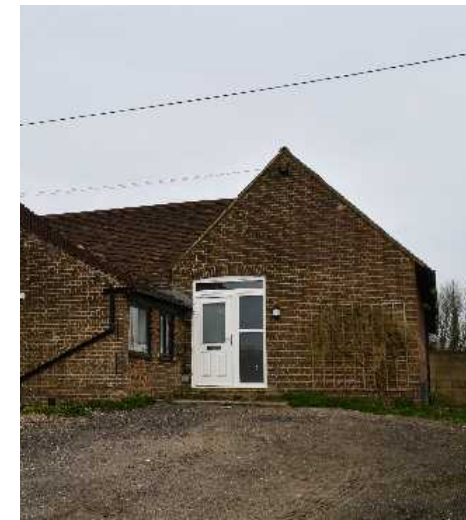
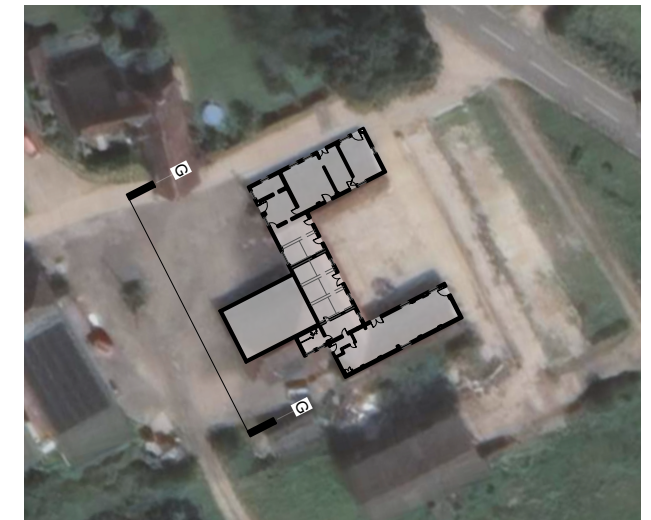
This elevation of the building shows various interventions as the use has changed.

The original and modified openings would have provided light to the workshop/store whilst no other openings were required on this elevation as a cart shed. These openings were timber frames painted black. The door was also timber and painted black.

All the openings have been replaced with uPVC frames with black wood grain effect as part of this scheme.
