**Surface Water (Drainage) Assessment**  
in support for the application for an  
a retrospective application for carpark alterations at  
Hurstpierpoint College,  
College Lane, Hurstpierpoint, West Sussex, BN6 9JS.

Building Solutions Consultants (BSC) has been instructed by Hurstpierpoint College (HPPC), to undertake a Surface Water (Drainage) Assessment.

This statement is prepared on behalf of Hurstpierpoint College in support of a full planning application for the retrospective carpark extension and alterations.

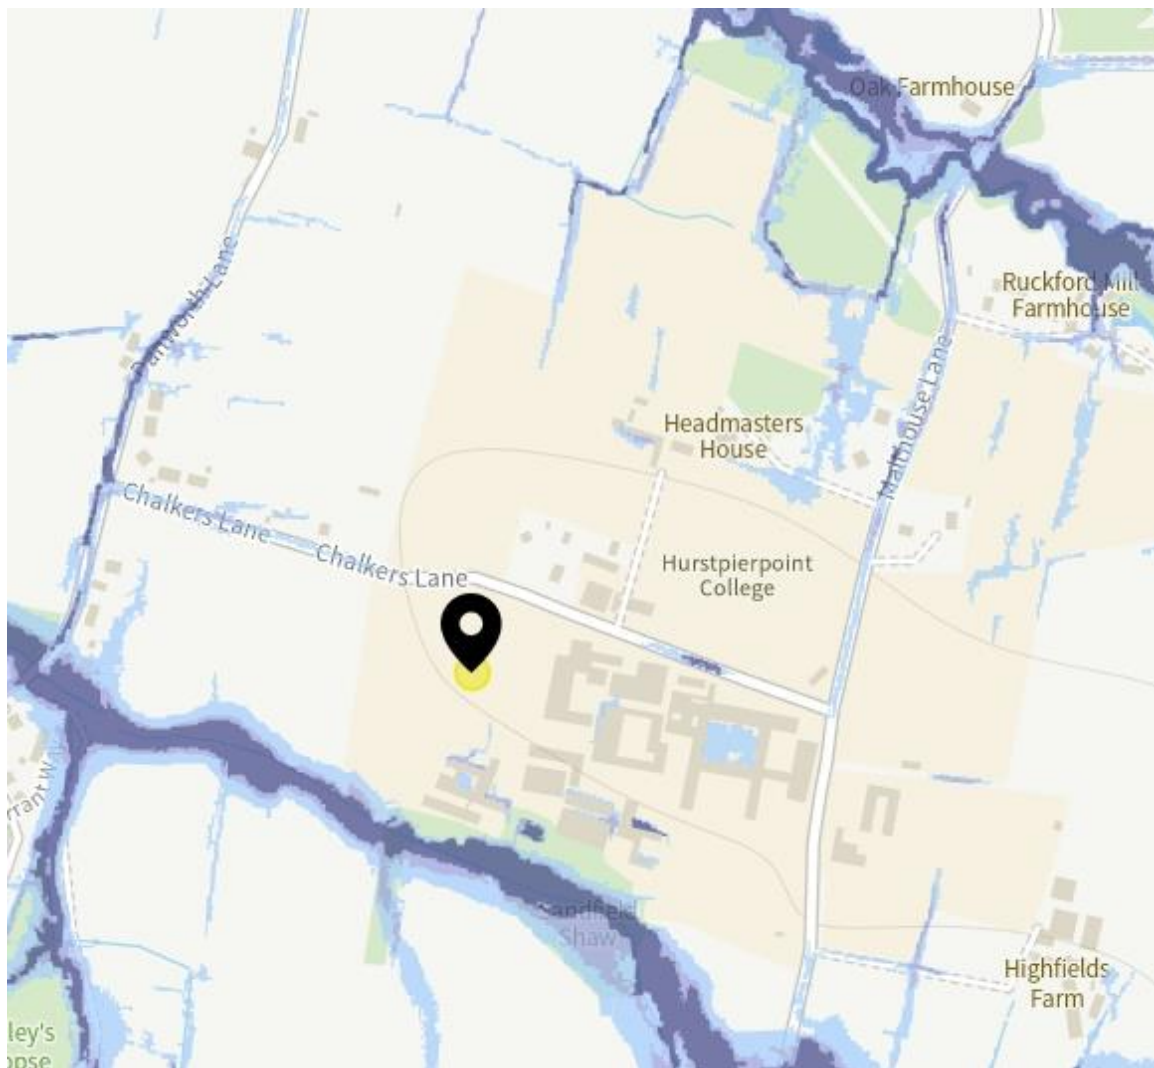
**Figure 3 – Extract from EA Mapping: Surface Water Extent**

EA flood mapping data indicates that the site is located outside of all categorised risk areas of surface water flooding, therefore has a risk of surface water flooding less than 0.1% per year, as shown in Figure 3, with surface water flood depth data shown in Figure 4.

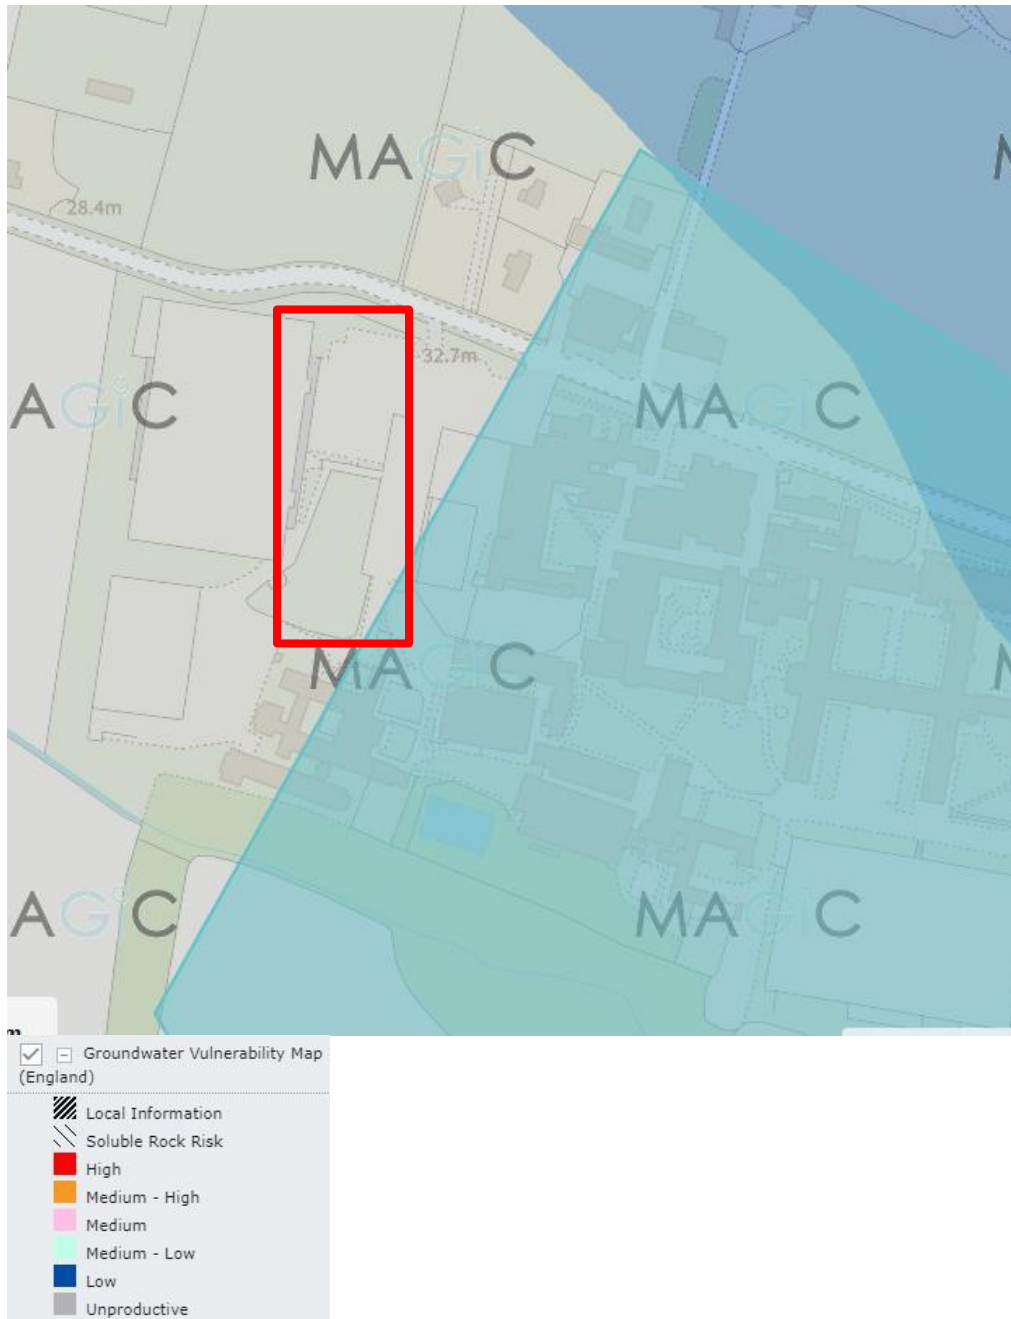
**Figure 5 – Extract from Magic Map: Groundwater Vulnerability**

Online mapping of groundwater vulnerability shows the site is located in the 'Unproductive' zone, as shown in Figure 5. This classification results in a very low risk of contaminant infiltration into groundwater source protection zones.
