**AN ARCHAEOLOGICAL INTERPRETIVE STUDY FOR  
KEYSFORD BARN, TREEMANS ROAD, HORSTED KEYNES,  
WEST SUSSEX, RH17 7EA.**

**Report number: ASL 354-25**

*This three bay threshing barn was built in the late 16<sup>th</sup> – early 17<sup>th</sup> century [Period A] with some significant alterations carried out during the early-late 19<sup>th</sup> century [Period B] and in the 20<sup>th</sup> century [Period C].*

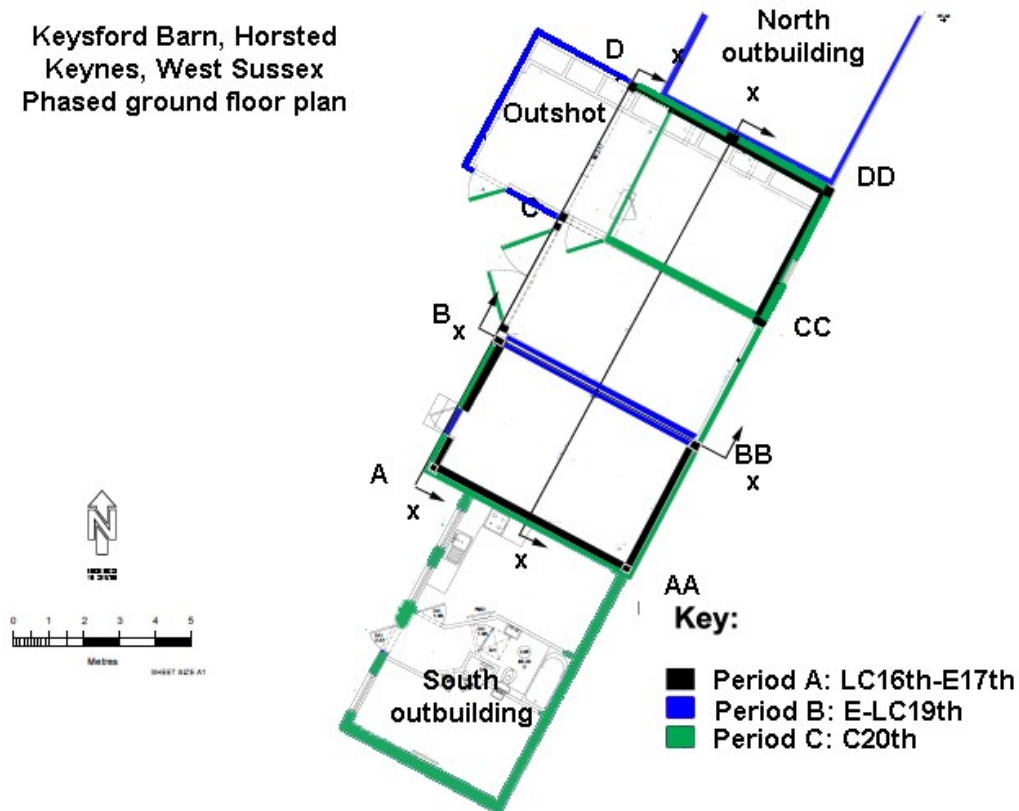
Fig. 9. Phased ground floor plan of the Barn.

- 3.1 This three bay threshing barn was built in the late 16<sup>th</sup> – early 17<sup>th</sup> century [**Period A**] with some significant alterations (Fig. 9) carried out during the early-late 19<sup>th</sup> century [**Period B**]. A further round of alterations took place in the 20<sup>th</sup> century [**Period C**].

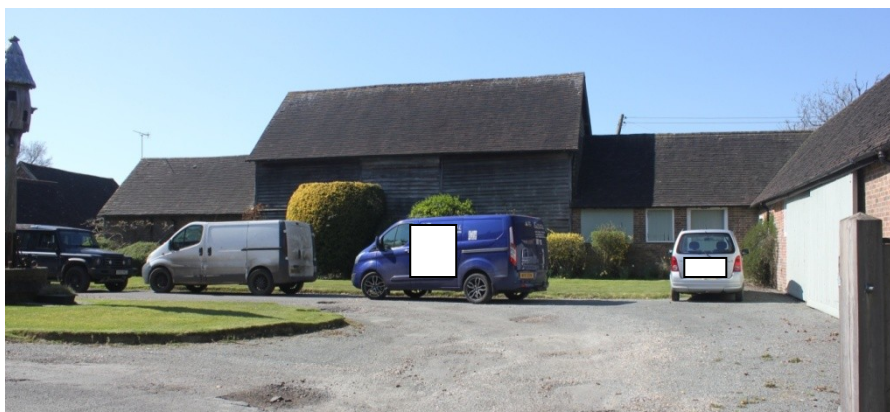
Plate 1. The east facing elevation fronting onto the farmyard.

The Principal elevation of this faces east-south-east into the former farmyard (Plate 1; herein described as being on a north-south alignment for ease of reading), although the full height Midstrete or wagon way doorway here has since been blocked over. The main entrance is now within the former rear elevation to the west (Plate 2), where a second double-width wagon way is served by modern doors (Late 20<sup>th</sup> century). The doors do not extend the full height as part of the door has been boarded over at the top. However, there are still two door pintles on the north post but they are not original to the building.

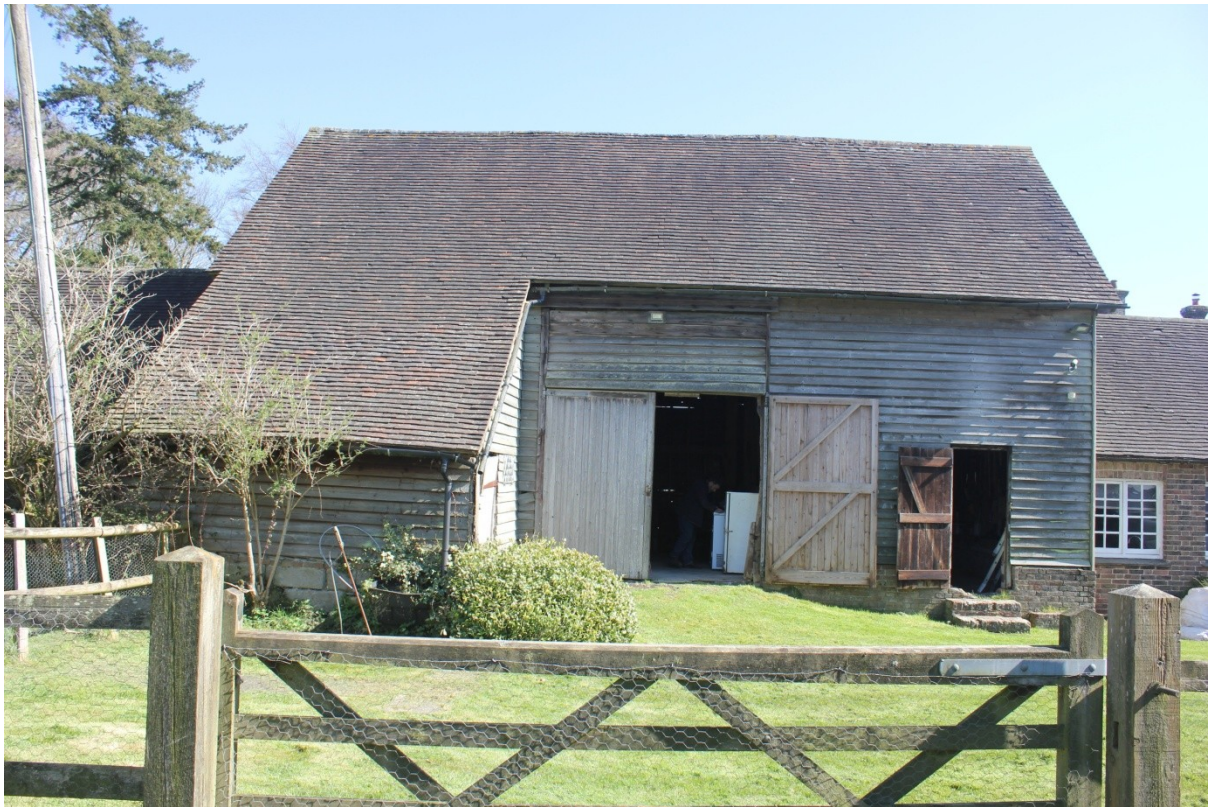
**Plate 2. The rear, west elevation.**

- 3.2 The wagon way entrance is fairly narrow, which is discussed more fully below. There is also a ledge and braced, pedestrian doorway to the south side of the Midstreys in the west elevation here but this is a later addition as the brick steps do not match the plinth bricks. The single bay outshot on the north side of this elevation is a Period B addition.

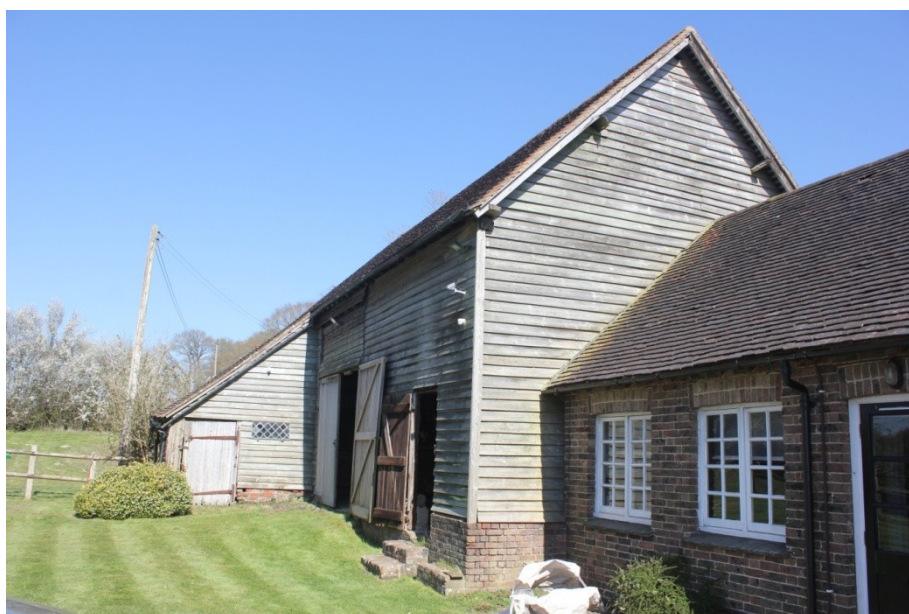
**Plate 4. Early 20<sup>th</sup> century outbuilding attached to the south elevation.**

- 3.5 There is evidence for an original  $\frac{3}{4}$  garret floor over the first bay to the south although this has since been removed.
- 3.6 The south elevation of the Barn is covered with weather-boarding of 20<sup>th</sup> century date but is partially exposed as there is an early-20<sup>th</sup> century outbuilding added to this end of the building (Plate 4).

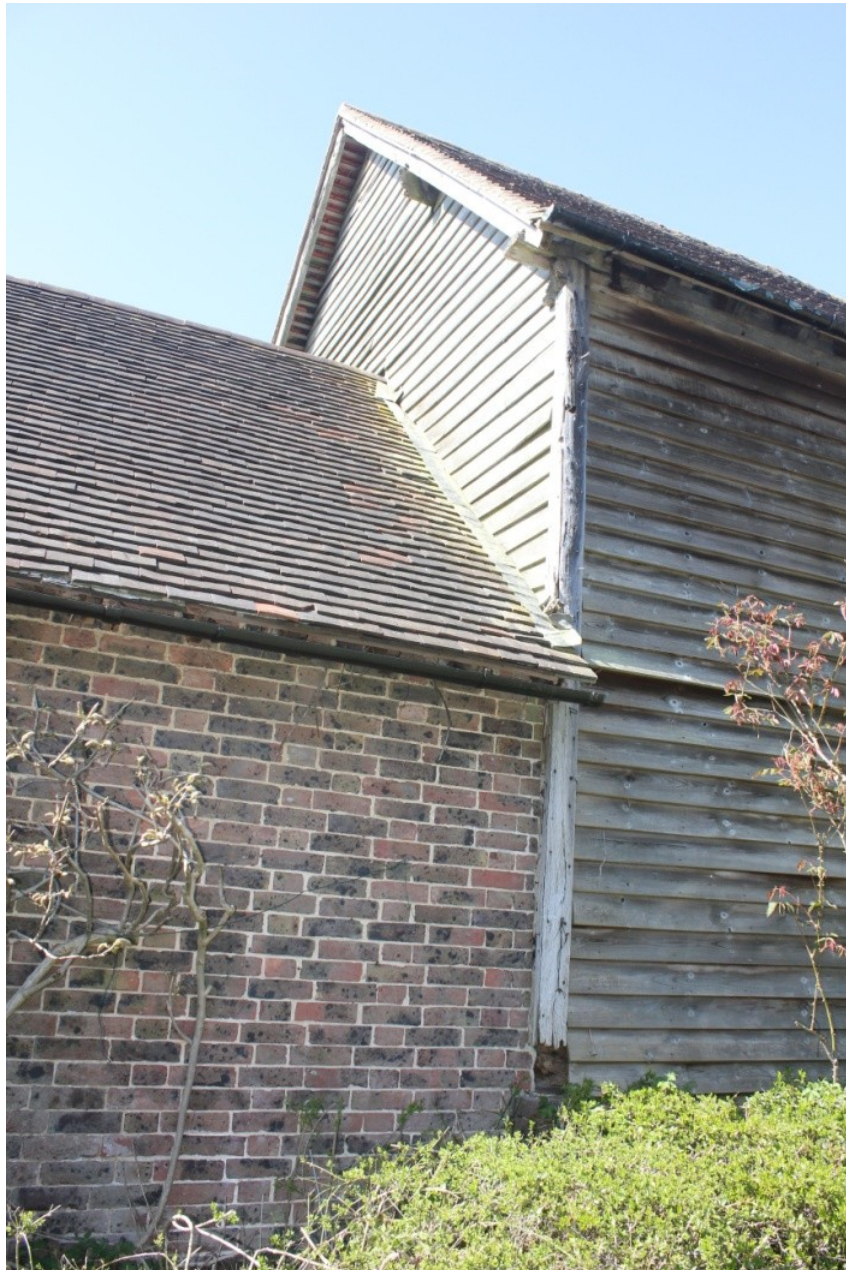
**Plate 5. Projecting timbers in the south gable.**

However, the English Bond brick plinth is partly exposed on this southern elevation showing the same clamp fired bricks as seen in the west elevation, with 11 courses exposed above ground which slopes slightly to the north. The Period C purlins, wallplates and ridge-boards are exposed in this elevation, which project slightly (Plate 5).

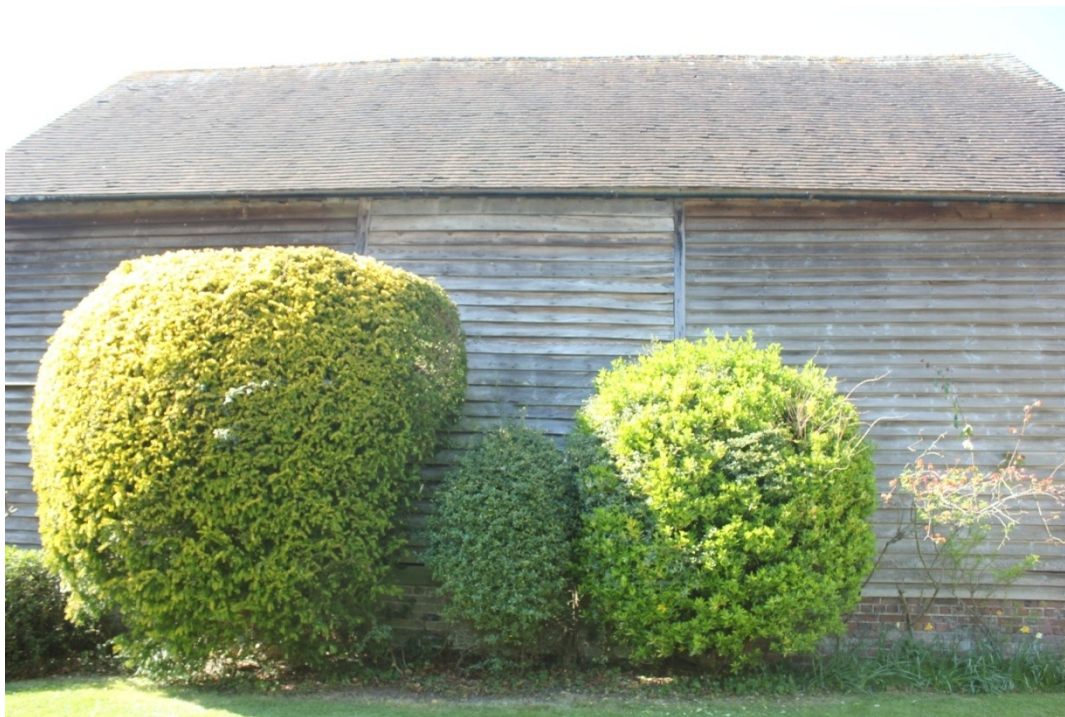
**Plate 6. Infilled Midstray to the east.**

- 3.7 The east elevation of the Barn currently has no doorway, as discussed above, and the posts are covered with attached fillets. There is an iron coach strap in the south post of the Midstrey, usually indicative of 19<sup>th</sup> century repairs. The Midstrey elevation is covered by 20<sup>th</sup> century weather-boarding (Plate 6) and the brickwork below this is also from this period. A butt joint is visible with the earlier brick to the south side of the Midstrey proving that the wagon-way was in-filled in Period C (Plate 7).

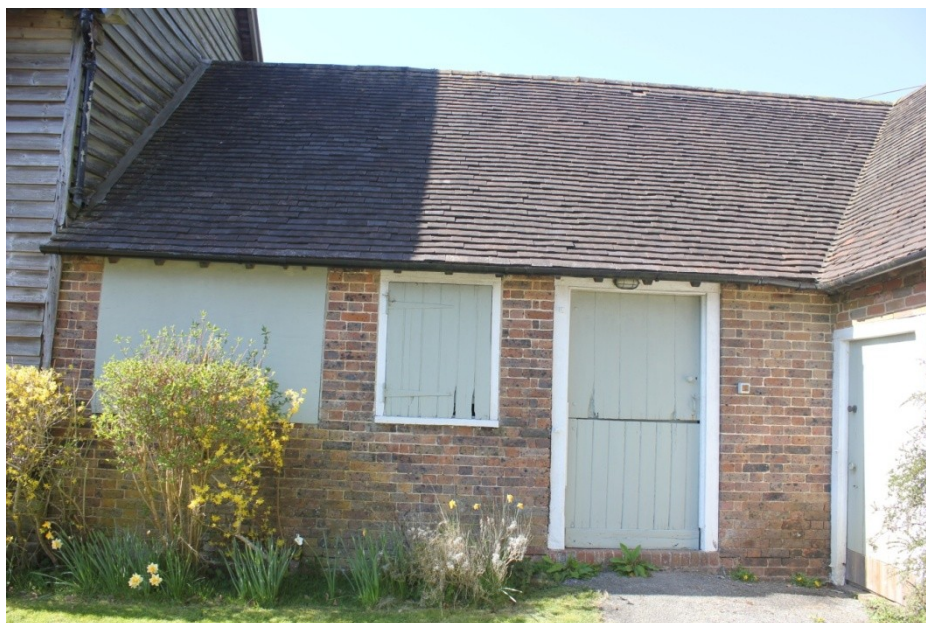
**Plate 8. Outbuilding to the north.**

- 3.8 There is another brick outbuilding attached to the north side of the Barn which was built between 1874 and 1896 (Plate 8).

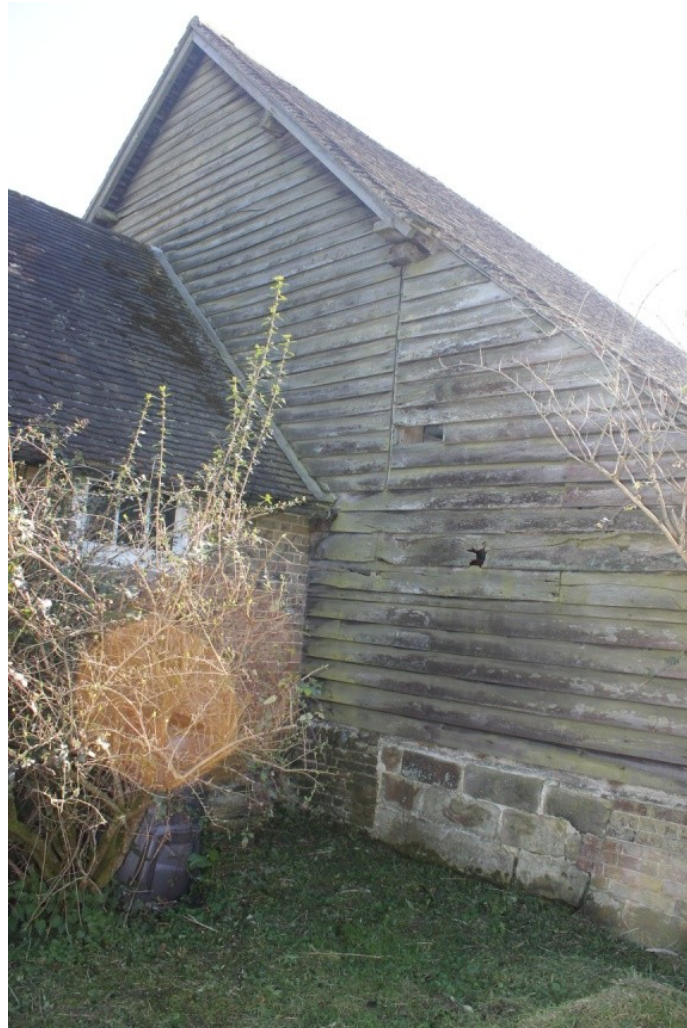
**Plate 10. The north side of the single bay outshot attached to the west elevation.**

- 3.10 The single bay outshot on the west side of the third bay to the north (Plate 10), first depicted in the historic maps in 1839 but may replace an earlier form although this is not confirmed.

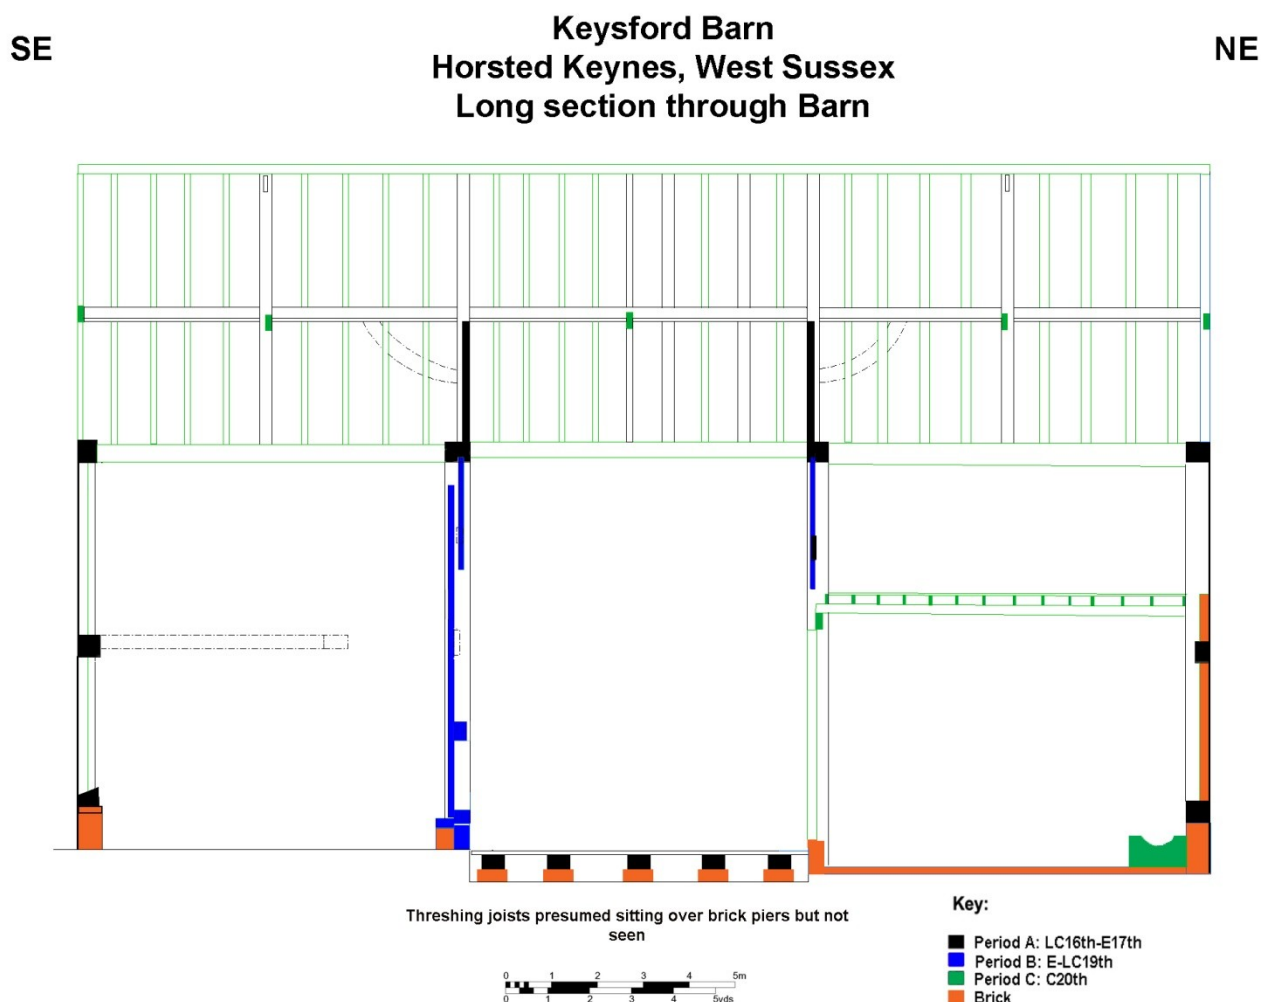
**Fig. 10. East facing long section through the Barn.**

This bay (Plate 11) was partially floored during this period but the floor was removed (Fig. 10). The gabled elevation within Truss A has been largely re-built above the tiebeam with some stud replacements below.

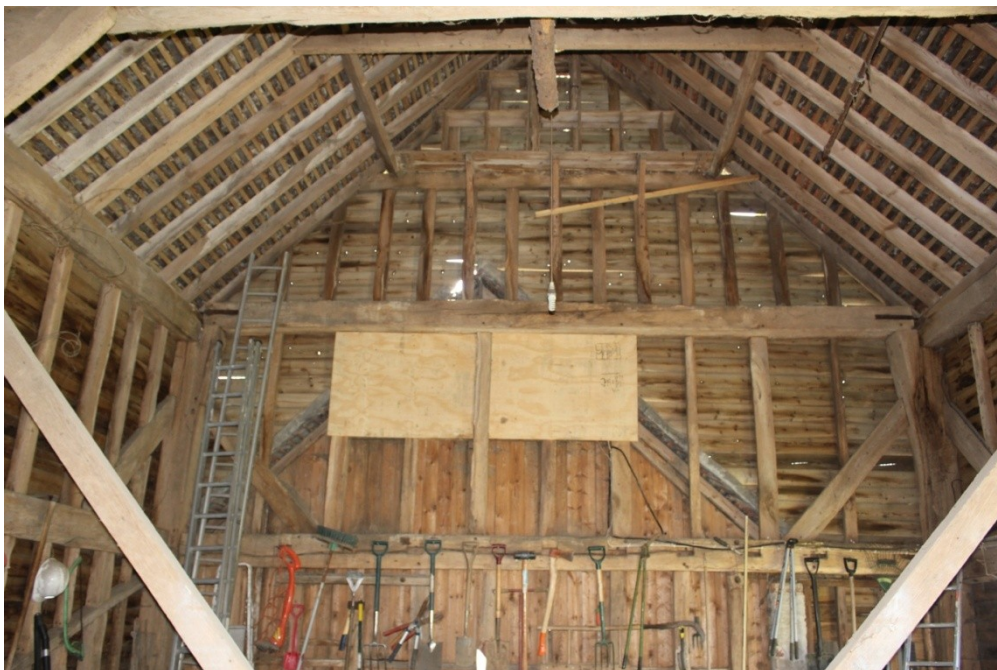
**Plate 11. The southern wall of the South Bay.**

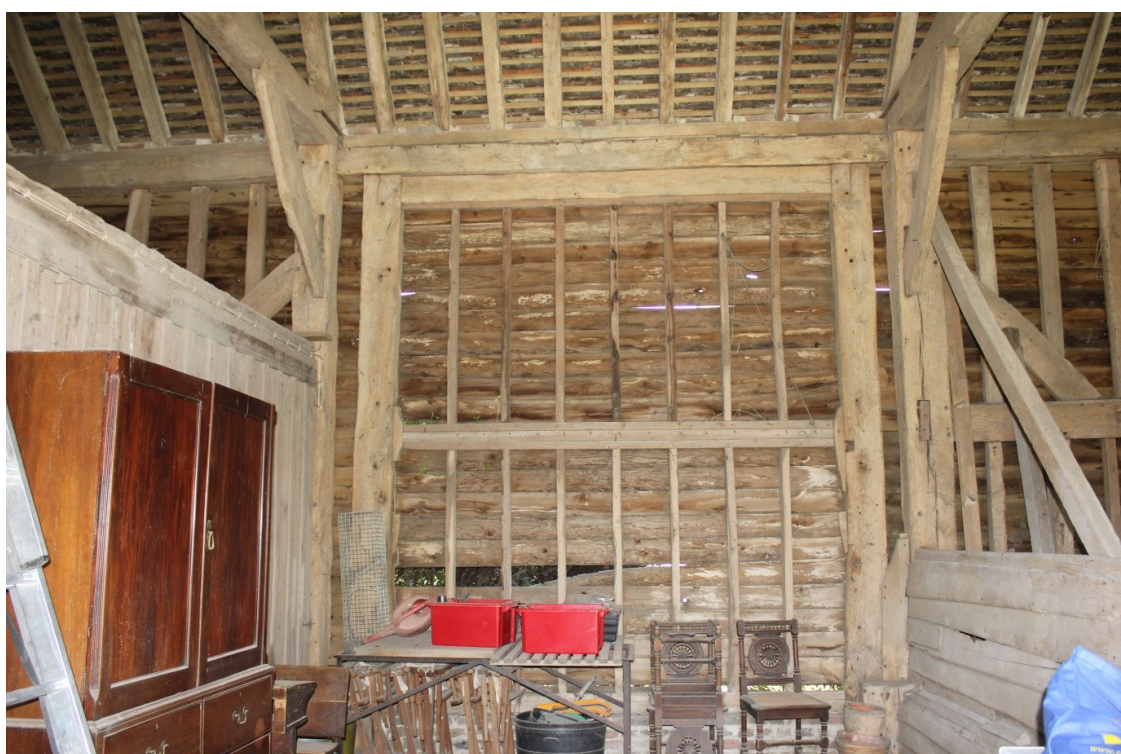
**Plate 14. The east side of the threshing bay.**

This bay consists of the threshing floor which is the narrowest bay in the building at 3.67m long (Plate 14).

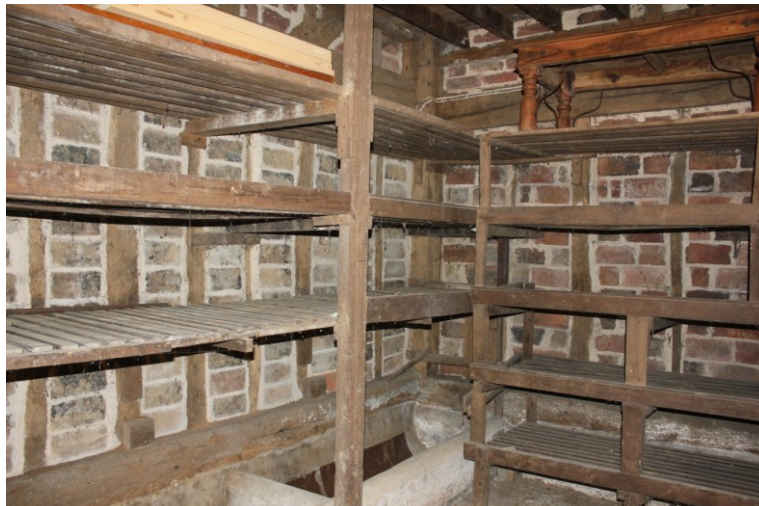
**Plate 15. Enclosed north bay with 20<sup>th</sup> century racks and infilled walls.**

This northern bay is slightly longer than the southern bay at 3.89m long but in all other ways it mirrors the first bay apart from the presence of an intermediate post in the Truss D end wall. There is an enclosed storage room created on the ground during the 20<sup>th</sup> century which does not belong to this period (Plate 15).

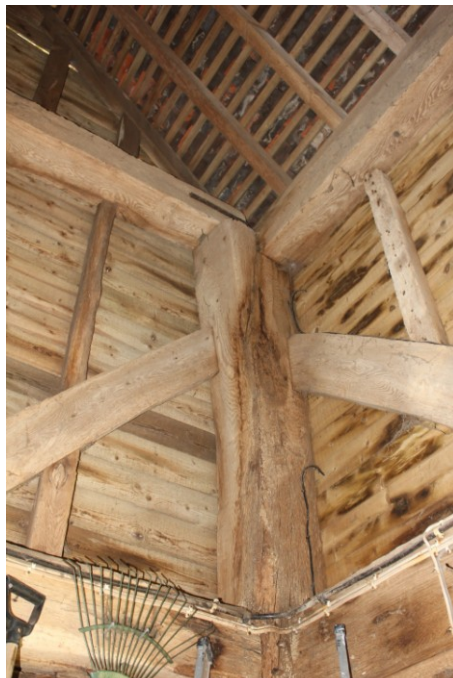
**Plate 16. Post A with slightly curved foot bracing.**

The foot braces to all the corners are slightly curved (Plate 16) but pegged centrally within the mortices due to the unusual shape of the mortices as previously discussed. The posts have slightly swelling jowls and are on average 26cm at the base and 34cm at the top.

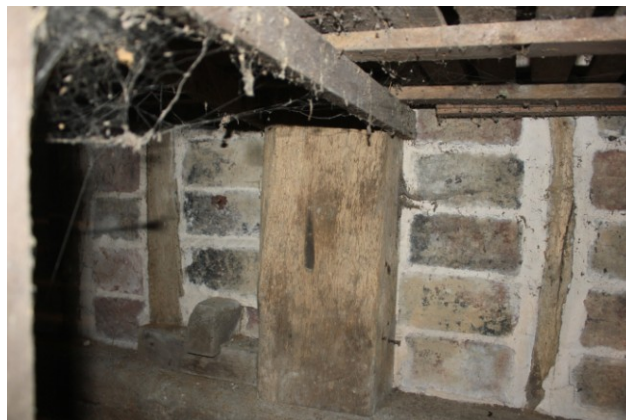
**Plate 17. Taper burn mark at the base of the intermediate post in Truss D.**

The northern end wall of Truss D has an intermediate post which has a taper burn mark at the base of the post (Plate 17). There are no other intermediate posts within the building so it is not clear why this wall has one. There are also a pair of foot braces extending from the intermediate post to the mid-tiebeam.

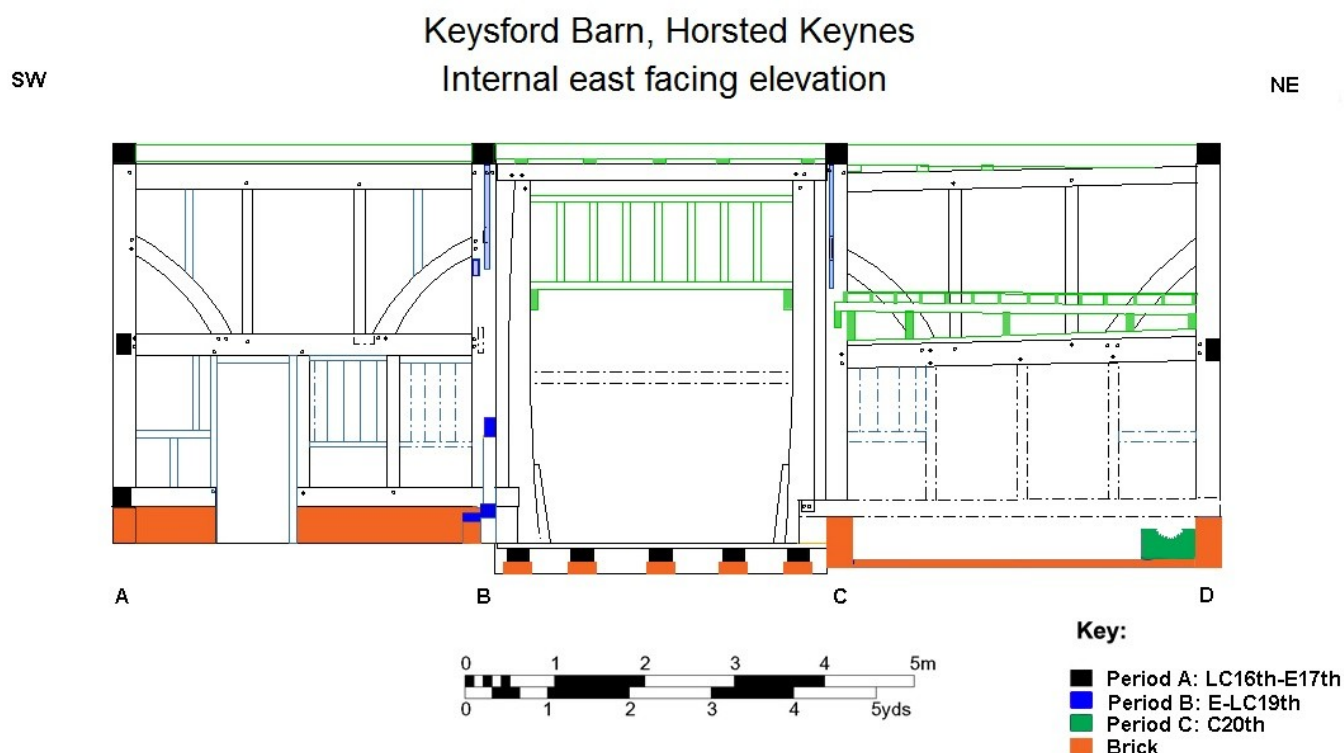
**Fig. 11. East facing elevation of the Barn.**

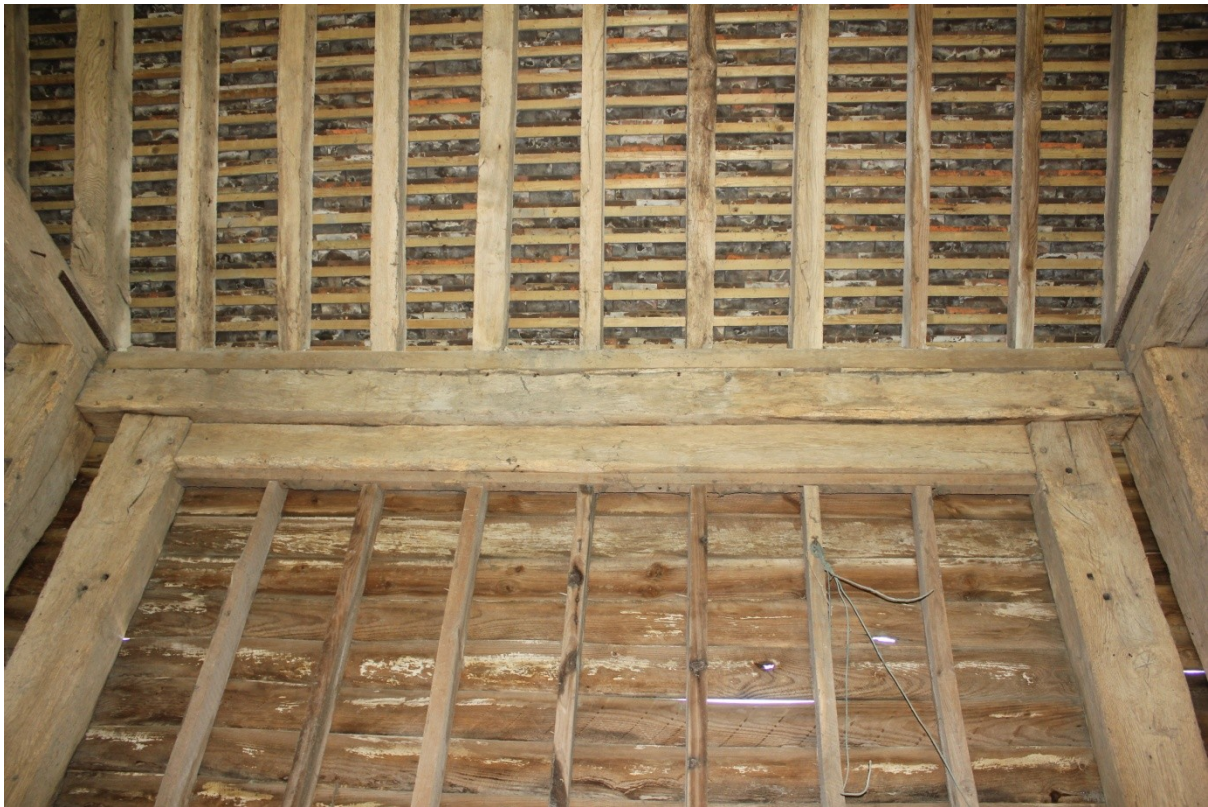
**Plate 18. Internal frame within the Wagon way aperture.**

There are two full height wagon doors on opposing sides of the Midstray as would be expected. However, the apertures have an internal frame (Plate 18) built to hang the doors on. These are purposely framed from the outset, with tenons and mortices and all the timber is pegged. This is an unusual feature and the side posts are substantial, tapering more widely to the base (Fig. 11 and Plate 19). The base of the posts are clearly tenoned to the cill beams, which purposely extended beyond the Midstray posts to the side of the inner frame. This is a rare form which neither recorders have seen elsewhere and it is not clear why a separate frame was necessary to hang the doors off.

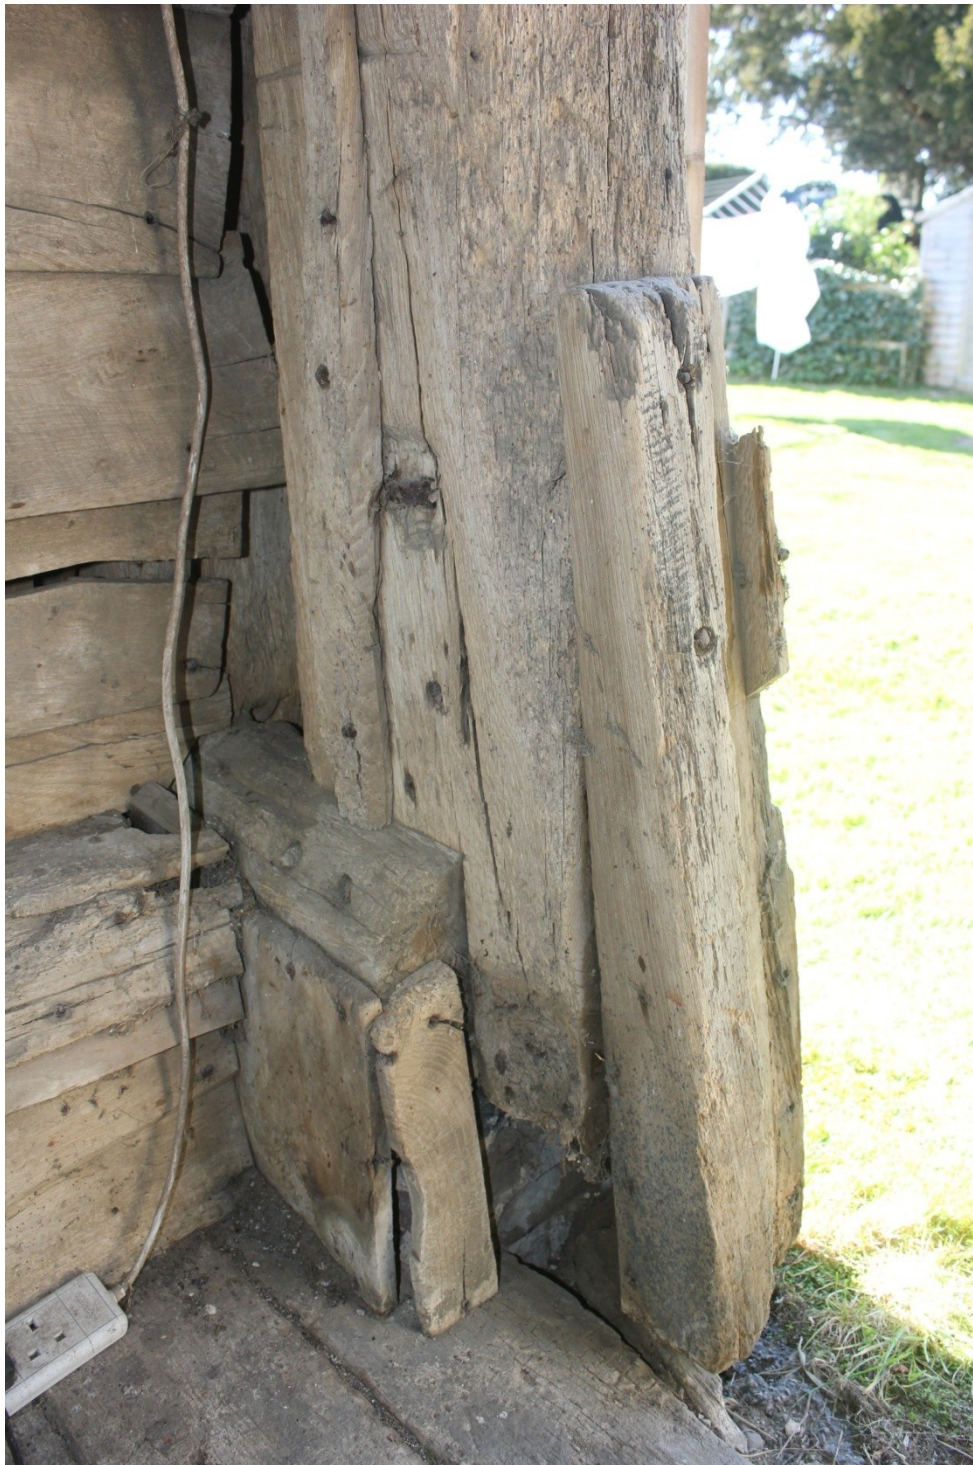
**Plate 20. Southern 'slide' *in-situ* on Post B.**

The doorway of the western wagon-way has two slides present (Plate 20) for the threshold boards which would have slid into place. The slides are nailed into place,

not pegged so they could be a later addition. There are no slides present in the eastern door but some bolt holes plus the 'hacked' appearance of the posts in this location would suggest they have been removed.

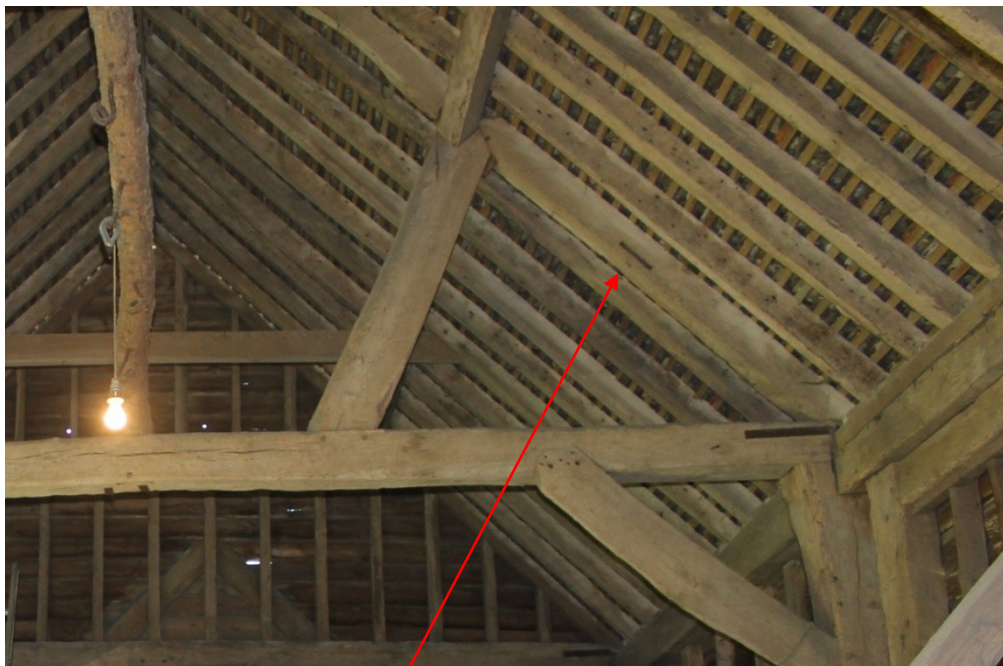
There is rebate evidence for Period A wind braces which have since been removed. In particular, two slim mortices can be seen on the inner edges of the Midstray in Trusses B and C where the Principal rafters have been re-positioned. These have been turned 180° where a pair of wind braces would have been in place from the

southern side of Truss B and the northern side of Truss C adjacent to the Midstray (Plate 22).

**Plate 22. Wind brace mortice on the inner face of Truss B.**

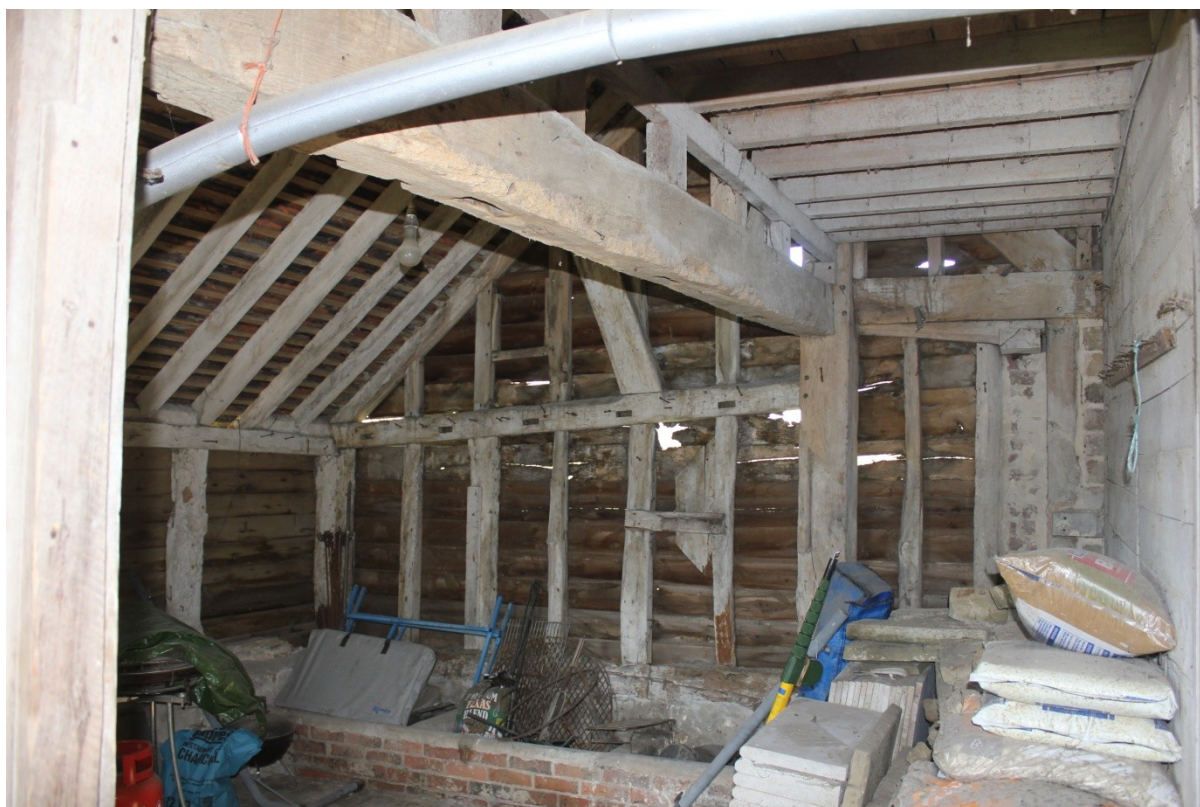
During this period the only change to the layout was the attachment of an outshot to the west side of the northern bay only. The current outshot is *likely* to be a replacement of an earlier structure which would have been much narrower if it had followed the pitch of the original roof. The structure, as it stands has ties which are tenoned and pegged to the west side of the Period A Posts C and D (Plate 24), but nailed to the rafters with all other timbers also nailed and lime washed.

**Plate 24. The outshot, looking north.**

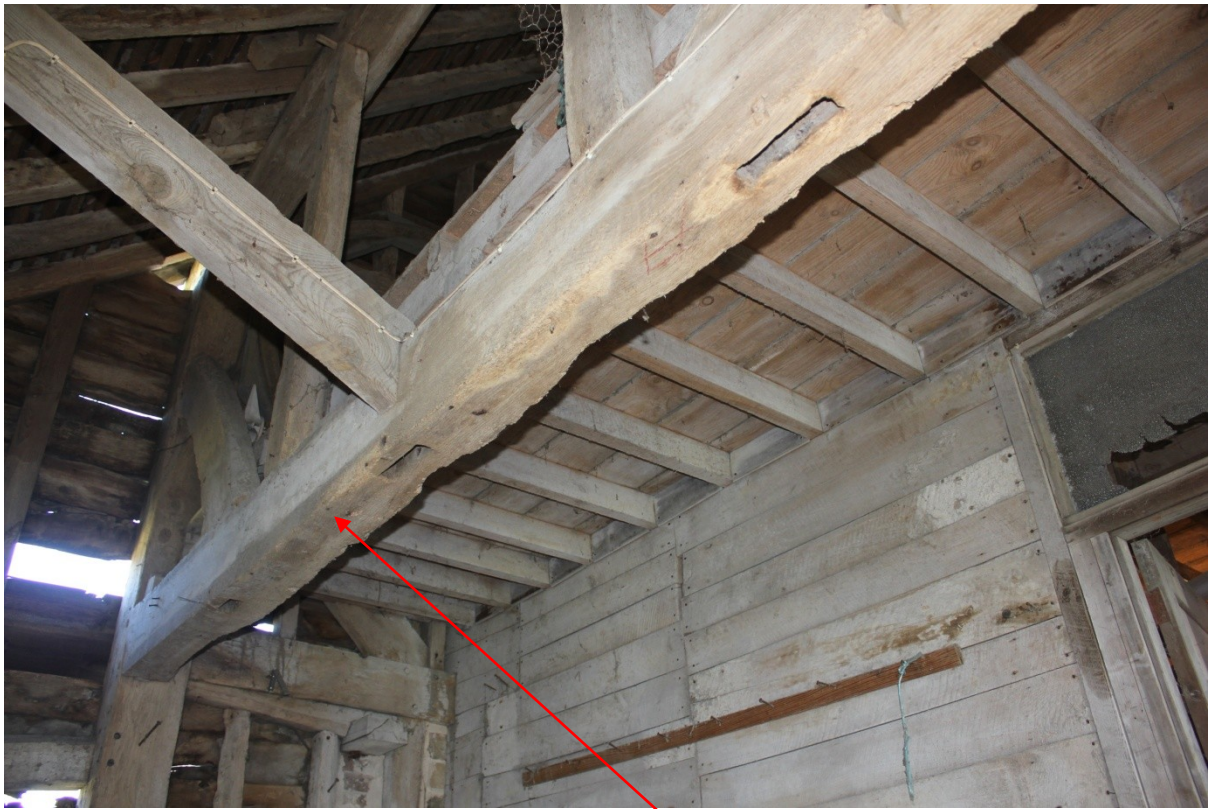
There are a series of nail holes running the length of Posts C and D which are either for an internal boarded partition wall or for an external wall prior to the outshot being built. It is not clear if this outshot did replace an earlier one but the lack of weathering on the outside face of the Period A frame suggests there may have been one from the outset. However, there were two windows inserted into the original Period A west wall utilizing the wall studs (Plate 25; now missing), mirroring the inserted windows in the southern bay to some extent although all of the timbers are missing here. The mortises for the cills and shadow marks of the removed window heads can be clearly seen so it is perhaps more likely that this represents an external wall with inserted windows. The wall paneling and windows were removed, most likely at a later date during this period when this end of the Barn was altered to house animals.

**Plate 25. Mortices for missing wall studs and shadow line of missing window head.**

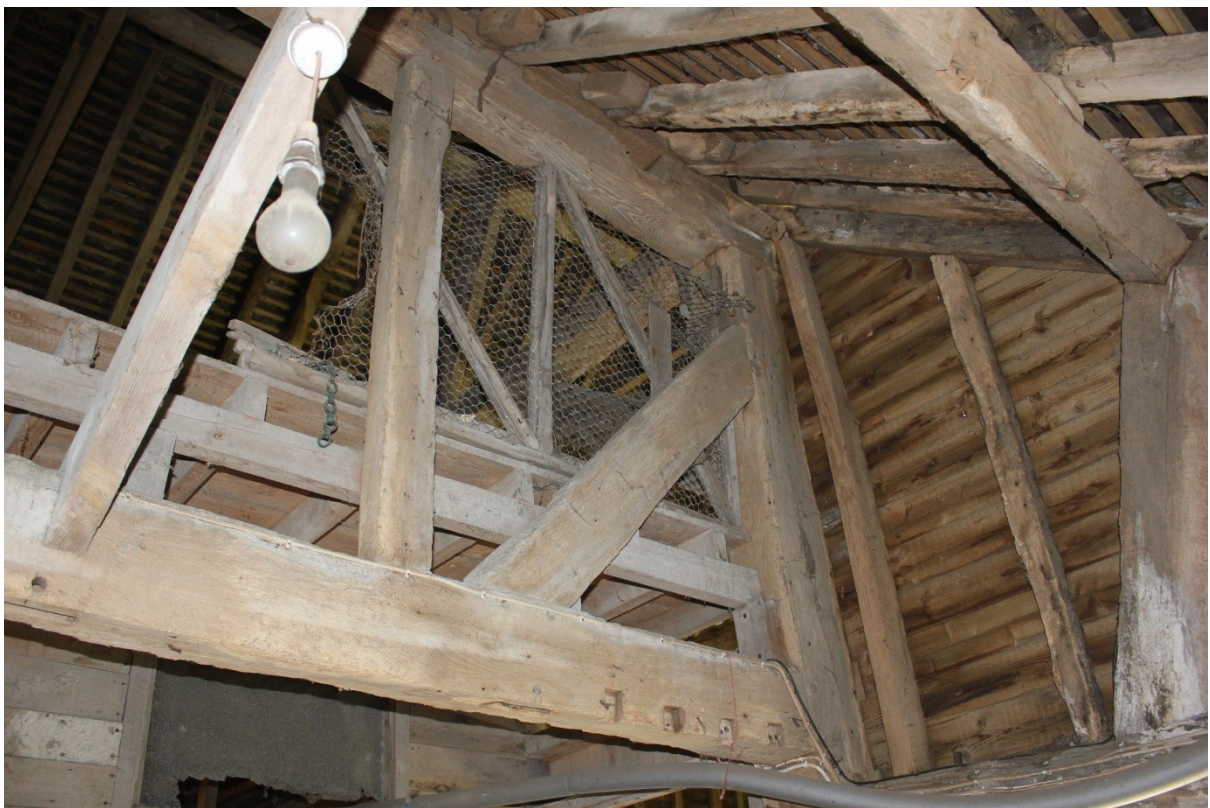
The window to the south side of the bay was clearly cut and nailed into the Period A side girt with four notches for the mullions clearly exposed (Plate 26).

**Plate 26. Notches for window mullion in the south side of the western girt.**

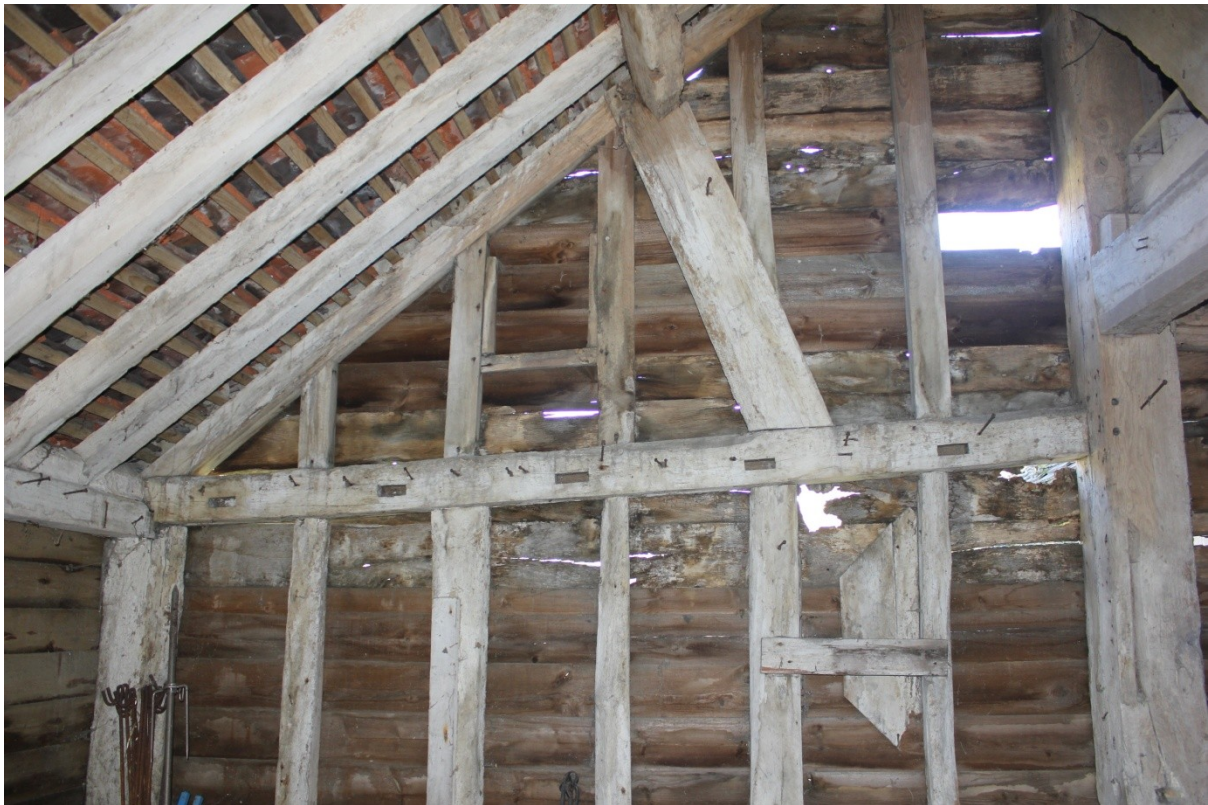
There is an element of re-use within the structure which includes a series of joist mortices in the north tie (Plate 27), as well as some empty mortices within a purlin (Plate 28) all from another structure.

**Plate 27. Joist mortices in the northern tie.**

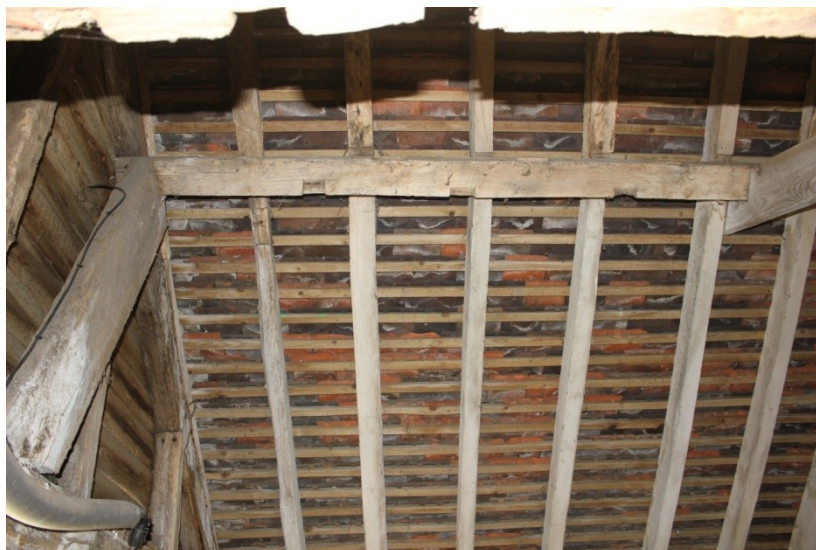
**Plate 28. Empty notches from a former wallplate in the outshot purlin.**

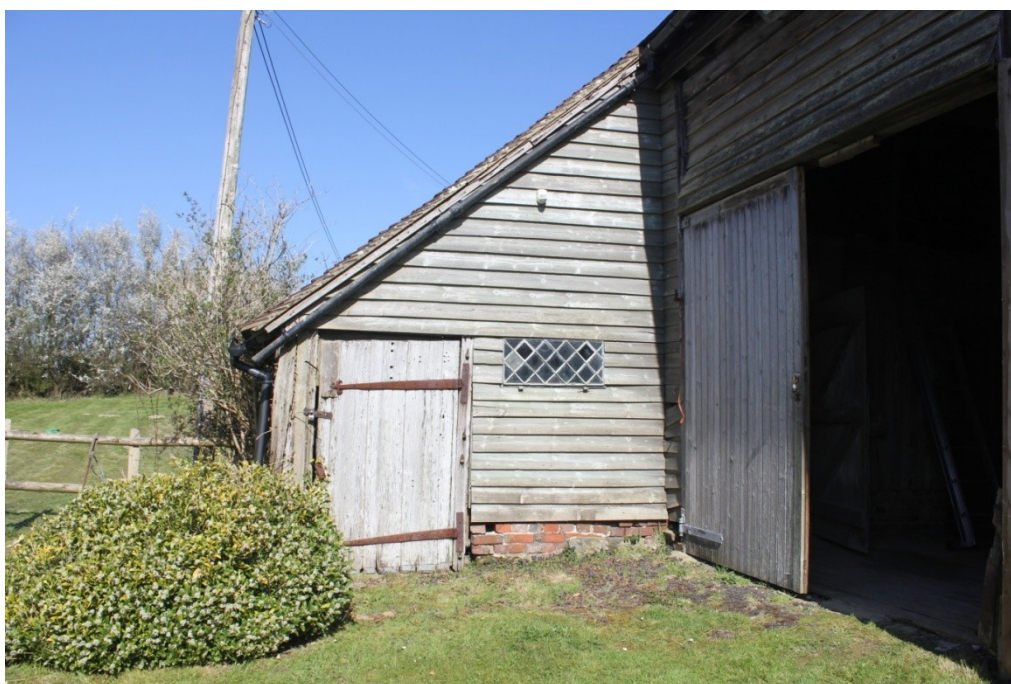
Externally, the south elevation is covered with modern weatherboarding with a brick plinth as well as small amount of stone forming the base of the wall here (Plate 30).

**Plate 30. The southern wall of the Outshot.**

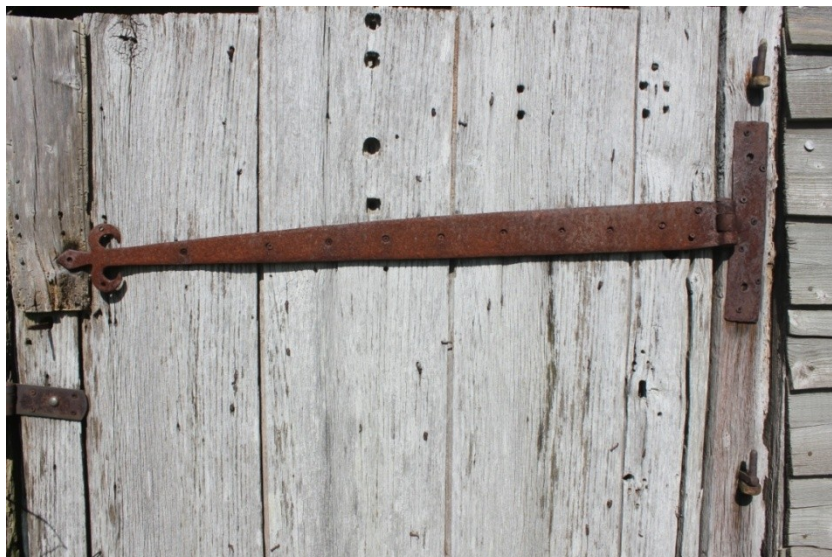
A pedestrian door in the southern elevation gives access into the outshot. This door is a much later addition as there is evidence internally for two vertical studs which have been cut through and removed in order to insert the doorway. The strap hinges for the door are blacksmith forged with fleur-de-lys terminals (Plate 31). However, there are pintles evident for a stable door which preceded this ledge and braced door. The planks are thick and wide and could be re-used floorboards.

**Plate 31. Blacksmith made strap hinges in the outshot door.**

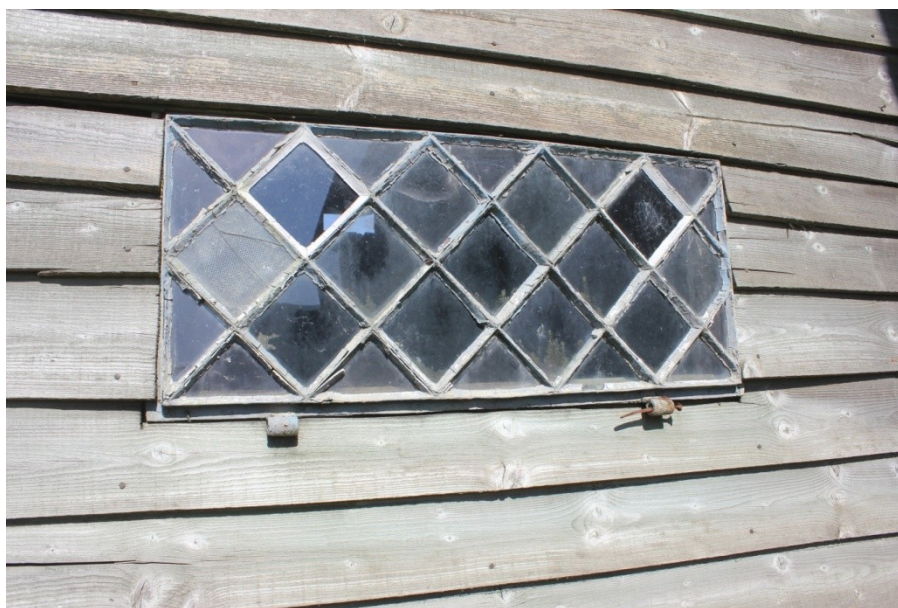
There is a diamond light, lead glazed Crittall style metal window (Plate 32) which is re-used and positioned on its side. The attached window furniture suggests an early 20<sup>th</sup> century date for this window.

**Plate 32. Re-used, inserted window in the outshot southern wall.**
