**AN ARCHAEOLOGICAL INTERPRETIVE STUDY FOR  
KEYSFORD BARN, TREEMANS ROAD, HORSTED KEYNES,  
WEST SUSSEX, RH17 7EA.**

**Report number: ASL 354-25**

*This three bay threshing barn was built in the late 16<sup>th</sup> – early 17<sup>th</sup> century [Period A] with some significant alterations carried out during the early-late 19<sup>th</sup> century [Period B] and in the 20<sup>th</sup> century [Period C].*

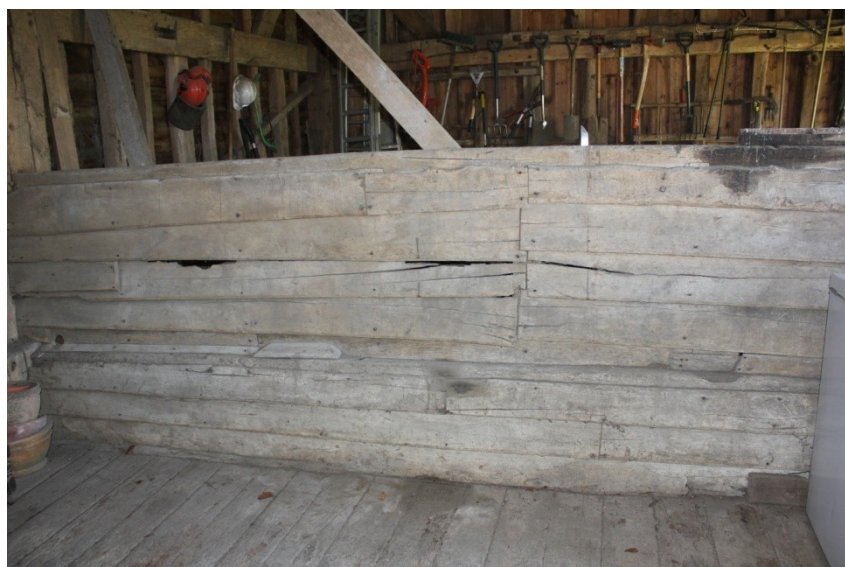
Truss B has a pair of inserted raking shores which were morticed into the top of the posts (not pegged) and which sit on brick piers on the floor. They are almost square in section and are contemporary with the low threshing partition on the south side of the threshing floor (Plate 34). This partition (Plate 35) is also a later insertion as it is not morticed and pegged at both sides to the Period A posts. Instead it is morticed on the east side and lapped and bolted into place at the west side (Fig. 12).

Plate 35. Threshold partition to the south side, with two phases evident.

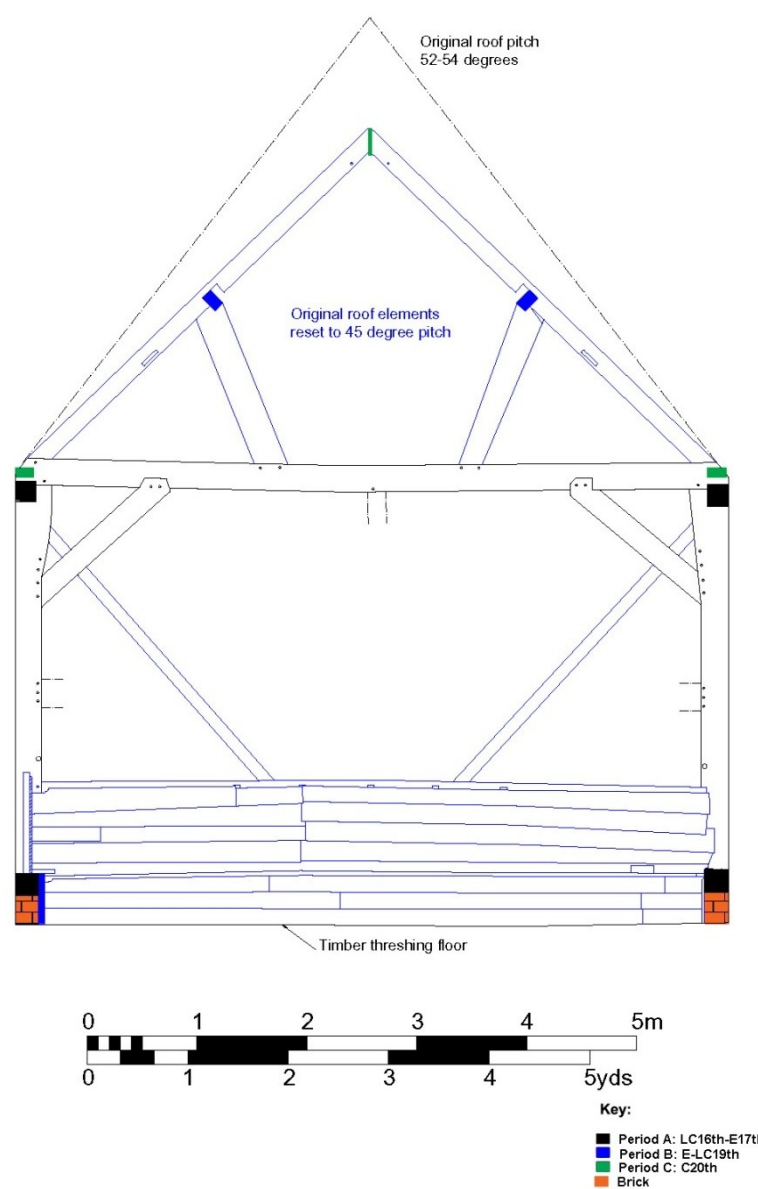
Fig. 12. North facing cross section through Truss B.

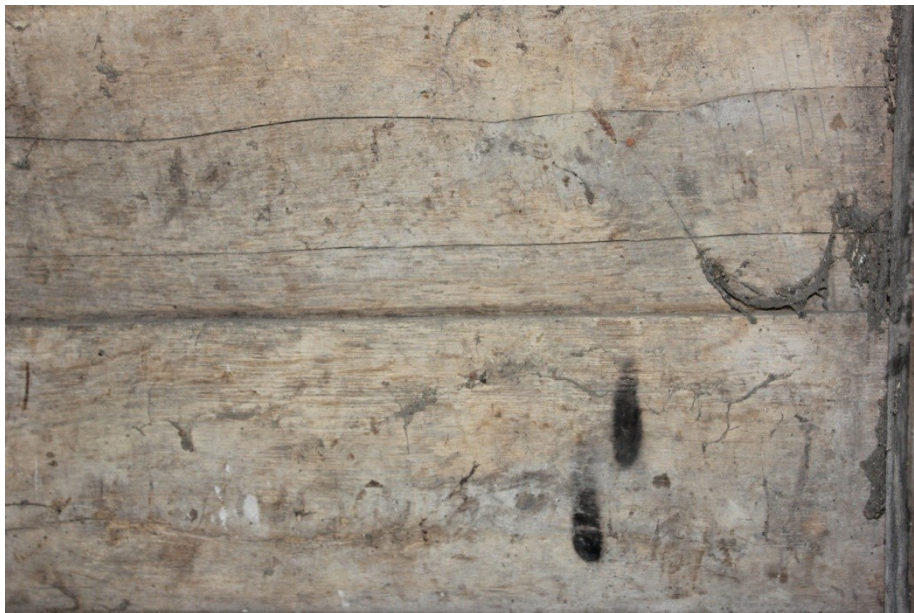
There may be two phases here as the lower plate is much wider, has a different colour to the other timbers above it and has just three rows of different weatherboarding attached to it forming a low partition. The vertical studs above this are attached to two horizontal plates as well as the raking shores so are contemporary. It was noted that the partition was unusually high for a threshing barn so it may be that once they stopped using the barn for threshing, an alternative use was found which is likely to have been for stacking bales, hence the shores and a higher partition needed. It's likely this was when the floor was removed as it is easier to stack bales from the ground to the roof without a floor present. There are at least two taper burn marks on the south side of the partition (Plate 36) but there could be more masked by the timber panels on this side. There is also an inscribed alphabet on the top rail of the partition although the complete alphabet does not extend beyond the letter H (Plate 37).

**Plate 36. Taper burns marks on the south side of the threshing partition.**

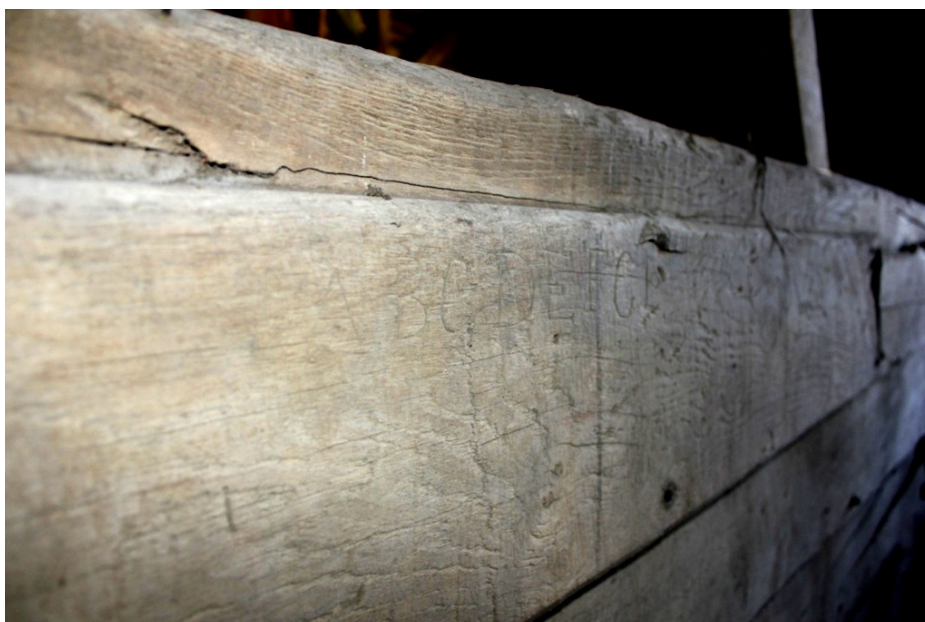
**Plate 37. Inscribed partial alphabet on the north side of the partition wall.**

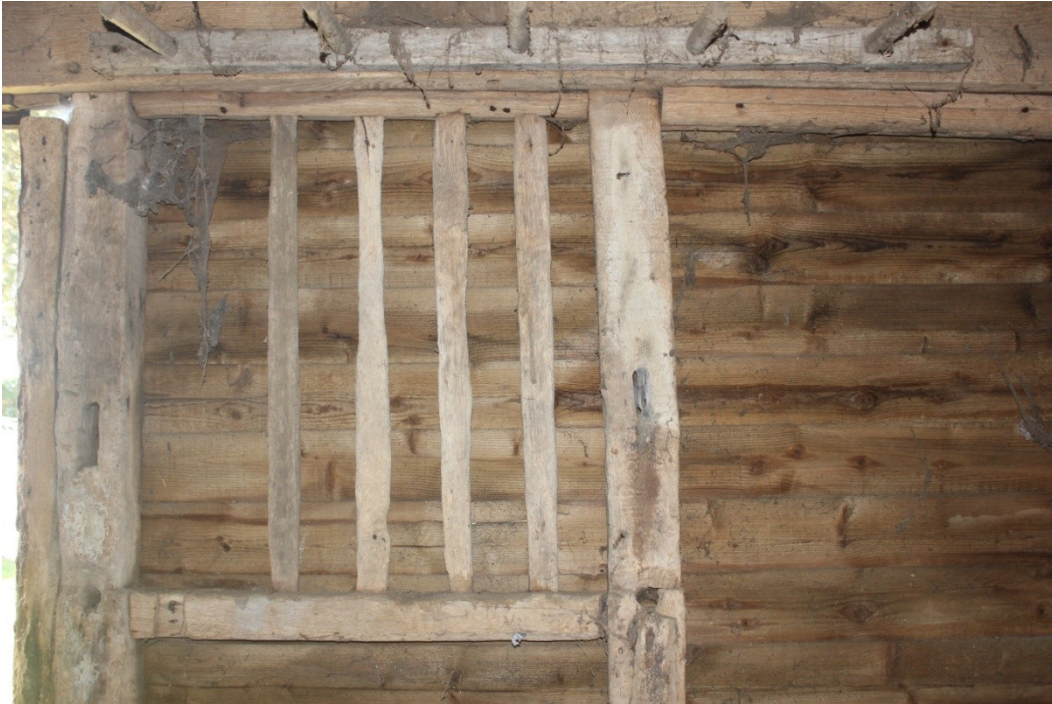
There are two inserted windows in the west elevation which have mullions still *in-situ* in one of the apertures (Plate 38) although they have both been boarded over during the 20<sup>th</sup> century. These are adjacent to an inserted pedestrian doorway in the southern bay, which is still in use. One of the window heads has utilized an ovolo moulding from a domestic window (Plate 39) and the round ended mortices are evident in the soffit of the timber. A peg rack is positioned above the window, possibly utilizing the air circulation for drying items.

**Plate 38. Makeshift mullion window north of the pedestrian doorway to the west.**

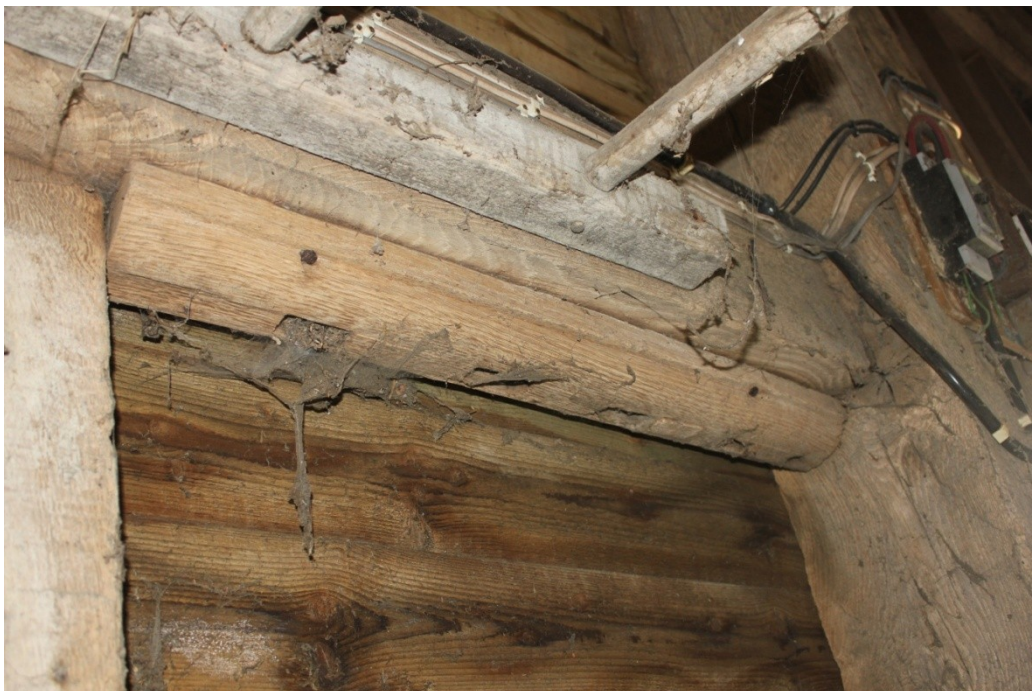
**Plate 39. Re-used ovolo moulding in the second window head.**

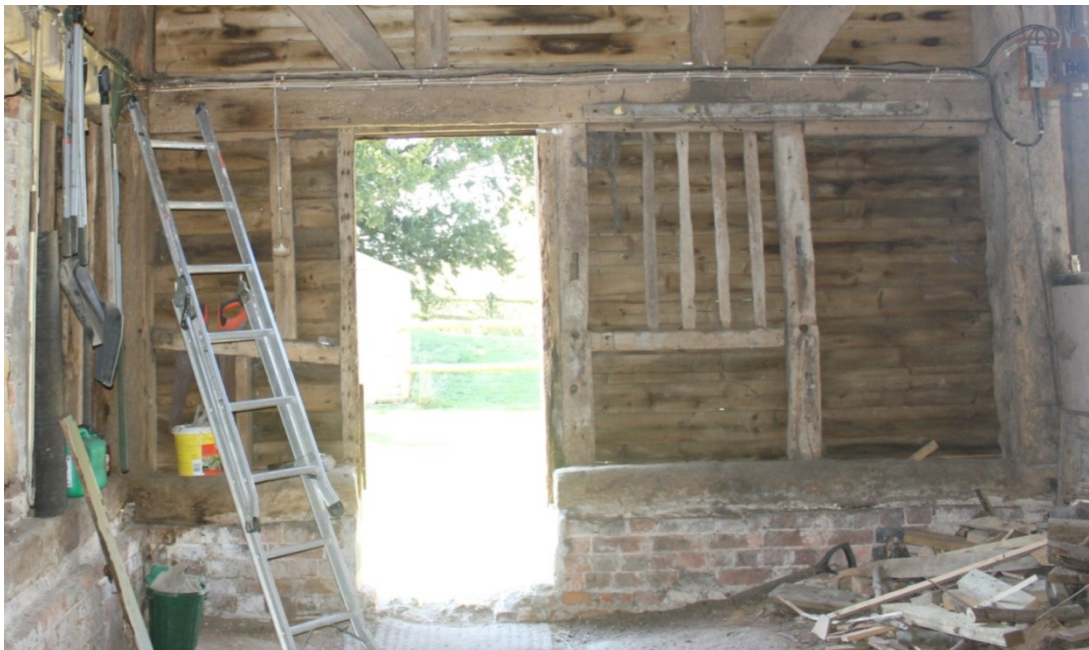
The pedestrian door in the western side of the southern bay is an insertion, most likely from this period, which required the removal of the brick plinth and the cill beam (Plate 40). Two studs have been used to form the door frame (one has since been replaced) with a door head nailed between the two and a set of brick steps added externally. The door is a modern ledge and braced replacement and there are some inserted studs and a rail to the side of the door.

**Plate 40. Inserted Period B doorway adjacent to the inserted windows.**

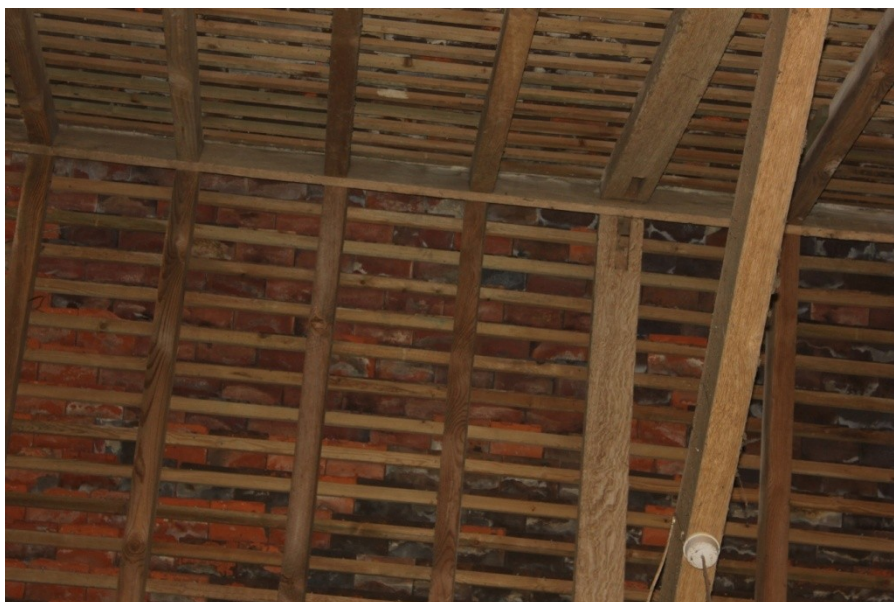
As has already been discussed, the roof has been re-built at least twice and the first re-roofing event was probably undertaken in Period B when the roof pitch was dropped, a ridge-board inserted and new common rafters were inserted as well as the terminals switched from hips to gable ends. This is evident in the truncation of the hip rafters which once had a high set collar, which now places it almost at ridge height (Plate 42).

**Plate 42. High set collar mortices at the ridge.**

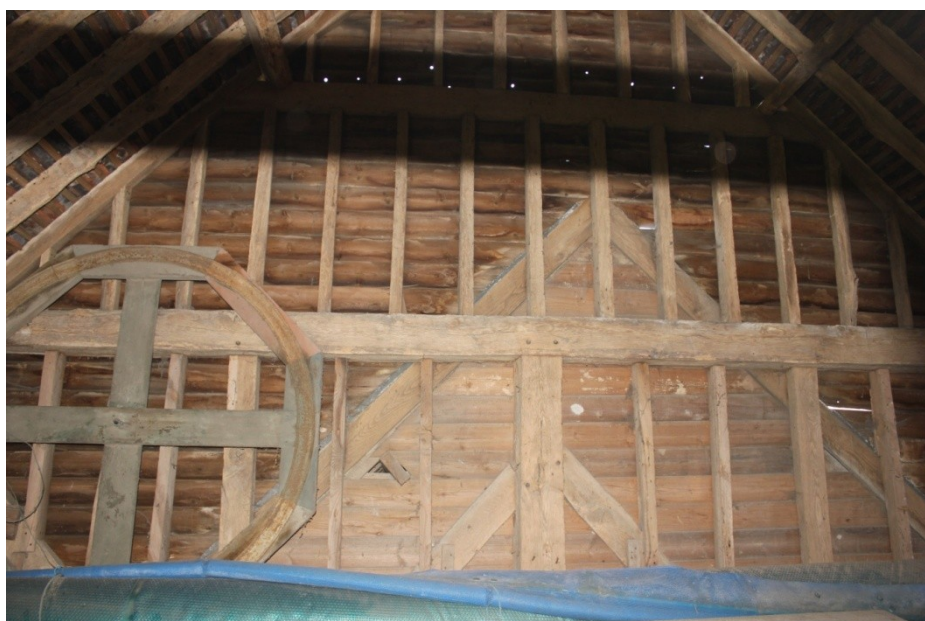
The change of roof terminals enabled the outbuilding to the north side to be built against the new gable (Plate 43).

**Plate 43. The northern outbuilding built against the gable.**

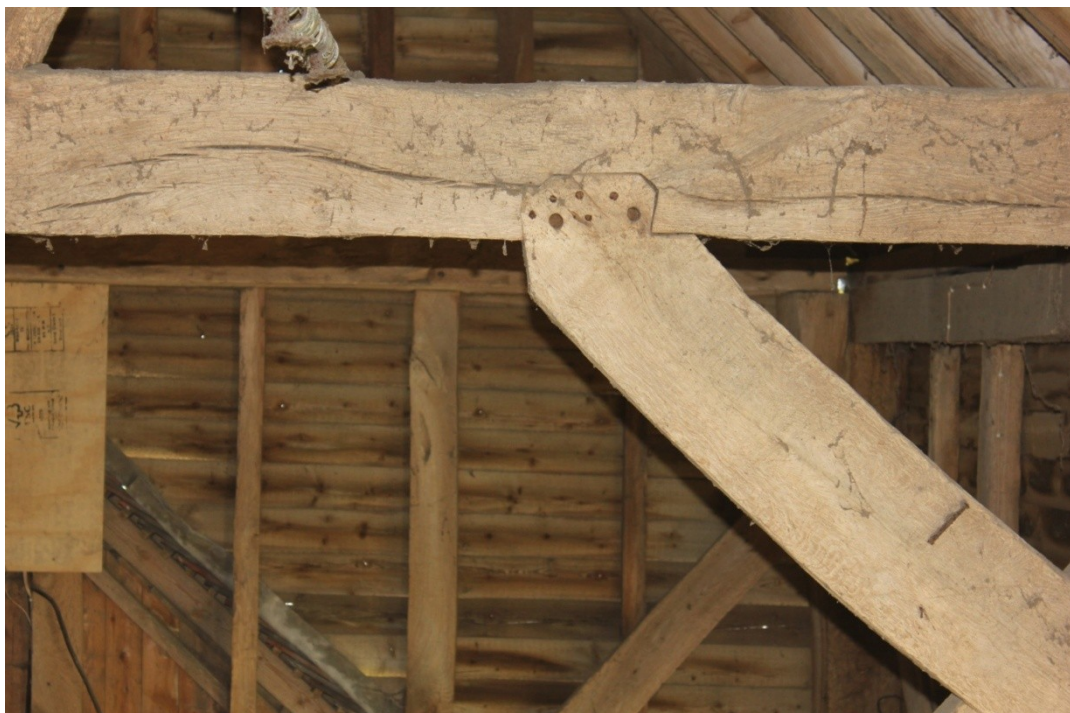
In addition, the head bracing to the tiebeams of Trusses B and C was removed, cut down in size and turned 180° and set into the tiebeams (Plate 45). They were then attached by nails at the top but pegged into the post in lower cut mortices with square pegs. The higher, original mortices are present but it is not entirely clear why these adaptations were necessary.

**Plate 45. Head bracing in Truss B turned and nailed into place.**

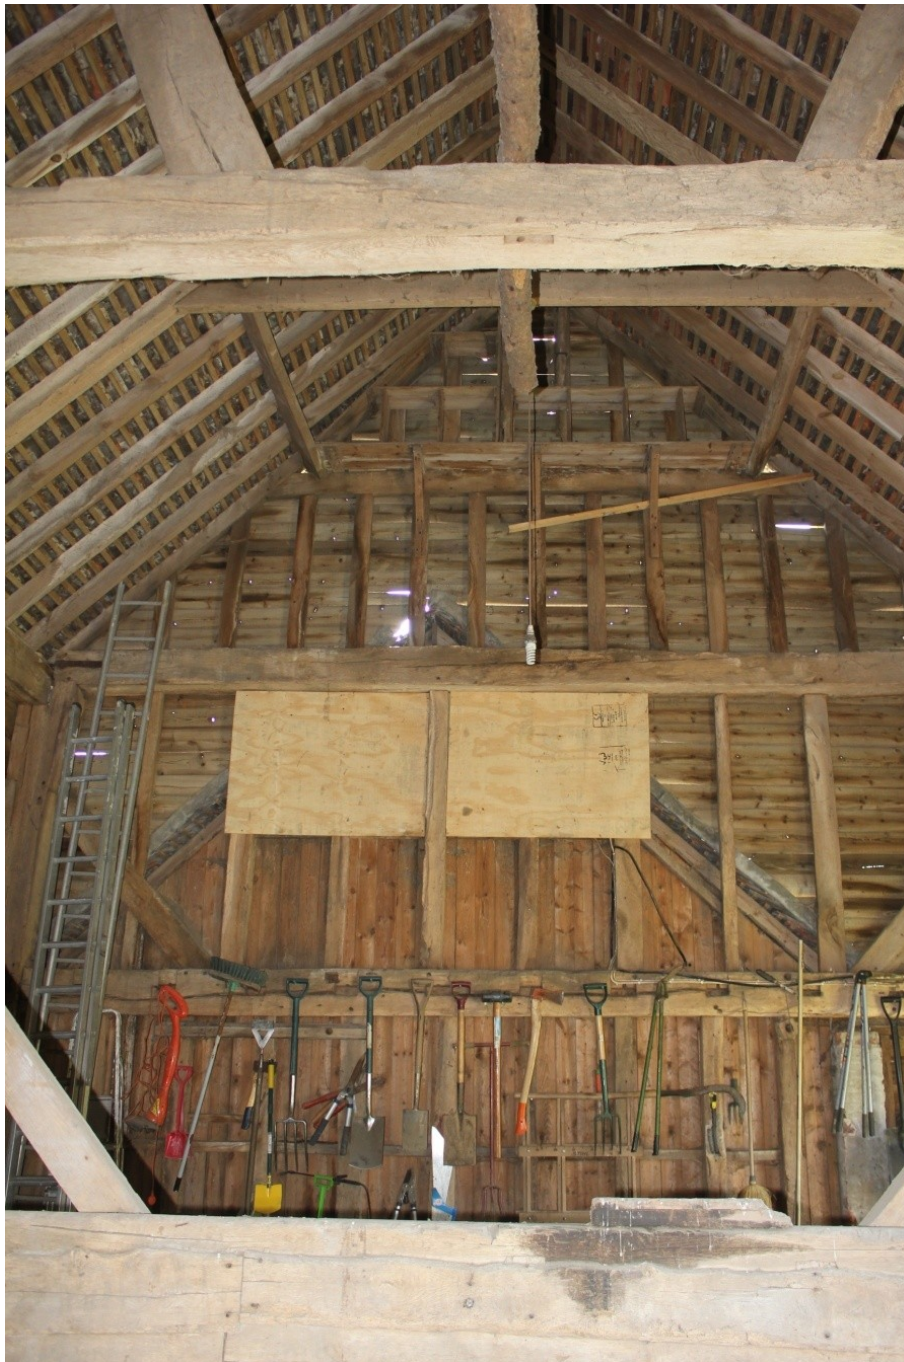
The stub gables are also a re-build and the roof purlins in the southern bay have been replaced by softwood timbers (Plate 46) and it appears that the original purlins have been moved across (and rotated) to the second and third bays.

**Plate 46. Softwood purlins in the southern bay.**

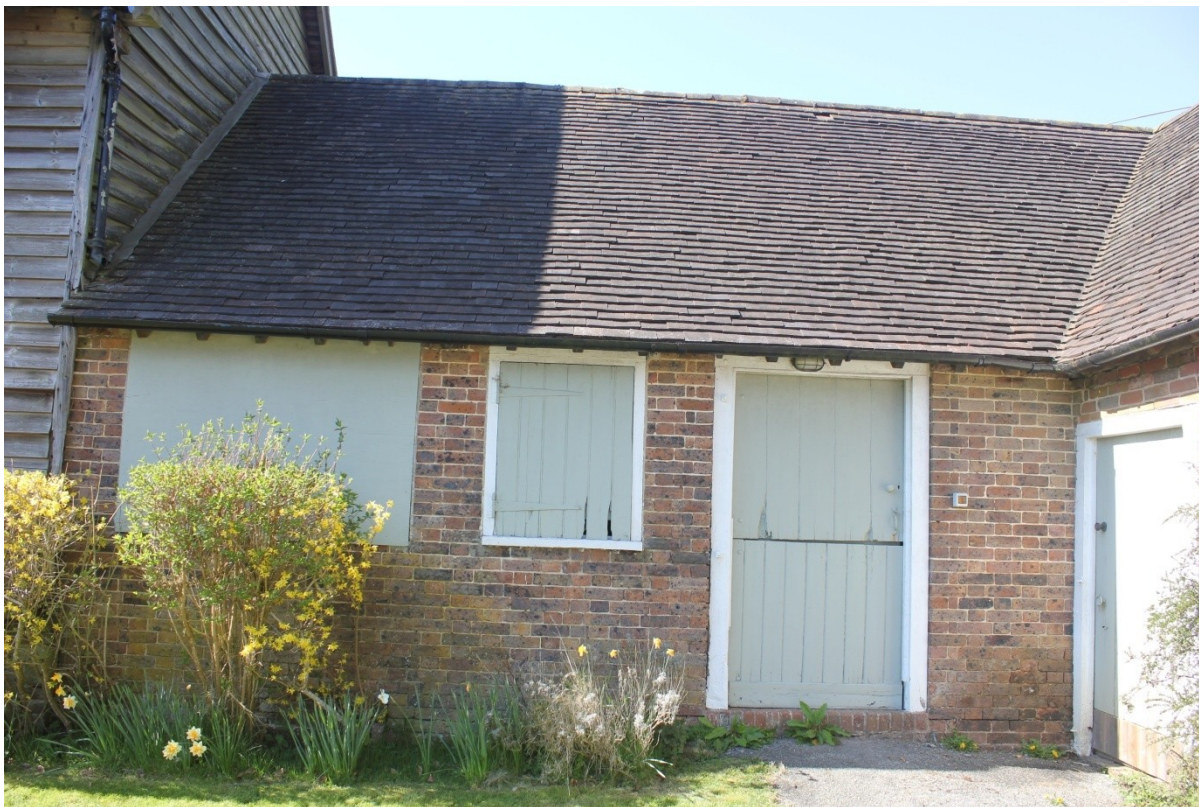
This building (Plate 47) was built between 1874 and 1896 is attached immediately to the north elevation of the Barn. This is a brick structure laid in Flemish Bond with clamp fired bricks and the east elevation has a blocked window and a hatch with beaded tongue and groove boards. No glass is apparent. There is a stable door next to the apertures with late 19<sup>th</sup> century, painted brass door furniture.

**Plate 47. The east elevation of the northern outbuilding, facing into the farmyard.**

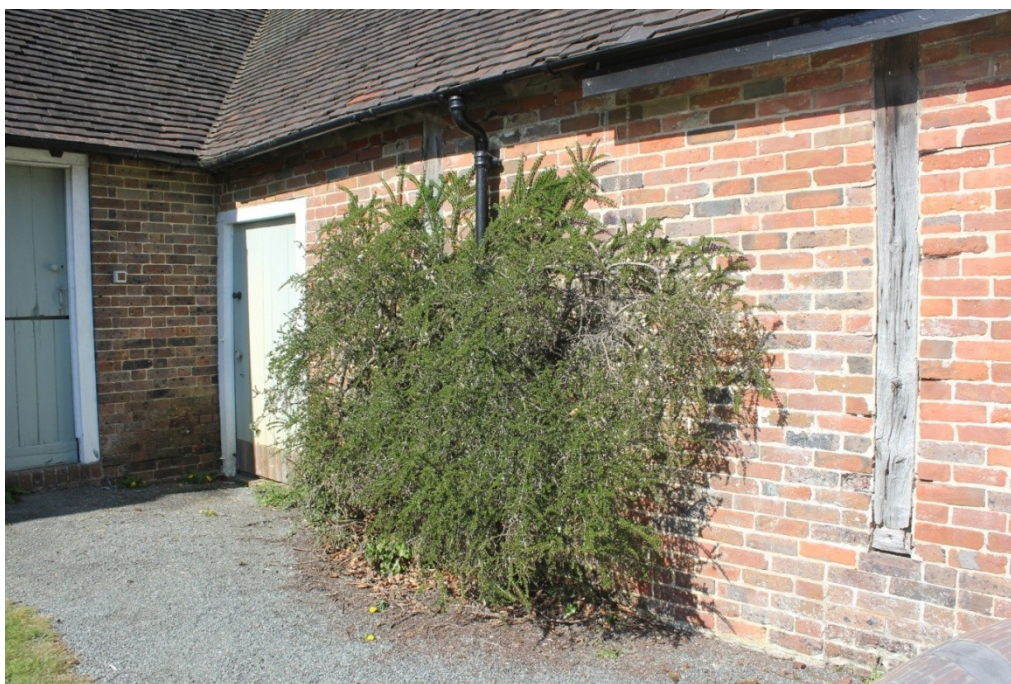
The door frame is pegged and may be original with patched repairs and there are brick closers in place for the doorway but not for the apertures, which appear to be insertions. There is cast iron guttering and downpipes and the roof is covered with ceramic peg tiles. The east west range of the outbuilding was formerly open fronted to the south with brickwork infilling the open spaces (Plates 48 and 49).

**Plate 48. Former post of the open-fronted bay.**

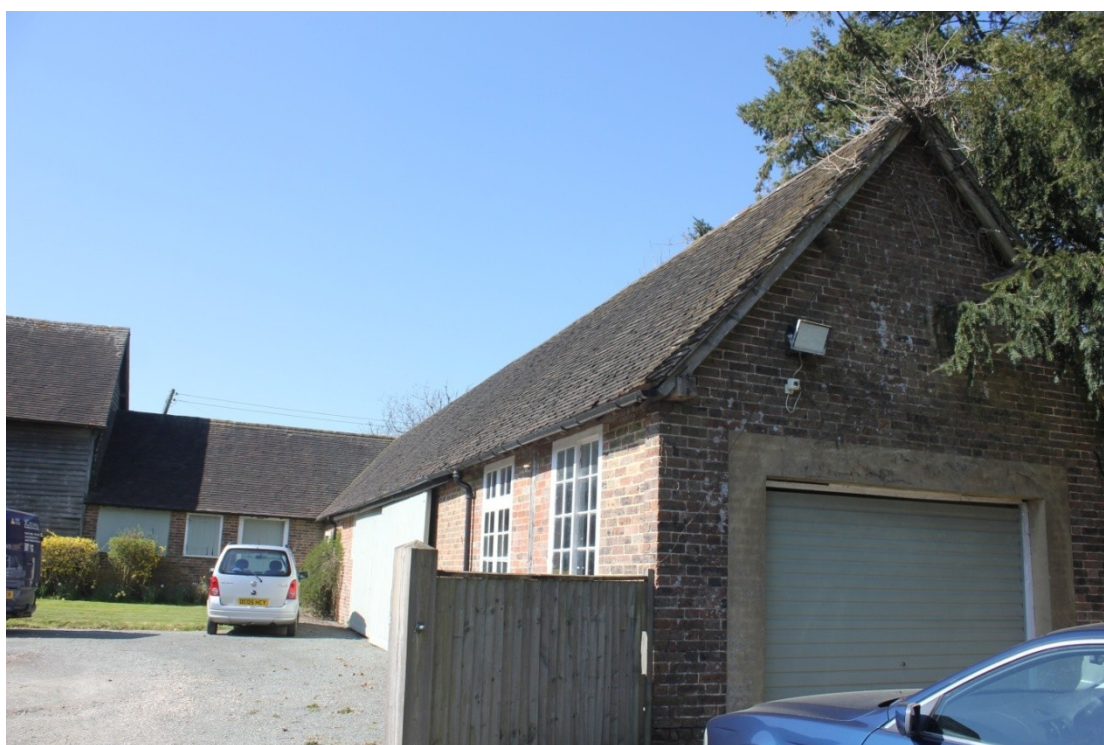
The east gable of this outbuilding has also been heavily modified in the 20<sup>th</sup> century, with a wide up and over garage door and an inserted concrete lintel (Plate 51). In addition, there is new brickwork which suggests either the gable end was re-built or extended slightly.

**Plate 51. New garage door inserted into the eastern end of the northern outbuilding.**

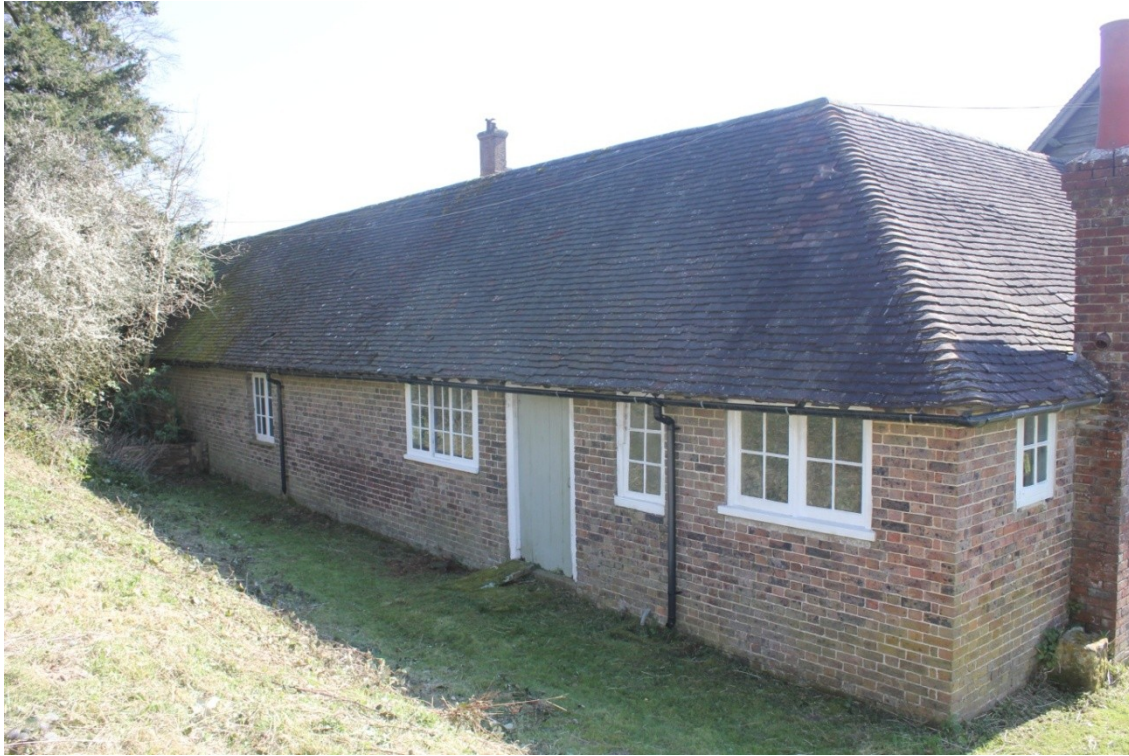
There are three non-matching casement windows in the west side of the north elevation (Plate 52) and a pedestrian door which has been patch repaired at the bottom with a 20<sup>th</sup> century bakerlight door knob and an earlier, broken doorknob evident; a re-used door essentially. The west elevation has three further casements and an external chimney stack (Plate 53).

**Plate 52. Windows and doorway in the northern elevation.**

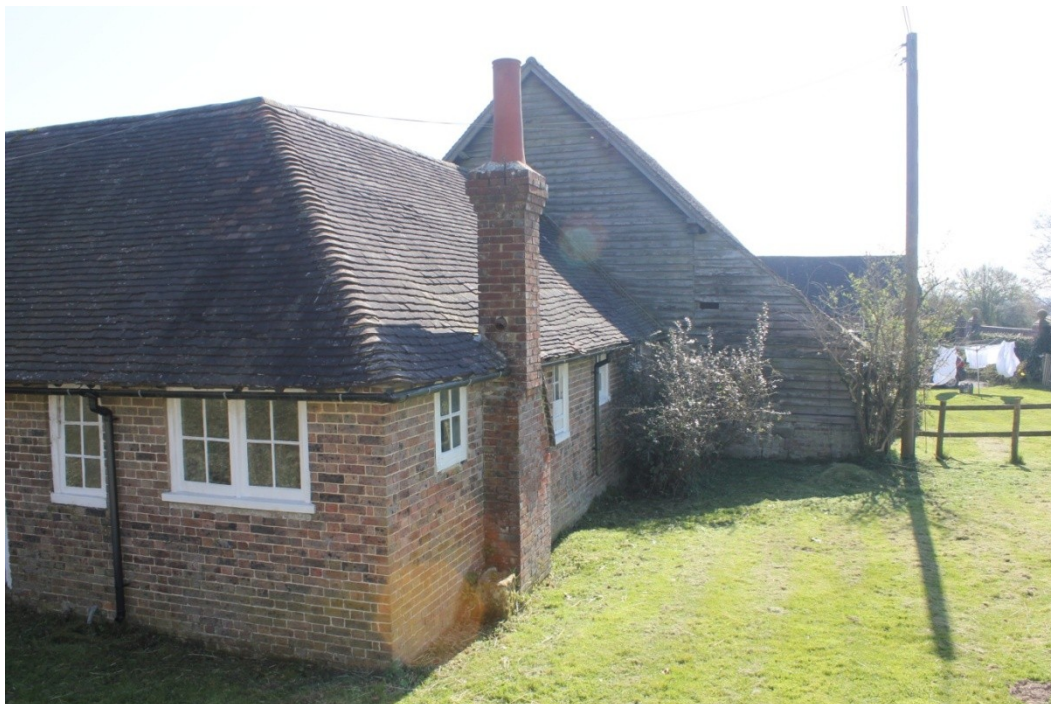
**Plate 53. West elevation of the northern outbuilding with chimney stack and windows.**

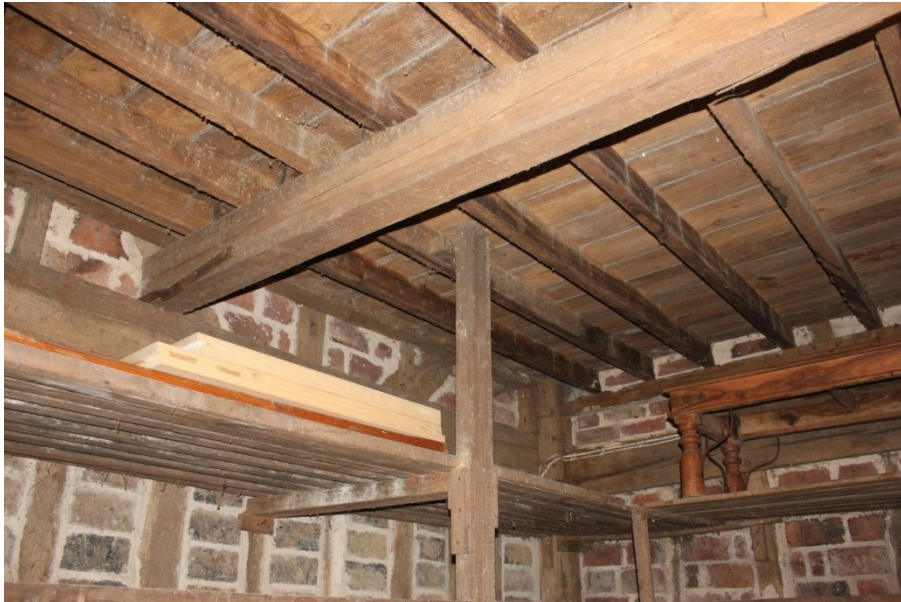
There are no changes to the layout of the Barn during this period but an outbuilding was attached to the south side and an enclosed storage room was created in the northern bay (Plate 54) which includes the insertion of partitions and the flooring of the bay creating a garret.

**Plate 54. The enclosed storage room in the northern bay.**

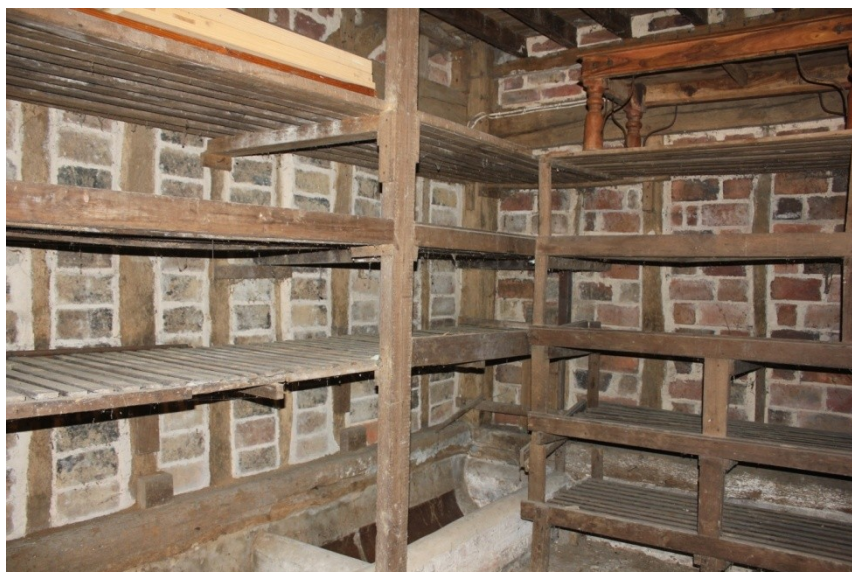
There are 20<sup>th</sup> century feeding troughs against the north wall (Plate 55), but here they are lined internally with salt glazed half pipes and cement rendered. The walls have been internally lined with brickwork panels in-between the Period A vertical studs, all of which have cementitious mortar so these are also 20<sup>th</sup> century in date. The bricks are also clamp fired Rowfrants or other locally made bricks. There are wooden shelves to all sides of the room, which could be for apples.

**Plate 55. Feeding troughs in the north bay.**

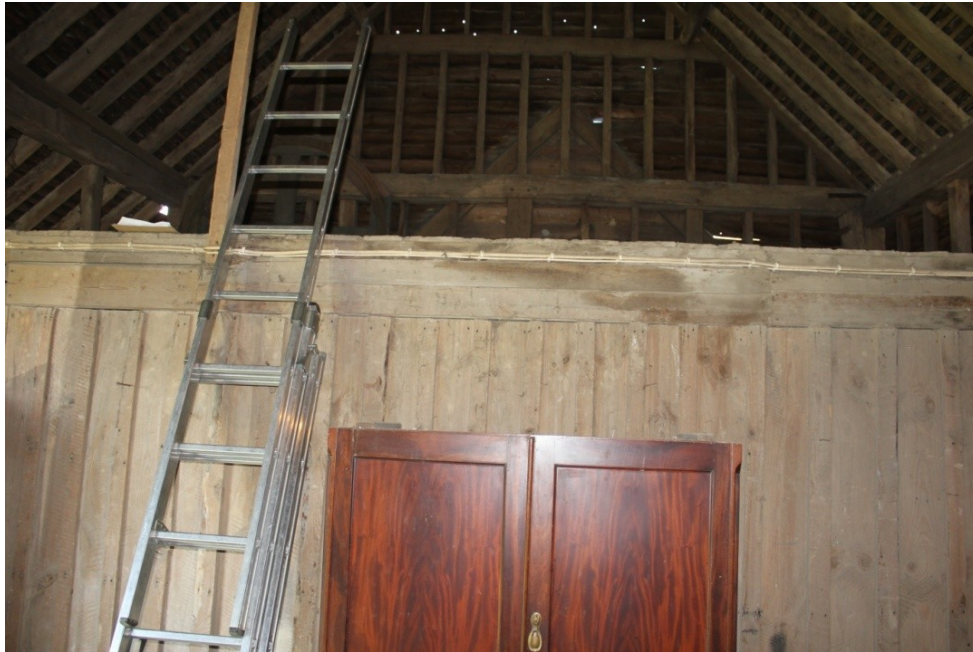
The original threshing partition has been removed on the north side in Truss C and has been replaced by a Period C brick and timber wall which also provides support for the inserted floor in the north Bay C-D. The brick plinth is bonded with a cementitious mortar and the plank and muntin timber partition above this is circular sawn (Plate 56).

**Plate 56. Period C plank and muntin wooden partition wall in Truss C.**

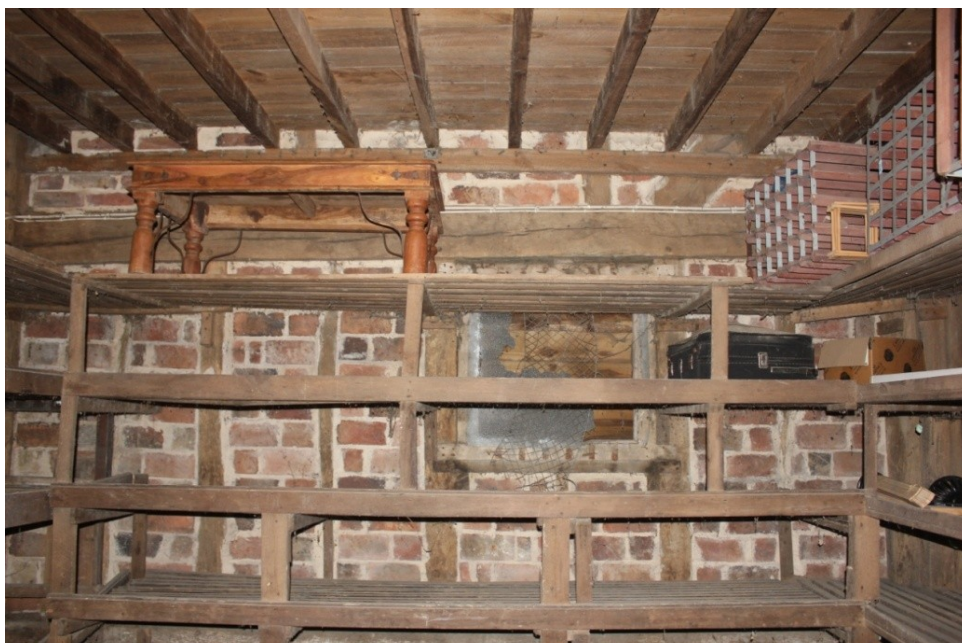
There is a blocked, inserted window in the east side (Plate 57) of the northern bay which is set in-between two Period A studs so is a much later addition. This has since been boarded over externally.

**Plate 57. Window inserted in the eastern wall.**

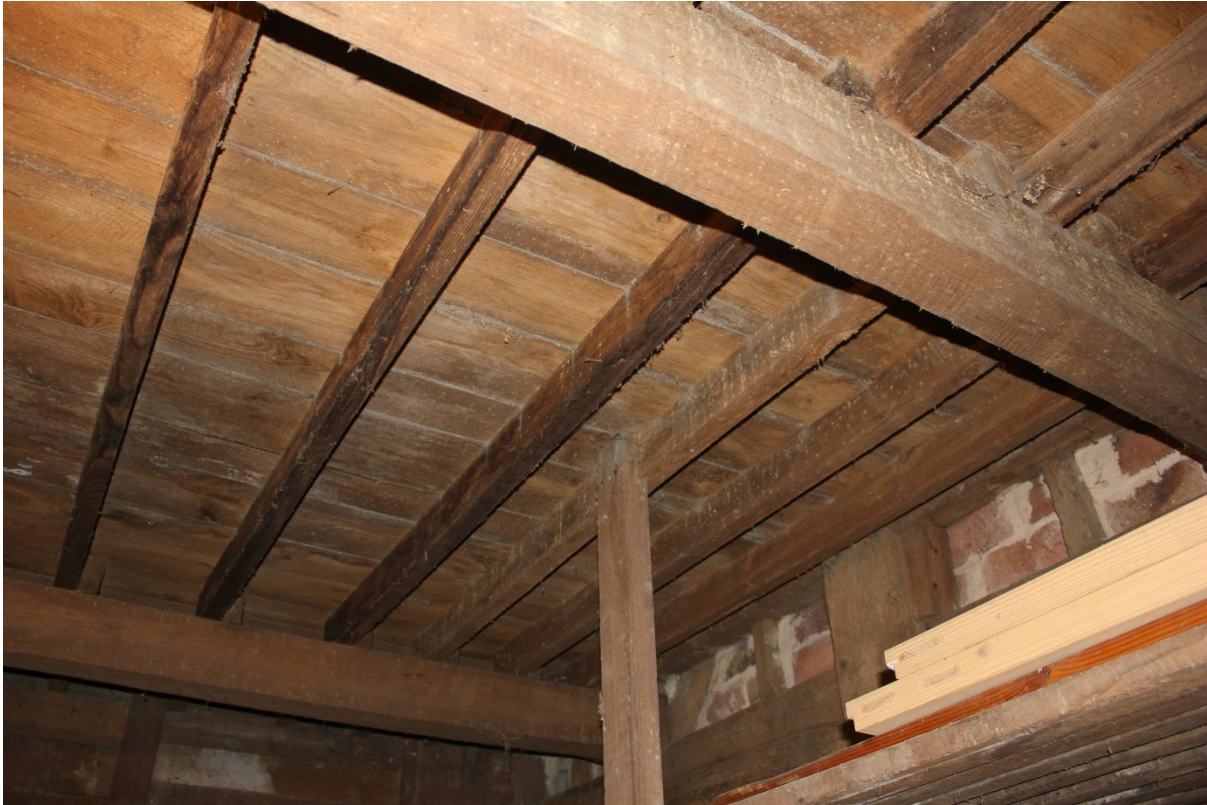
The floor over the northern bay was inserted during this period and consists of machined, softwood planks nailed into place (Plate 58).

**Plate 58. Period C floor inserted into the northern bay.**

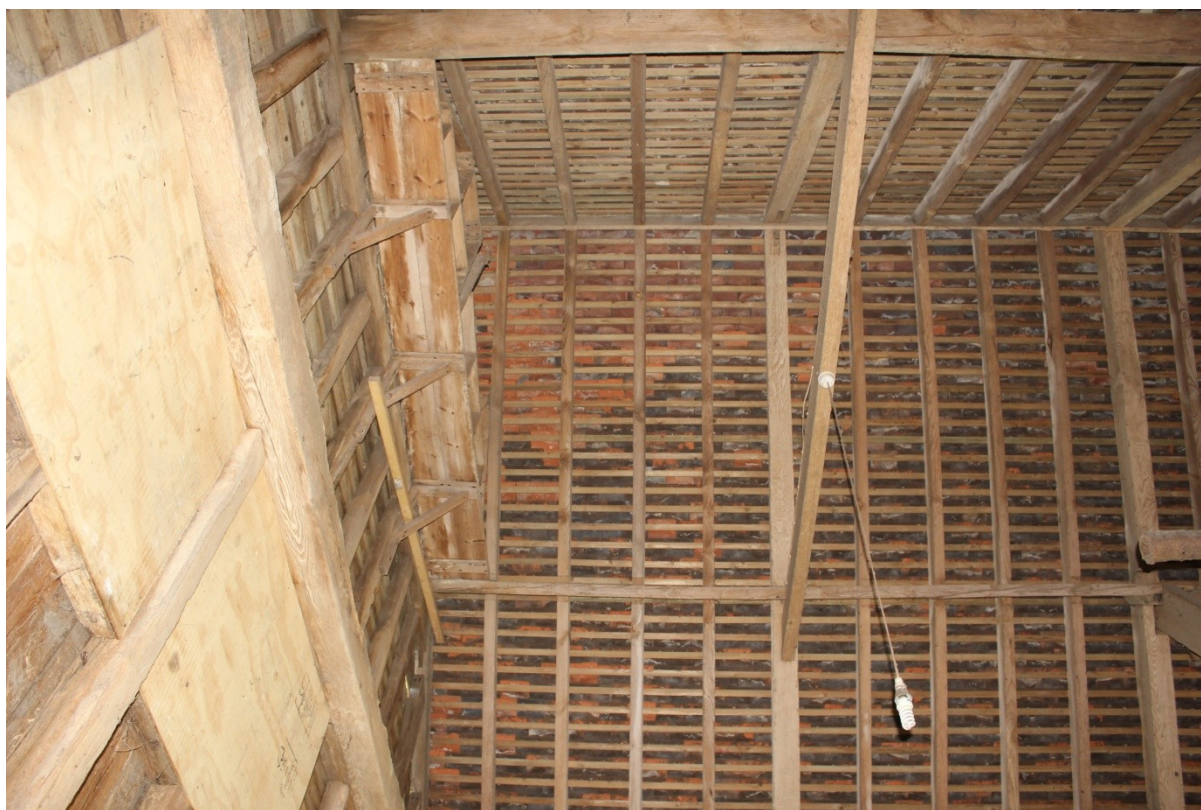
The roof is very level and was re-built during this period when the gables and common rafters were replaced along with new battens and re-covering (Plate 59). The roof purlins in the first bay were also replaced by softwood timbers and the original purlins were moved across (and rotated) to the second and third bays when the roof was re-built. In addition, the original wallplates had second sets of modern wallplates positioned over the top of the original timbers with packing pieces in-between to level the roof (Plate 60).

**Plate 59. New gable, battens, ridge-board, intermediate collar, rafters and purlins.**

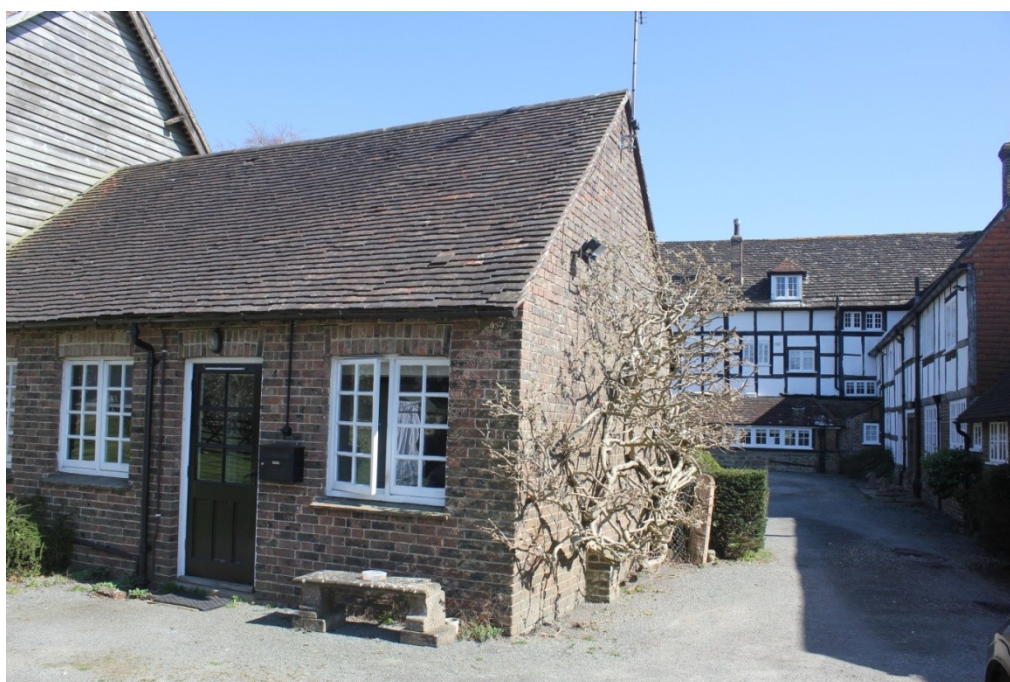
- 6.8 The southern outbuilding  
This building (Plate 61) was built between 1909 and 1938, presumably as stables. This has since been converted into ancillary accommodation. It is of single-storey in

height and gabled to the south end. The bricks are laid in Sussex Bond and are very similar to the plinth bricks of the Barn appearing to be contemporary. However, these locally made bricks have altered very little over the past two hundred years or so, which should be taken into consideration. The western elevation of the stables has a 20<sup>th</sup> century glazed pedestrian door with three sets of opening casement windows with tiled cills and machined rafters and a ceramic peg tiled roof. There is a very low brick buttress of some form in the south elevation, which is entirely brick laid in Sussex Bond once again. The eastern elevation has no windows or doors but has two timber vertical studs (Plate 62) showing the structure to consist of three bays, so there are likely to be two roof trusses internally although the inside was not inspected. The structure has previously been converted to ancillary use.

**Plate 61. The western elevation of the southern outbuilding.**

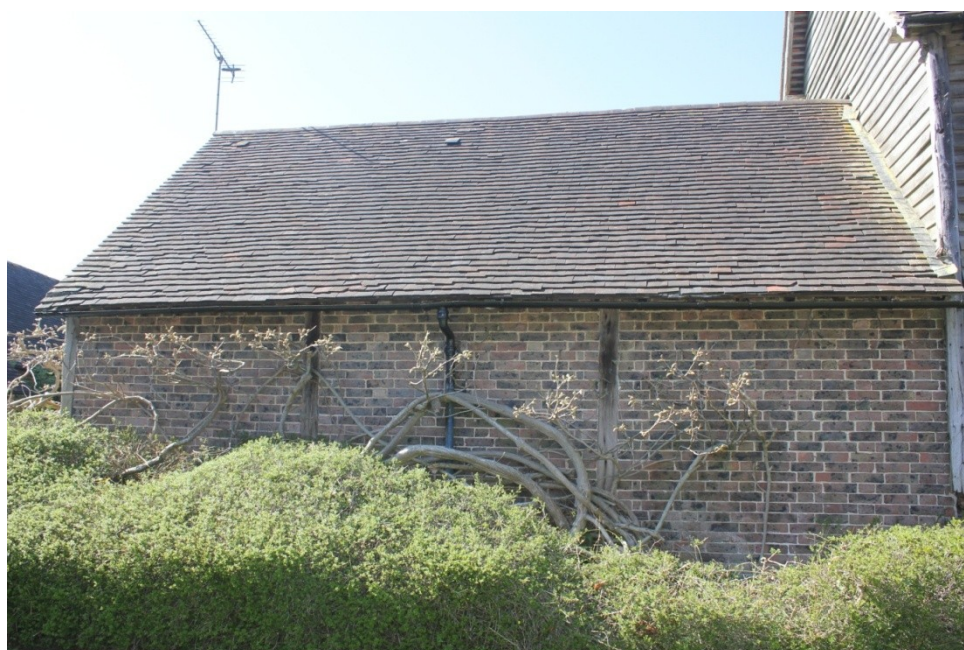
**Plate 62. Front, east elevation of the southern outbuilding.**

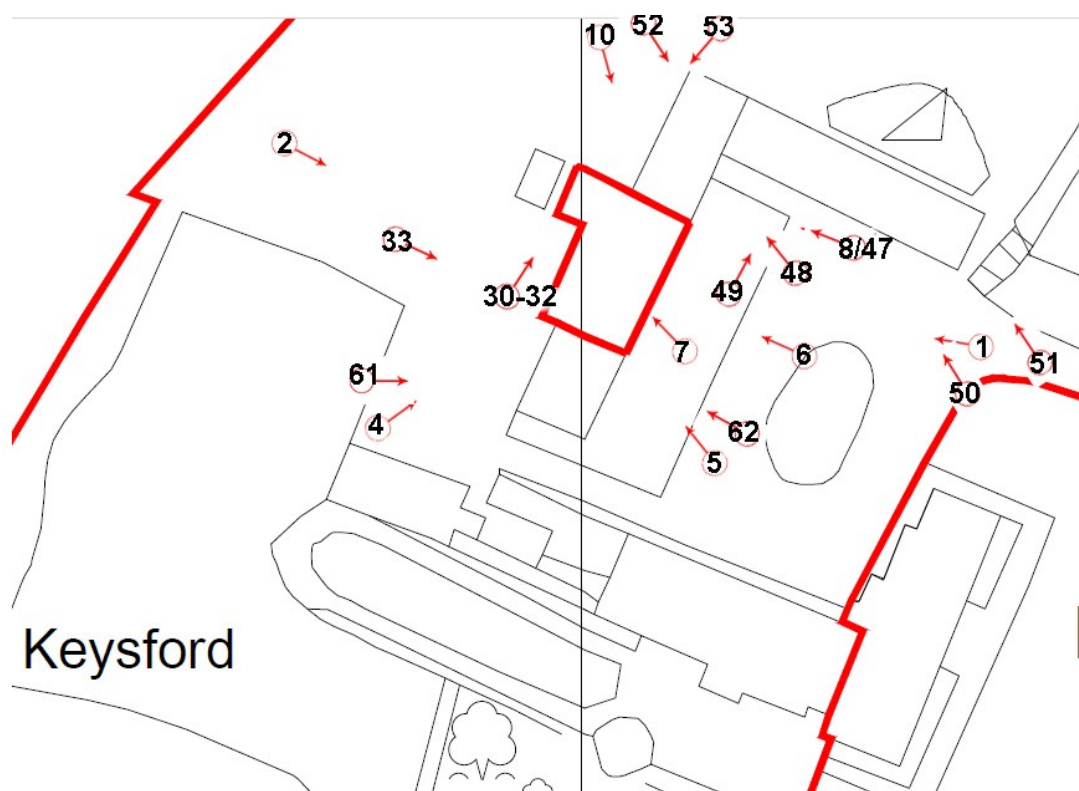
Exterior photographic location plan.

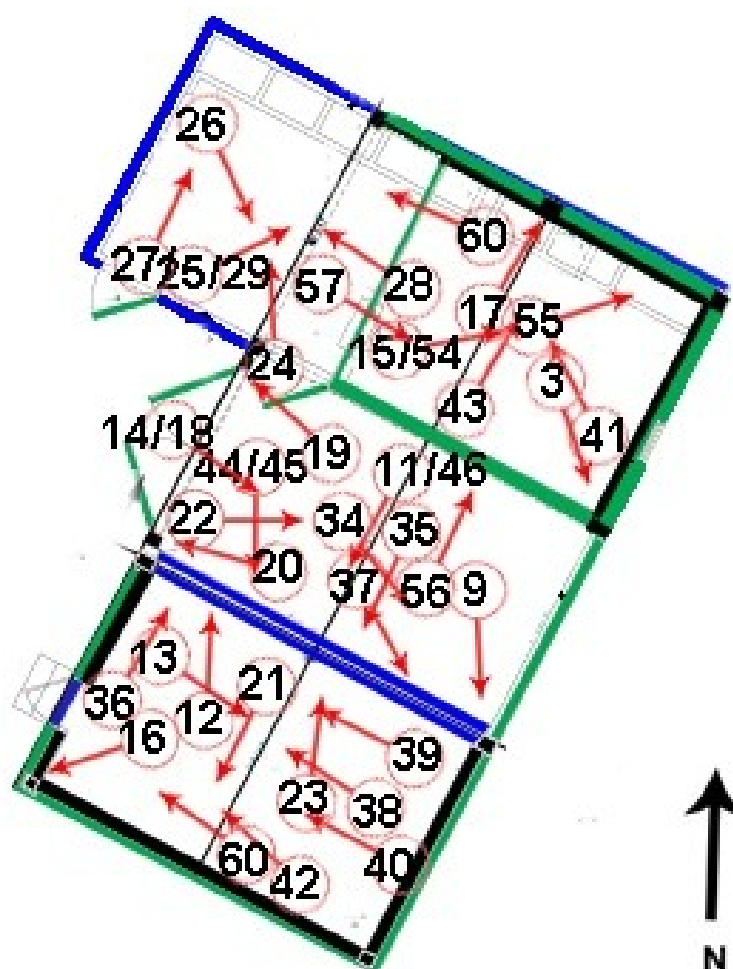
Internal photographic location plan.
